James Haskins
19365 Warrington Dr
Detroit MI 48221
Sherwood Forest District

Renewal by Andersen 37720 Amrhein Livonia, MI 48150

- Homeowner wants to replace all the windows around house except for one stained glass window unit
- Windows are original steel
- Renewal by Andersen windows are Fibrex (wood composite) material
- Total of 24 windows to be replaced
- Windows exterior color will be black if approved
- Most windows matching style except for bay windows – flankers changed to operable and middle window changed to fixed.
- Windows will match existing mutton bar “pattern”
- Homeowner unable to get quotes for repair

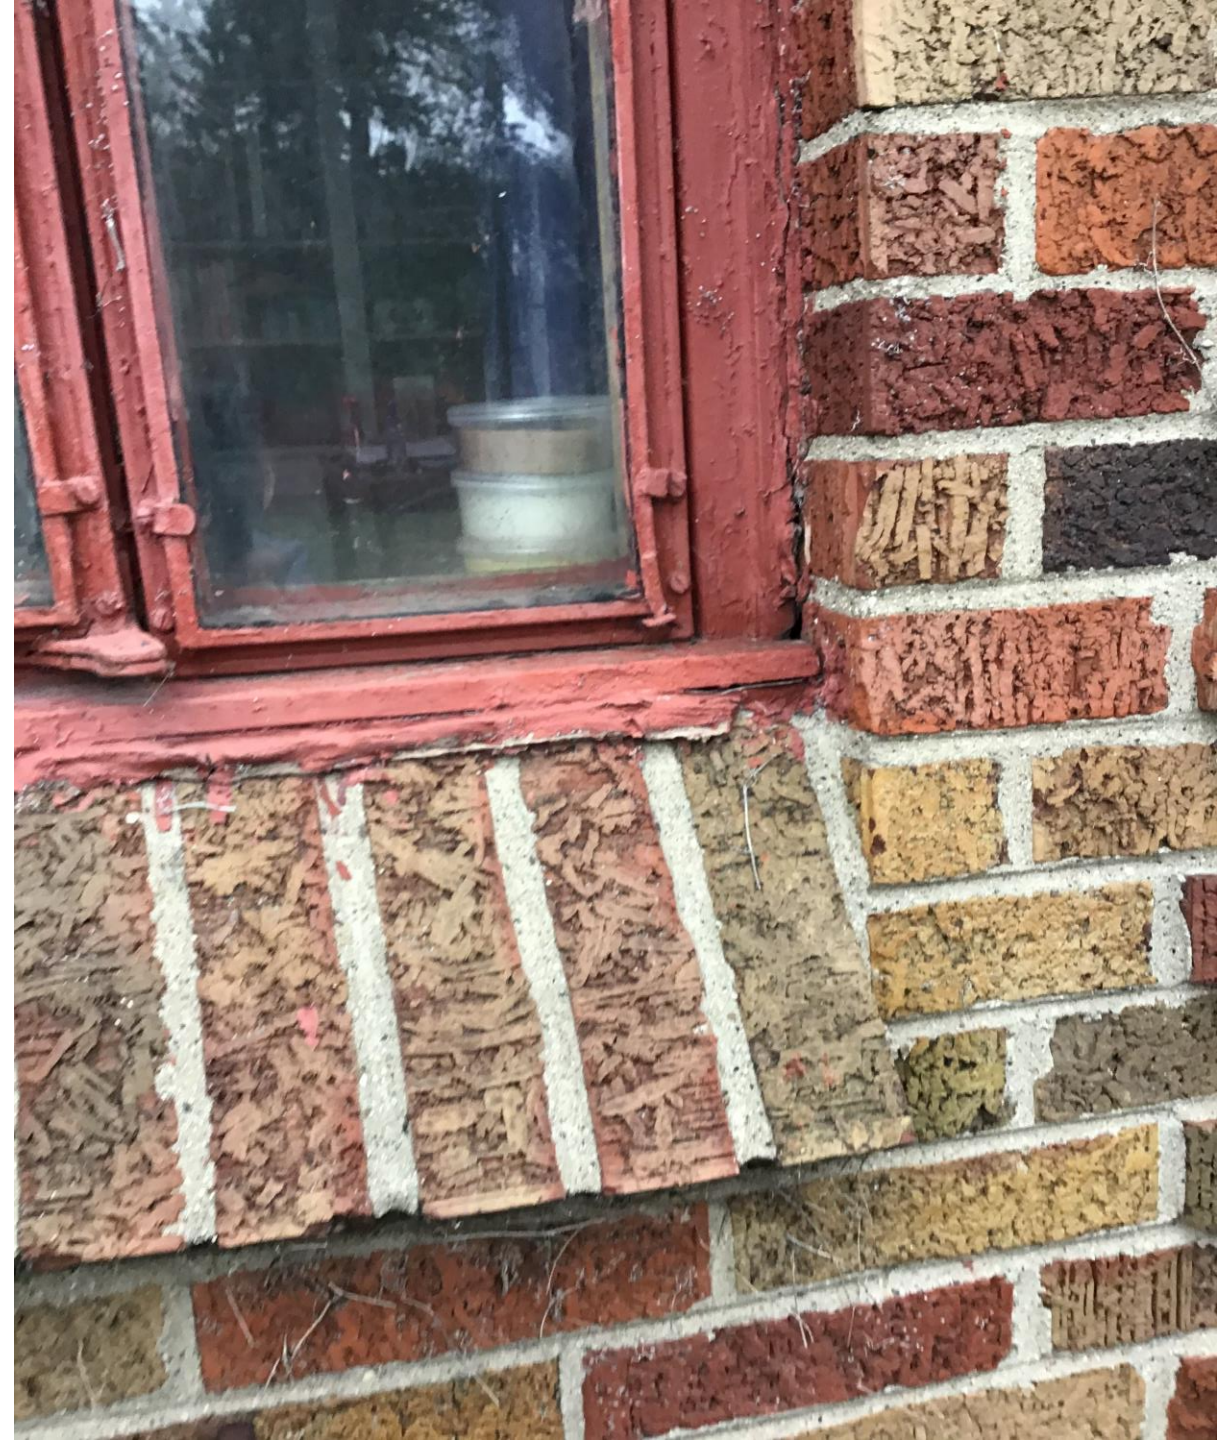
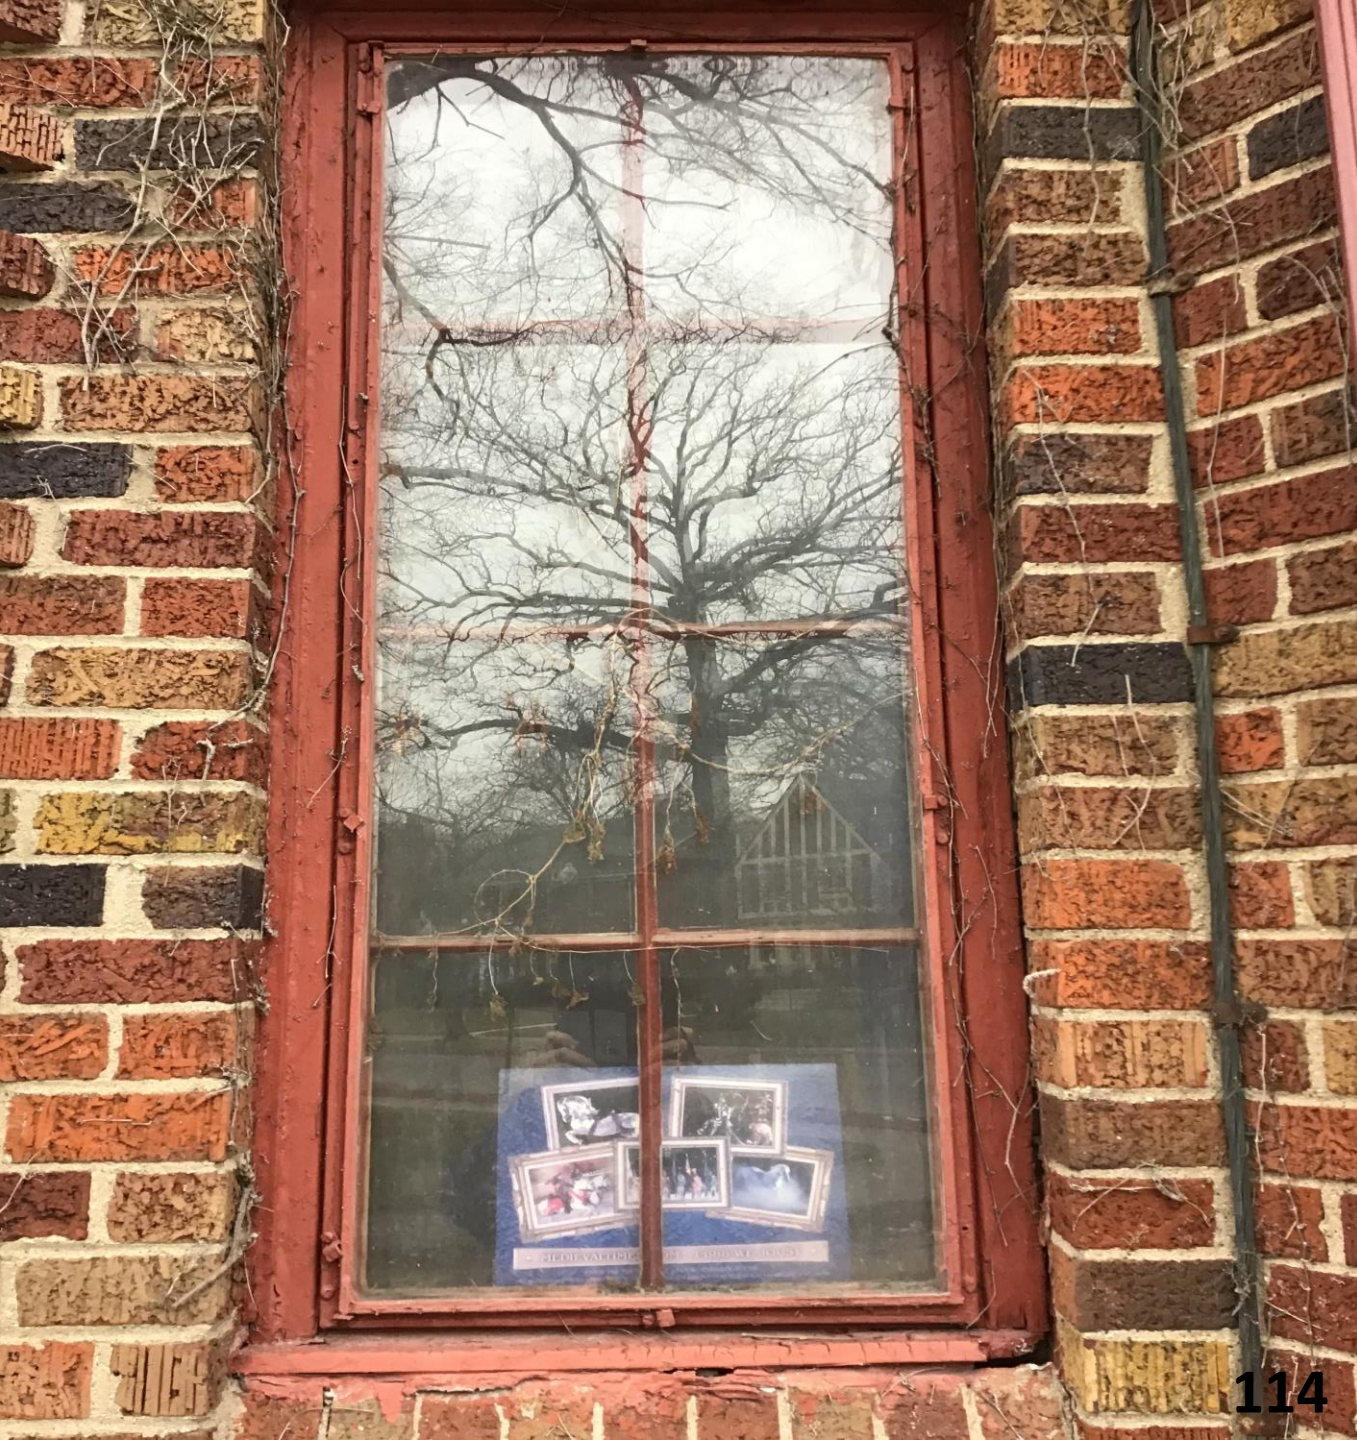
WINDOW OPENING 113 Office - Left side of House

- Casement Single Window
- Window is in an office
- Window is hard to close if opened
- Exterior of window showing signs of rotting around frame

Window: Casement, Fixed Window, Base Frame, Exterior Black, Interior Black, **Glass:** All Sash: High Performance SmartSun Glass, No Pattern, **Grille Style:** Grilles Between Glass (GBG), **Grille Pattern:** All Sash: Colonial 4w x 4h, **Misc:** None

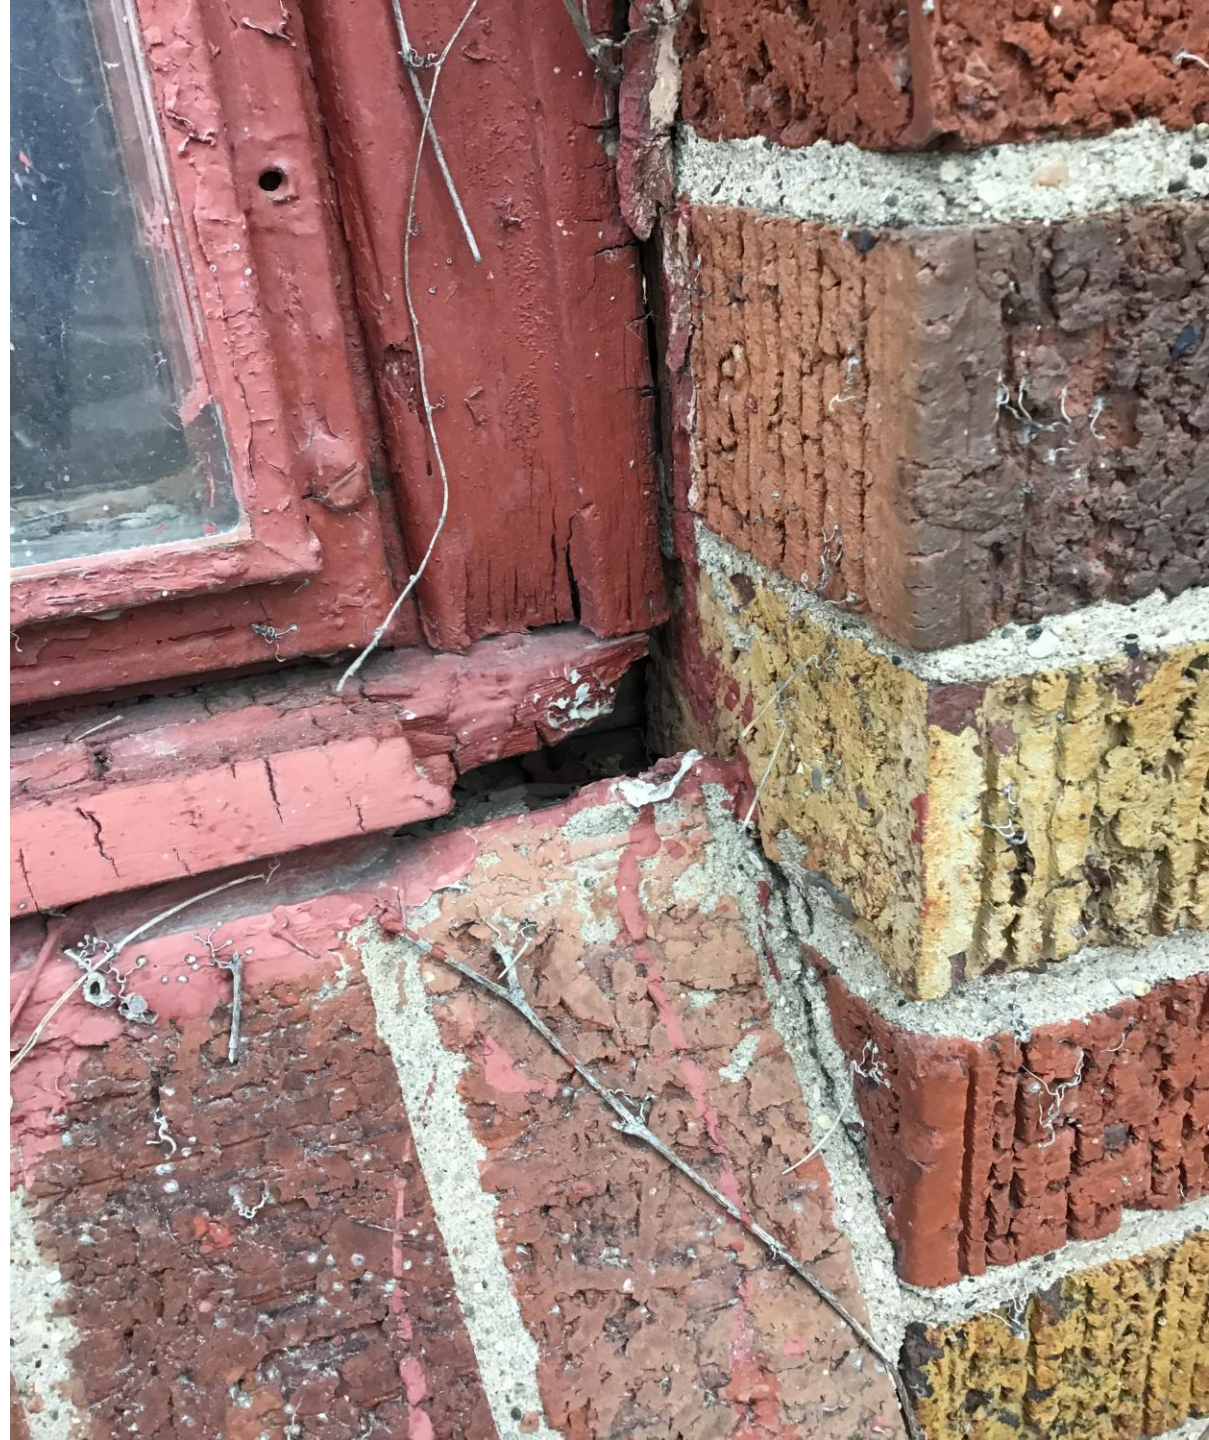
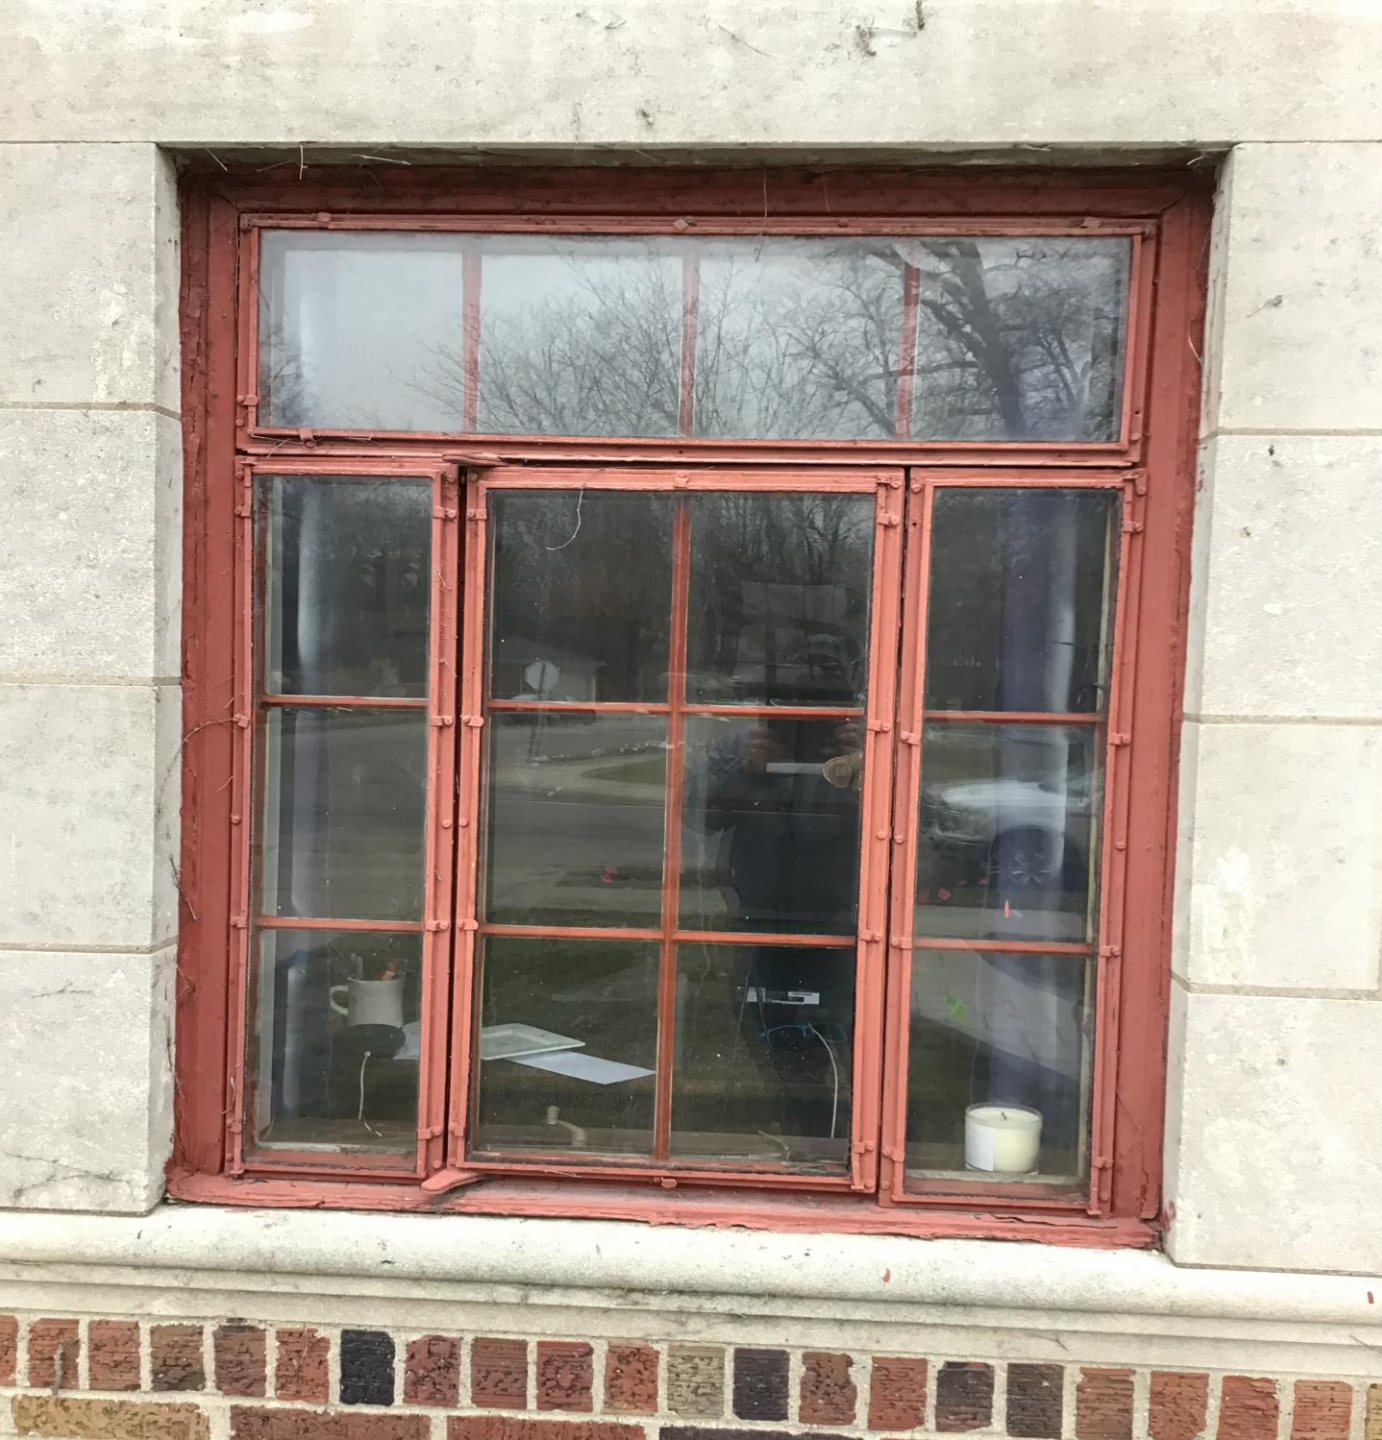
WINDOW OPENING 114 Office - Left side of House

- Fixed window – Steel casement
- Window is in an office
- Ivy stuck between window and storm
- Exterior of window showing signs of rotting around frame

Window: Casement, Single, Right, Base Frame, 2"

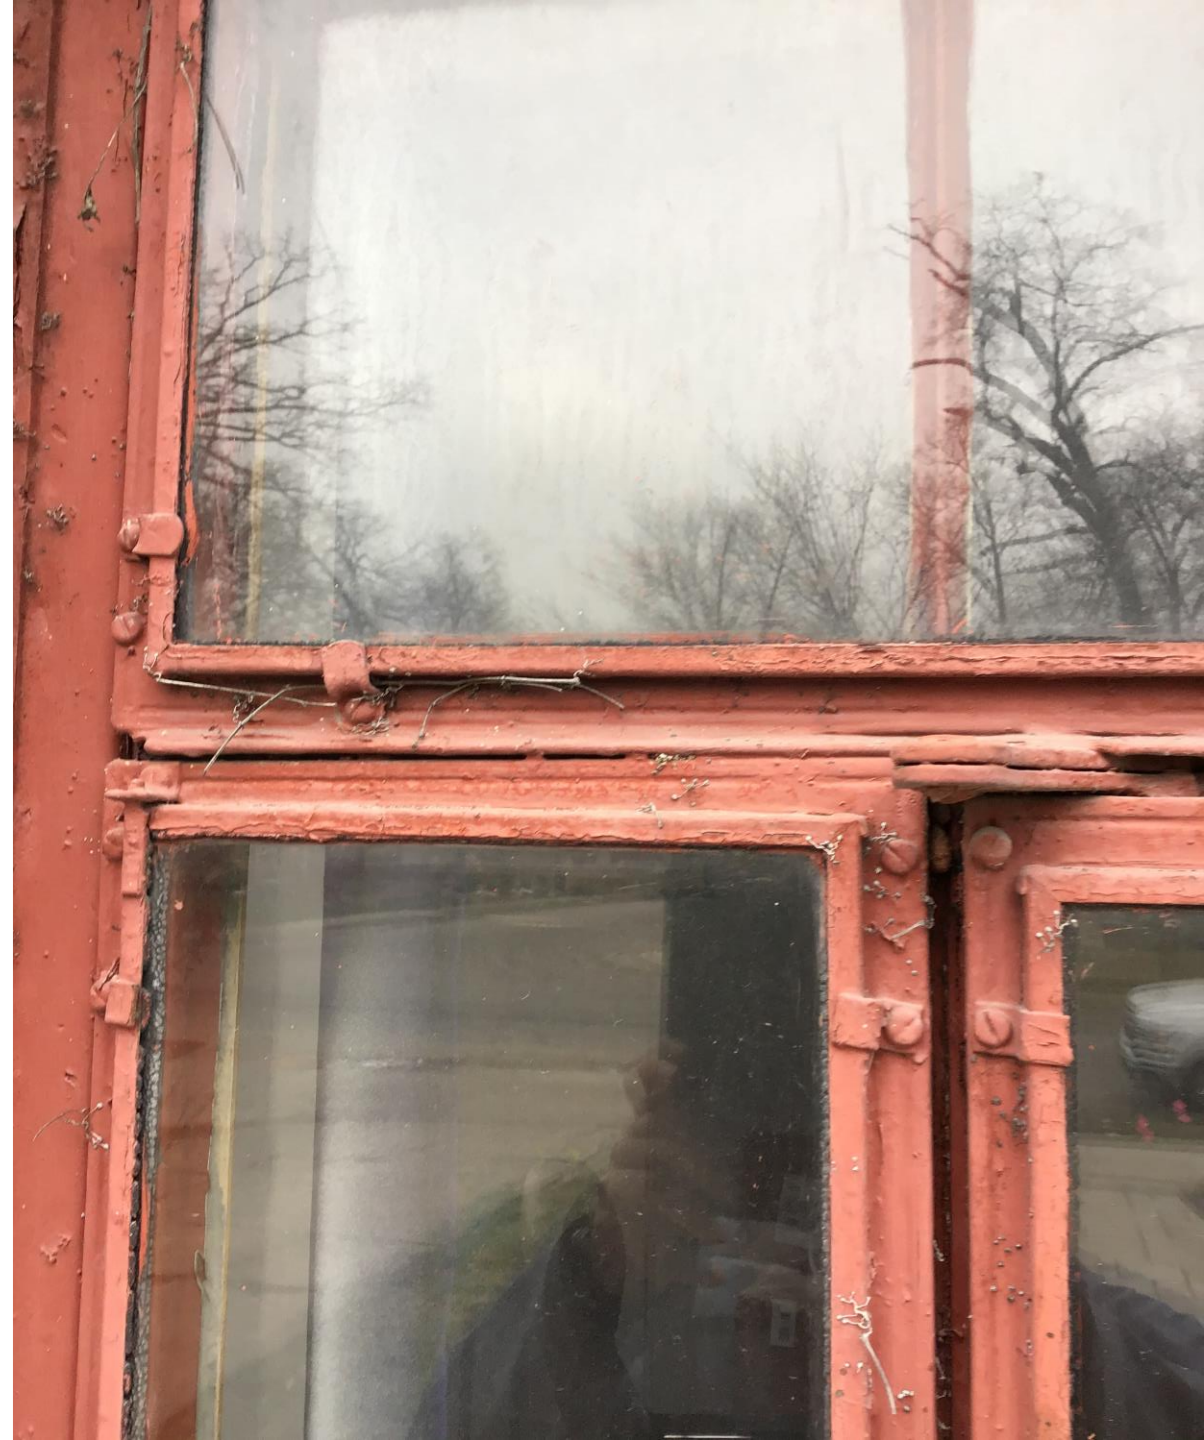
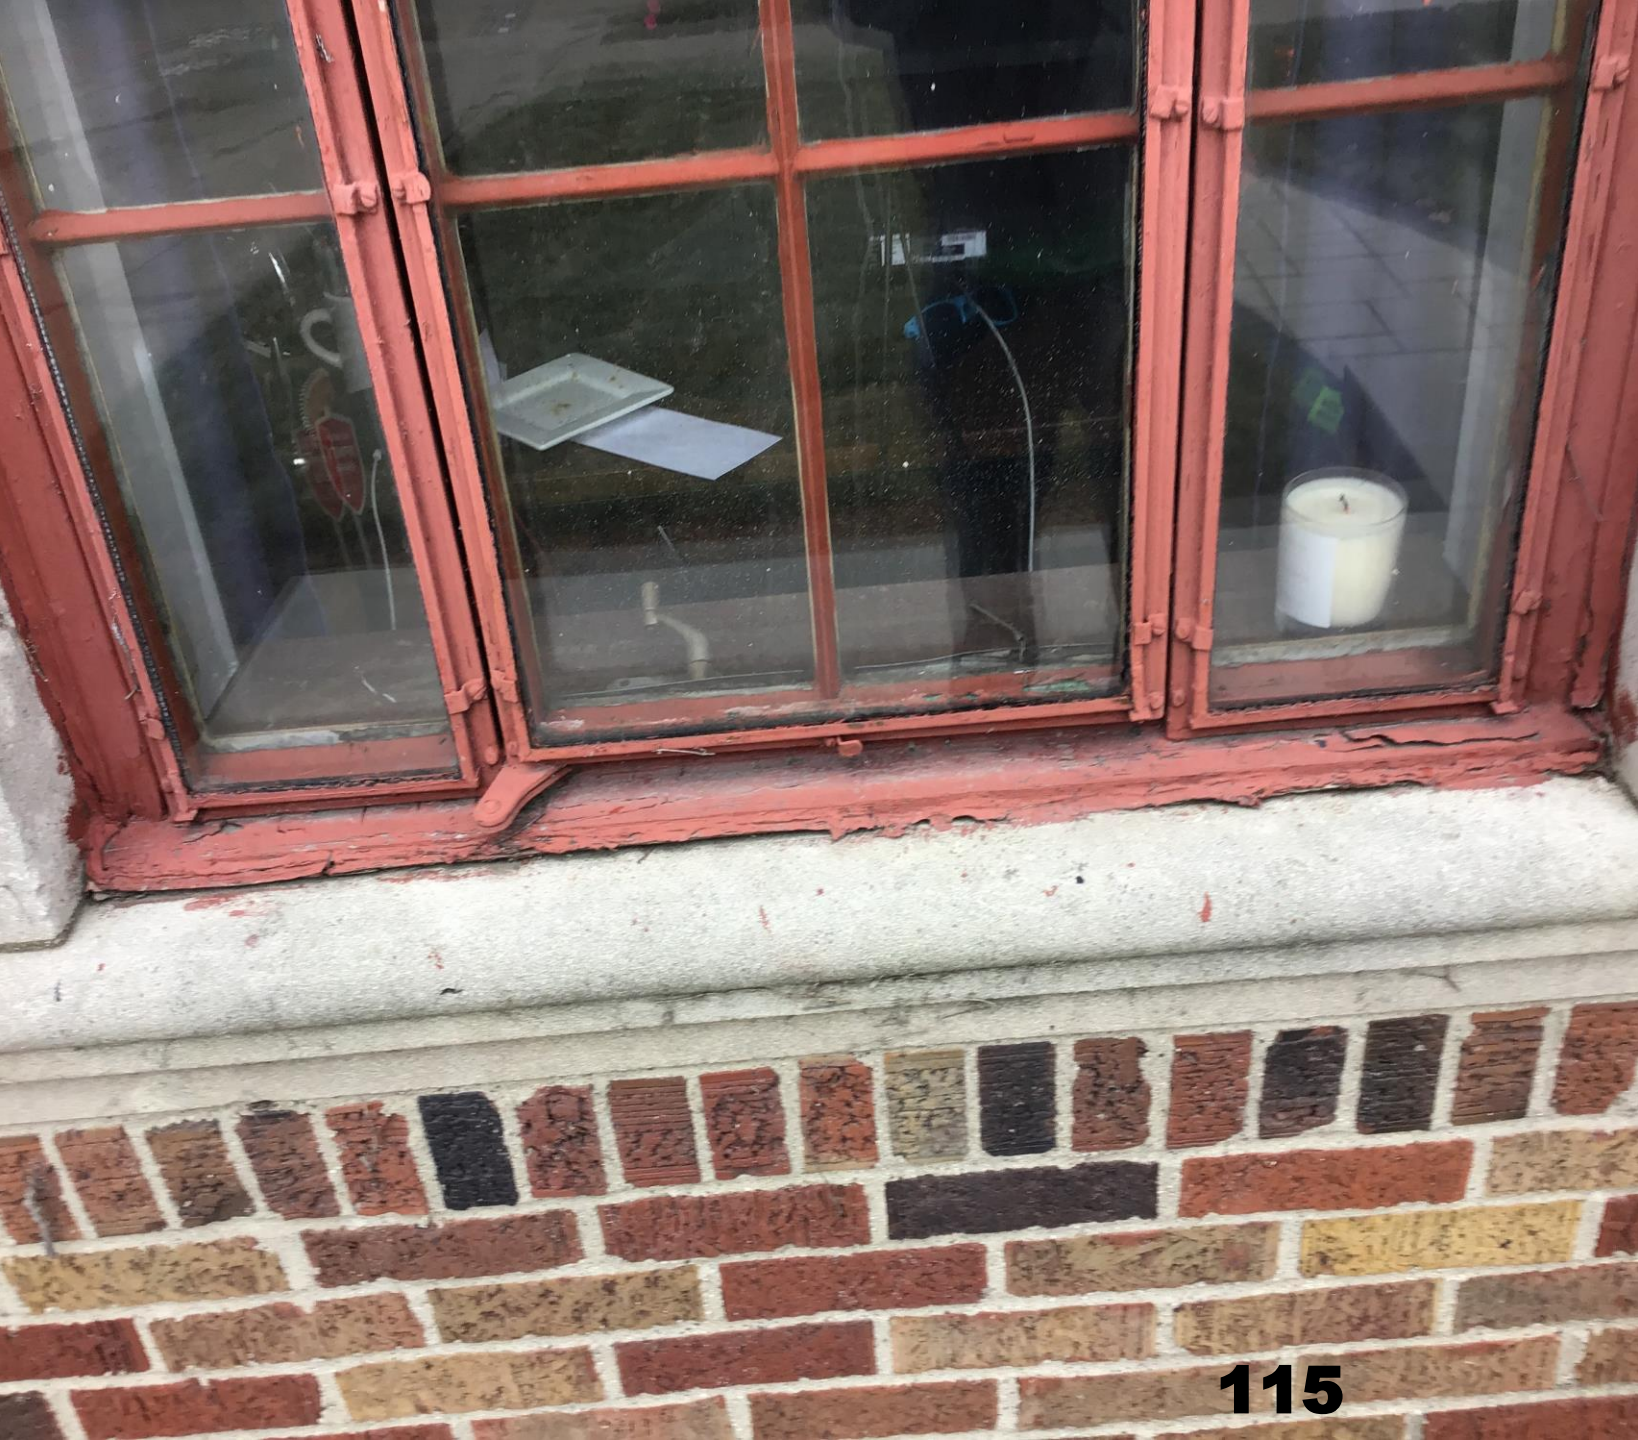
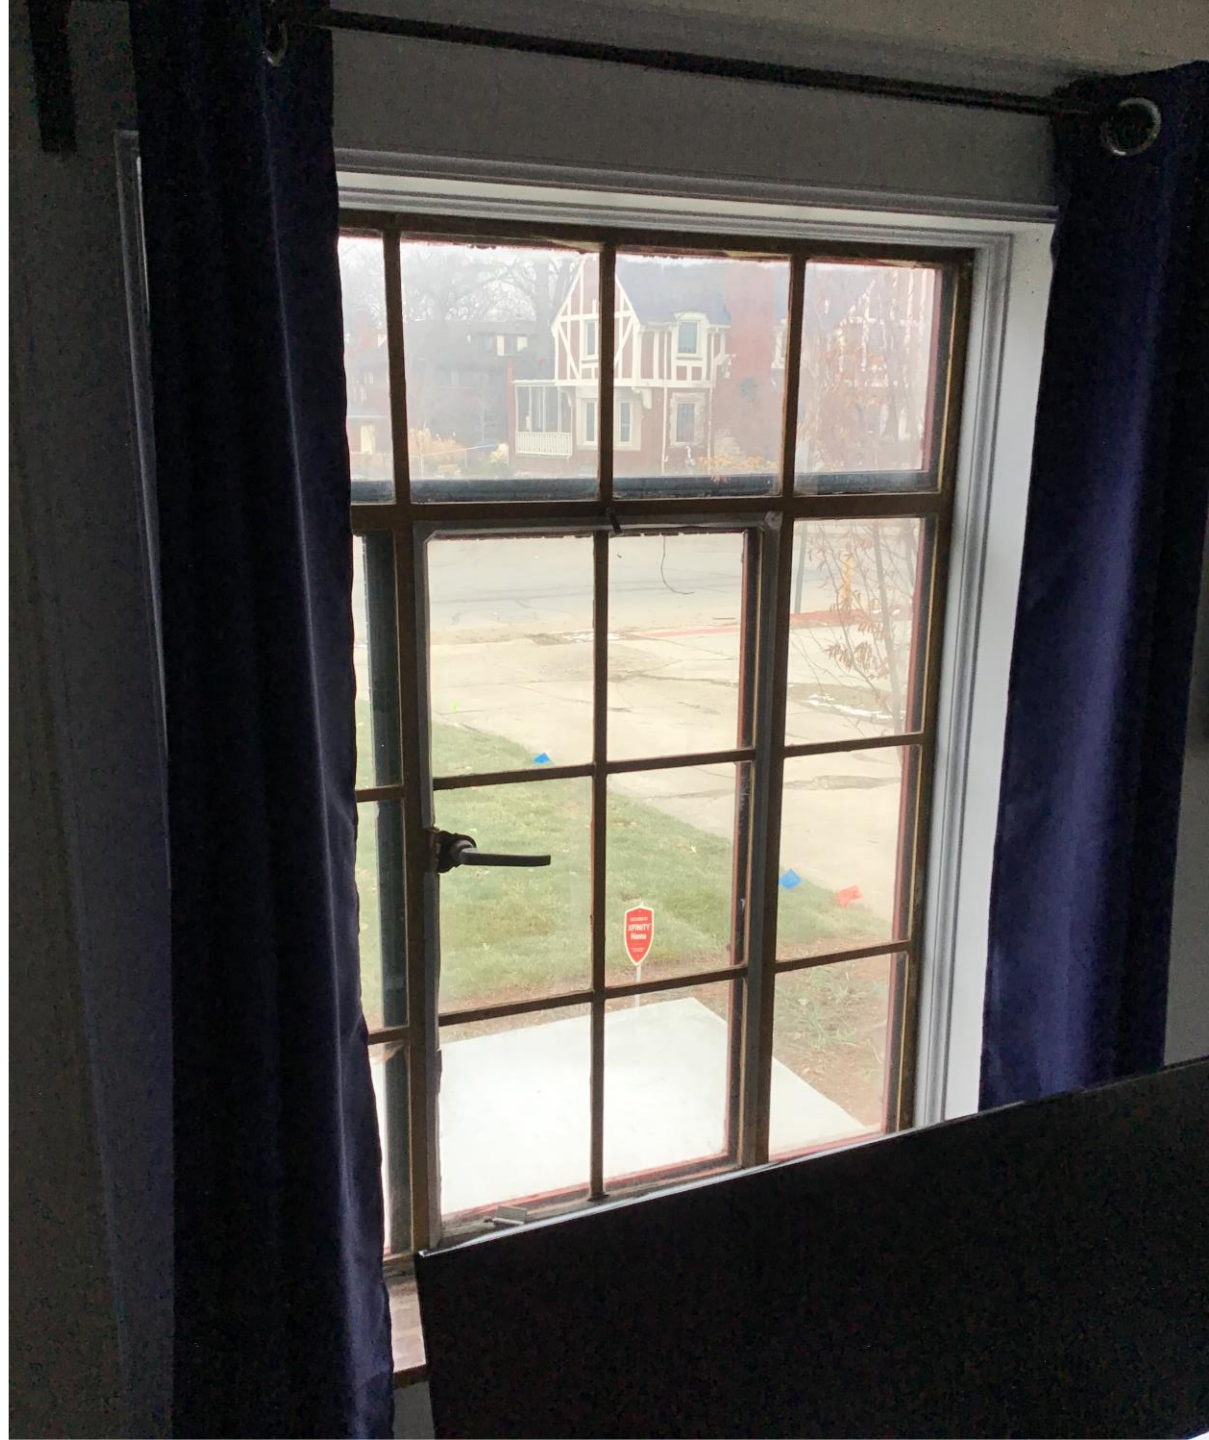
WINDOW OPENING 115 Office - Front of House

- Casement Single Window
- Window is in an office
- Window is hard to close if opened
- Exterior of window showing signs of rotting around frame

Window: Casement, Single, Left, Base Frame, 2" Brickmould / Traditional, Exterior Black, Interior Black, **Glass:** All Sash: High Performance SmartSun Glass, No Pattern, **Hardware:** Black, **Screen:** TruScene, Full Screen, **Grille Style:** Grilles Between Glass (GBG), **Grille Pattern:** All Sash: Colonial 4w x 4h, **Misc:** None

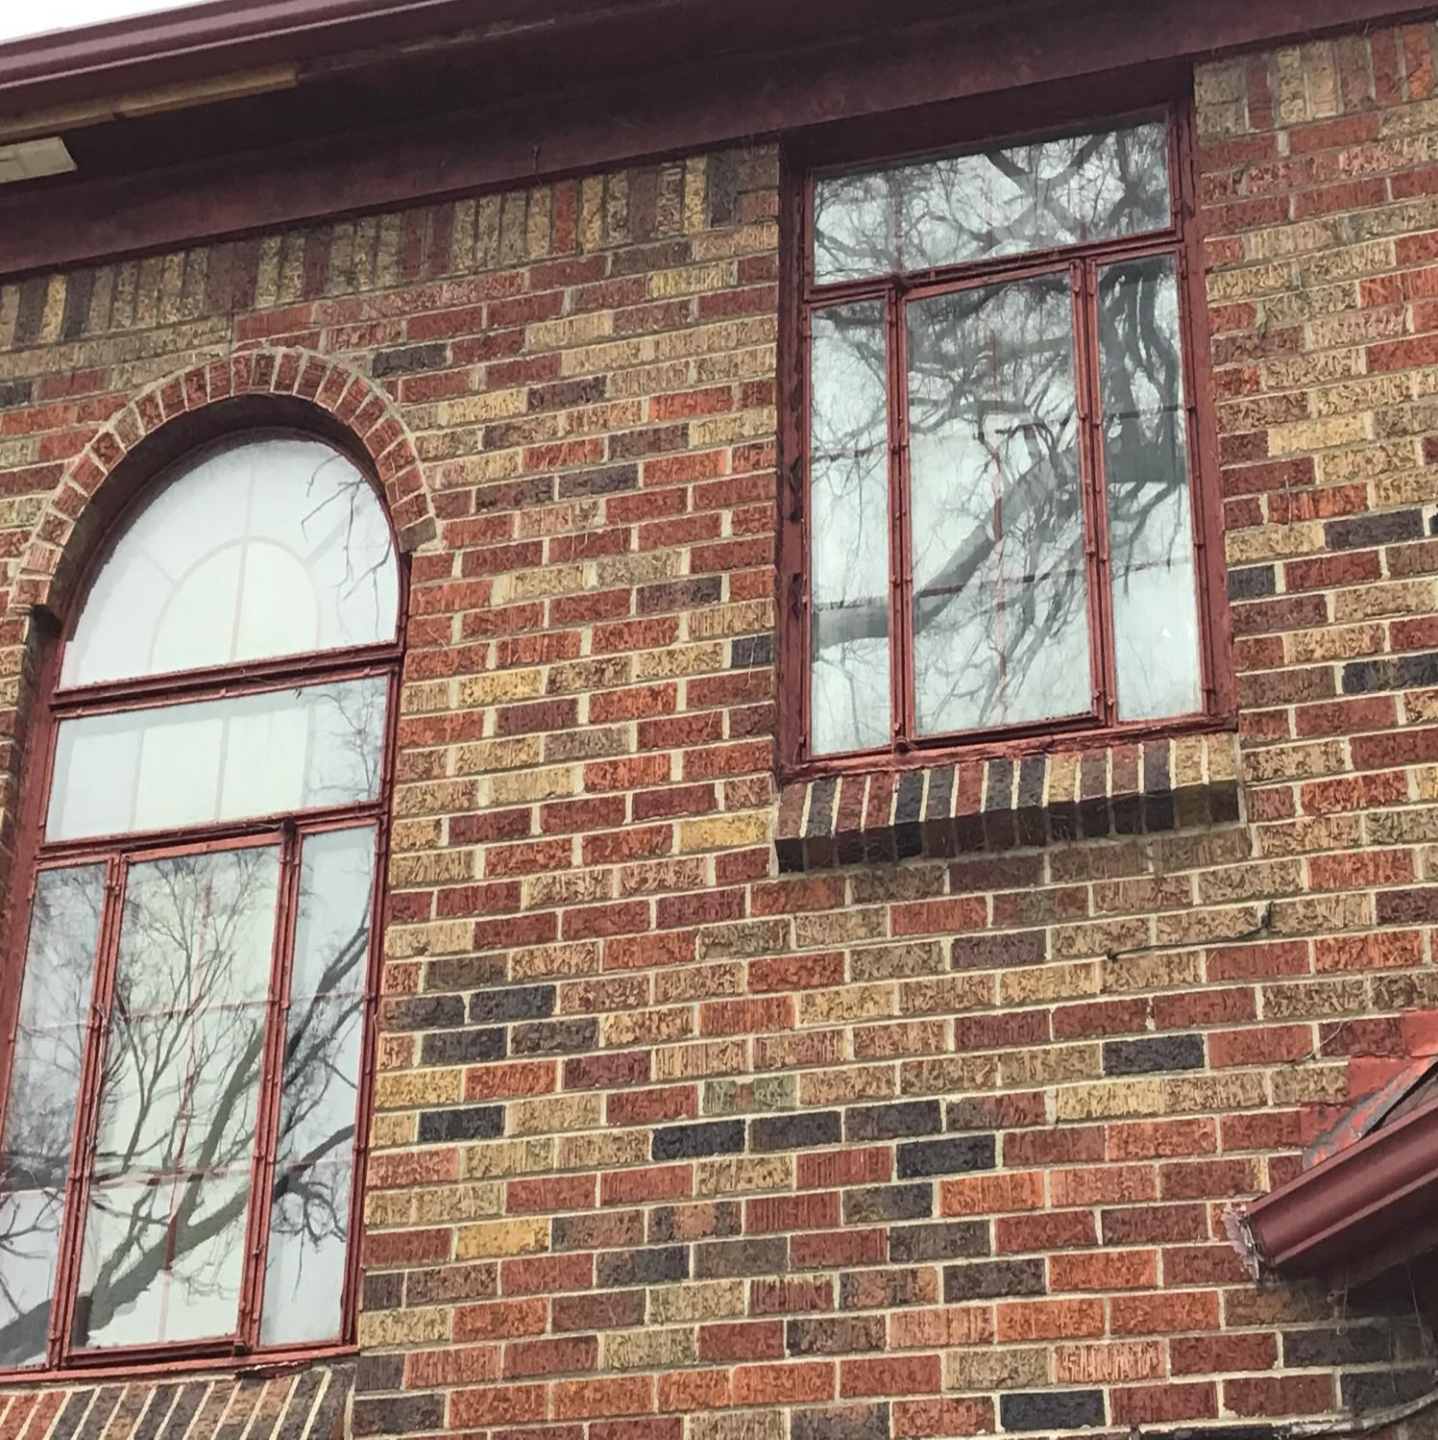
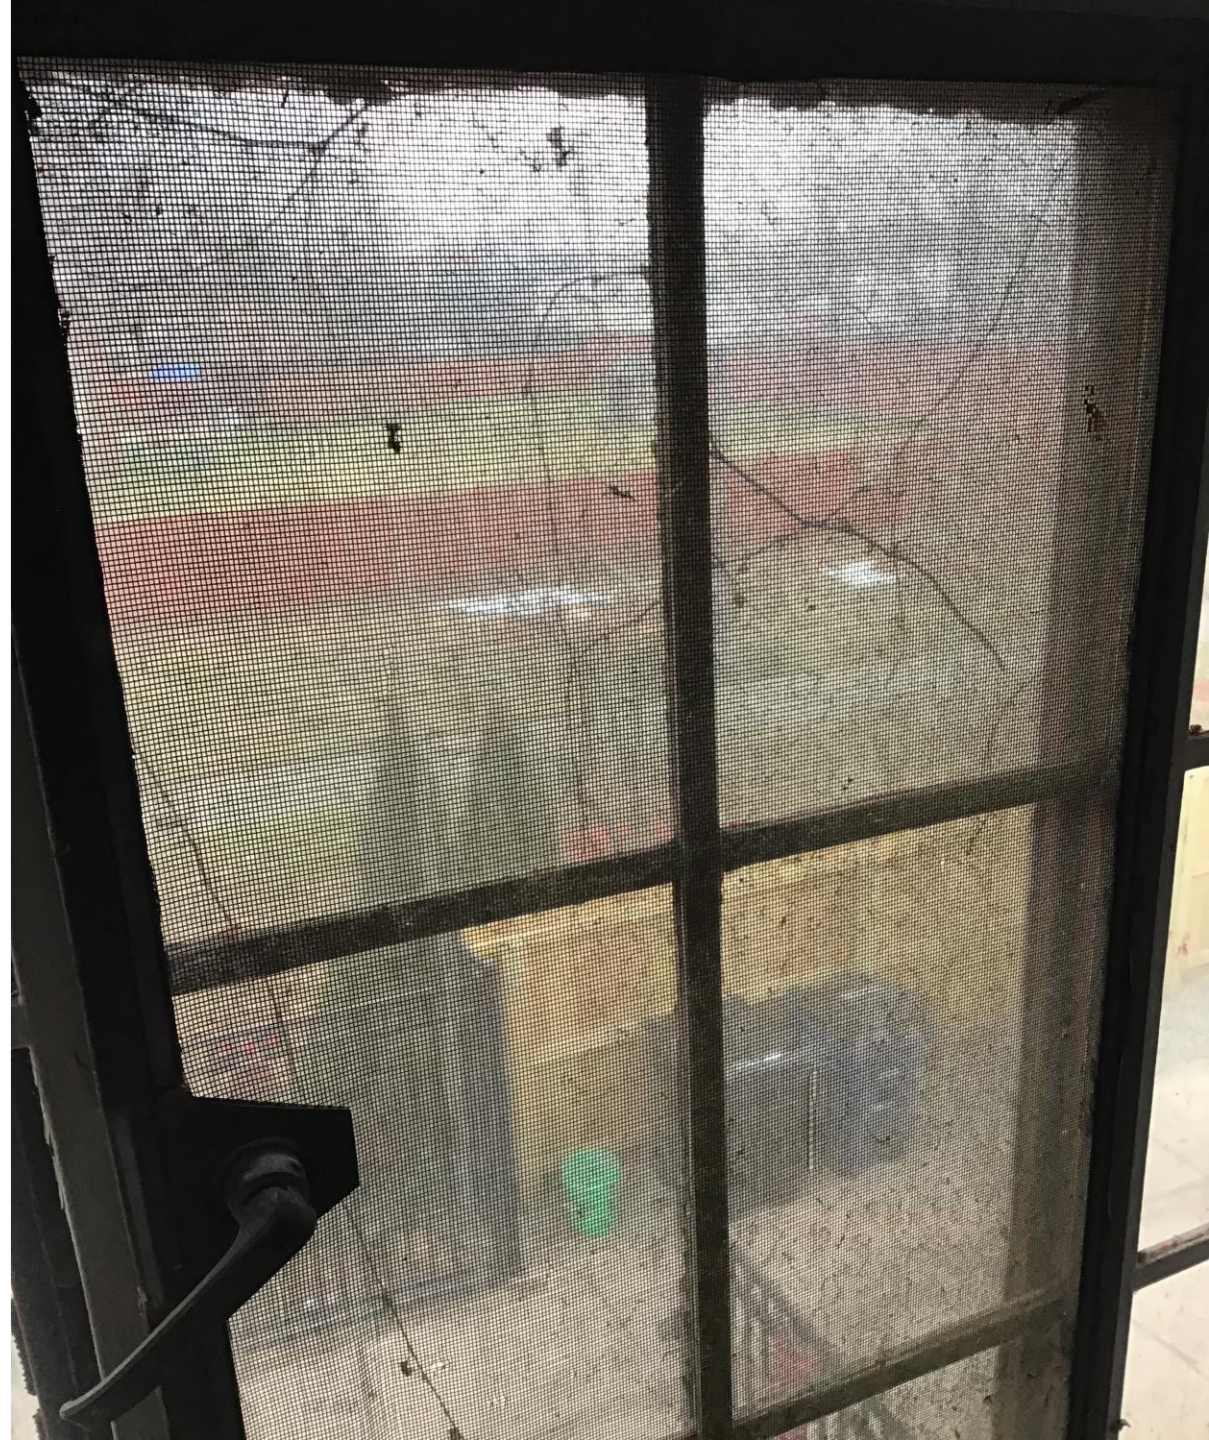
WINDOW OPENING 201 Office – Left side of House

- Casement Single Window
- Window is in an office
- Window is hard to close if opened
- Exterior of window showing signs of rotting around frame

Window: Casement, Single, Left, Base Frame, 2" Brickmould / Traditional, Exterior Black, Interior Black, **Glass:** All Sash: High Performance SmartSun Glass, No Pattern, **Hardware:** Black, **Screen:** Fiberglass, Full Screen, **Grille Style:** Grilles Between Glass (GBG), **Grille Pattern:** All Sash: Colonial 4w x 4h, **Misc:** None

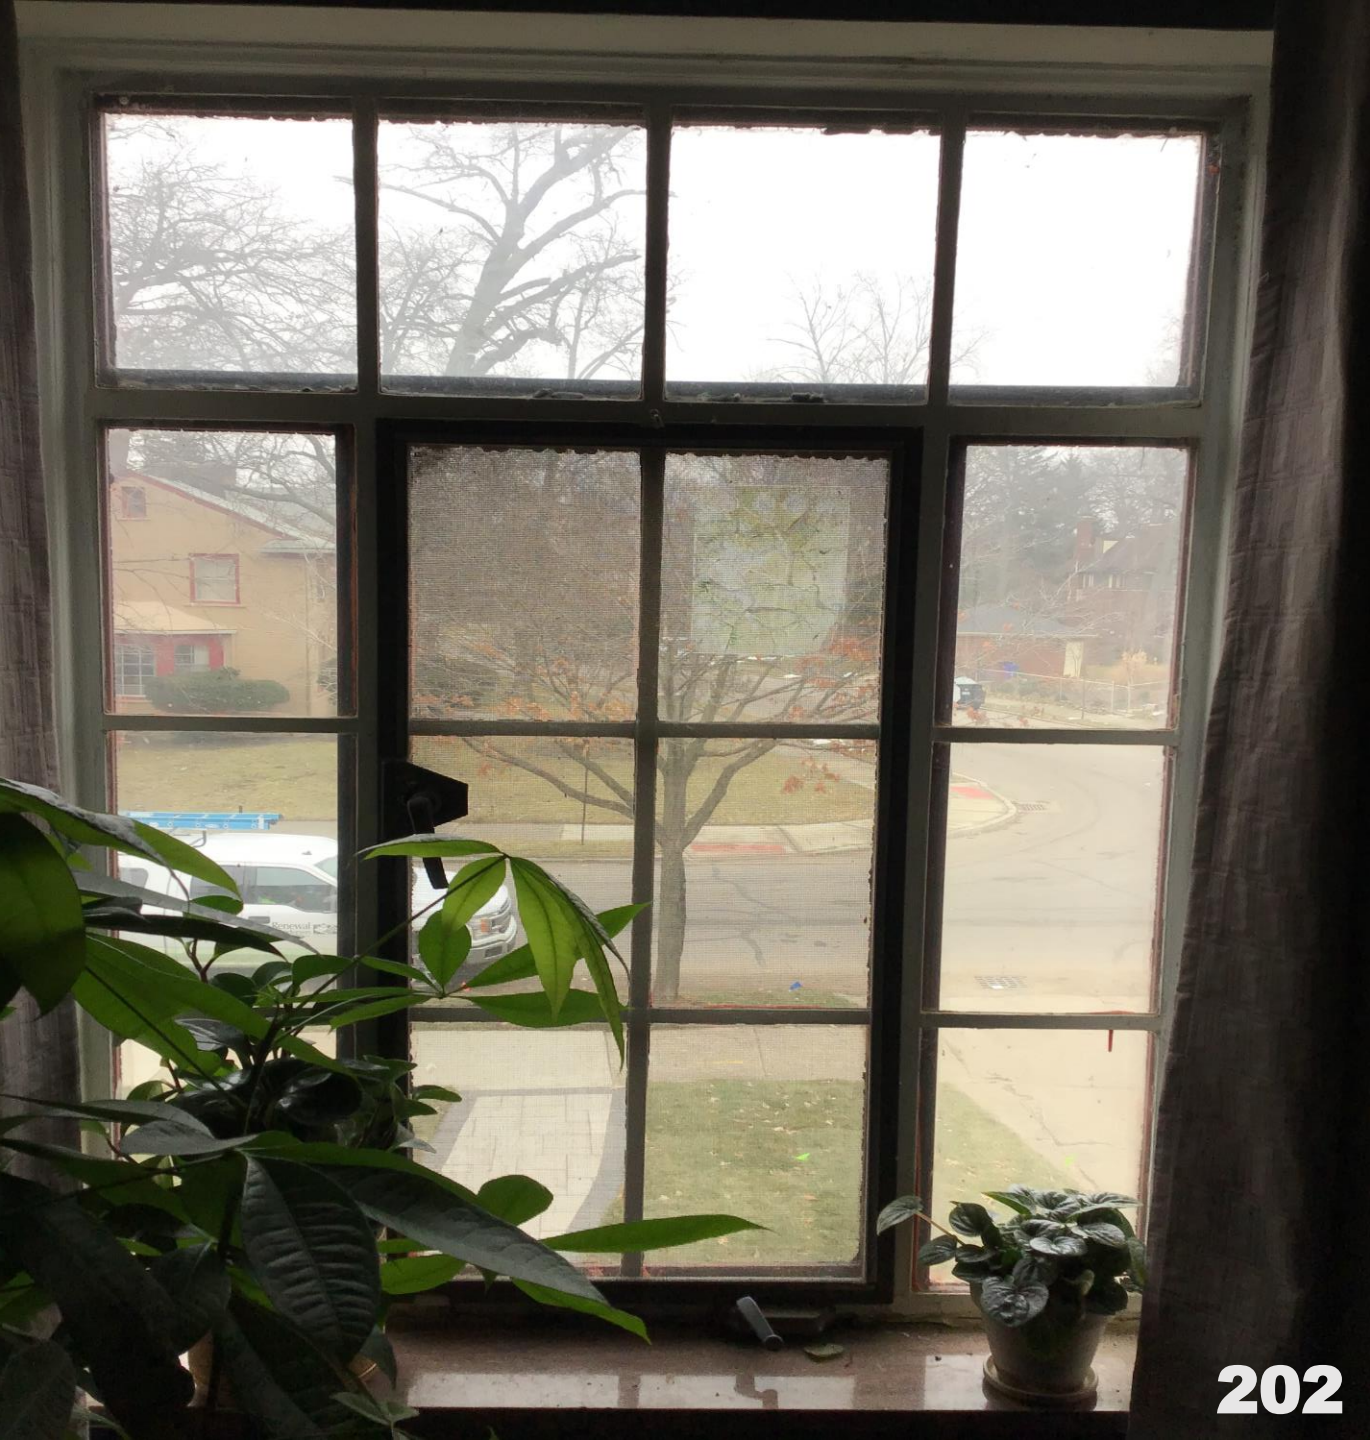
WINDOW OPENING 202 Office – Front of House

- Casement Single Window
- Window is in an office
- Window is hard to close if opened
- Exterior of window showing signs of rotting around frame

Window: Casement, Single, Left, Base Frame, 2" Brickmould / Traditional, Exterior Black, Interior Black, **Glass:** All Sash: High Performance SmartSun Glass, No Pattern, **Hardware:** Black, **Screen:** Fiberglass, Full Screen, **Grille Style:** Grilles Between Glass (GBG), **Grille Pattern:** All Sash: Colonial 4w x 4h, **Misc:** None

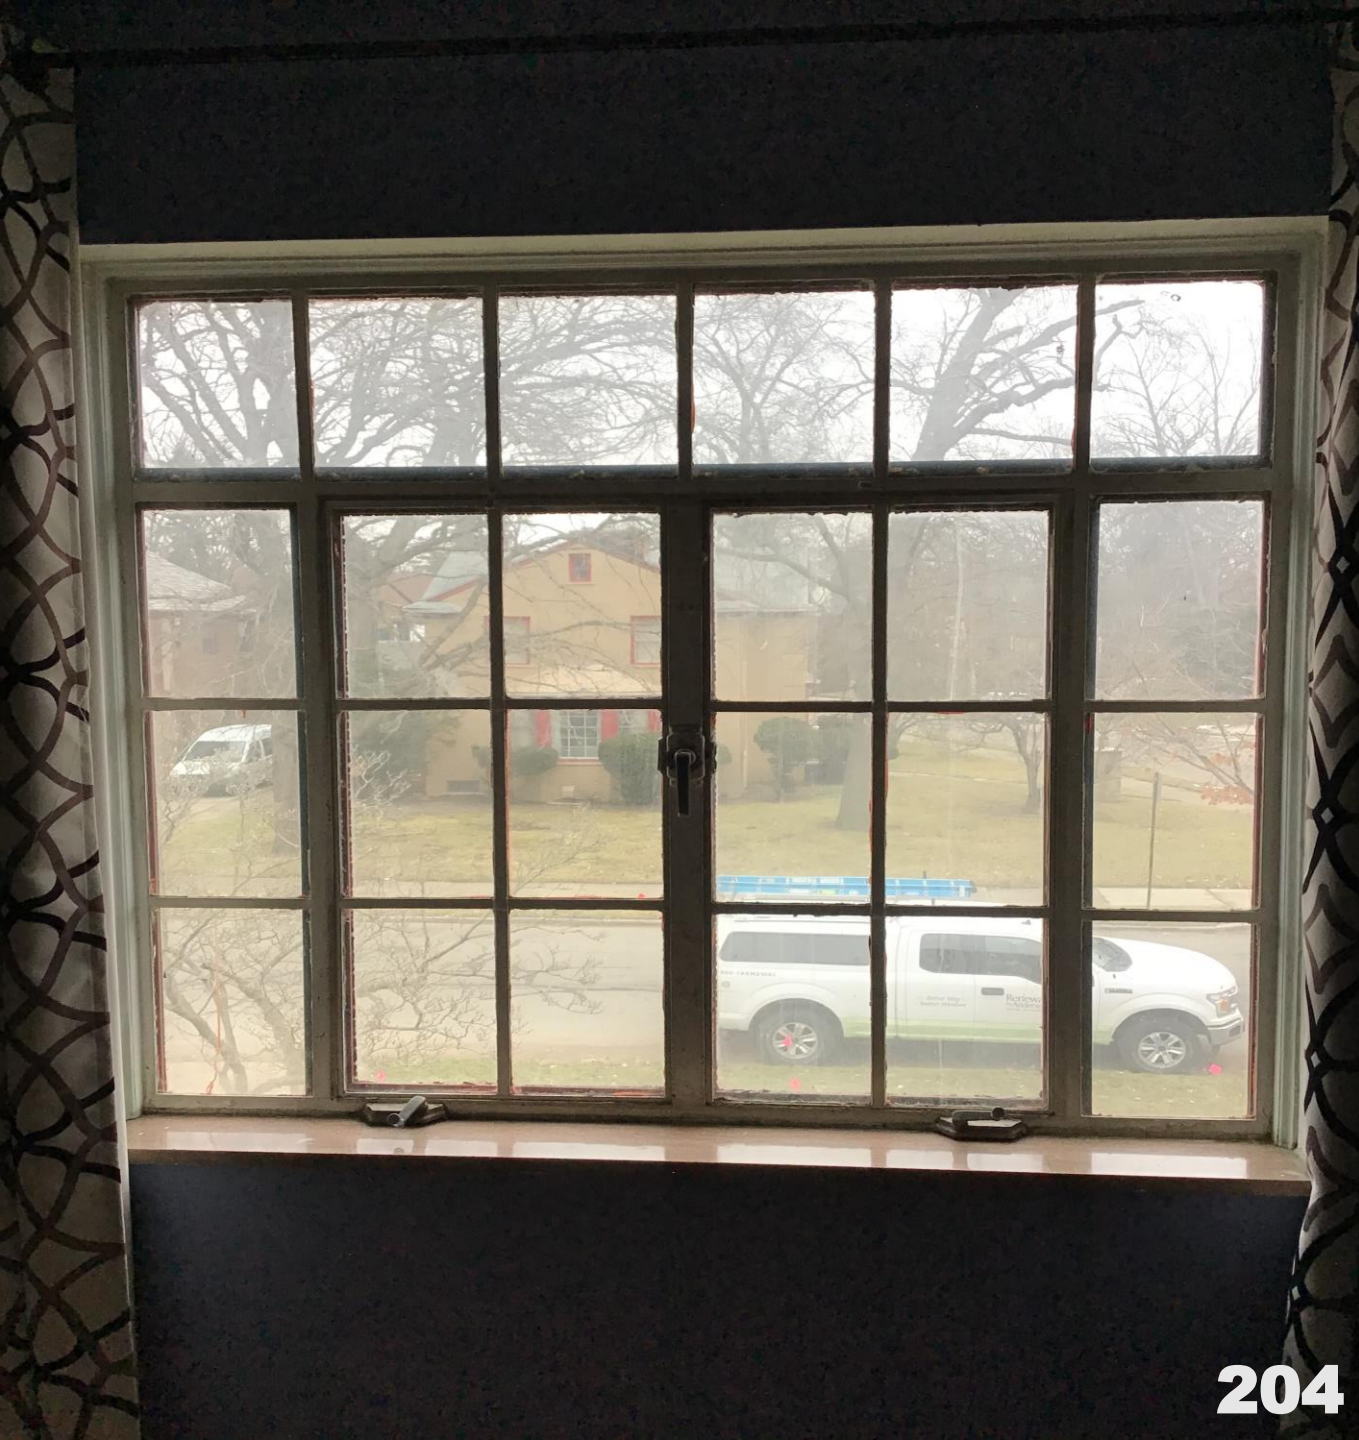
WINDOW OPENING 204 Bedroom - Front of House

- Double Casement Window
- Window is in Bedroom
- Window doesn't open
- Exterior of window showing signs of rotting around frame

Window: Casement, Double, Vented, Base Frame, 2"
