James Haskins
19365 Warrington Dr
Detroit MI 48221
Sherwood Forest District

Renewal by Andersen 37720 Amrhein Livonia, MI 48150

- Homeowner wants to replace all the windows around house except for one stained glass window unit
- Windows are original steel
- Renewal by Andersen windows are Fibrex (wood composite) material
- Total of 24 windows to be replaced
- Windows exterior color will be black if approved
- Most windows matching style except for bay windows – flankers changed to operable and middle window changed to fixed.
- Windows will match existing mutton bar “pattern”
- Homeowner unable to get quotes for repair

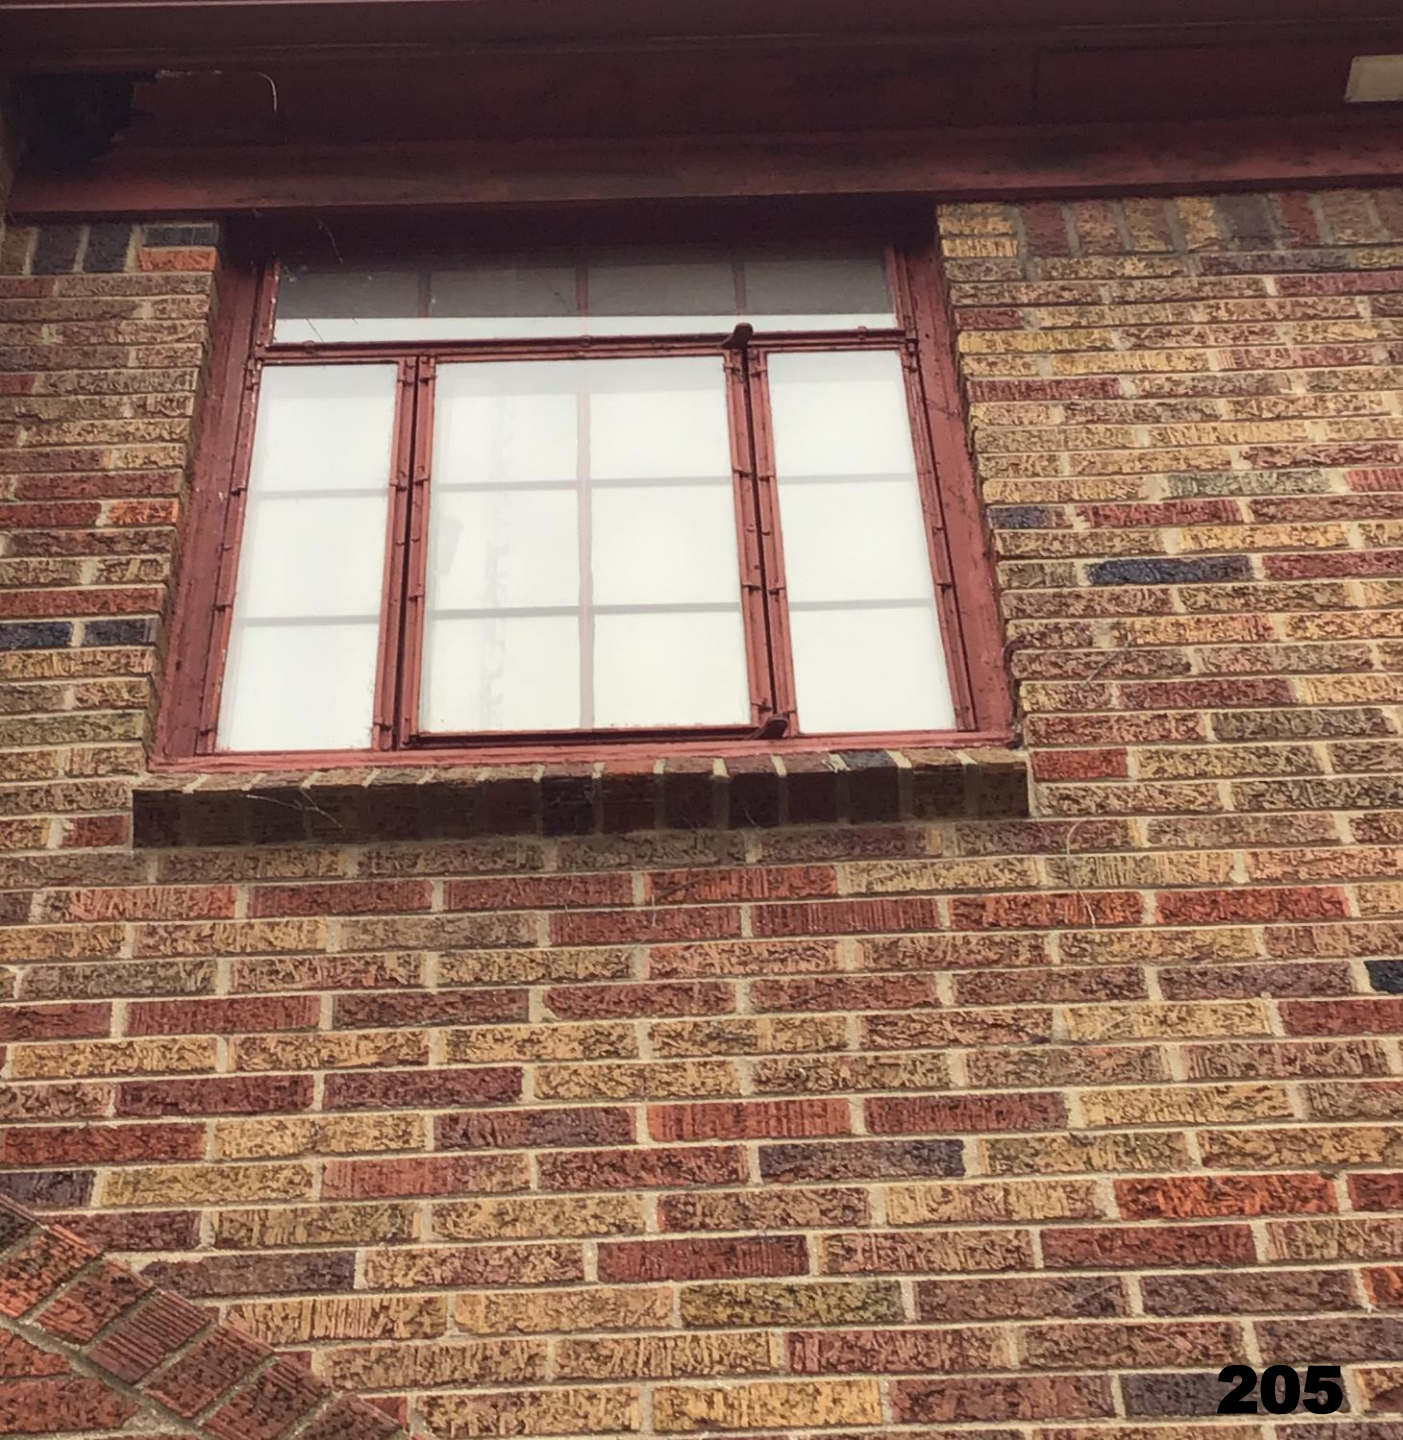
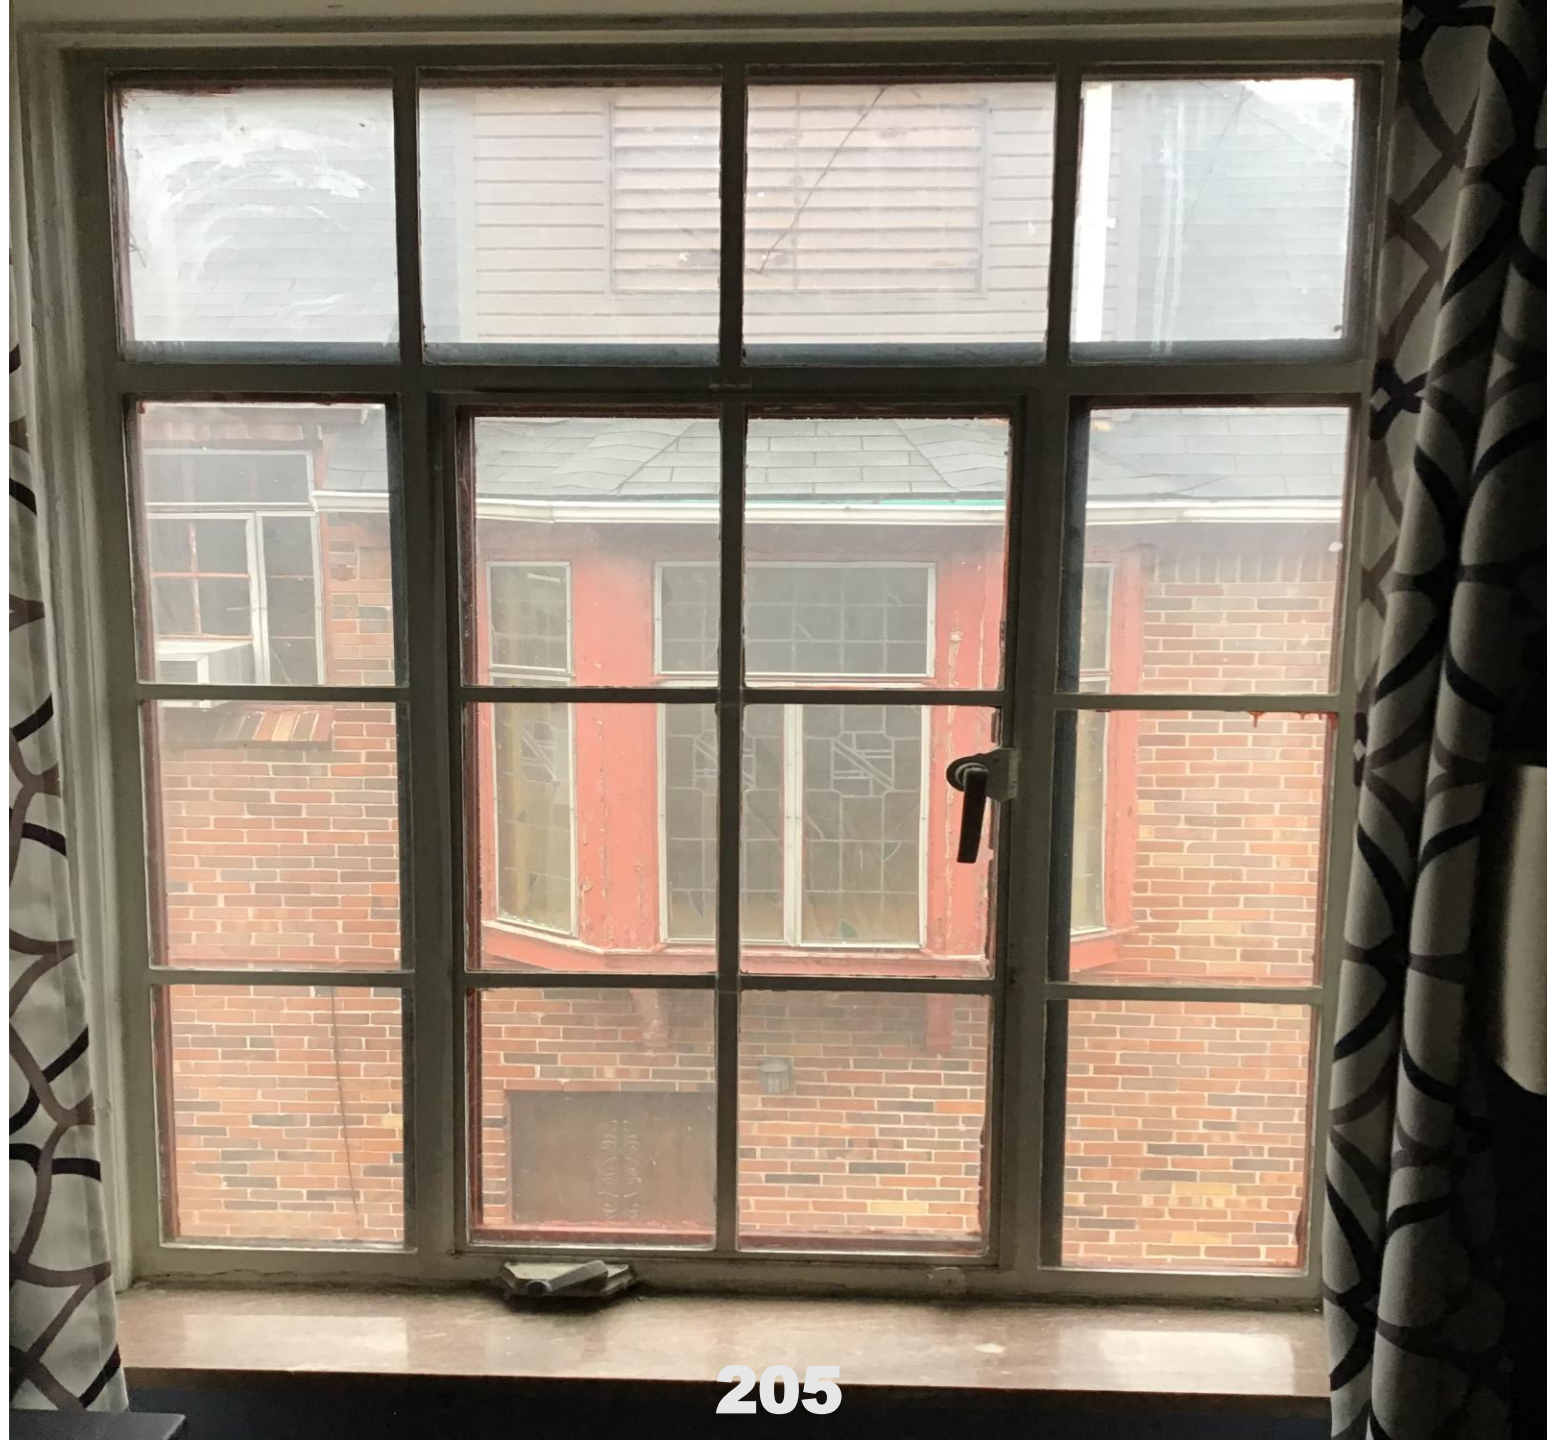
WINDOW OPENING 205 Bedroom – Right side of House

- Single Casement Window
- Window is in Bedroom
- Window is hard to close if opened
- Exterior of window showing signs of rotting around frame

Window: Casement, Single, Right, Base Frame, 2"

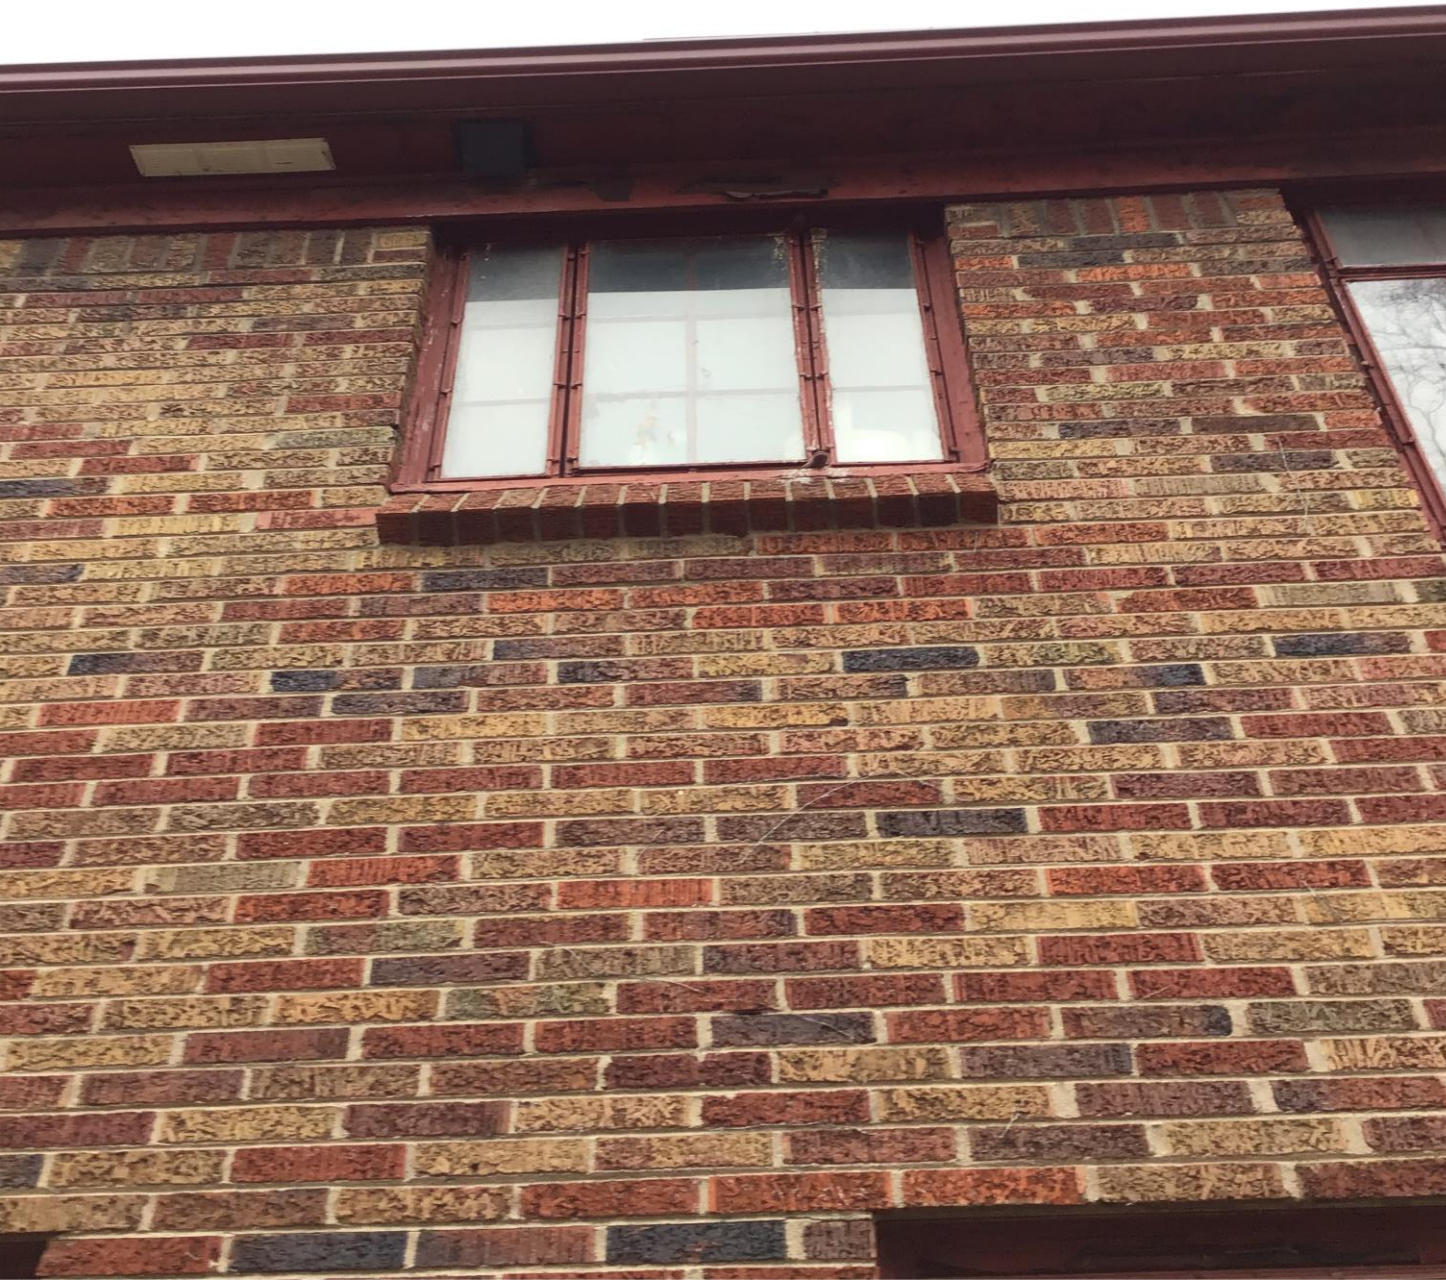
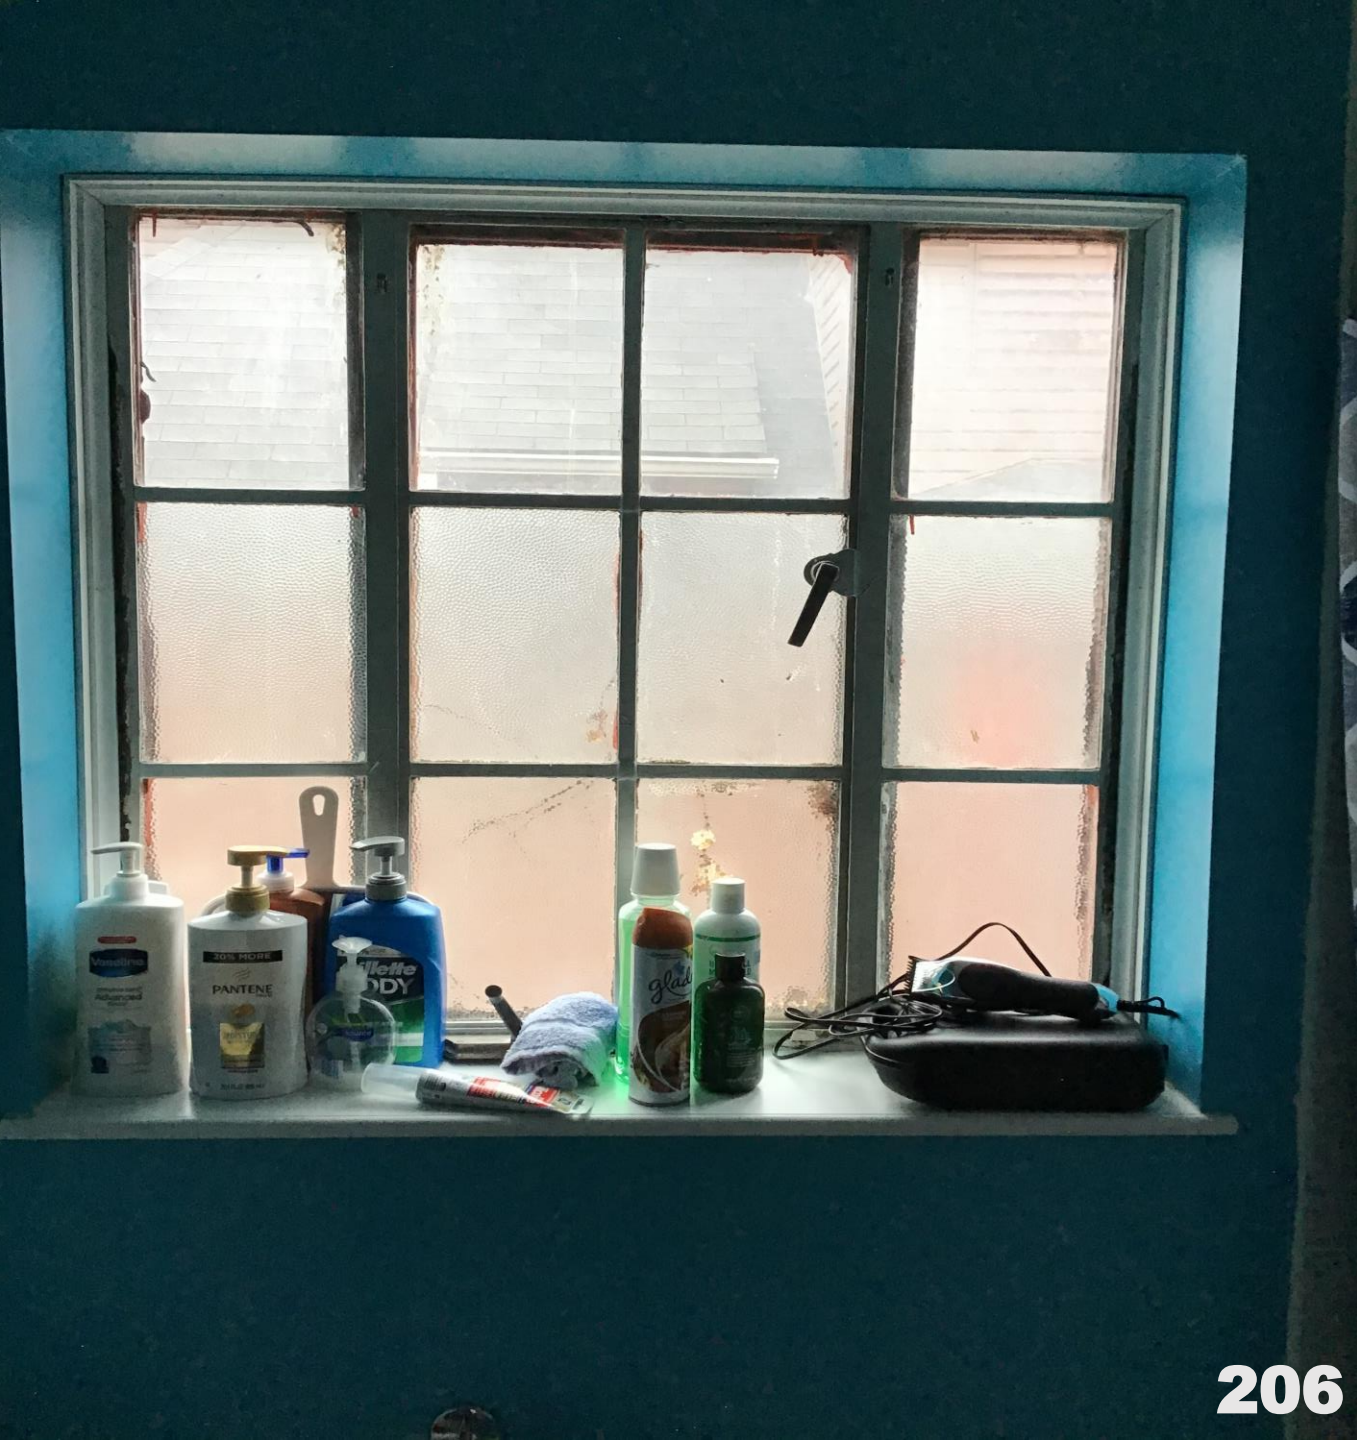
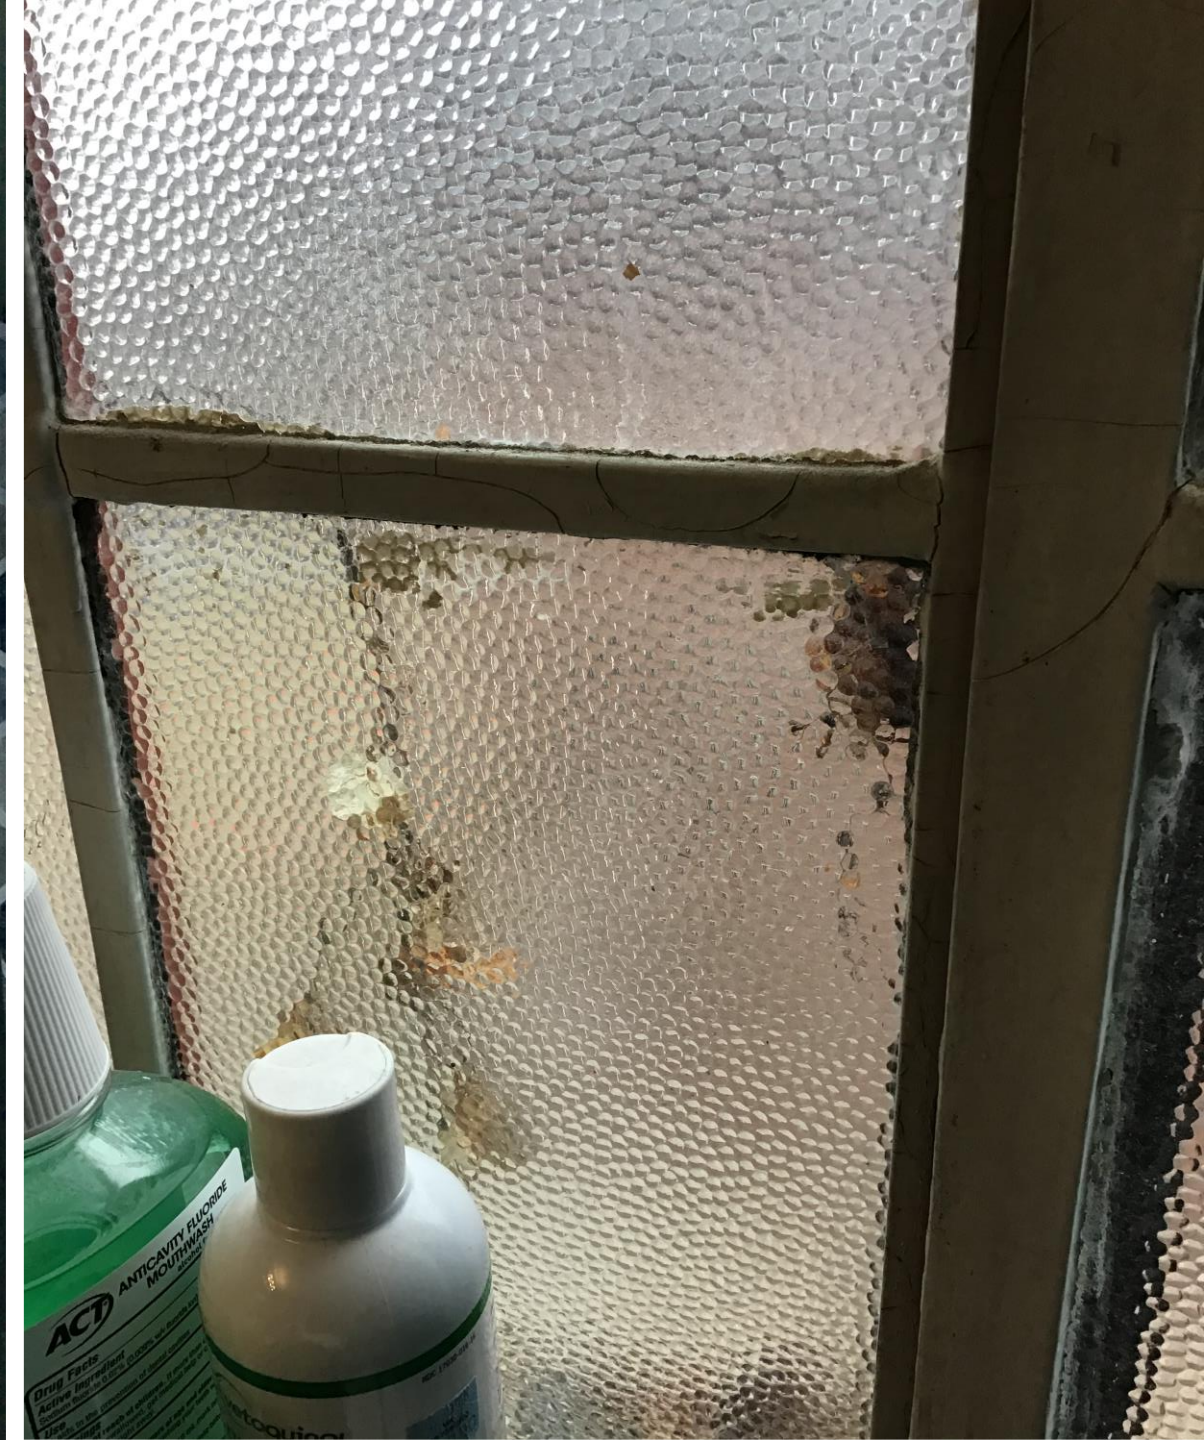
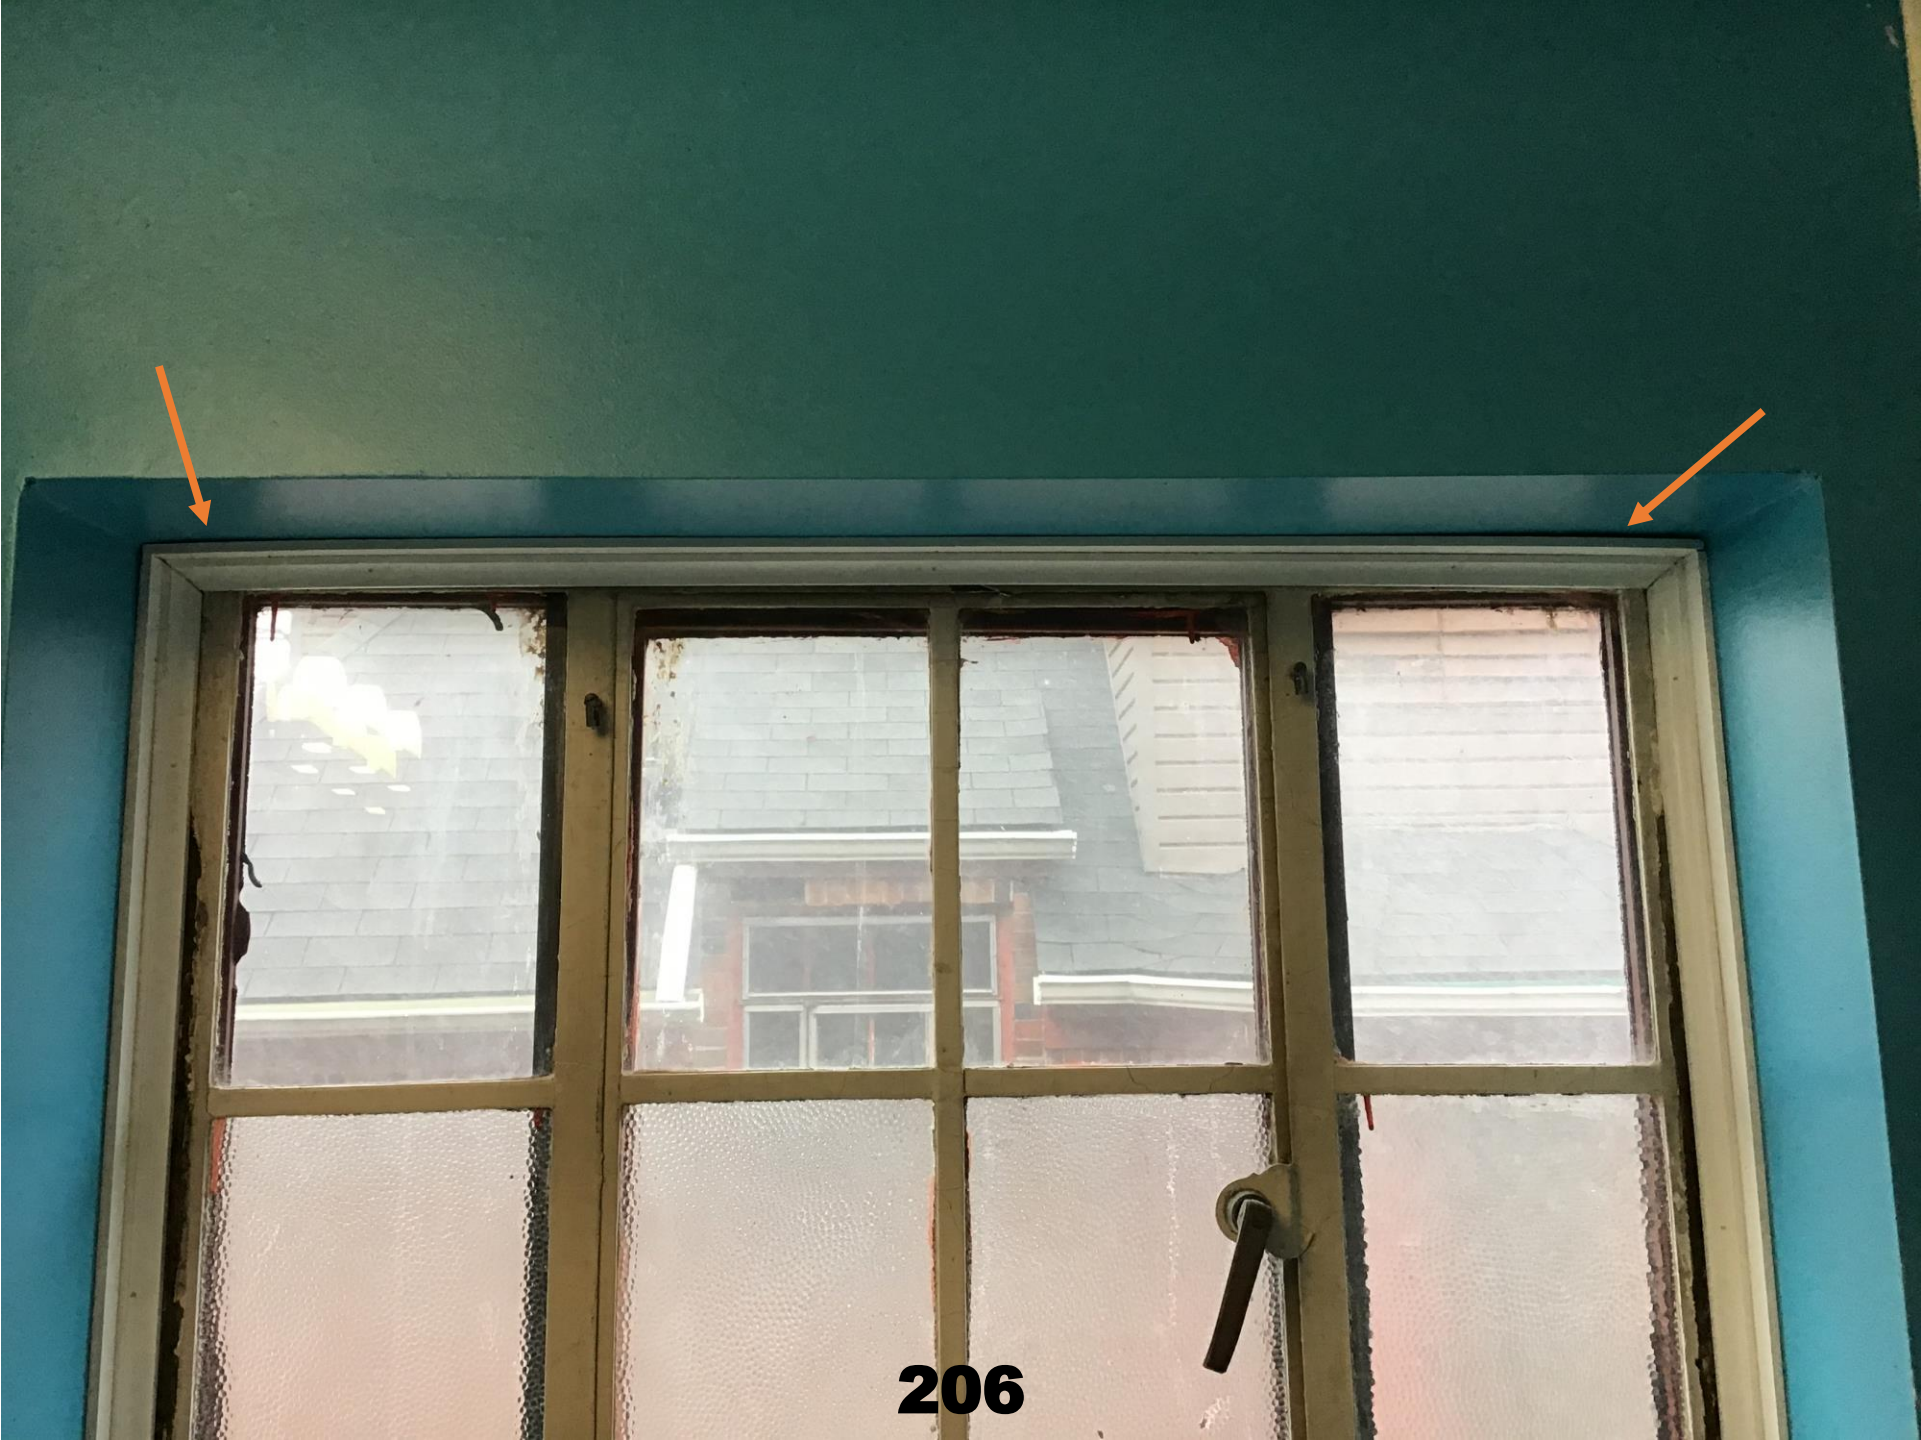
WINDOW OPENING 206 Bedroom - Right side of House

- Single Casement Window
- Window is in Bedroom
- Window is hard to close if opened
- Exterior of window showing signs of rotting around frame

Window: Casement, Single, Right, Base Frame, Exterior Black, Interior Black, **Glass:** All Sash: High Performance SmartSun Glass, Obscure, Tempered Glass, **Hardware:** Black, Wide Opening Hinge, **Screen:** Fiberglass, Full Screen, **Grille Style:** Grilles Between Glass (GBG), **Grille Pattern:** All Sash: Colonial 4w x 4h, **Misc:** None

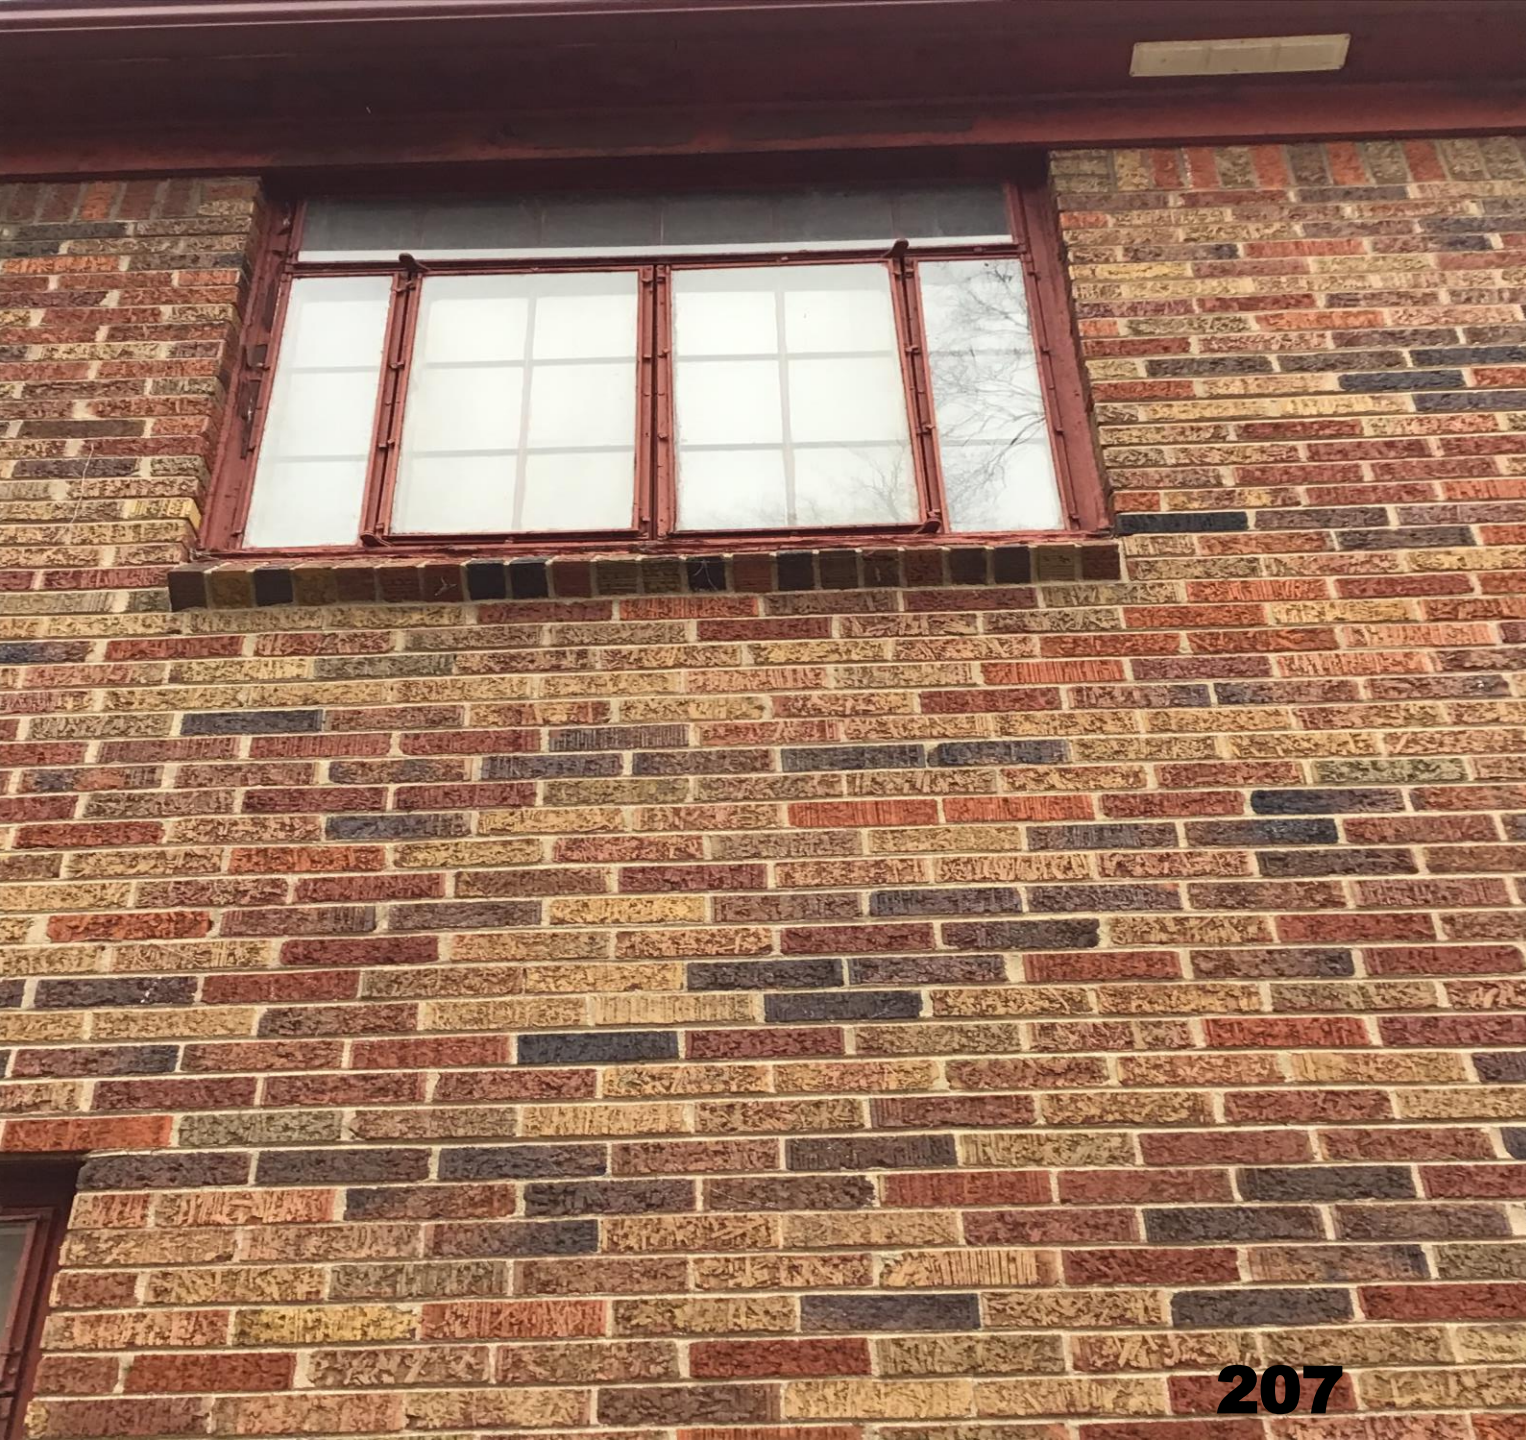
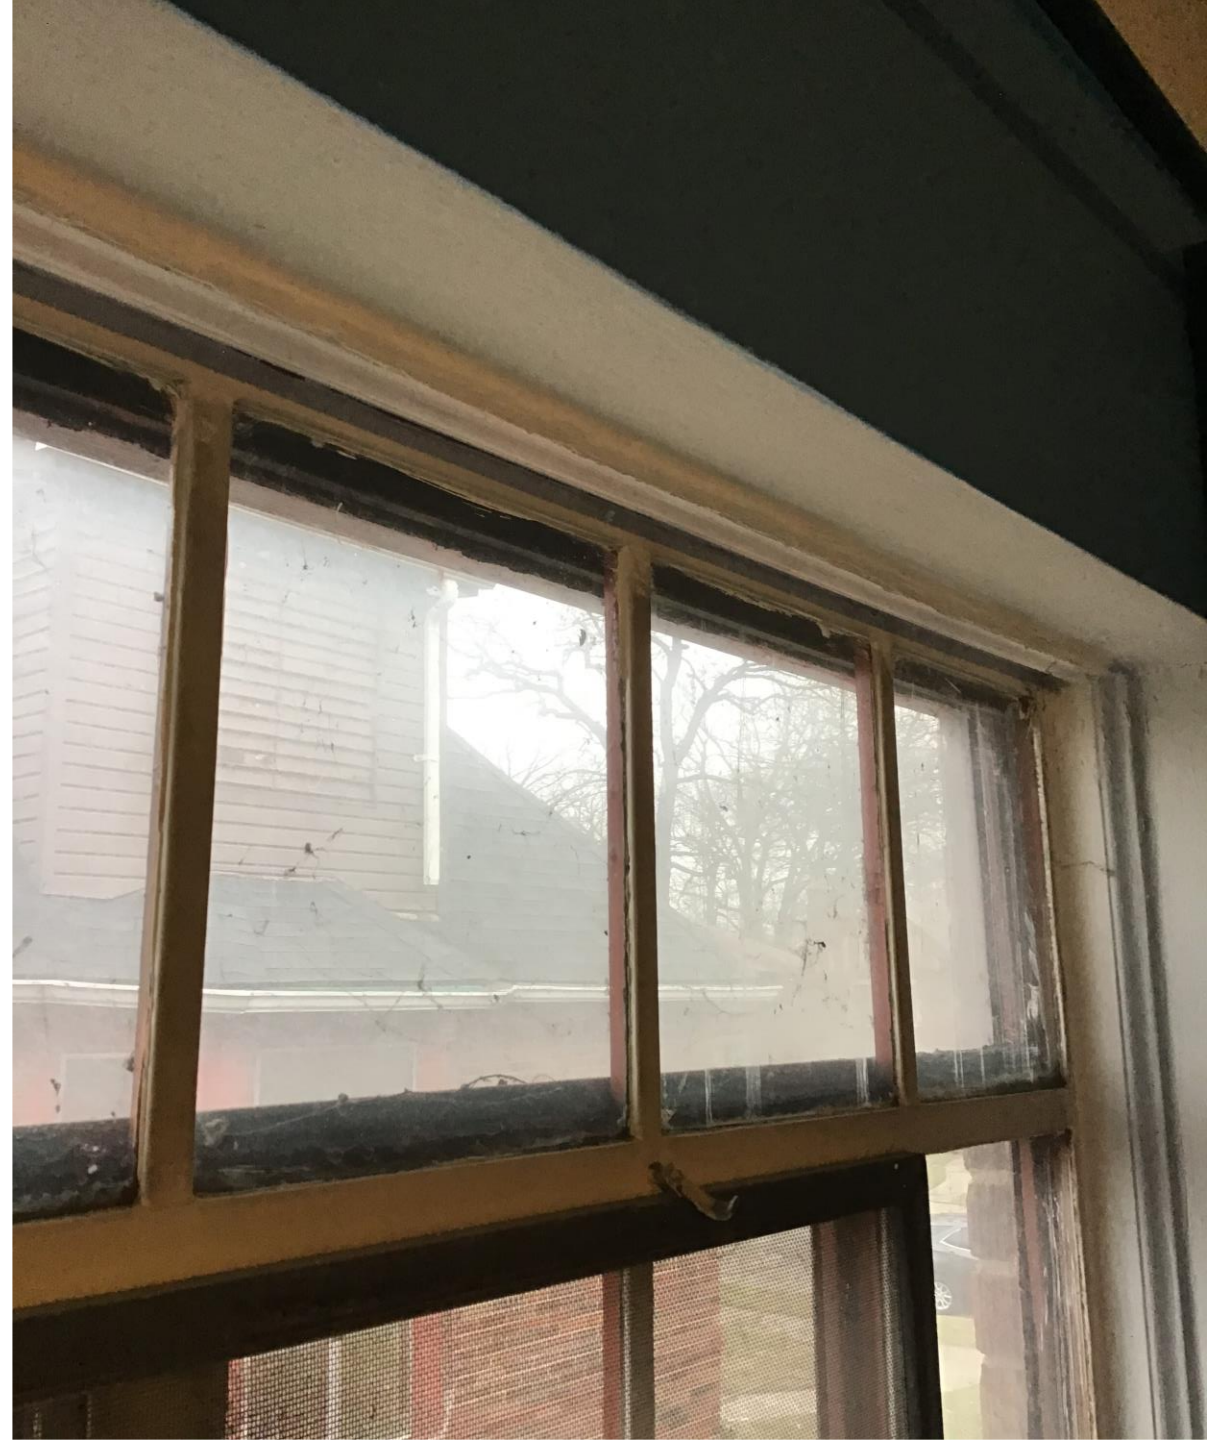
WINDOW OPENING 207 Bedroom - Right side of House

- Double Casement Window
- Window is in Bedroom
- Window is hard to close if opened
- Exterior of window showing signs of rotting around frame

Window: Casement, Double, Vented, Base Frame, 2"
