James Haskins
19365 Warrington Dr
Detroit MI 48221
Sherwood Forest District

Renewal by Andersen 37720 Amrhein Livonia, MI 48150

- Homeowner wants to replace all the windows around house except for one stained glass window unit
- Windows are original steel
- Renewal by Andersen windows are Fibrex (wood composite) material
- Total of 24 windows to be replaced
- Windows exterior color will be black if approved
- Most windows matching style except for bay windows – flankers changed to operable and middle window changed to fixed.
- Windows will match existing mutton bar “pattern”
- Homeowner unable to get quotes for repair

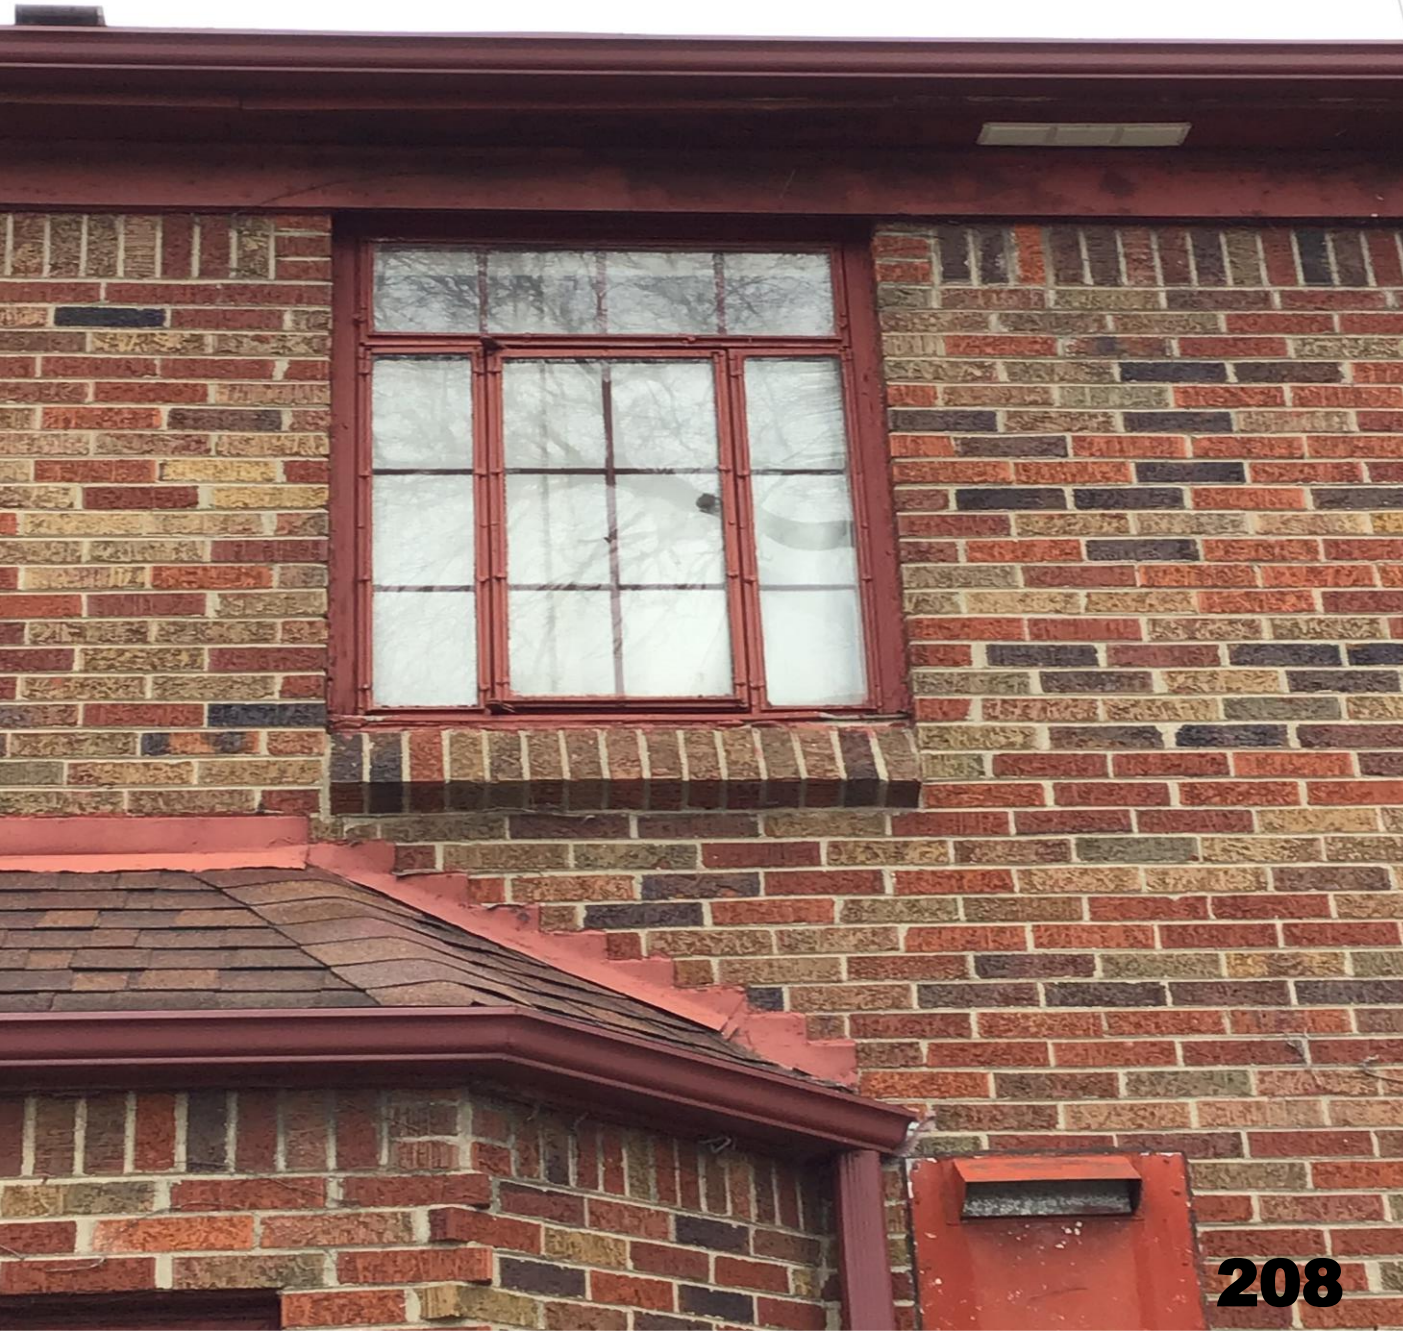
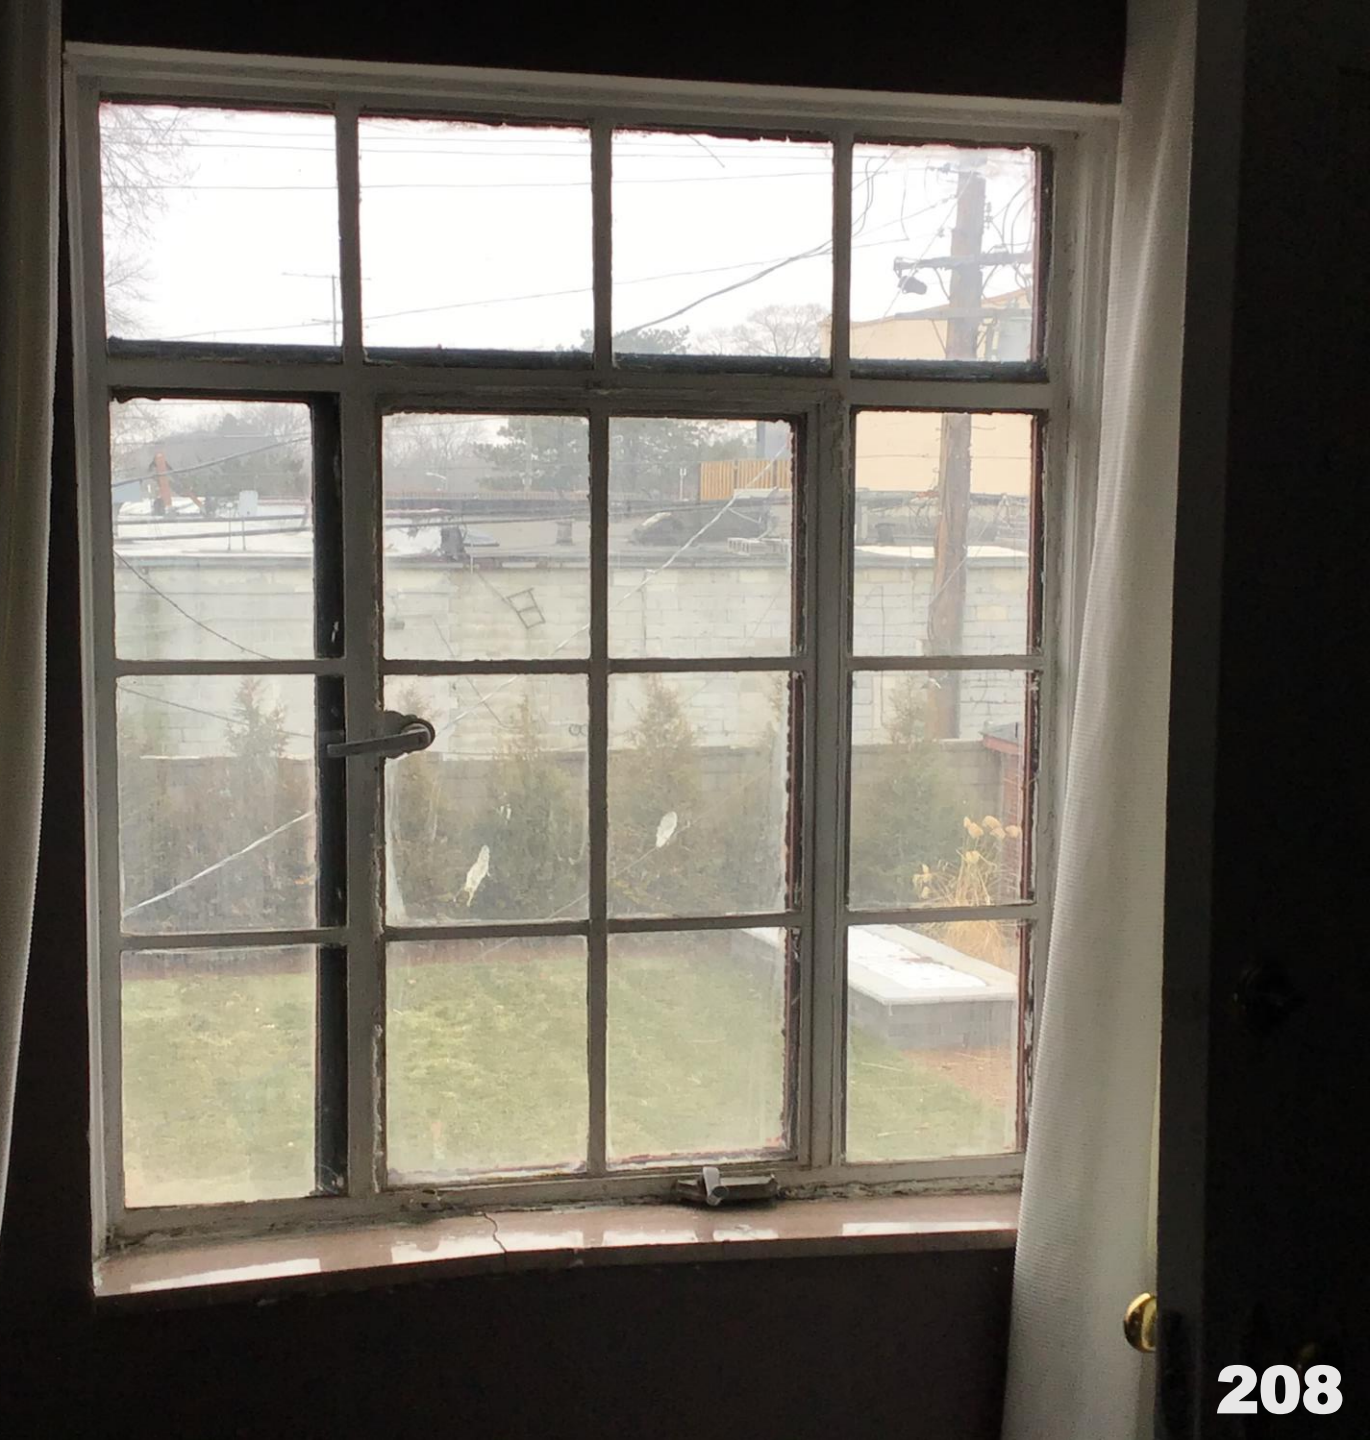
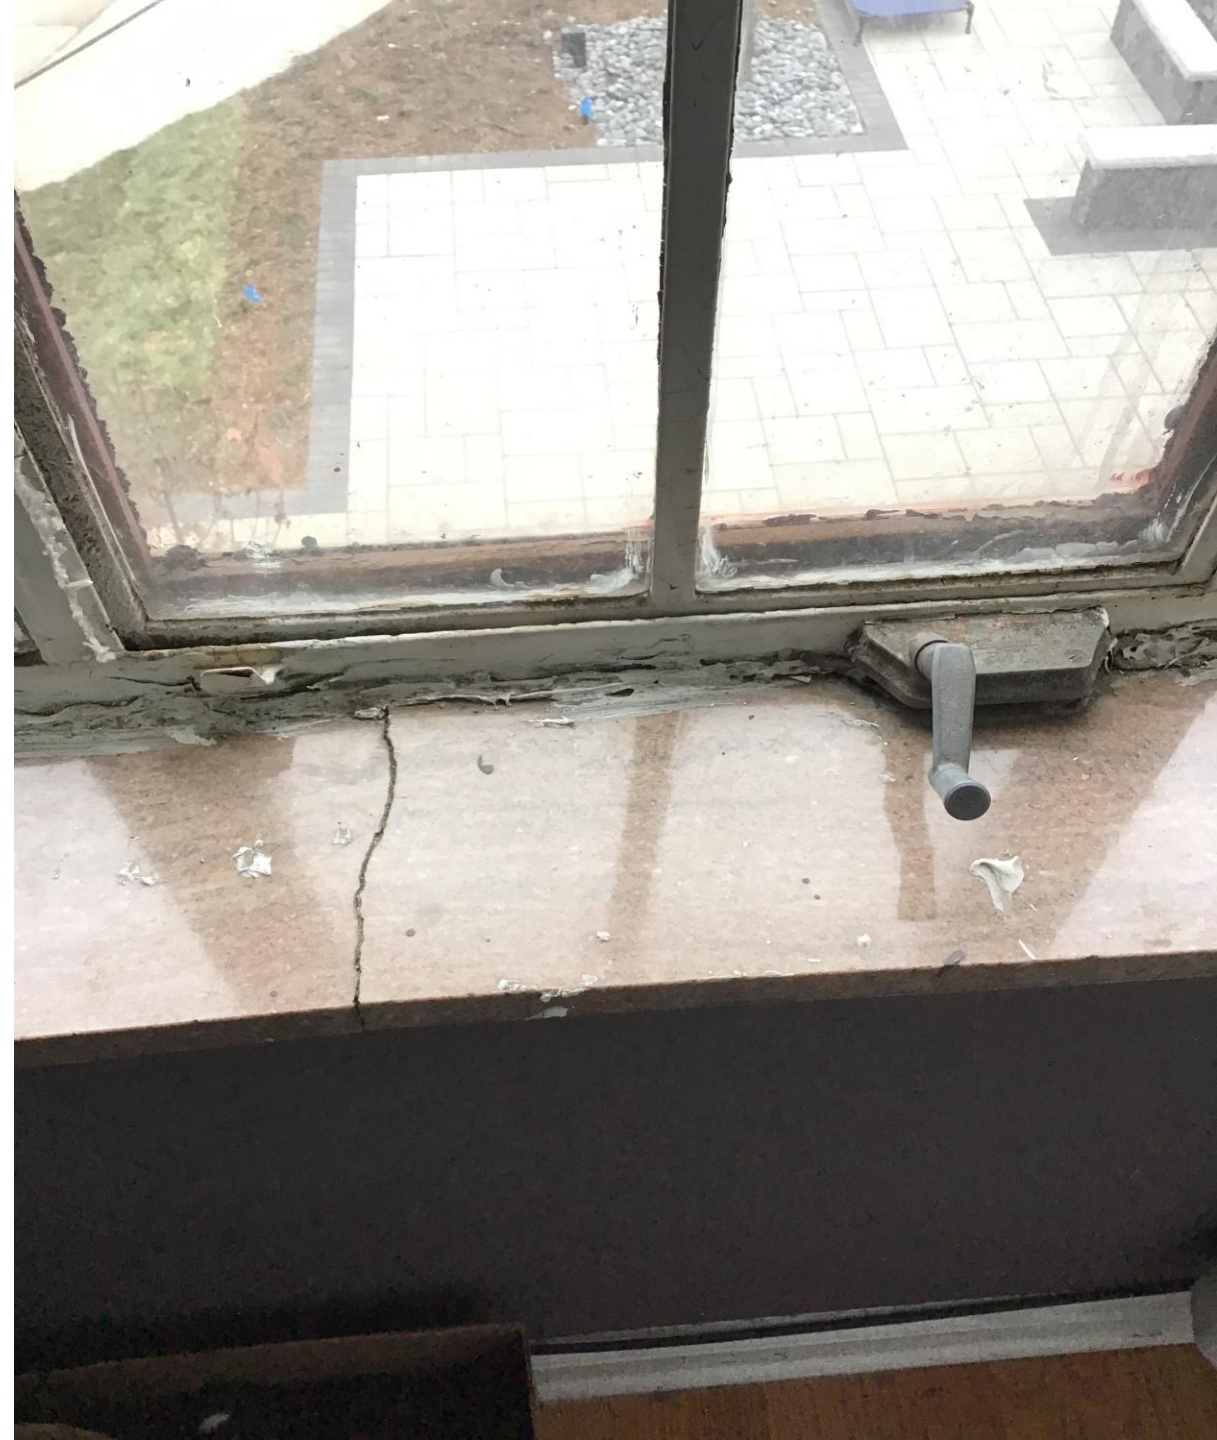
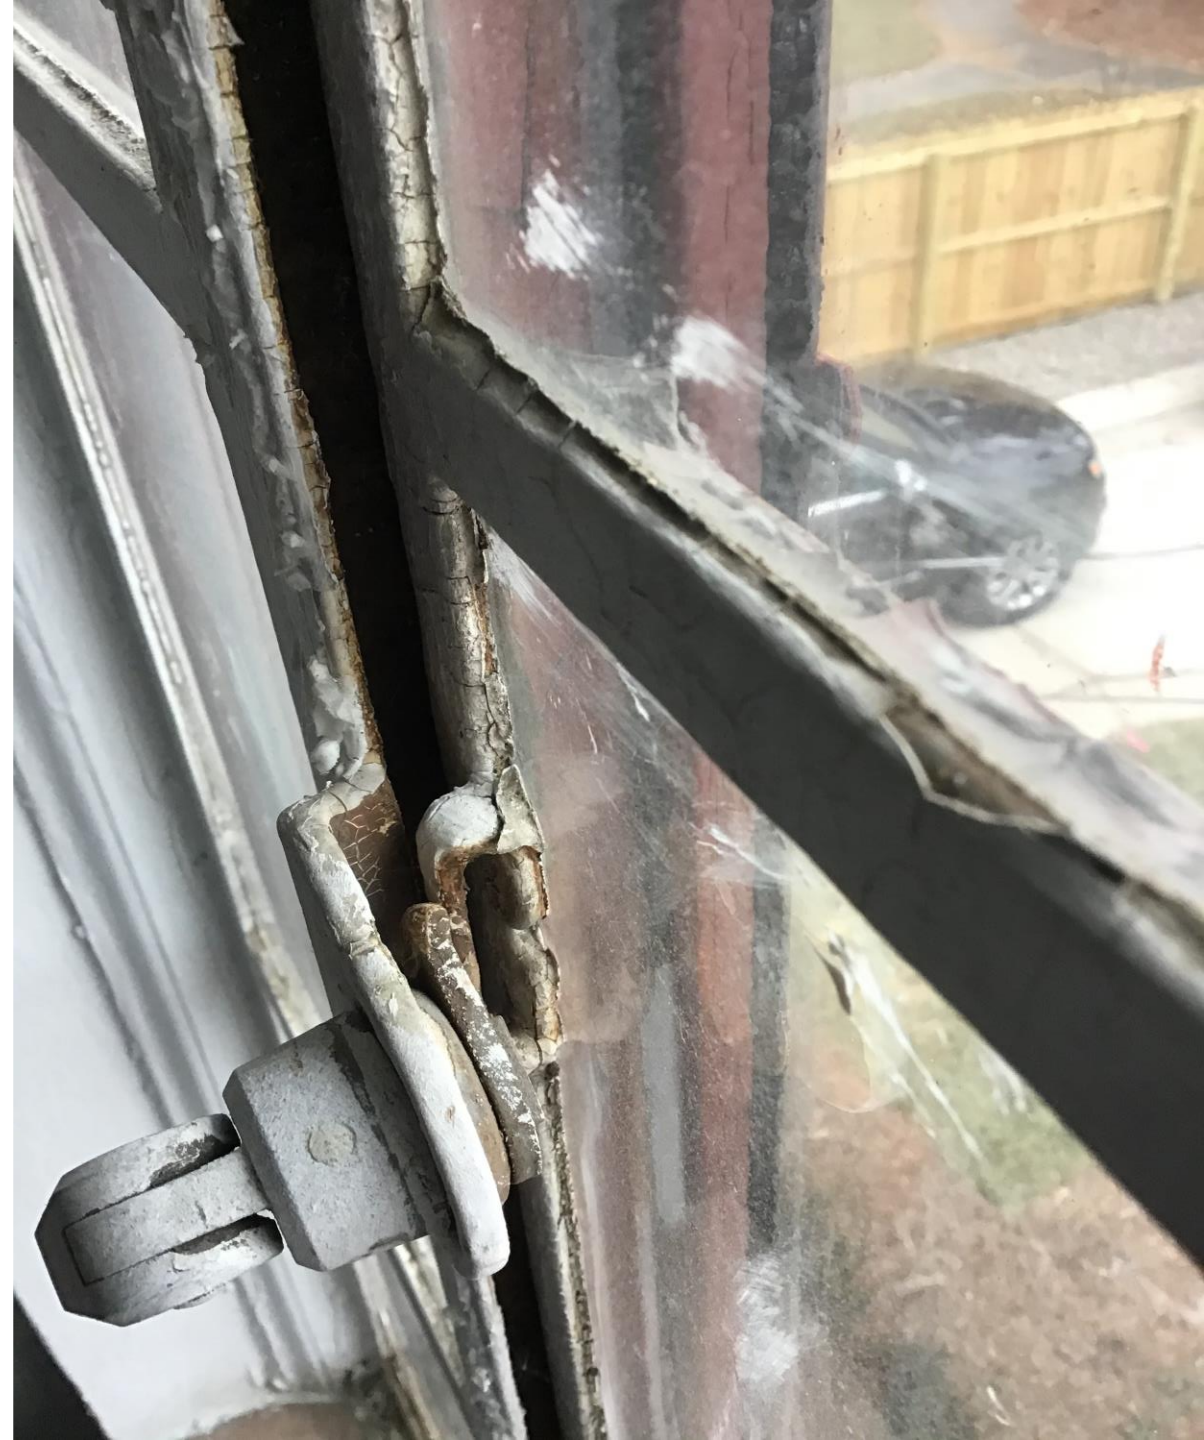
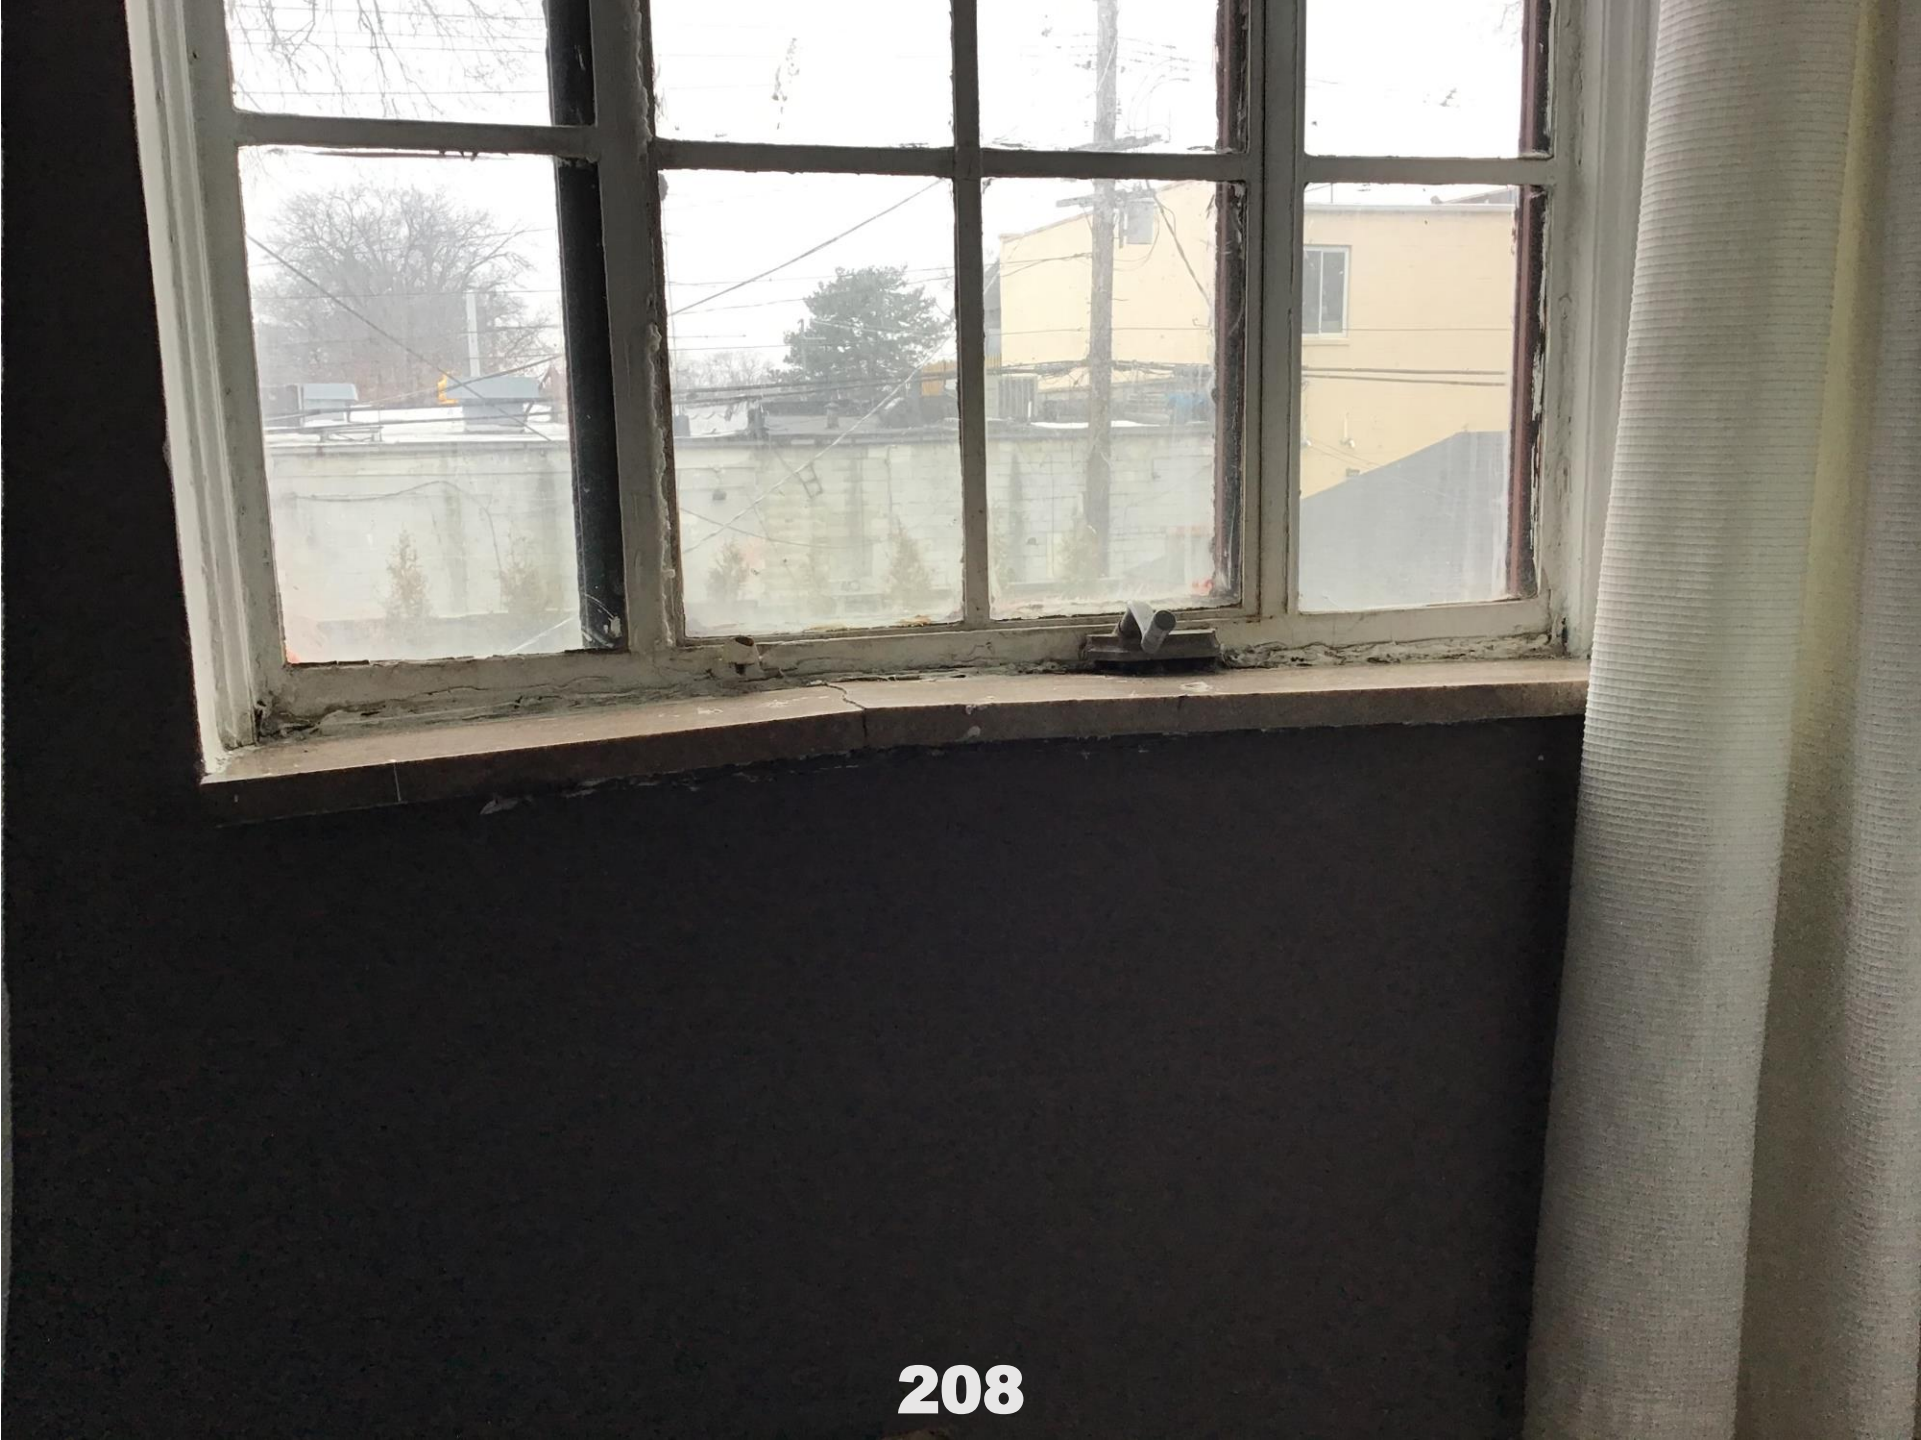
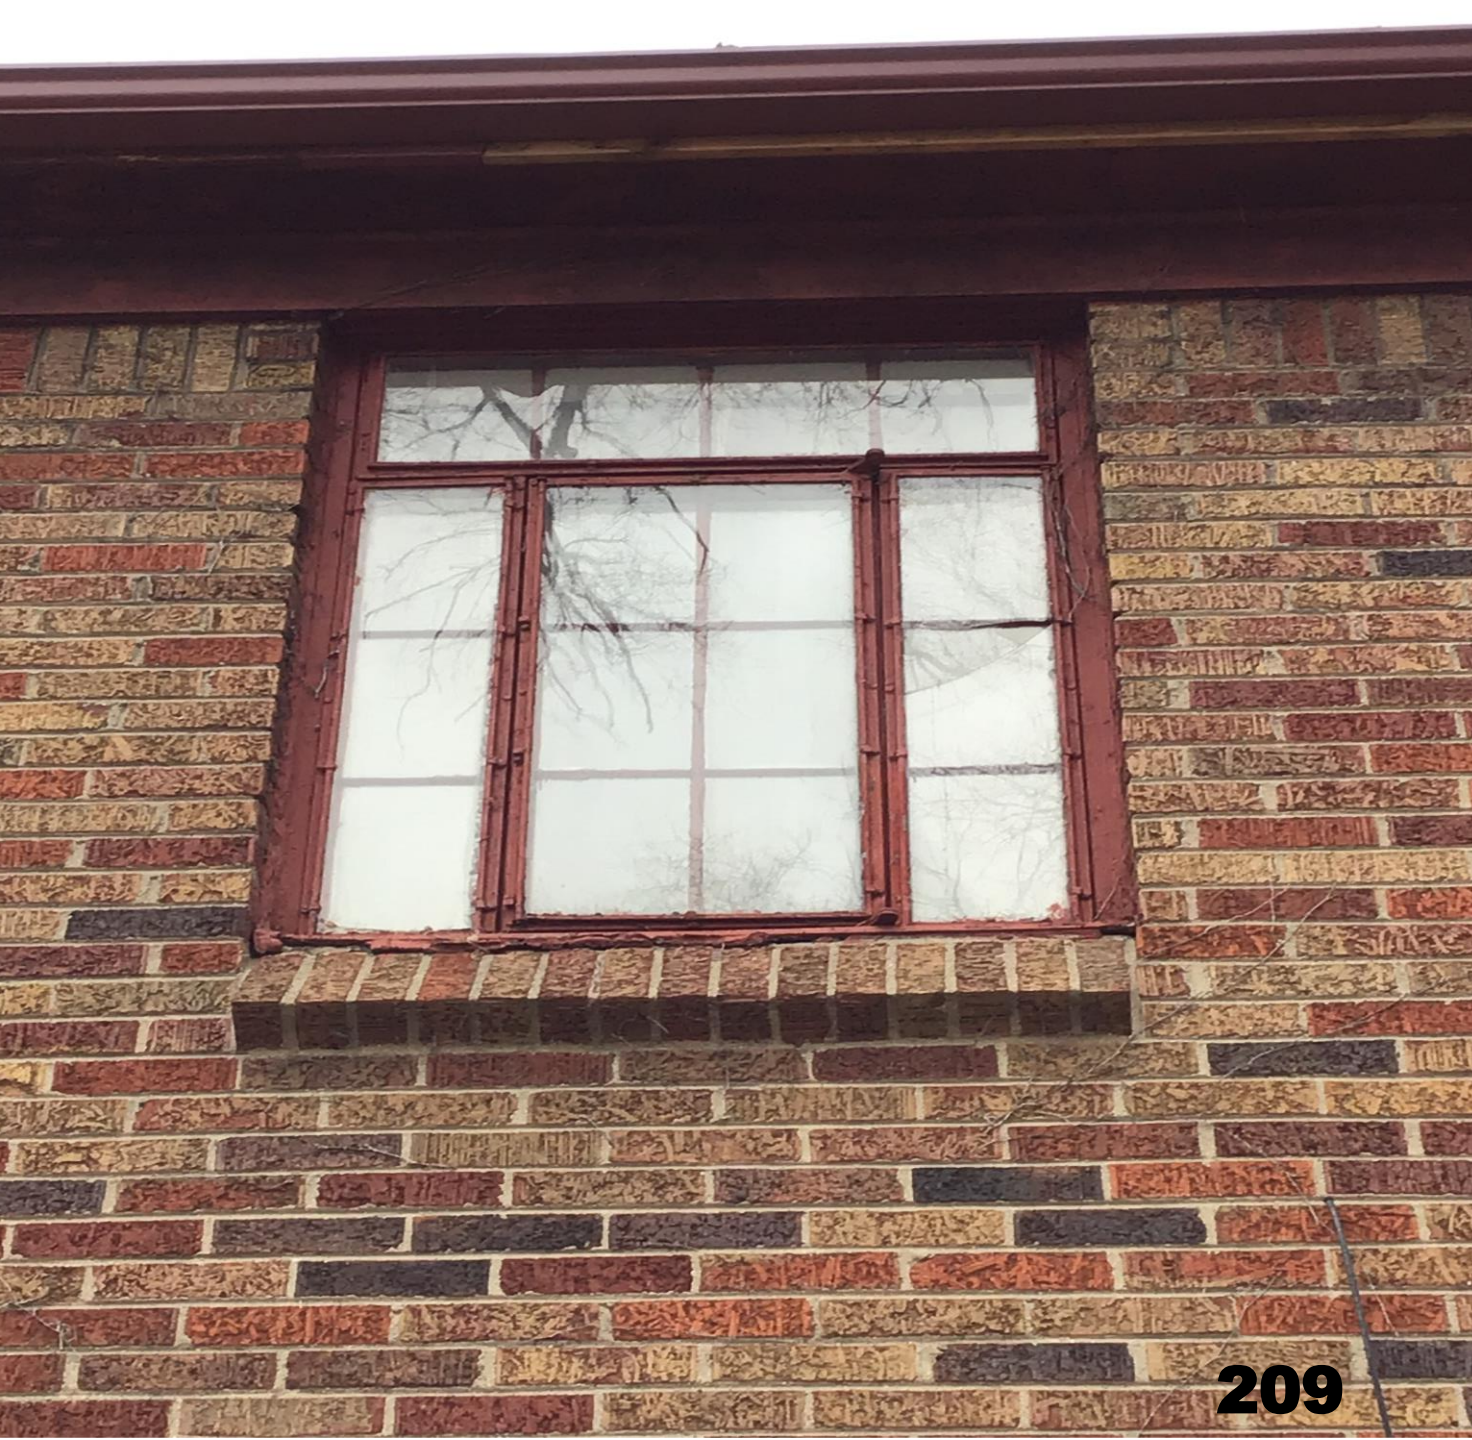
WINDOW OPENING 208 Bedroom - Back of House

- Single Casement Window
- Window is in Bedroom
- Window is hard to close if opened
- Exterior of window showing signs of rotting around frame

Window: Casement, Single, Left, Base Frame, 2" Brickmould / Traditional, Exterior Black, Interior Black, **Glass:** All Sash: High Performance SmartSun Glass, No Pattern, **Hardware:** Black, Wide Opening Hinge, **Screen:** Fiberglass, Full Screen, **Grille Style:** Grilles Between Glass (GBG), **Grille Pattern:** All Sash: Colonial 4w x 4h, **Misc:** None

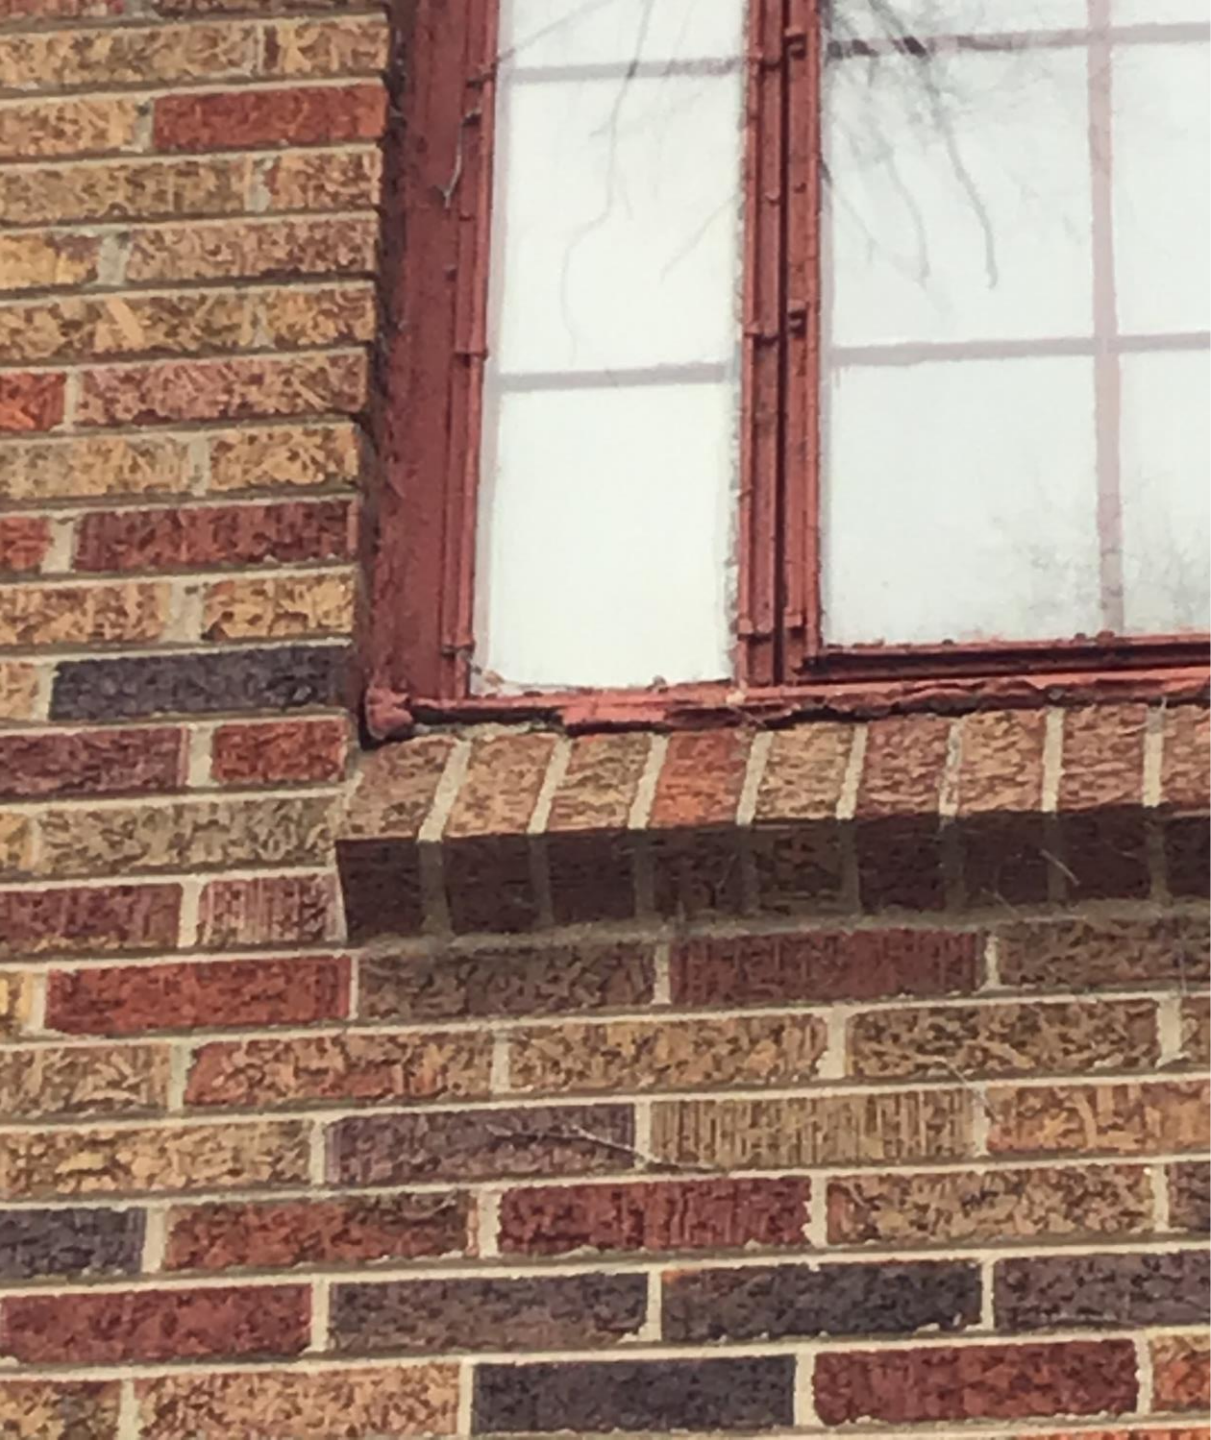
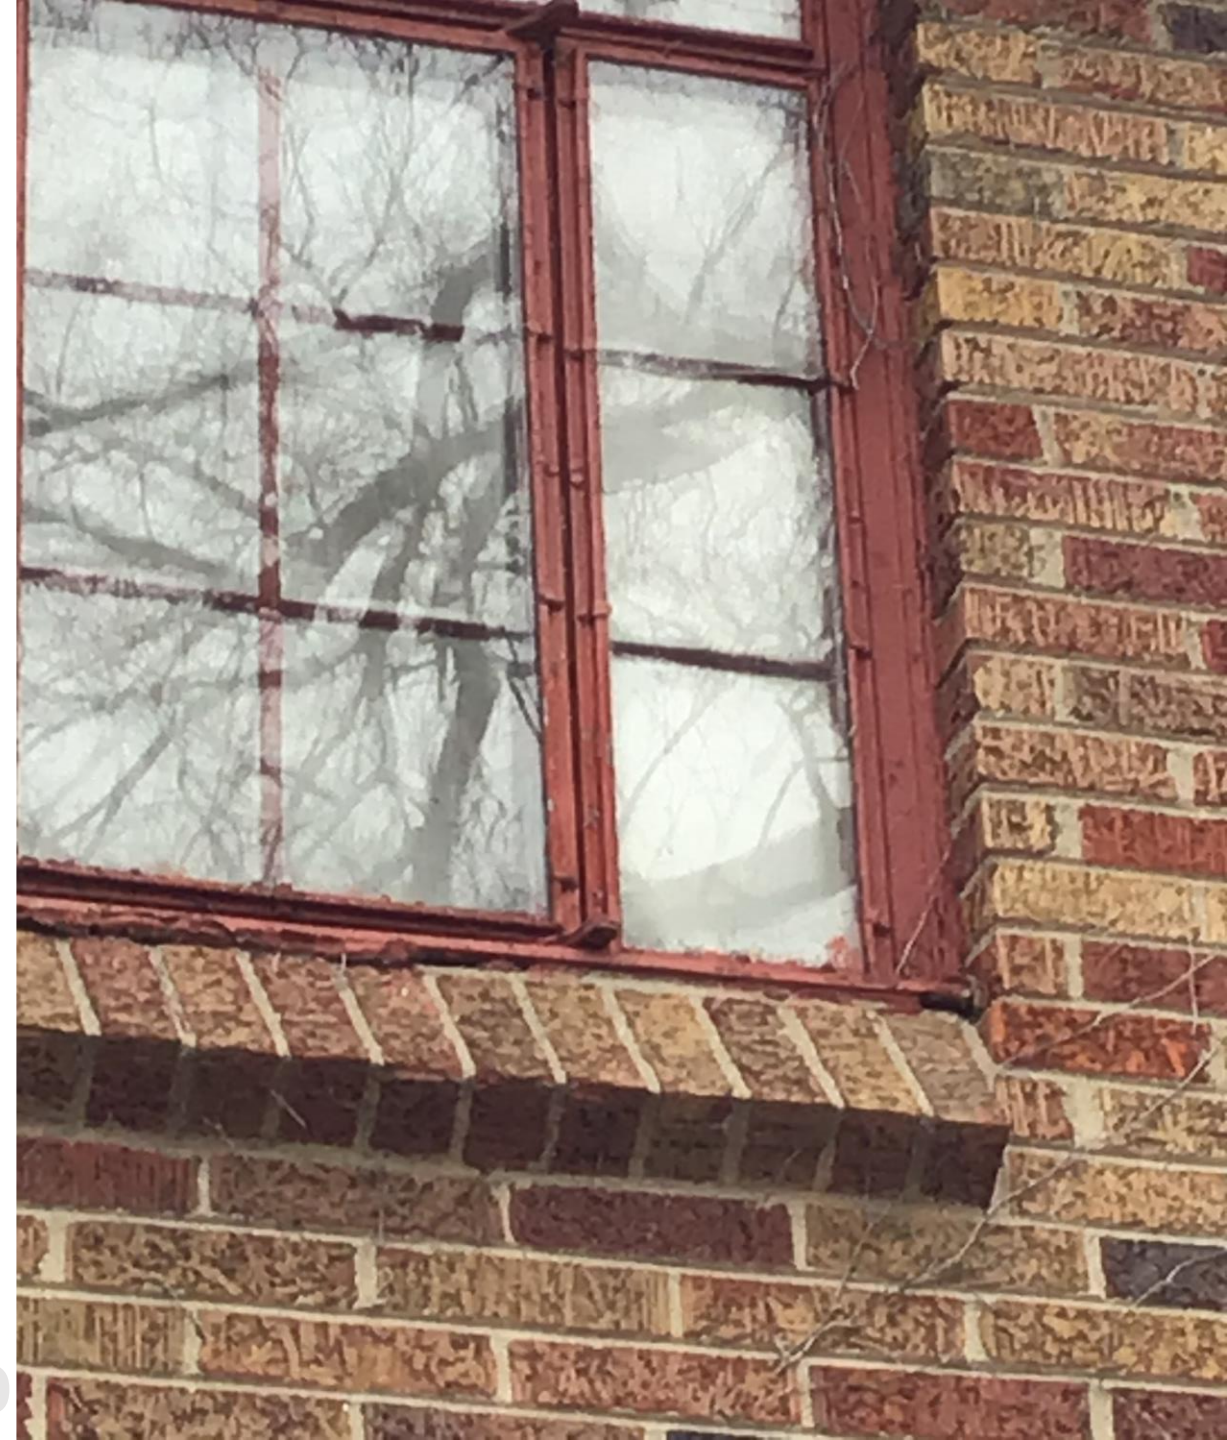
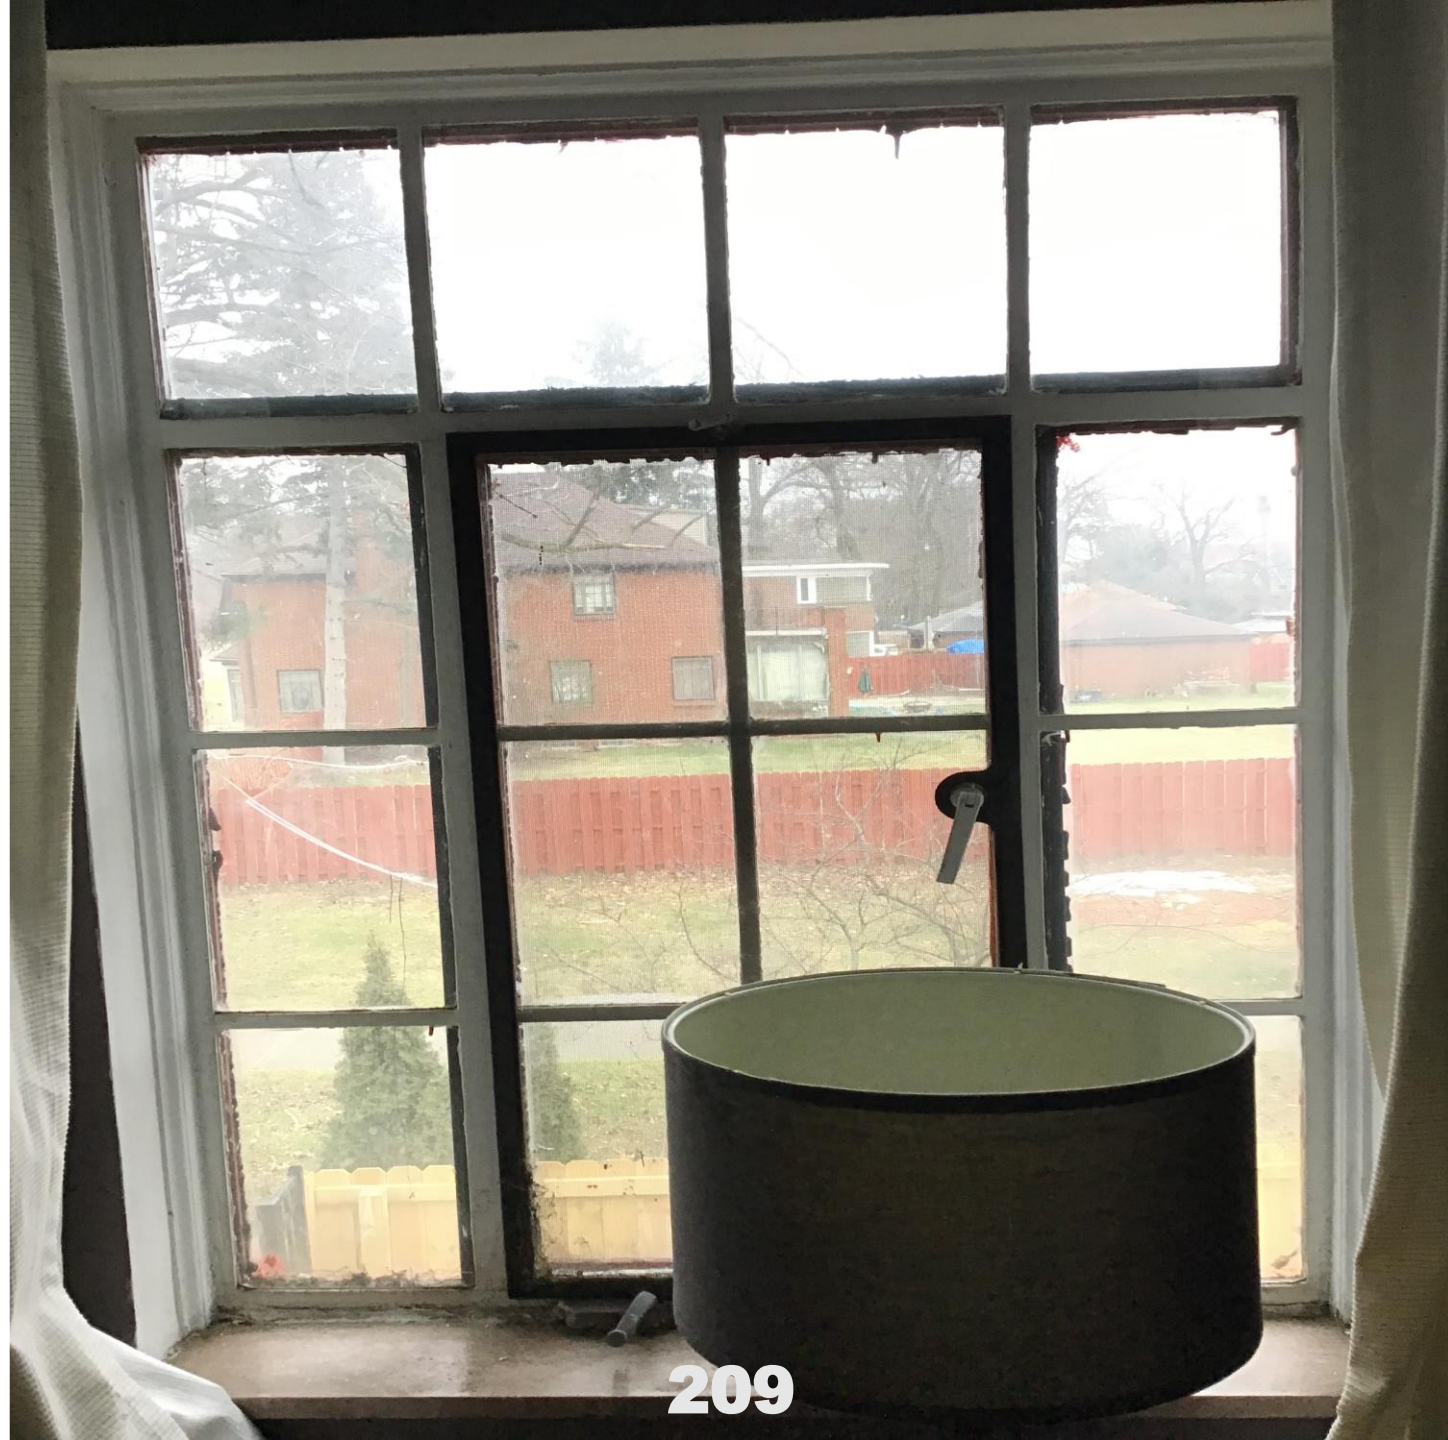
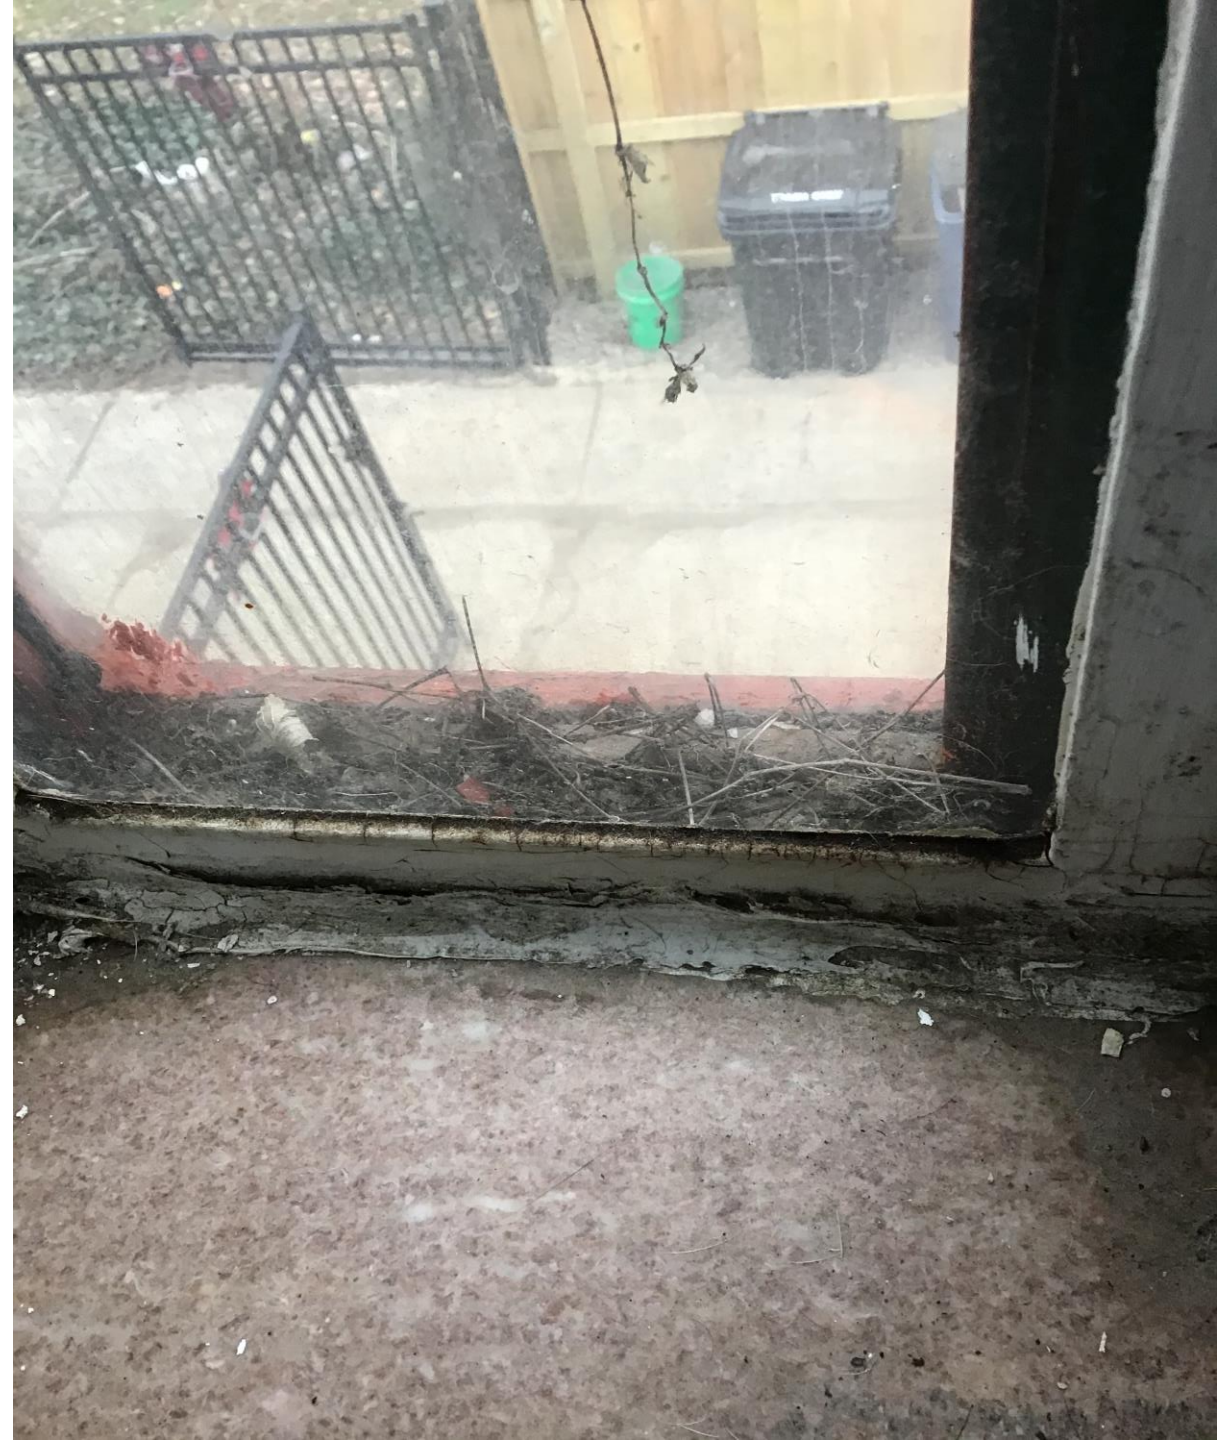
WINDOW OPENING 209 Bedroom – Left Side of House

- Single Casement Window
- Window is in Bedroom
- Window doesn't open
- Exterior of window showing signs of rotting around frame

Window: Casement, Single, Right, Base Frame, 2"
