4138 Lincoln St. Renovation  
Window Details

## 4138 Lincoln St. Renovation

### Existing Window Conditions

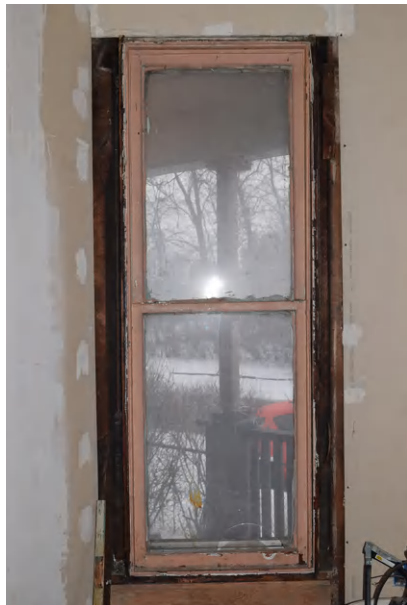
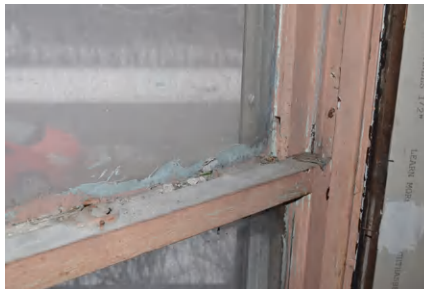
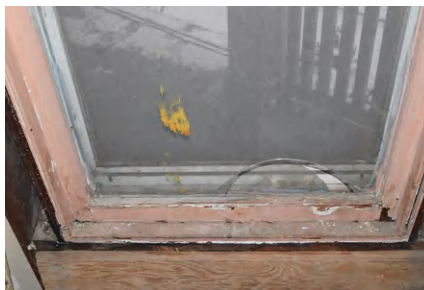
#### Window 1.0

Location First Level, Front Facade (Southwest)  
Operation Double Hung  
Condition Meeting rail is separating from stile, bottom glass broken, closure hardware missing, weights and pulley hardware missing

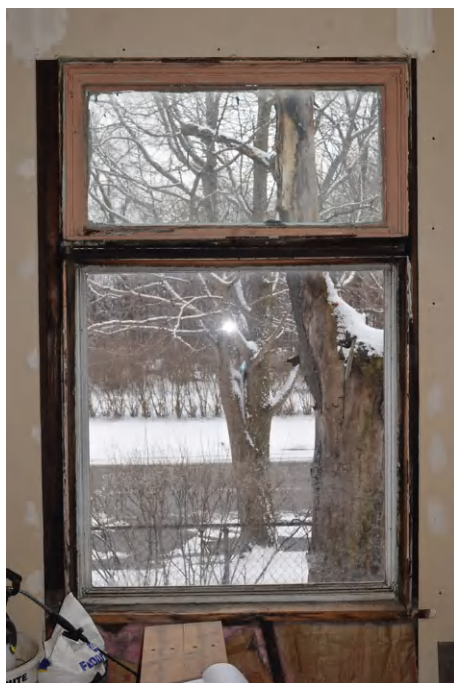
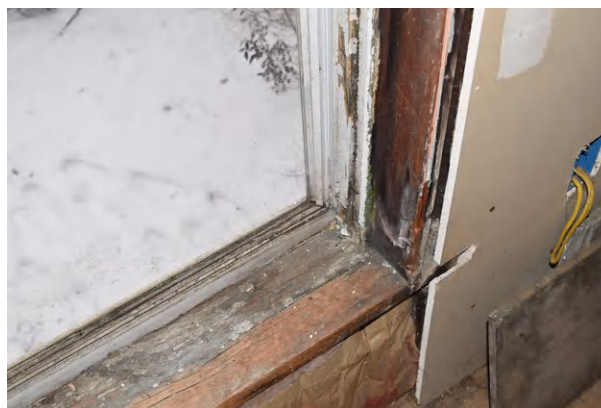
#### Window 1.1

Location First Level, Front Facade (Southwest)  
Operation Fixed (Top and Bottom)  
Condition Entire bottom window missing (storm window only), some water damage at bottom of frame

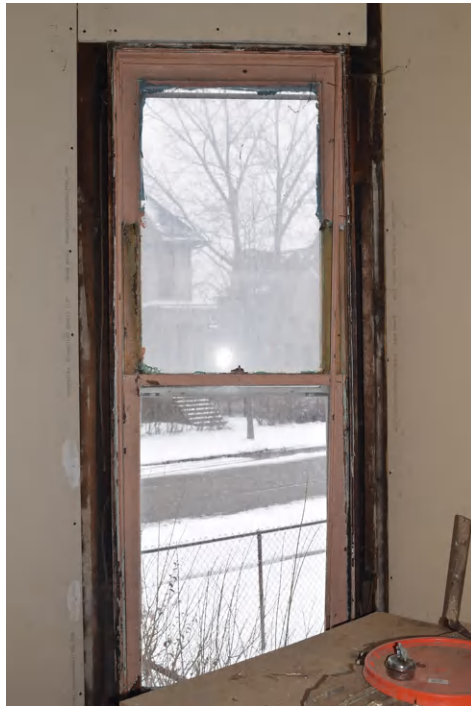
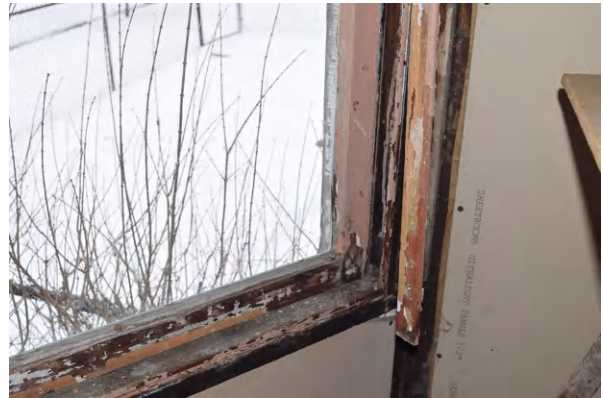
## Window 1.2

Location First Level, Front Facade (Southwest)  
Operation Double Hung  
Condition Water damage to frame, stops are detached, weights and pulley hardware missing

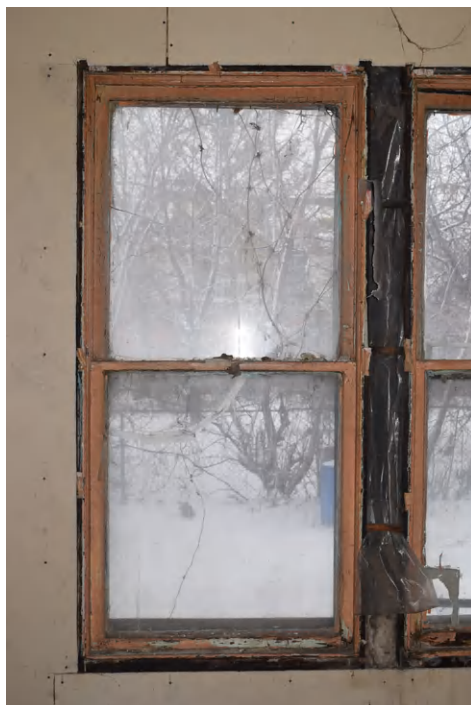
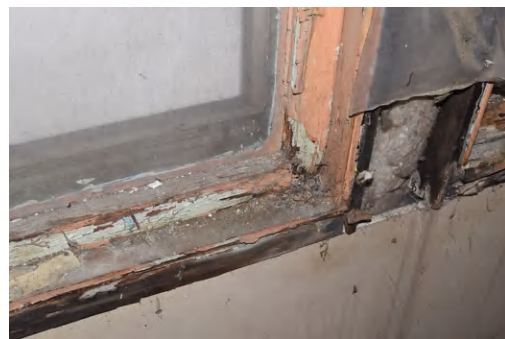
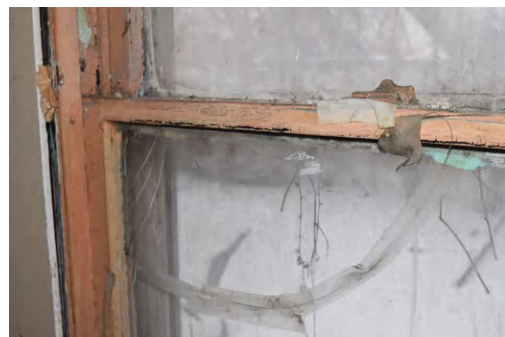
## Window 1.5

Location First Level, Side Facade (Southeast)  
Operation Double Hung  
Condition Water damage to bottom of frame, both glass panes broken, weights and pulley hardware missing

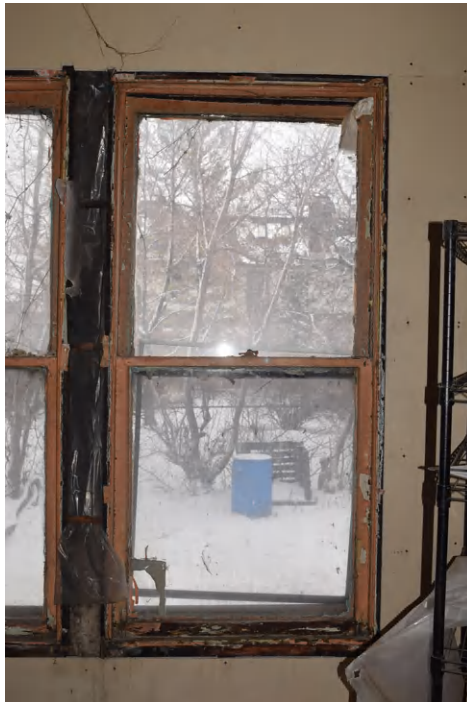
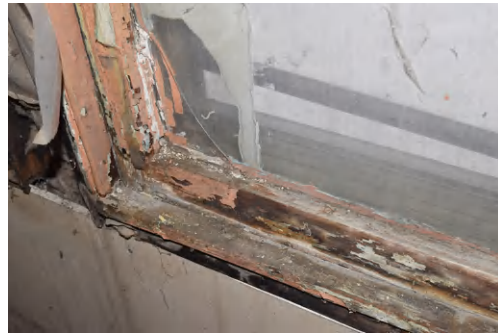
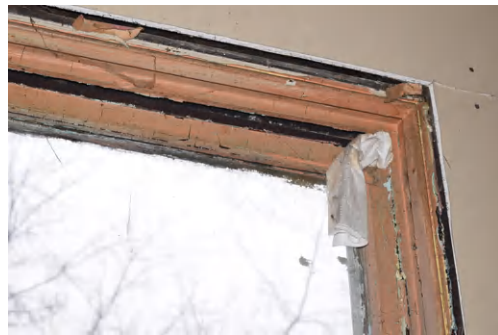
## Window 1.6

Location First Level, Side Facade (Southeast)  
Operation Double Hung  
Condition Water damage at bottom of frame, top sash rail detached from stile, weights and pulley hardware missing

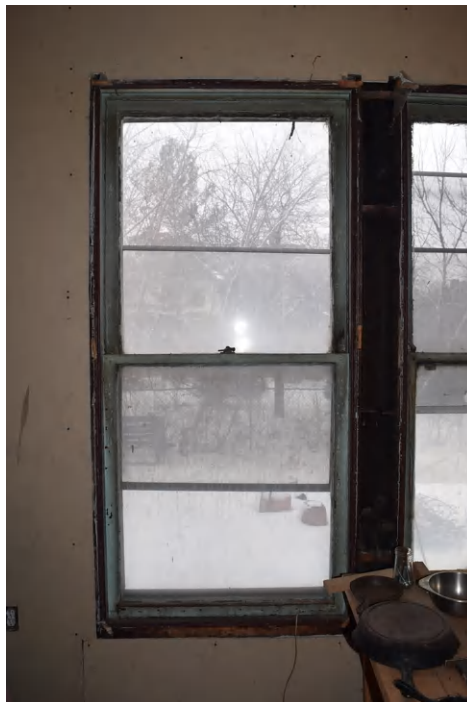
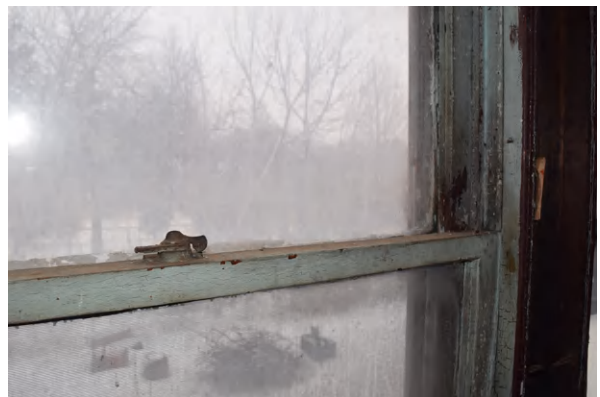
## Window 1.7

Location First Level, Side Facade (Southeast)  
Operation Double Hung  
Condition Some water damage, frame is warping

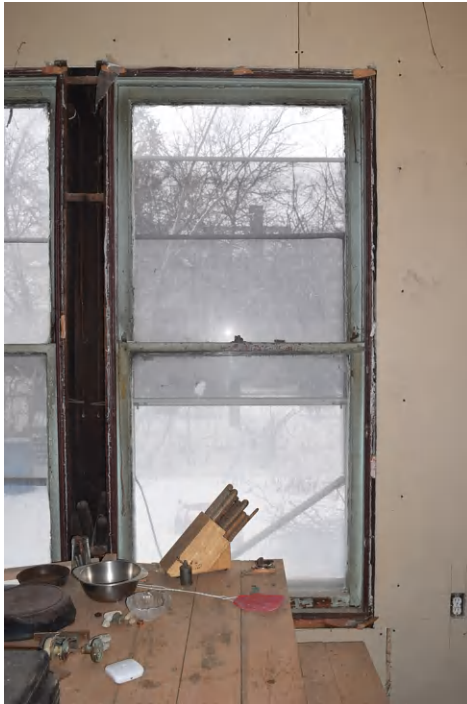
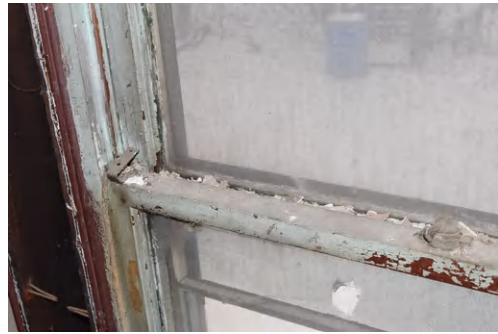
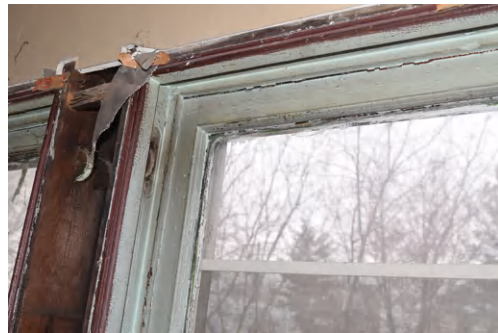
## Window 1.8

Location First Level, Side Facade (Southeast)  
Operation Double Hung  
Condition Top rail of bottom window separating from stile, glass broken

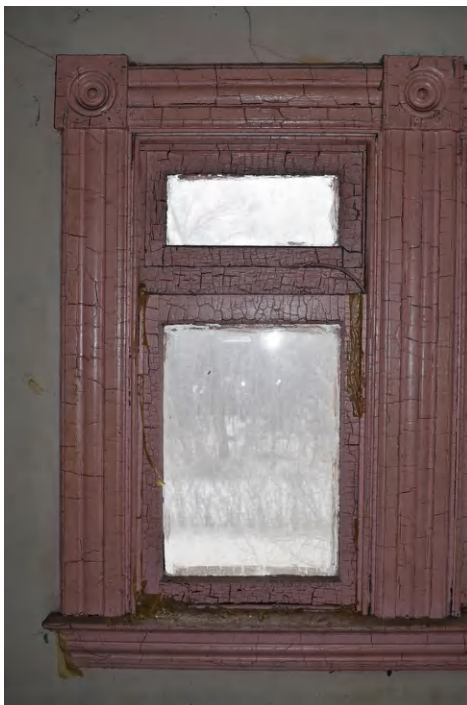
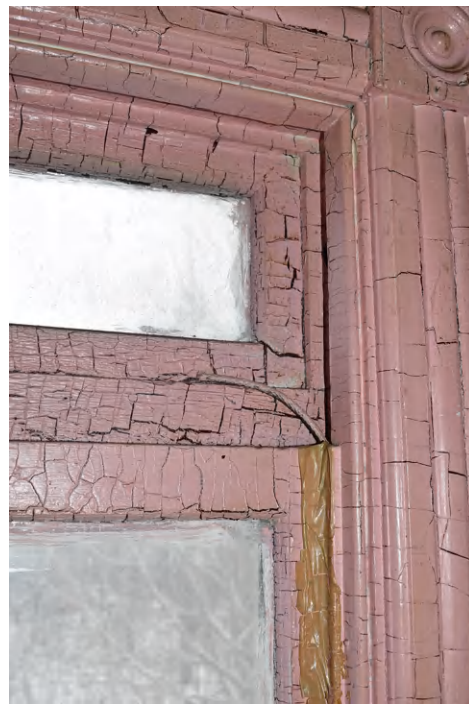
## Window 2.0

Location Second Level, Front Facade (Southwest)  
Operation Single Hung  
Condition Operable sash glued shut, enamel paint on glass

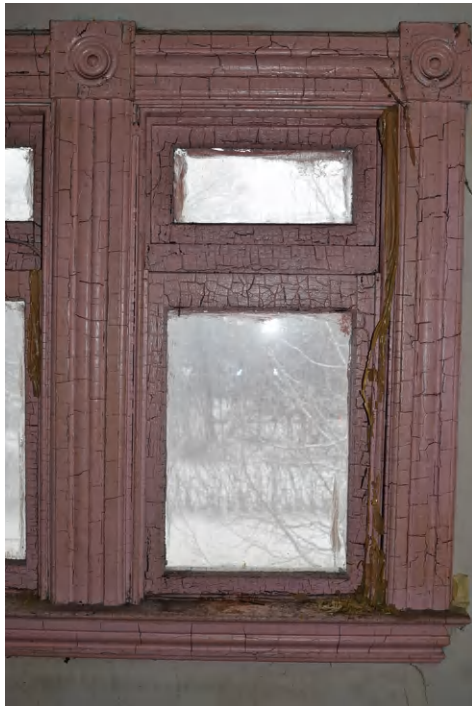
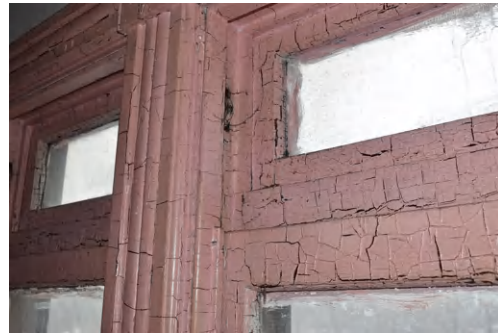
## Window 2.1

Location First Level, Front Facade (Southwest)  
Operation Single Hung  
Condition Operable Sash glued shut, enamel paint on glass

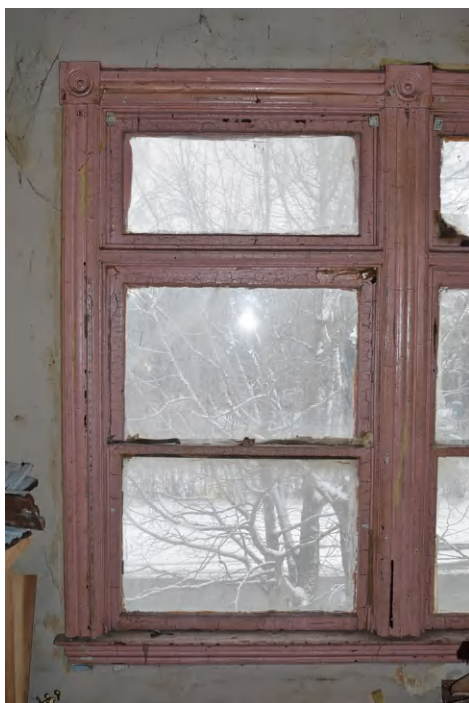
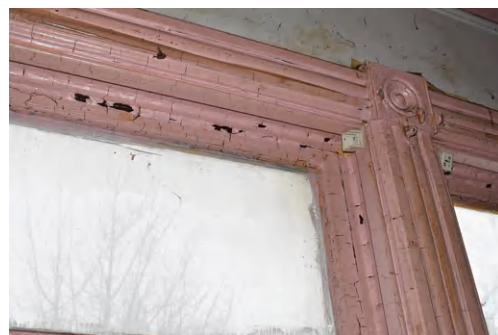
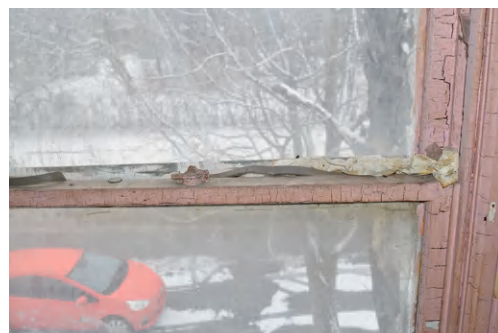
## Window 2.2

Location Second Level, Front Facade (Southwest)  
Operation Double Hung (Bottom), Fixed (Top)  
Condition Enamel paint on glass, some sash warping

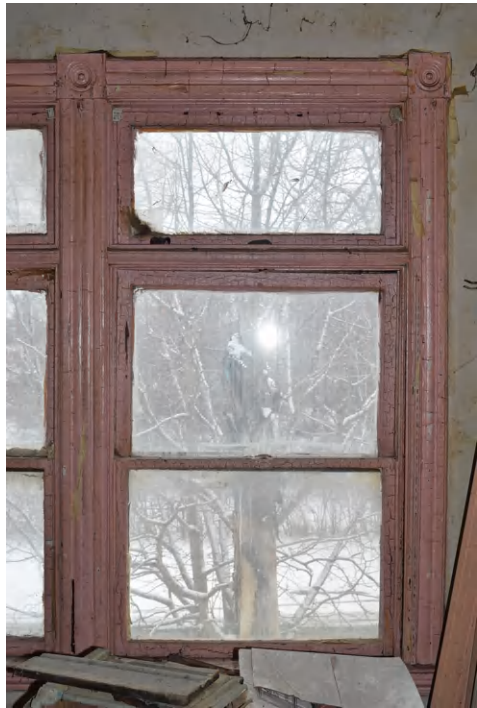
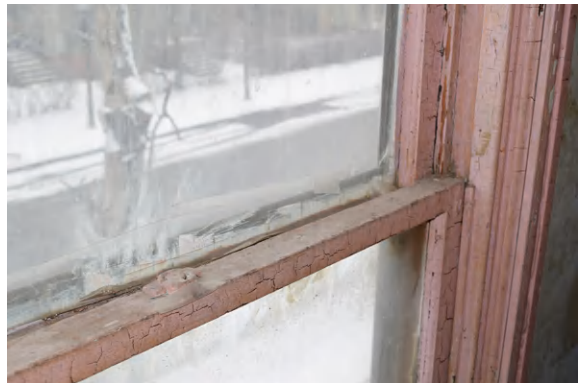
### Window 2.3

Location First Level, Front Facade (Southwest)  
Operation Double Hung (Bottom, Fixed (Top))  
Condition Water damage to bottom sash, broken closure hardware

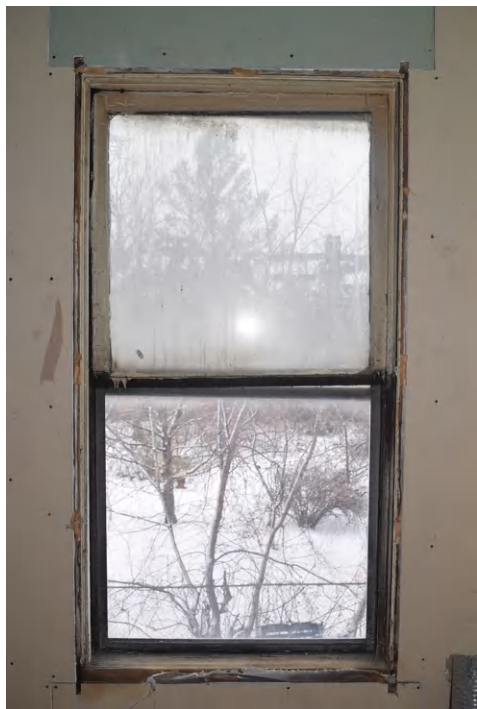
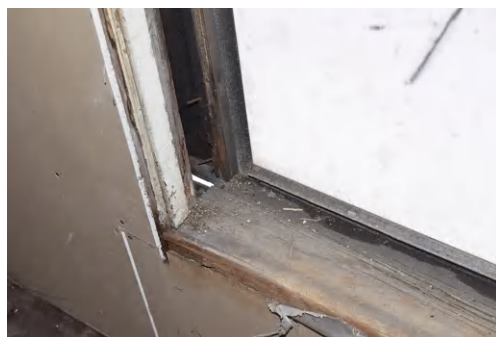
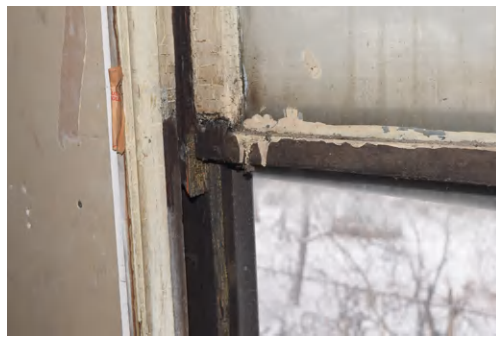
### Window 2.8

Location Second Level, Side Facade (Southeast)  
Operation Double Hung  
Condition Bottom sash and portion of frame missing , water damage across entire frame

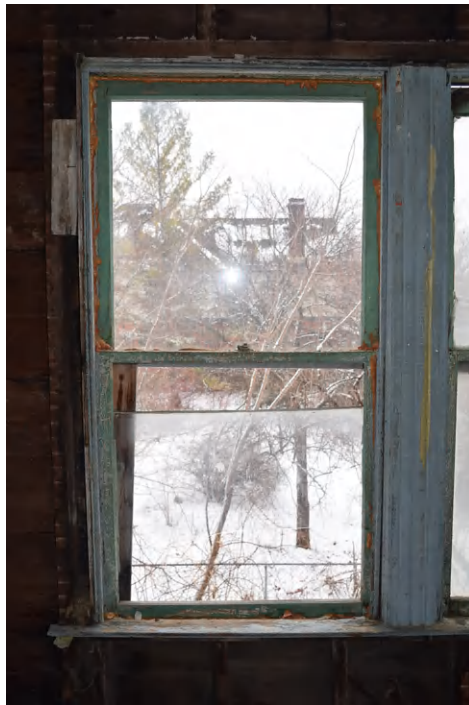
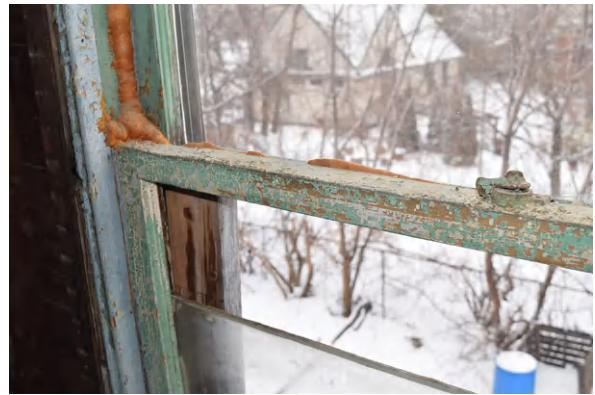
## Window 2.9

Location Second Level, Side Facade (Southeast)  
Operation Double Hung  
Condition Water damage to entire frame, bottom sash glass detached

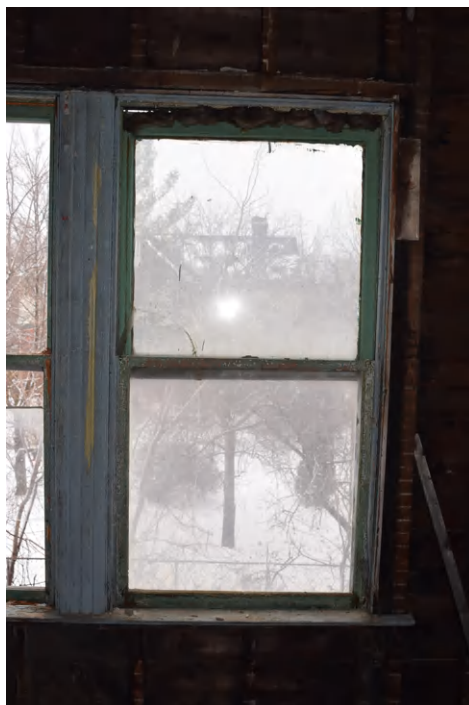
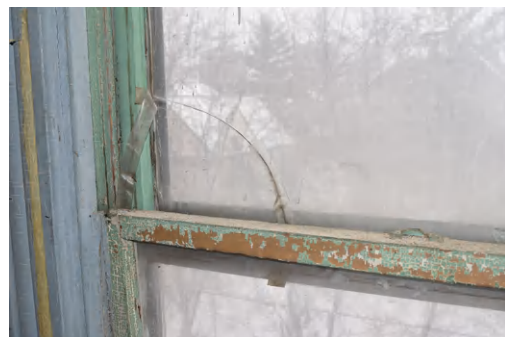
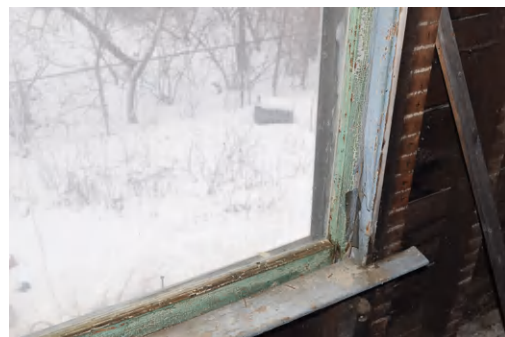
## Window 2.10

Location Second Level, Side Facade (Southeast)  
Operation Double Hung  
Condition Water damage to entire frame, top sash detaching from frame, closure hardware missing, weights and pulley hardware missing

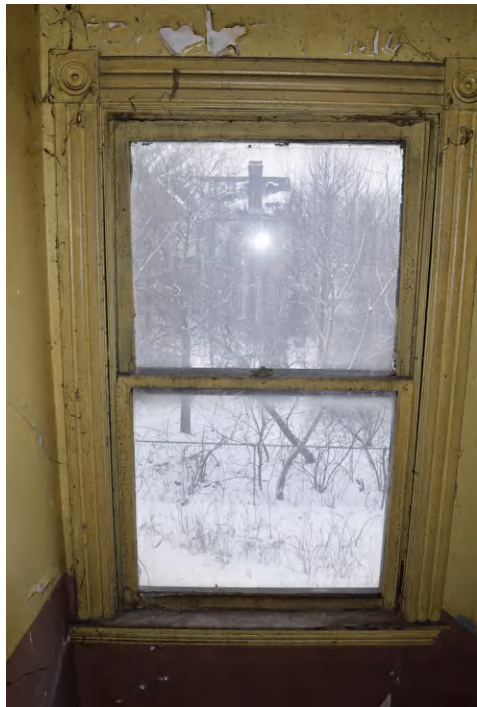
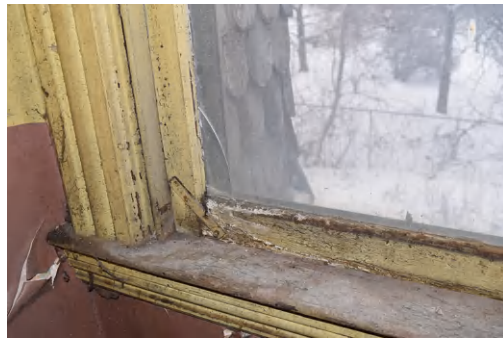
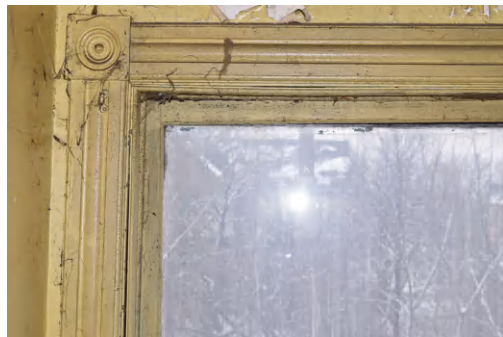
## Window 2.11

Location Second Level, Side Facade (Southeast), Stairway  
Operation Double Hung  
Condition Bottom sash rail detached from stile, some water damage to frame

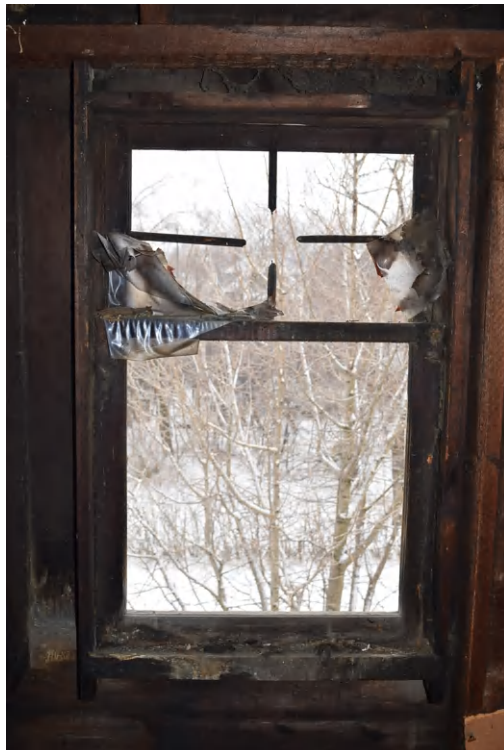
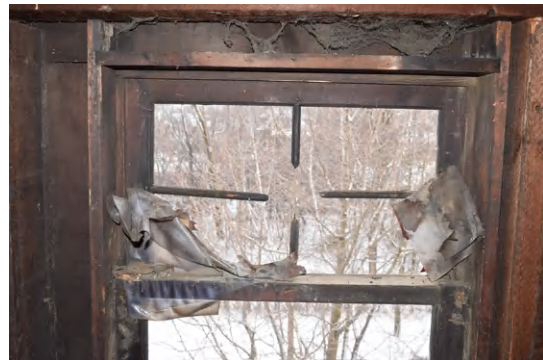
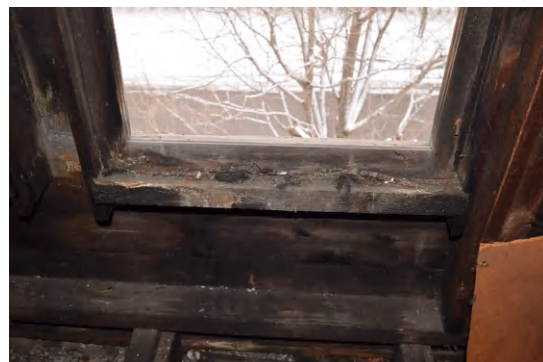
## Window 3.0

Location Third Level, Front Facade (Southwest), Attic  
Operation Single Hung  
Condition Water damage to frame, glass missing from both sashes, gbroken and missing grille

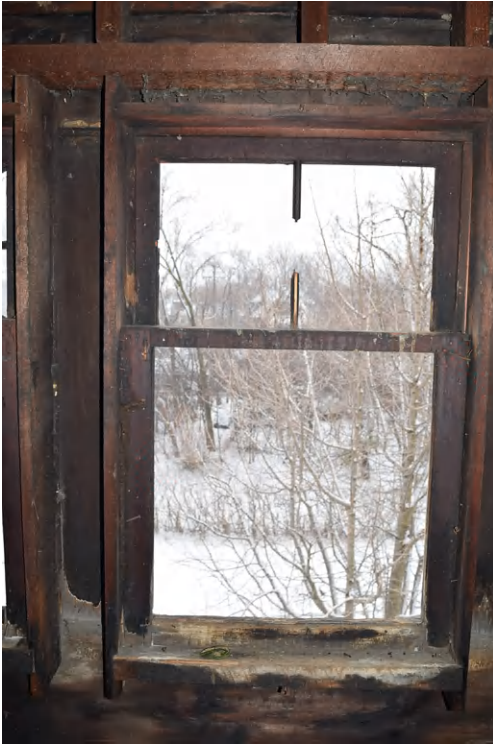
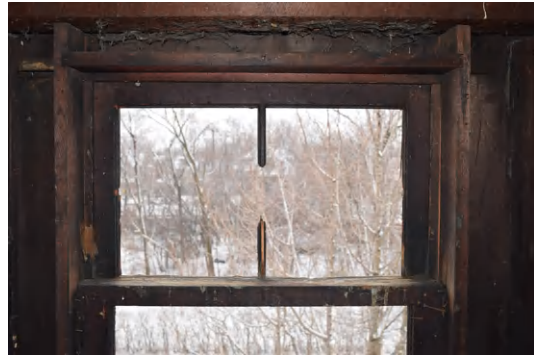
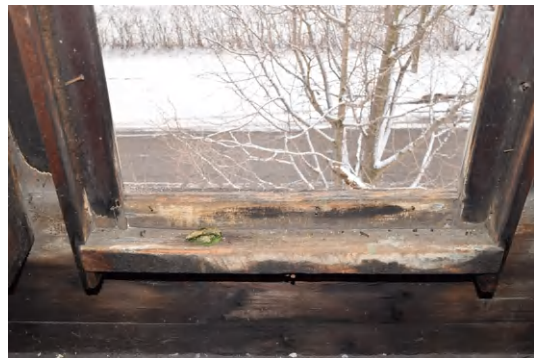
### Window 3.1

Location Third Level, Front Facade (Southeast), Attic  
Operation Single Hung  
Condition Water damage to frame and bottom sash, broken and missing grille, glass missing

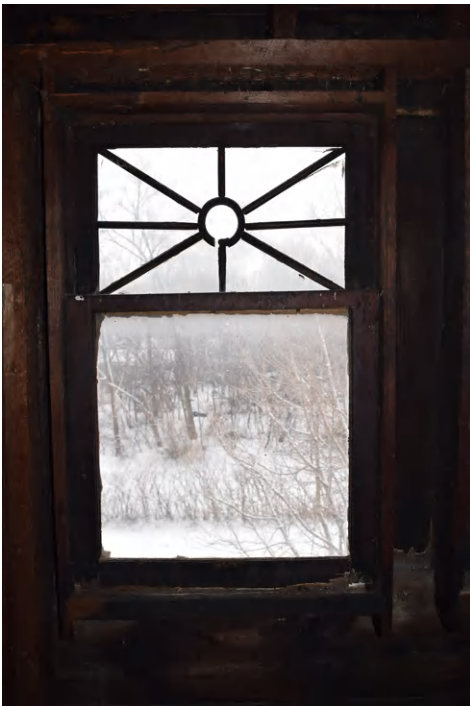
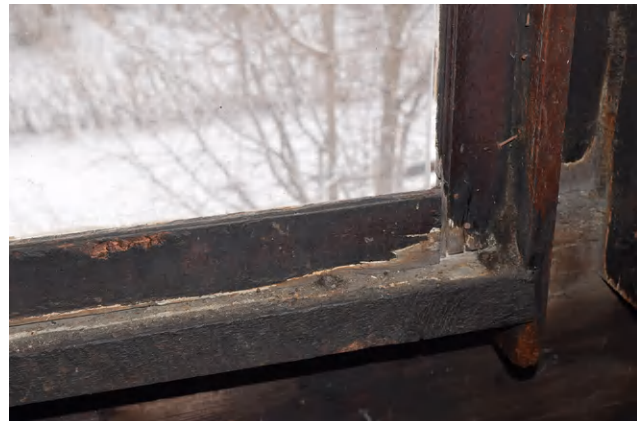
### Window 3.2

Location Third Level, Front Facade (Southwest), Attic  
Operation Single Hung  
Condition Water damage to frame and sash, broken grille
