Mildred Cross
3790 Sturtevant
Detroit MI 48202
Russell Woods District

Renewal by Andersen 37720 Amrhein Livonia, MI 48150

- Customer wants to replace the windows in two openings that currently have wood window units with Renewal by Andersen Fibrex window units.
- Renewal by Andersen windows are Fibrex (wood composite) material
- Windows are located in the front of the house and front right (right when looking at front of home from the road).
- Windows will be red rock and exterior trim will be replaced with something similar (this isn't traditional brickmould)

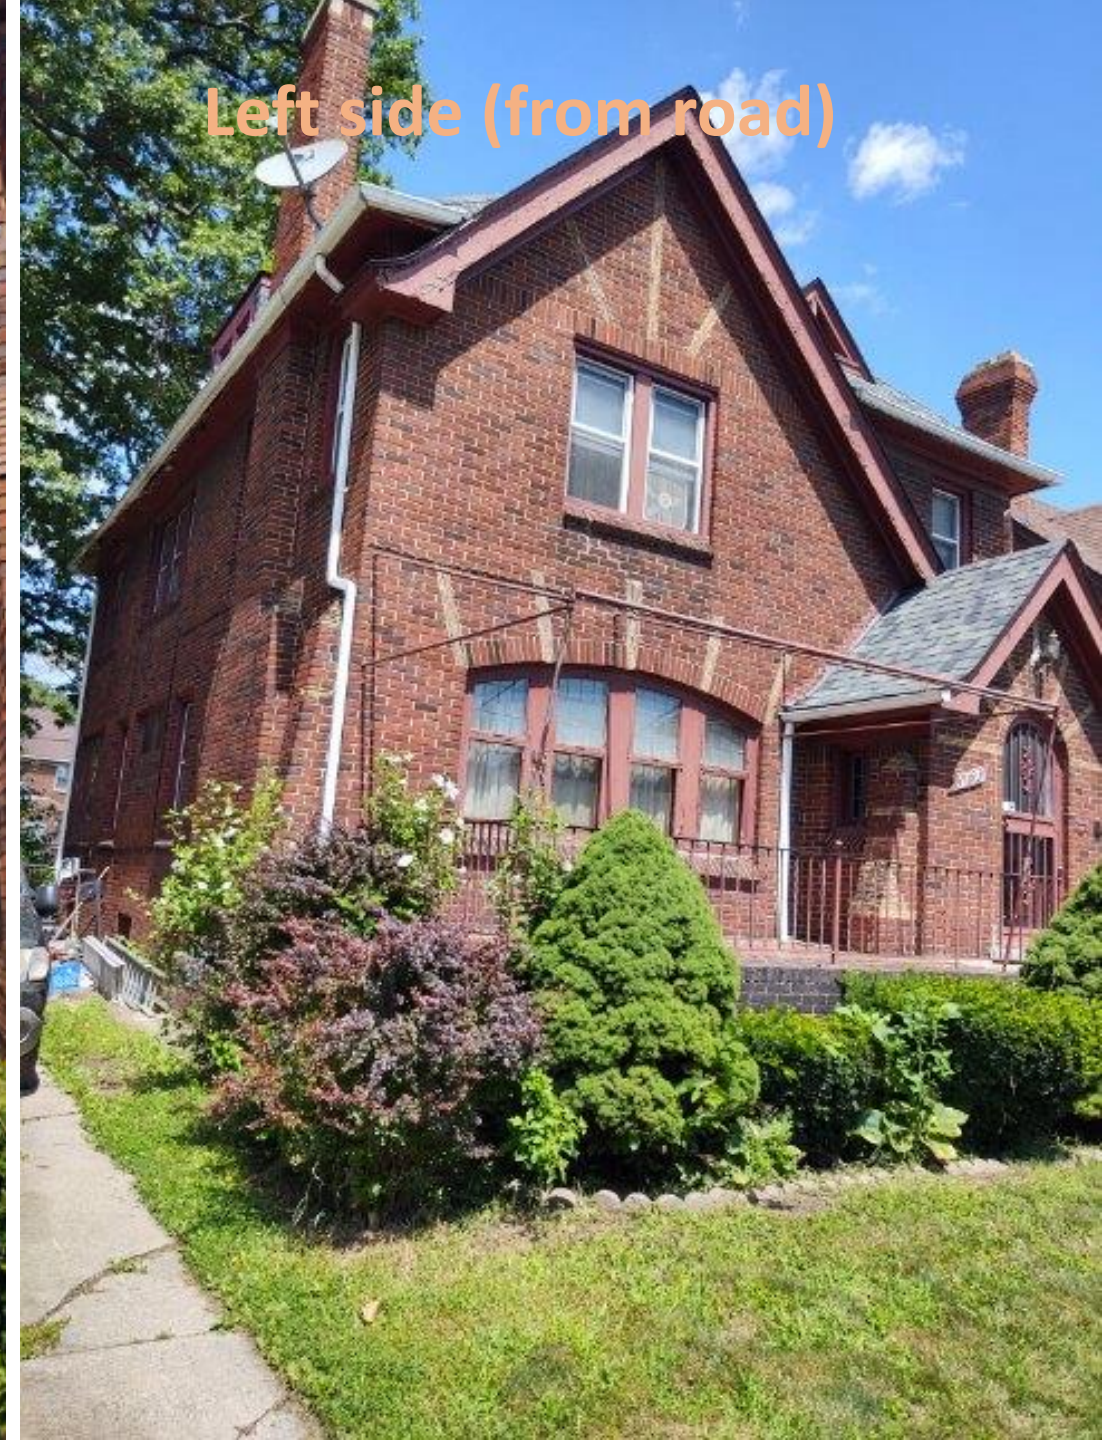
WINDOW OPENING 1

- **Double Hung**
- **Window is in Livingroom**
- **Exterior shows signs of deterioration and exterior has not been maintained**
- **Outside glass “storm windows” are broken out on some of the windows**
- **Interior windows won’t close all the way to lock properly**
- **All “pulley” ropes are broken**

- 110 – Unequal leg arch (non operable)
- 111 – Unequal leg arch (non operable) above an awning (operable)
- 112 – Unequal leg arch (non operable) above an awning (operable)
- 113 – Unequal leg arch (non operable)
- Matching grille pattern currently in the upper sashes with GBG or FDL.
- Fibrex – Wood Composite window
- Red rock exterior color
- No storm window units

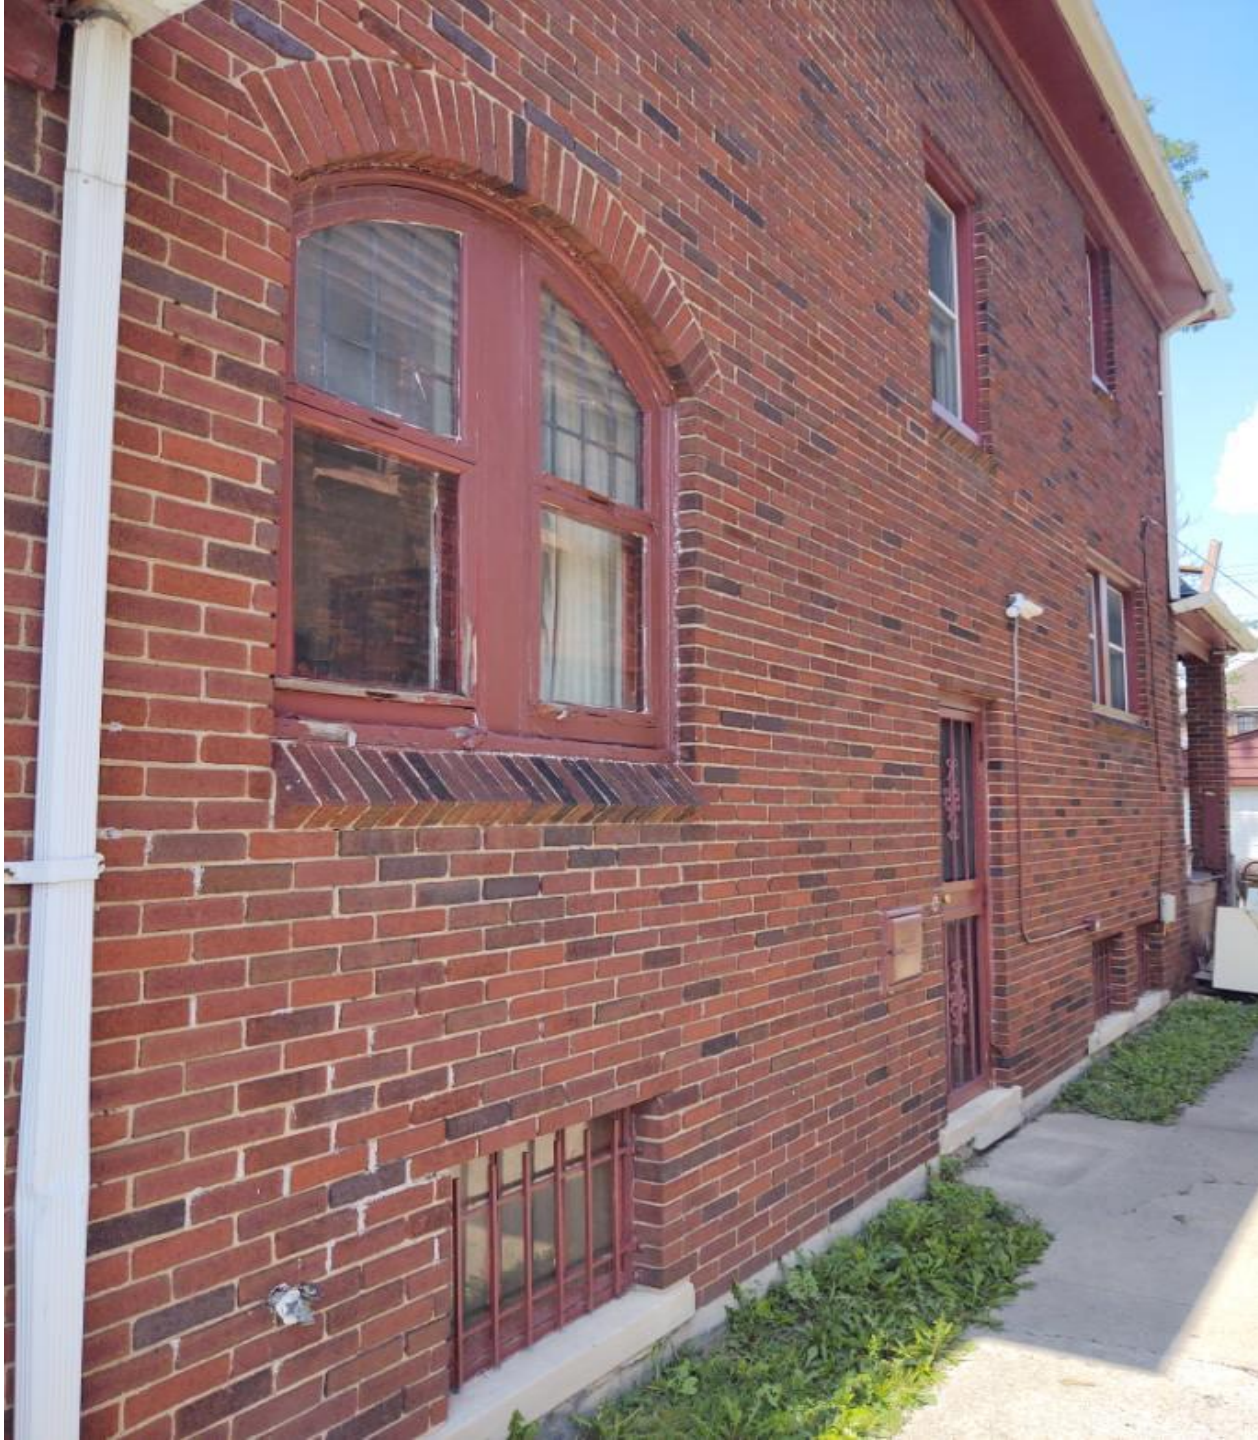
WINDOW OPENING 2

- **Double Hung**
- **Window is at bottom of stairs**
- **Exterior shows signs of deterioration and exterior has not been maintained**
- **Interior windows won't close all the way to lock properly**
- **All "pulley" ropes are broken**

- 101a – Unequal leg arch (non operable)
- 111b – Unequal leg arch (non operable)
- Matching grille pattern currently in the upper sashes with GBG or FDL.
- Fibrex – Wood Composite window
- Red rock exterior color
- No storm window units
