## FIELD OBSERVATION REPORT

*Date:* March 31, 2020 (REV April 10, 2020)      *Project:* Stuberstone Lofts  
Concrete Headers  
*From:* Glen L. Spangler      *Client Project No.:* -  
*To:* Robert Knapp      *DNCE Project No.:* 9819-03  
*Company:* -

Observation Information:      Date: 02/11/2020 @ 430 PM

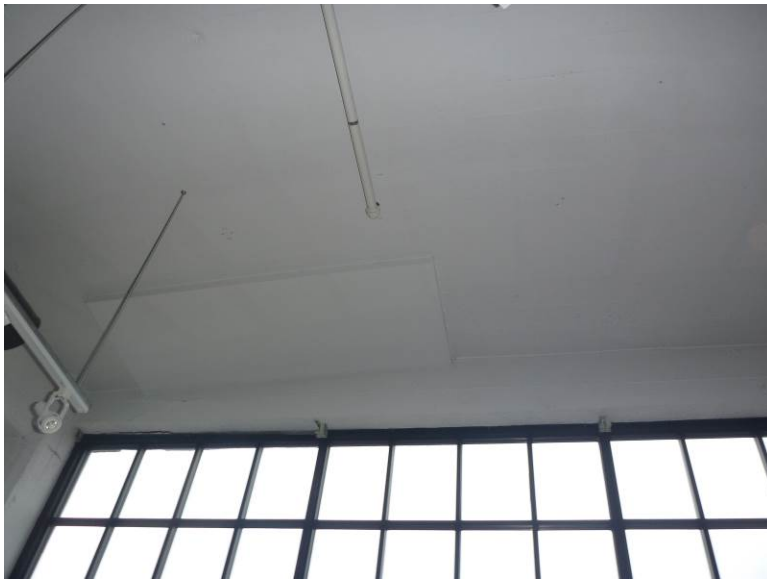
Photo No. 1 – Unit 300

Item No.1:      There is cracking/spalling at the bottom of the beam over the window.

Suggested repair:      Remove delaminated concrete, clean corroded reinforcing steel. The reinforcing steel will need to be evaluated for section loss to determine if additional reinforcement is required. Apply SIKA Armatec 110 EpoCem to resteel. Replace removed concrete with repair mortar (Xypex MEGA MIX II, hand applied). Shoring may be required.

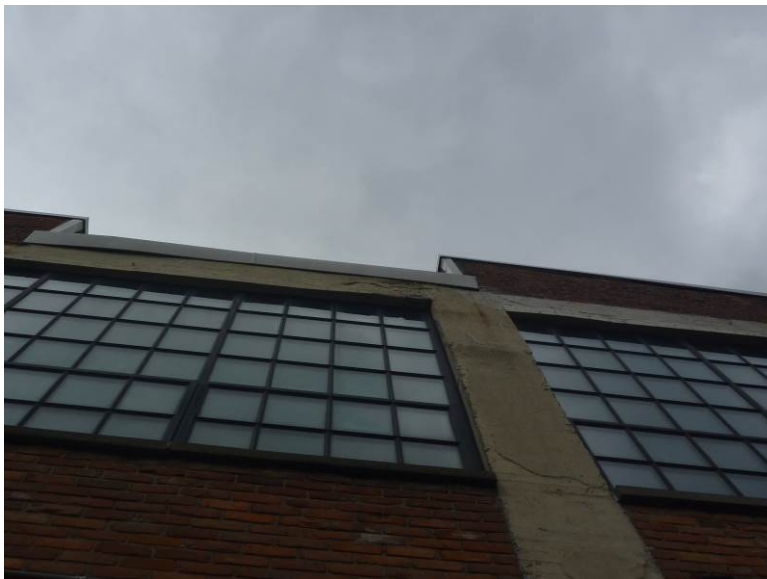
Photo No. 4 – Exterior above Unit 300

Item No. 2:      On the exterior of the building, for the beams both above and below of the windows, there are cracks that appear to have been previously repaired by just filling them with joint sealant. Refer to Photos 4 & 5.

Suggested repair:      Route out cracks. Inject with structural crack repair. If concrete is delaminated, remove delaminated concrete, clean corroded reinforcing steel. Replace removed concrete with repair mortar.

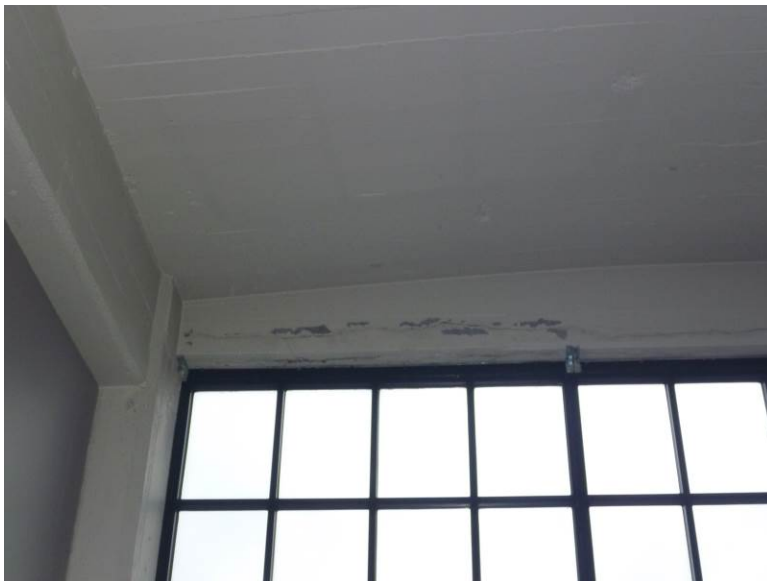
Photo No. 6 – Unit 400

Item No.3: There is cracking/spalling at the bottom of the beam over the window.

Suggested repair: Remove delaminated concrete, clean corroded reinforcing steel. The reinforcing steel will need to be evaluated for section loss to determine if additional reinforcement is required. Apply SIKA Armatec 110 EpoCem to resteel. Replace removed concrete with repair mortar (Xypex MEGA MIX II, hand applied). Shoring may be required.

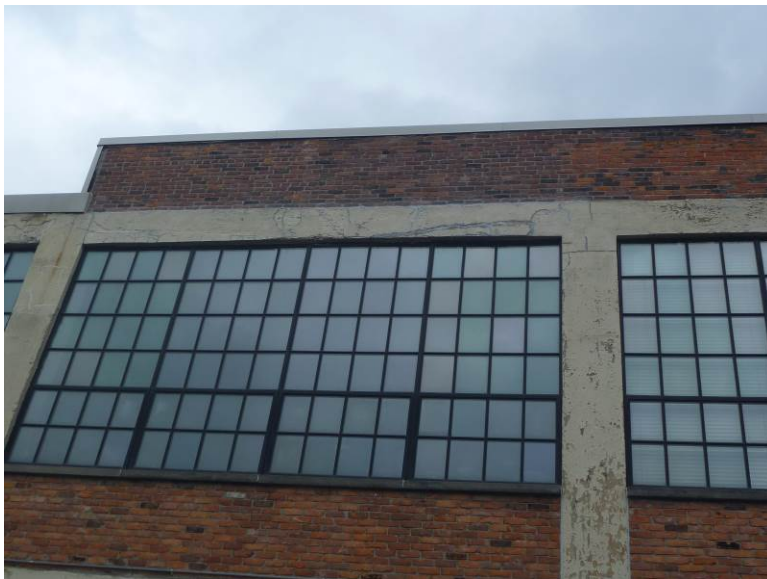
Photo No. 8 – Exterior Unit 400

Item No. 4: On the exterior of the building, for the beams both above the windows, there are cracks that appear to have been previously repaired by just filling them with joint sealant. Refer to Photos 8 & 9.

Suggested repair: Route out cracks. Inject with structural crack repair (SIKADUR 35 HI-MOD LV, Cap seal with SIKADUR HI-MOD GEL). If concrete is delaminated, remove delaminated concrete, clean corroded reinforcing steel. Replace removed concrete with repair mortar.

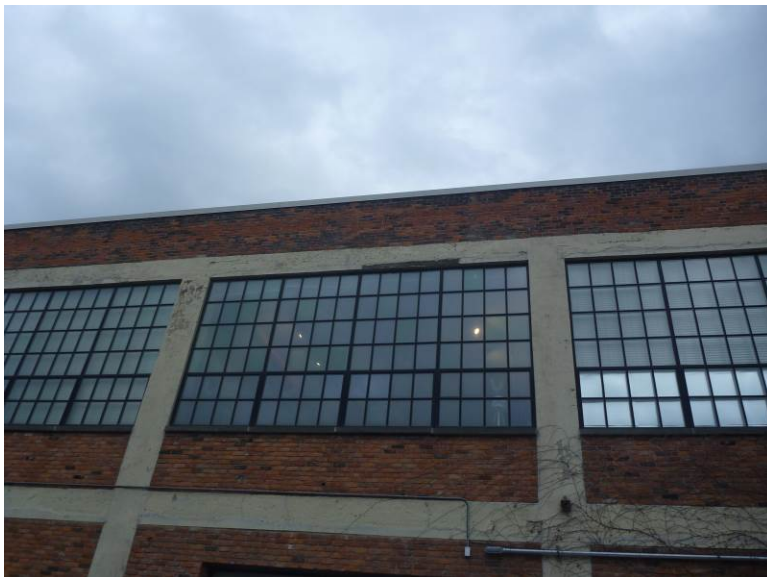
Photo No. 10 – Exterior Above Unit 600

Item No.5: On the exterior of the building, for the beams above the windows, there is some spall  
Refer to Photos 10 & 11.

Suggested repair: Route out cracks. Inject with structural crack repair (SIKADUR 35 HI-MOD LV, Cap seal with SIKADUR HI-MOD GEL). If concrete is delaminated, Remove delaminated concrete, clean corroded reinforcing steel. The reinforcing steel will need to be evaluated for section loss to determine if additional reinforcement is required. Apply SIKA Armatec 110 EpoCem to resteel. Replace removed concrete with repair mortar (Xypex MEGA MIX II, hand applied). Shoring may be required.

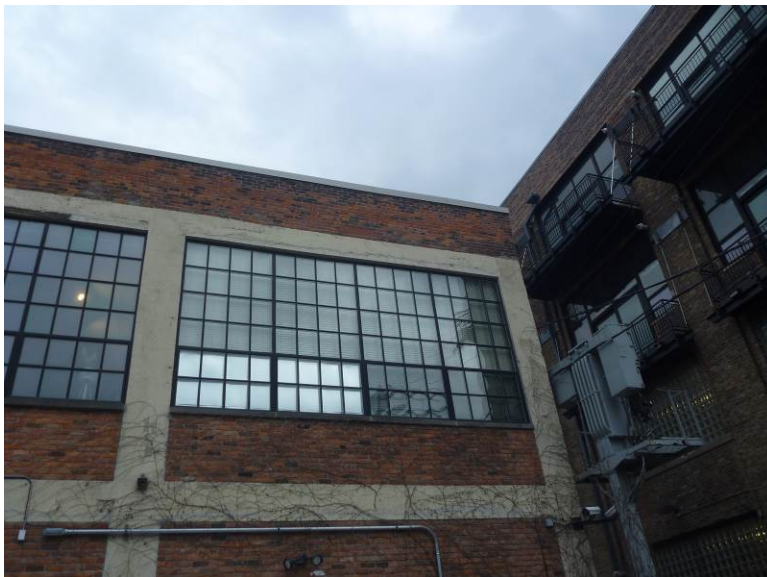
Photo No. 12 – Exterior Unit 700

Item No. 6: On the exterior of the building, for the beam above the windows, there are cracks that appear to have been previously repaired by just filling them with joint sealant. Refer to Photo 12.

Suggested repair: Route out cracks. Inject with structural crack repair (SIKADUR 35 HI-MOD LV, Cap seal with SIKADUR HI-MOD GEL). If concrete is delaminated, Remove delaminated concrete, clean corroded reinforcing steel. The reinforcing steel will need to be evaluated for section loss to determine if additional reinforcement is required. Apply SIKA Armatec 110 EpoCem to resteel. Replace removed concrete with repair mortar (Xypex MEGA MIX II, hand applied). Shoring may be required.
