**Stuber Stone Lofts – Concrete Header Beam  
Delamination Survey**

**June 18<sup>th</sup>, 2020**

## **Delamination Survey:**

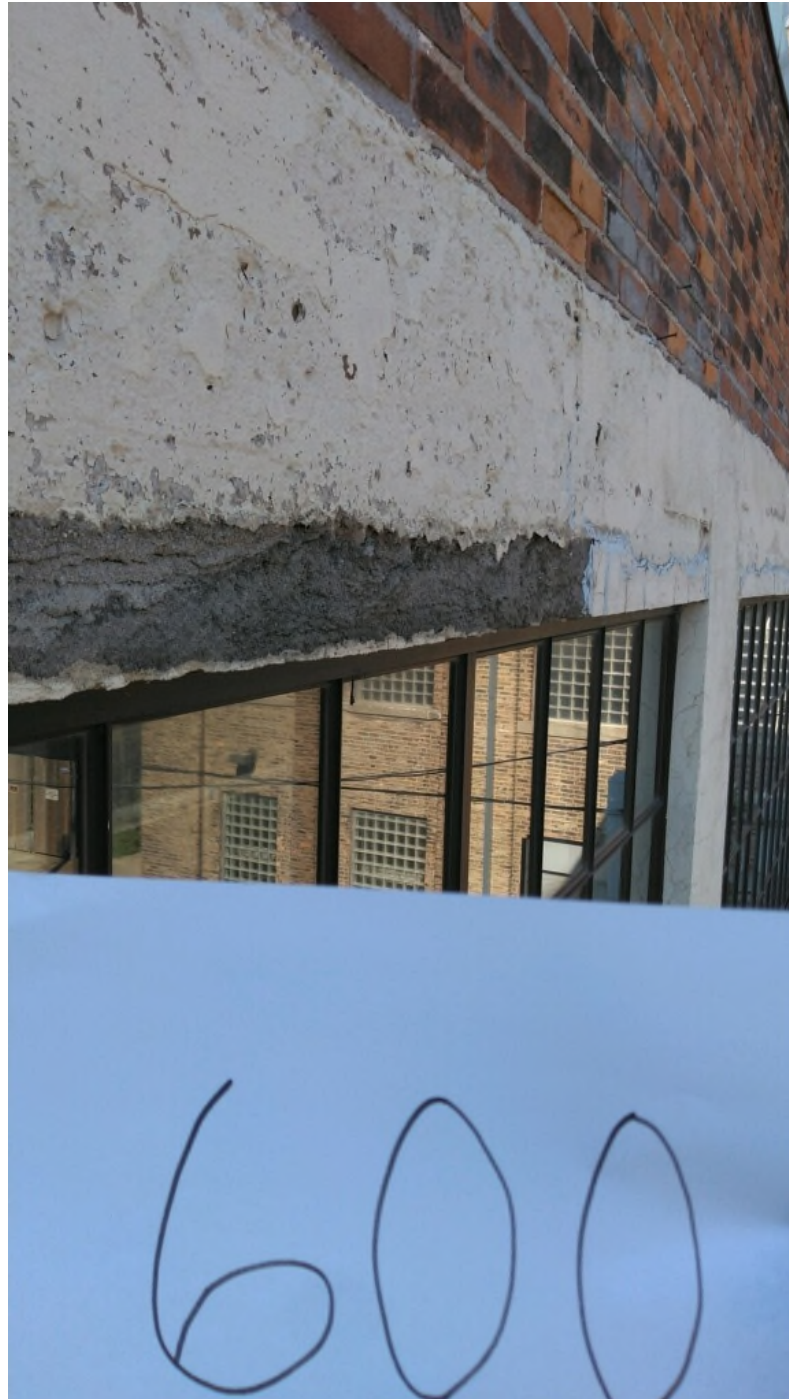
**Unit #600:**

Unit #600 was visually inspected from the interior and hammer sounded from the exterior. During the survey, we noted an area of severe delamination at a location near the bottom of the beam (above the window). No large crack separation was visible; however, there were several locations of small cracks near the damaged concrete. Pullman recommends fixing these areas to eliminate falling debris hazards (both inside and outside) and the potential for growth of the deteriorated areas.

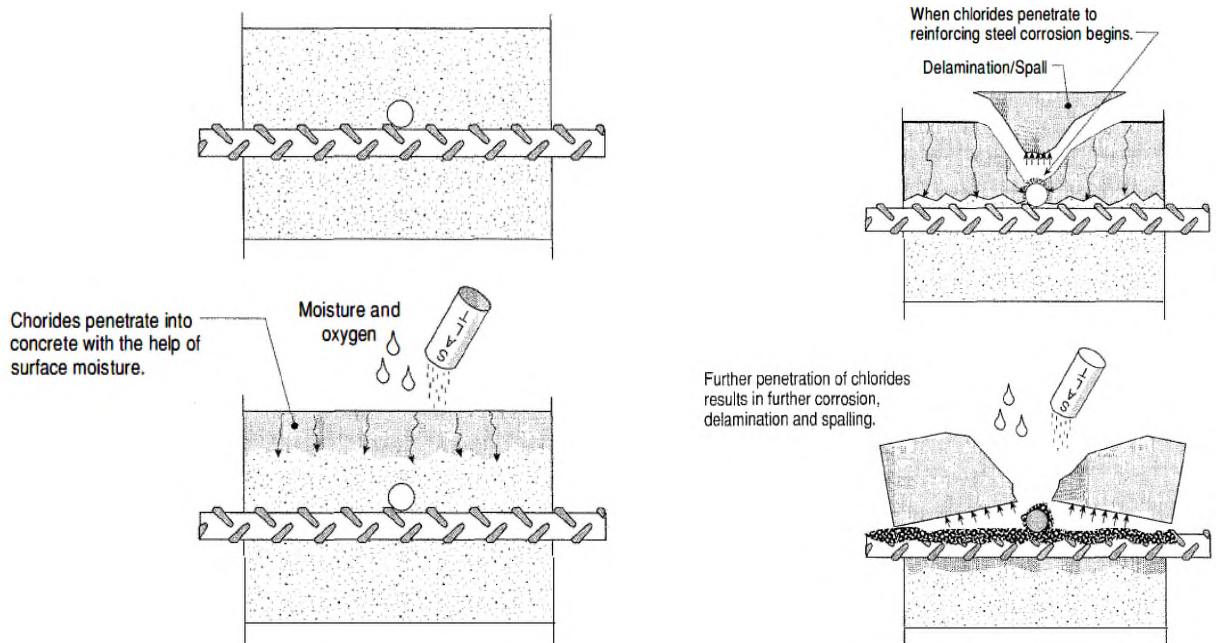
The damage caused by freeze-thaw damage can eventually lead to more harmful causes of concrete deterioration by eventually exposing reinforcement steel and enhancing the corrosion process. Often, this corrosion is accelerated by exposure to moisture, chloride contamination and carbonation. The volume of steel corrosion byproduct (i.e. rust) is up to ten times larger than the steel, and the forces incurred when the embedded steel corrodes causes concrete distress in the form of cracks, delamination, or spalls within the concrete.
