# LIVING ROOM - Side A

# Family Room / Living room 7

## 1<sup>st</sup> floor

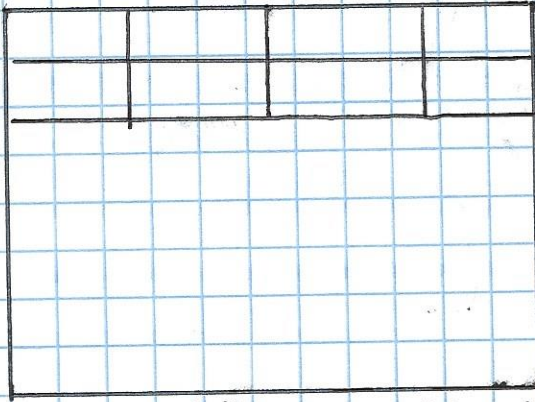
1/3 - 2/3  
DOUBLE  
HUNG

← 56" BRICK TO BRICK →  
FIXED UNIT

- Brickmole VARIES IN SIZE FROM 1 1/4" - 1 1/2" - 1 3/4" - 2" NOT UNIFORM
- THESE ARE IN A BRICK OPENING, JUST ALL PAINTED TRIM
- FIXED STORM WINDOW IN POOR NON-WORKING CONDITION

- New W/IZs  
will be  
within 3/8"  
on all edges  
& frame

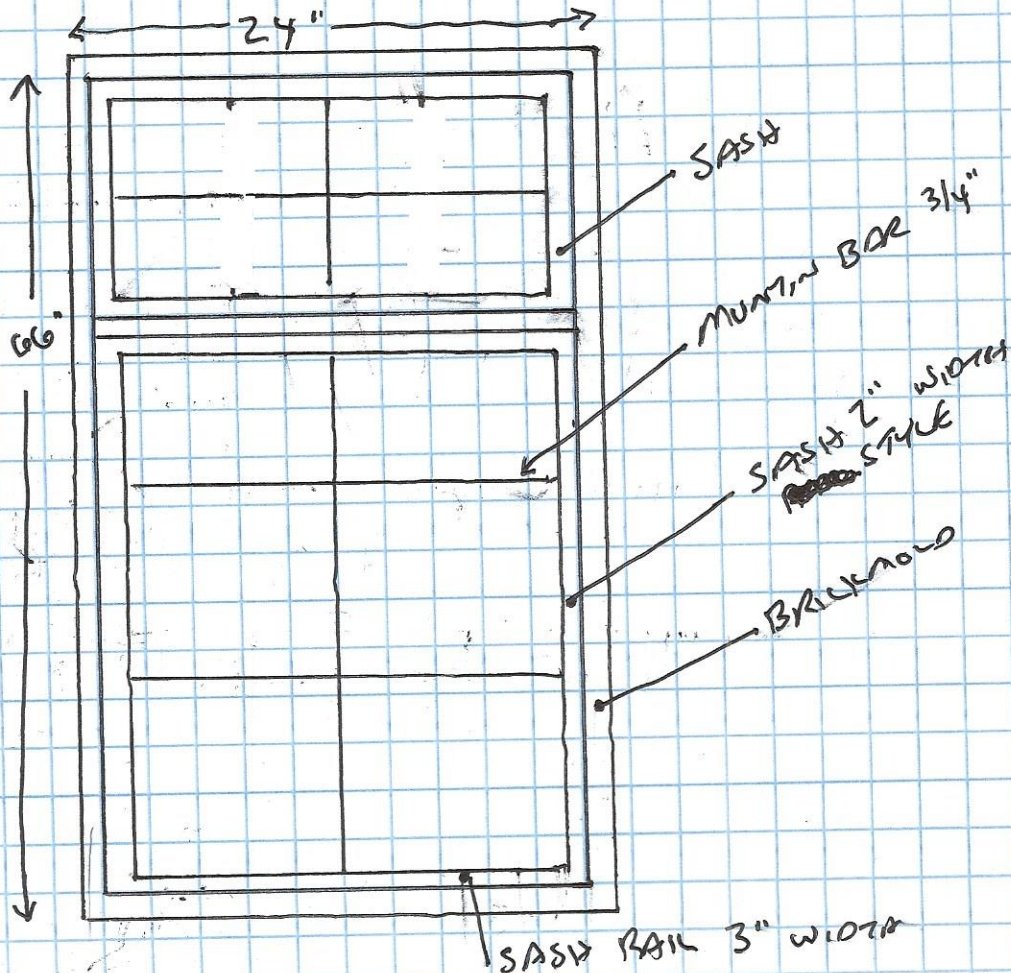
DRAWING OF  
SIDE  
DOUBLE HUNG  
ON FRONT  
WINDOWS

SASH RAIL 3" WIDTH

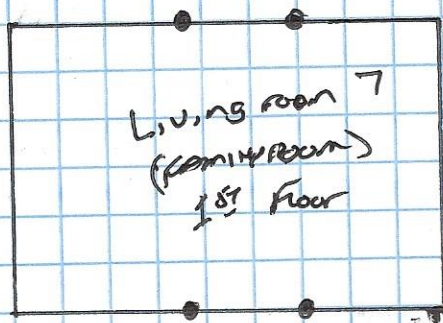
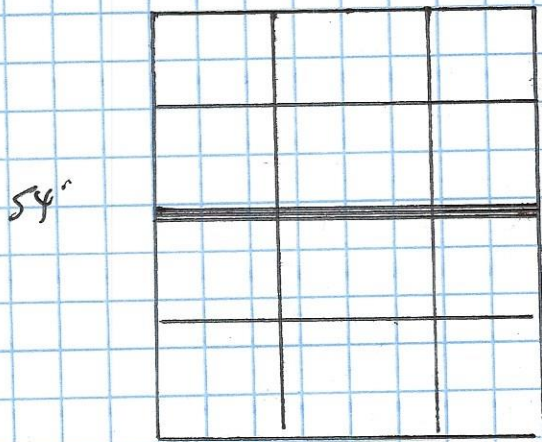
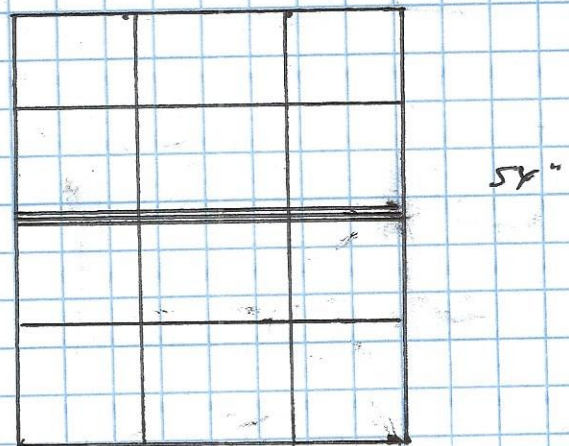
44' = FRONT ASIDE = 44'

- These windows are set in brick openings
- Brick mold varies on perimeter from 1 1/2" - 2" in width
- New units will be within 3/8" of original frame
- Sash frames & glass type are the same as all others
- Mullion bars are laid on glass on both sides  
3/4" width. new will be 7/8" width & size.  
New will also lay on glass.

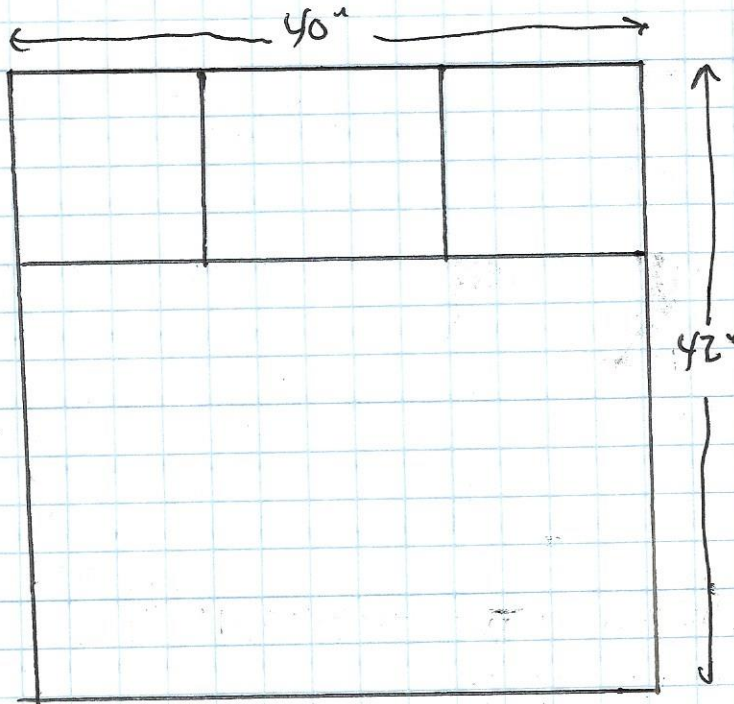
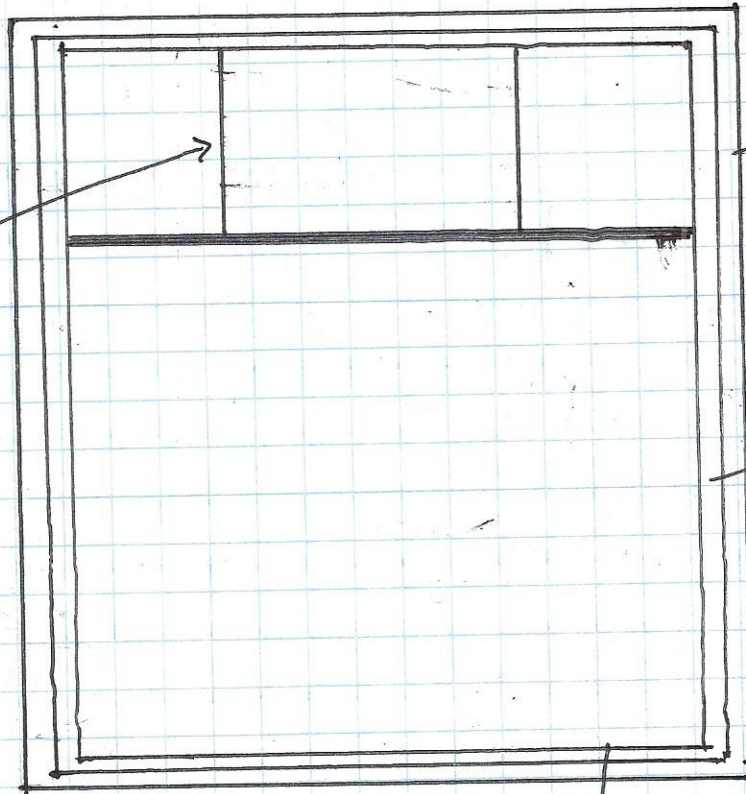
# KITCHEN - Rear 1<sup>st</sup> floor

- Brick opening
- Colored muntin bars on upper sash only
- Brick mold varying from 1 1/4" - 2" on sides.
- No trim is painted white
- No storm window is present. Broken & missing

40/100  
1 2/3  
Double  
Hung

Muntin bars  
colored sash  
3/4" each

BRICK MOLD VARIES  
IN SIZE

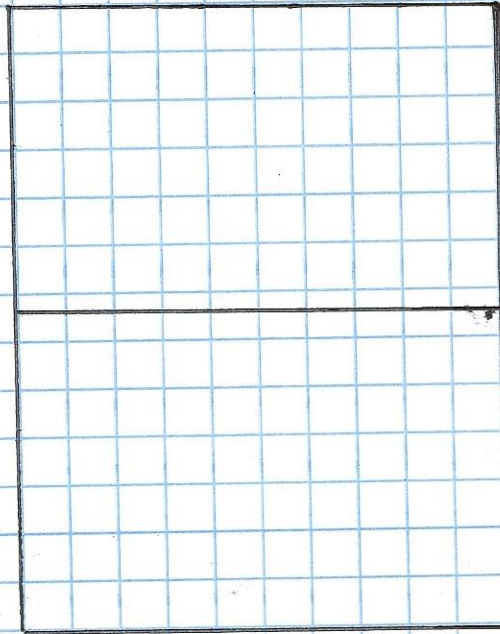
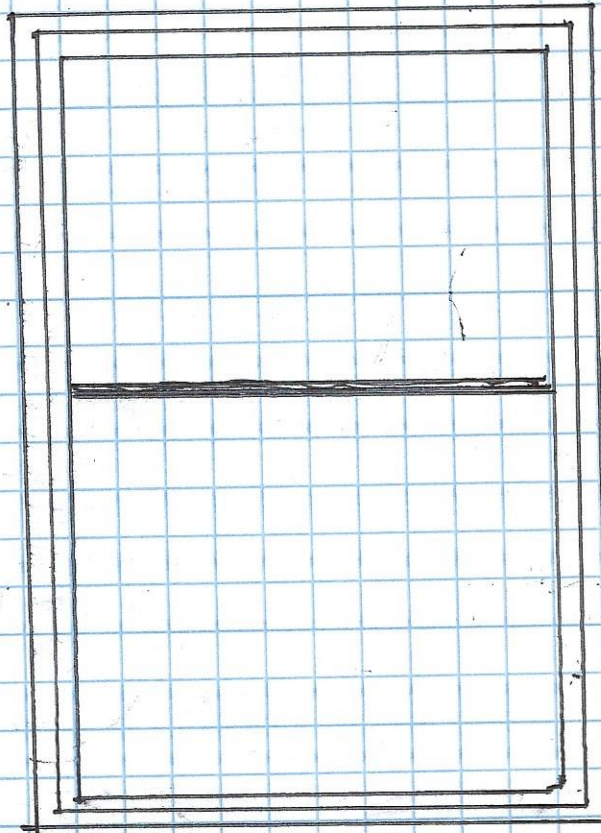
1/2 BATH = 1<sup>st</sup> FLOOR REAR

- Double Hung Unit
- Glass has been changed over the years. ↳ no longer has metal bars / colored bars on glass

- This window is on 1<sup>st</sup> floor rear side D
- Brick opening
- No storm window on ext<sup>o</sup>
- Security Bars will be taken off

- Current glass has an obscure film stuck to glass to frost glass

- original would have had colored grids / window bars

- Brick mold varies on thickness of 1 1/4 - 1 3/4"
- SASH frame is the same as all others
- new units will have original ~~bars~~ & colored grids put back on glass

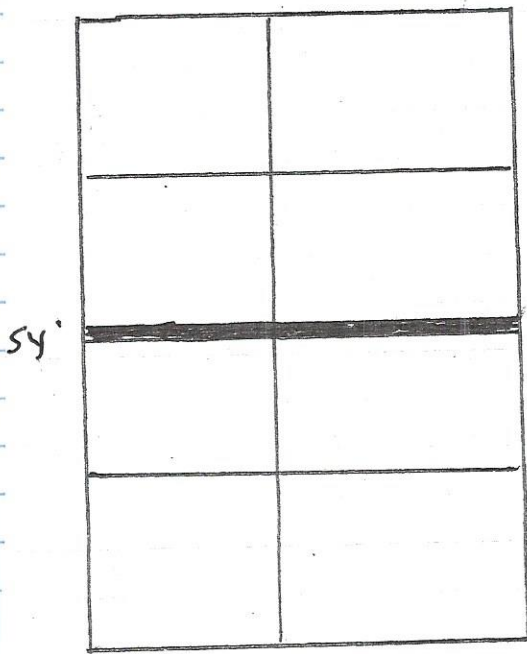
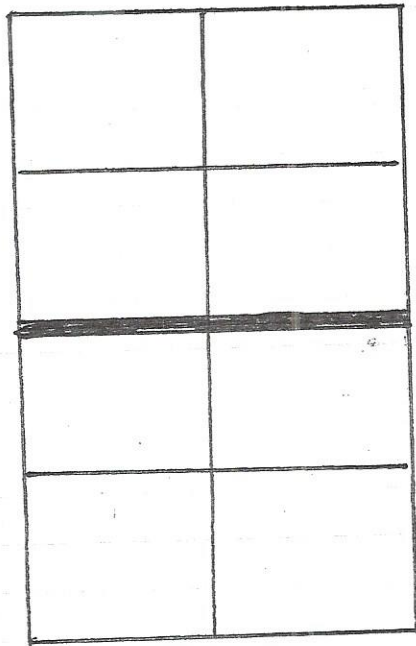
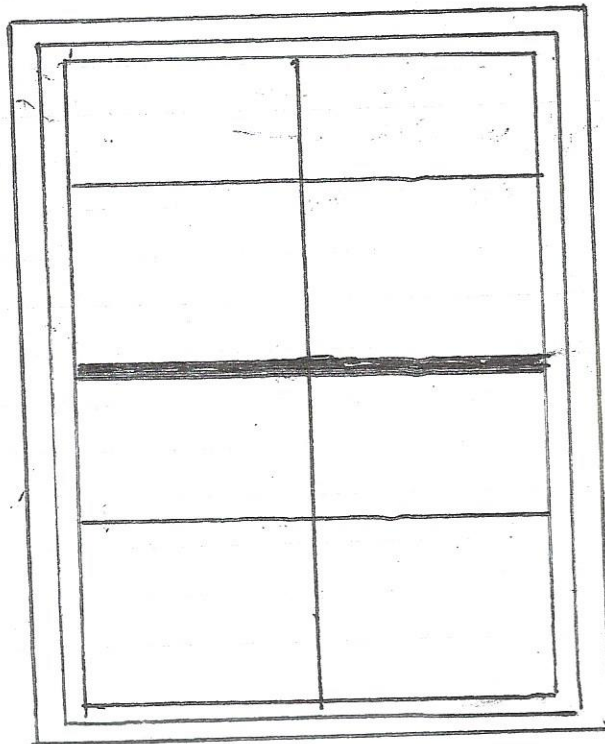
24' REAR SIDE C 24'

- These window units are in Brick openings
- Brickmole varies  $1\frac{1}{2}$  - 2" in dimension on perimeter
- Colored muntin bars laid on glass  $3\frac{1}{4}$ " wide
- Aluminum storm doors are broke & poor condition, missing parts

- Brickmole varies from  $1\frac{1}{4}$ " - 2" on sides

- Sash frames are the same as others.

- muntin bars are laid on glass
- ↳ new units will have muntin bars on glass.  $7\frac{1}{8}$ " in width

- New units will be within  $3\frac{1}{8}$ " of original size on all sides of frame

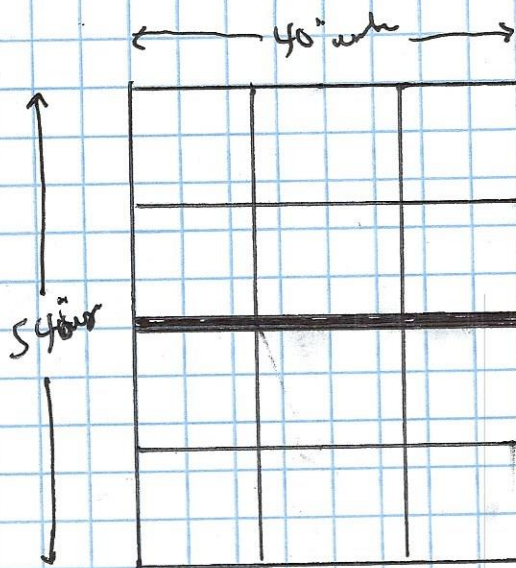
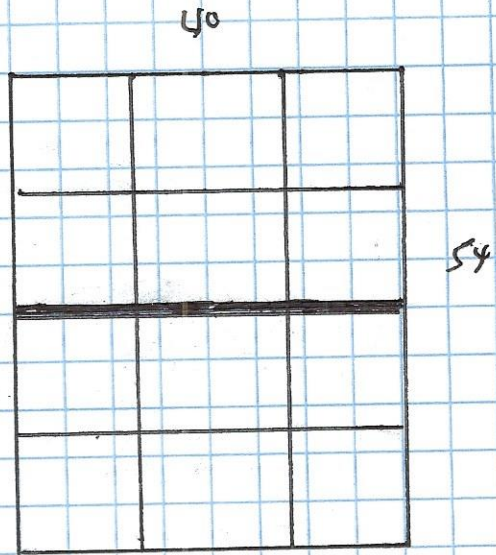
# FRONT UPPER BEDROOMS - SIDE A

COLONIAL  
MUNTIN STYLE  
BARS  
ON  
UNITS  
6/6

- Double Hung 50/50
- Brick molo is wrapped with aluminum trim coil
- Perimeter of windows is BUTTERED w/ Aluminum siding
- Window TRIM & SIDING are white aluminum

- New units will be within 3/8" of sink on all edges of frame

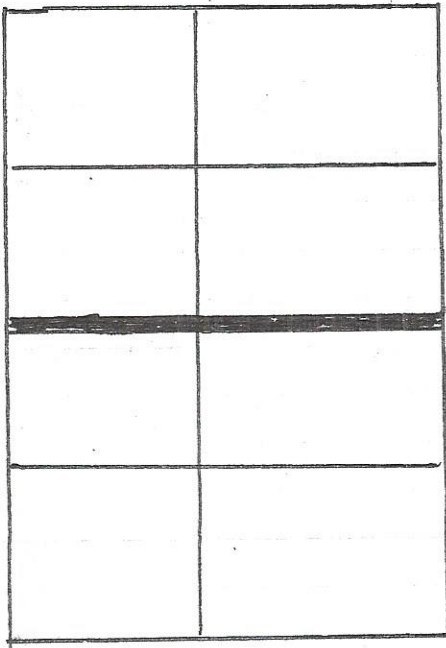
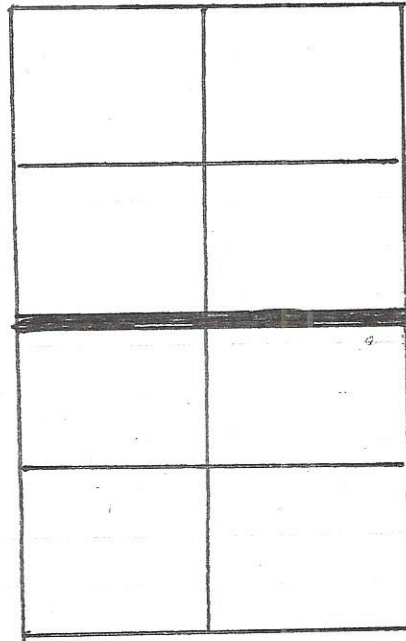
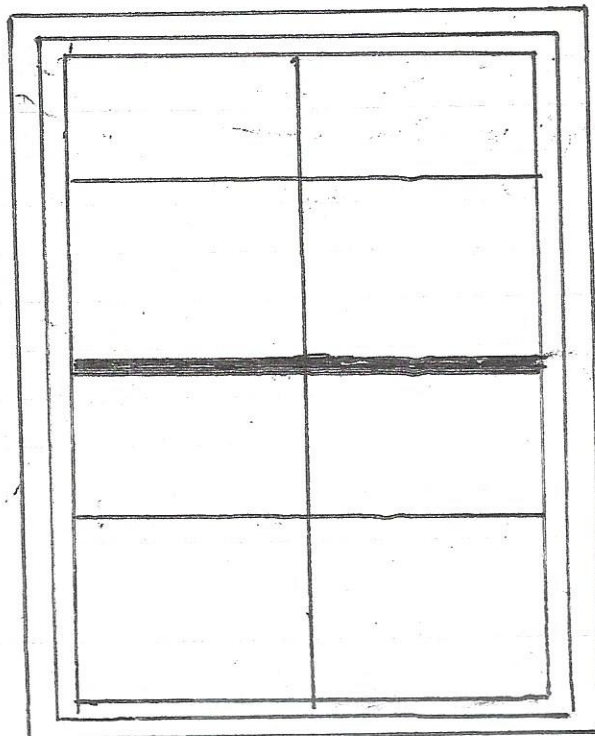
# Upper Side D

- These window units are in Brick openings
- Brick mullion varies  $1\frac{1}{2}$  - 2" in dimension on perimeter
- Colored muntin bars Laid on glass  $3\frac{1}{4}$ " wide
- Aluminum storm doors are broke & poor condition, missing parts

- Brick mullion varies from  $1\frac{1}{4}$ " - 2" on sides

- Storm frames are the same as others.

- mullin bars are Laid on glass

- New units will be within  $3\frac{1}{8}$ " of original size on all sides of frame

- ↳ New units will have mullin bars on glass.  $7\frac{1}{8}$ " in width

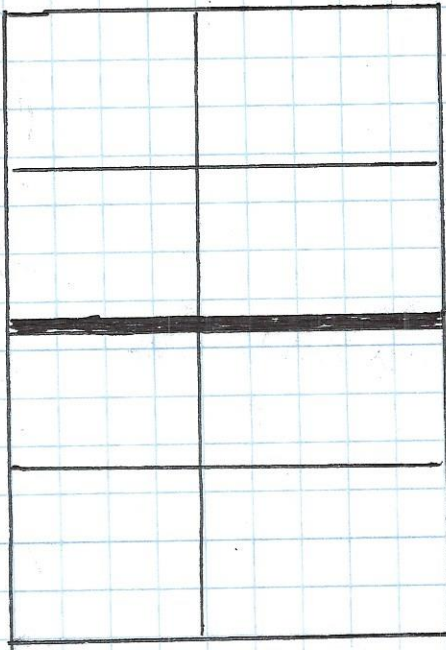
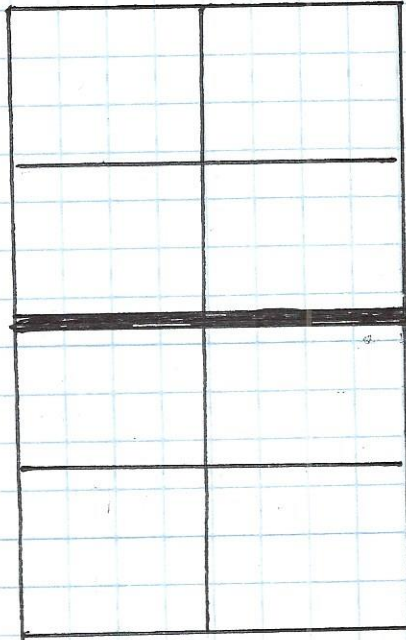
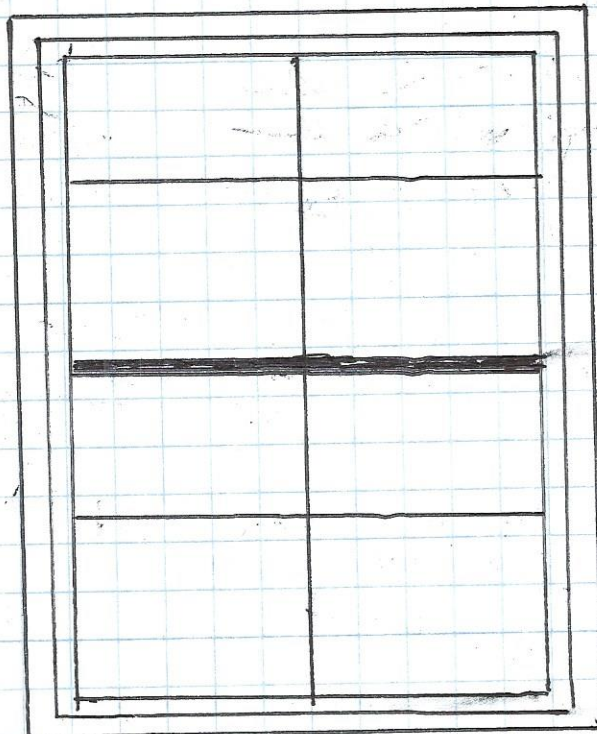
# SIDE B - UPPER

- These window units are in Brick openings
- Brick mullion varies  $1\frac{1}{2}$  - 2" in dimension on perimeter
- colored muntin bars laid on glass  $3\frac{1}{4}$ " wide
- Aluminum storm doors are broke & poor condition, missing parts

• Brick mullion varies from  $1\frac{1}{4}$ " - 2" on sides

• SASH frames are the same as others.

• Muntin bars are laid on glass

• New units will be within  $3\frac{1}{8}$ " of original size on all sides of frame

↳ New units will have muntin bars on glass.  $7\frac{1}{8}$ " in width
