# FIRE DAMAGE PHOTOS

# EXISTING CONDITIONS

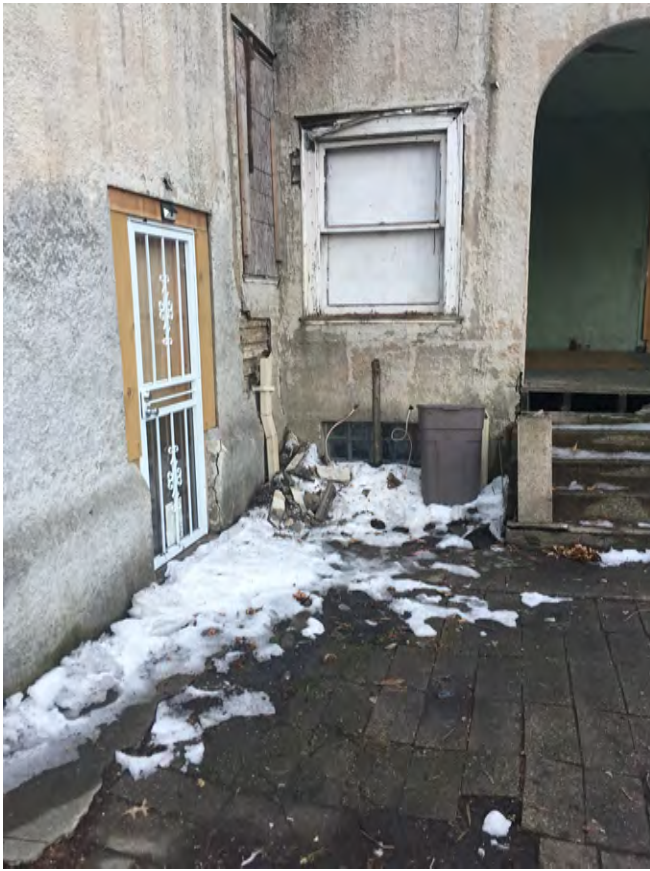
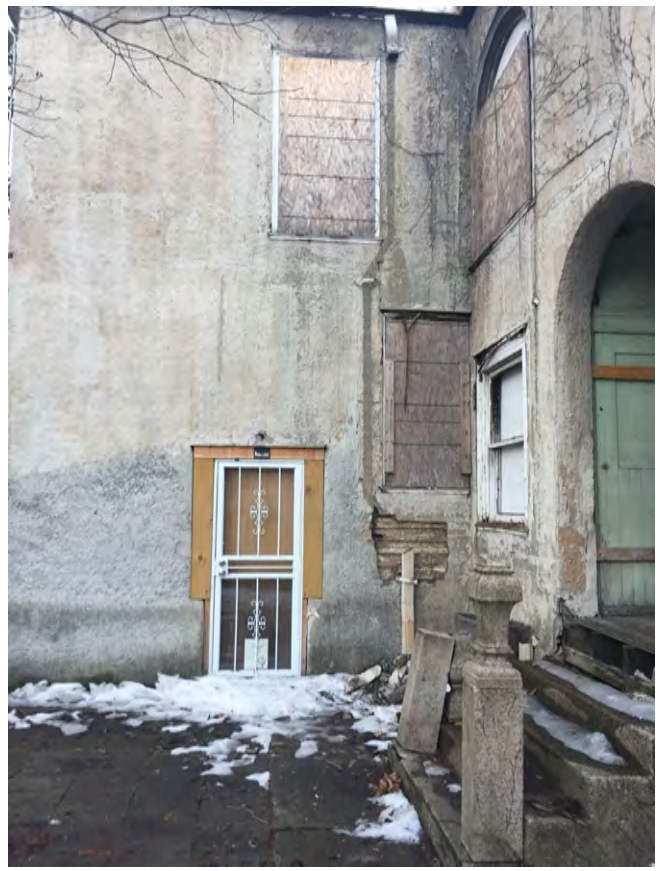
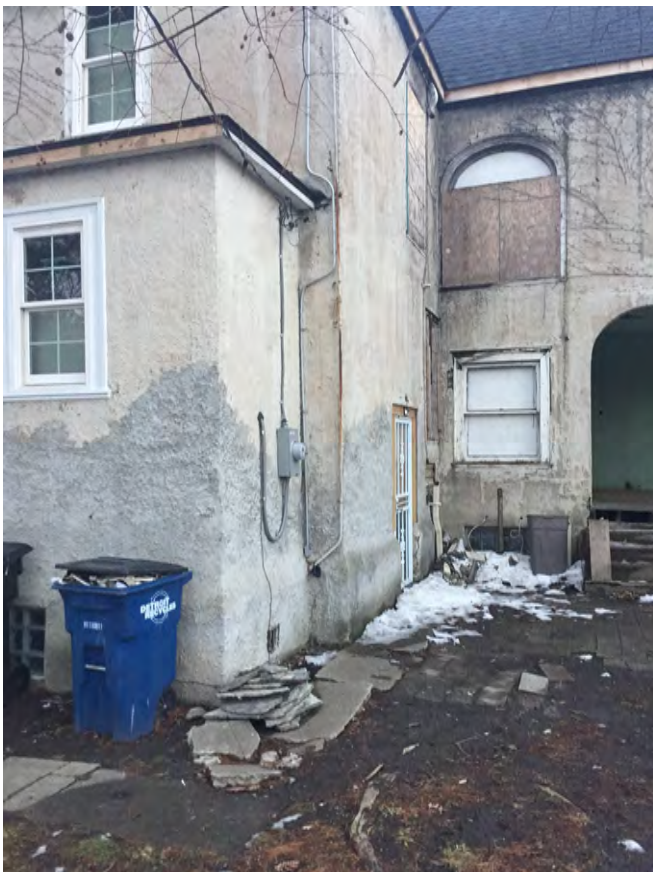
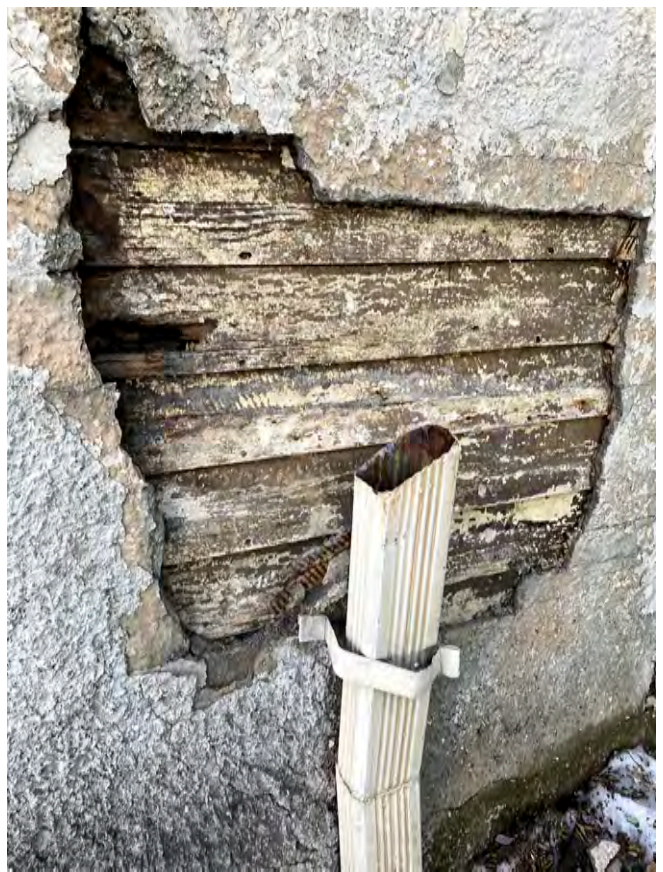
STUCCO DETERIORATION AT SW CORNER OF BUILDING

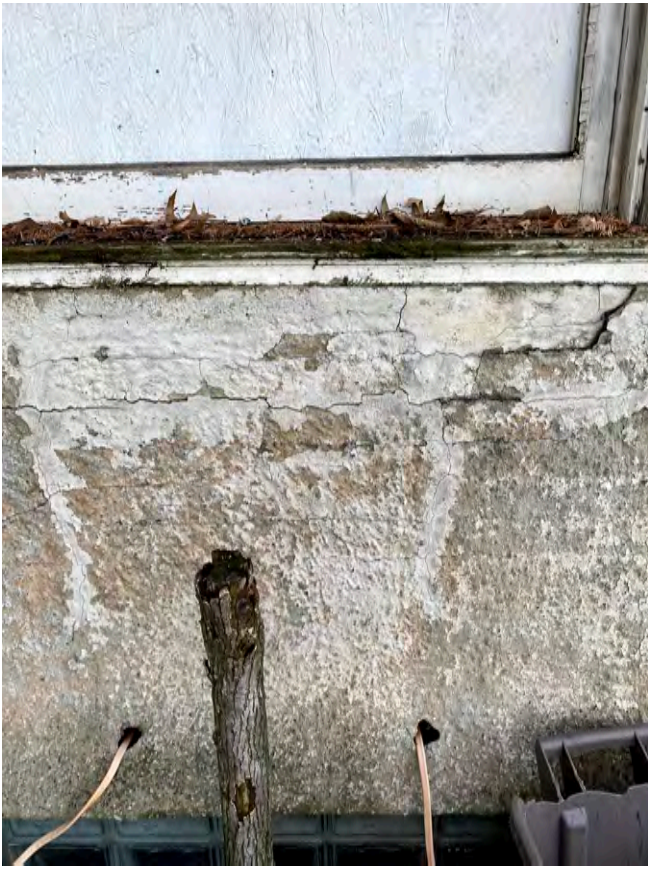
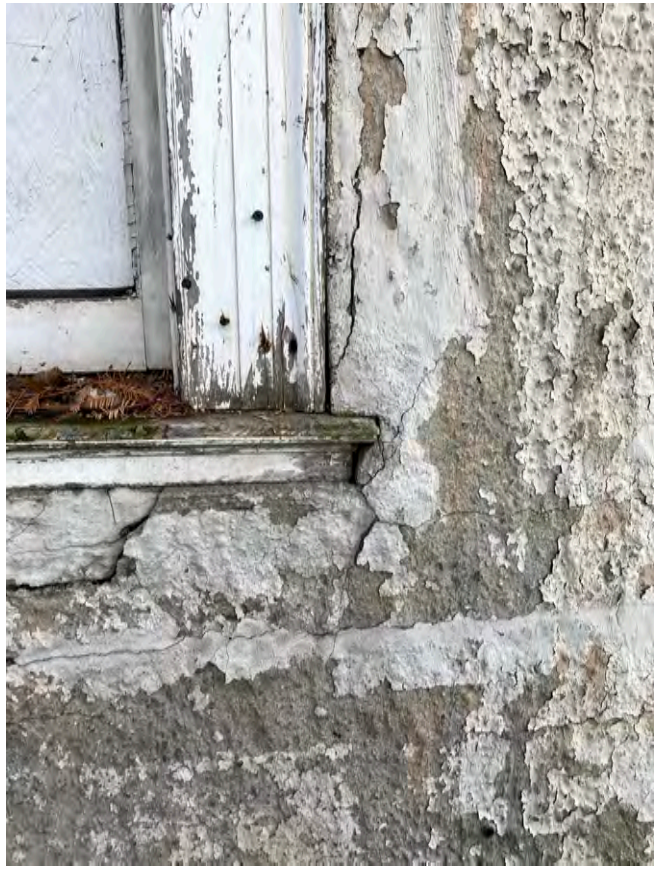
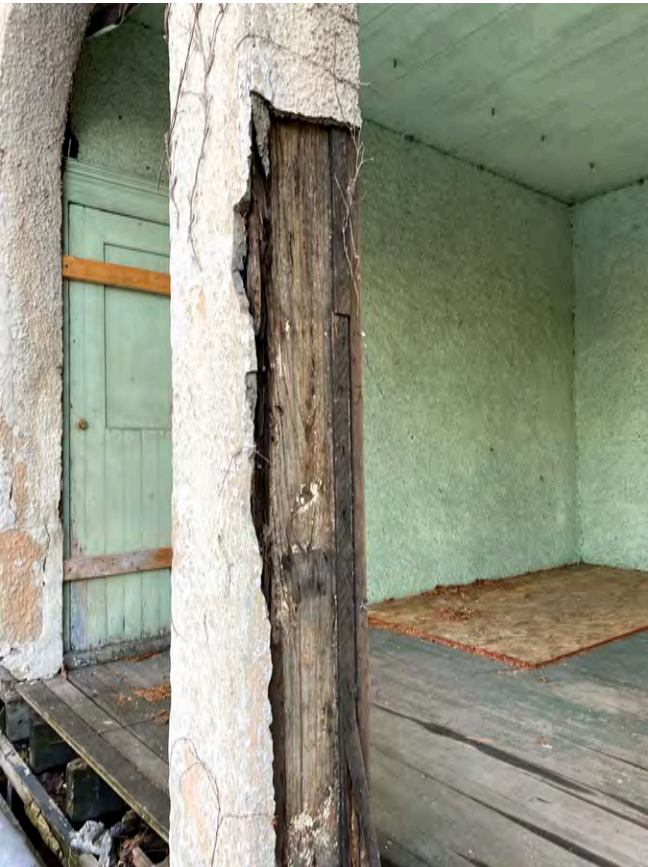
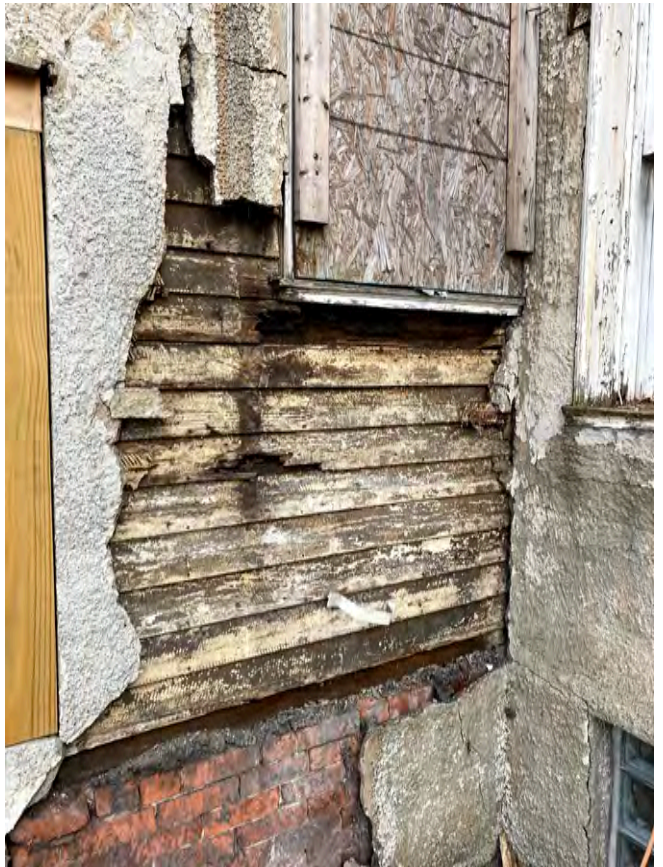
STUCCO DETERIORATION AT WEST ELEVATION, FIRST FLOOR

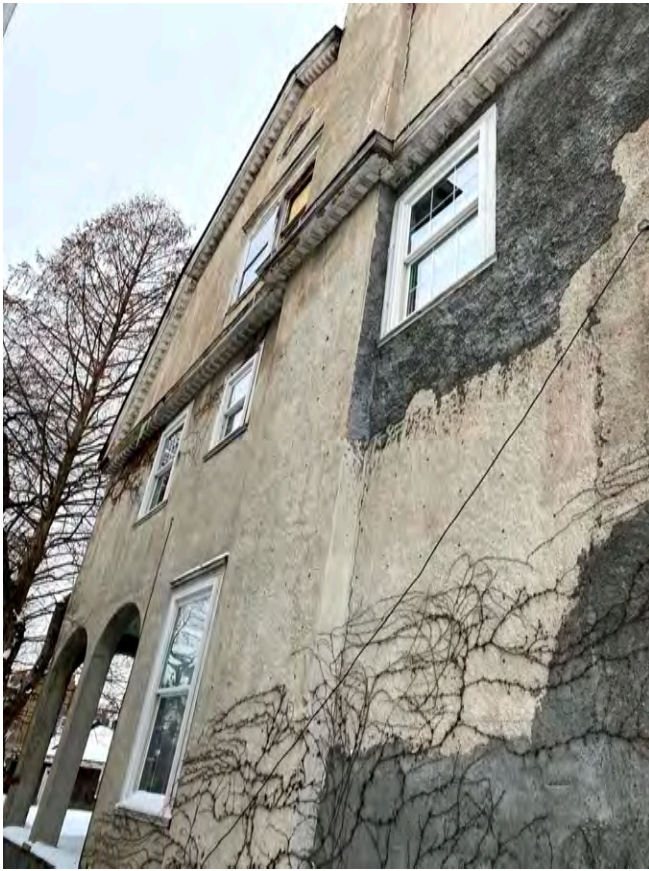
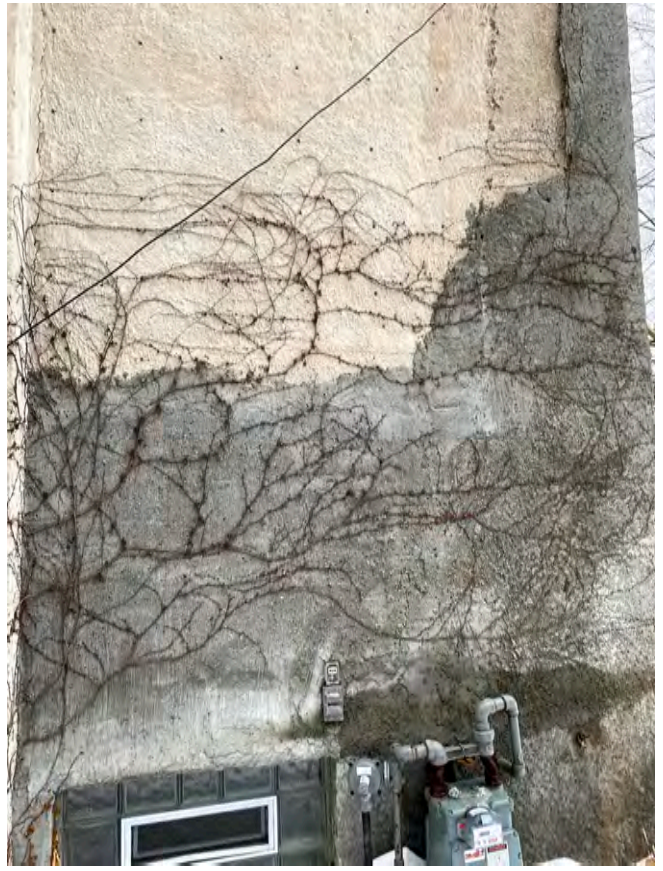
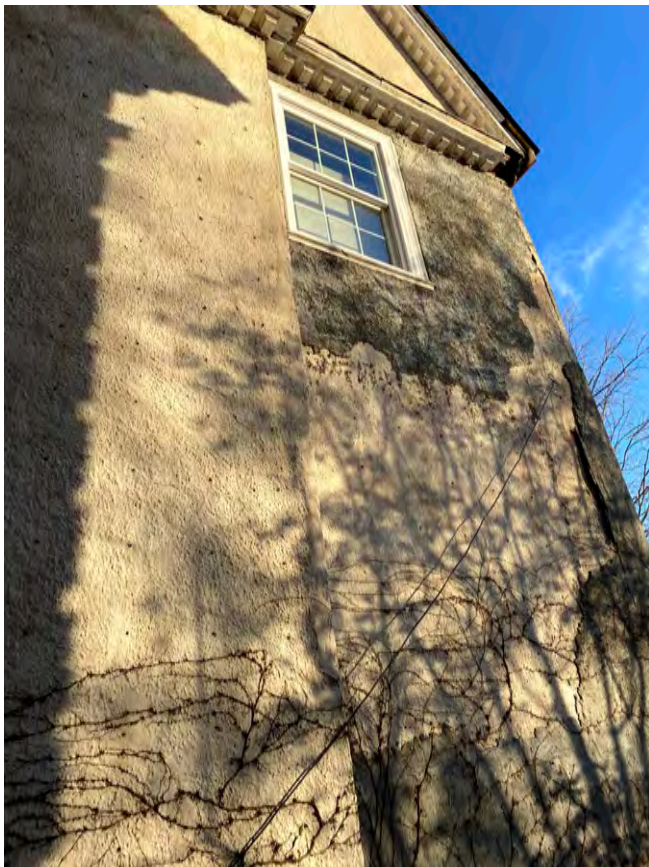
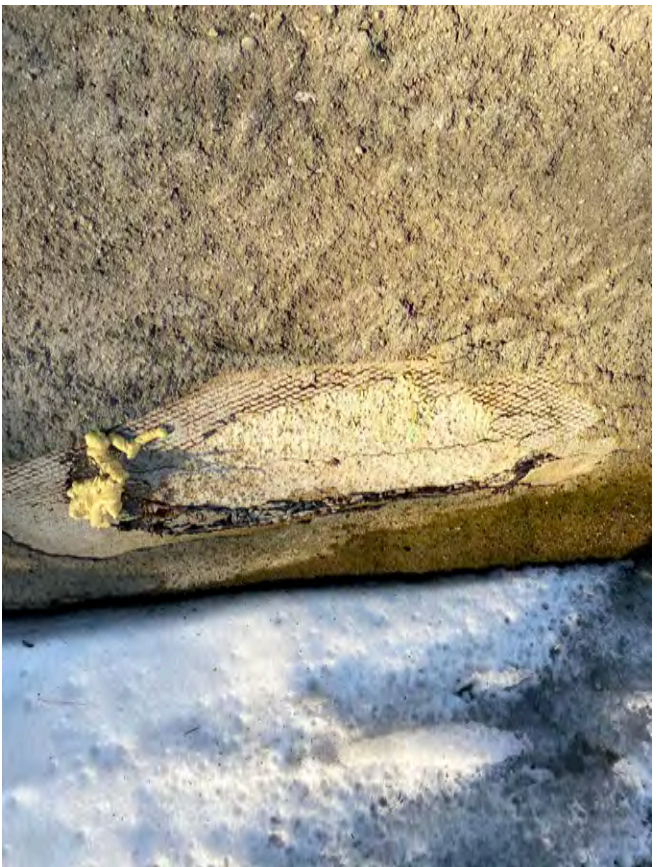
STUCCO DETERIORATION AT SOUTH ELEVATION

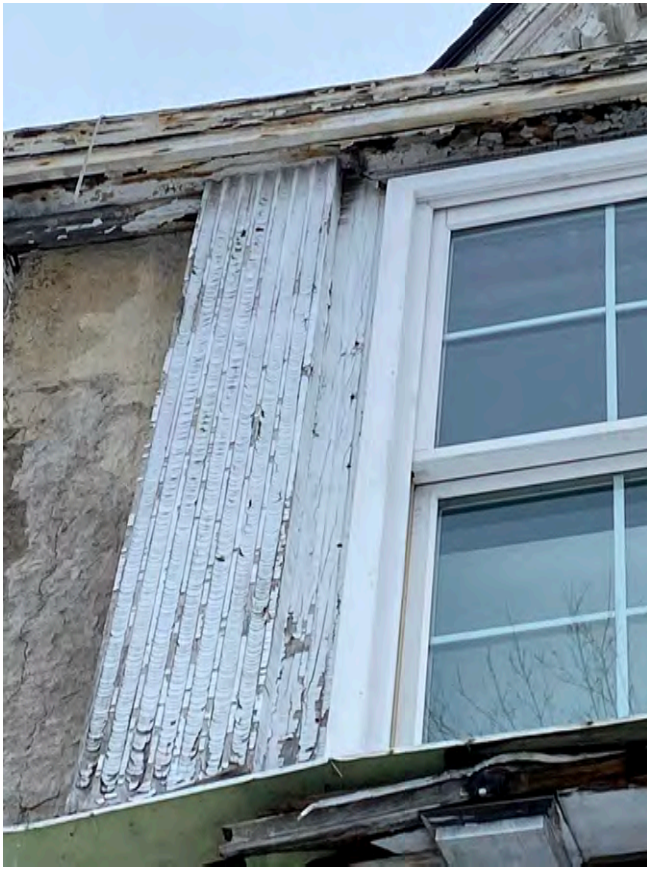
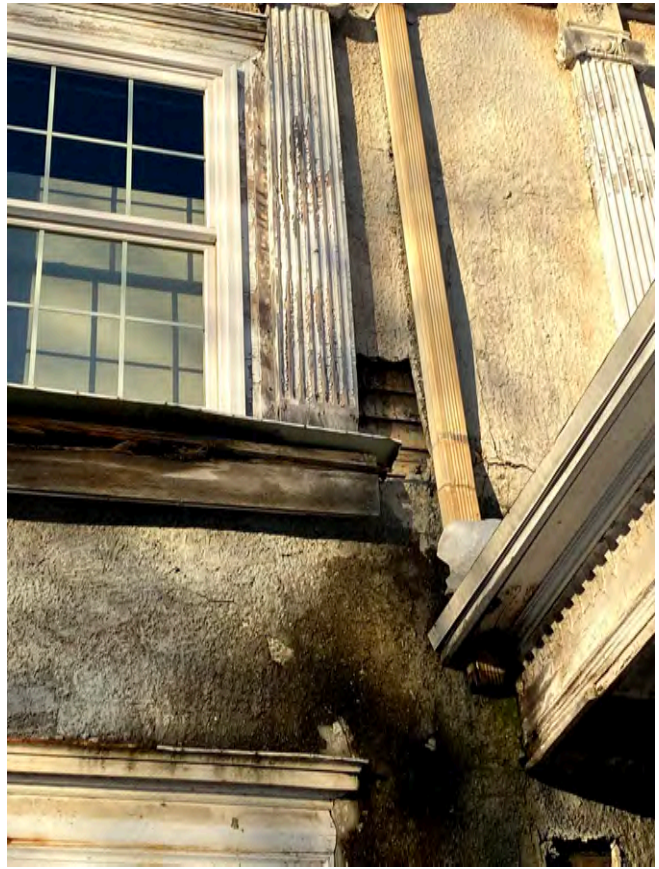
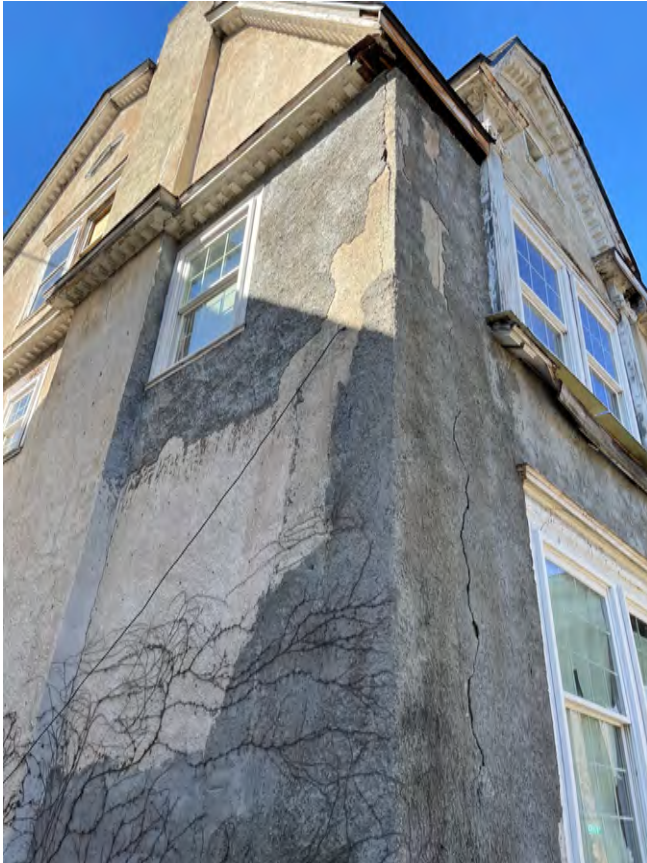
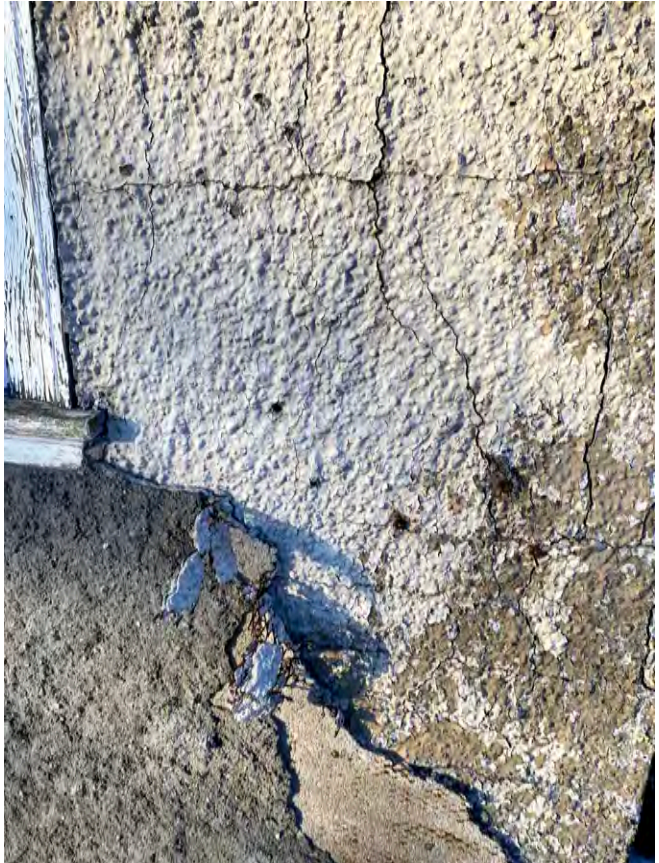
STUCCO DETERIORATION AT EAST FACADE

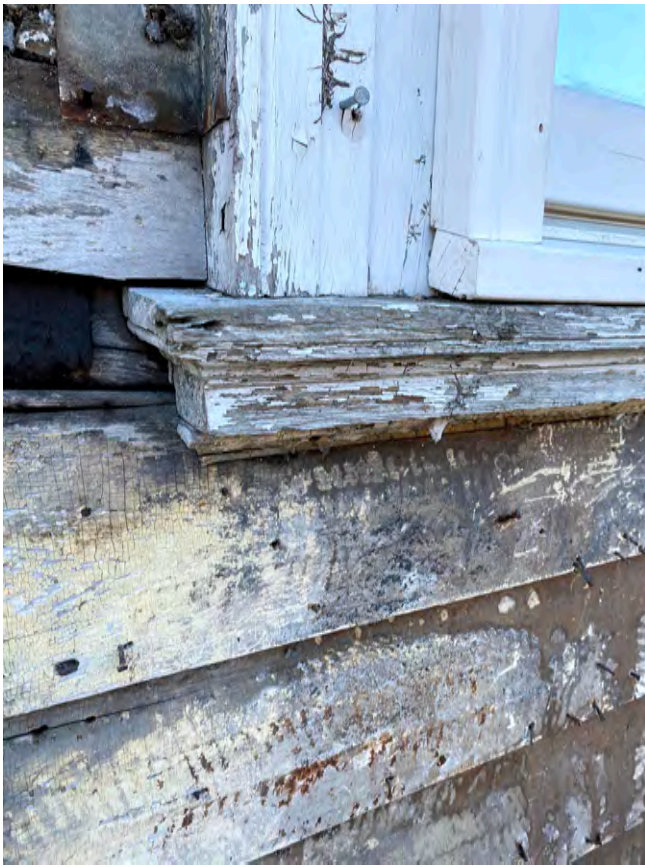
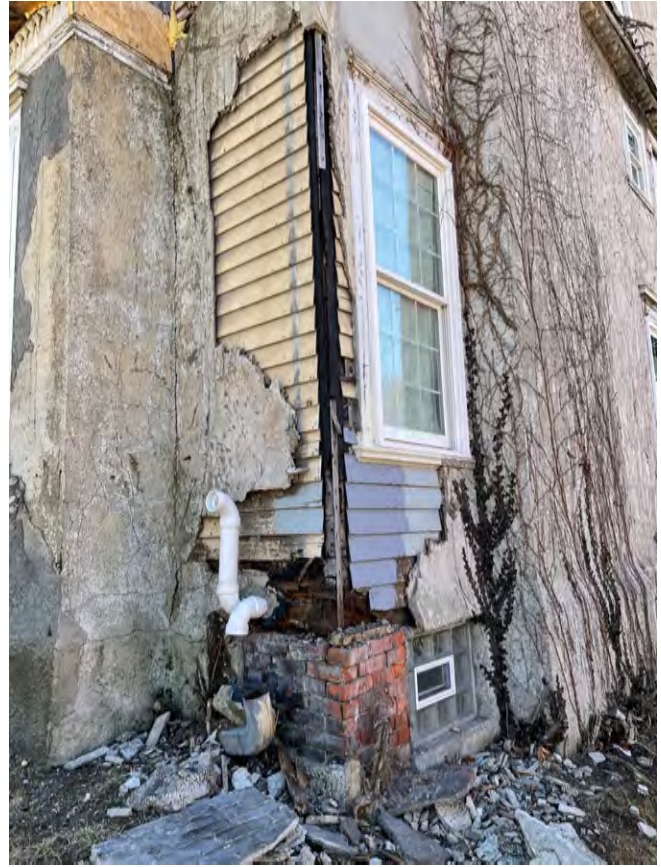
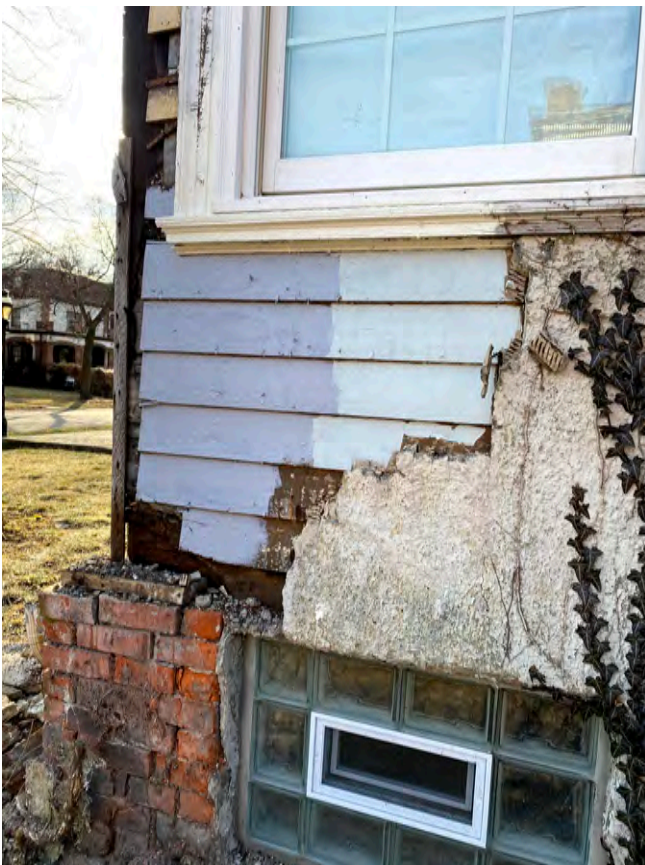
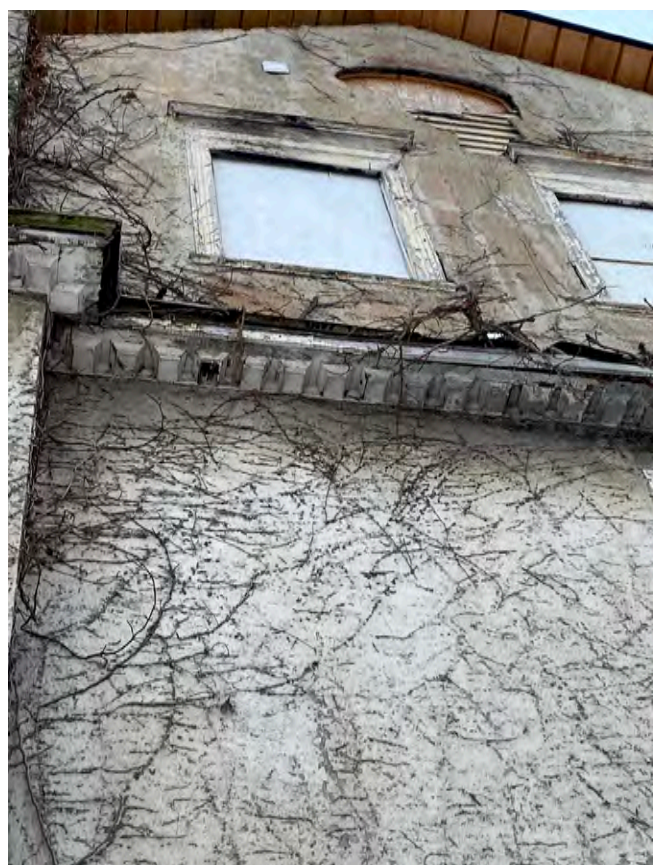
STUCCO DETERIORATION AT NORTH FACCADE

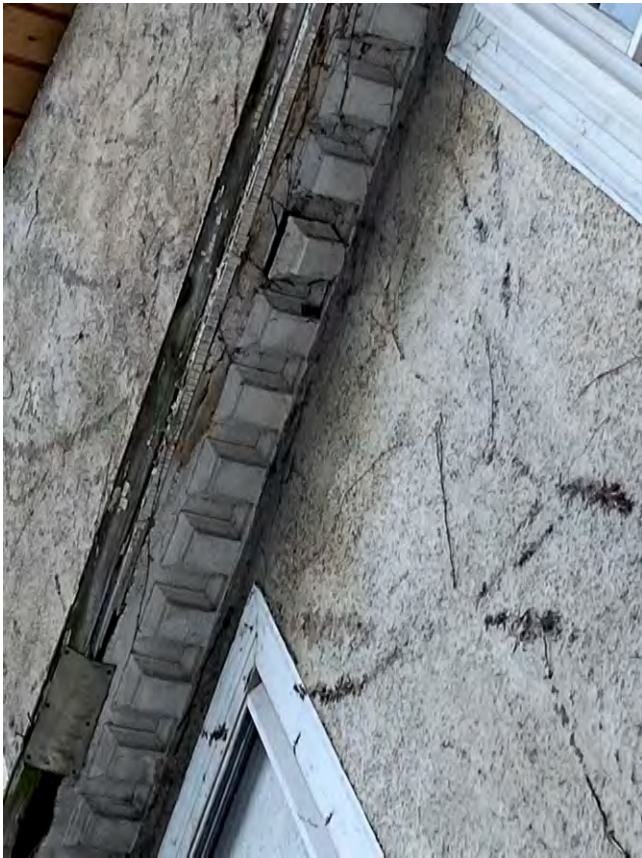
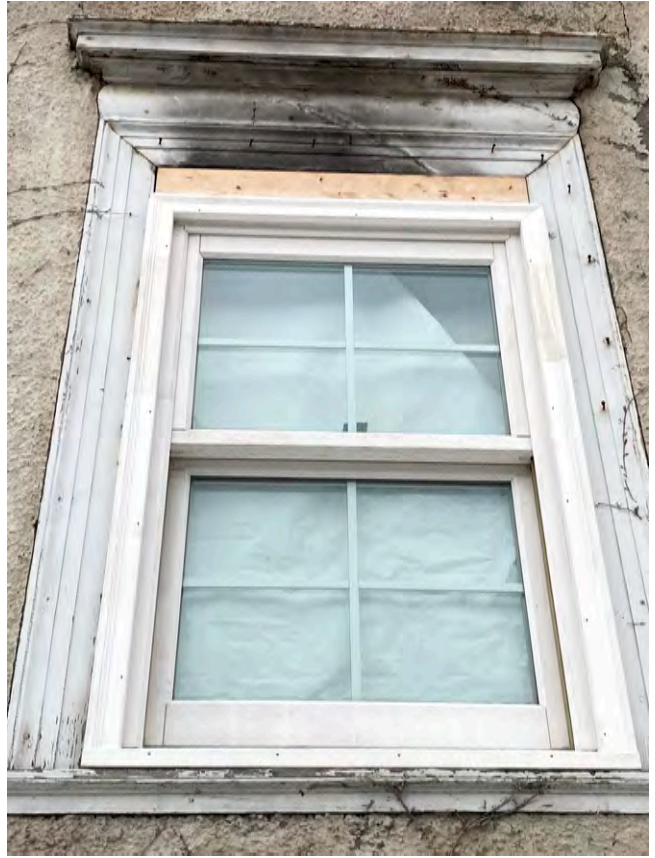
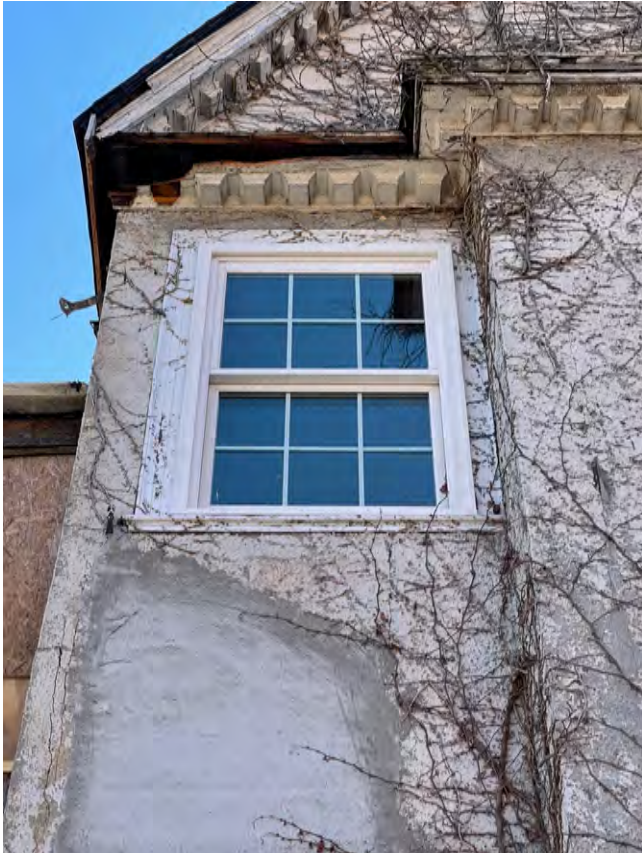
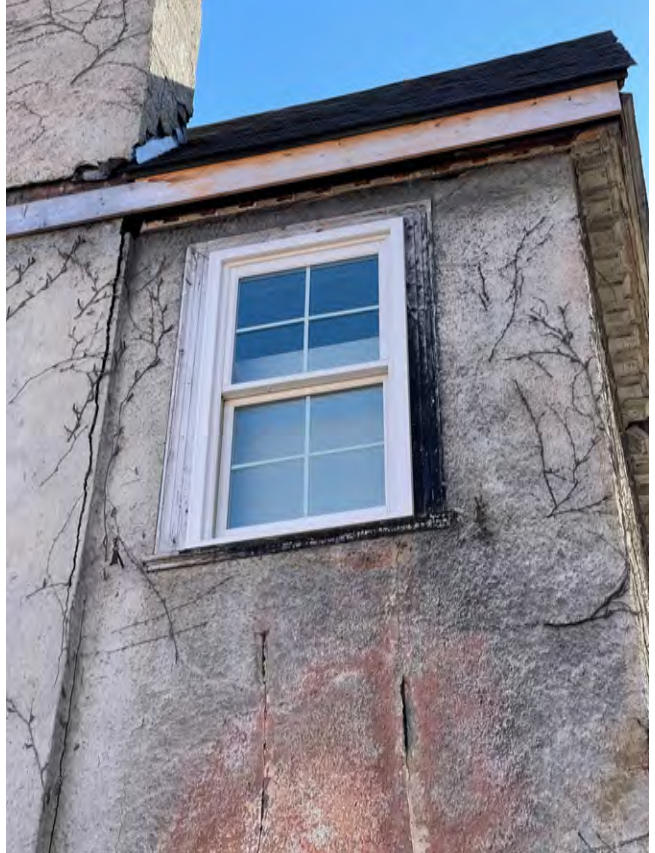
STUCCO DETERIORATION AT NORTH FACADE

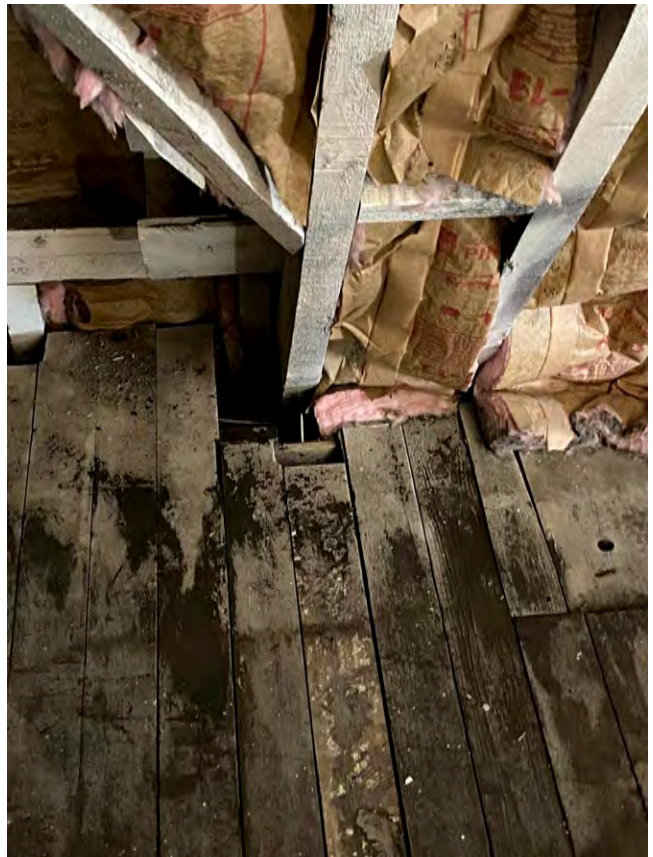
GAPS IN STRUCTURE CAUSED BY STUCCO WEIGHT

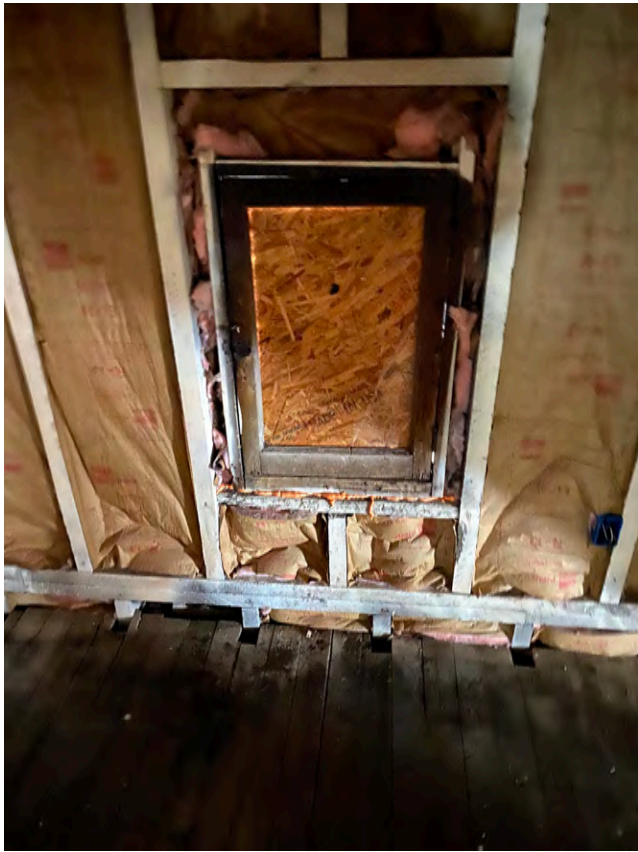
GAPS IN STRUCTURE CAUSED BY LOADS PLACED ON WALL BY THICK STUCCO OVERCOAT. WINDOW #8.
