Project:
Leverette Apartments - Exterior Corrections
Existing Apartment Renovations
Leverette Development, LLC
1627 Leverette Street
Detroit, Michigan 48216

SHEET TITLE
Rear Door and Wall Pictures

PROJECT NO.	SHEET NO.
DATE	HC-5
1/15/2021

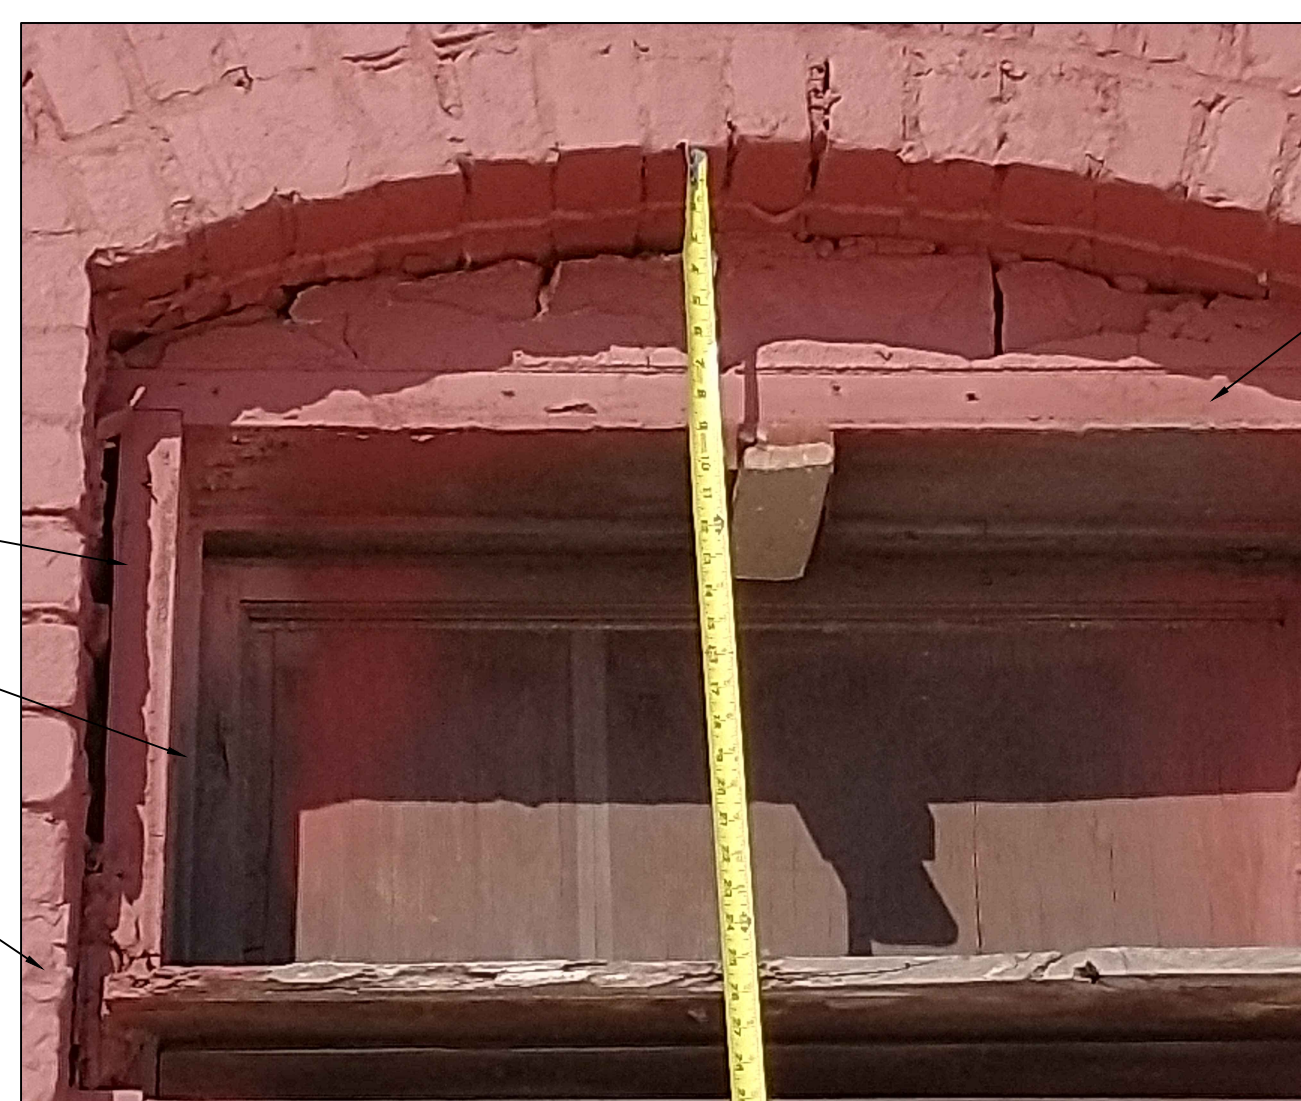
Enlarged View of Existing Door Transom Opening

- EXISTING WOOD FRAME TO REMAIN
- EXISTING TRANSOM WITH SOLID WOOD PANEL
- EXISTING WOOD MEETING RAIL (REPLACE WHERE REQUIRED DUE TO DAMAGE OR ROTTING CONDITIONS)
- SPECIAL NOTE: LOCATION OF OLD GABLE ROOF OVERHANG COMPLETELY CONCEAL THE UPPER TRANSOM PANEL

EXISTING WOOD FRAME w/MASONRY FILL-IN AT ARCHED HEAD

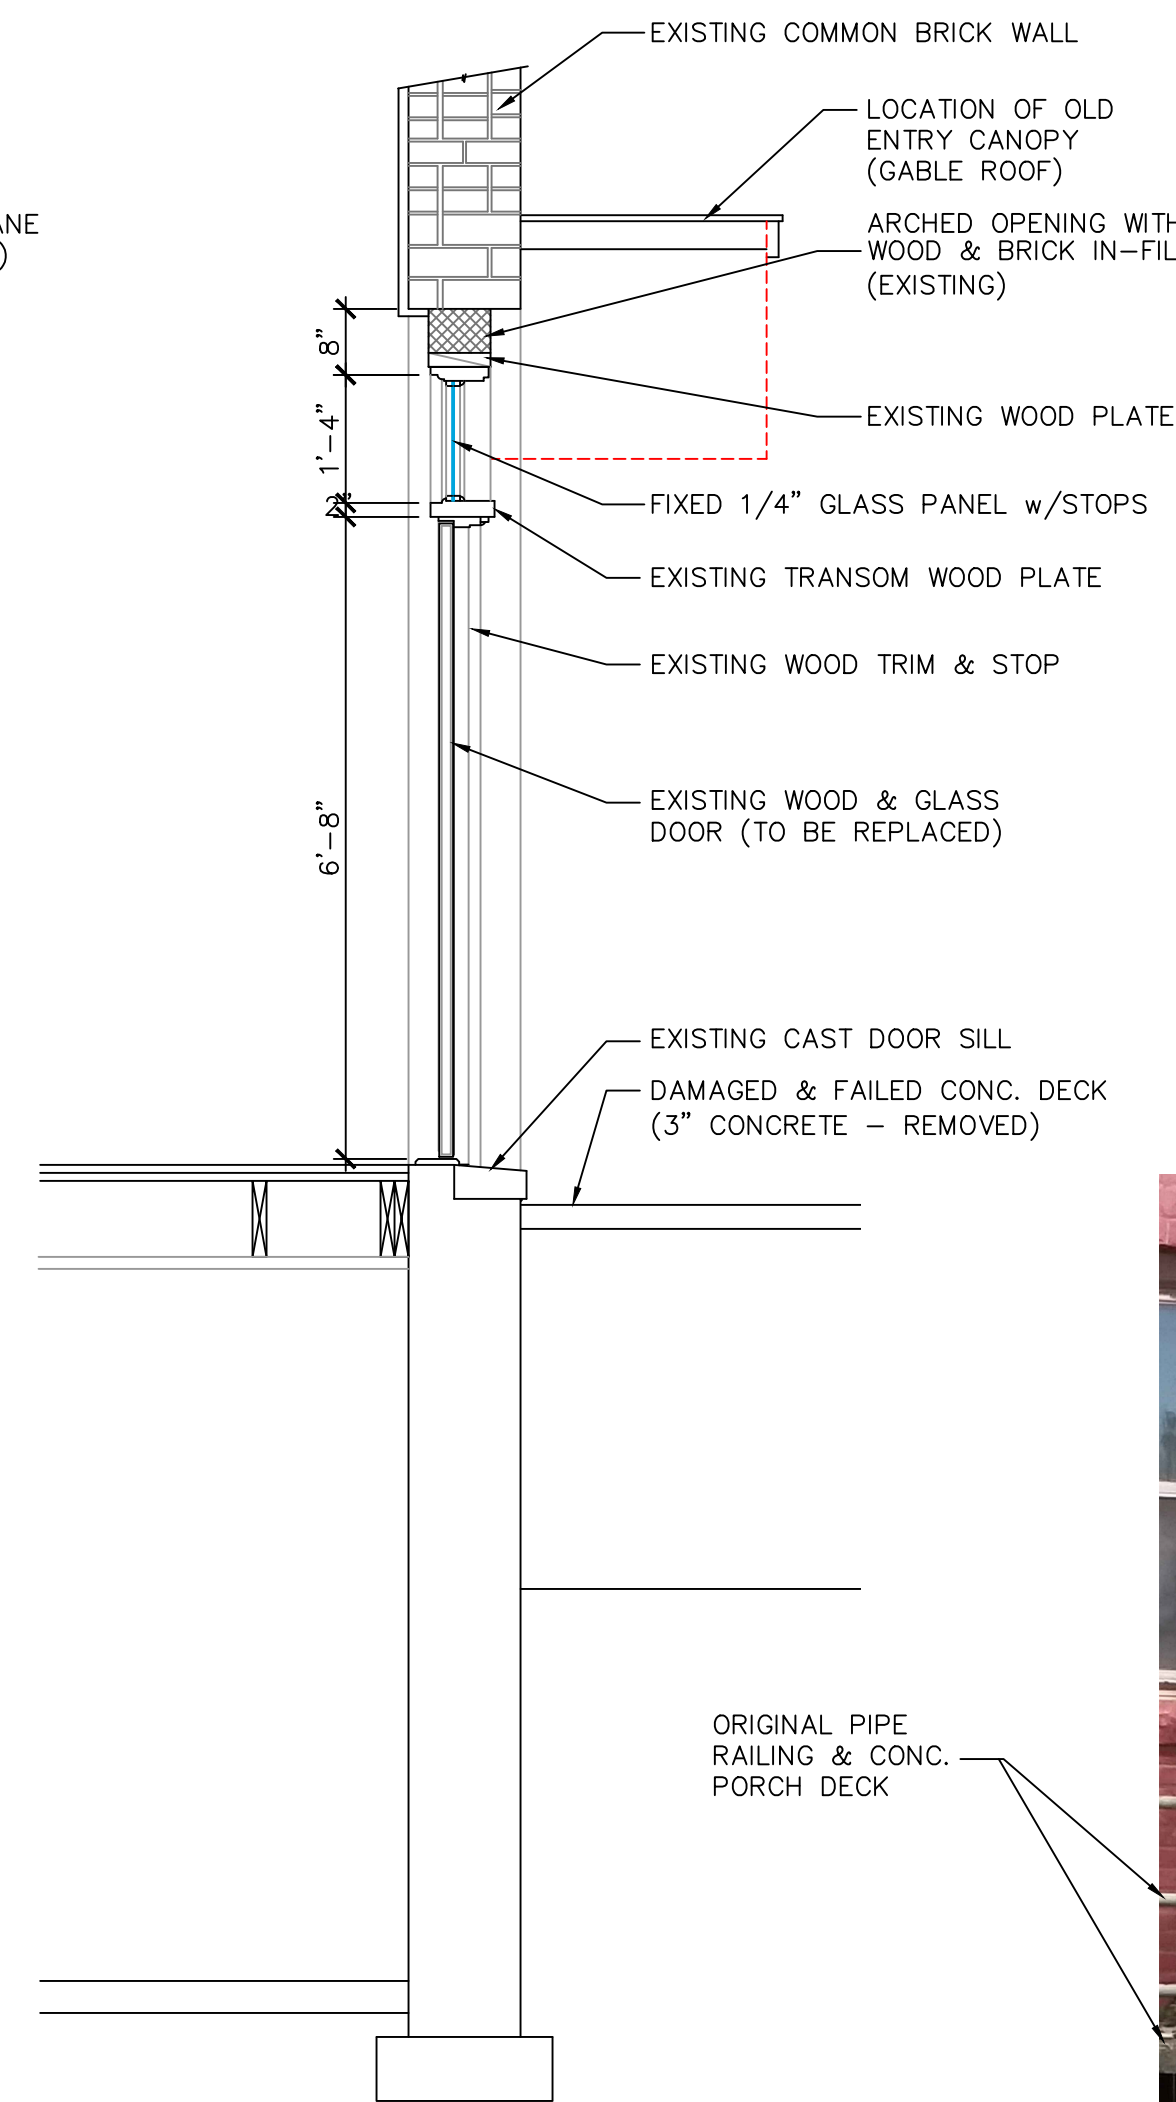
Existing Door Opening

Work Modified and Installed

- REMOVED GABLE ROOF ENTRY CANOPY
- REMOVED PIPE RAILING & FAILING CONCRETE PORCH DECK
- REMOVED & REPLACED EXISTING WINDOWS
- REMOVED & MODIFIED BASEMENT STAIR ENCLOSURE
- INSTALLED NEW TREATED WOOD PORCH DECK AND TREATED WOOD RAILING & PRIVACY SCREEN

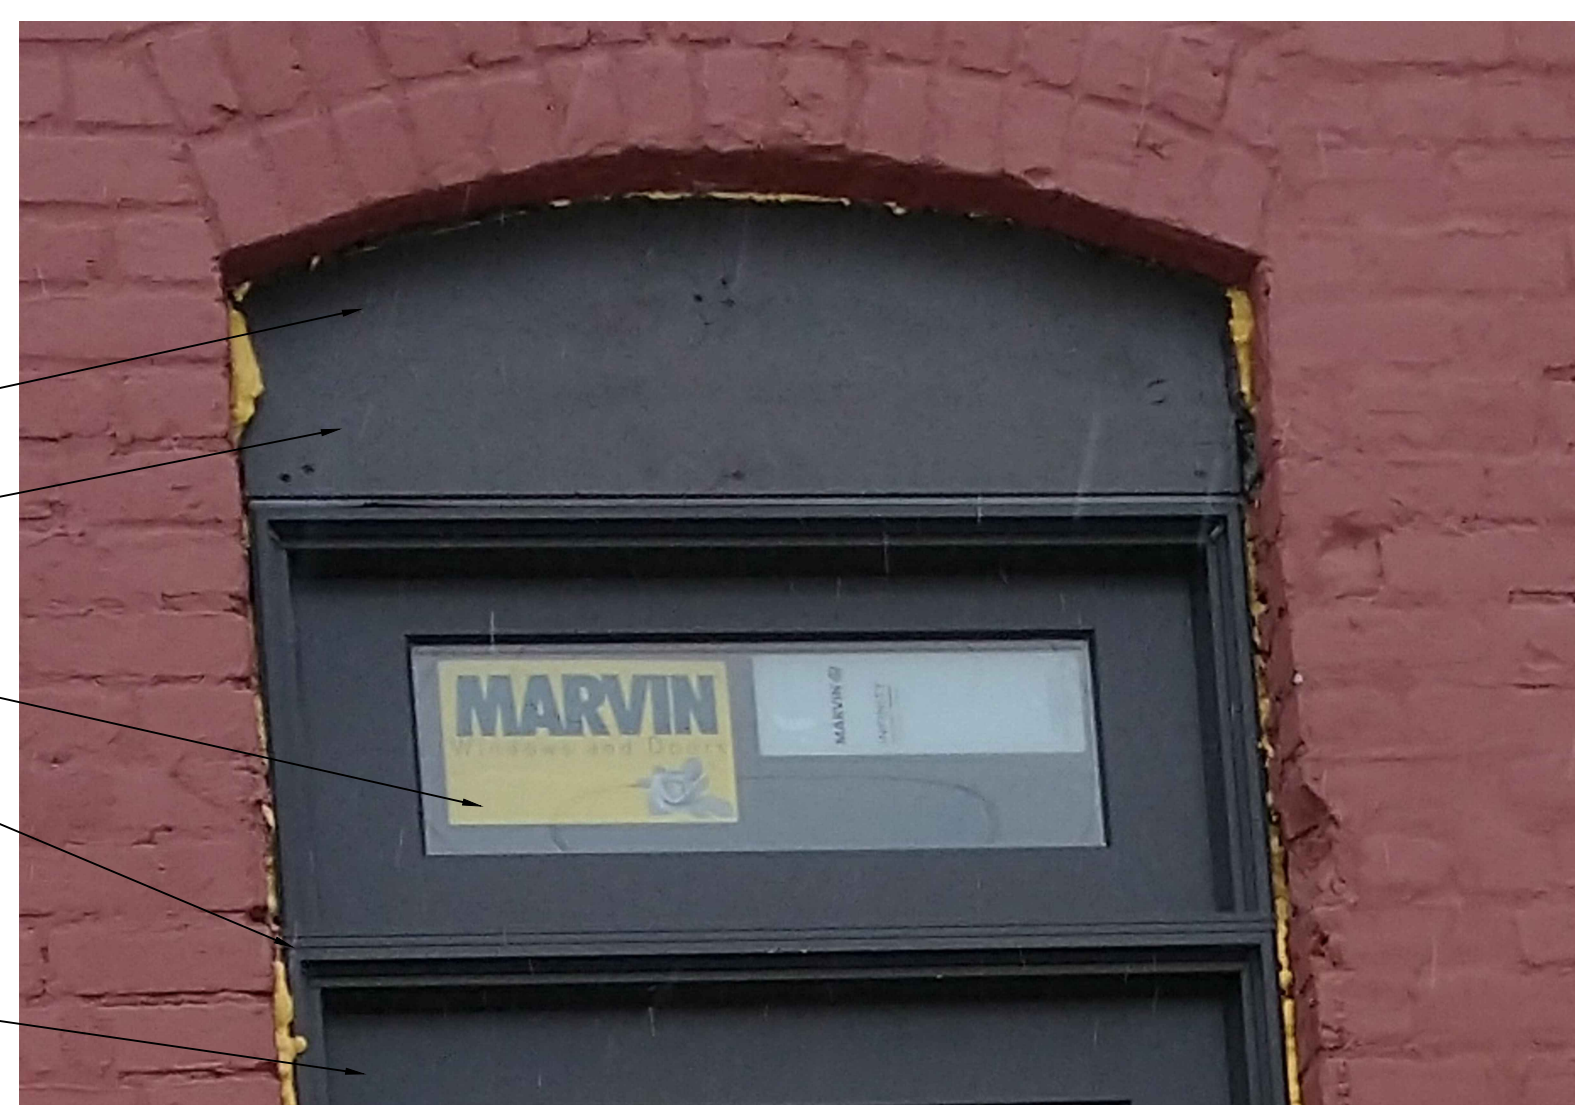
Enlarged View of New Door Transom Opening

- SPECIAL NOTE: NEW SHED ROOF CANOPY TO BE INSTALLED AFTER HISTORIC APPROVAL (IN VOID LOCATED ABOVE GLASS TRANSOM)
- NEW PLYWOOD CLOSURE PANEL OVER EXISTING
- NEW LOCATION FOR NEW ENTRY CANOPY ROOF
- NEW TRANSOM WINDOW INSTALLED
- WOOD MEETING RAIL REPLACE WHERE REQUIRED
- NEW WOOD CLAD DOOR

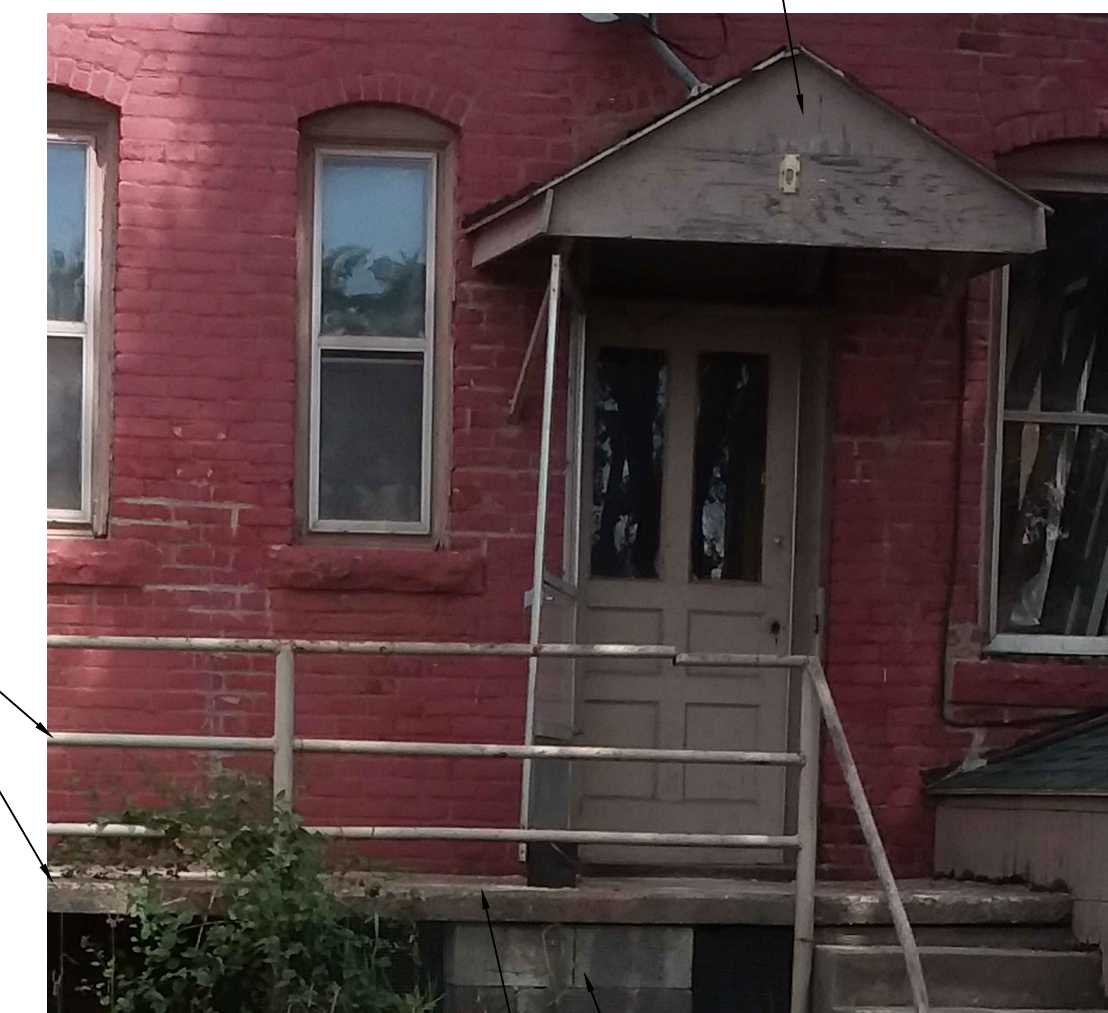
Existing Porch - Rear Door

DAMAGED CONC. DECK - STACKED CMU SUPPORT
