Description of current condition/Scope of Work:

- New windows have been installed throughout the entire home. The new windows are Pella Architect Traditional Series. Most are double hung, some with 1 over 1 patterns, others with divided light 9 over 1 and 6 over 1. All windows are a replica of the previous deteriorated window. The exterior is black clad and the interior is stained wood. The grilles are Ogee Integral Light Technology in $\frac{7}{8}$ ". The panes are Insulated Dual Low-E Glass.

Description of project:

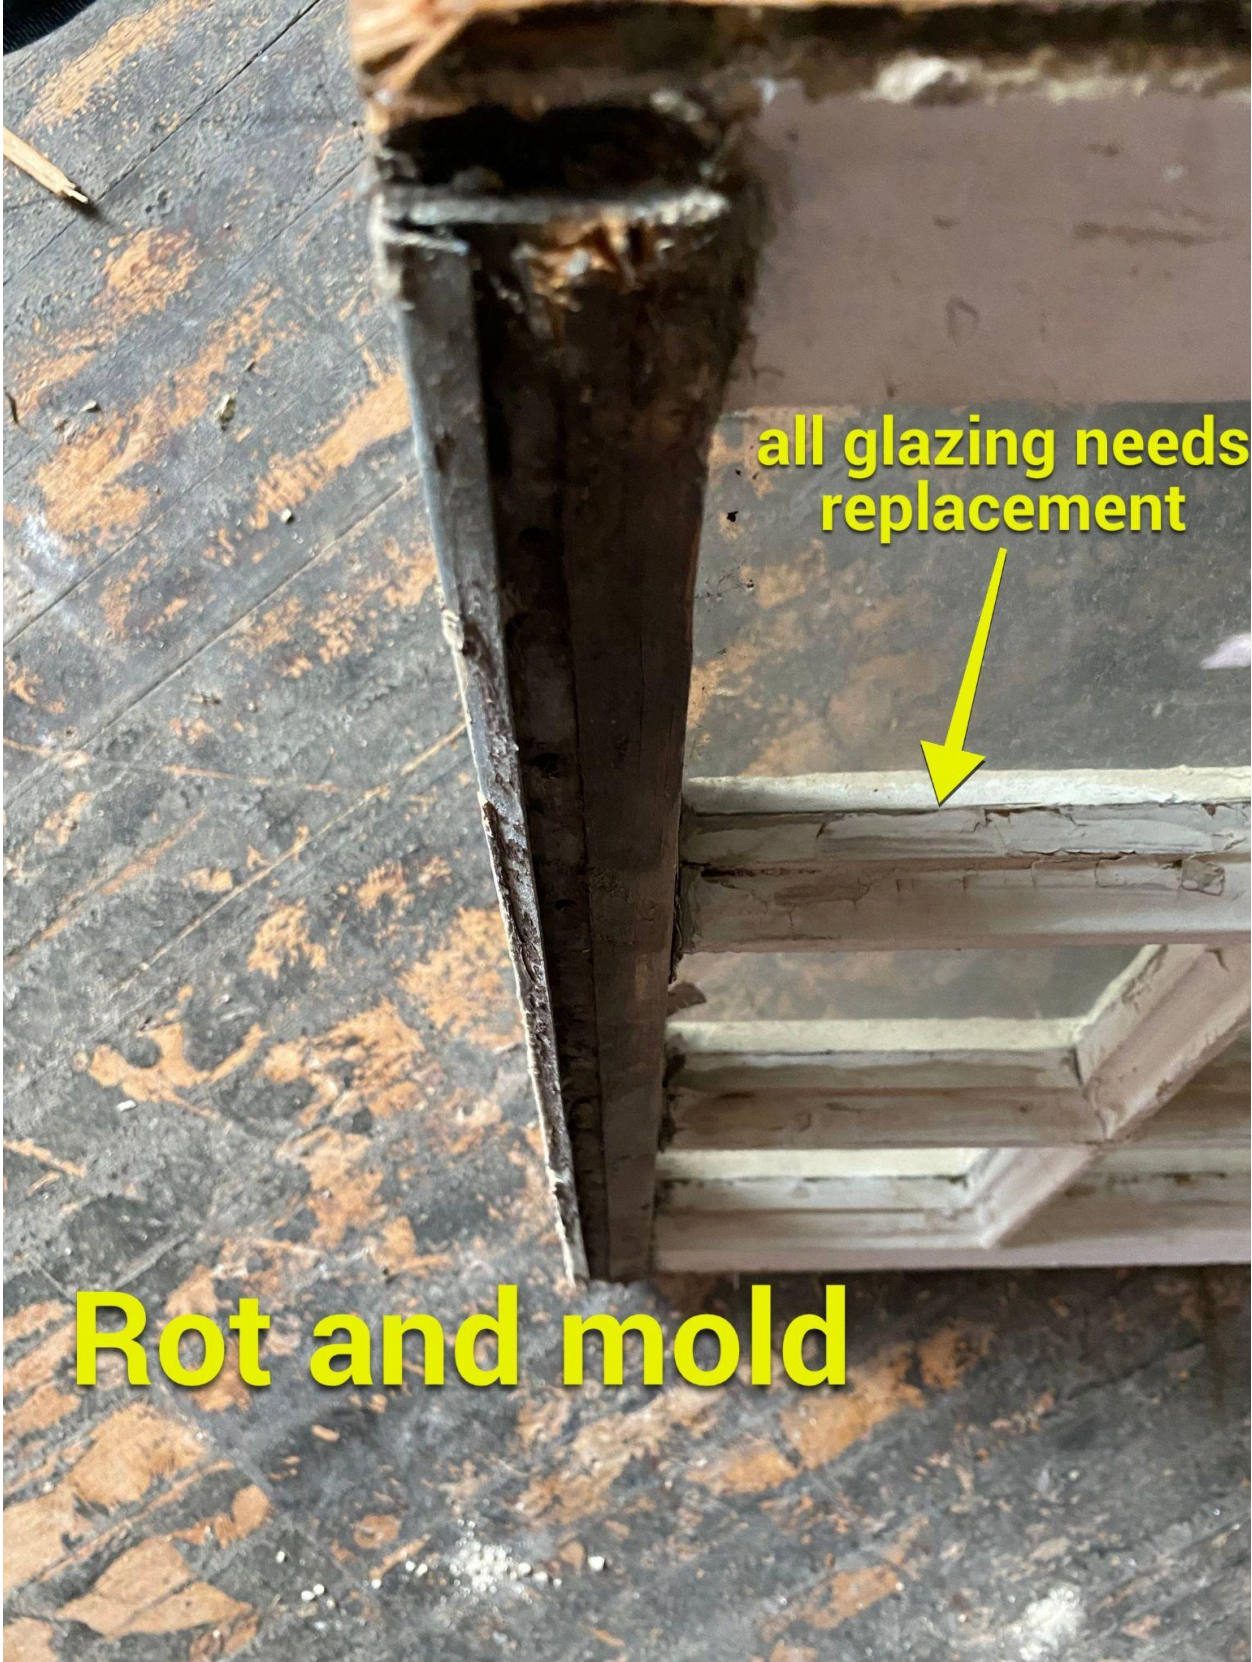
Window 5, 9/1divided light South Elevation

all glazing needs replacement

Rot and mold

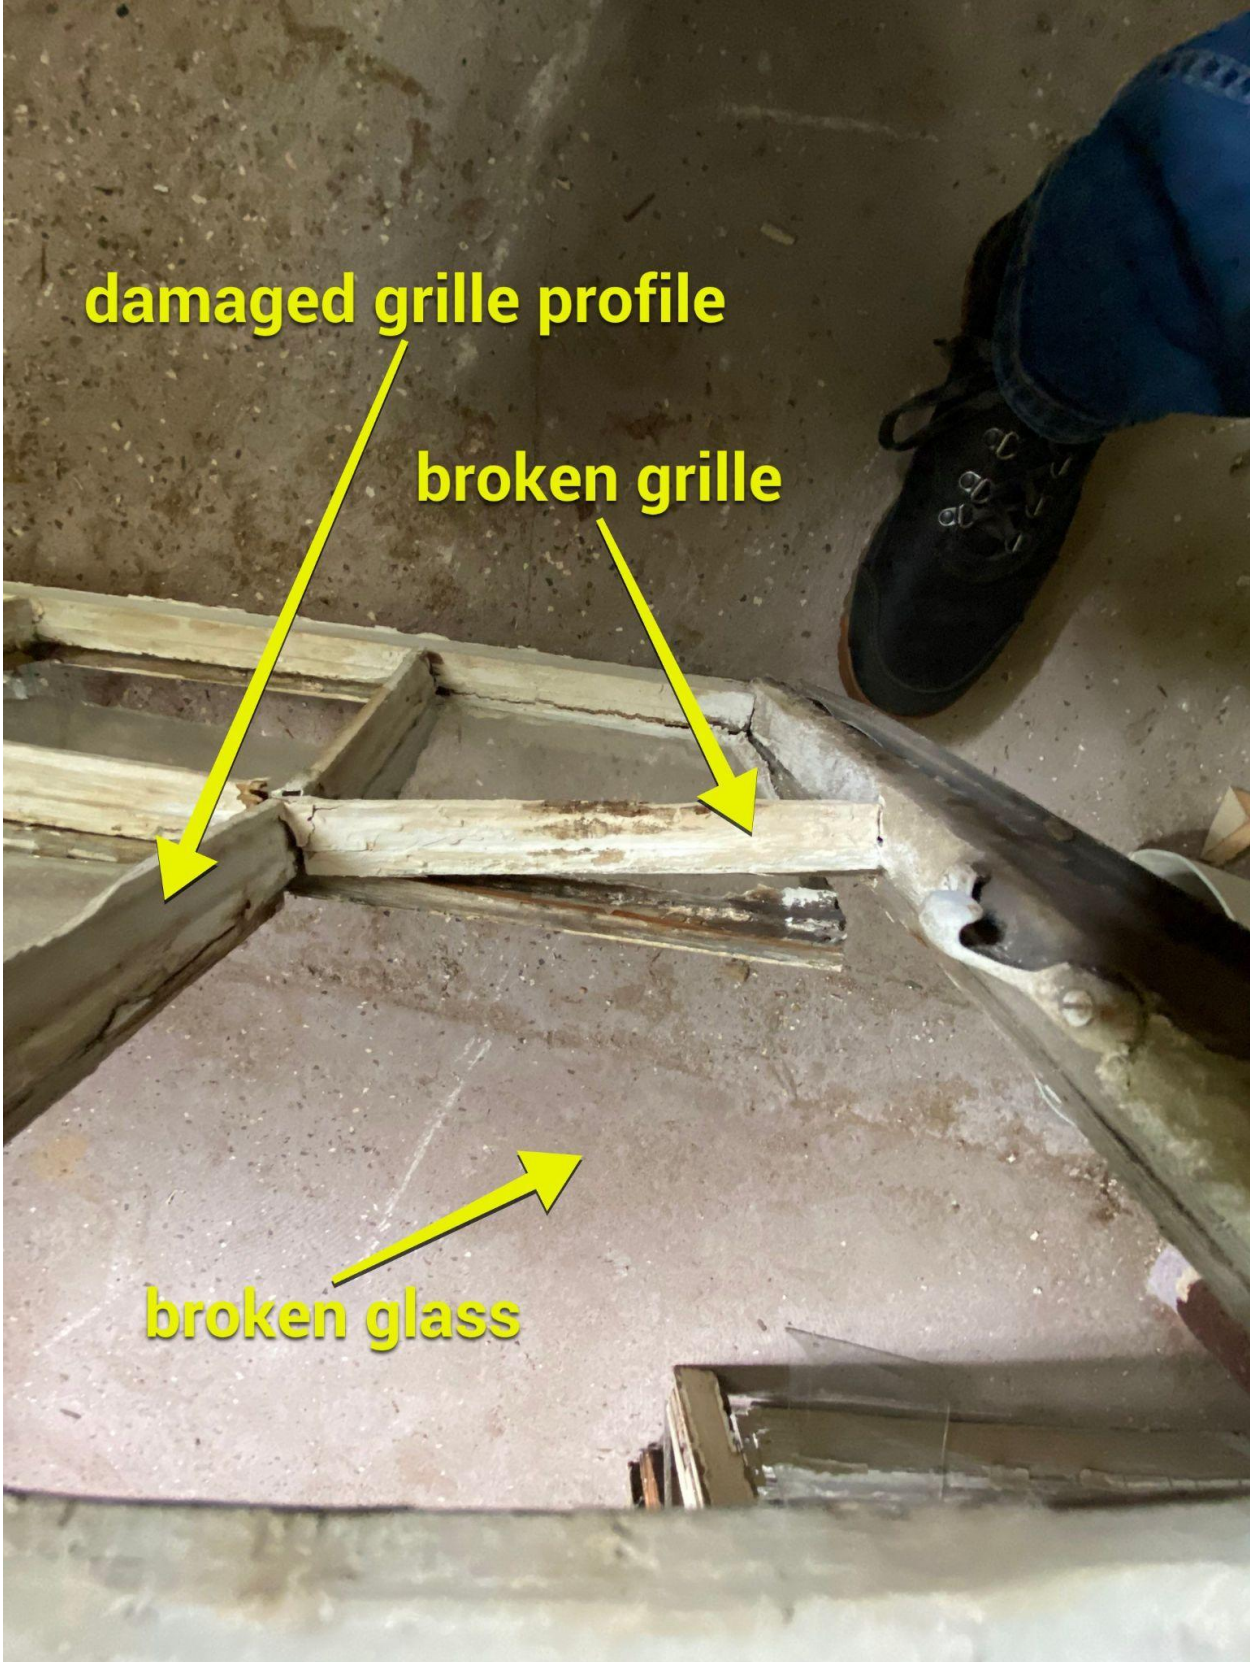
Window , 9/1 divided light South Elevation

damaged grille profile

broken grille

broken glass
