RE: 630 Virginia Park, Historic District Commission Submission

Description of Existing Window Conditions

Window Replacement

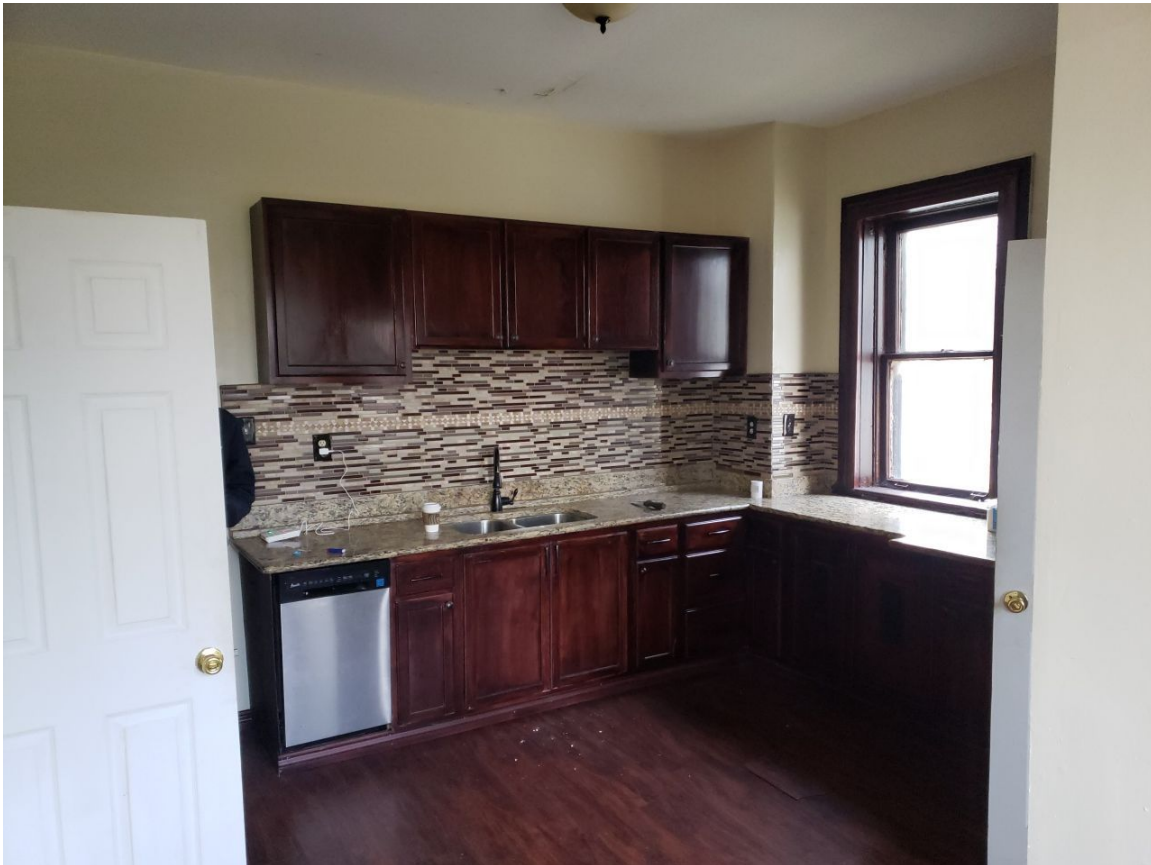
Window 1-01 (First Floor, West Elevation, Kitchen)

- Painted shut on inside and outside

Given the current state of the existing wood windows, and the introduction of non-compliant vinyl windows, the recommendation is to replace all windows with new wood windows to match the existing window operation and configurations.

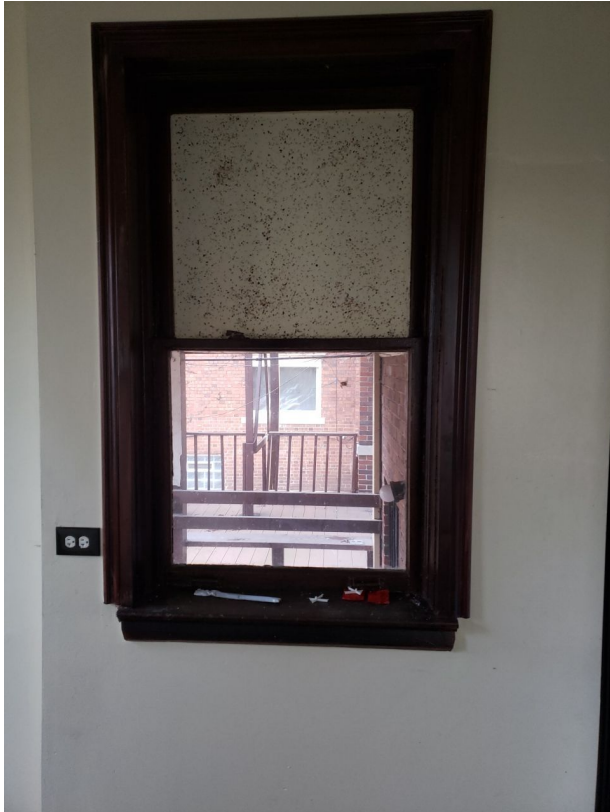
Window 1-02 (First Floor, East Elevation, Kitchen)

- Glass missing in upper Sash
- Upper sash blocked by existing addition (to be demolished)

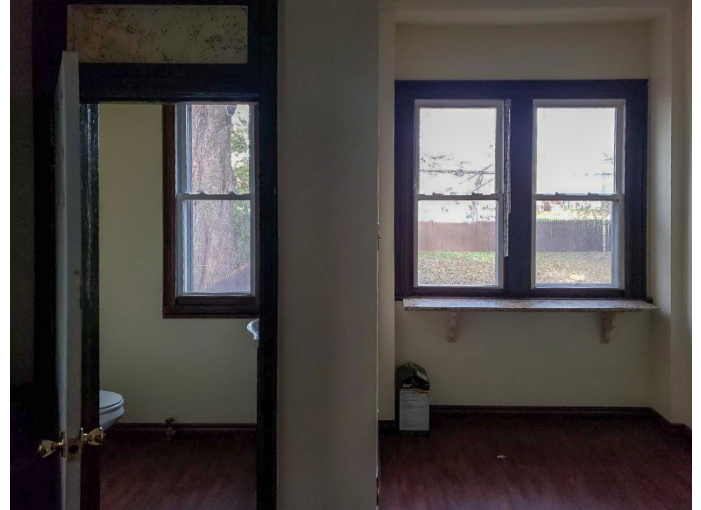
Window 1-03-05 (First Floor, North Elevation, Kitchen)

- Vinyl Replacement Windows

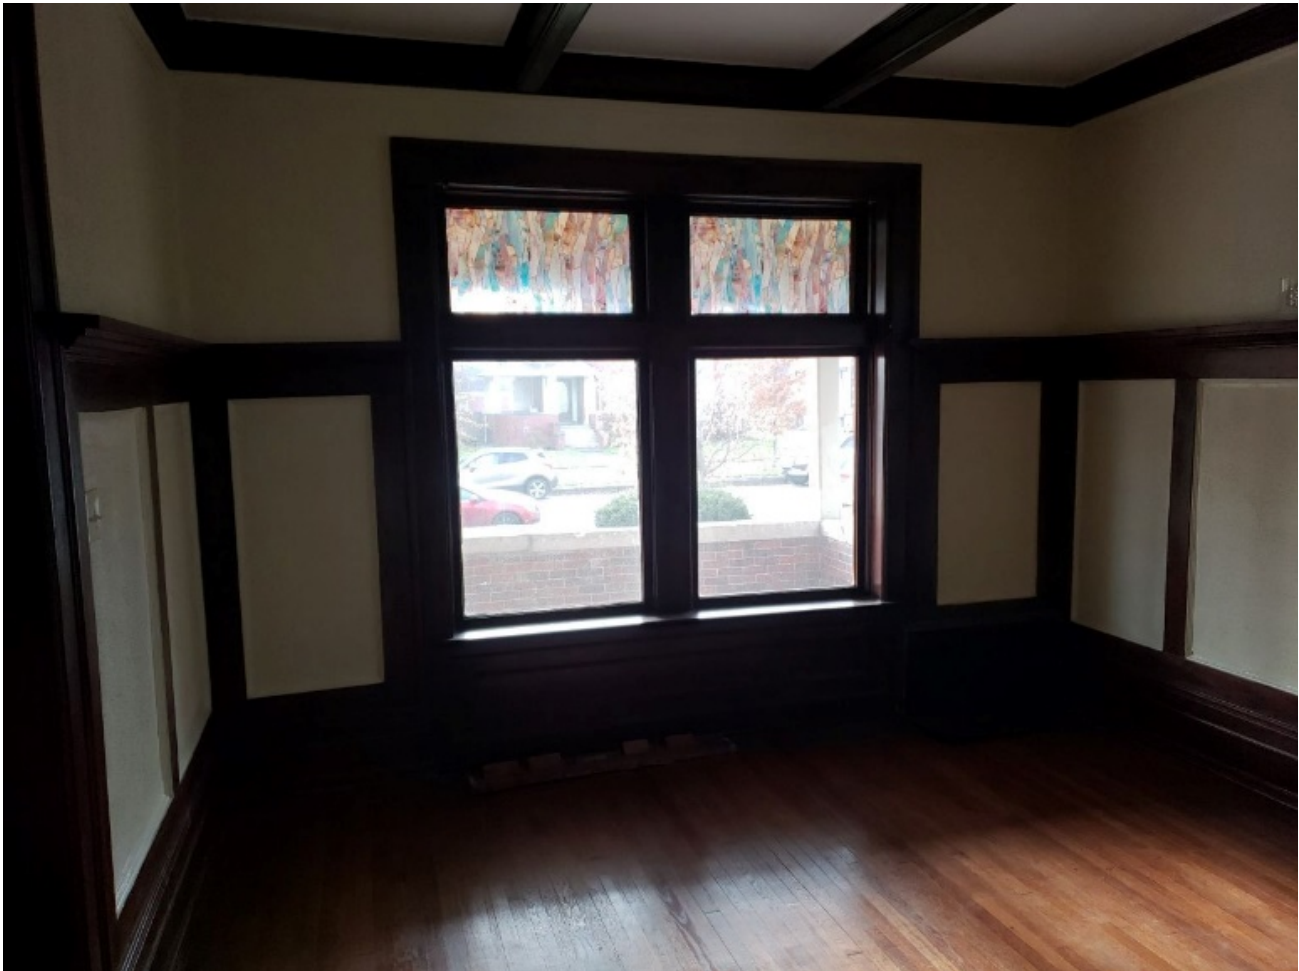
Window 1-06-07 (First Floor, South Elevation)

- Double Hung

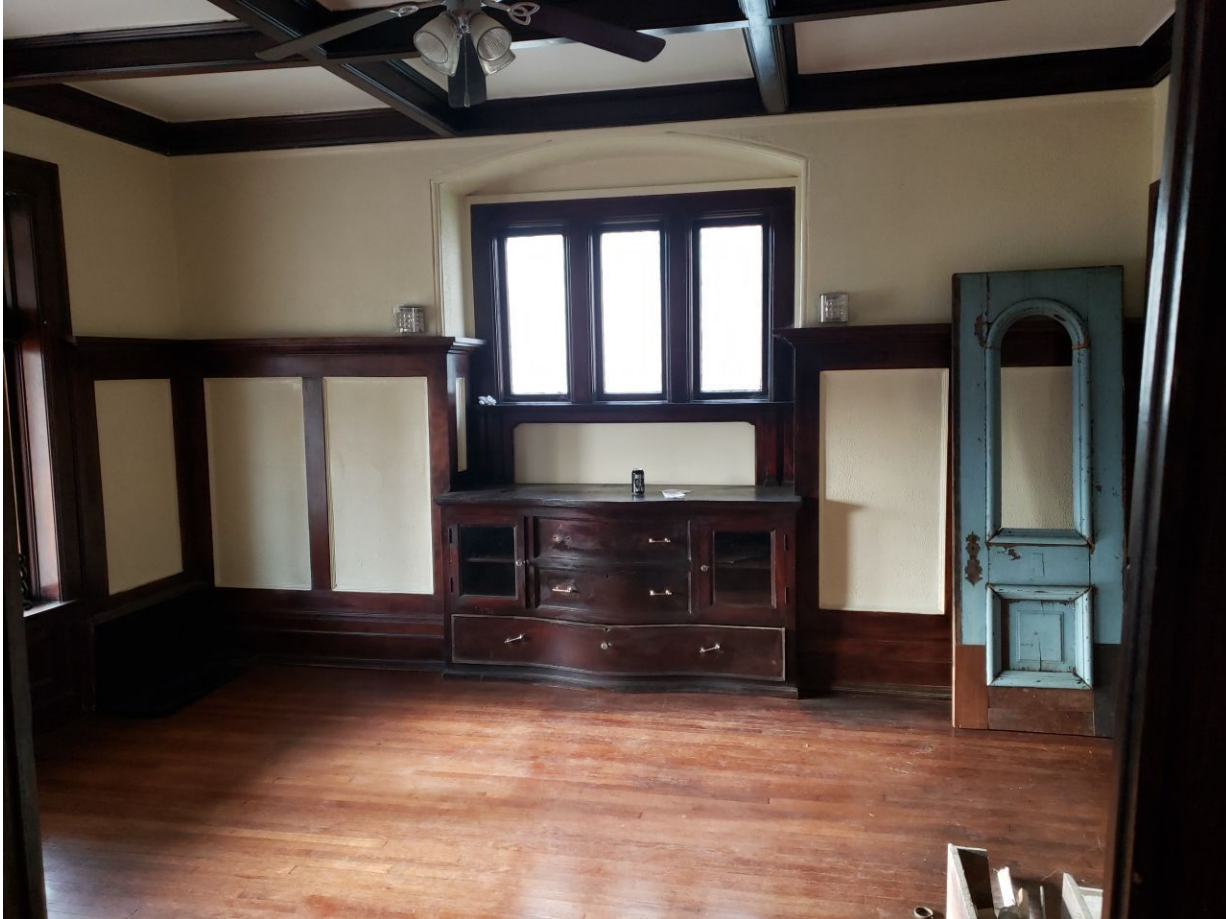
Window 1-08-10 (First Floor, West Elevation)

- fixed

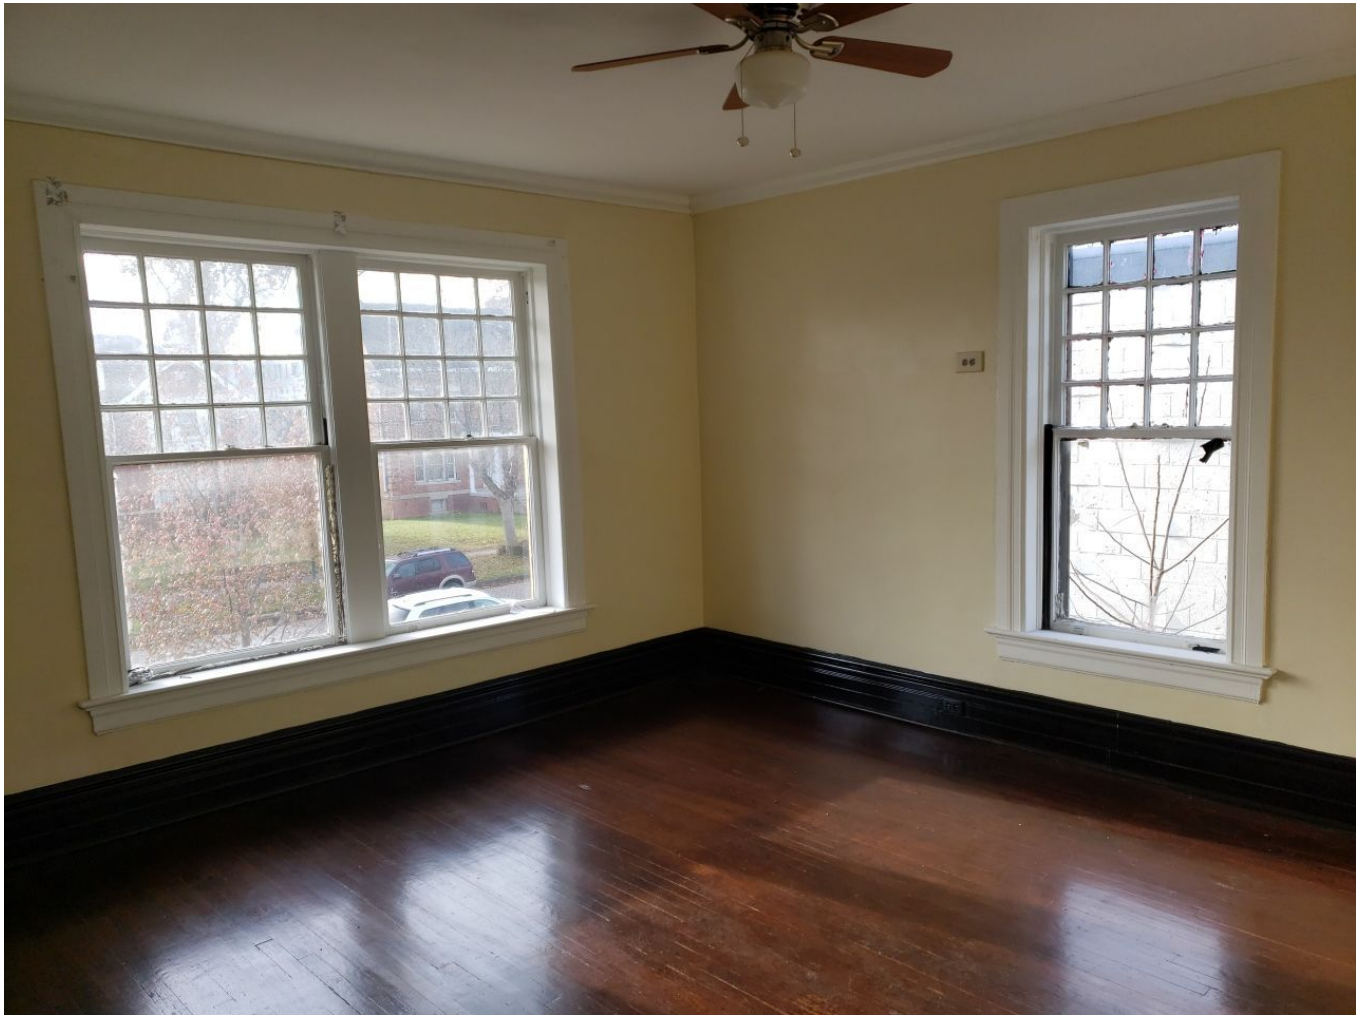
Window 2-01-03 (Second Floor, South/West Elevation)

- Double Hung, 16 over 1
- Weak weather seal due to rot
- Extensive rot at sills and vertical framing

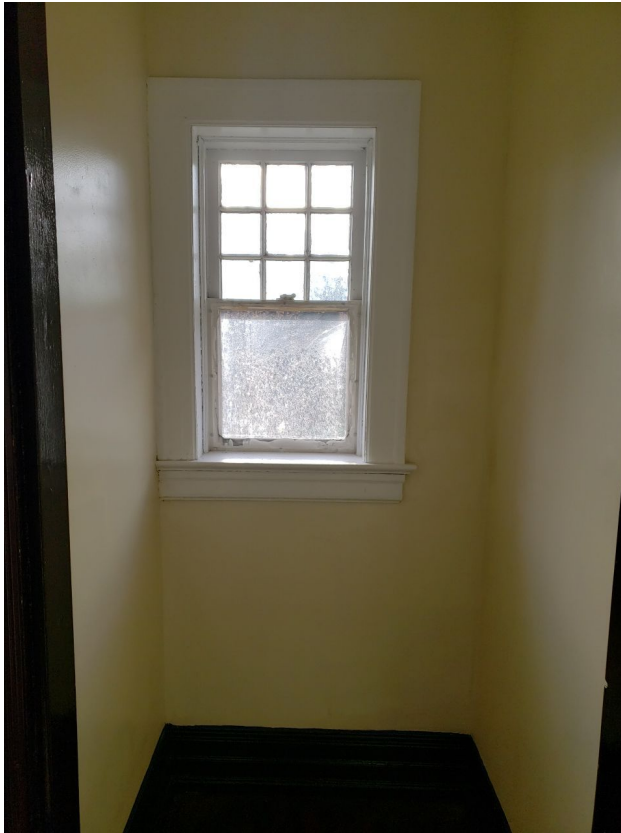
Window 2-04 (Second Floor, South Elevation)

- Double Hung, 9 over 1
- Extensive rot at sills and vertical framing

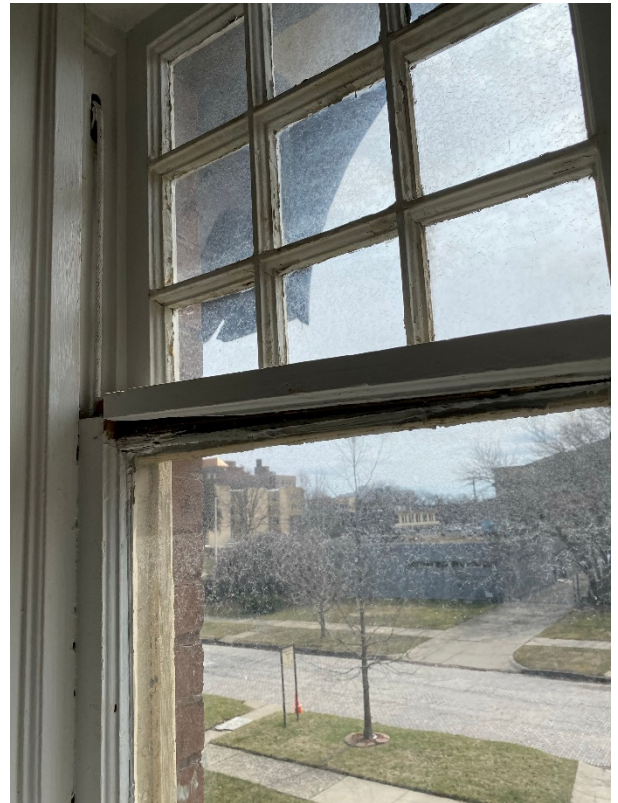
Window 2-05 (Second Floor, South Elevation)

- Double Hung, 9 over 1
- Extensive rot at sills and vertical framing
- Opening mechanism inoperable (painted shut)
- Broken lower sash

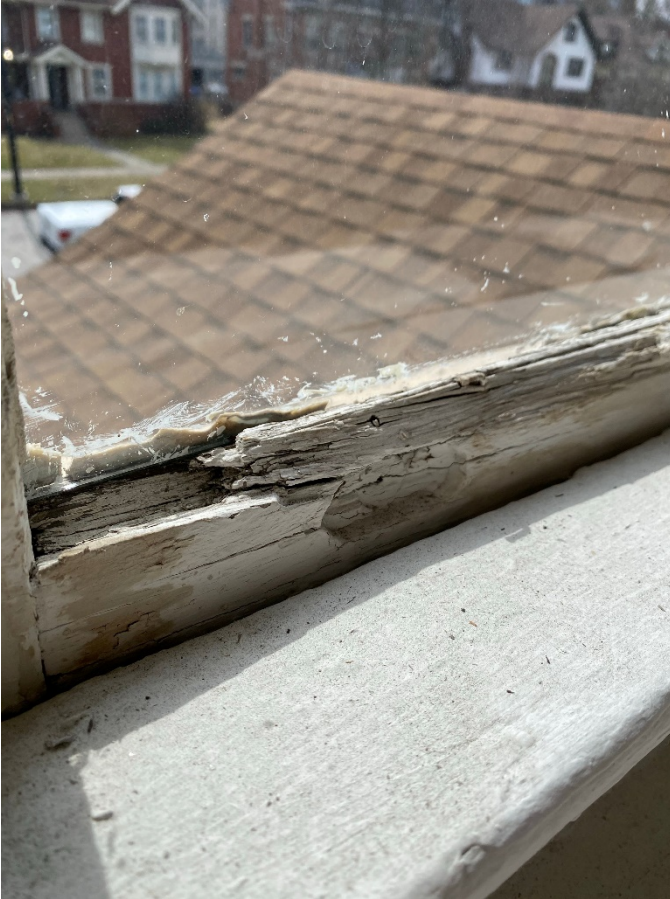
Window 2-06 (Second Floor, South Elevation)

- Double Hung, 9 over 1
- Extensive rot at sills and vertical framing

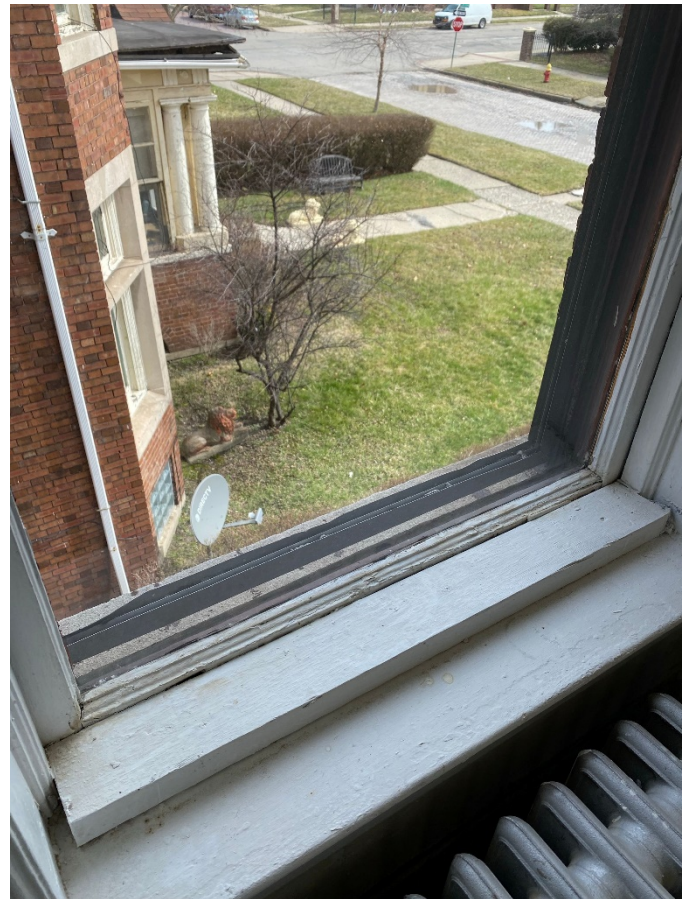
Window 2-07 (Second Floor, East Elevation)

- Double Hung, 1 over 1
- Extensive rot at sills

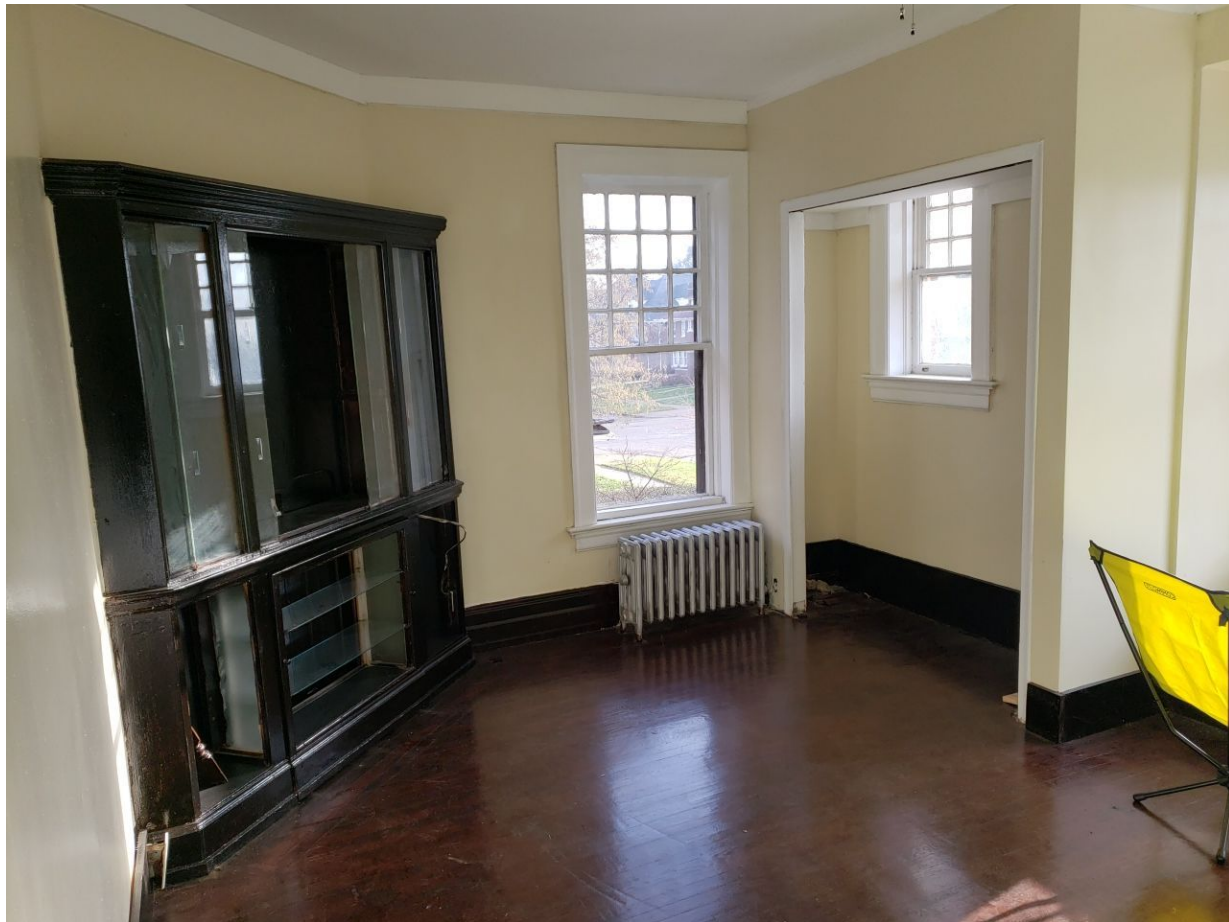
Window 2-08-09 (Second Floor, East/South Elevation)

- Double Hung, 16 over 1, 9 over 1
- Extensive rot at sills

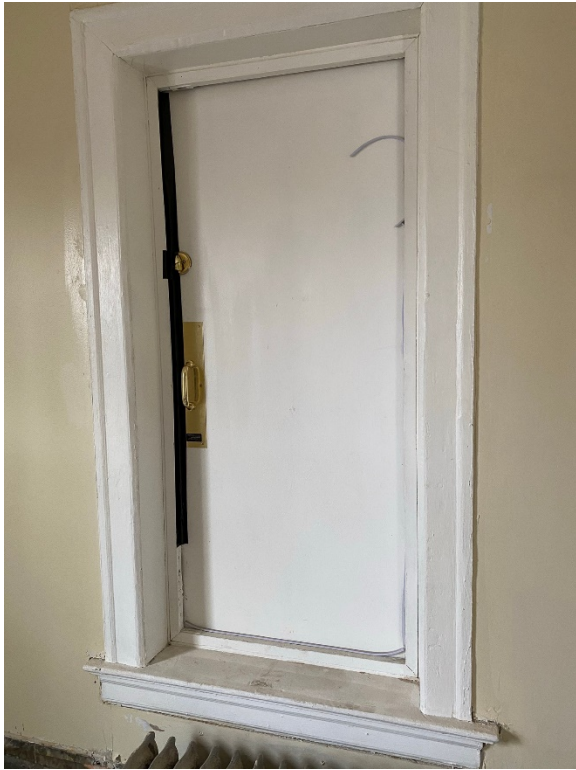
Window 2-10 (Second Floor, East Elevation)

- Currently door to fire escape that will be removed.
- Will be replaced with double-hung window

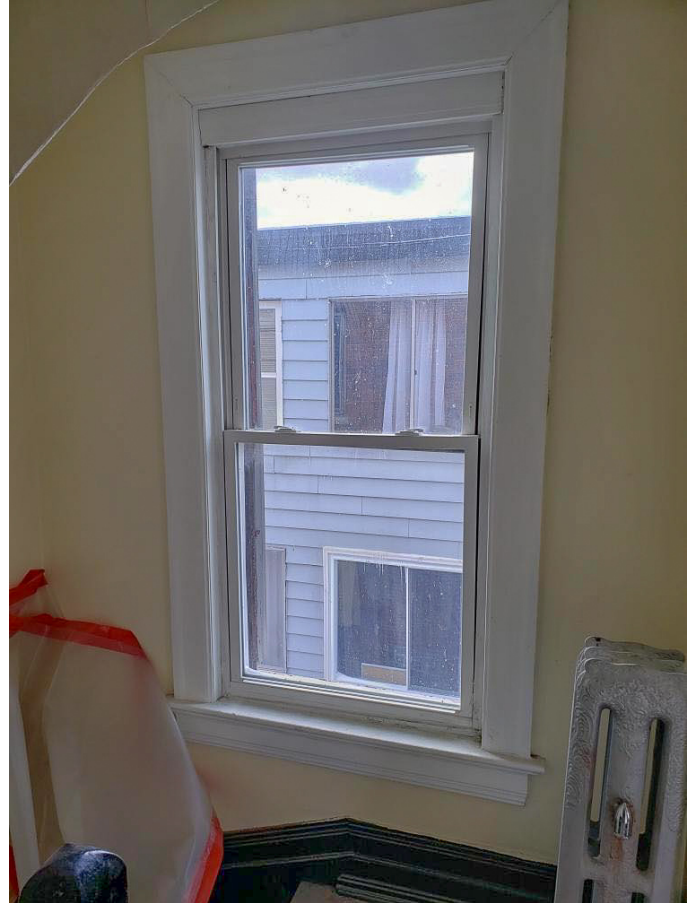
Window 2-11 (Second Floor, East Elevation)

- Double Hung, 1 over 1
- Vinyl Window

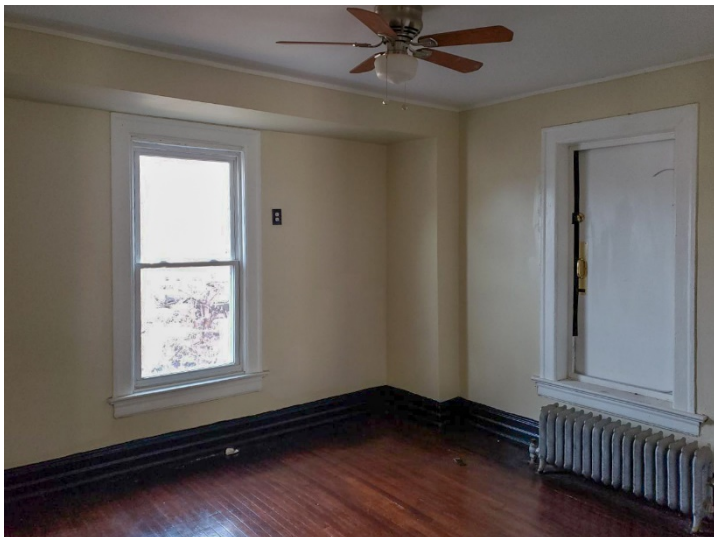
Window 2-12 (Second Floor, North Elevation)

- Double Hung, 1 over 1
- Vinyl Window

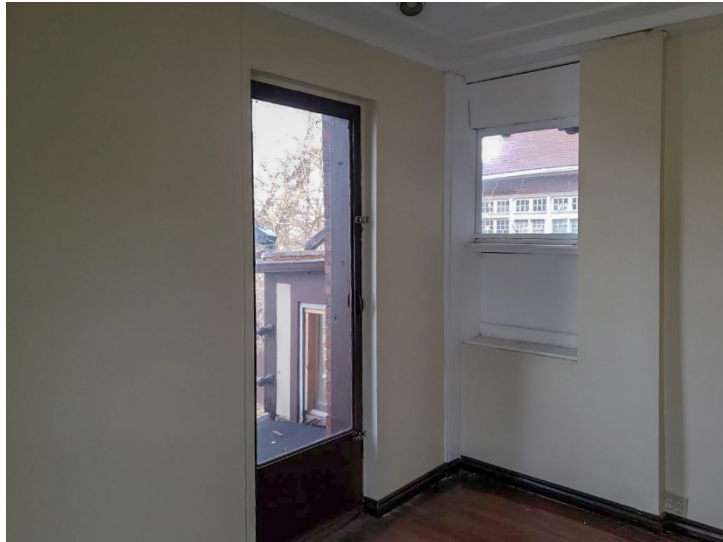
Broken Glass

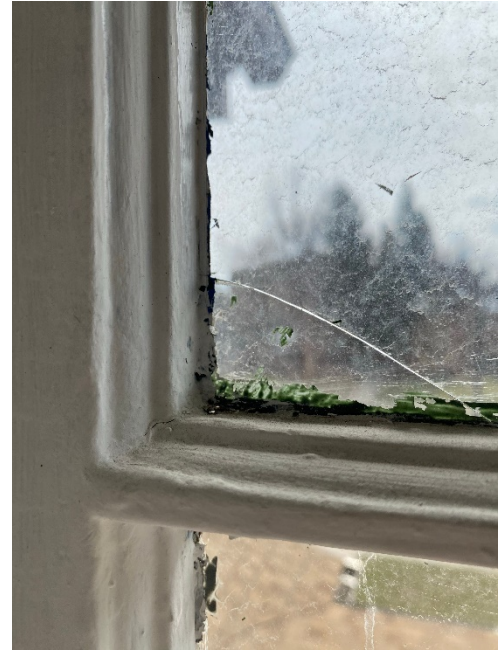
Examples of typical damage

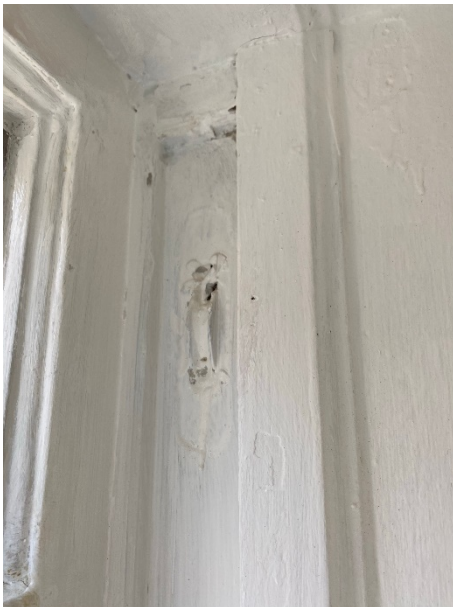
Operating hardware missing or inoperable

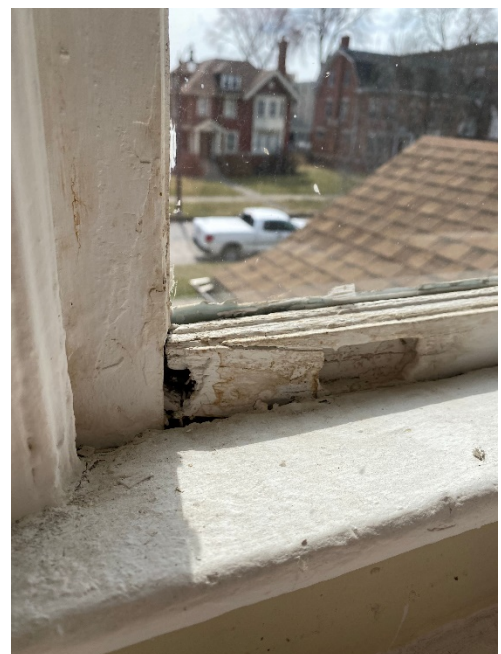
Rot at window sashes

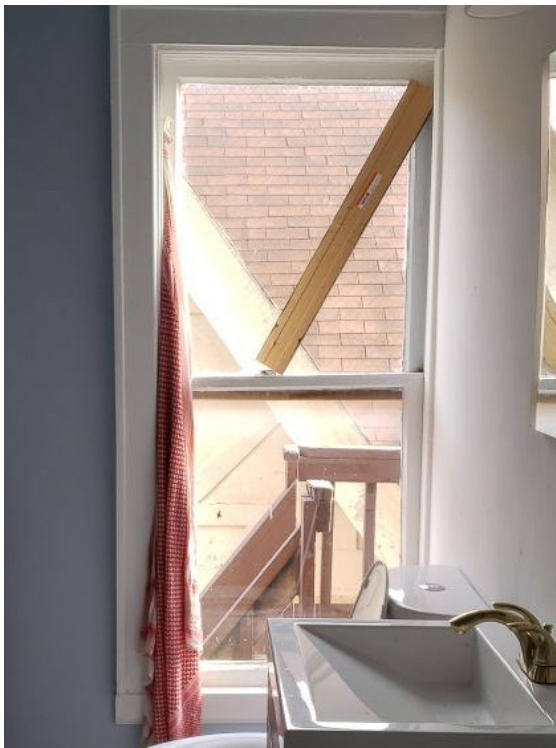
Window 3-01

ALL THIRD FLOOR WINDOWS ARE VINYL, AND ARE RECOMMENDED FOR REPLACEMENT WITH WOOD WINDOWS
