6/11/2021

Hannah-Neumann/Smith  
Attn: J. Michael Kirk AIA  
1457 Griswold St.  
Detroit, MI 48226

Name: Isaac Agree Downtown Synagogue  
Job Location: Detroit, MI

## **HISTORIC WINDOW SITE REVIEW:**

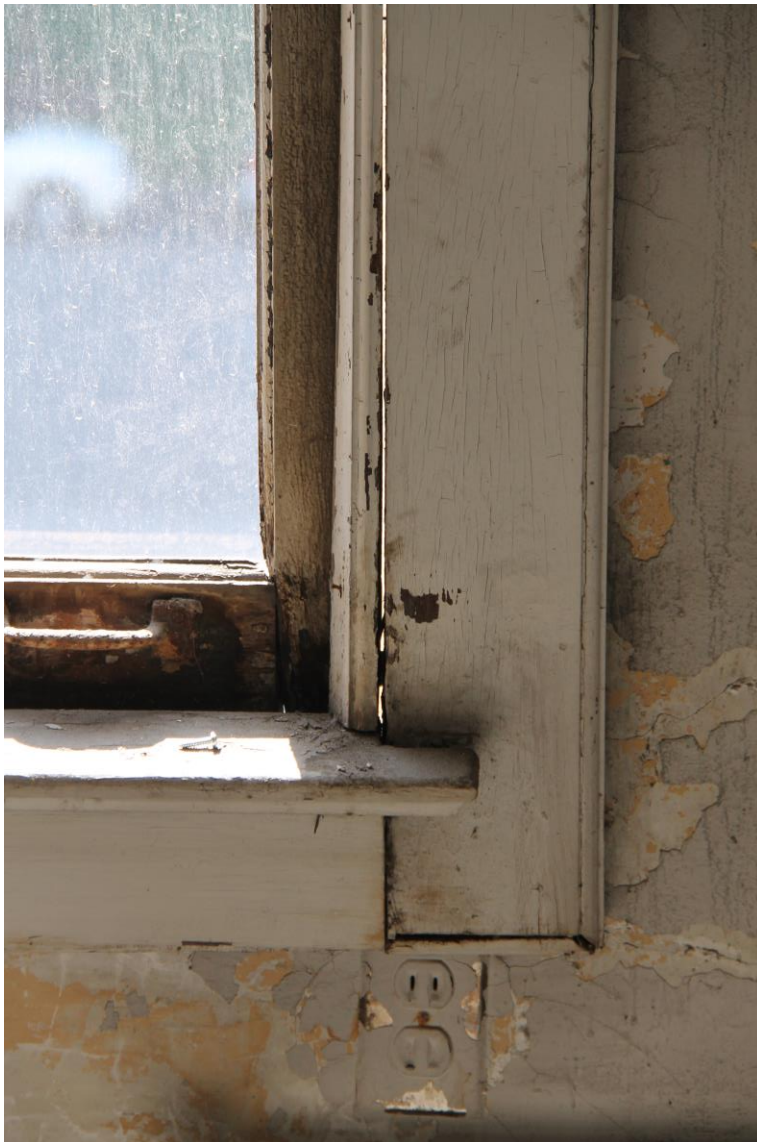
**INTERIOR JAMB WITH DAYLIGHT SHOWING**
