# Elevated Blood Lead (EBL) Investigation Report

1772 Seyburn St.  
Detroit, MI 48214  
1912

Date of Inspection: 11/20/2020

Date of Report 11/30/2020

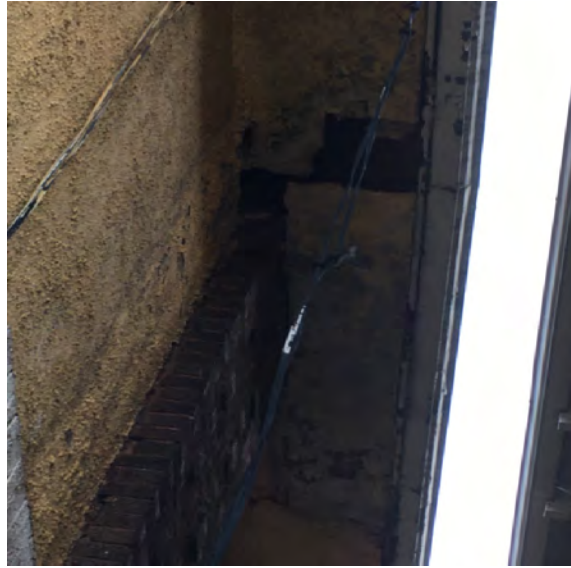
Roof Soffit Damage

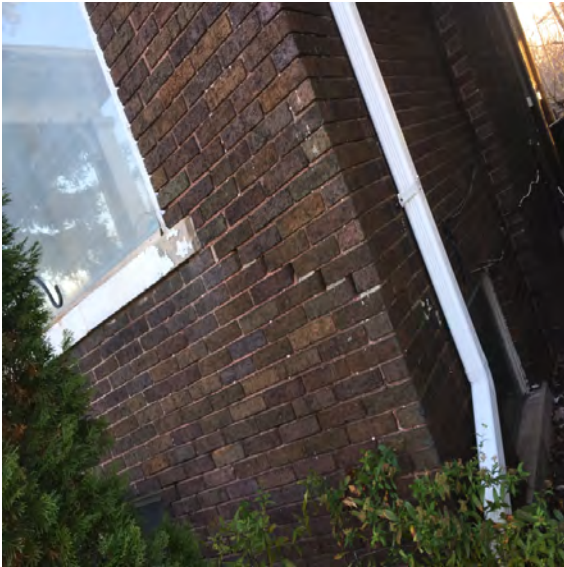
Possible Foundation Damage (Wall A)

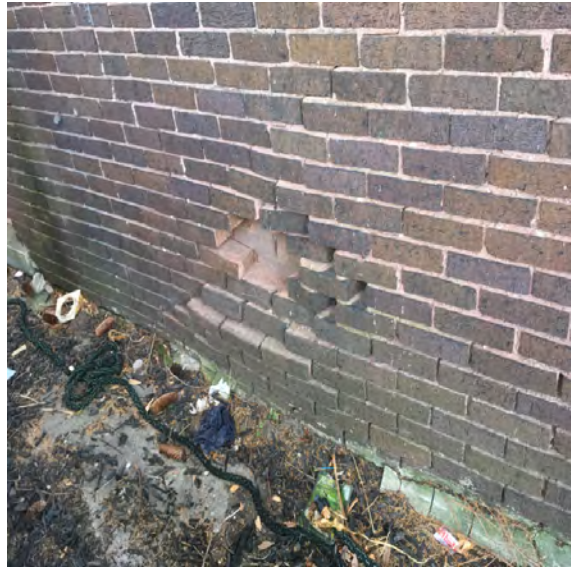
Possible Foundation Damage (Wall B)

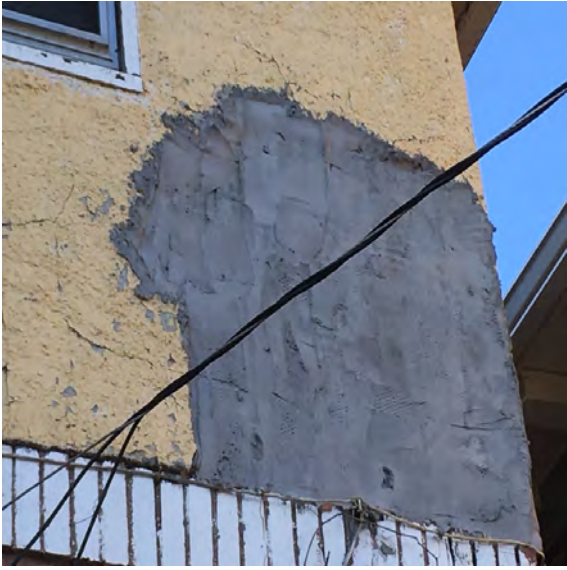
Deteriorated Exterior Walls

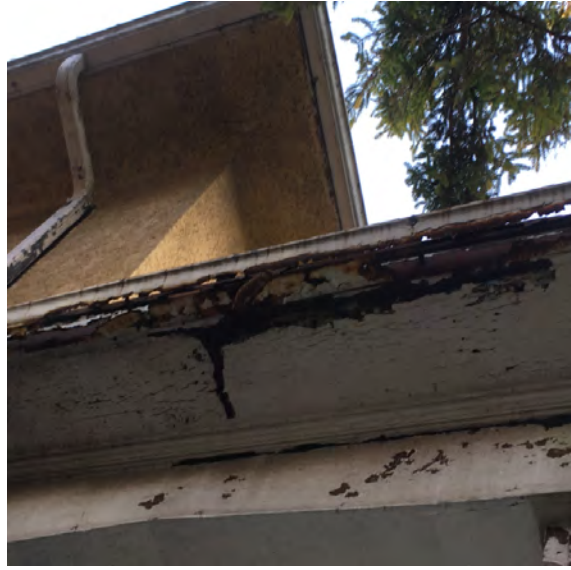
Damaged Gutter

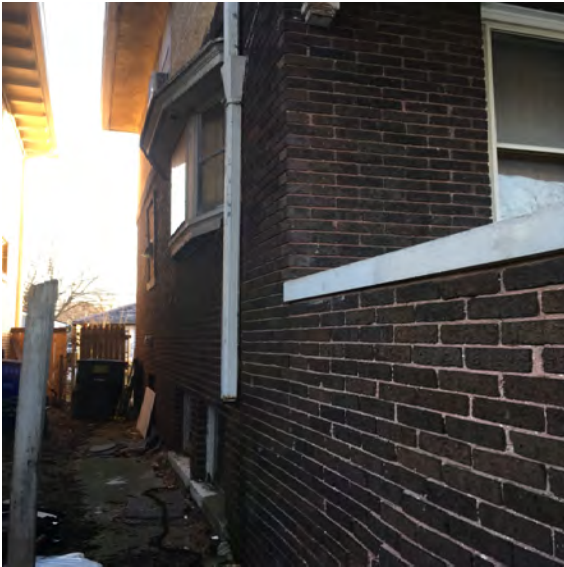
Damaged Gutter Downspout Pic 1

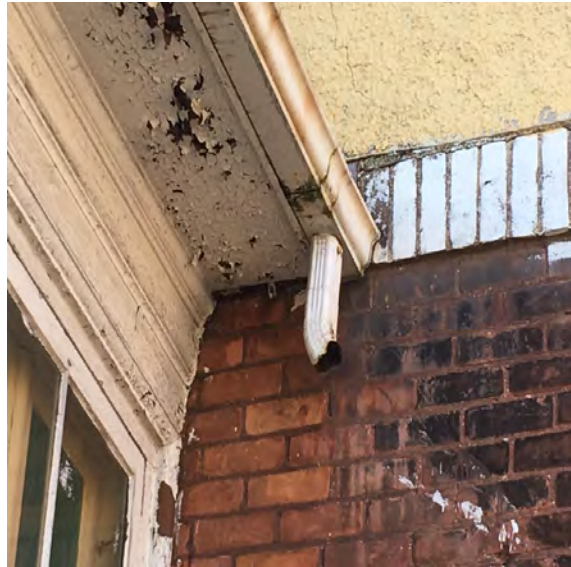
Damaged Gutter Downspout Pic 2

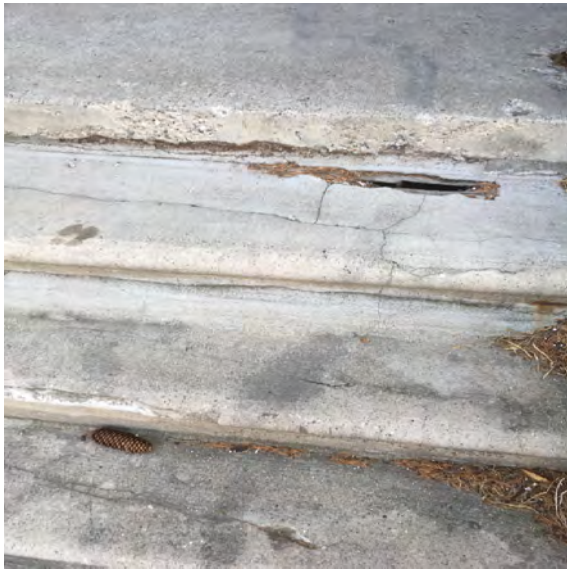
Porch Step Damage (Side A)

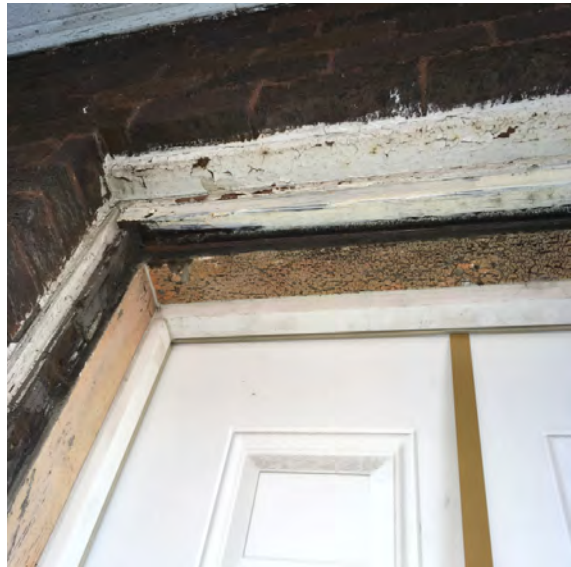
Deteriorated Exterior Door Jamb, Lintel & Casing

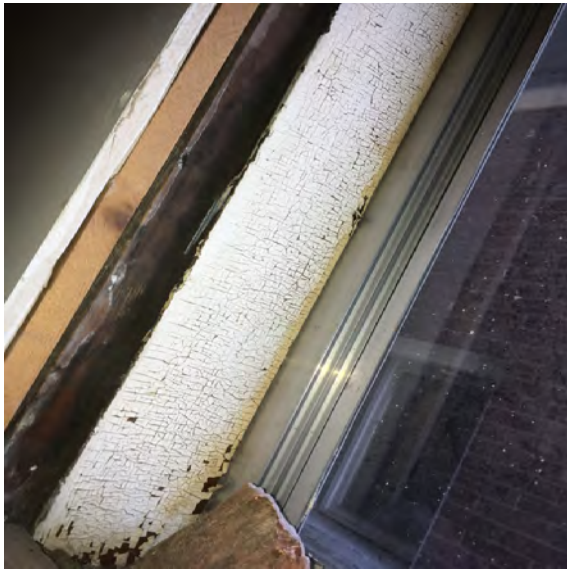
Deteriorated Exterior Fixed Window Jamb

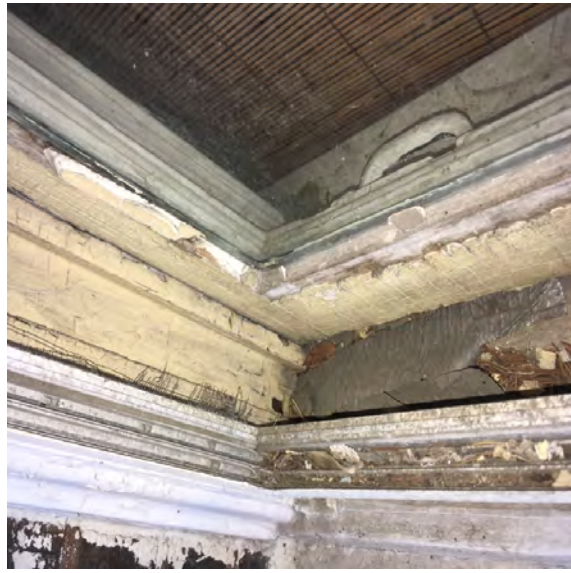
Deteriorated Exterior Window Components  
Pic 1

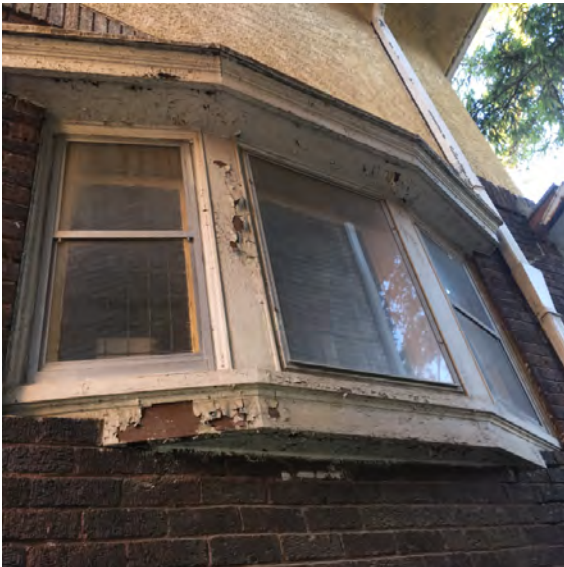
Deteriorated Exterior Window Components  
Pic 2

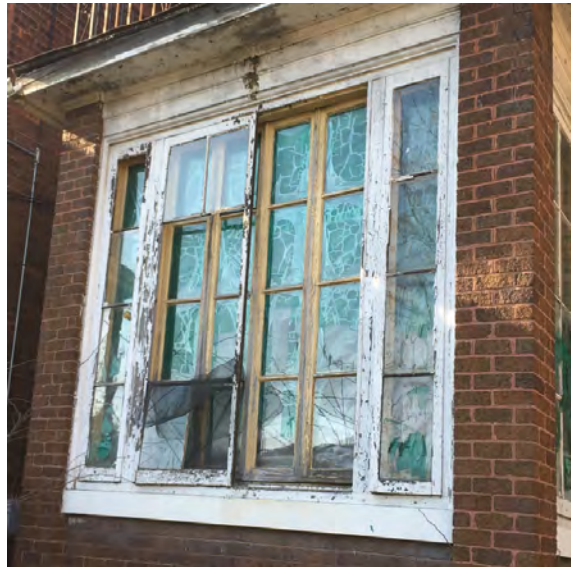
Deteriorated Exterior Window Components  
Pic 3

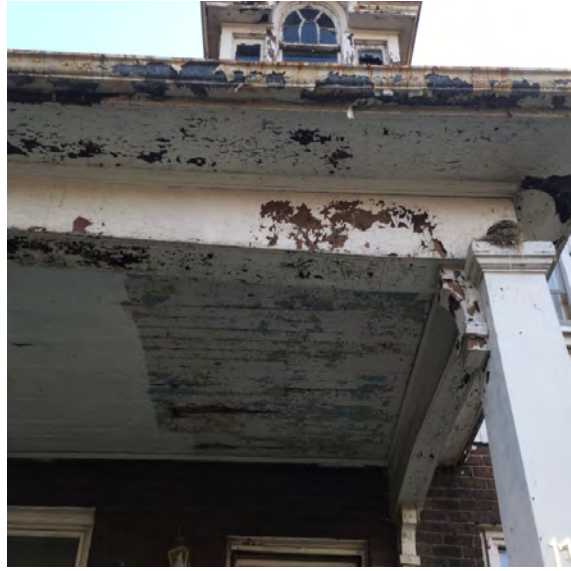
Deteriorated Porch Ceiling, Ceiling Beam & Columns

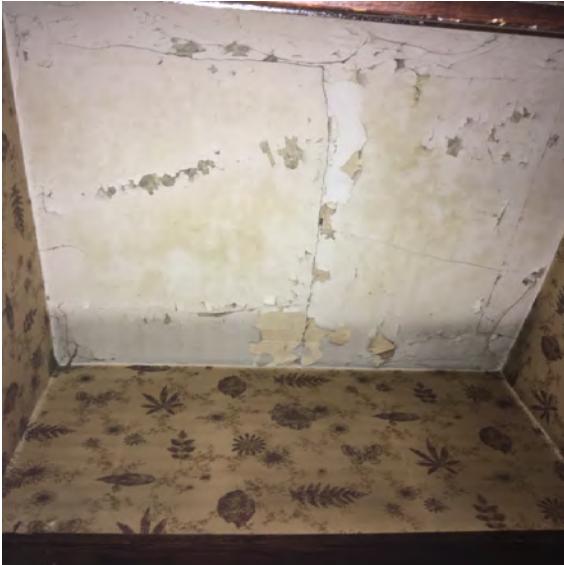
Foyer Ceiling Moisture Damage

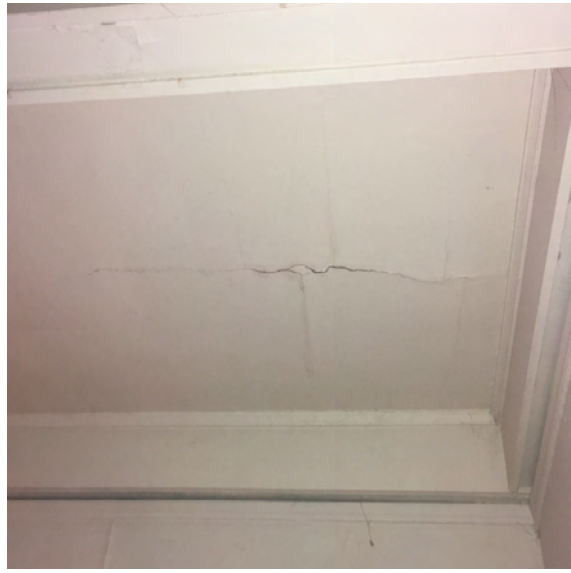
Living Room Ceiling Damage

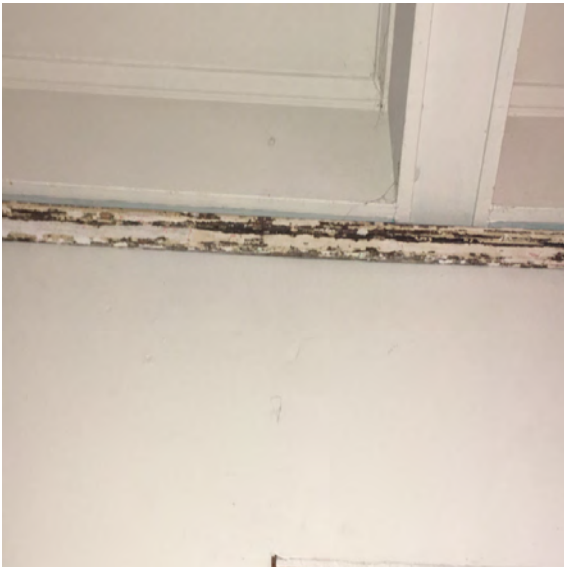
Living Room Deteriorated Crown Molding

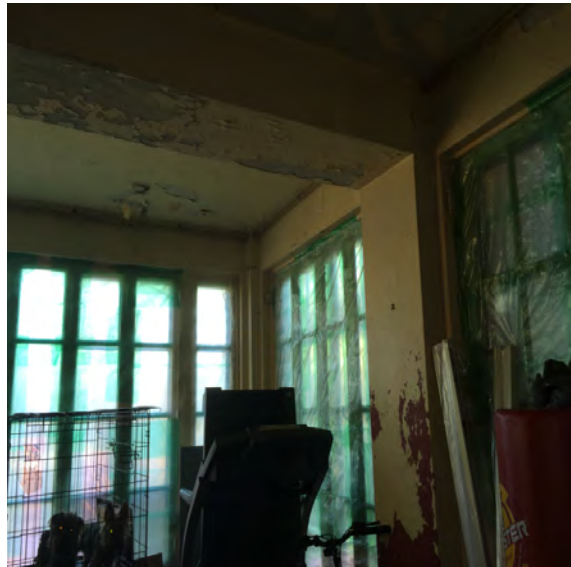
Enclosed Porch Deteriorated Ceiling & Walls

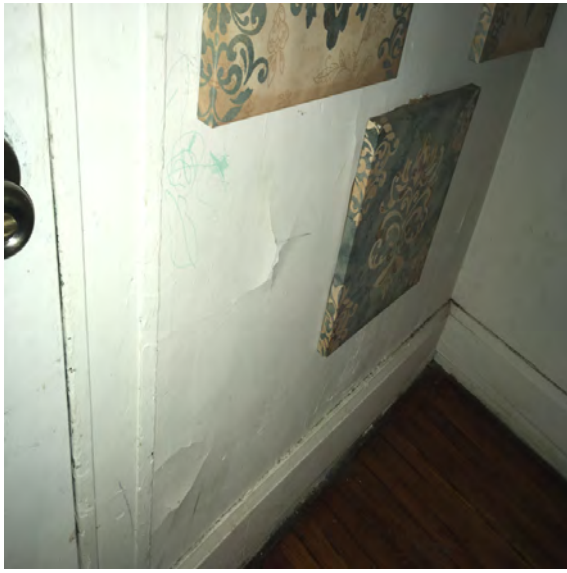
Stairwell 1 Wall Damage

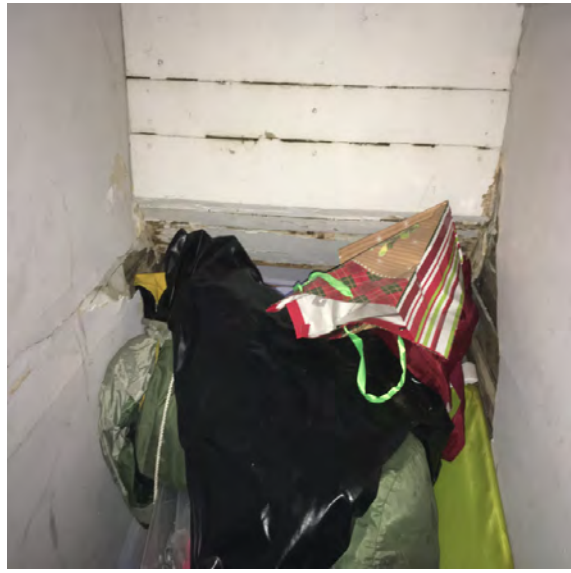
Stairwell 1 Closet Damage

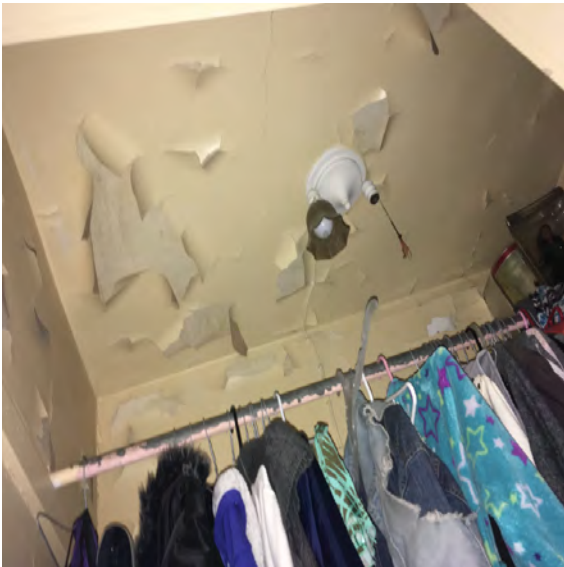
Bedroom 1 Closet Moisture Damage

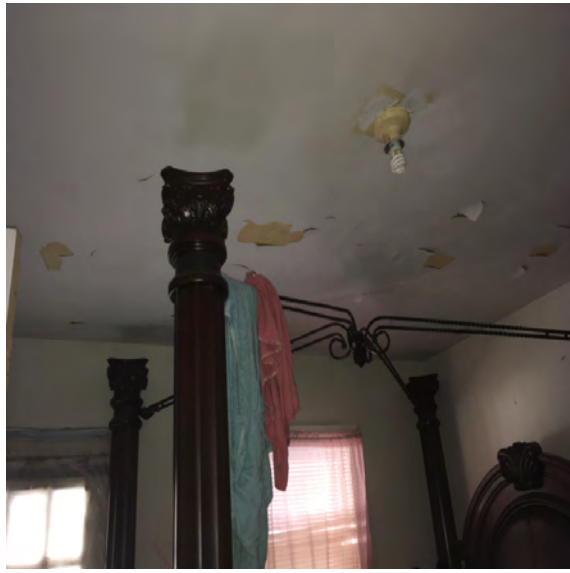
Bedroom 1 Ceiling Moisture Damage

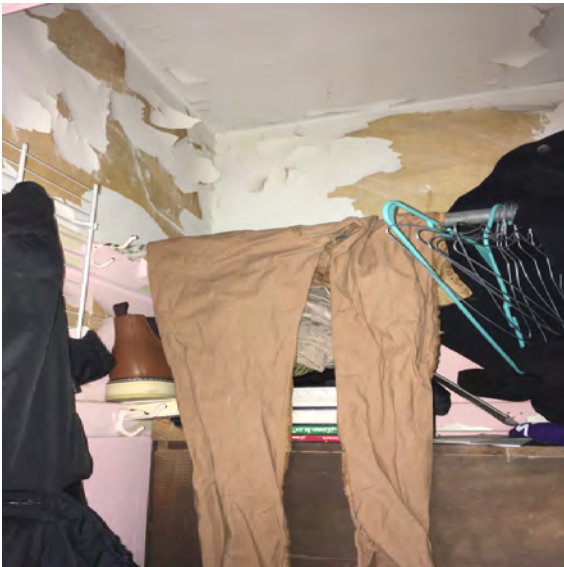
Bedroom 2 Closet Moisture Damage

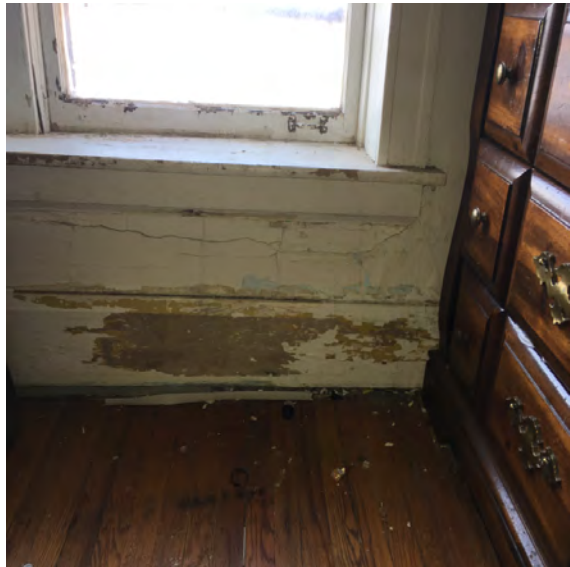
Bedroom 2 Moisture Damaged Wall & Baseboard

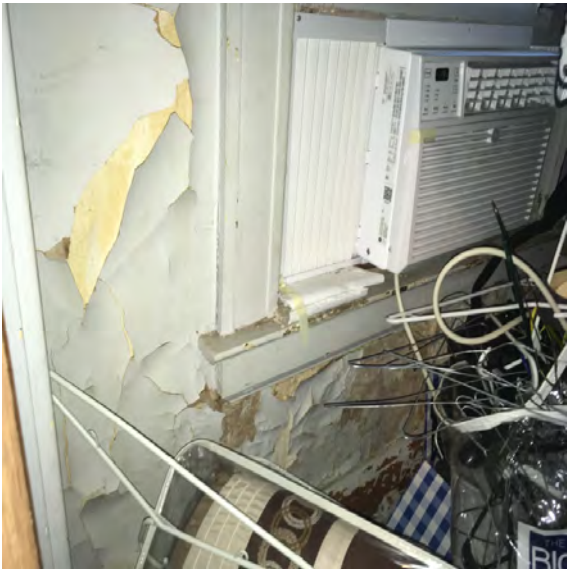
Bedroom 3 Closet 1 Moisture Damage

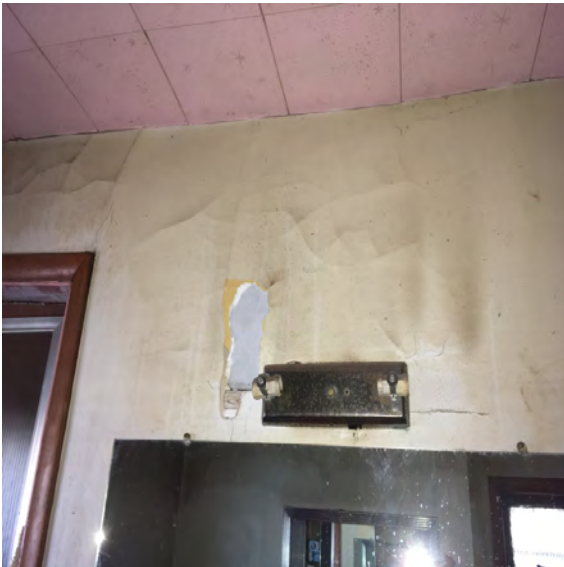
Bathroom Deteriorated Walls

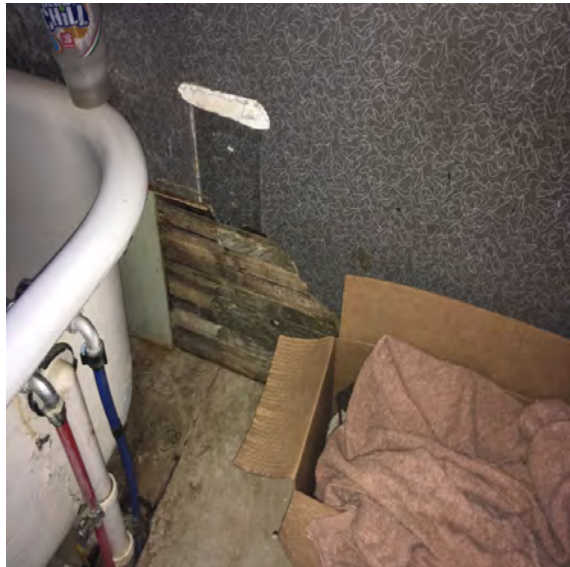
Bathroom Wall Damage

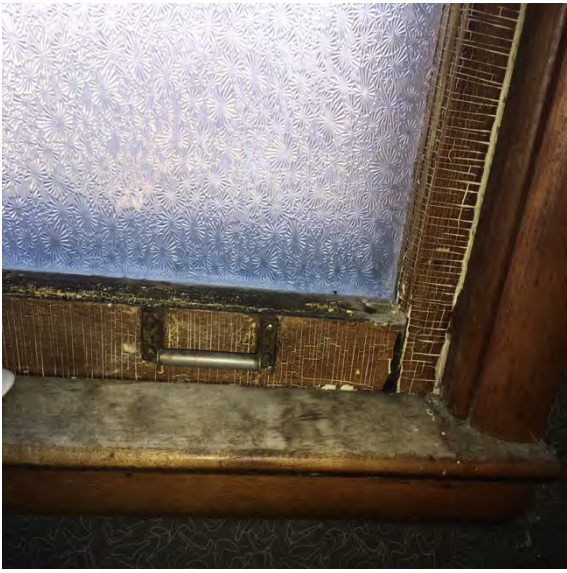
Bathroom Deteriorated Varnish Window Sash

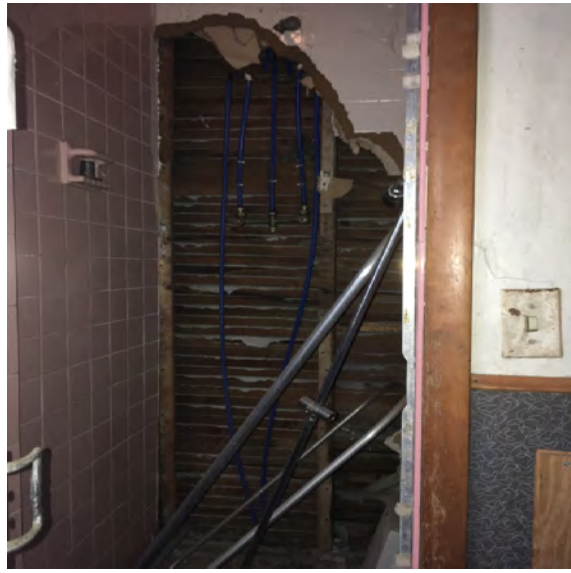
Bathroom Shower Damage

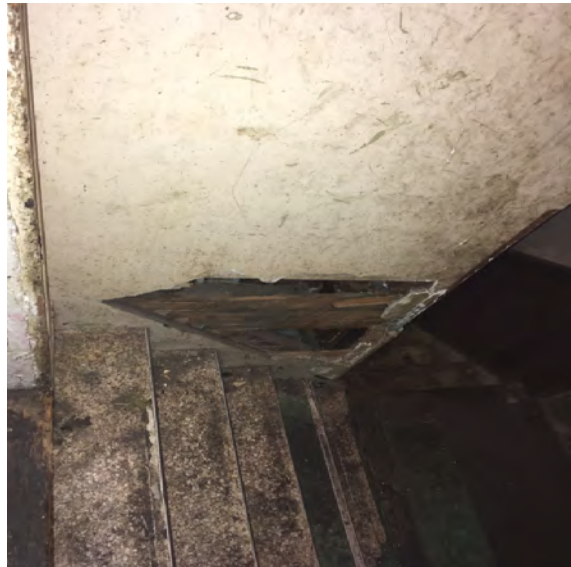
Stairwell 3 Wall Damage

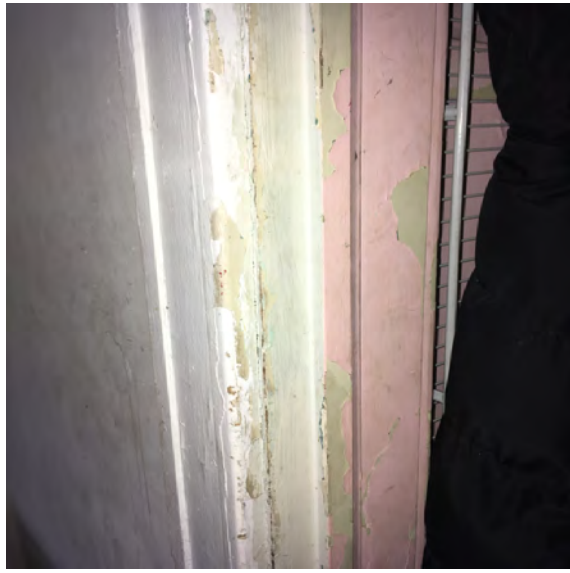
Deteriorated Interior Door Components

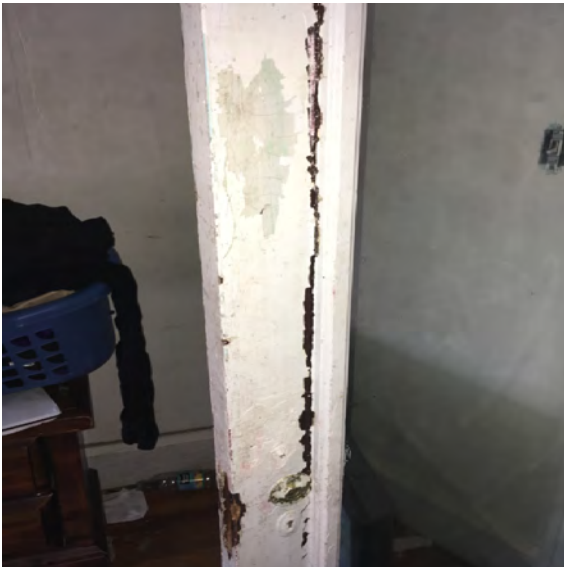
Deteriorated Interior Door Stile

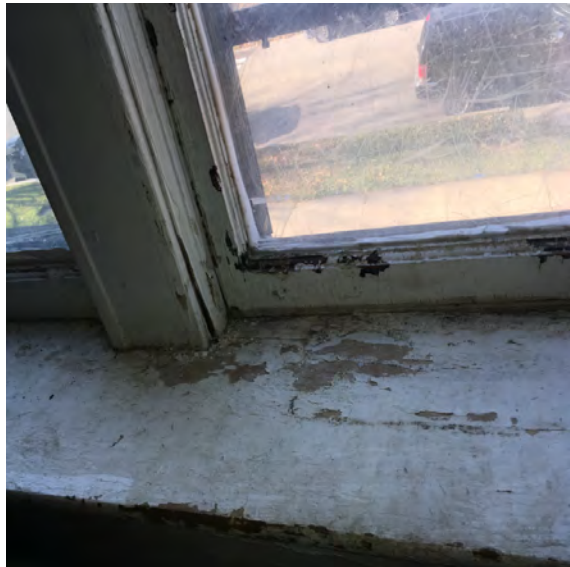
Deteriorated Interior Window Components

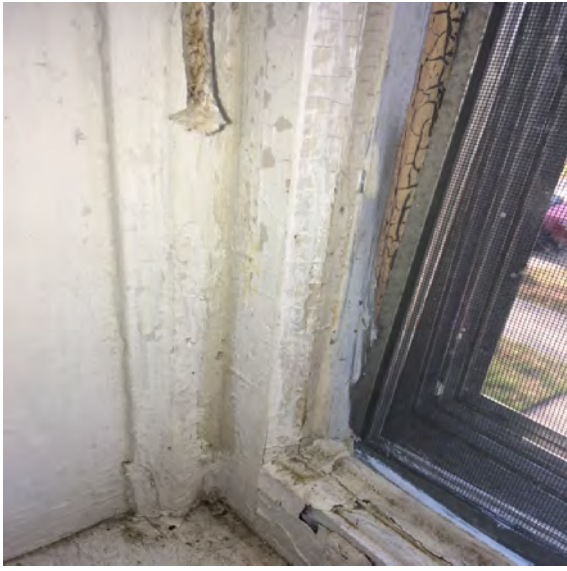
Some Windows are Painted Shut Pic 1

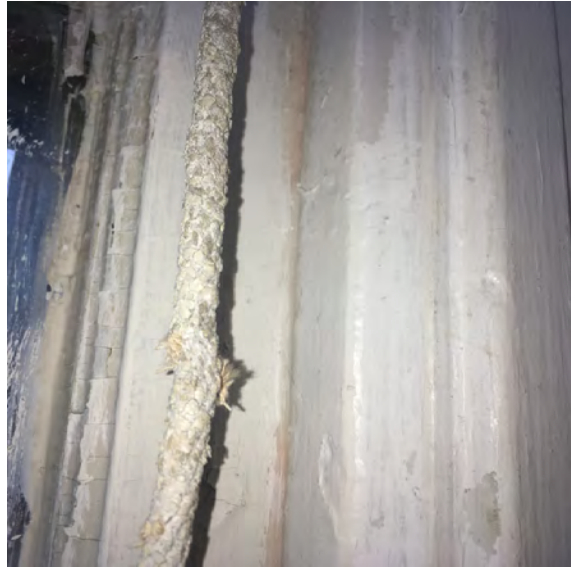
Some Windows are Painted Shut Pic 2
