Window Assessment Form

Address: 1772 Seyburn
 Inspector : Martha H. Delgado

Window Survey Form—Window Condition Report

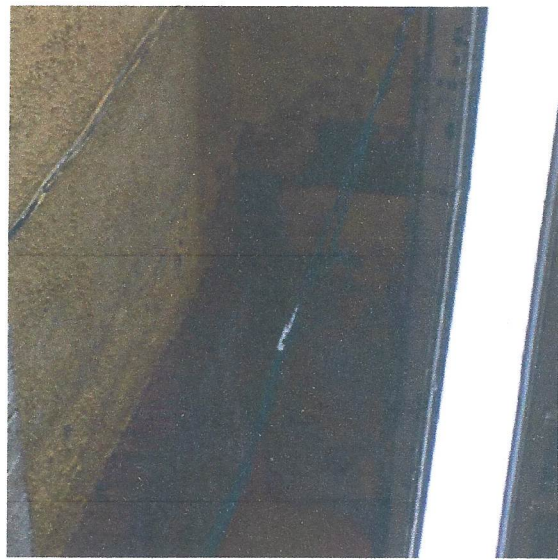
Roof Soffit Damage

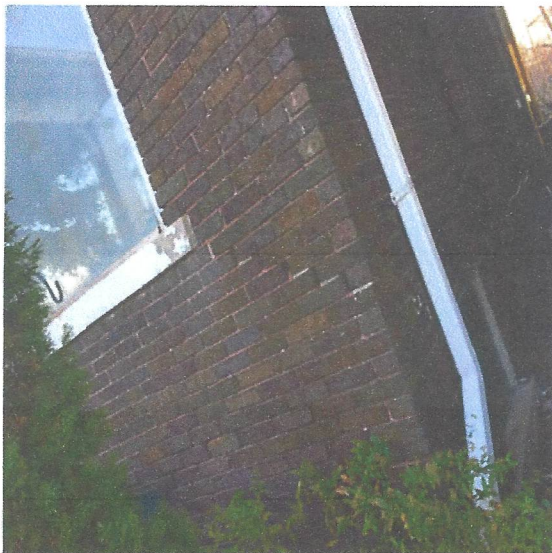
Possible Foundation Damage (Wall A)

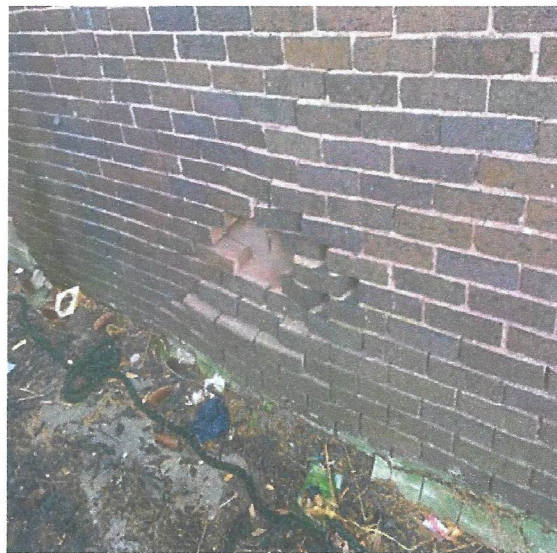
Possible Foundation Damage (Wall B)

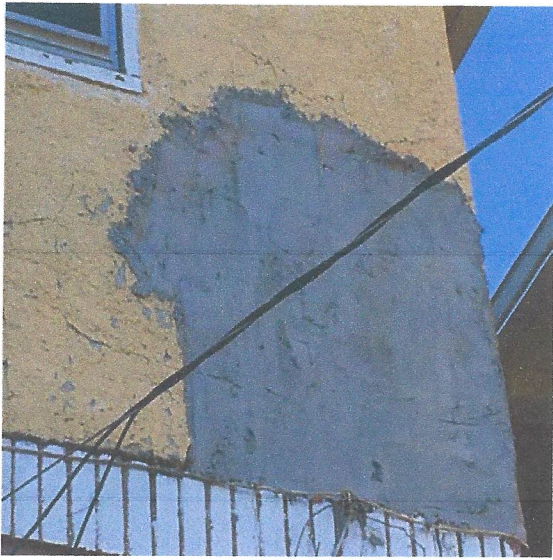
Deteriorated Exterior Walls

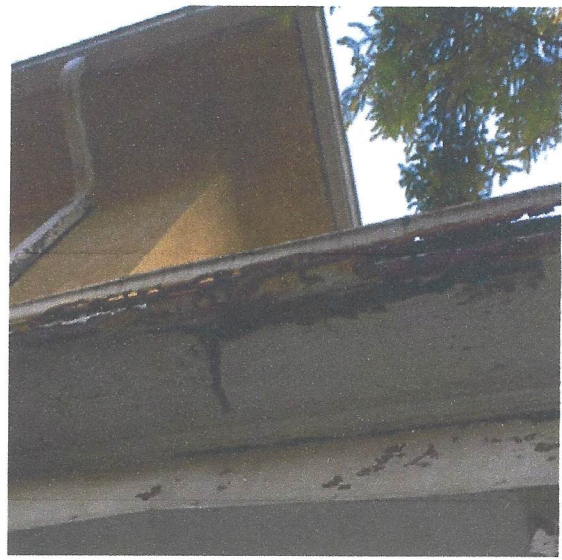
Damaged Gutter

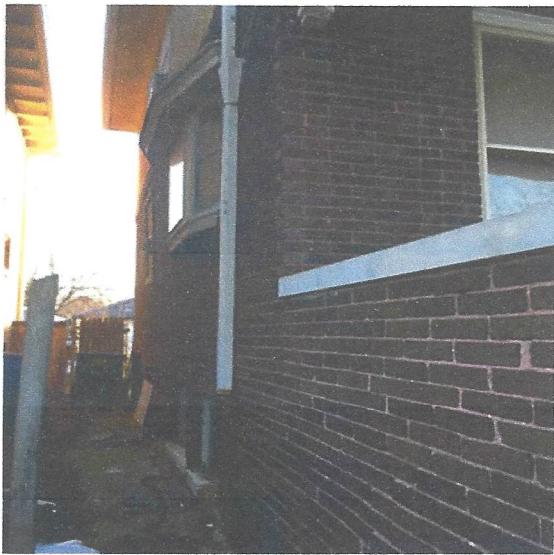
Damaged Gutter Downspout Pic 1

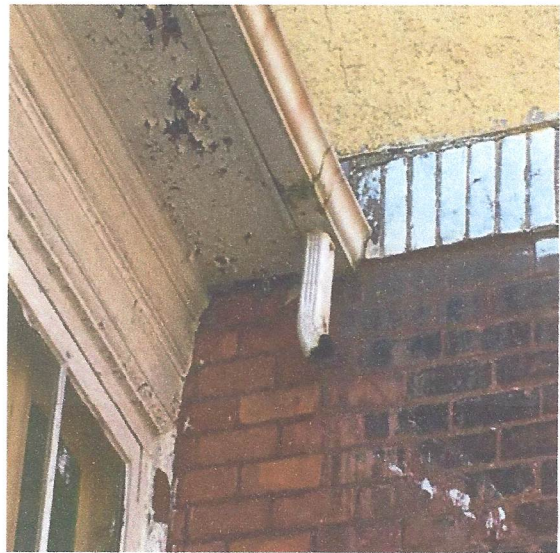
Damaged Gutter Downspout Pic 2

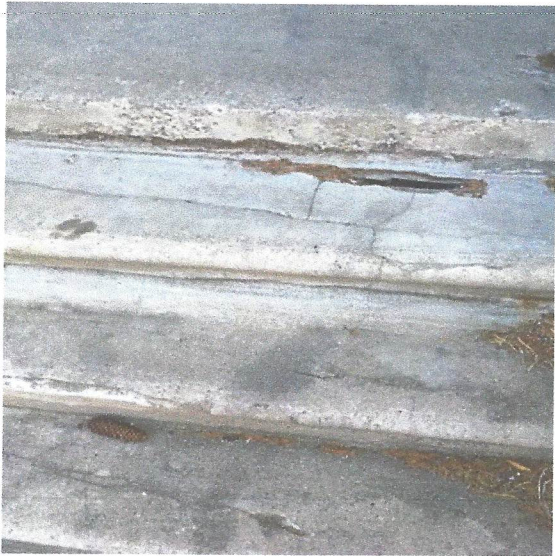
Porch Step Damage (Side A)

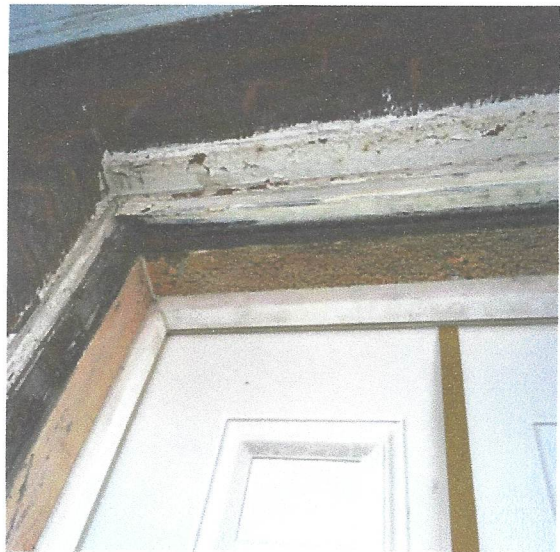
Deteriorated Exterior Door Jamb, Lintel & Casing
