Artisan Renovations LLC

ASSESSMENT

7 October 2021

**1315 Broadway
Detroit, MI**

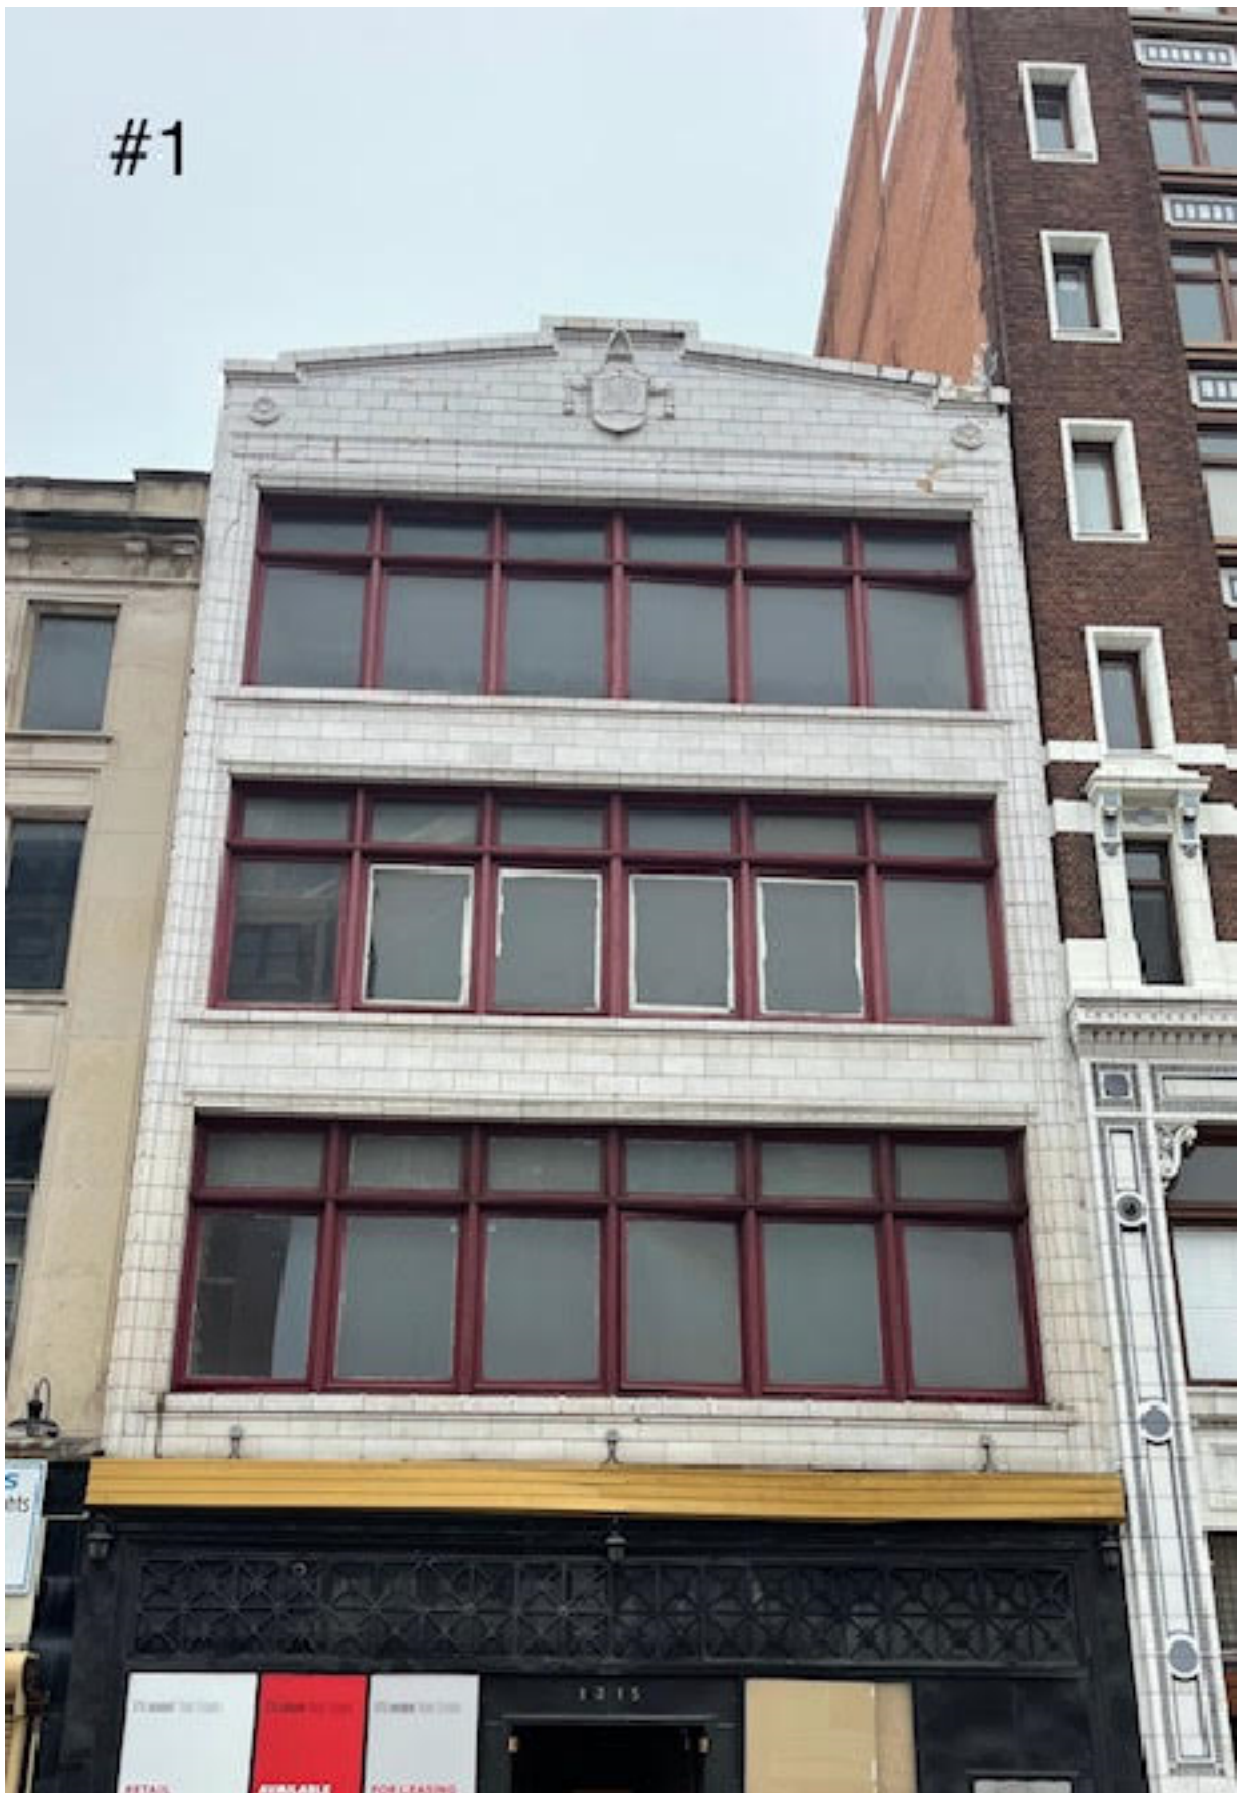
#1

- (18) Outswing pivot windows and (18) hopper windows to be fully restored (Photo #1)
- Sills and frames are in very good condition. No “wood rot” evident on any unit. Wood sills and entire window frames to be restored and repainted (Photo #2)
- Several units have damaged or missing glazing stop. All damaged glazing trim on sash to be restored and/or replaced with exact replica as needed (Photo #3)
- Some units have damaged or missing inner stop and mullion trim. All existing inner stop to be restored or new will be fabricated where missing or damaged beyond restoration (Photos #4, 5 & 6)

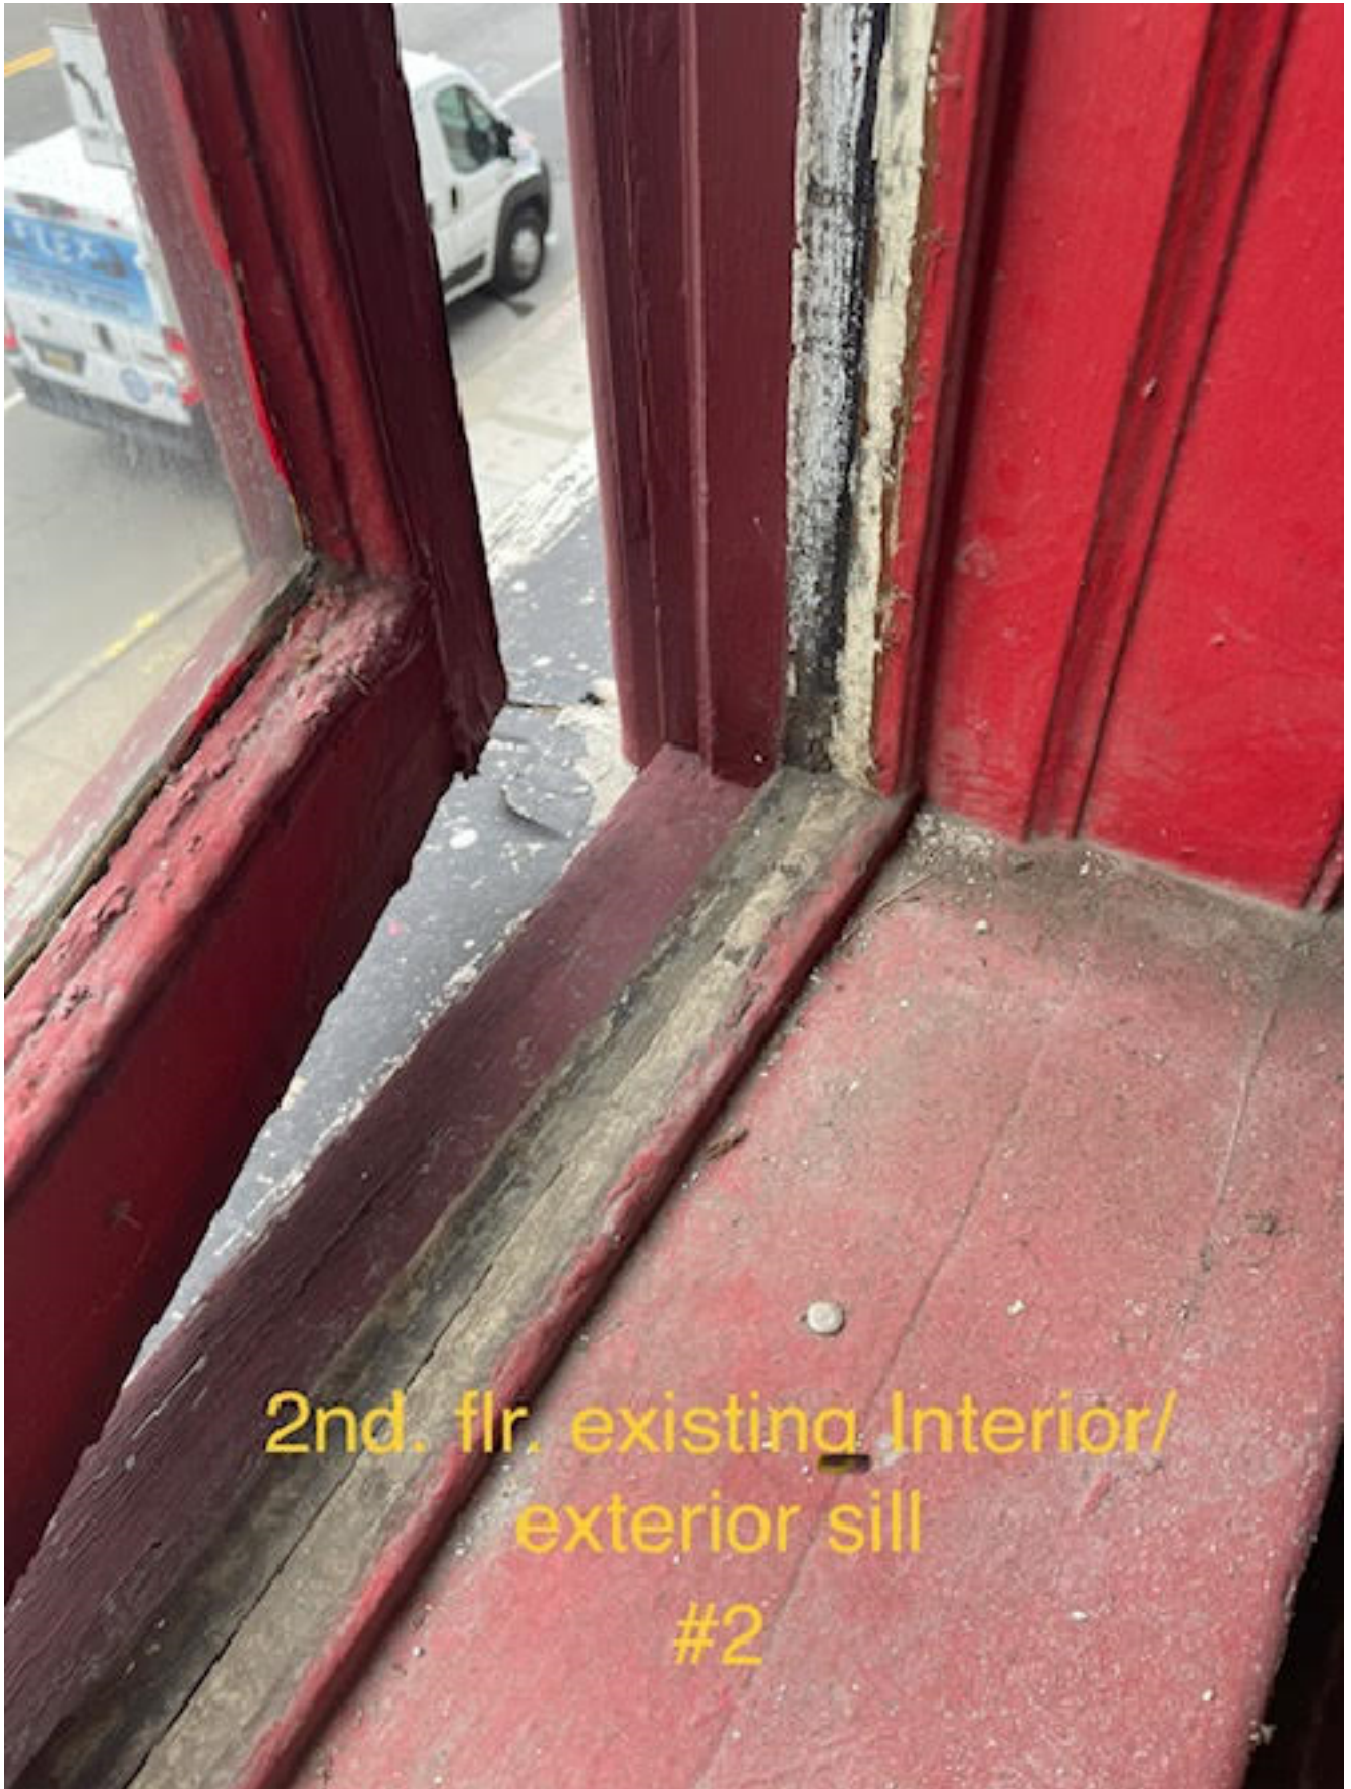
#2

2nd. flr. existing Interior/
exterior sill
