Lead Inspection & Risk Assessment Report

4825 Sturtevant
Detroit, MI 48204
1925

Date of Inspection: 05/27/2021

GS GROUP, LLC
17800 Woodward Ave., Suite 200
Detroit, MI 48203
313-279-0449

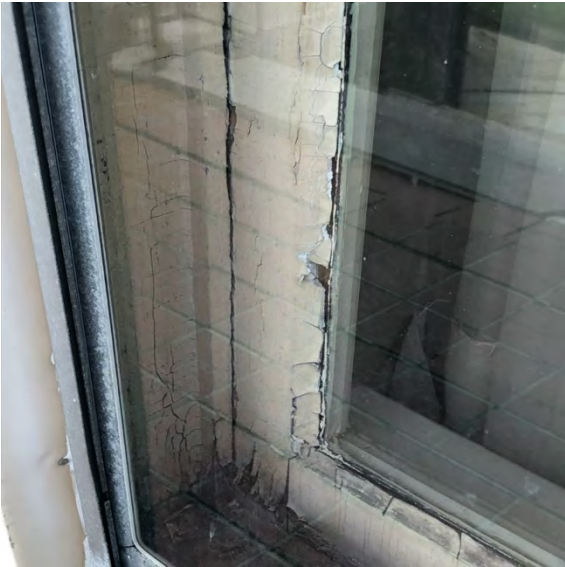
Deteriorated Window Sash

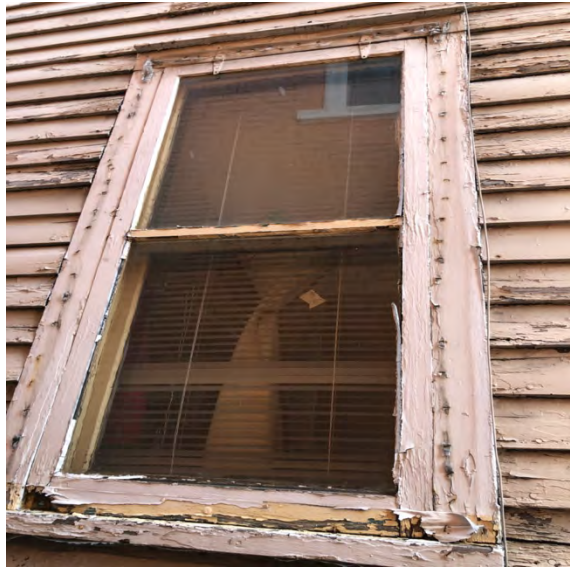
Deteriorated Window
