9710 W Outer Dr

Existing Condition Photos

Current Design Description

A 3-story apartment structure with 10 residential units, constructed in 1940, brick on wood stud wall construction, shingle roof, stone corner details, stone details at palladian window, stone sills, wood detailing at front entry, steel and wood canopy at back entry, wood windows throughout with the exception of steel windows at bathrooms and the lowest level. The addition of a brick shed to house the gas meter was made at a later date.

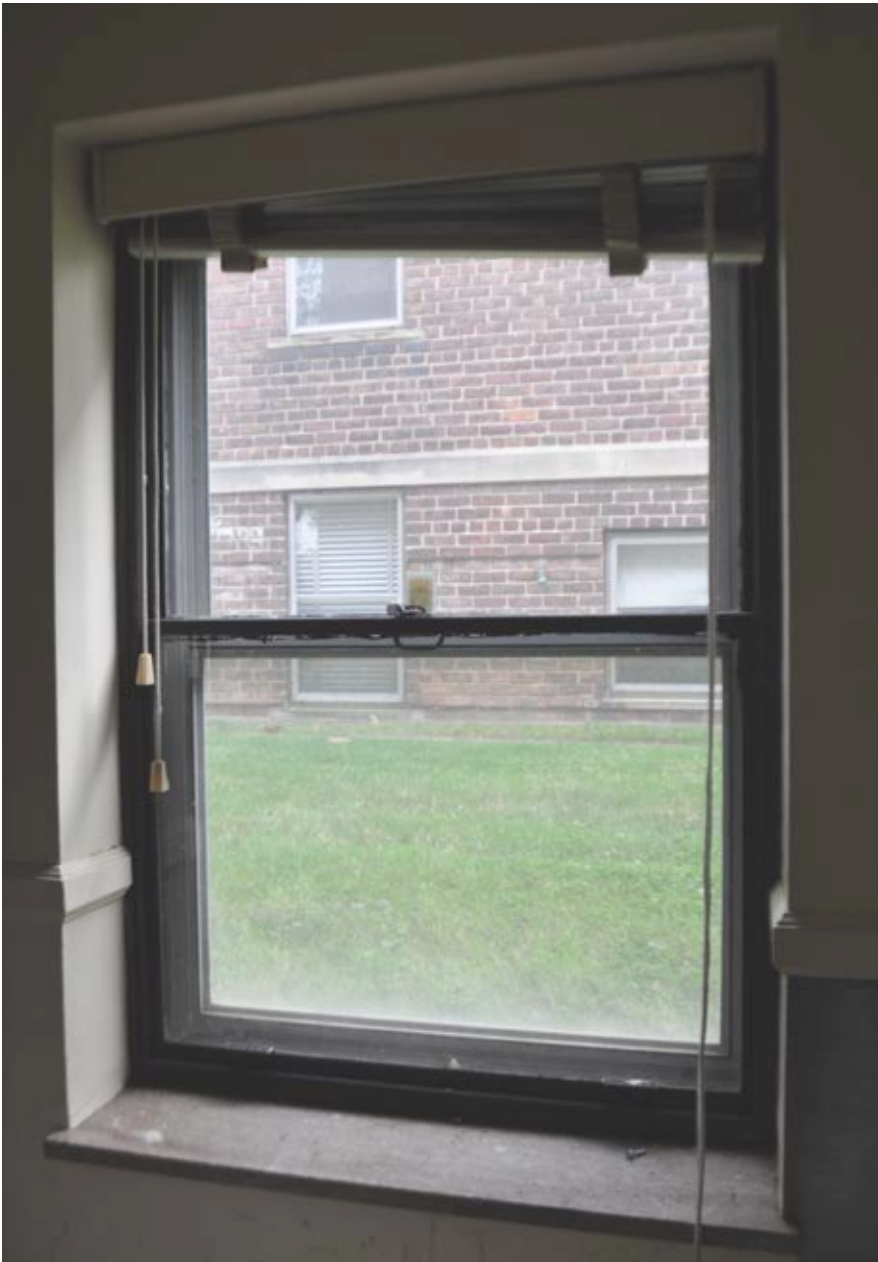
Window G3, Type F2

- Note: Extent of exterior deterioration, dry rot, and loss of operability is not fully apparent in interior photos. Replacement parts for existing windows are unavailable, making restoration of thermal and operable functionality impossible, and long-term maintenance infeasible. Recommendation is for replacement, for quality of life of future tenants and for feasibility of long-term maintenance.
- See Window Assessment (Blackberry) in appendix for further detail and information, including further notes on deterioration beyond repair
- See Appendix for Window Schedule & Measurements

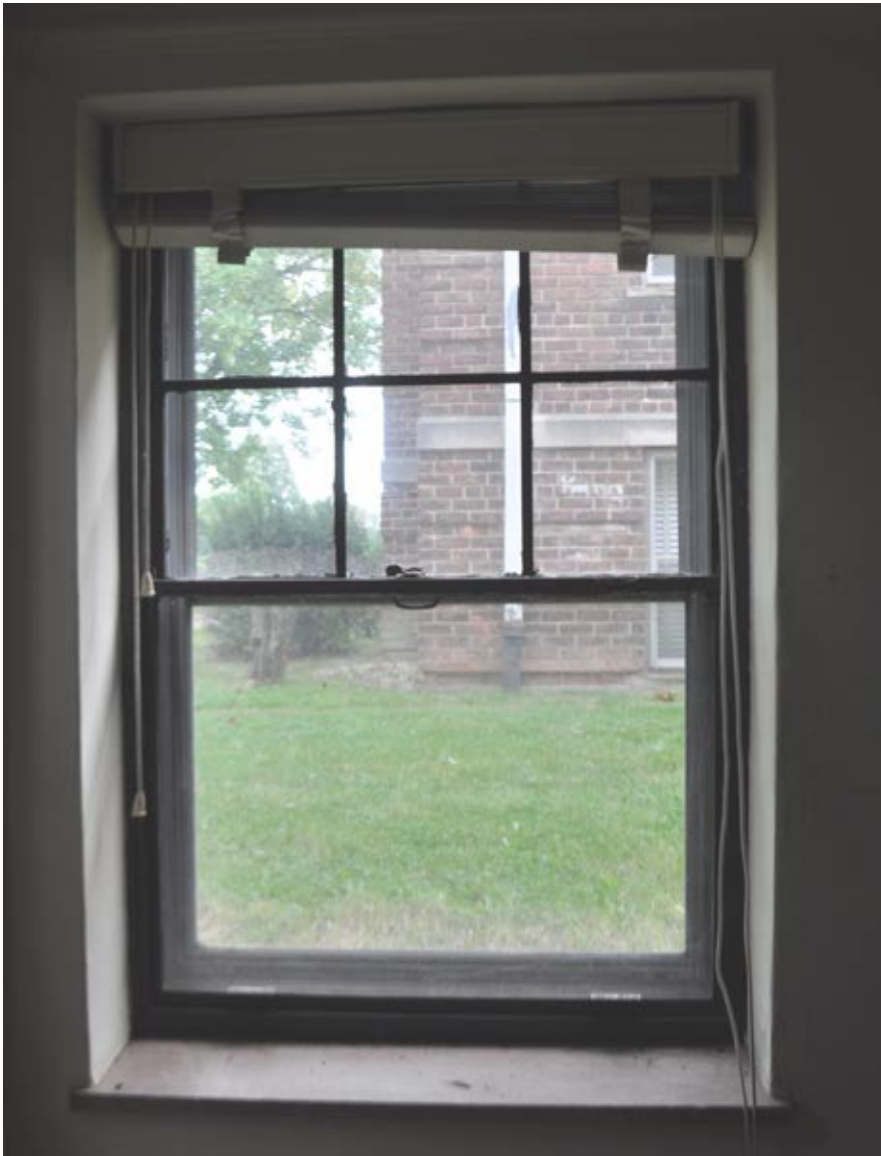
Window G4, Type D1

- Note: Extent of exterior deterioration, dry rot, and loss of operability is not fully apparent in interior photos. Replacement parts for existing windows are unavailable, making restoration of thermal and operable functionality impossible, and long-term maintenance infeasible. Recommendation is for replacement, for quality of life of future tenants and for feasibility of long-term maintenance.
- See Window Assessment (Blackberry) in appendix for further detail and information, including further notes on deterioration beyond repair
- See Appendix for Window Schedule & Measurements

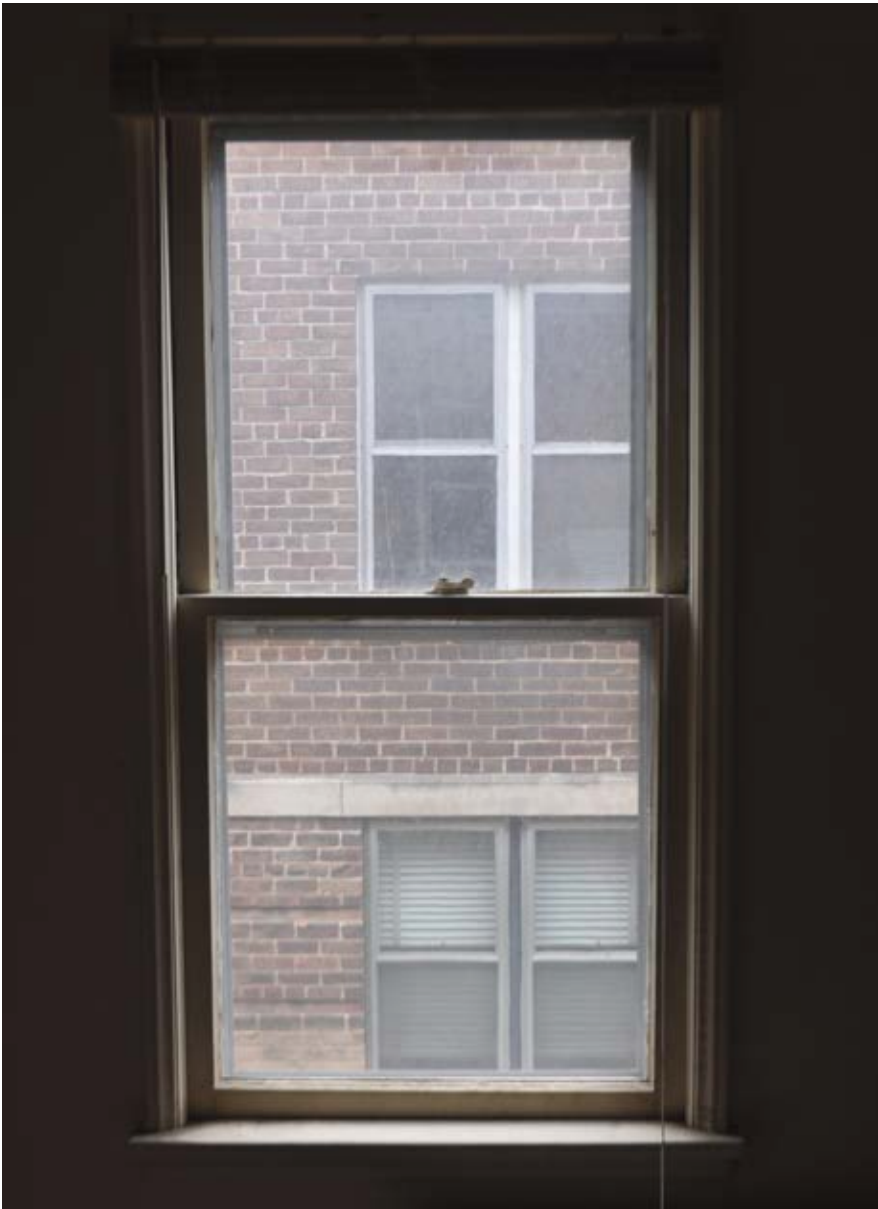
Window H3, Type J1

- Exterior Rotted Sill
- Note: Extent of exterior deterioration, dry rot, and loss of operability is not fully apparent in interior photos. Replacement parts for existing windows are unavailable, making restoration of thermal and operable functionality impossible, and long-term maintenance infeasible. Recommendation is for replacement, for quality of life of future tenants and for feasibility of long-term maintenance.
- See Window Assessment (Blackberry) in appendix for further detail and information, including further notes on deterioration beyond repair
- See Appendix for Window Schedule & Measurements

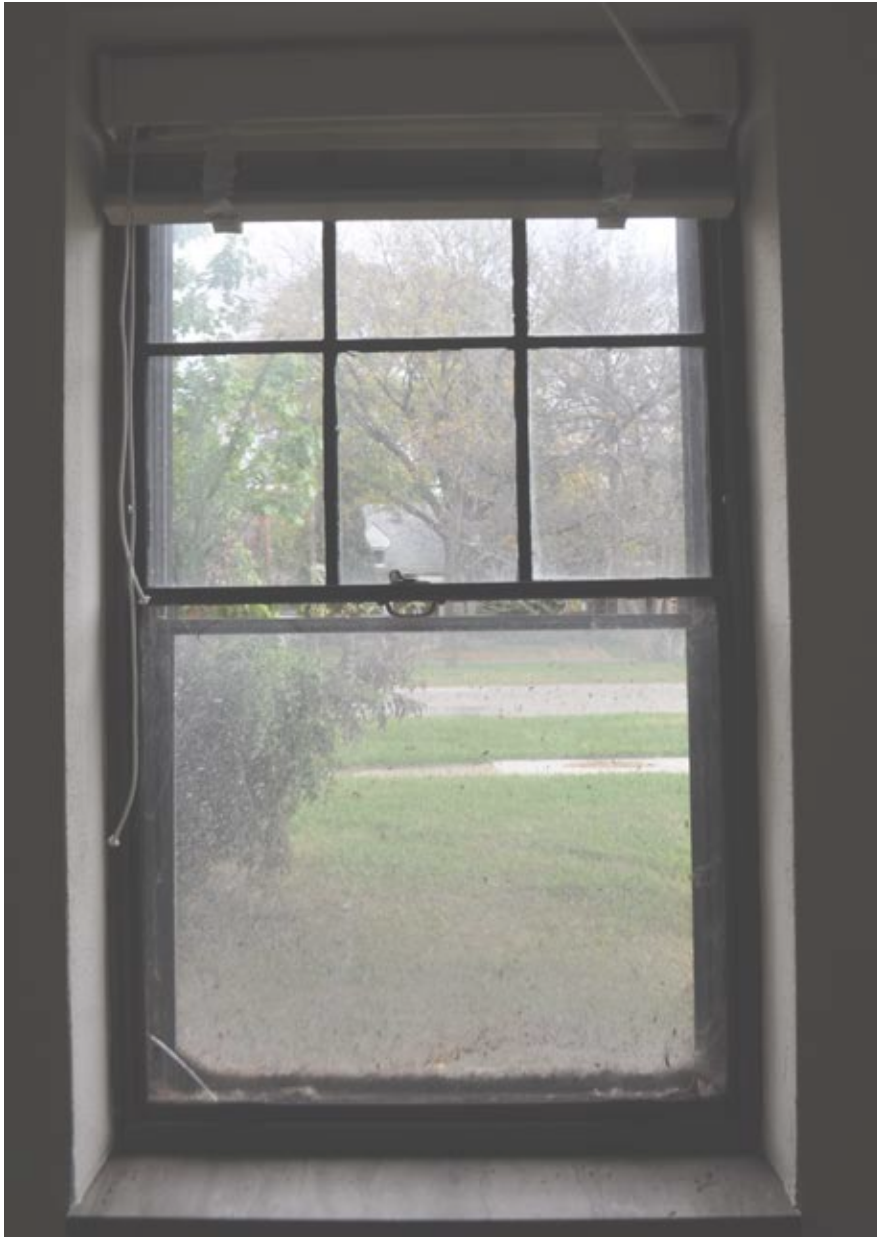
Window S1, Type M1

- Badly Corroded
- Broken Glass
- Note: Extent of exterior deterioration, corrosion, and loss of operability is not fully apparent in interior photos. Replacement parts for existing windows are unavailable, making restoration of thermal and operable functionality impossible, and long-term maintenance infeasible. Recommendation is for replacement, for quality of life of future tenants and for feasibility of long-term maintenance.
- See Window Assessment (Blackberry) in appendix for further detail and information, including further notes on deterioration beyond repair
- See Appendix for Window Schedule & Measurements

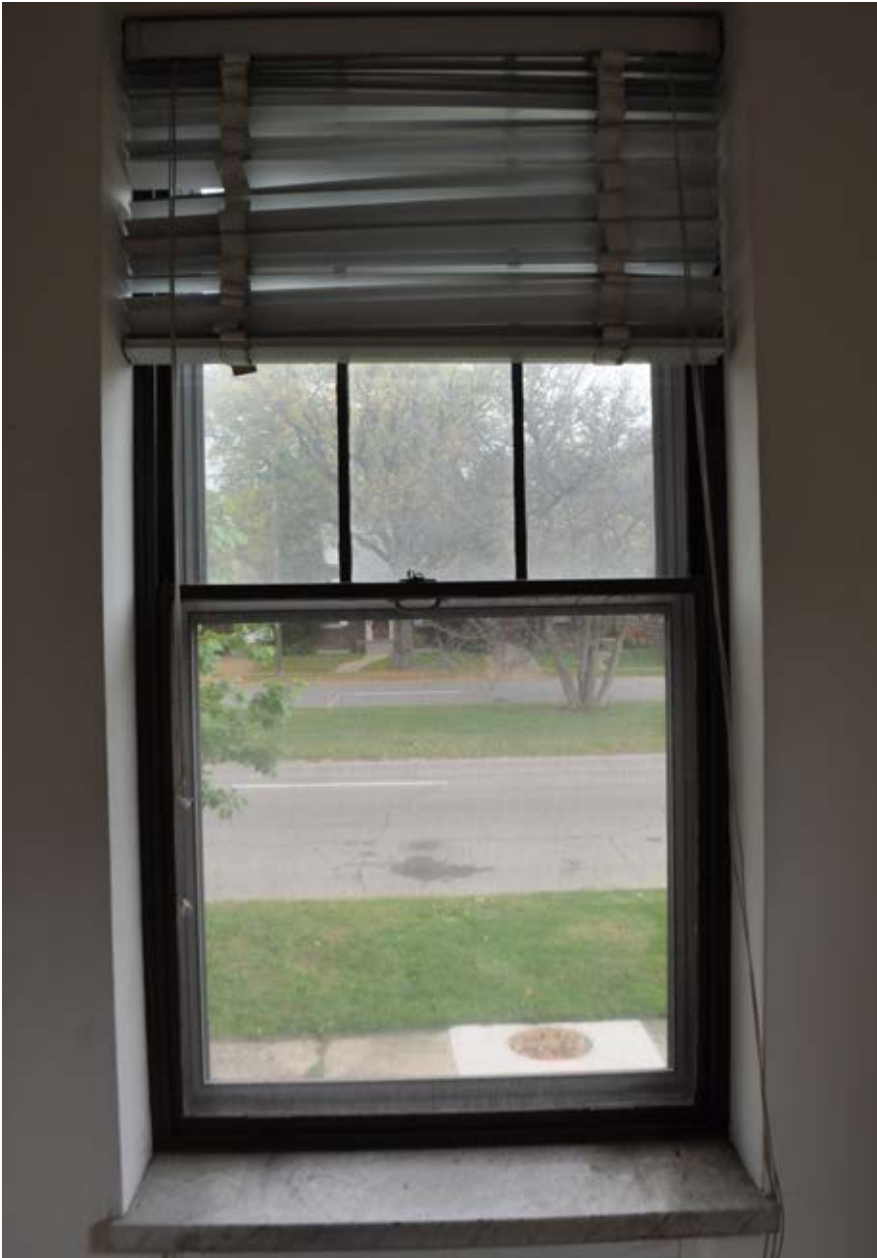
Window T1, Type N1

- Note: Extent of exterior deterioration, corrosion, and loss of operability is not fully apparent in interior photos. Replacement parts for existing windows are unavailable, making restoration of thermal and operable functionality impossible, and long-term maintenance infeasible. Recommendation is for replacement, for quality of life of future tenants and for feasibility of long-term maintenance.
- See Window Assessment (Blackberry) in appendix for further detail and information, including further notes on deterioration beyond repair
- See Appendix for Window Schedule & Measurements

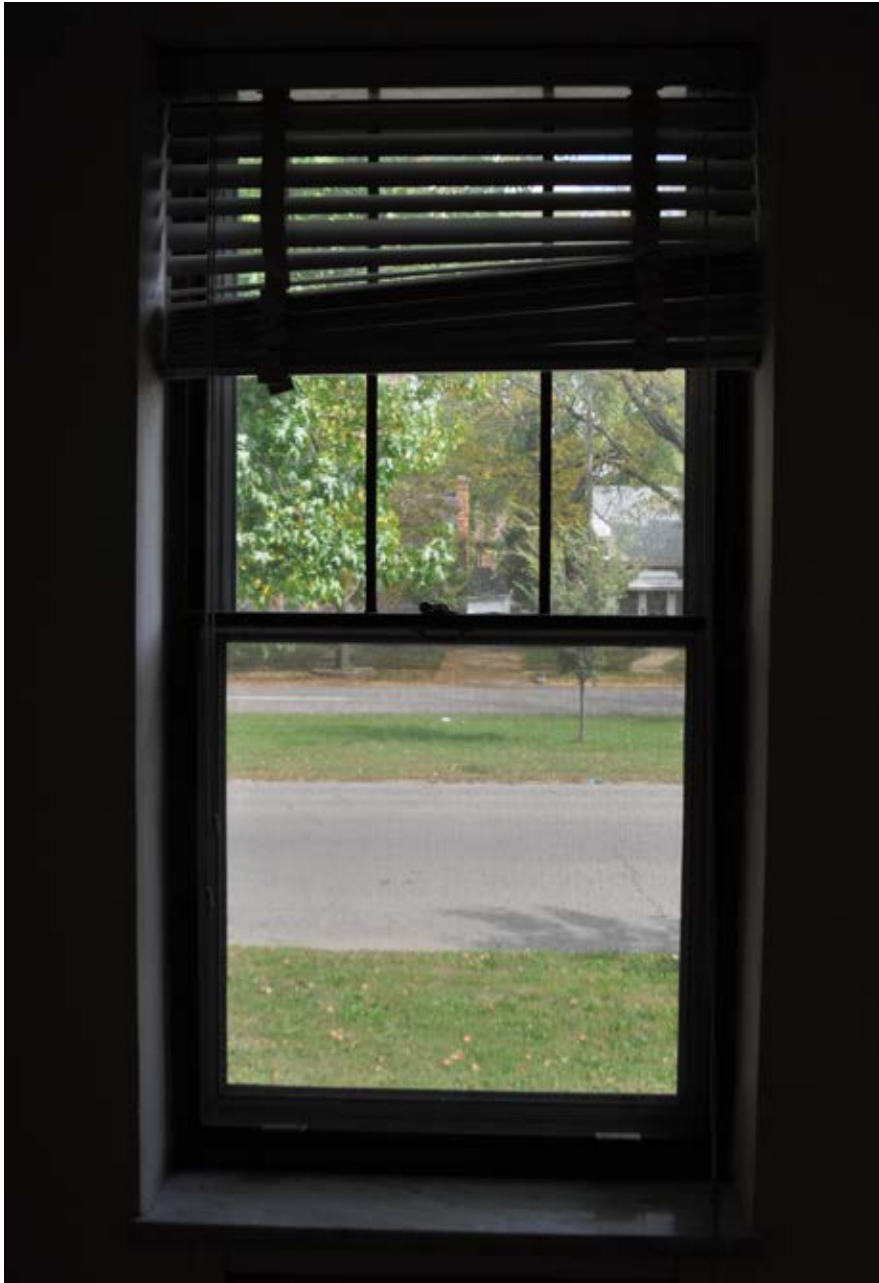
Window T4, Type N1

- Note: Extent of exterior deterioration, corrosion, and loss of operability is not fully apparent in interior photos. Replacement parts for existing windows are unavailable, making restoration of thermal and operable functionality impossible, and long-term maintenance infeasible. Recommendation is for replacement, for quality of life of future tenants and for feasibility of long-term maintenance.
- See Window Assessment (Blackberry) in appendix for further detail and information, including further notes on deterioration beyond repair
- See Appendix for Window Schedule & Measurements

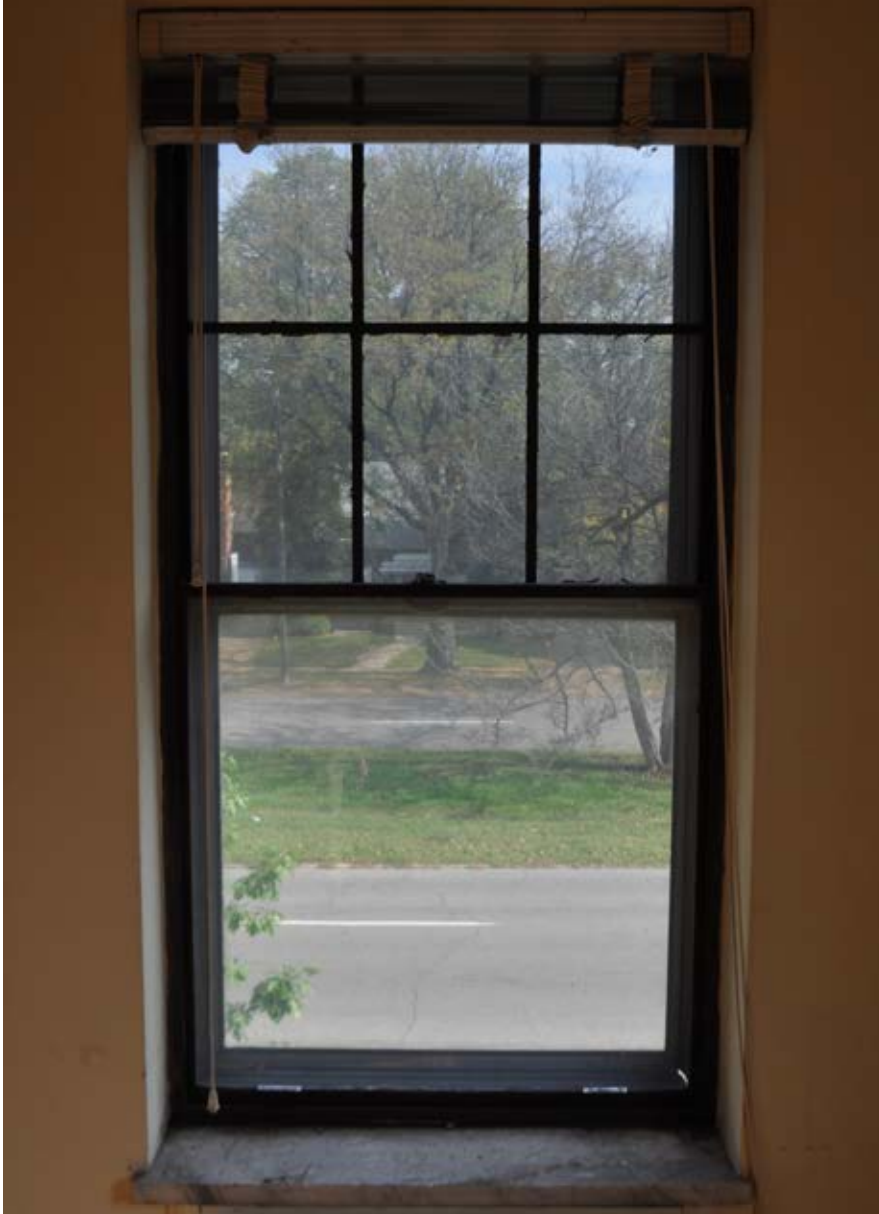
Window U1, Type N1

- Note: Extent of exterior deterioration, corrosion, and loss of operability is not fully apparent in interior photos. Replacement parts for existing windows are unavailable, making restoration of thermal and operable functionality impossible, and long-term maintenance infeasible. Recommendation is for replacement, for quality of life of future tenants and for feasibility of long-term maintenance.
- See Window Assessment (Blackberry) in appendix for further detail and information, including further notes on deterioration beyond repair
- See Appendix for Window Schedule & Measurements

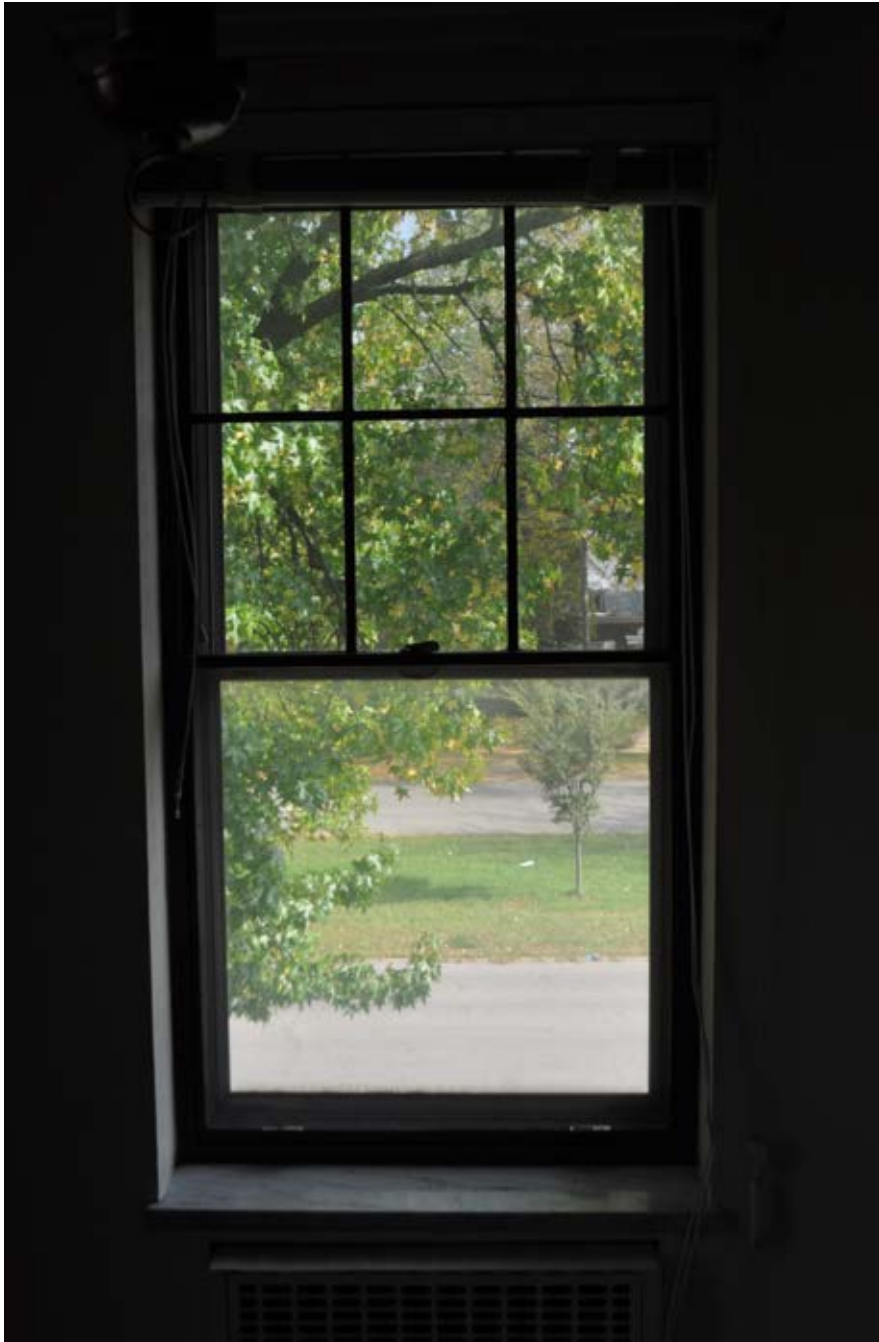
Window U4, Type N1

- Note: Extent of exterior deterioration, corrosion, and loss of operability is not fully apparent in interior photos. Replacement parts for existing windows are unavailable, making restoration of thermal and operable functionality impossible, and long-term maintenance infeasible. Recommendation is for replacement, for quality of life of future tenants and for feasibility of long-term maintenance.
- See Window Assessment (Blackberry) in appendix for further detail and information, including further notes on deterioration beyond repair
- See Appendix for Window Schedule & Measurements

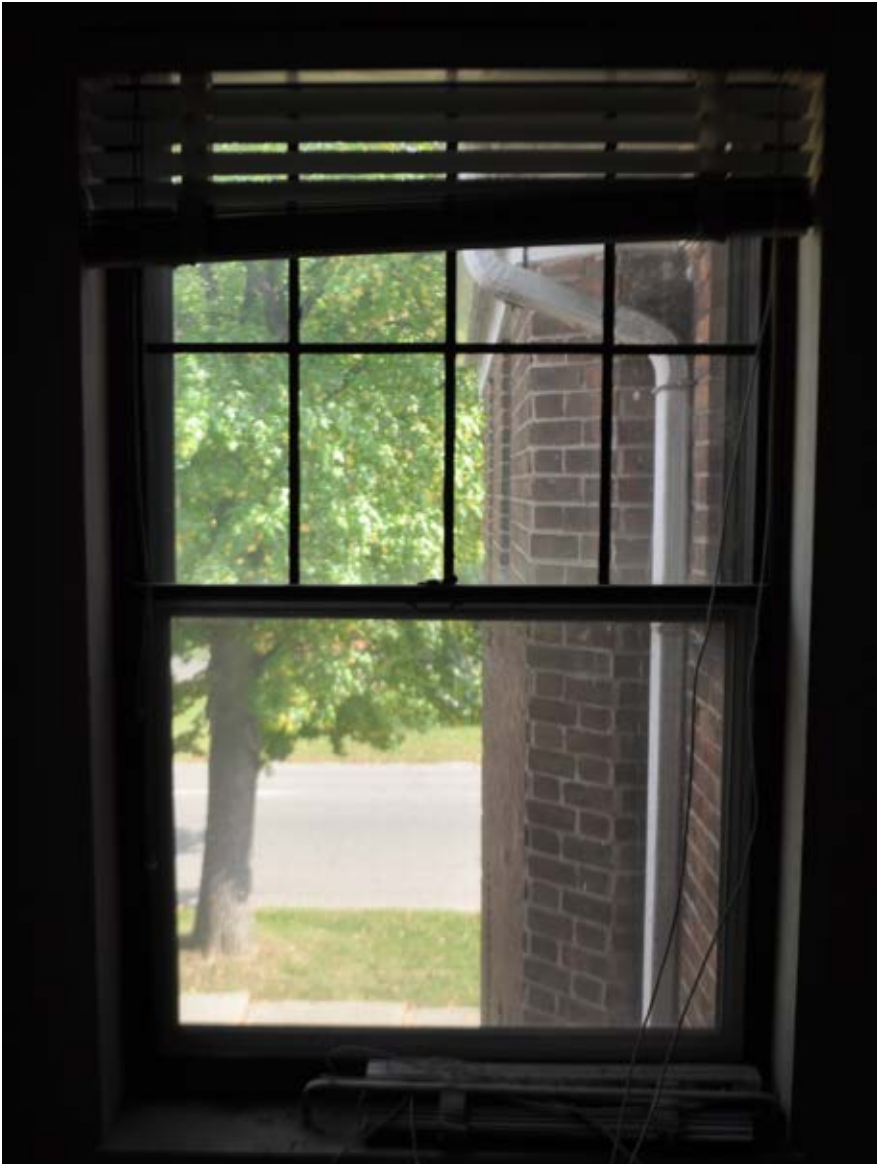
Window U8, Type R1

- Note: Extent of exterior deterioration, corrosion, and loss of operability is not fully apparent in interior photos. Replacement parts for existing windows are unavailable, making restoration of thermal and operable functionality impossible, and long-term maintenance infeasible. Recommendation is for replacement, for quality of life of future tenants and for feasibility of long-term maintenance.
- See Window Assessment (Blackberry) in appendix for further detail and information, including further notes on deterioration beyond repair
- See Appendix for Window Schedule & Measurements

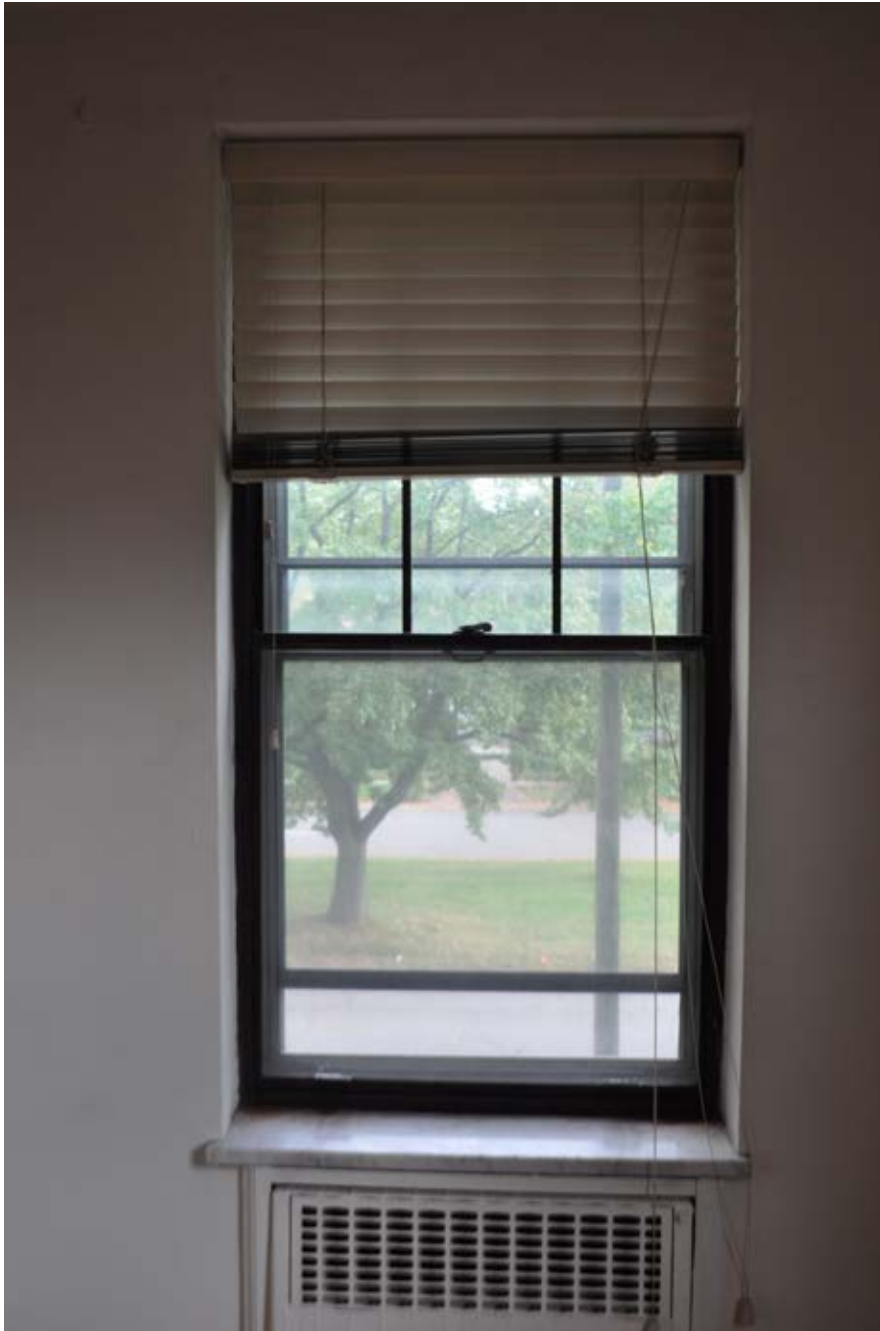
Window U16, Type N1

- Note: Extent of exterior deterioration, corrosion, and loss of operability is not fully apparent in interior photos. Replacement parts for existing windows are unavailable, making restoration of thermal and operable functionality impossible, and long-term maintenance infeasible. Recommendation is for replacement, for quality of life of future tenants and for feasibility of long-term maintenance.
- See Window Assessment (Blackberry) in appendix for further detail and information, including further notes on deterioration beyond repair
- See Appendix for Window Schedule & Measurements

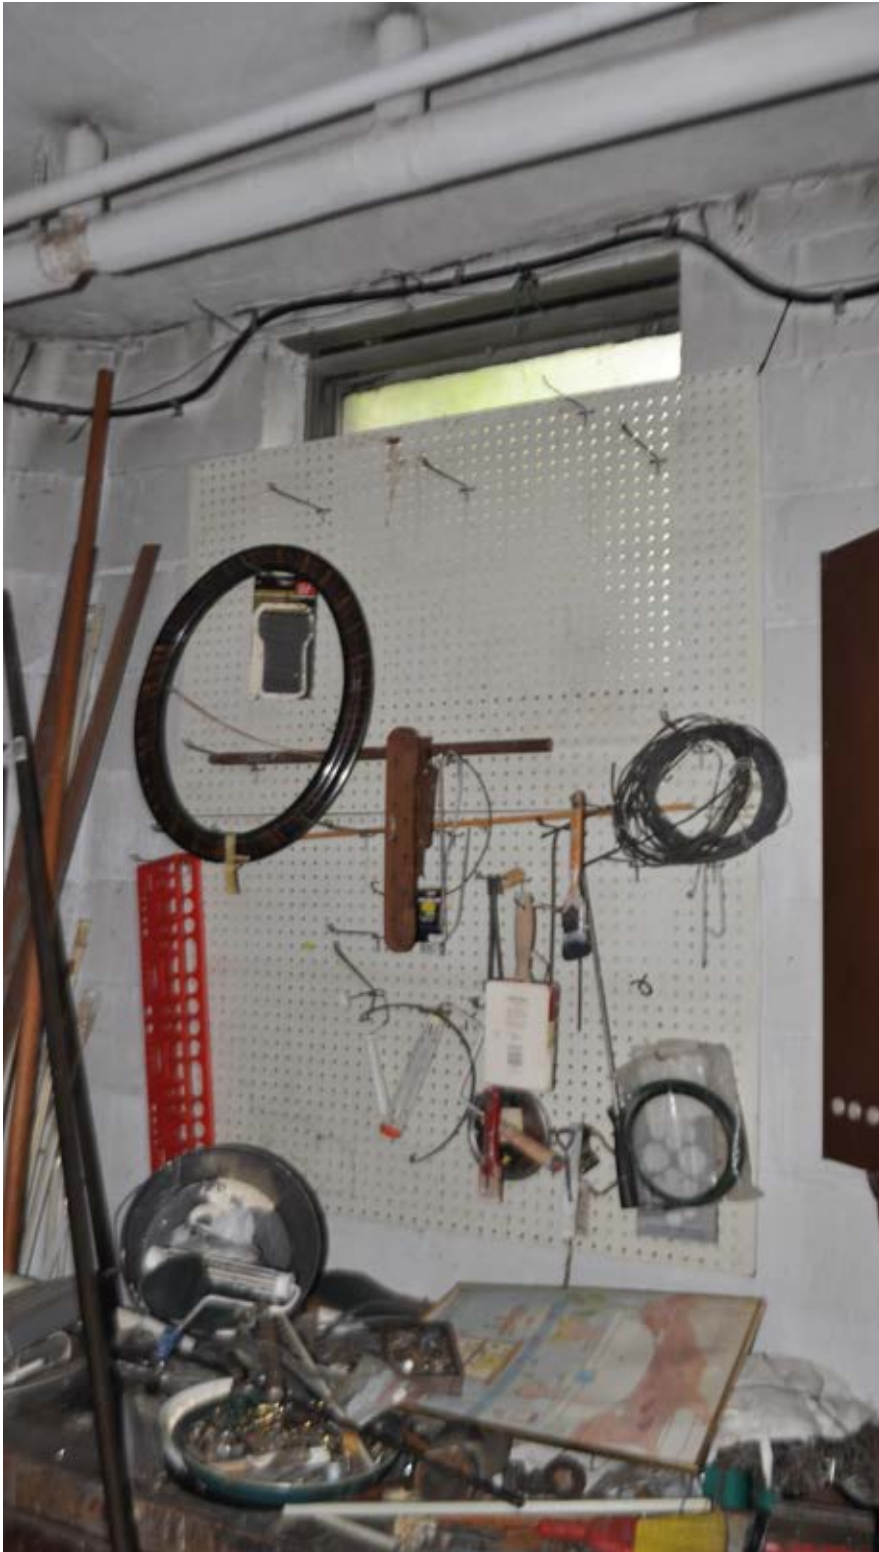
- Badly Corroded
- Note: Extent of exterior deterioration, corrosion, and loss of operability is not fully apparent in interior photos. Replacement parts for existing windows are unavailable, making restoration of thermal and operable functionality impossible, and long-term maintenance infeasible. Recommendation is for replacement, for quality of life of future tenants and for feasibility of long-term maintenance.
- See Window Assessment (Blackberry) in appendix for further detail and information, including further notes on deterioration beyond repair
- See Appendix for Window Schedule & Measurements

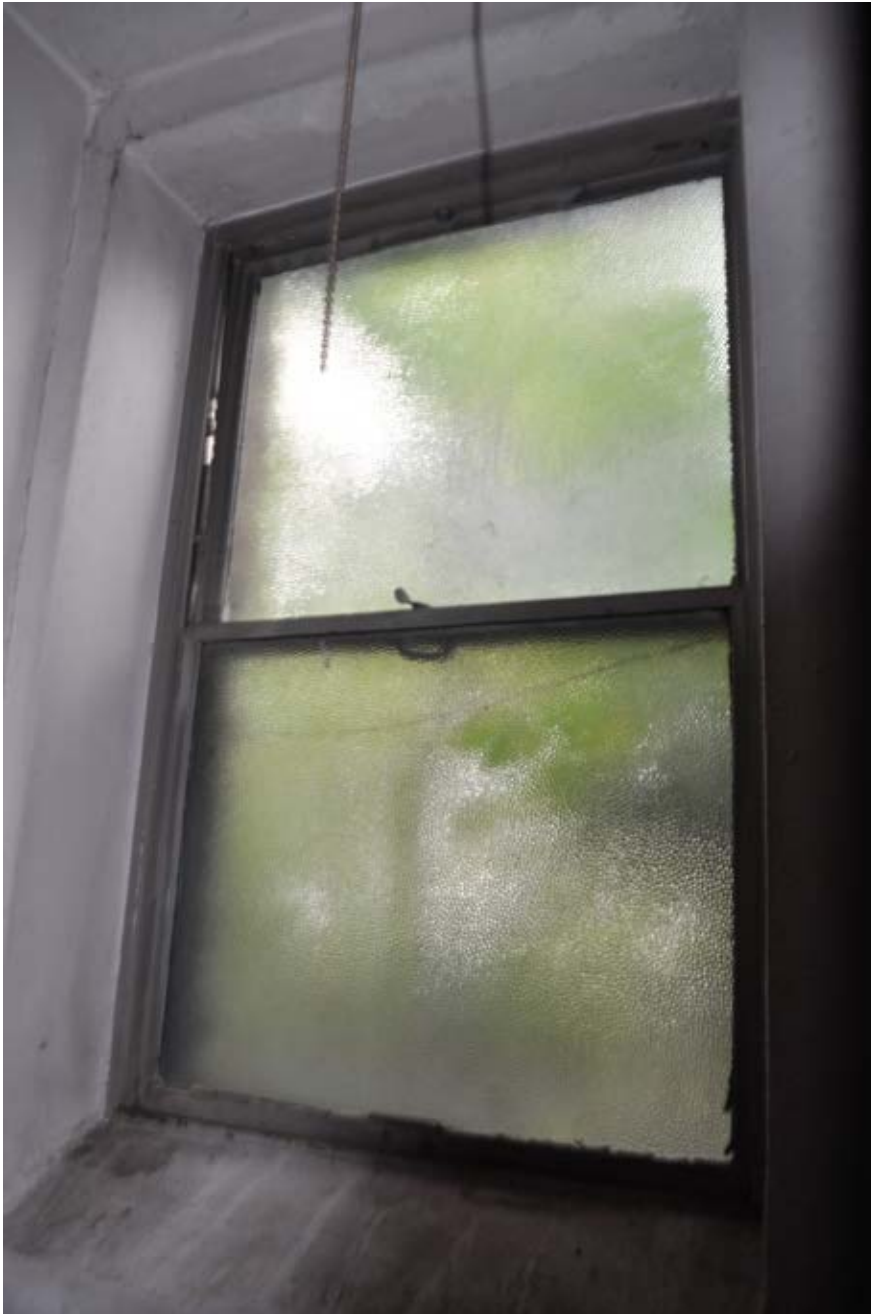
- Badly Corroded
- Note: Extent of exterior deterioration, corrosion, and loss of operability is not fully apparent in interior photos. Replacement parts for existing windows are unavailable, making restoration of thermal and operable functionality impossible, and long-term maintenance infeasible. Recommendation is for replacement, for quality of life of future tenants and for feasibility of long-term maintenance.
- See Window Assessment (Blackberry) in appendix for further detail and information, including further notes on deterioration beyond repair
- See Appendix for Window Schedule & Measurements

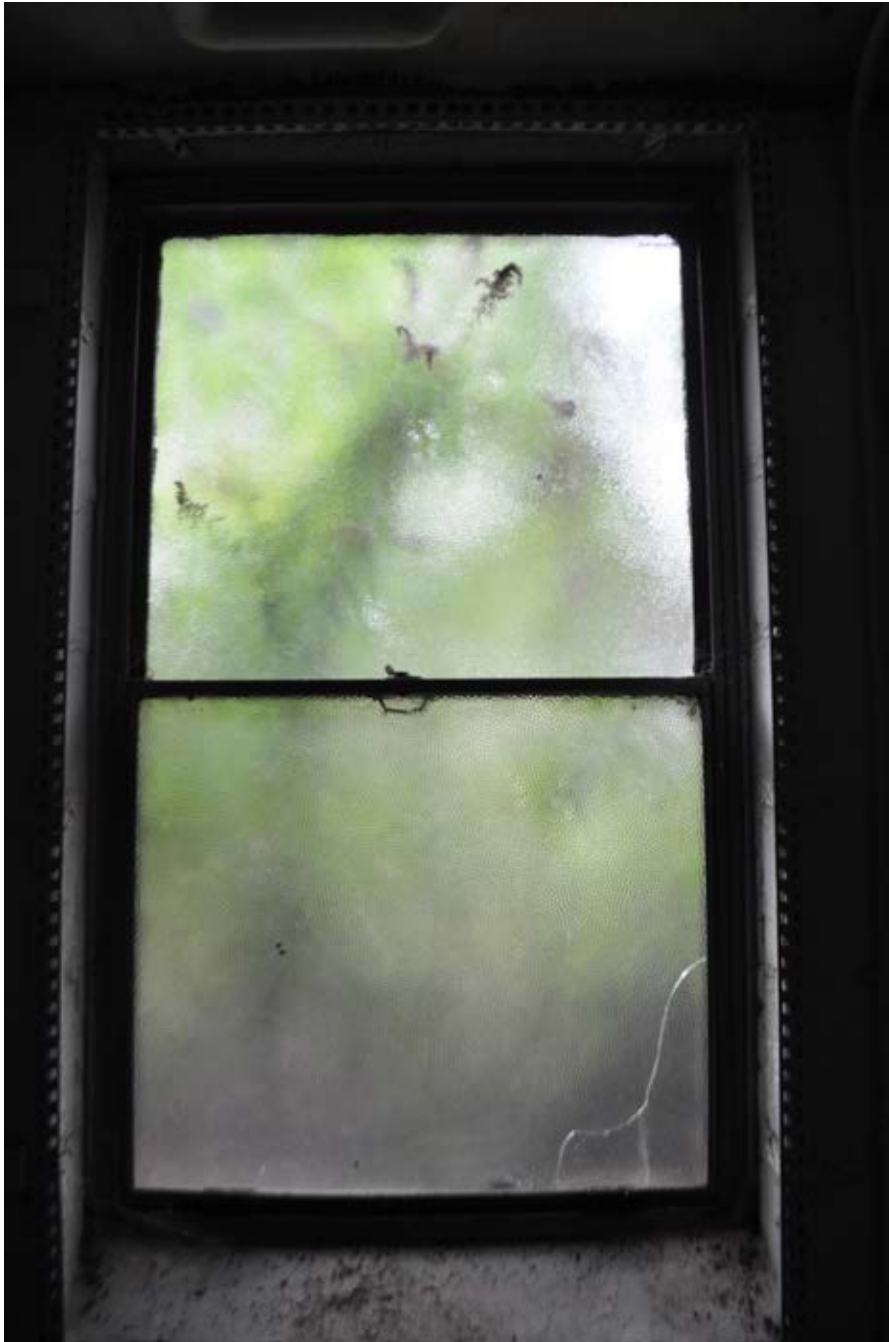
Window V9, Type M2

- Broken Glass
- Badly Corroded
- Note: Extent of exterior deterioration, corrosion, and loss of operability is not fully apparent in interior photos. Replacement parts for existing windows are unavailable, making restoration of thermal and operable functionality impossible, and long-term maintenance infeasible. Recommendation is for replacement, for quality of life of future tenants and for feasibility of long-term maintenance.
- See Window Assessment (Blackberry) in appendix for further detail and information, including further notes on deterioration beyond repair
- See Appendix for Window Schedule & Measurements

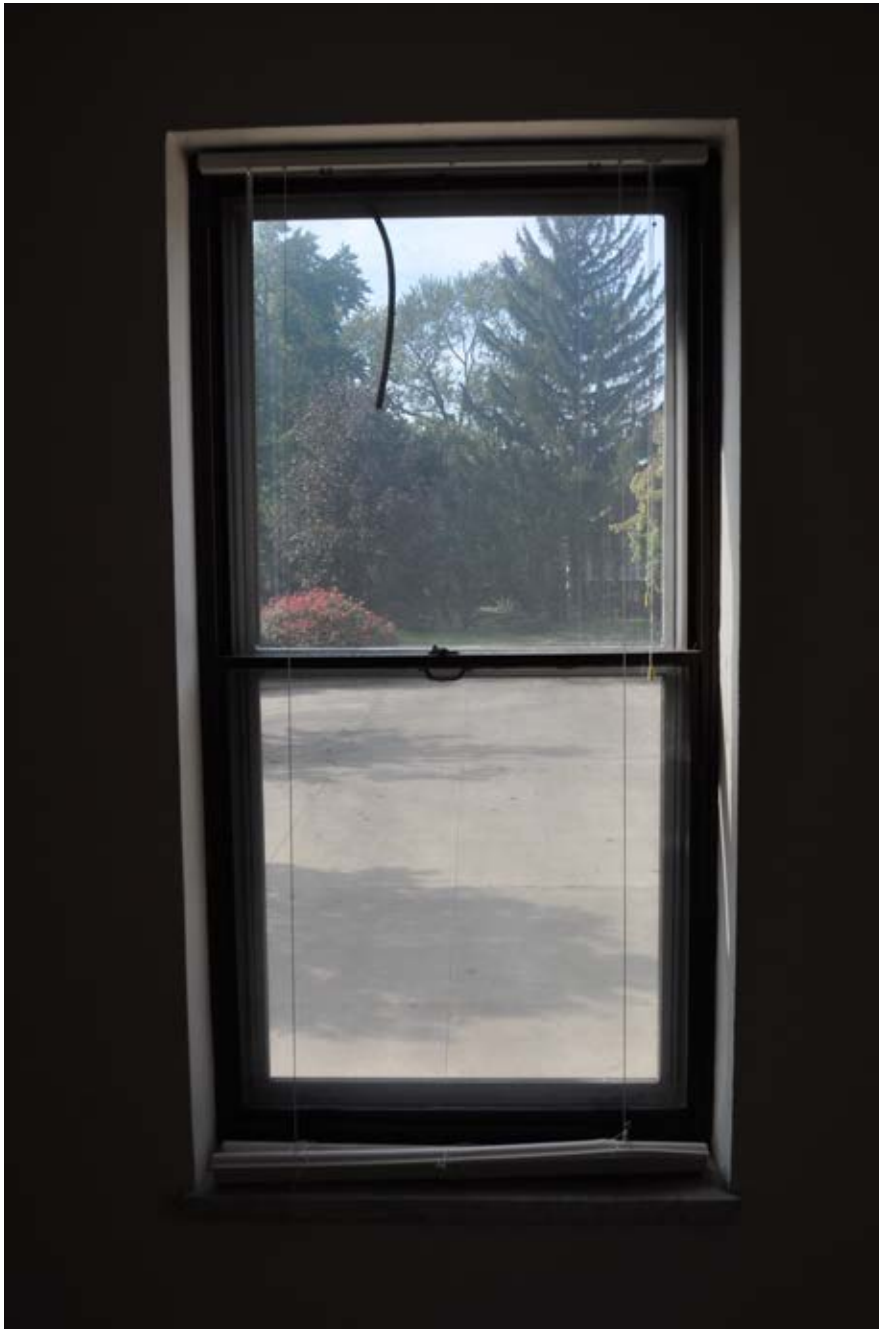
Window W1, Type N2

- Broken Glass
- Note: Extent of exterior deterioration, corrosion, and loss of operability is not fully apparent in interior photos. Replacement parts for existing windows are unavailable, making restoration of thermal and operable functionality impossible, and long-term maintenance infeasible. Recommendation is for replacement, for quality of life of future tenants and for feasibility of long-term maintenance.
- See Window Assessment (Blackberry) in appendix for further detail and information, including further notes on deterioration beyond repair
- See Appendix for Window Schedule & Measurements

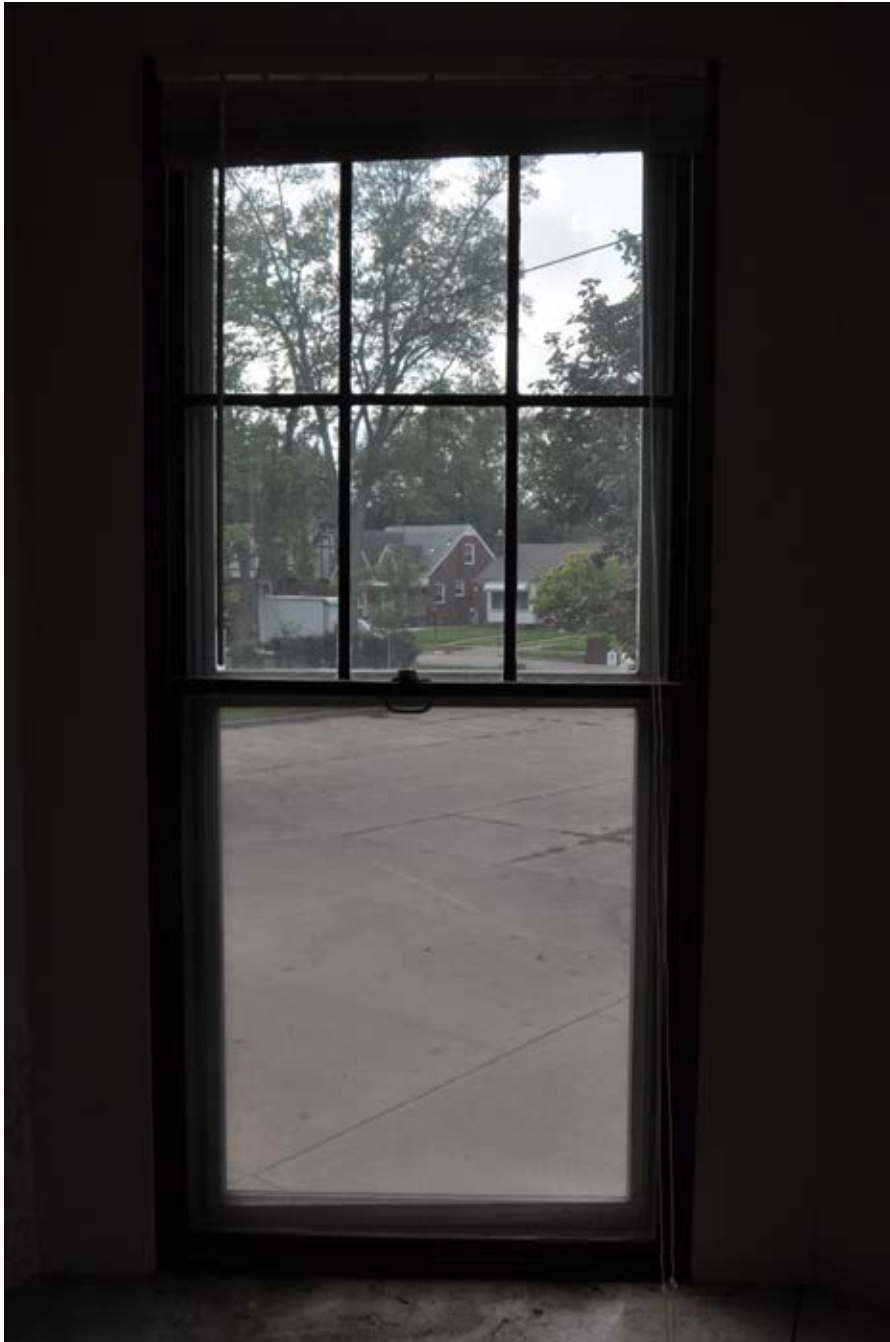
Window W5, Type V1

- Missing Balance
- Note: Extent of exterior deterioration, corrosion, and loss of operability is not fully apparent in interior photos. Replacement parts for existing windows are unavailable, making restoration of thermal and operable functionality impossible, and long-term maintenance infeasible. Recommendation is for replacement, for quality of life of future tenants and for feasibility of long-term maintenance.
- See Window Assessment (Blackberry) in appendix for further detail and information, including further notes on deterioration beyond repair
- See Appendix for Window Schedule & Measurements

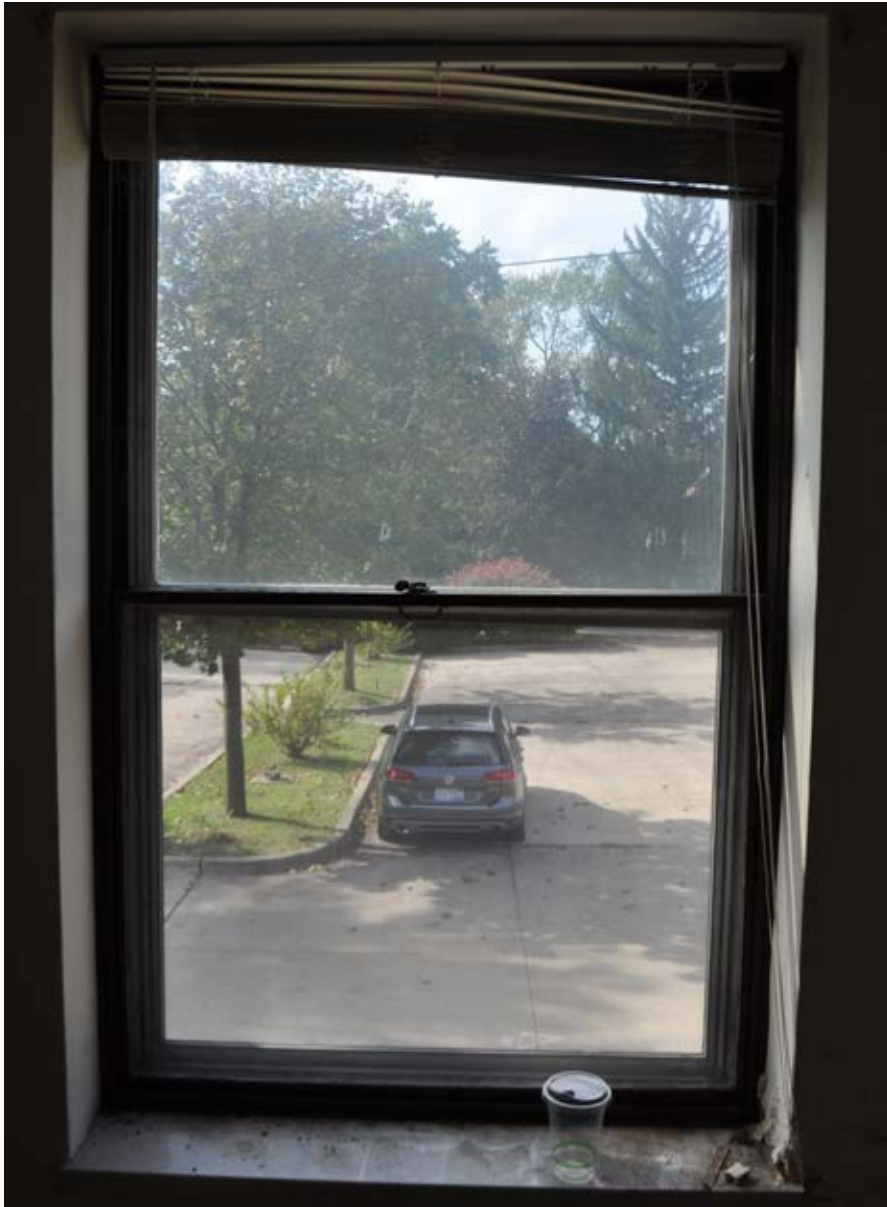
Window W6, Type R2

- Note: Extent of exterior deterioration, corrosion, and loss of operability is not fully apparent in interior photos. Replacement parts for existing windows are unavailable, making restoration of thermal and operable functionality impossible, and long-term maintenance infeasible. Recommendation is for replacement, for quality of life of future tenants and for feasibility of long-term maintenance.
- See Window Assessment (Blackberry) in appendix for further detail and information, including further notes on deterioration beyond repair
- See Appendix for Window Schedule & Measurements

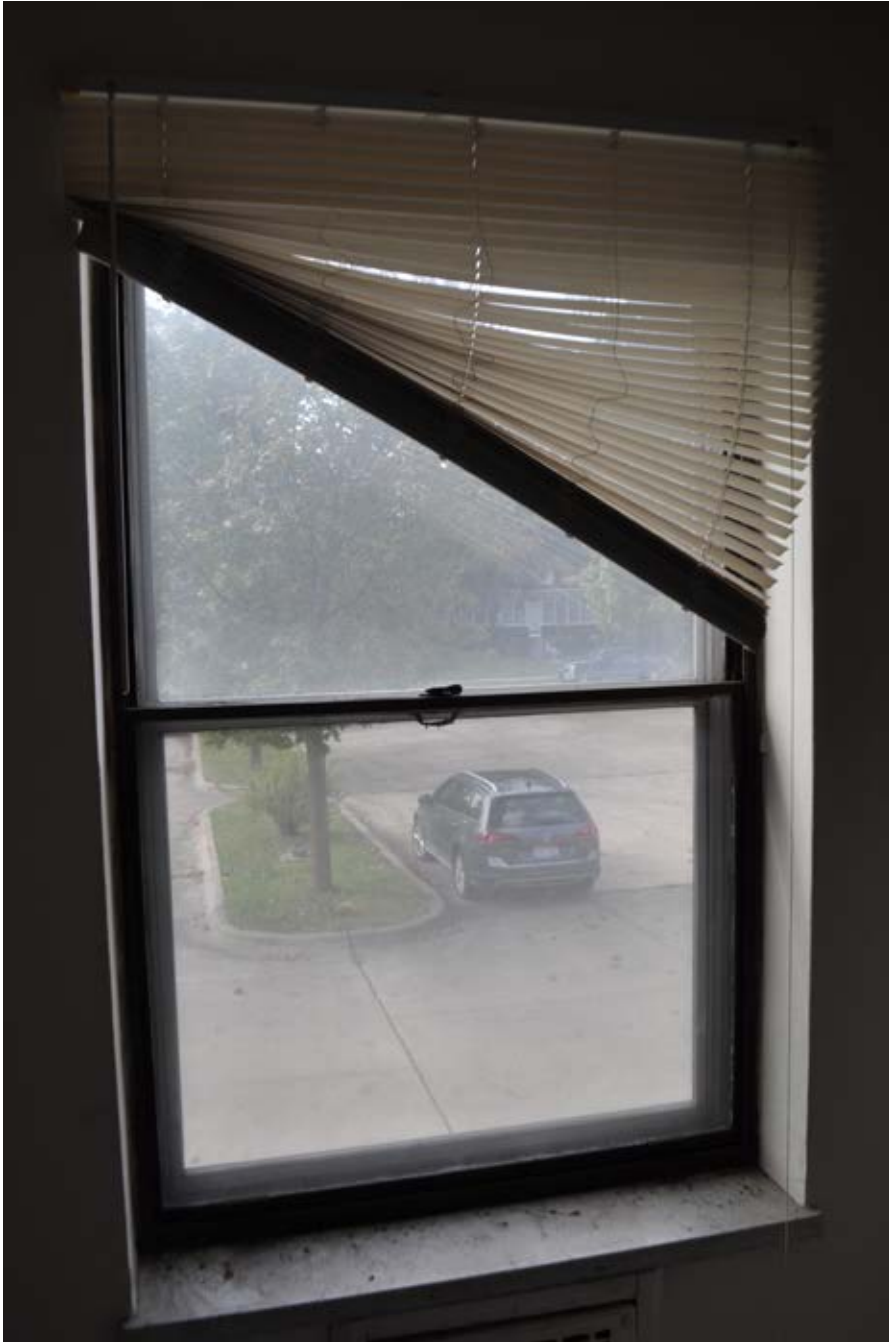
Window W7, Type R2

- Note: Extent of exterior deterioration, corrosion, and loss of operability is not fully apparent in interior photos. Replacement parts for existing windows are unavailable, making restoration of thermal and operable functionality impossible, and long-term maintenance infeasible. Recommendation is for replacement, for quality of life of future tenants and for feasibility of long-term maintenance.
- See Window Assessment (Blackberry) in appendix for further detail and information, including further notes on deterioration beyond repair
- See Appendix for Window Schedule & Measurements
