9710 W Outer Dr

Existing Condition Photos

Current Design Description

A 3-story apartment structure with 10 residential units, constructed in 1940, brick on wood stud wall construction, shingle roof, stone corner details, stone details at palladian window, stone sills, wood detailing at front entry, steel and wood canopy at back entry, wood windows throughout with the exception of steel windows at bathrooms and the lowest level. The addition of a brick shed to house the gas meter was made at a later date.

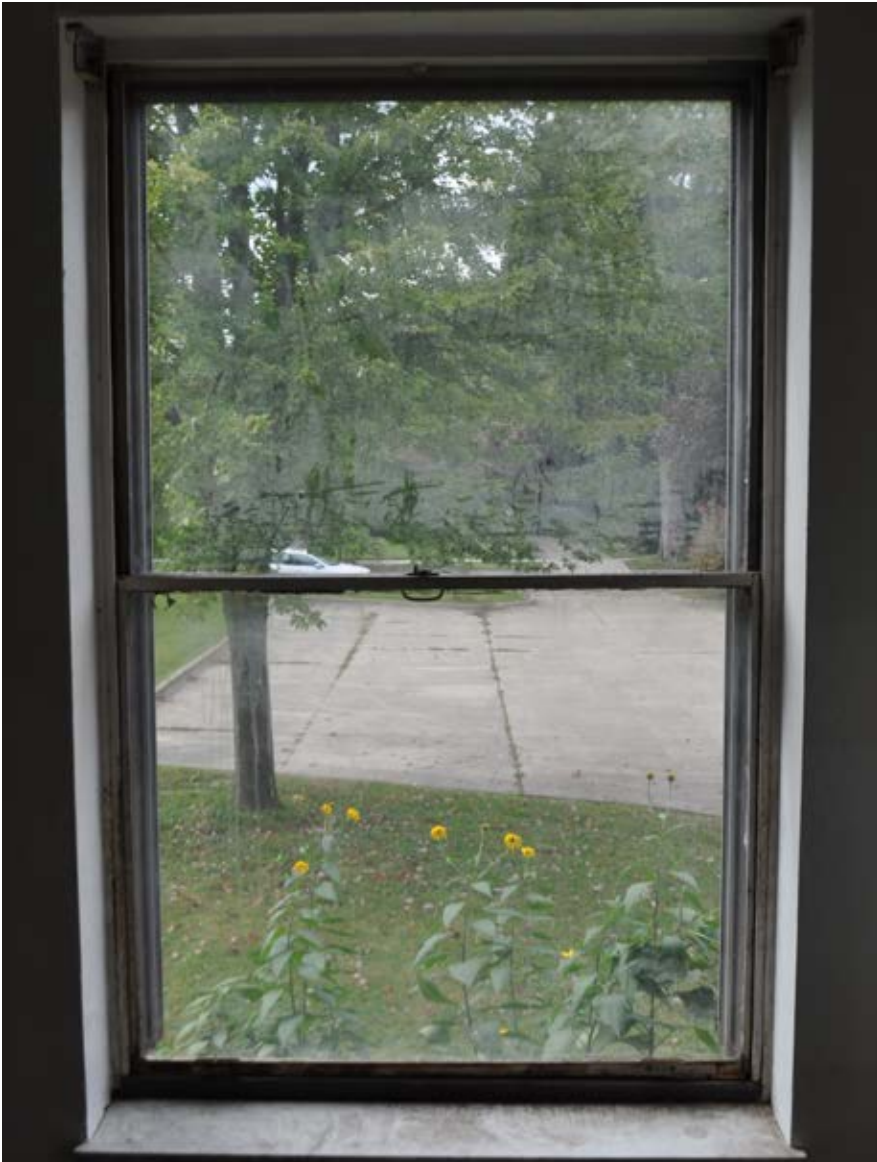
Window W15, Type R2

- Badly Corroded
- Note: Extent of exterior deterioration, corrosion, and loss of operability is not fully apparent in interior photos. Replacement parts for existing windows are unavailable, making restoration of thermal and operable functionality impossible, and long-term maintenance infeasible. Recommendation is for replacement, for quality of life of future tenants and for feasibility of long-term maintenance.
- See Window Assessment (Blackberry) in appendix for further detail and information, including further notes on deterioration beyond repair
- See Appendix for Window Schedule & Measurements

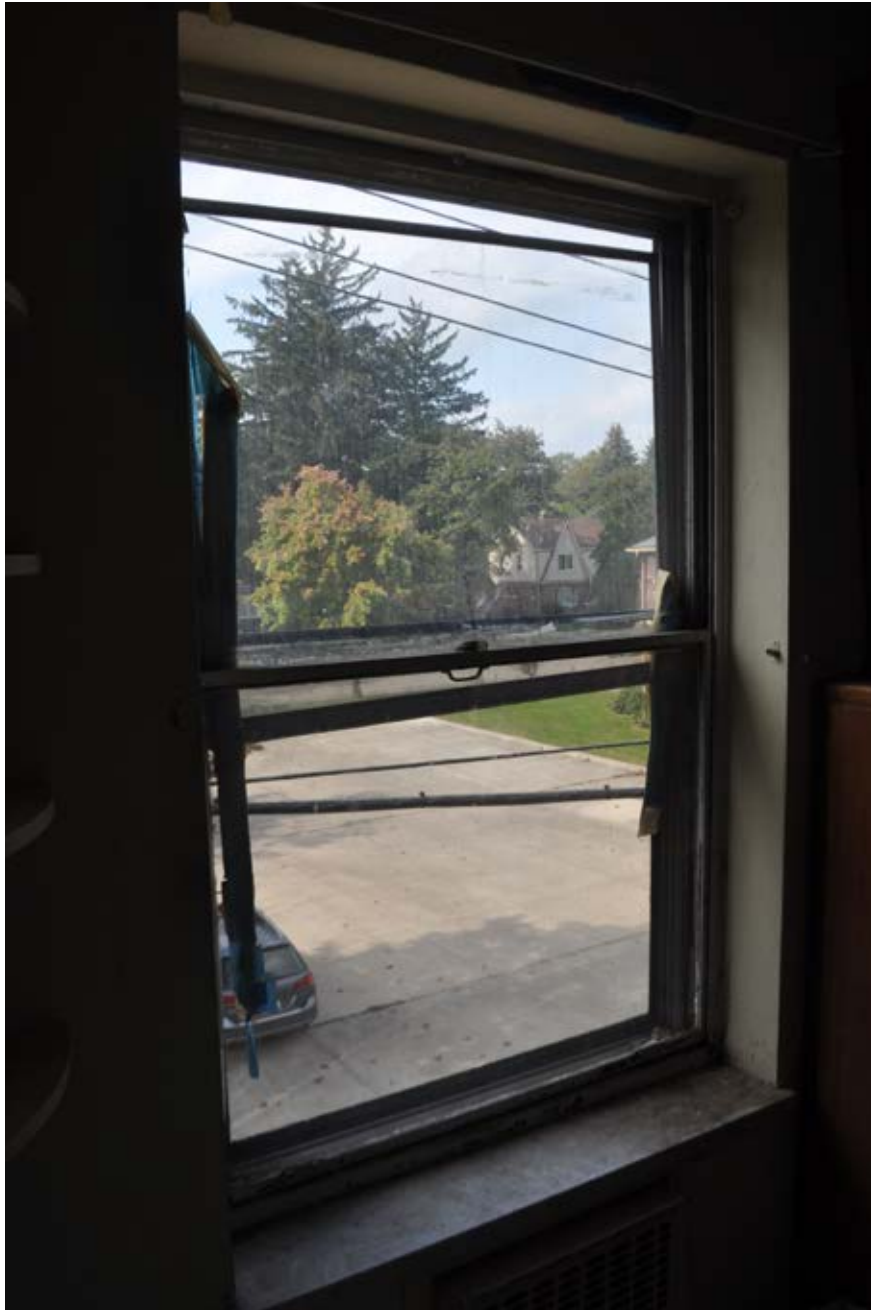
- Note: Extent of exterior deterioration, corrosion, and loss of operability is not fully apparent in interior photos. Replacement parts for existing windows are unavailable, making restoration of thermal and operable functionality impossible, and long-term maintenance infeasible. Recommendation is for replacement, for quality of life of future tenants and for feasibility of long-term maintenance.
- See Window Assessment (Blackberry) in appendix for further detail and information, including further notes on deterioration beyond repair
- See Appendix for Window Schedule & Measurements

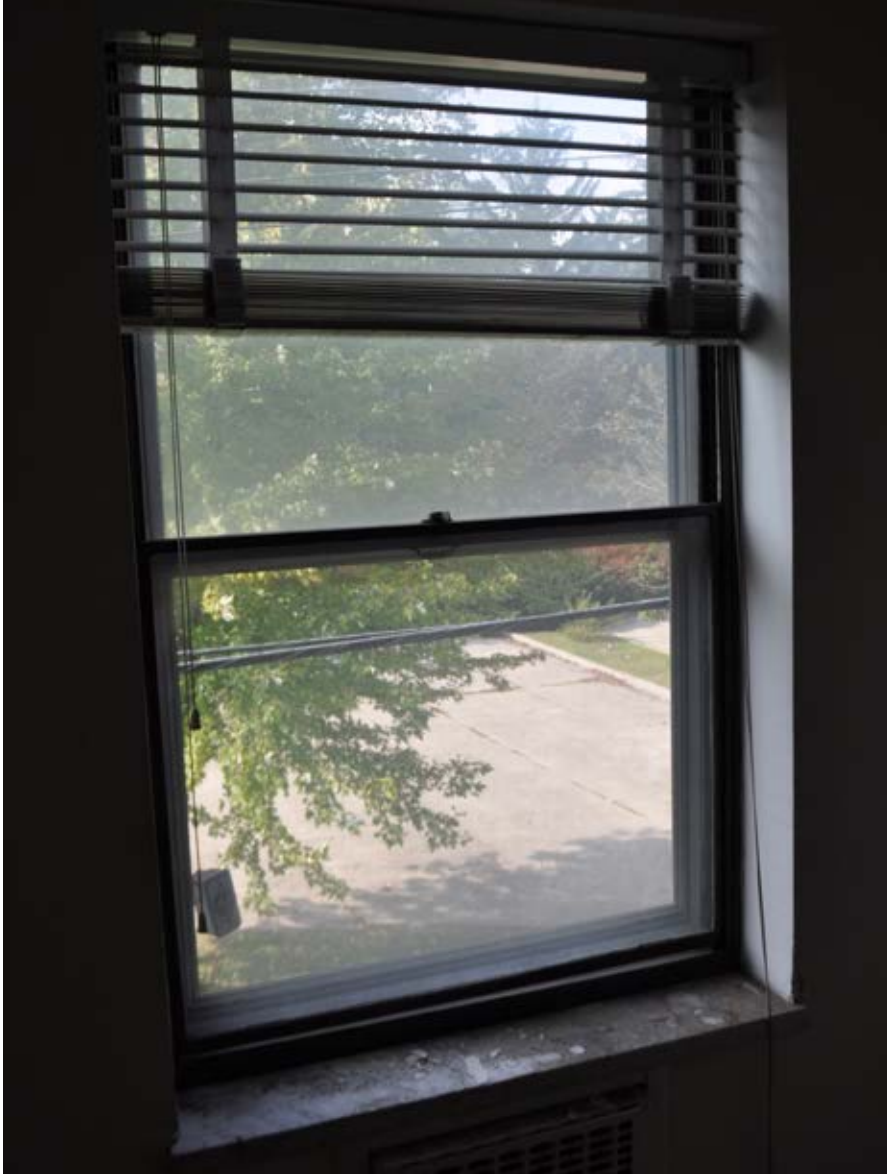
Window X11, Type R2

- Note: Extent of exterior deterioration, corrosion, and loss of operability is not fully apparent in interior photos. Replacement parts for existing windows are unavailable, making restoration of thermal and operable functionality impossible, and long-term maintenance infeasible. Recommendation is for replacement, for quality of life of future tenants and for feasibility of long-term maintenance.
- See Window Assessment (Blackberry) in appendix for further detail and information, including further notes on deterioration beyond repair
- See Appendix for Window Schedule & Measurements
