Porch Rebound in the 1990's

I received these pictures from the previous owner (Cheryl Huff). She rebuilt a large section of this porch in the 1990s. There are some scanned images of the rebuilding of the porch. As you can see – nothing is up to historical accuracy, or code.

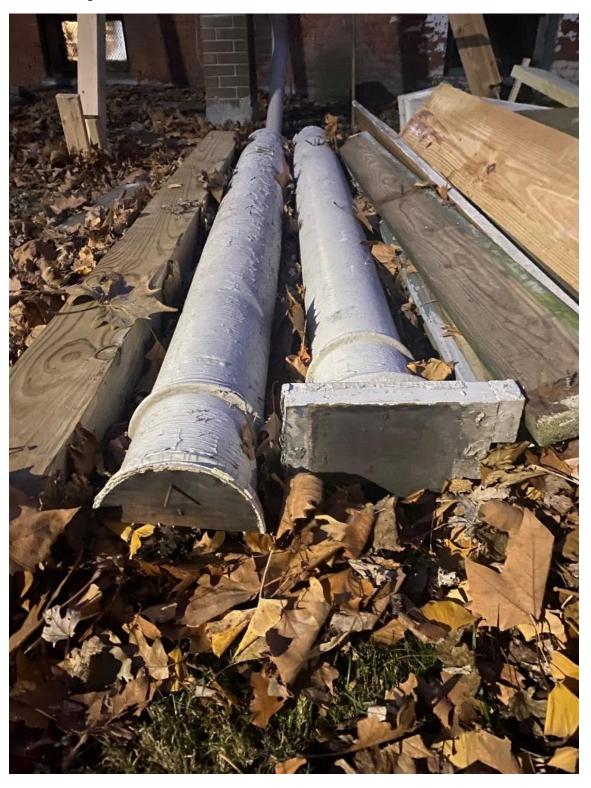
These the original columns to the house.

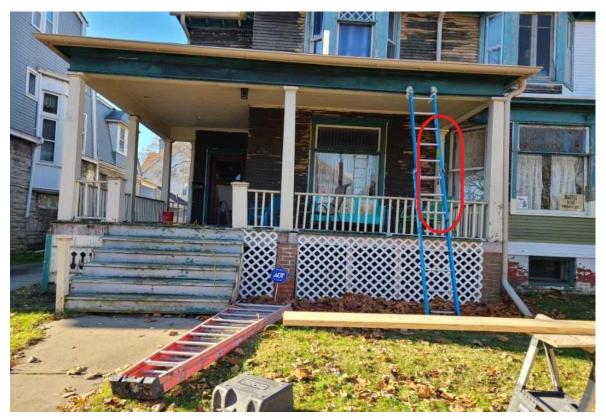
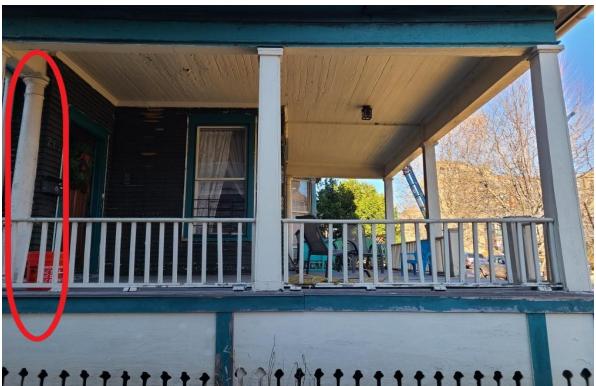
Locations of the rounds on the porch.

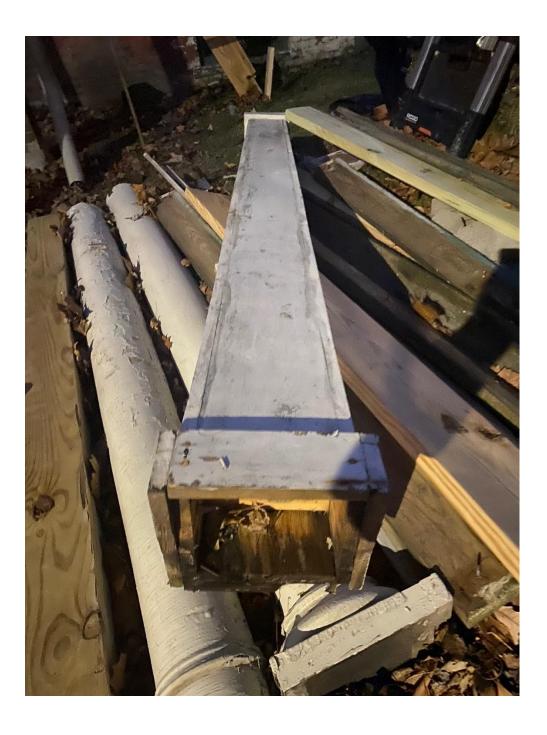
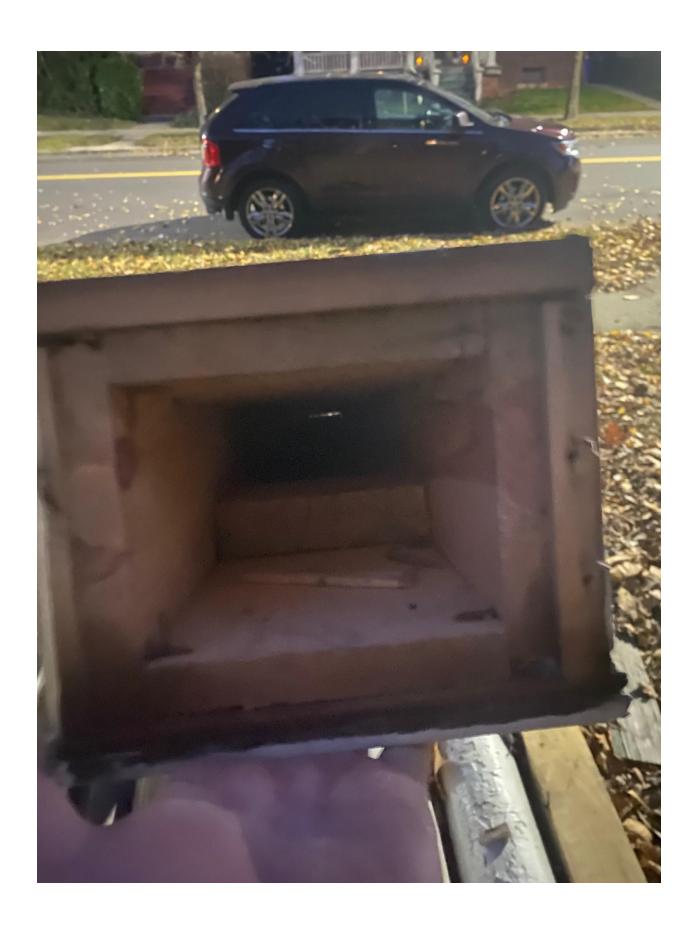
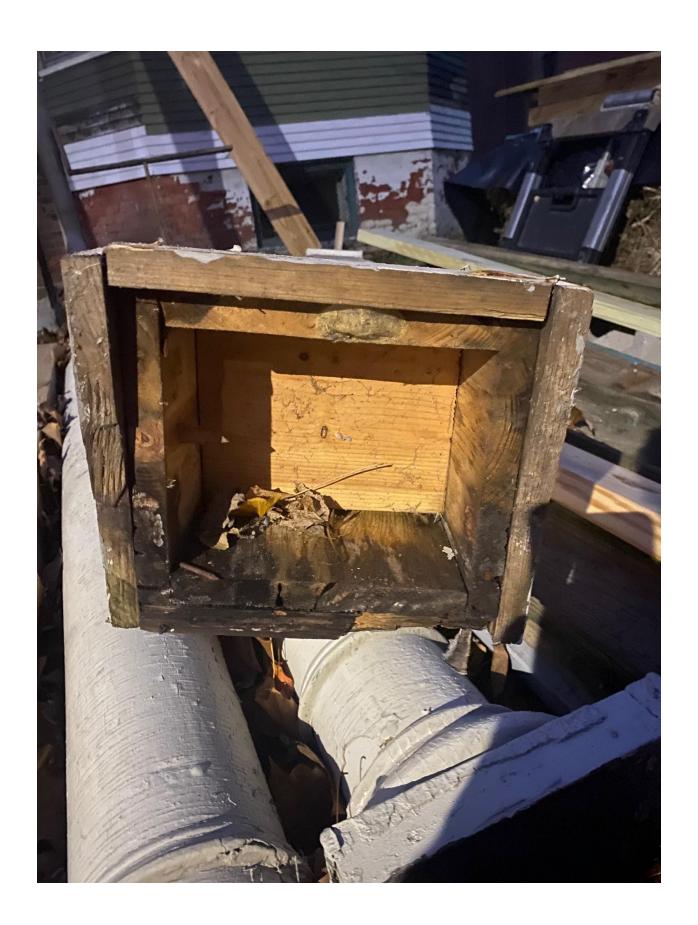
Square Columns:

Here is one of the square columns that is currently sitting in my font yard. You can see that is only made of 1x4 boards and is starting to rot at the base.

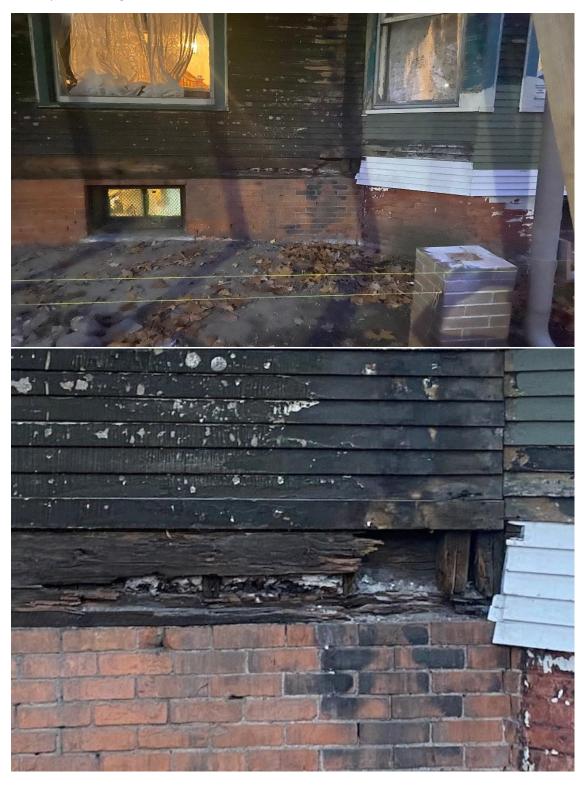
Rotting of the porch. As you can see that is actually part of the house so with out taking a significant part of the porch to begin with, I am not sure how we could fix this.

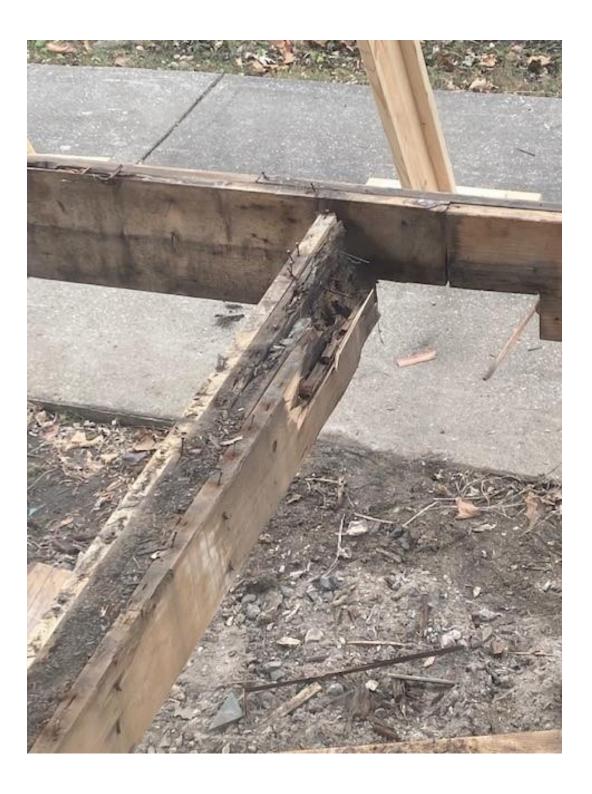
You can see from this picture the framing was done incorrectly in the (1990s). Instead of replacing they just added boards onto each other.

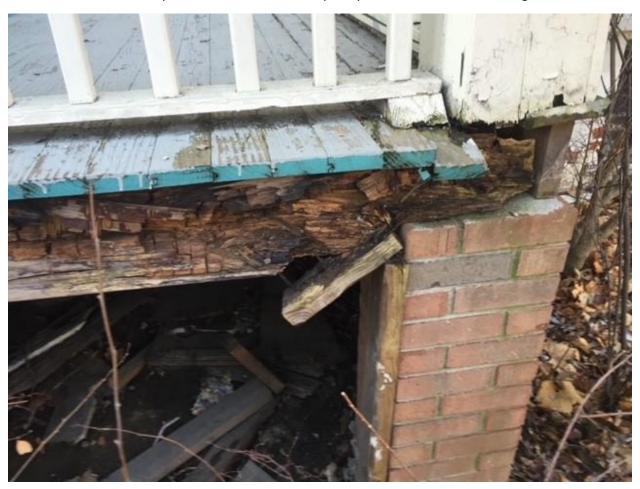
This was from earlier this year where I had to do temporary fix because the wood had gotten so rotted.

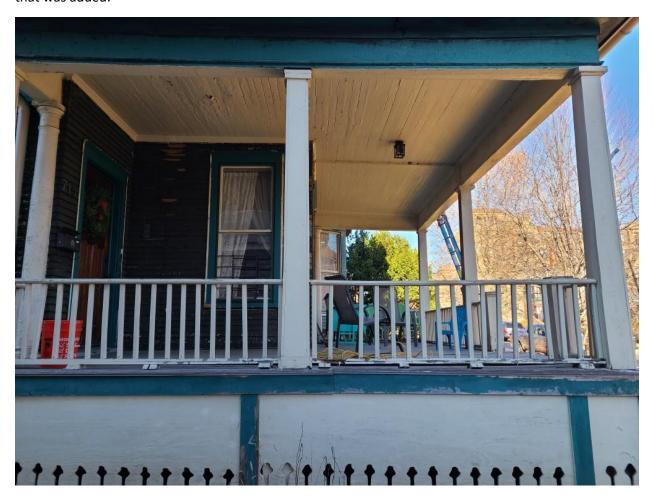
Not that I am that worried about the skirting at this point but as you can see the "decorative" Victorian that was added.
