Existing Pictures

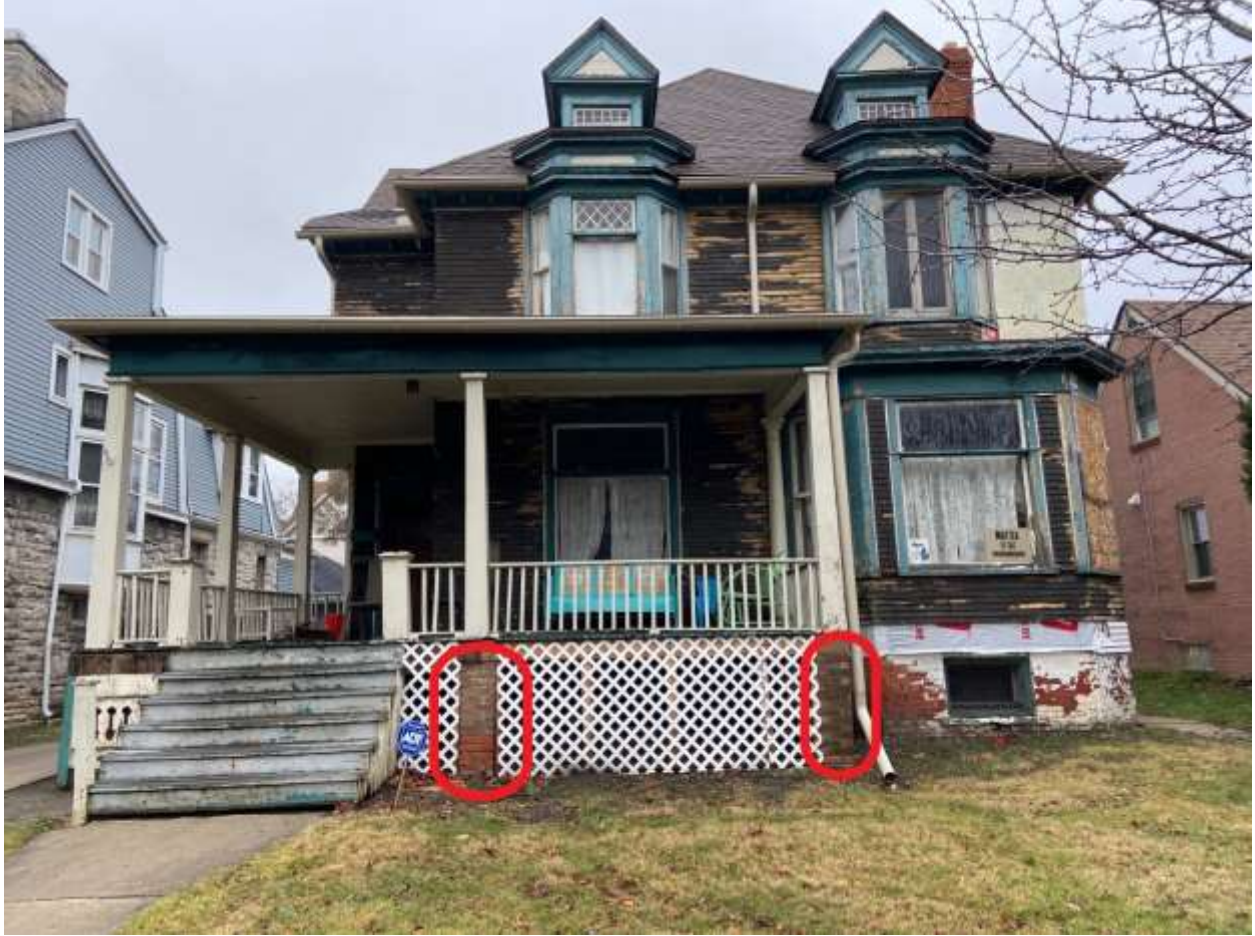
Original brick piers: you can see from this pic that they are angled and are off centered

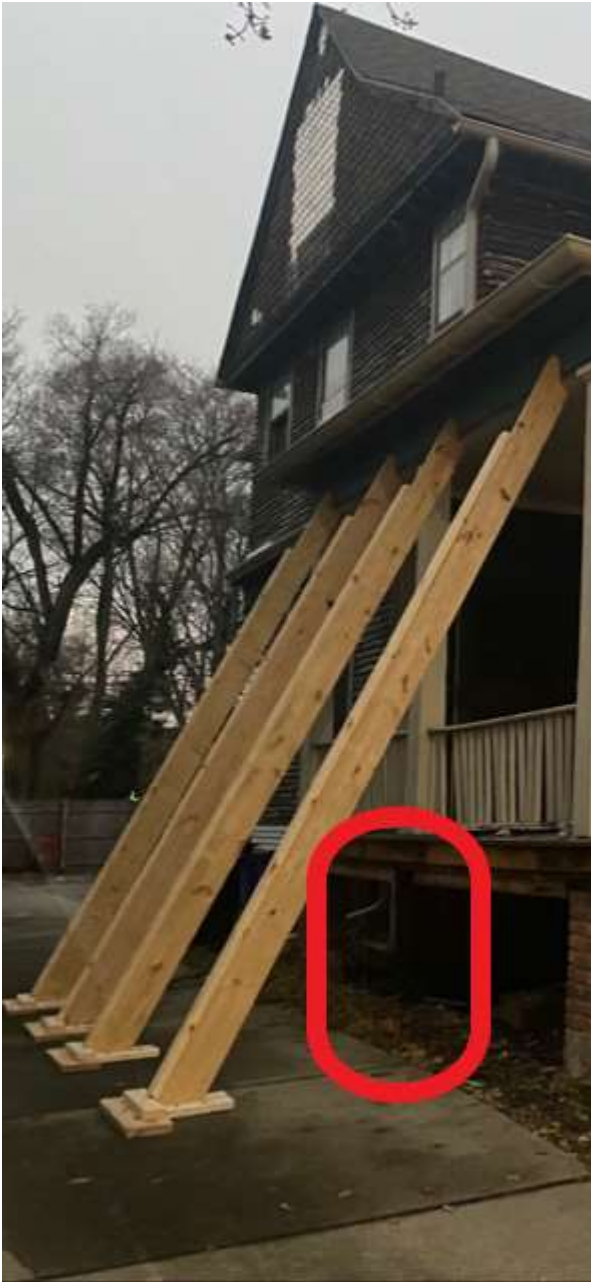
Here the pier is missing.

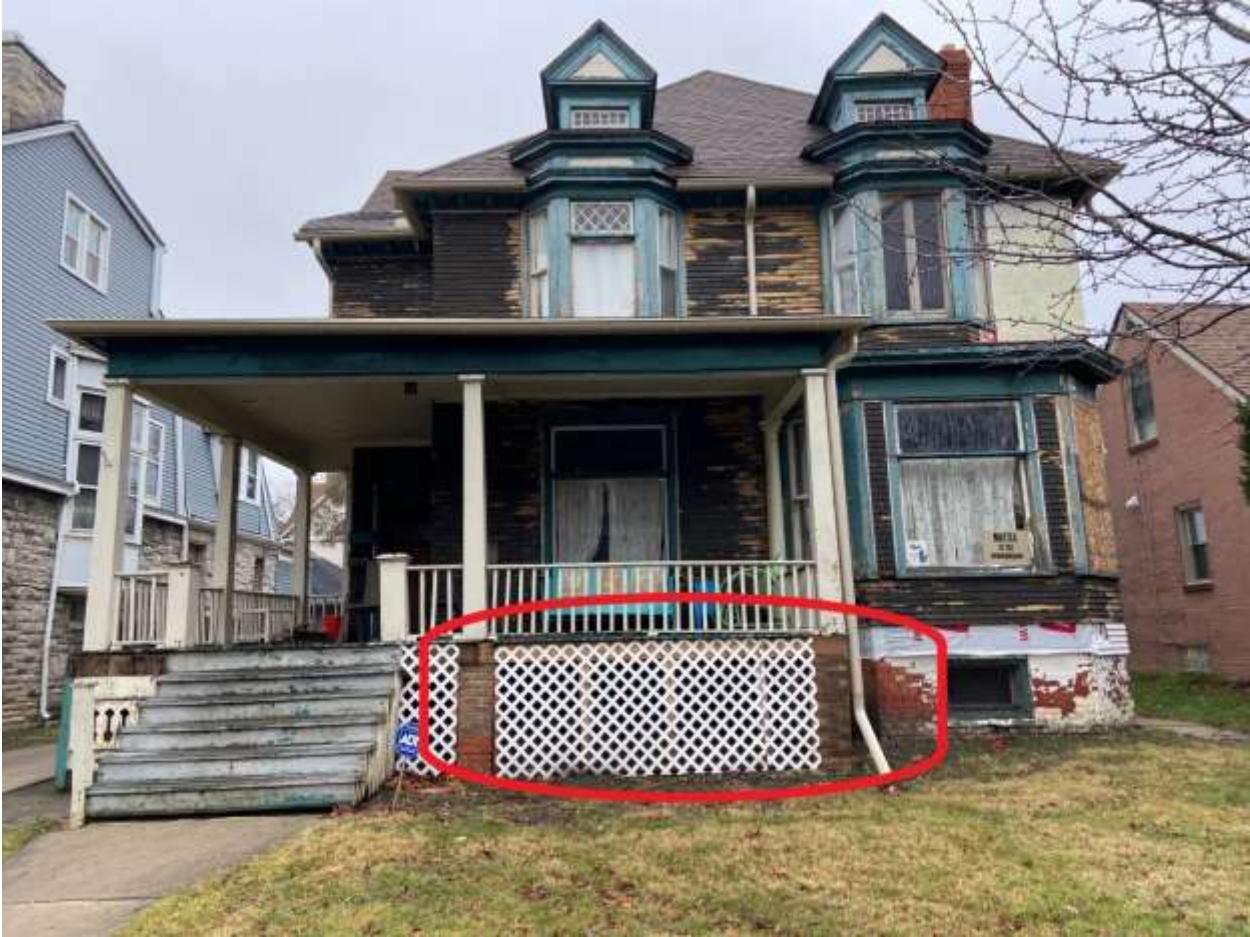
Here you can how bad the right side of the porch is off from the rest of the porch. We have estimated that is it 8" lower than the other part of the porch

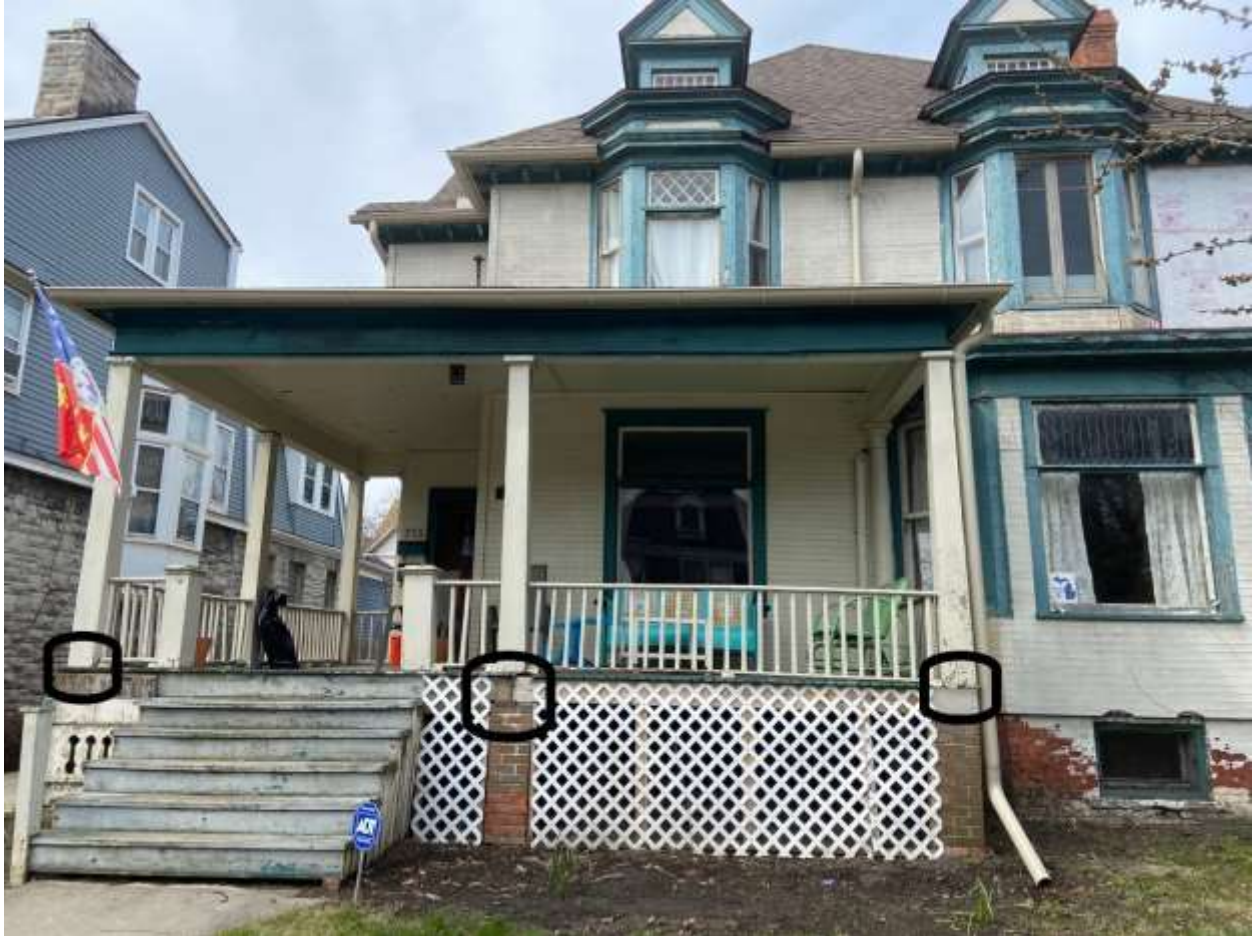
In this picture you can see the pillars have no bases, are not connect to porch and are rotting at the base

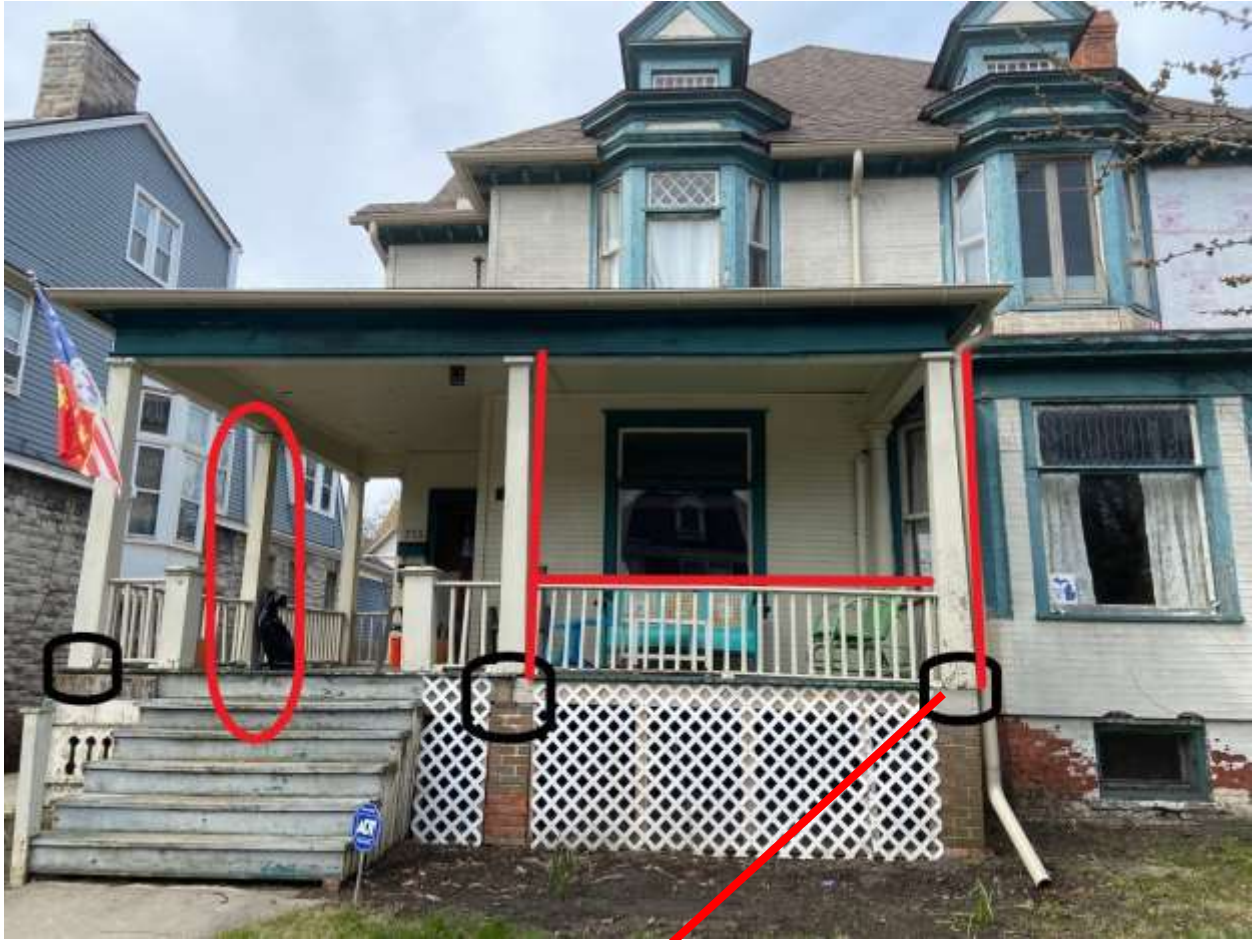
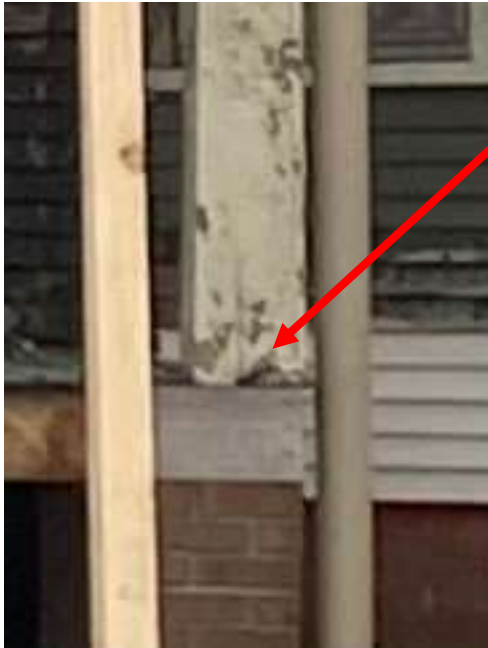
Here you can see the columns are leaning and rotting. There are no base for the columns, so they are not attached to the porch. The center column on the south elevation is not connected to the roof .

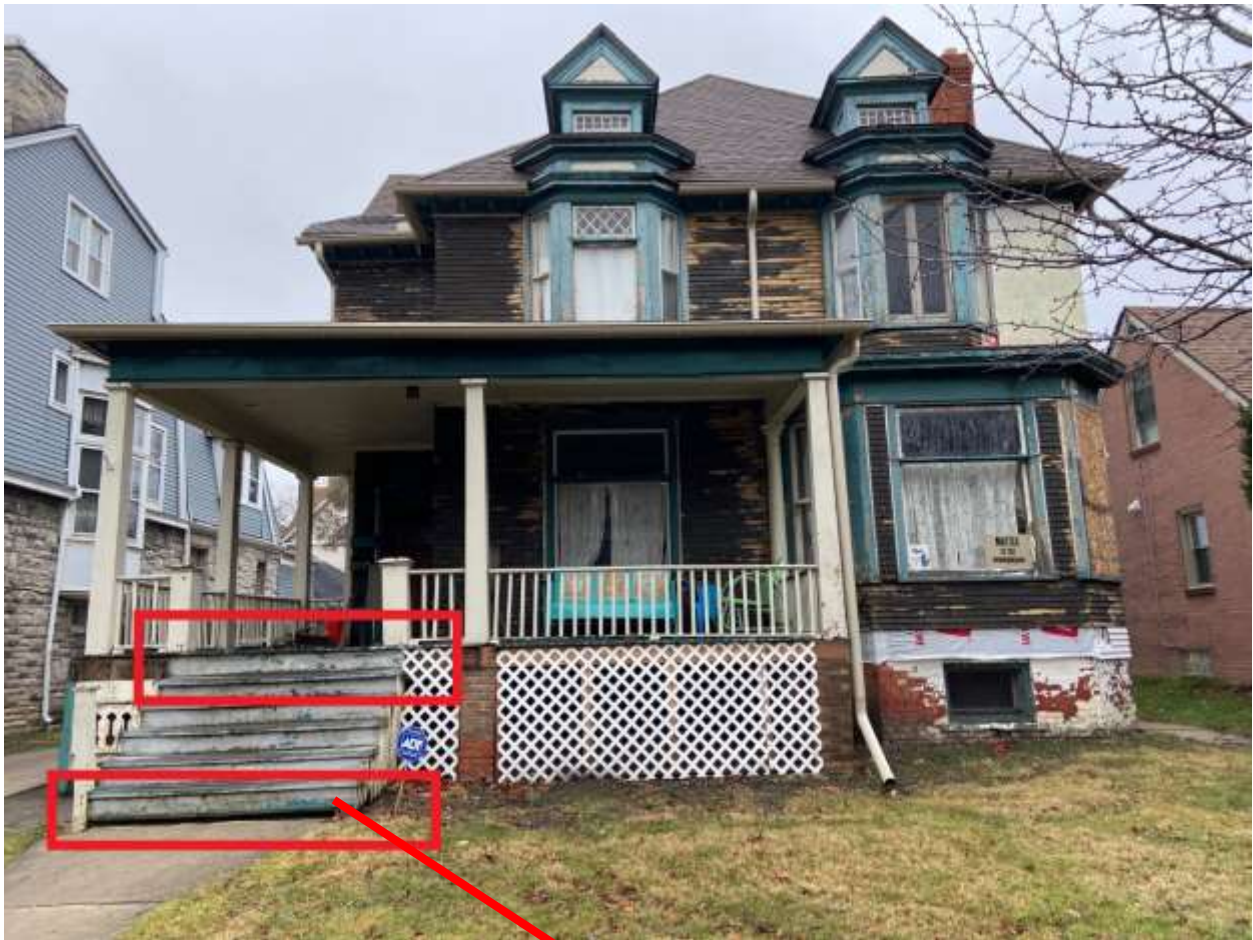
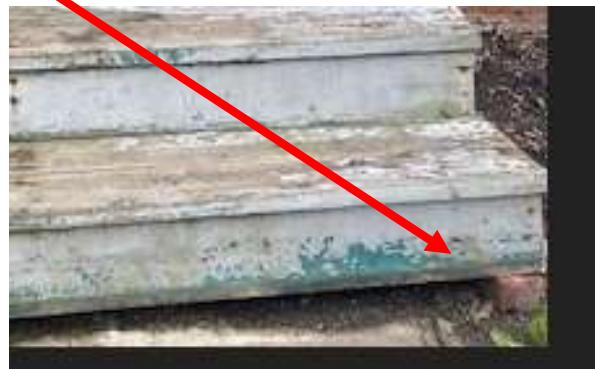
Stairs:

You can see from the pictures the stairs are not to code missing handrails, risers at different heights, bricks use to level the stairs.
