**ROOF INSPECTION REPORT**

**KING  
SOLOMON  
BAPTIST  
CHURCH**

**NOVEMBER 19, 2021**

**MICHIGAN STRATEGIC FUND**

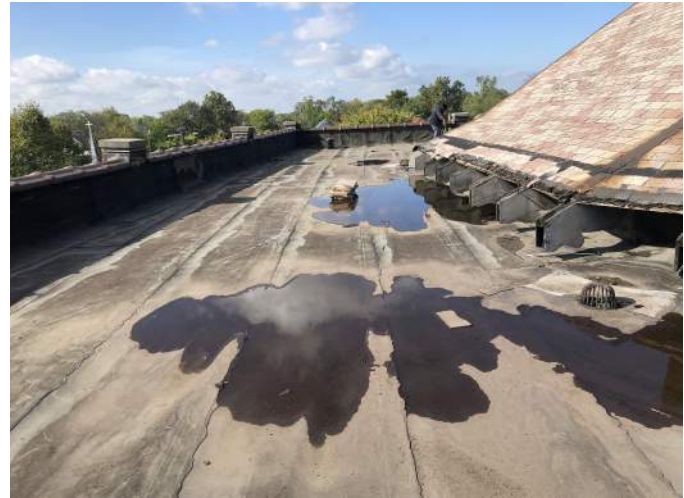
**FIGURE A1.1** OVERVIEW LOOKING WEST AT VARIOUS POOLS OF STANDING WATER; FRAYED WARPED ROOFING MEMBRANE SEAMS; NO INDICATION OF ROOF INSULATION OR TAPERING

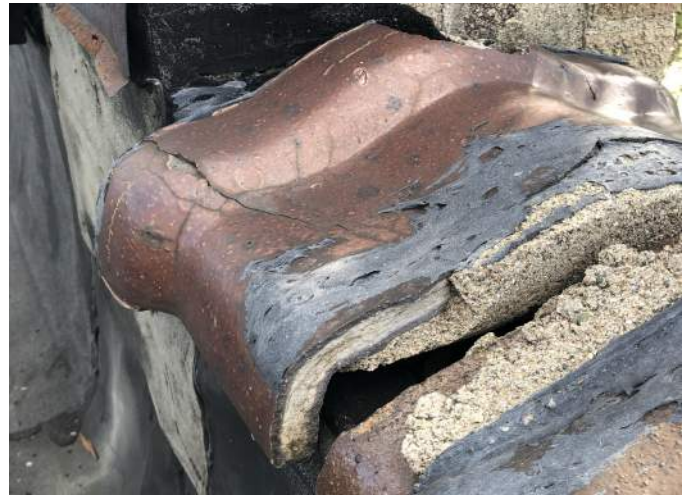
- Missing, detached or cracked clay tile parapet caps leaving membrane roofing termination and top of masonry wall exposed along approx. 25% the length; 50% clay tile caps are in fair to good condition (see figure A1.9 and A1.10)

FIGURE A1.9 CRACKED AND DETACHED CLAY TILES AT THE PARAPET

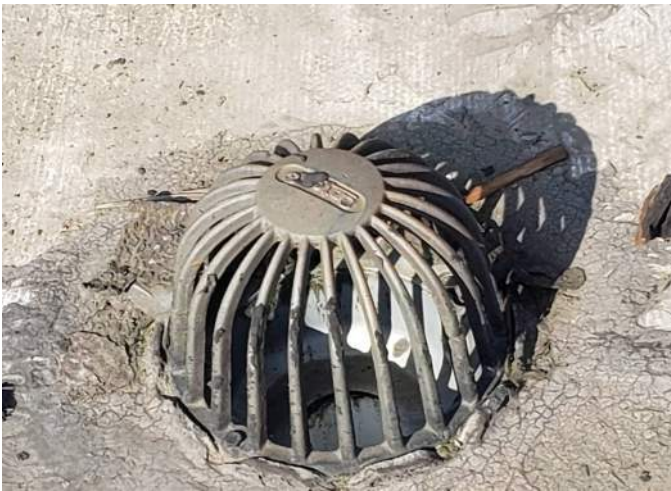
FIGURE A1.6 EXISTING ROOF DRAIN CAP BODY

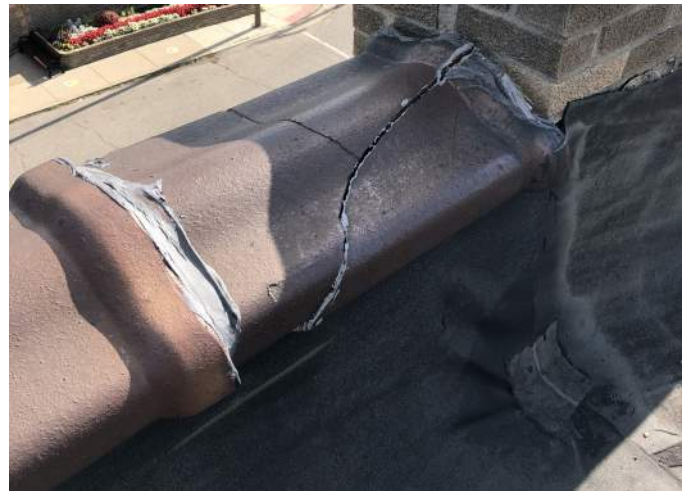
FIGURE A1.10 CRACKED CLAY TILES ALONG EAST ELEVATION

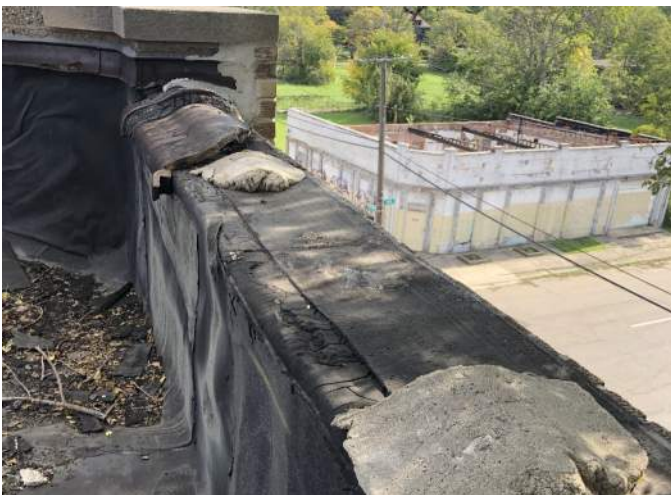
FIGURE A1.8 MISSING AND DAMAGED PARAPET CLAY TILES (SOUTHEAST CORNER)

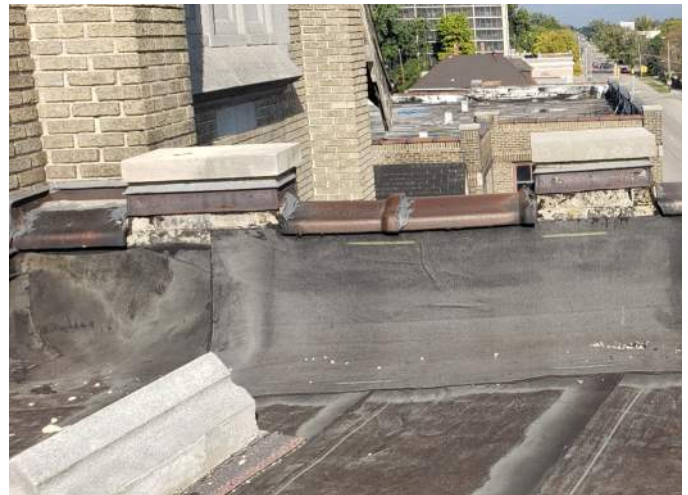
- Water Infiltration along the masonry wall between the flat roof and bell tower
- Rusted or missing metal termination flashing at the upturn along the parapet wall and pier columns (see figure A1.11 and A1.12)

FIGURE A1.11 FLASHING MISSING UNDER COLUMN CAP

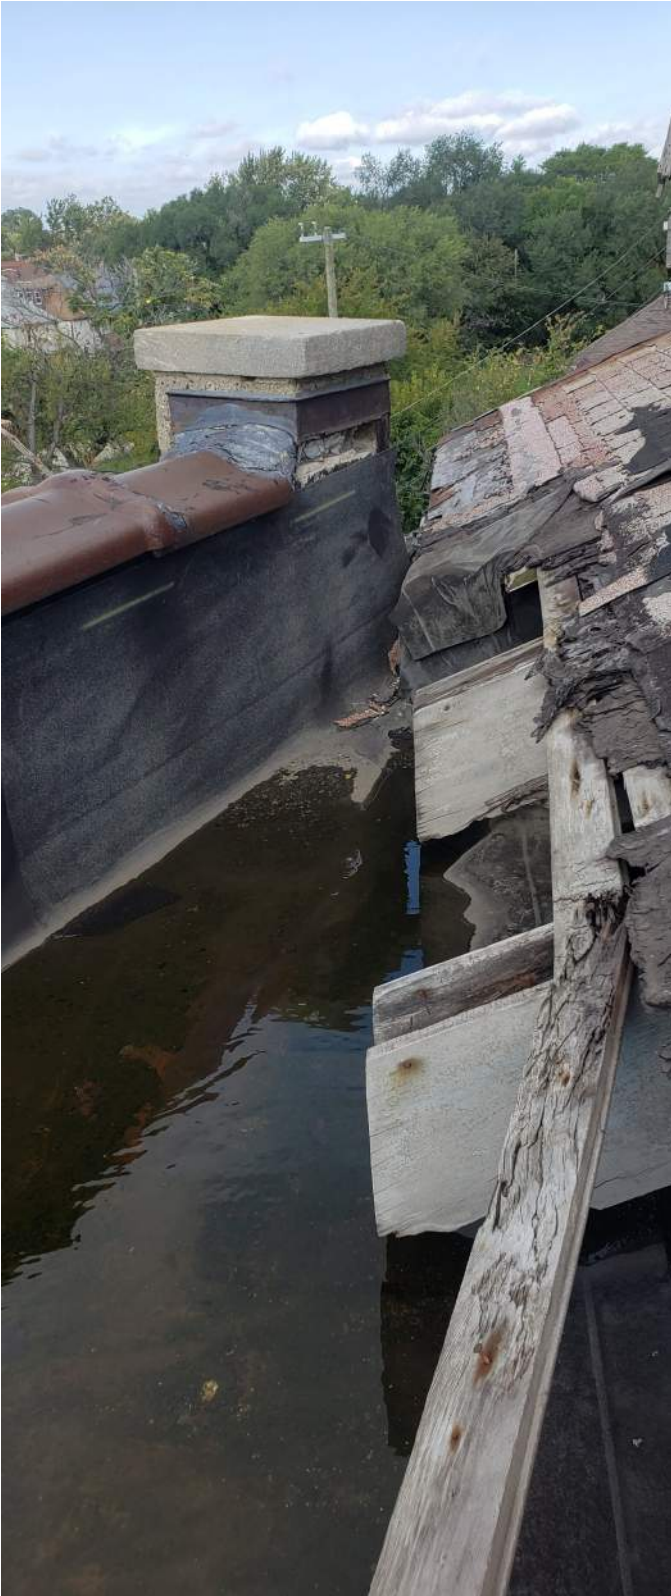
**FIGURE A1.15** DETERIORATING CORNER COLUMN, UNFLASHSED MASONRY AT PIER COLUMN; 3" OR MORE PONDING WATER AT SOUTHWEST CORNER

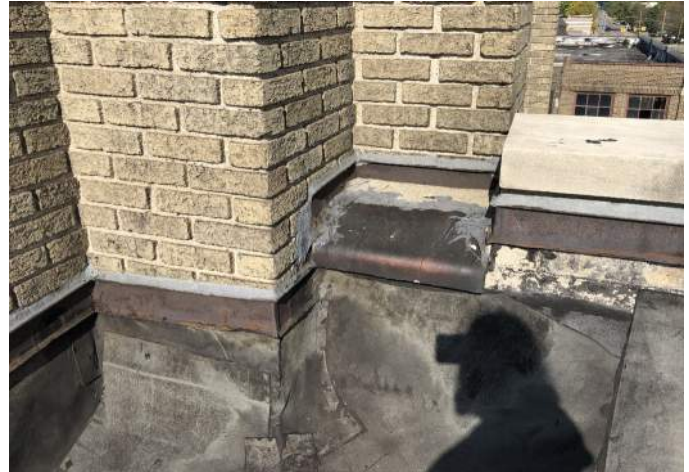
**FIGURE A1.12** RUSTED FLASHING; WEATHERED SEALANTS, FLASHING MISSING AT THE UNDERSIDE OF THE COLUMN CAP

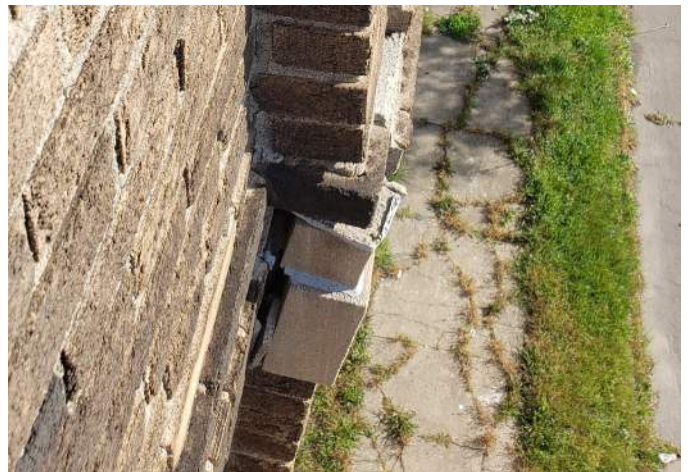
**FIGURE A1.16** "ROLLING" BRICK DISPLACEMENT AT THE EXTERIOR PARAPET PIER COLUMN

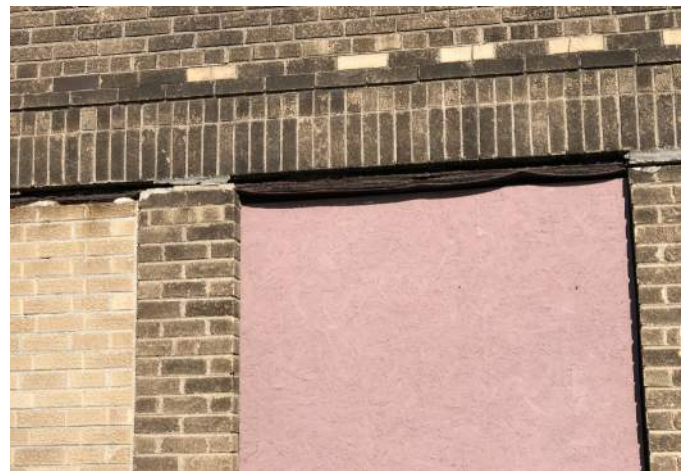
**FIGURE A1.21** CORRODED AND EXPANDING STEEL LINTEL ABOVE THE WINDOWS ON THE THIRD FLOOR

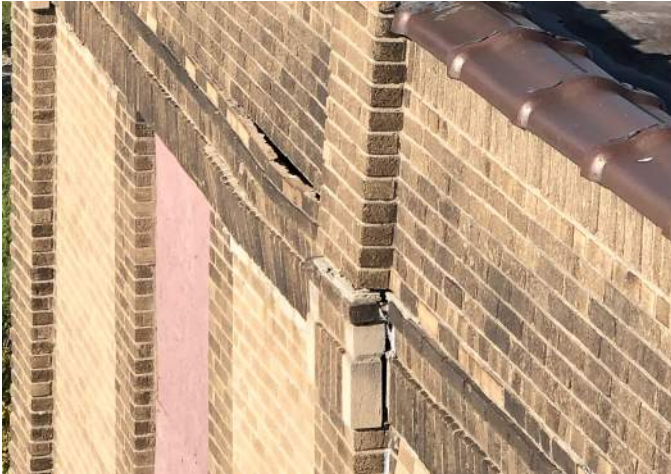
**FIGURE A1.22** "ROLLING" BRICK DISPLACEMENT AT THE EXTERIOR PARAPET;  
BUCKLING AT PIER COLUMN

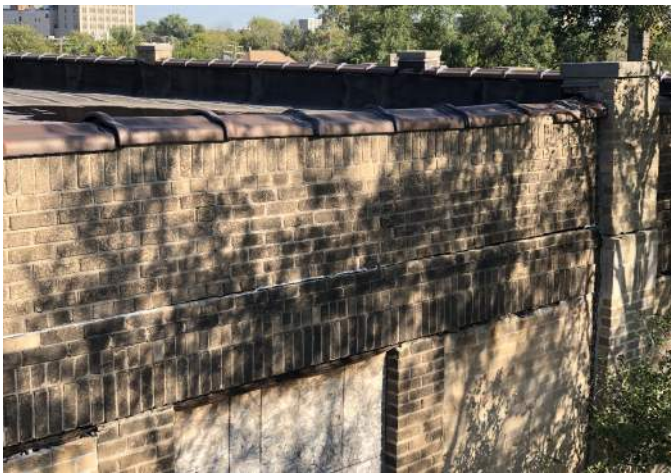
**FIGURE A1.23** CORRODED AND EXPANDING LINTELS; "ROLLING" BRICK  
DISPLACEMENT AT THE EXTERIOR PARAPET

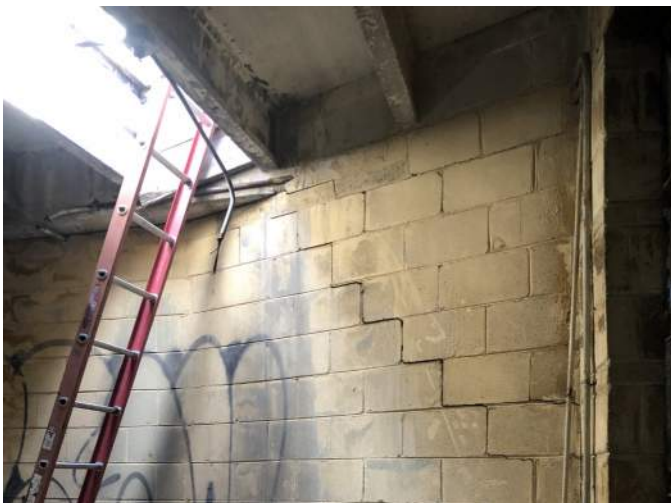
FIGURE S1.5 STAIR STEP CRACKING ALONG THE WEST WALL BEHIND THE ROOF HATCH ACCESS

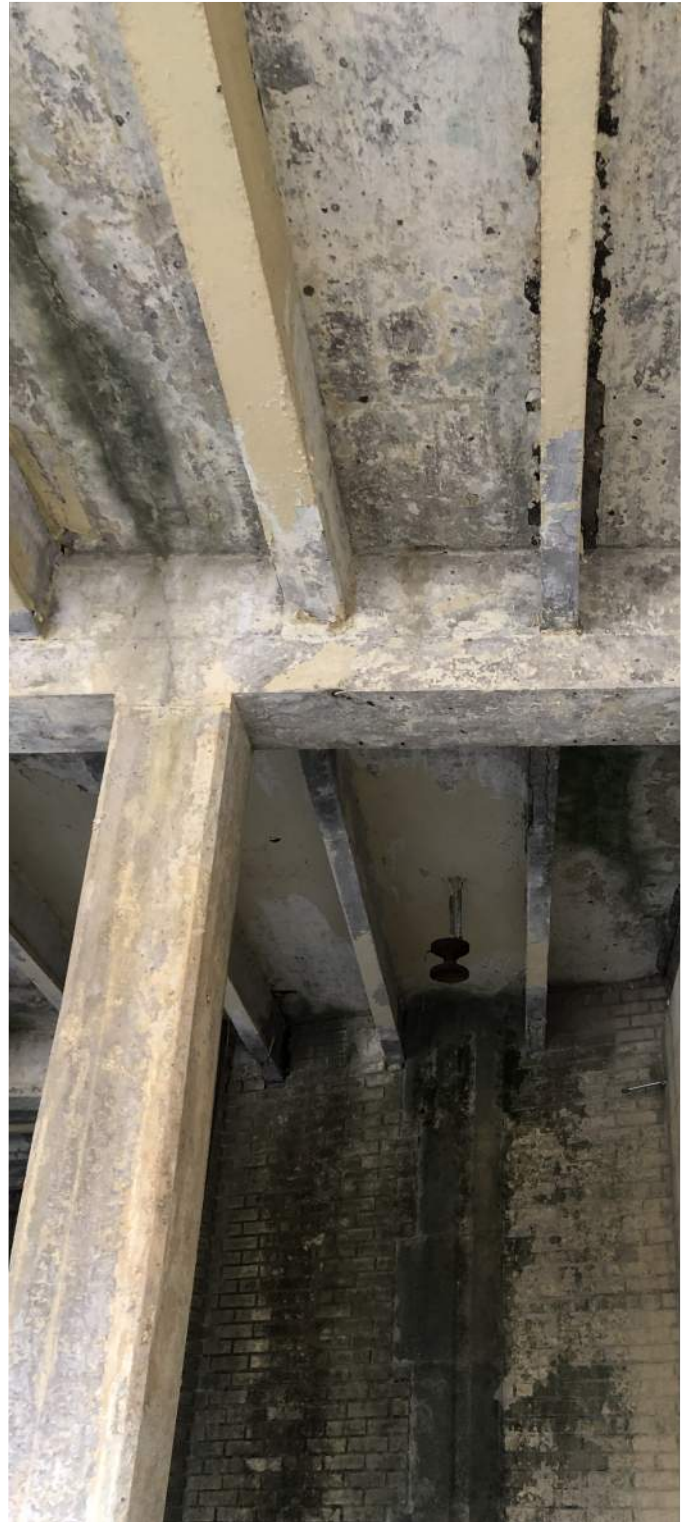
FIGURE S1.6 INTERNAL WATER DAMAGE FROM THE ROOF ABOVE; THE WATER INFILTRATION IS STARTING TO SHOW SIGNS OF FREEZE/THAW DAMAGE INCLUDE SPALLING AND SCALING OF THE CONCRETE SURFACE, SURFACE PARALLEL CRACKING, OR EXPOSED AGGREGATE.

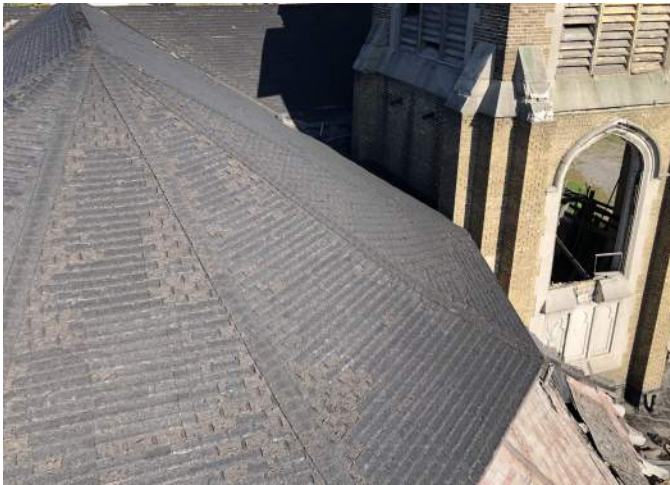
FIGURE A2.10 UPPER TIER OF HEPTAGON ROOF; WORN, MISSING CURLED, DISCOLORED, AND FRAYED ASPHALT SHINGLES

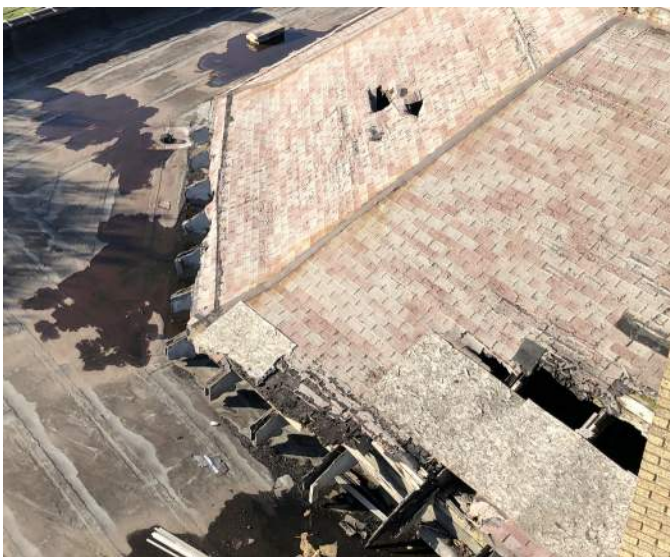
FIGURE A2.12 OVERVIEW OF THE HEPTAGON ROOF ABOVE, SHOWS THE EXTENT OF THE ROOF DETERIORATION WITH VARIOUS HOLES ALONG THE SURFACE

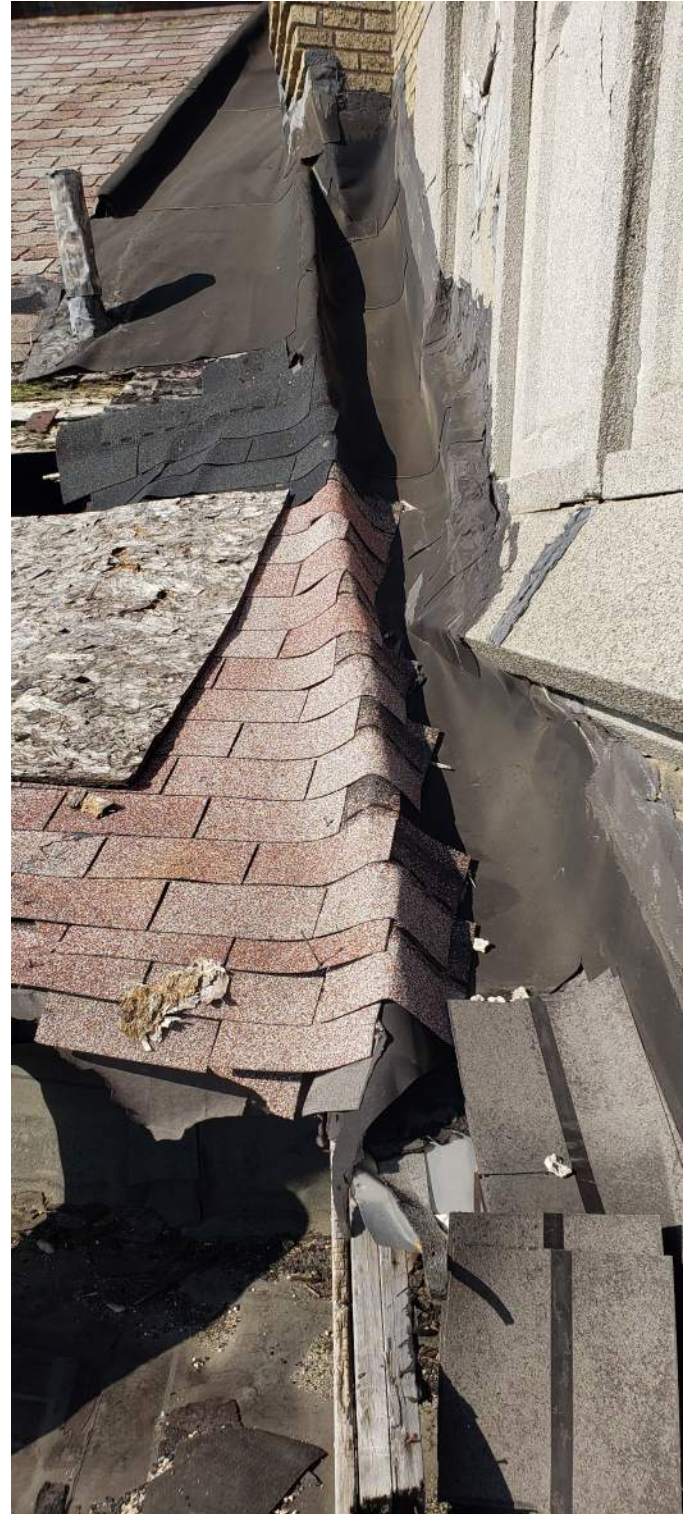
- Flashing failure along the supporting masonry wall under the eaves (see figure A2.7)
- Patched valley flashing with improper terminations along bell tower masonry wall and of asphalt roofing. Excessive mastic on masonry wall. (see figure A2.13)

FIGURE A2.13 IMPROPER FLASHING AND PATCHING AT THE VALLEY JUNCTION BETWEEN THE POLYGONAL ROOF AND BELL TOWER; THE ASPHALT SHINGLES ARE NOT PROPERLY TERMINATED; EXCESSIVE USE OF ROOFING MASTIC ALONG THE BELL TOWER WALL; DETERIORATED ROOF VENT NEAR THE LARGE HOLE IN THE ROOF.

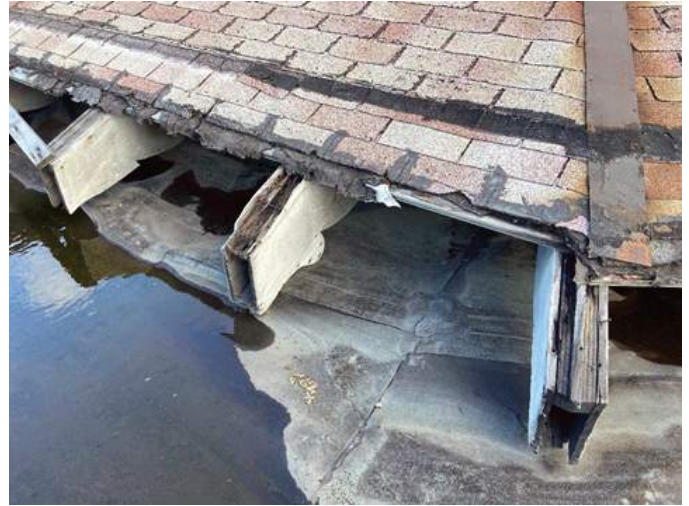
FIGURE S2.1

- The lower overhang extending over the flat roof is in poor condition with missing and deteriorated sheathing. The structural rafters inside the decorative side panels are in very poor condition. The wood is rotten beyond serviceability. Water shedding off the roof flows over exposed wood sides and edges, accelerating the deterioration of the support structure. (see figure S2.1)

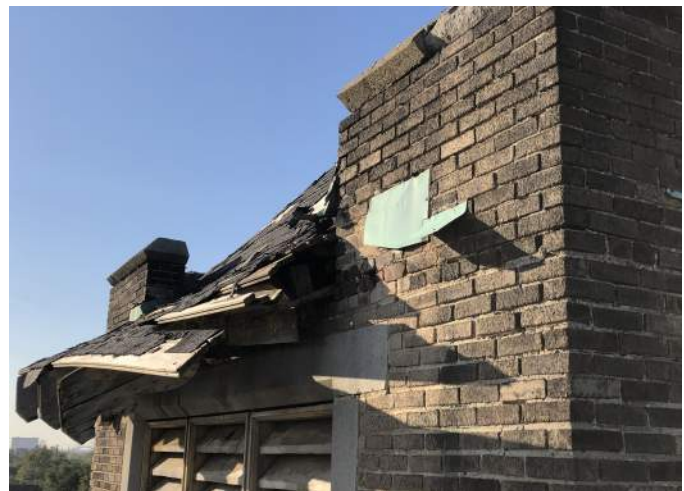
- Extensive roof damage at extended eave overhangs
- Decorative wood rafter tails are rotted or missing; wood frieze board and trim is detaching from the masonry wall where still existing, weathered with worn paint. (see figure A3.4 and A3.6)

**FIGURE A3.4** DECORATIVE WOOD OVERHANGS COLLAPSING AND OPEN AT ENDS TO INTERIOR; BRICK MASONRY SHOWS SIGNS OF DIFFERENTIAL MOVEMENT; REMAINING STEPPED COPPER FLASHING (EAST ELEVATION)

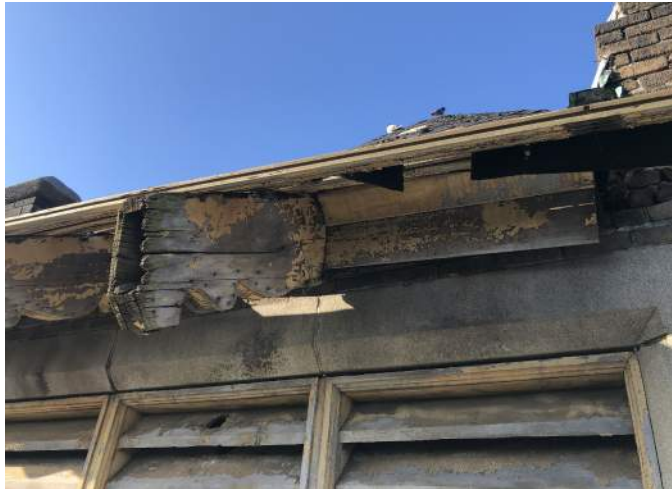
**FIGURE A3.8** ROTTED DECORATIVE WOOD RAFTER TAIL AND DETACHING FRIEZE BOARD TRIM

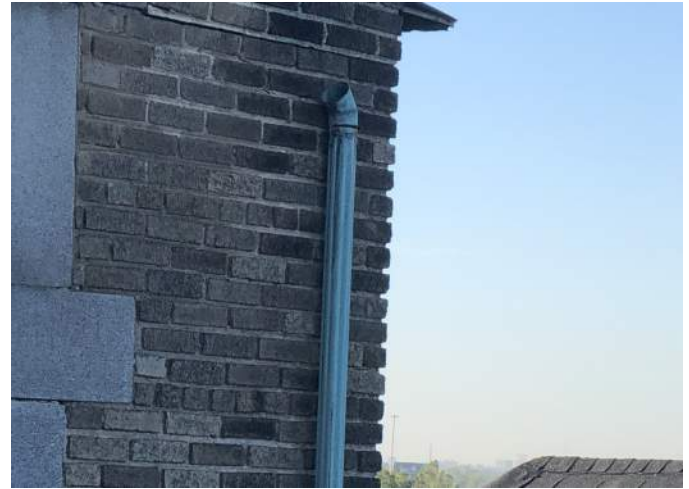
**FIGURE A3.11** DETACHED COPPER DOWNSPOUT AND MISSING ASSOCIATED COPPER GUTTER

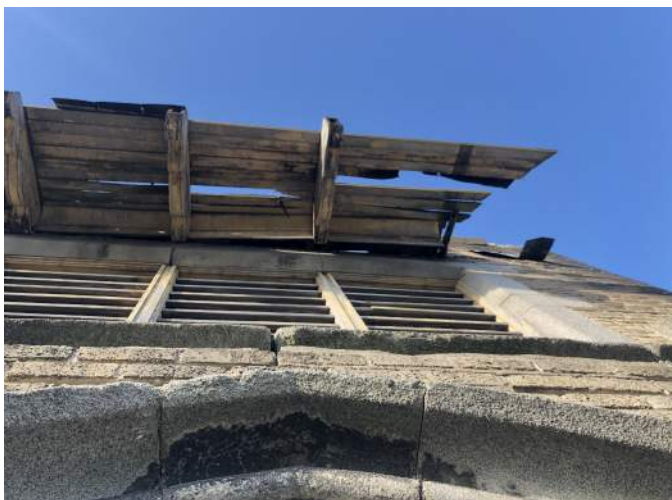
**FIGURE A3.9** UNDERSIDE OF THE PAINTED DECORATIVE OVERHANGS; WEATHERED DETERIORATED WOOD DECKING (EAST ELEVATION)

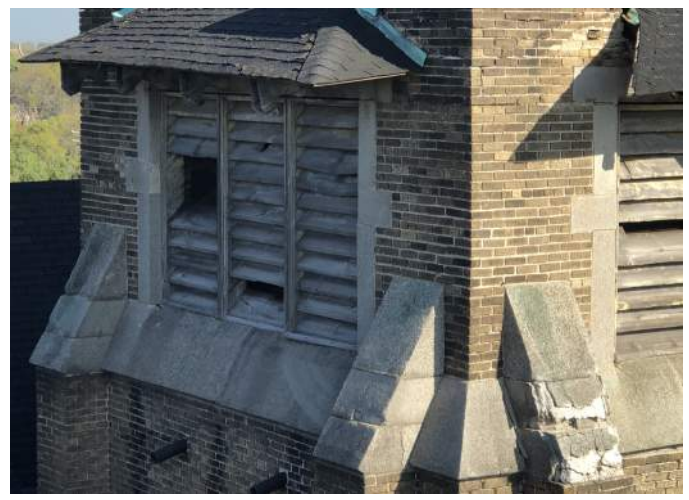
**FIGURE A3.12** SOUTH WEST ELEVATION OF BELL TOWER; CRUMBLING STONE AT THE COLUMN CAP; BRICK MOVEMENT DIRECTLY UNDER THE ROOF

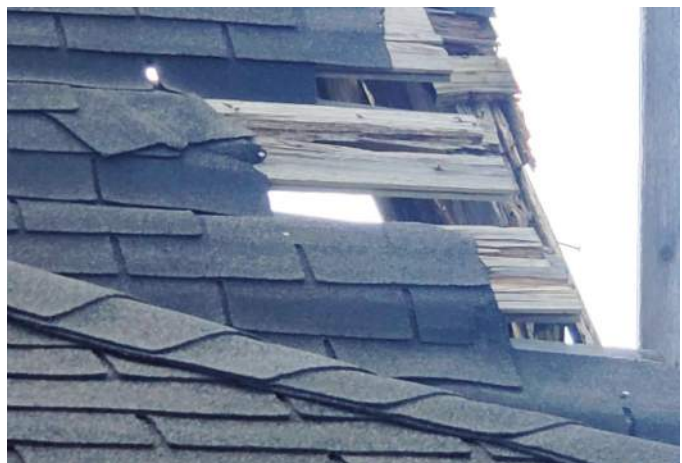
FIGURE 4.1 DETERIORATED WOOD DECKING, MISSING/FALLEN SHINGLES AT THE EAVE (WEST ELEVATION)

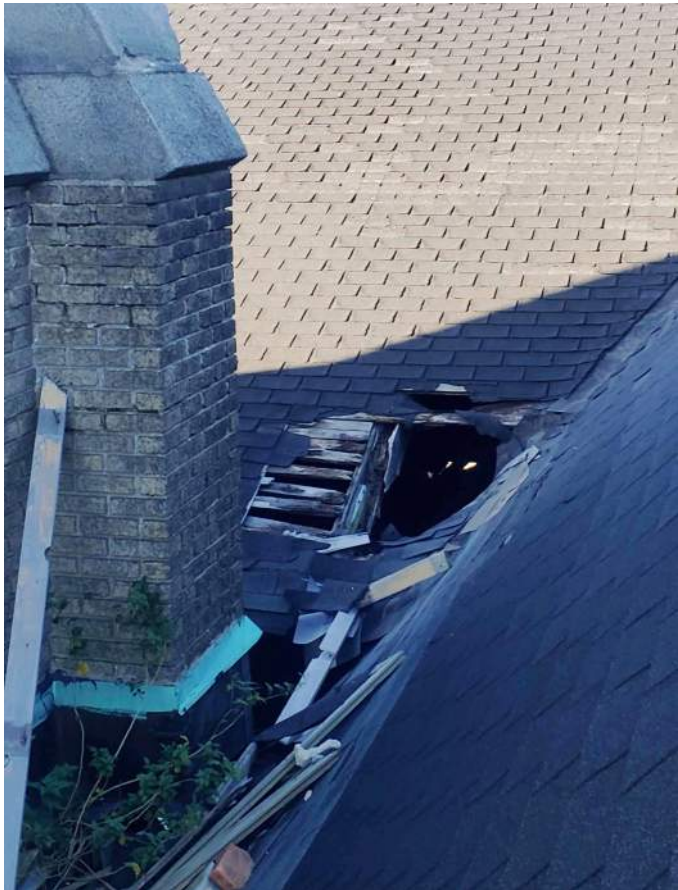
**FIGURE A4.17** LARGE HOLE IN THE ROOF; DETERIORATED SHINGLES, WOOD DECKING AT THE ROOF VALLEY ; FALLEN WOOD DECKING FROM THE BELL TOWER ROOF ABOVE

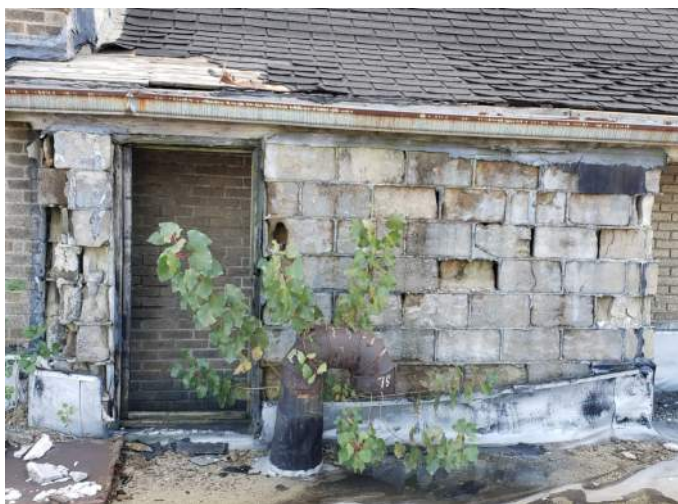
**FIGURE A4.23** EXTENSIVE EXTERIOR MASONRY DETERIORATION AT ROOFTOP STAIR ENTRY/EXIT; MISSING AND DETERIORATED MORTAR JOINTS; DETACHED ROOFTOP STAIR ENTRY DOOR; DAMAGED DOOR FRAMING. DETACHED FLASHING AT THE UPTURN OF THE NORTH MEMBRANE ROOFING

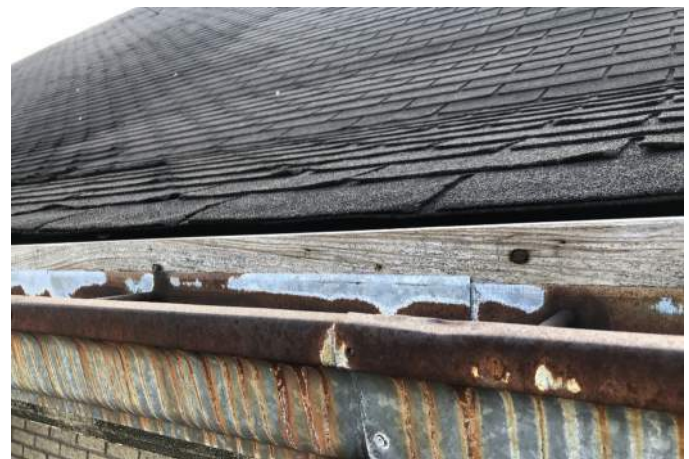
**FIGURE A4.5** RUSTED GUTTER, CURLLED AND FRAYED ASPHALT SHINGLES

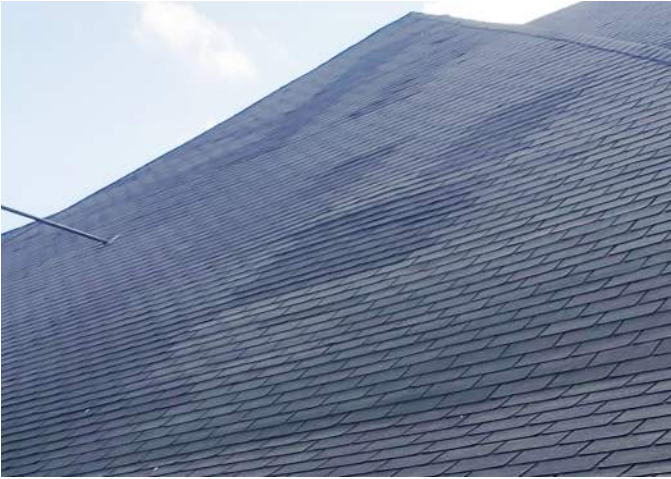
**FIGURE A4.6** OVERVIEW OF NORTHERN ROOF; CURLLED, DISCOLORED, AND FRAYED ASPHALT SHINGLES; SHOW SIGNS OF DEPRESSIONS AND UNEVEN SURFACES ALONG THE ROOF

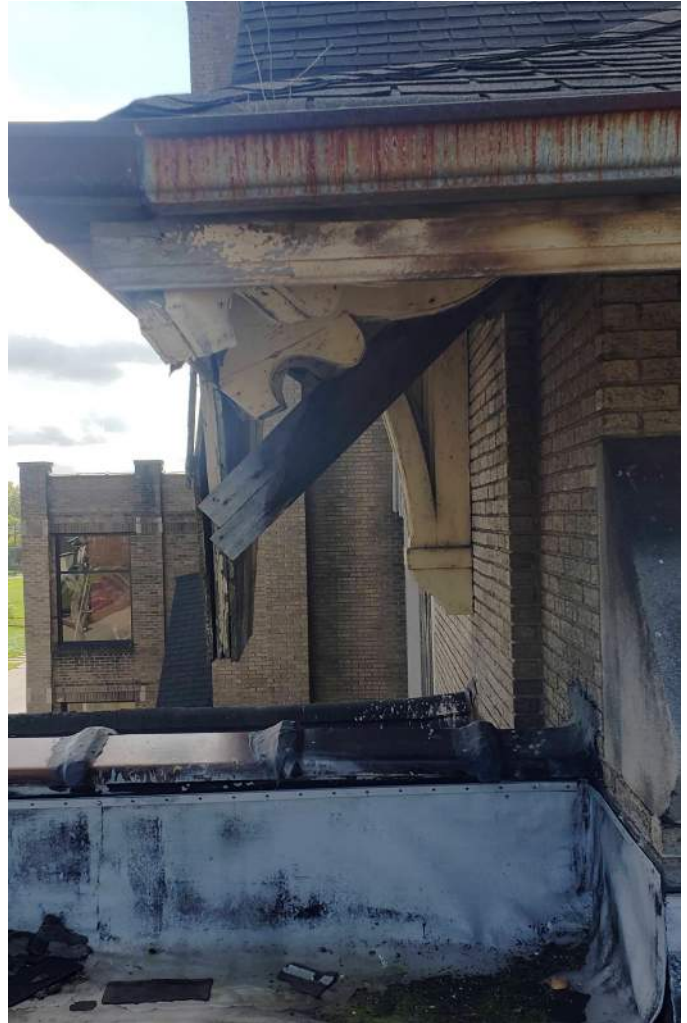
**FIGURE A4.12** WEATHERED, FADED EAVES; RUSTED GUTTER (EAST ELEVATION)

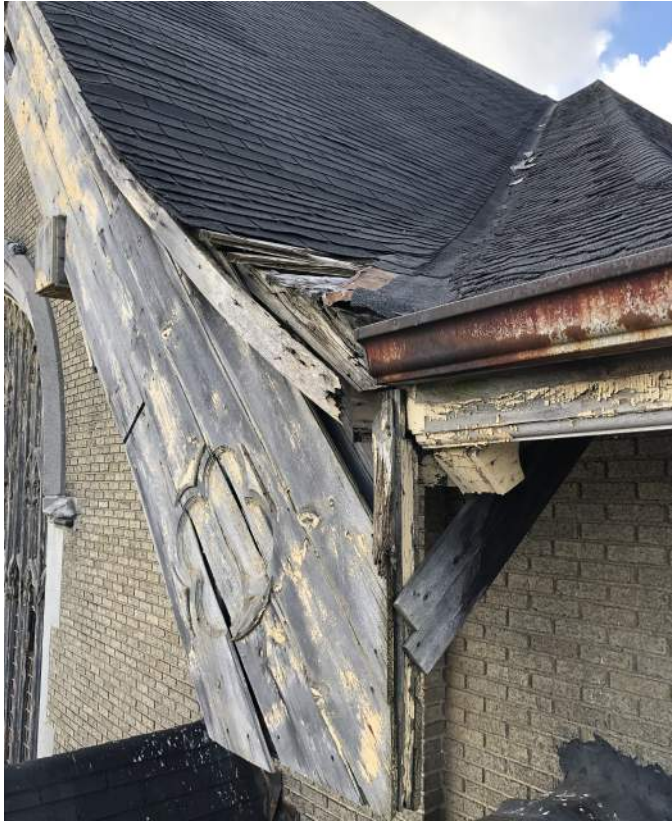
**FIGURE 4.13** DECORATIVE FASCIA BOARDS ARE WEATHERED AND FADED; THEY ARE DETACHING FROM THE SUBSTRUCTURE. WOOD DECKING AT VALLEY TERMINATION IS EXPOSED, DECAYED WITH MISSING SHINGLES

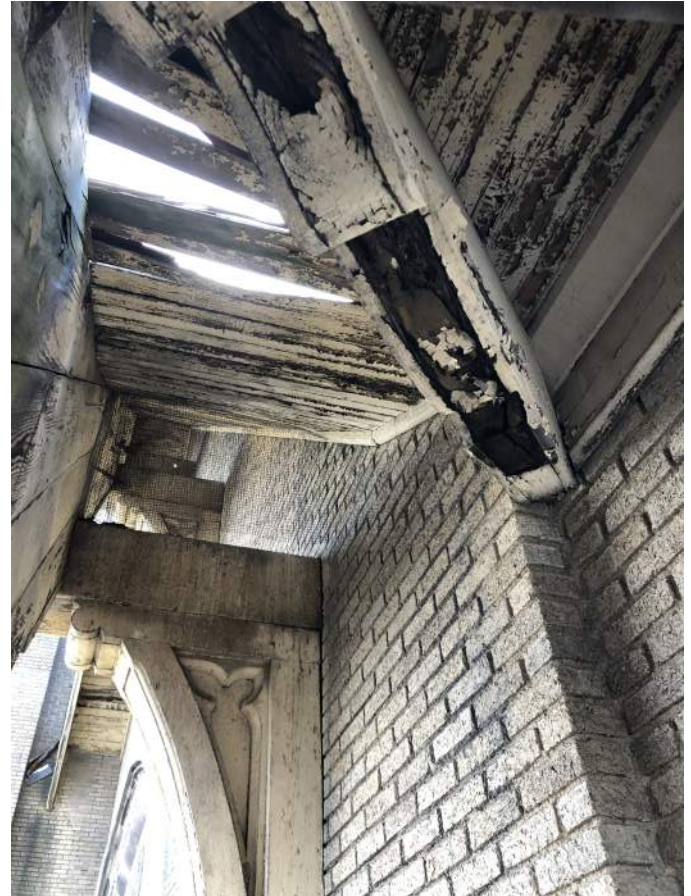
**FIGURE A4.16** UNDERSIDE OF EAVES ON THE EAST ELEVATION AT THE MAIN ENTRANCE; WOOD DECKING IS DETERIORATION AT THE EAVE; MISSING WOOD DECKING; WEATHERED AND DECAYING SUPPORT BRACKETS

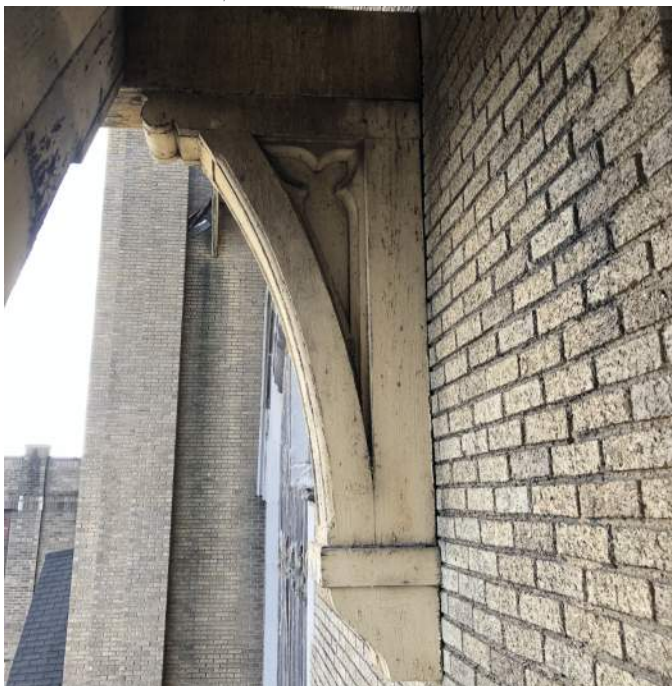
**FIGURE A4.15** UNDERSIDE OF THE EAVES; PAINTED WOODEN BRACKET EAVE SUPPORT; (EACH BRACKET SHOULD BE INDIVIDUALLY EVALUATED)

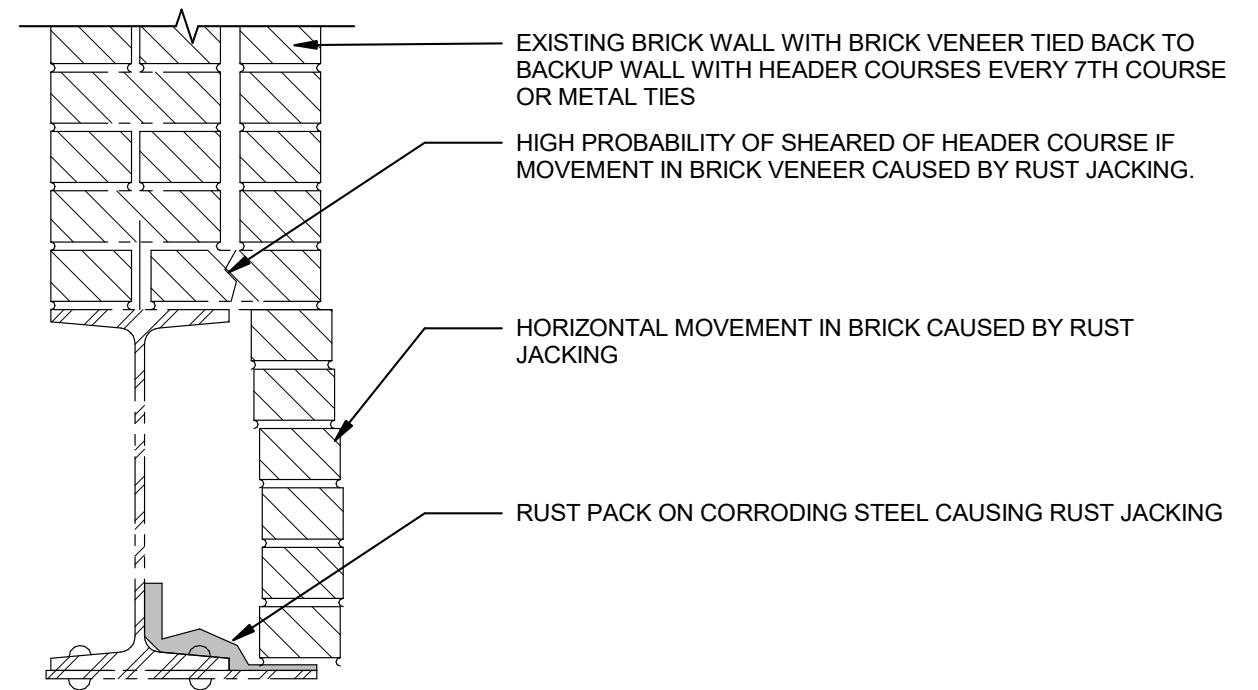
**1 CORROSION AT EXISTING STEEL LINTEL**  
SCALE: 1 1/2" = 1'-0"

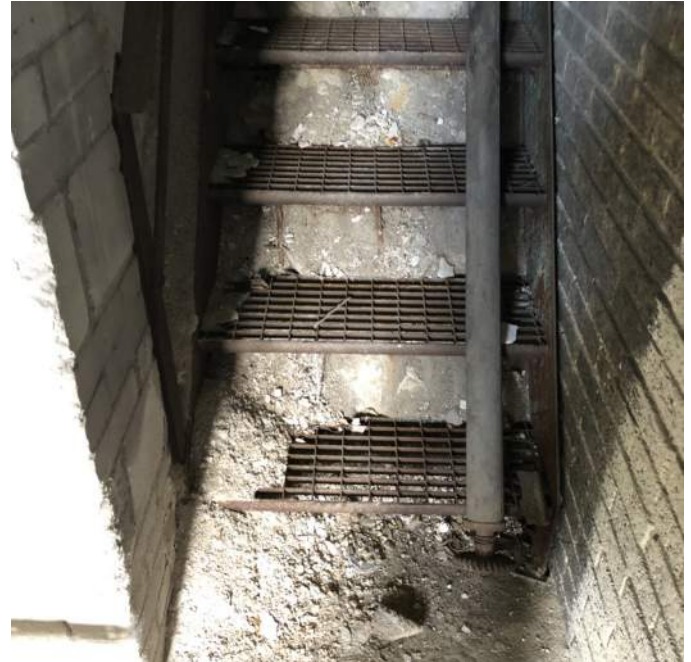
**FIGURE INT 1.3** INTERIOR PLASTER HAS CRUMBLLED FROM THE WALLS, CEILING AND STRINGER BEHIND THE STAIR (LEADS TO THE ROOFTOP EXIT)

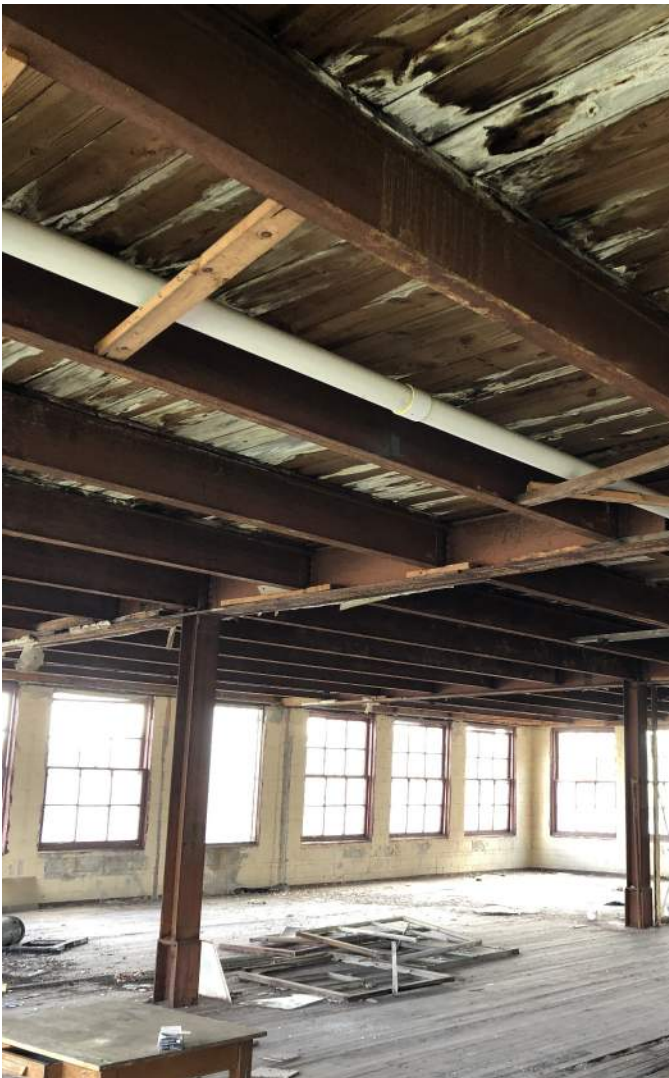
**FIGURE INT 1.2** WATER STAINED AND LOOSE WOOD DECKING; OXIDIZED STRUCTURAL BEAM AND COLUMNS; VARIOUS DEBRIS; AT 1917 ADDITION INTERIORS

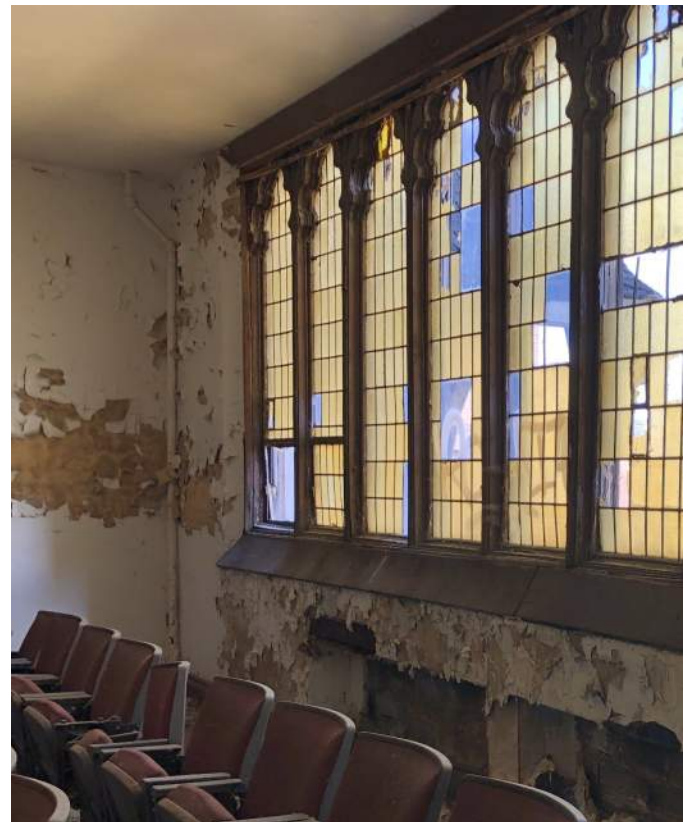
**FIGURE INT 1.4** WATER DAMAGED PAINT AND PLASTER FINISHES AND FURNISHINGS. DAMAGED STAINED GLASS WINDOWS WITH MISSING GLASS AND FAILED JOINTS

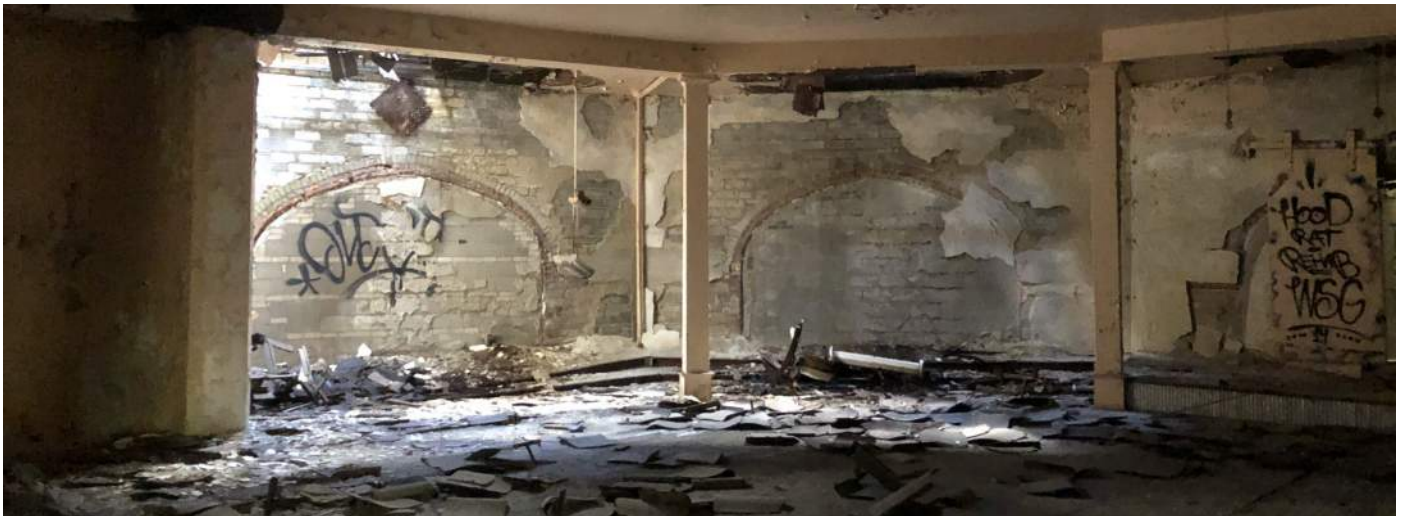
FIGURE INT.1.6 FAILED FINISHES AND DEBRIS IN CLASSROOMS OVER SANCTUARY; OPENINGS THRU ROOFS TO DAYLIGHT ABOVE

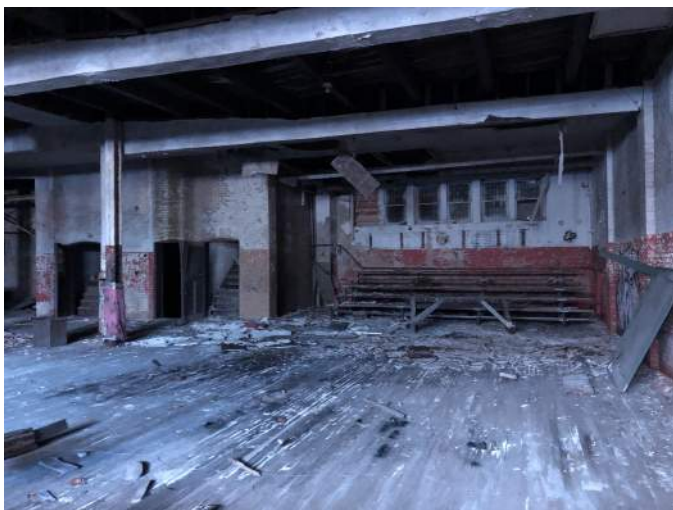
FIGURE INT.7 FAILED FINISHES AND DEBRIS IN LOWER LEVEL SPACES

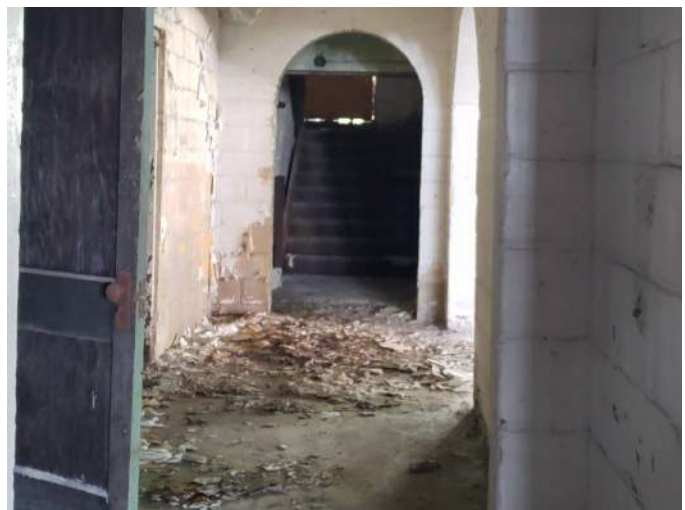
FIGURE INT.1.8 FAILED FINISHES AND DEBRIS IN ENTRYWAY AND CORRIDORS

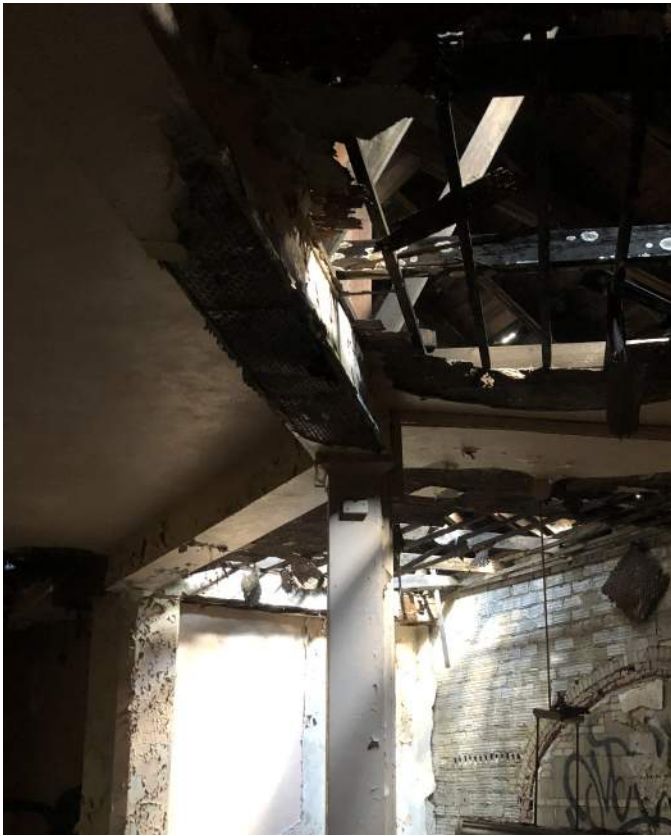
FIGURE INT 1.9 FAILED FINISHES AND DEBRIS IN CLASSROOMS OVER SANCTUARY; OPENINGS THRU ROOFS EXPOSING INTERIOR TO ELEMENTS

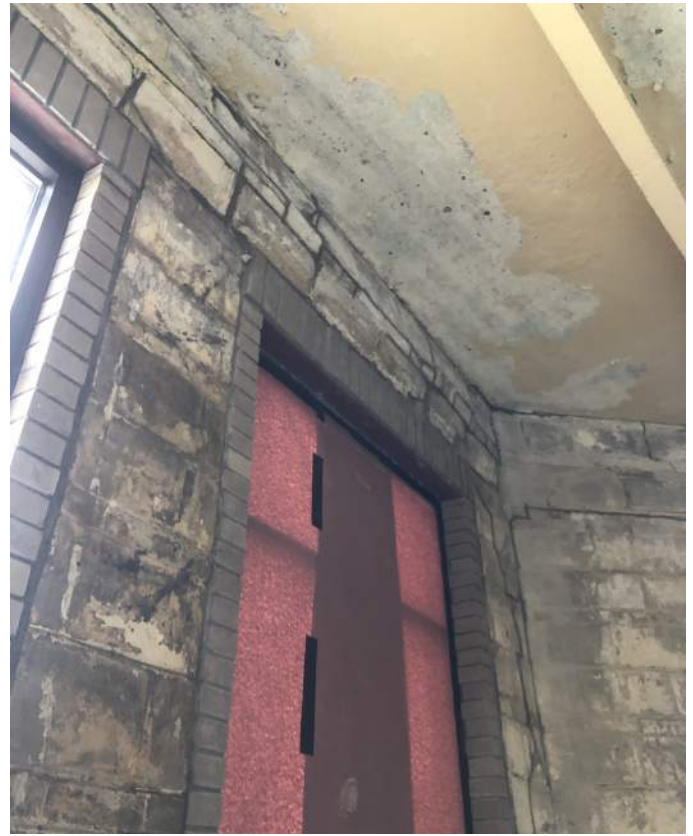
FIGURE INT 1.10 BUCKLING AND CRACKED MASONRY EXTERIOR WALLS

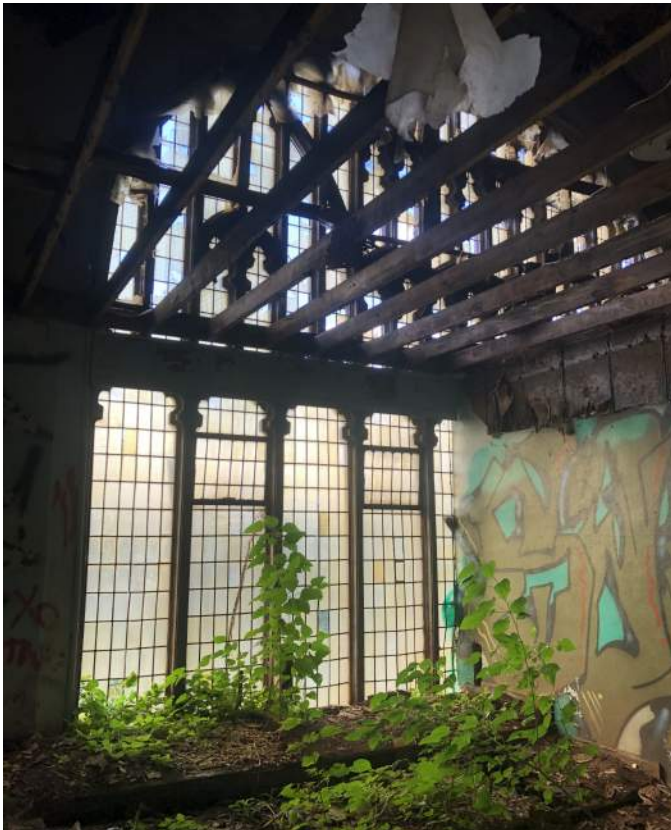
FIGURE INT 1.8 FAILED FINISHES AND VEGETATION IN SANCTUARY MEZZANINE OPEN TO THE ELEMENTS ABOVE

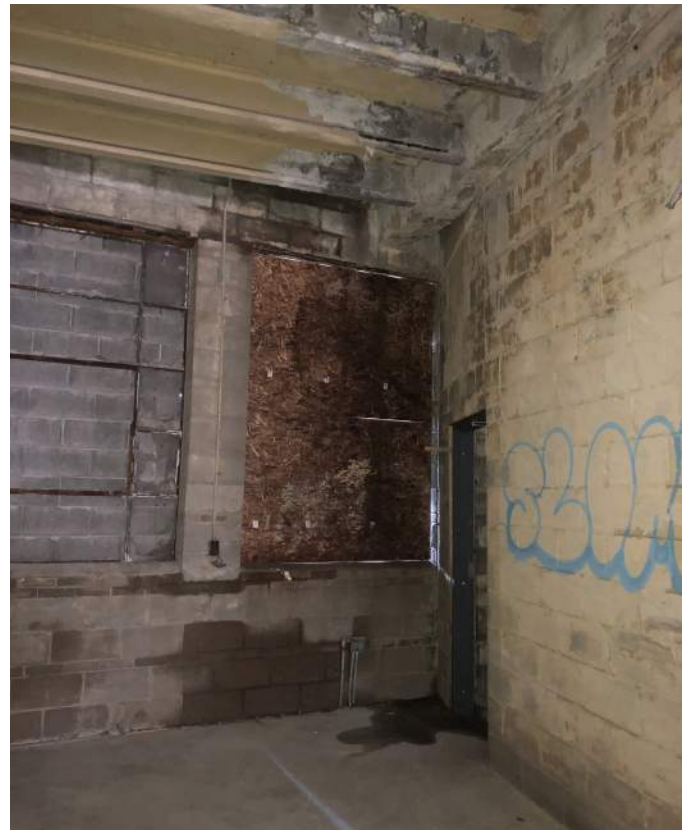
FIGURE INT 1.11 BOARDED UP FORMER WINDOW OPENINGS
