ZONE 2: HEPTAGONAL ROOF - ARCHITECTURAL ASSESSMENT

ZONE 2: HEPTAGONAL - STRUCTURAL ASSESSMENT

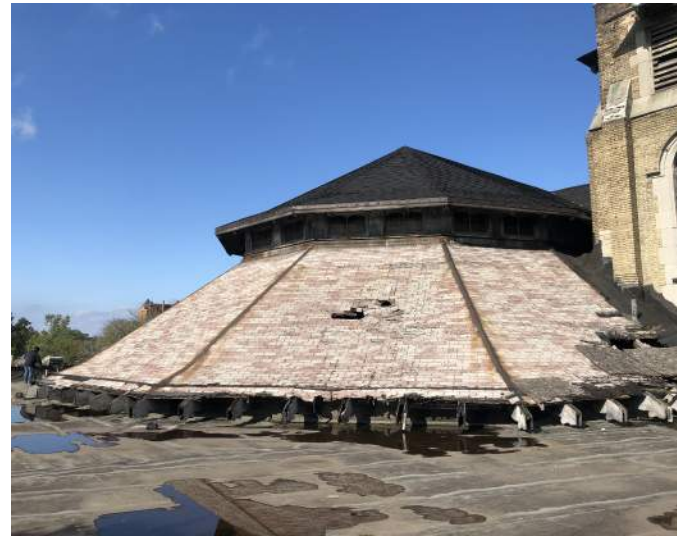
- Asphalt shingles worn, well beyond the end of their useful life
- Large, visible holes in the roof, exposing deteriorating wood structural framing; deteriorated plywood patching (see figure A2.1 and A2.7)

FIGURE A2.1 OVERVIEW OF THE TWO TIERED HEPTAGON ROOF; ROOF DECAY AND WATER INFILTRATION, WORN AND MISSING ASPHALT TILES, WEATHERED AND ROTTED DECORATIVE EAVE OUTRIGGERS/RAFTER TAILS.

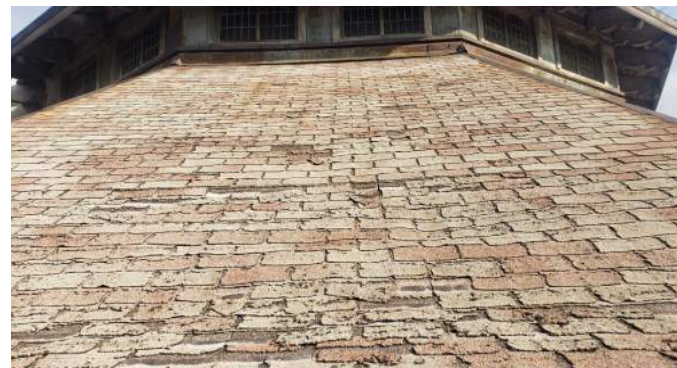
- Pronounced waviness to the roof surface which may indicate damage to the roof decking and structural framing below (see figure A2.2)
- Extensive deterioration of the decorative wooden eave brackets, particularly along the lower tier where the decking has mostly deteriorated completely away at the overhang (see figure A2.8)

FIGURE A2.2 SURFACE DEPRESSIONS ALONG THE ROOF; CURLED, DISCOLORED AND FRAYED ASPHALT SHINGLES; RUSTED METAL FLASHING UNDER THE UPPER WINDOWS

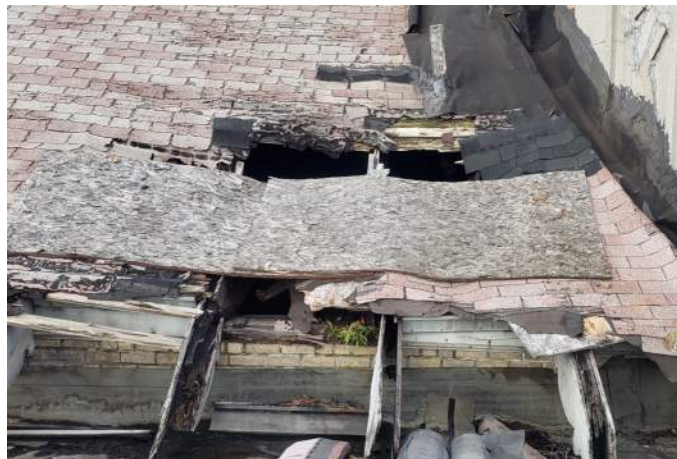
- Flashing failure along the supporting masonry wall under the eaves (see figure A2.7)
- Patched valley flashing with improper terminations along bell tower masonry wall and of asphalt roofing. Excessive mastic on masonry wall. (see figure A2.13)

FIGURE A2.7 COMPLETE DETERIORATION AND DECAY OF THE DECORATIVE WOOD EAVES AND DECORATIVE RAFTER TAILS; THE LEVEL OF DETERIORATION MAY REQUIRE LOCALIZED REPAIRS TO ADJACENT ELEMENTS SUCH AS THE BRICK WALL BELOW

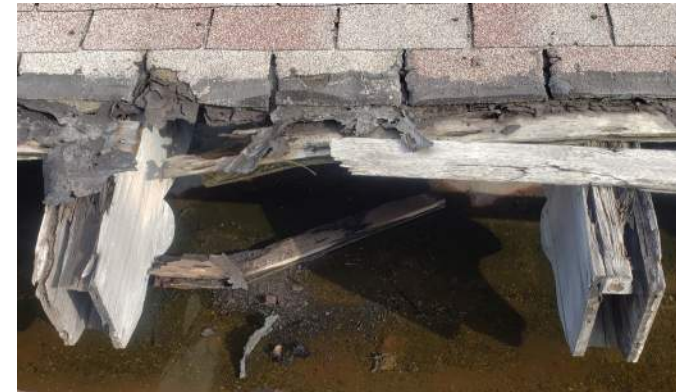
FIGURE A2.8 SIGNIFICANT DETERIORATION AT THE PERIMETER (TERMINATION OF DECORATIVE EAVES); EXTENSIVE WOOD ROT OF THE DECORATIVE EAVE OUTRIGGERS/RAFTER TAILS; PONDING WATER BELOW

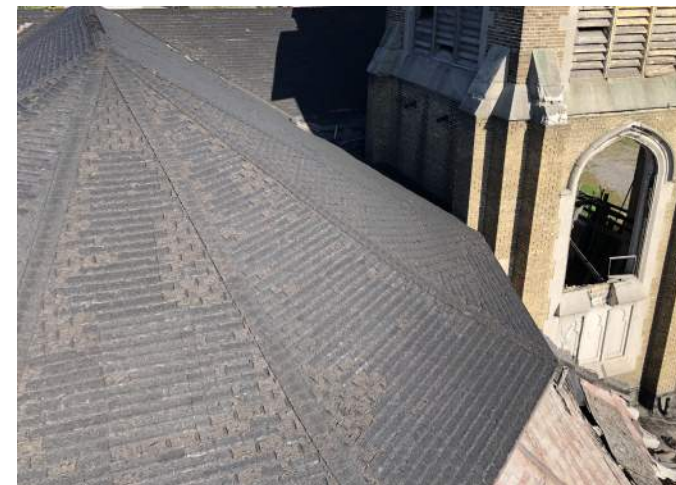
FIGURE A2.10 UPPER TIER OF HEPTAGON ROOF; WORN, MISSING CURLED, DISCOLORED, AND FRAYED ASPHALT SHINGLES

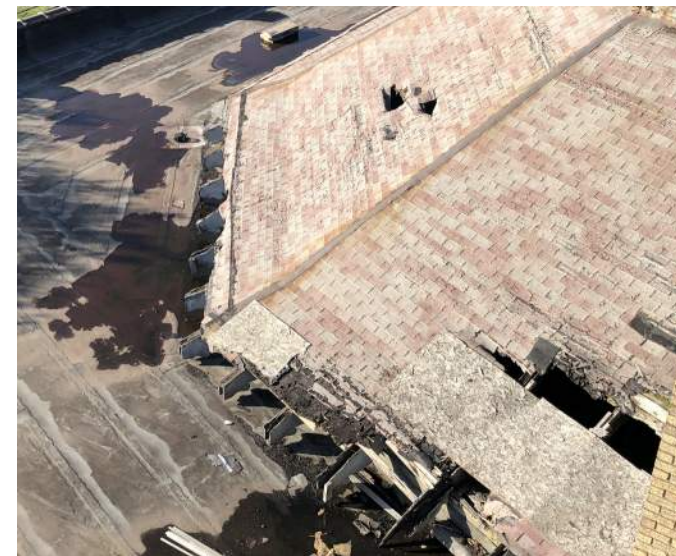
FIGURE A2.12 OVERVIEW OF THE HEPTAGON ROOF ABOVE, SHOWS THE EXTENT OF THE ROOF DETERIORATION WITH VARIOUS HOLES ALONG THE SURFACE

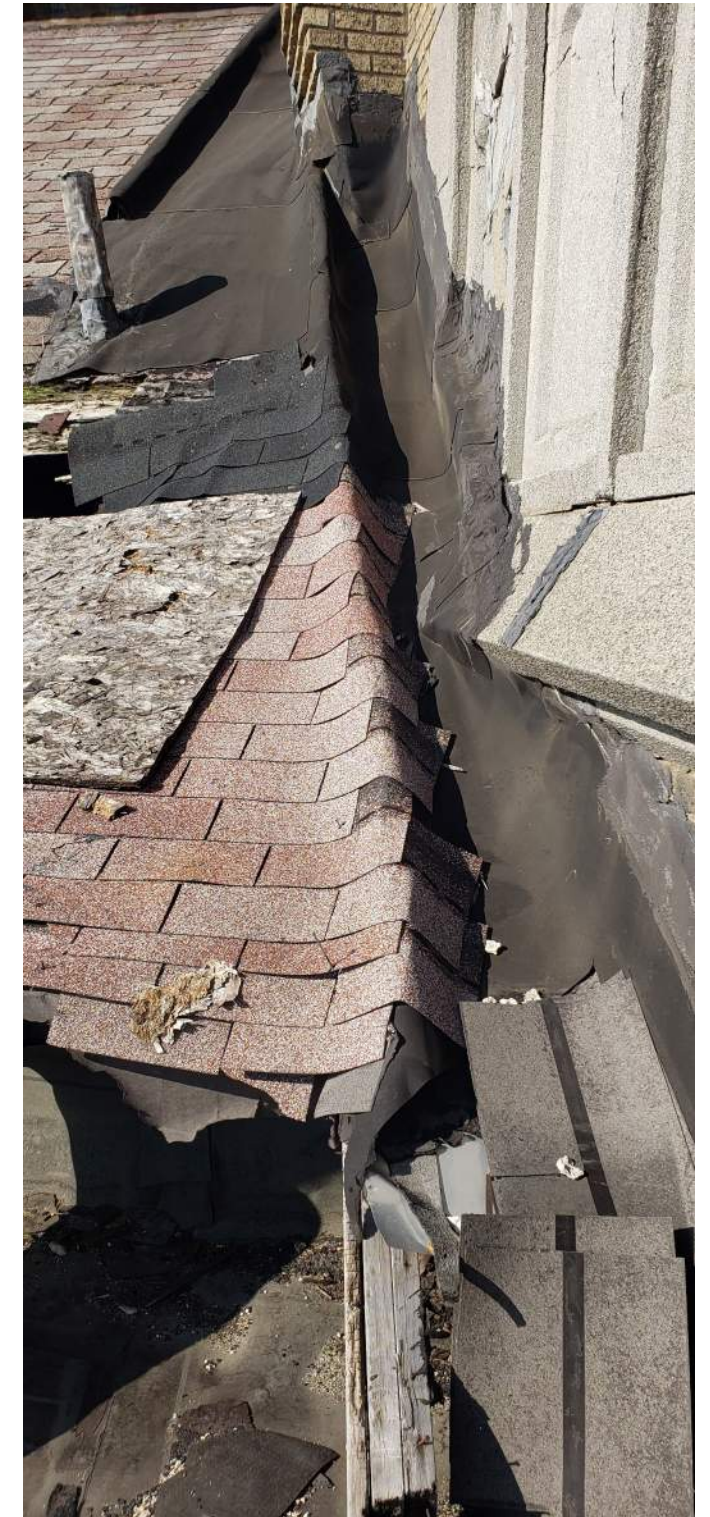
FIGURE A2.13 IMPROPER FLASHING AND PATCHING AT THE VALLEY JUNCTION BETWEEN THE POLYGONAL ROOF AND BELL TOWER; THE ASPHALT SHINGLES ARE NOT PROPERLY TERMINATED; EXCESSIVE USE OF ROOFING MASTIC ALONG THE BELL TOWER WALL; DETERIORATED ROOF VENT NEAR THE LARGE HOLE IN THE ROOF.

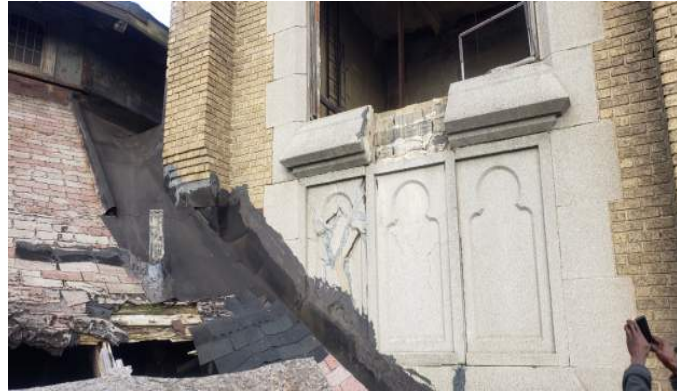
FIGURE A2.6 FAILURE OF THE FLASHING AT THE INTERSECTION WHERE THE POLYGONAL ROOF INTERSECTS WITH THE BELL TOWER; STAINING OF THE DECORATIVE STONE BY FLASHING SEALANT

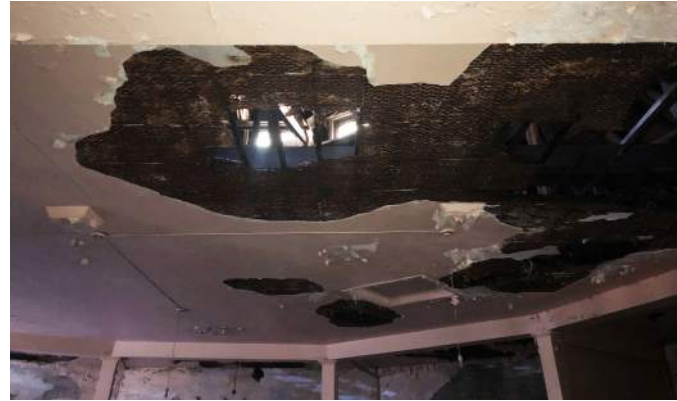
FIGURE A2.14 DETERIORATING INTERIOR PLASTER BELOW THE HEPTAGONAL ROOF STRUCTURE; SUN LIGHT IS VISIBLE THROUGH THE HOLE IN THE ROOF ABOVE

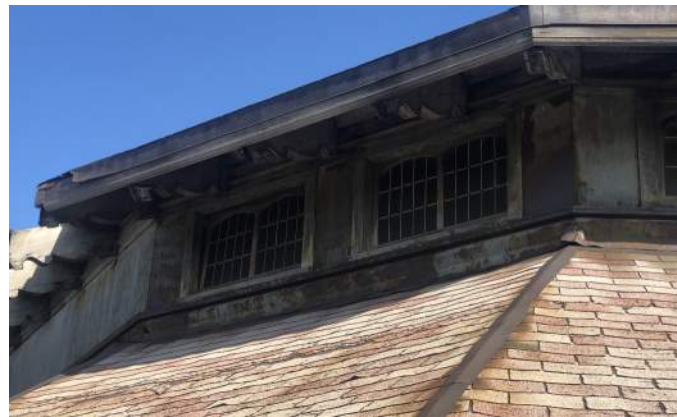
- Clerestory glazed windows set between metal trim between two roof tiers appear to be in fair to good condition, with metal trim exhibiting surface rust and worn paint (see figure A2.11)

FIGURE A2.11 THE UPPER TIER OF THE POLYGONAL ROOF; VISIBLE RUST ON THE METAL WINDOW FRAMING AND ROOF HIPs; METAL FLASHING IS CORRODING AND DETACHING FROM THE FASCIA BOARD AND HEAD OF LOWER ROOF

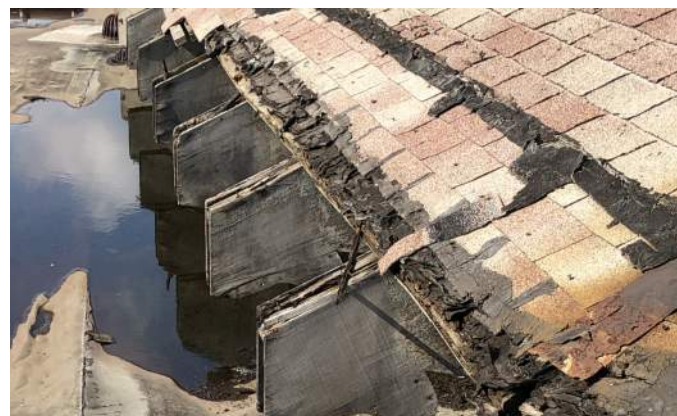
FIGURE A2.13 DECORATIVE WOOD EAVE SHOW SIGNS OF DECAY AND ROT; SIGNIFICANT DETERIORATION OF THE ROOF PERIMETER EDGE; WITH POOLS OF WATER GATHERING UNDER THE EAVES

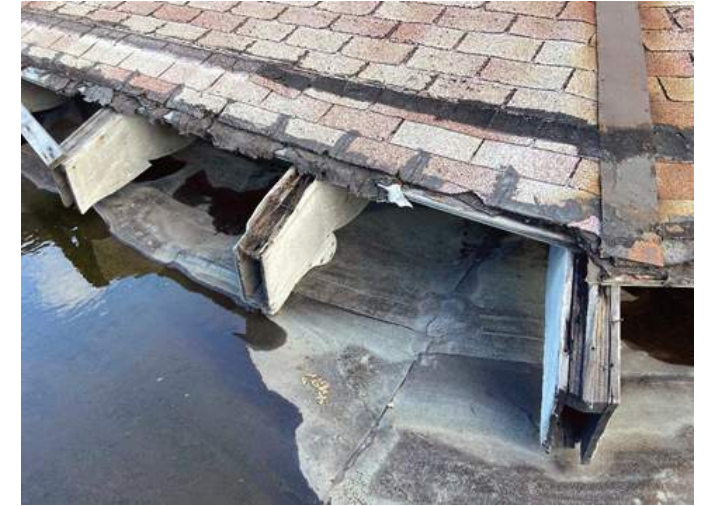
FIGURE S2.1

- The lower overhang extending over the flat roof is in poor condition with missing and deteriorated sheathing. The structural rafters inside the decorative side panels are in very poor condition. The wood is rotten beyond serviceability. Water shedding off the roof flows over exposed wood sides and edges, accelerating the deterioration of the support structure. (see figure S2.1)

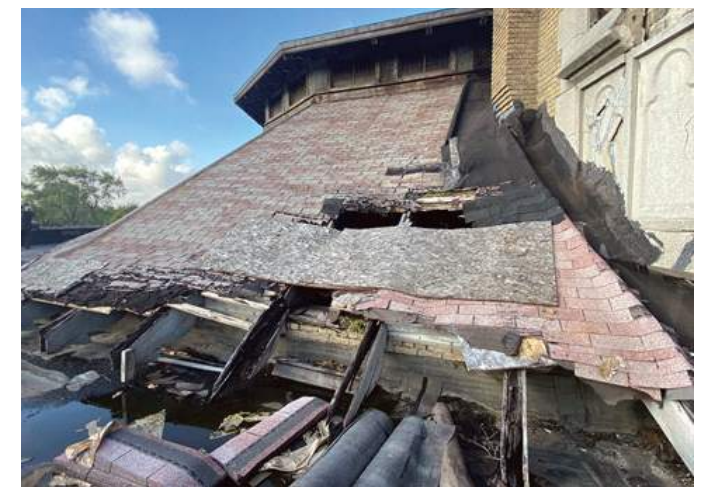
FIGURE S2.2

- The lower roof area up to the intermediate windows conditions varies. There is a large hole with severely deteriorated and damaged sheathing and support framing on the east side and in the valley behind the bell tower. The condition of the roof framing appears to improve towards the south side with only localized signs of damaged, deteriorated sheathing. The condition of the roof further deteriorates toward the northwest corner where the sheathing is visibly sagging between the support rafters. (see figure S2.2)

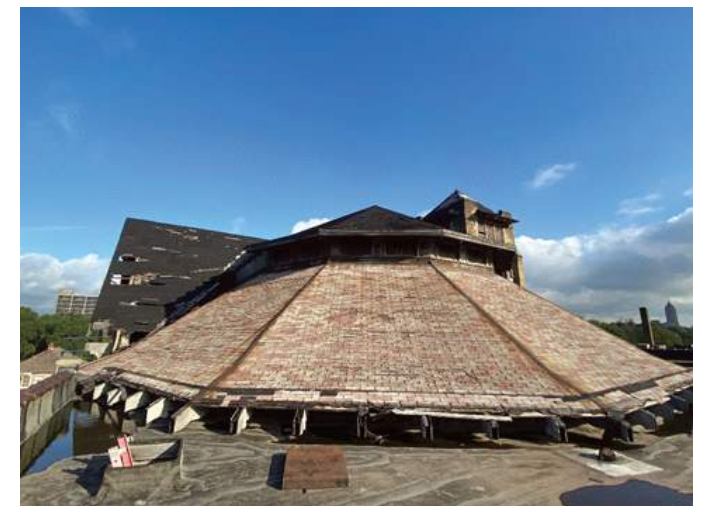
FIGURE S2.3

- The condition of the vertical walls, framing and windows at the intermediate window level appear in to be structurally functional. (see figure S2.3)
- The roof overhang above the intermediate windows appears intact for all segments except at the northwest corner where the overhang had been removed with only the exposed outrigger brackets remaining. It can be assumed that the exposed wooden brackets are rotten and are beyond serviceable condition. (see figure S2.4)

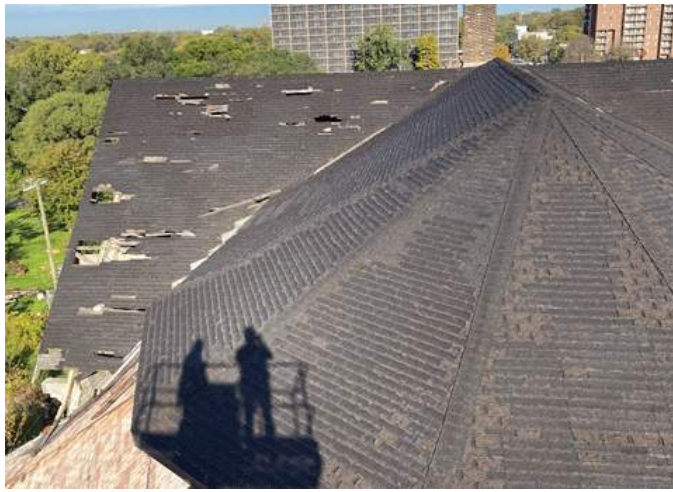
FIGURE S2.5

- Upper tier roof area appears in better condition than the lower roof. Localized deterioration of sheathing and rafters can be anticipated above the area with exposed overhang brackets. (see figure S2.5)

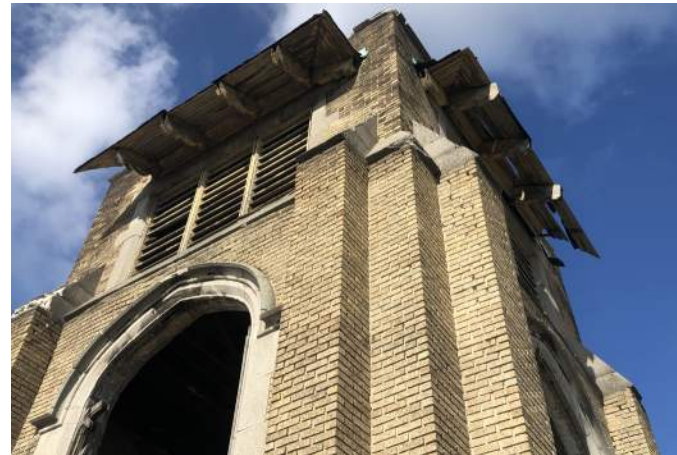
- Large arched windows in the bell tower are missing glass and framing, leaving the underside of the roof and bell tower interior exposed to the elements and increased deterioration. Wood louvers above the windows are weathered with worn pain, in poor to fair condition, with some sections missing. (see figure A3.1 and A3.2)

FIGURE A3.2 THE EAVE OVERHANG SHOWS EXTENSIVE WOOD DECAY AND DETERIORATION

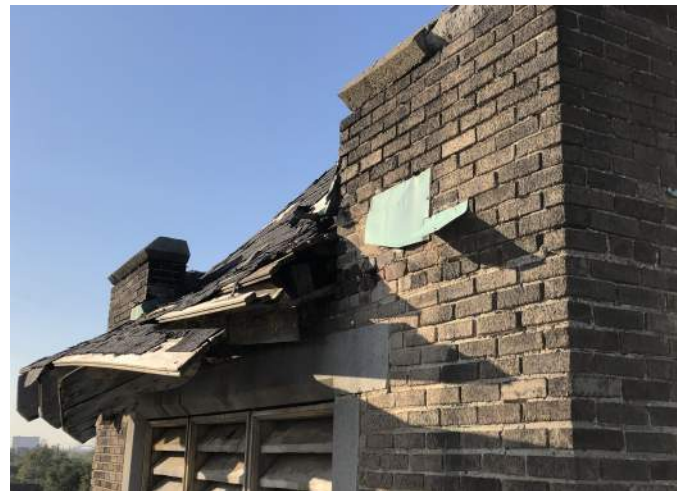
- Extensive roof damage at extended eave overhangs
- Decorative wood rafter tails are rotted or missing; wood frieze board and trim is detaching from the masonry wall where still existing, weathered with worn paint. (see figure A3.4 and A3.6)

FIGURE A3.4 DECORATIVE WOOD OVERHANGS COLLAPSING AND OPEN AT ENDS TO INTERIOR; BRICK MASONRY SHOWS SIGNS OF DIFFERENTIAL MOVEMENT; REMAINING STEPPED COPPER FLASHING (EAST ELEVATION)

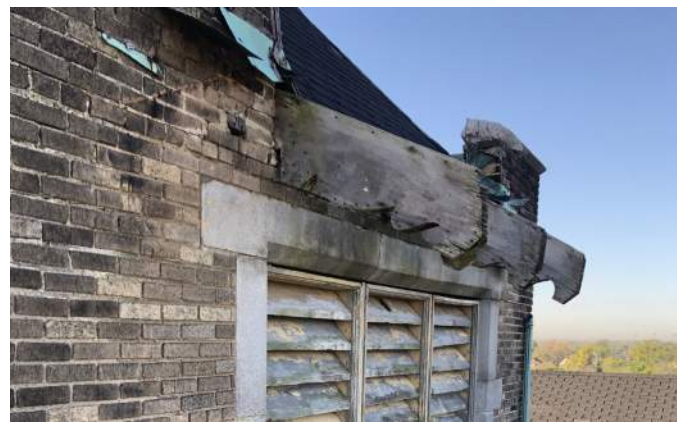
FIGURE A3.6 DIFFERENTIAL BRICK MOVEMENT UNDER EAVES; REMNANTS OF THE ORIGINAL STEPPED COPPER FLASHING; (NORTH ELEVATION)

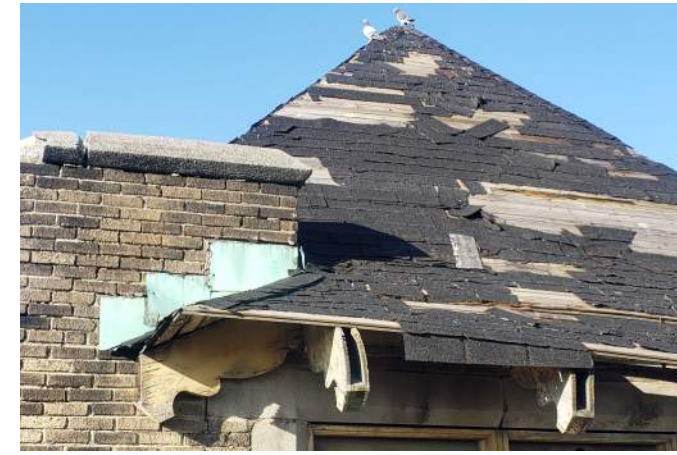
- Asphalt shingles are work, well beyond the end of their useful life, with a significant quantity missing and exposing the sheathing below
- Weathered, rotted, or missing roof decking and painted soffit trim (see figure A 3.7 and S3.0)

FIGURE A3.7 HIP ROOF IS IN VERY POOR CONDITION; WEATHERED AND DECAYED WOOD DECKING, MISSING/FALLEN SHINGLES AND EXPOSED DECKING AND ORIGINAL STEPPED COPPER FLASHING (EAST ELEVATION)

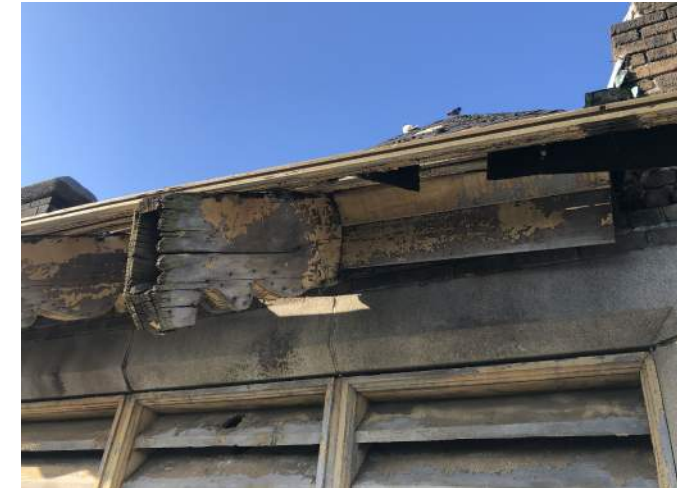
FIGURE A3.8 ROTTED DECORATIVE WOOD RAFTER TAIL AND DETACHING FRIEZE BOARD TRIM

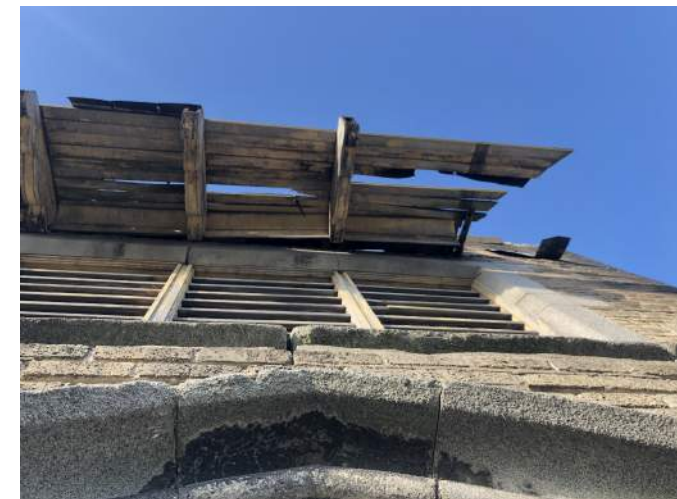
FIGURE A3.9 UNDERSIDE OF THE PAINTED DECORATIVE OVERHANGS; WEATHERED DETERIORATED WOOD DECKING (EAST ELEVATION)

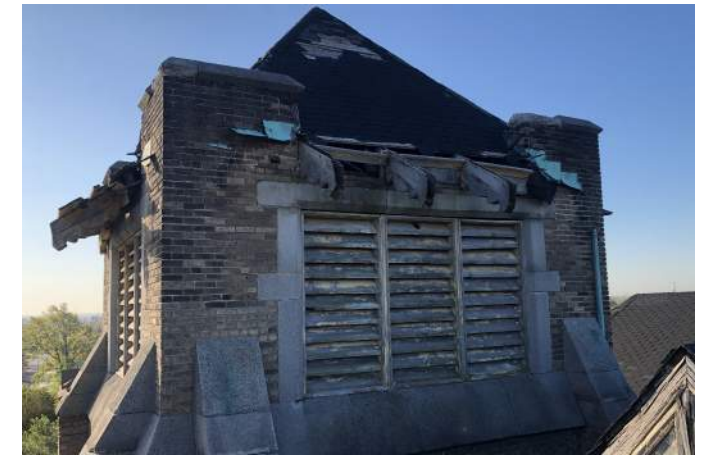
- Missing or detaching, deteriorated copper step flashing at the overhang returns and brick piers; original copper gutters are missing and remnants of some disconnected copper downs[pouts remain (see figure A3.10)

FIGURE A3.10 OVERVIEW OF THE BELL TOWER'S ROOF AND DECKING; THE DECKING ON TOP OF THE DECORATIVE EAVE HAS COMPLETELY DECAYED AND DETACHED FROM THE ROOF ASSEMBLY (NORTH ELEVATION)

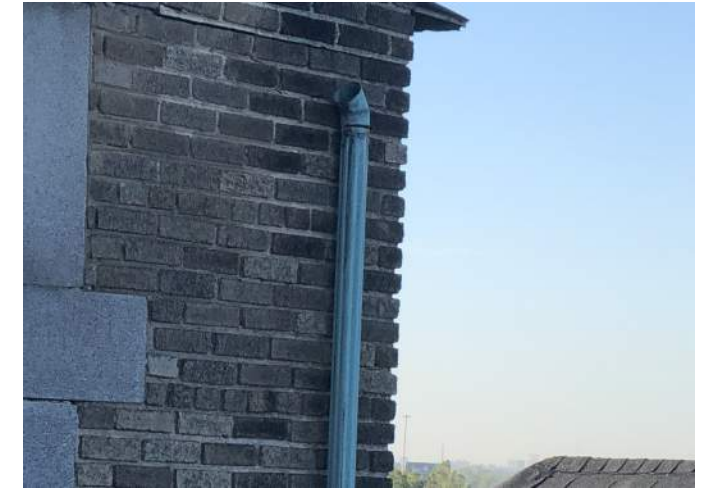
FIGURE A3.11 DETACHED COPPER DOWNSPOUT AND MISSING ASSOCIATED COPPER GUTTER

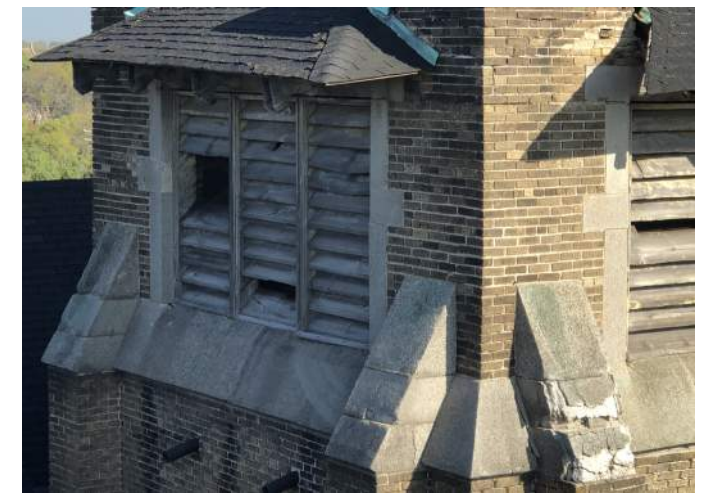
FIGURE A3.12 SOUTH WEST ELEVATION OF BELL TOWER; CRUMBLING STONE AT THE COLUMN CAP; BRICK MOVEMENT DIRECTLY UNDER THE ROOF

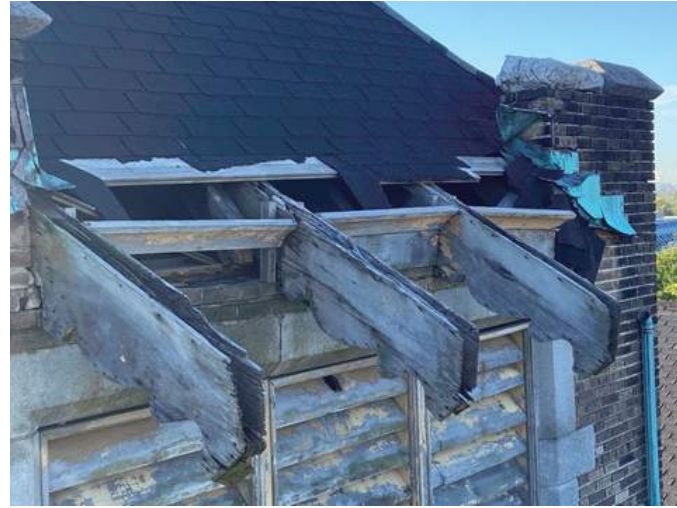
FIGURE S3.1

- The entire roof structure is in very poor condition and beyond serviceable condition. Large portions of the roof overhang area and support brackets are missing. The plank sheathing on the pyramid roof is exposed and is in poor condition. The nearby areas are badly deteriorated or missing. (see figure S3.1)
- The masonry piers and masonry below the roof support zone has limited cracking, moderate mortar joint deterioration and visible spalling. There is a significant risk of damage to people and property from falling debris due to the condition of the masonry. (see figure S3.2)
- There are large openings in the bell tower where the original windows and louvers have been removed or are damaged. These openings should be closed off as part of the roofing solution. (see figure S3.3)

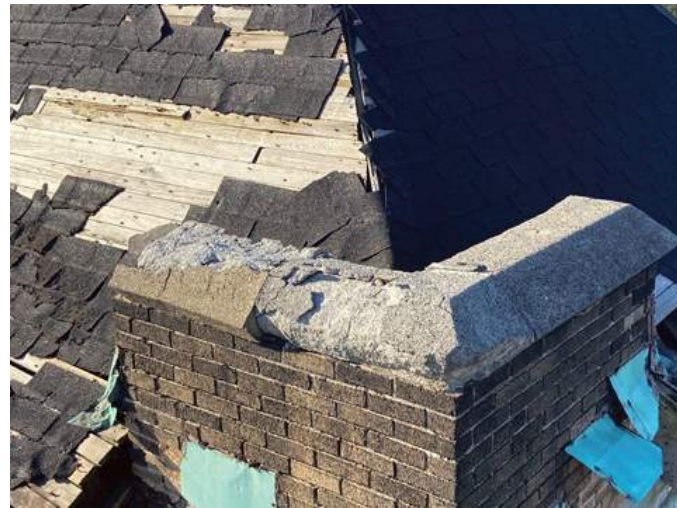
FIGURE S3.2

- Some displacement or movement is visible in the upper section of the four corner masonry piers (see figure S3.3)
- Several piece of stone caps over the masonry bell tower piers and buttress, as well as within the window and louver surrounds are cracked, detached, or already fallen to the roof or site below, exposing openings in the masonry wall assemblies (see figure S3.2)

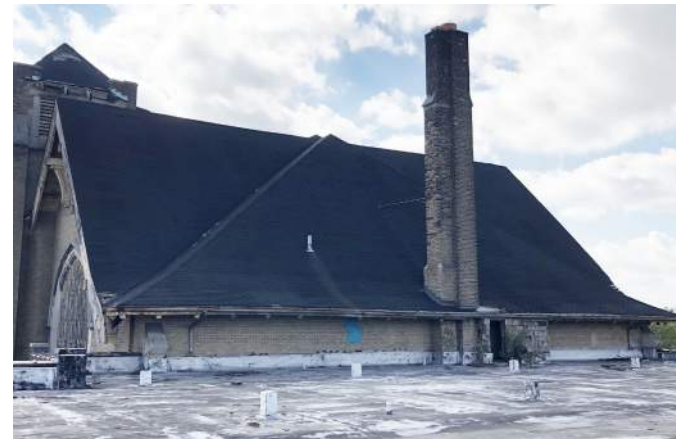
FIGURE A4.00 OVERVIEW OF NORTHERN SIDE OF THE CROSS GABLE ROOF

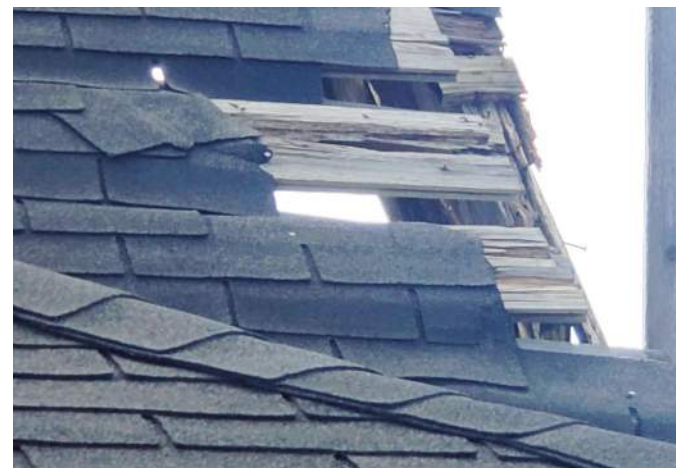
FIGURE 4.1 DETERIORATED WOOD DECKING, MISSING/FALLEN SHINGLES AT THE EAVE (WEST ELEVATION)

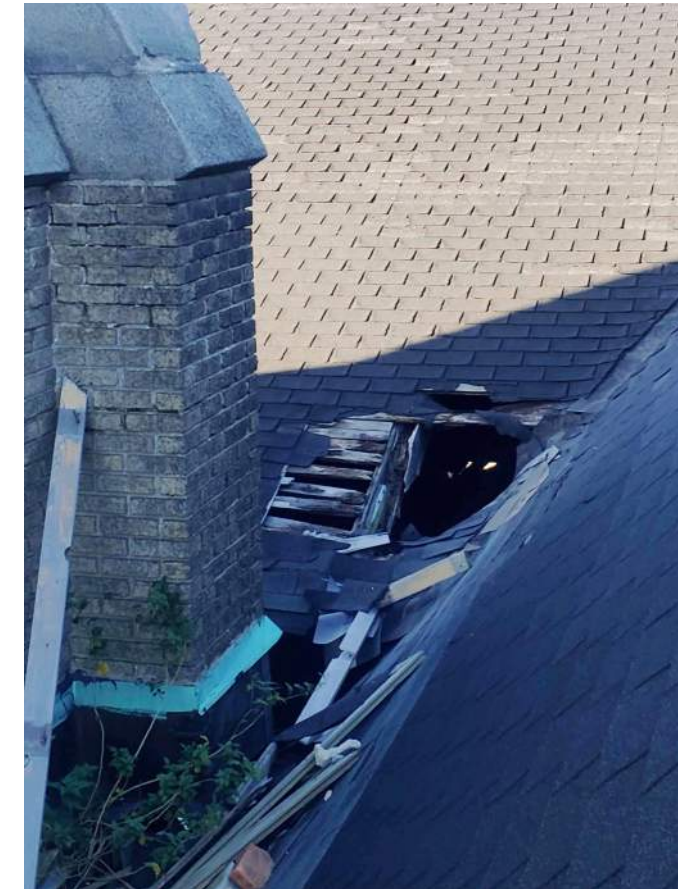
FIGURE A4.17 LARGE HOLE IN THE ROOF; DETERIORATED SHINGLES, WOOD DECKING AT THE ROOF VALLEY; FALLEN WOOD DECKING FROM THE BELL TOWER ROOF ABOVE

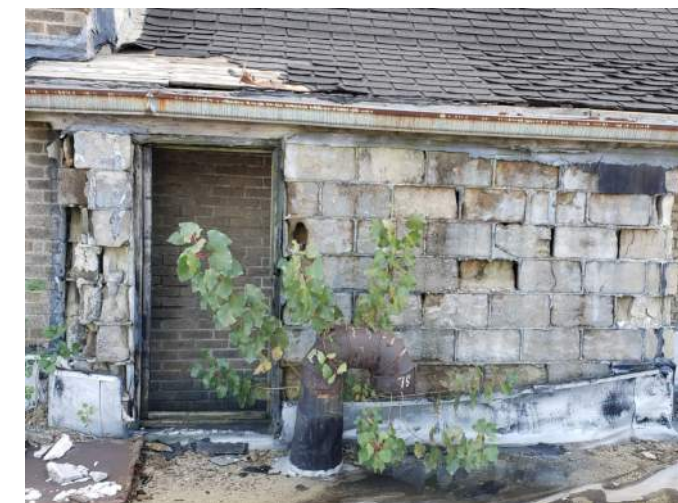
FIGURE A4.23 EXTENSIVE EXTERIOR MASONRY DETERIORATION AT ROOFTOP STAIR ENTRY/EXIT; MISSING AND DETERIORATED MORTAR JOINTS; DETACHED ROOFTOP STAIR ENTRY DOOR; DAMAGED DOOR FRAMING. DETACHED FLASHING AT THE UPTURN OF THE NORTH MEMBRANE ROOFING

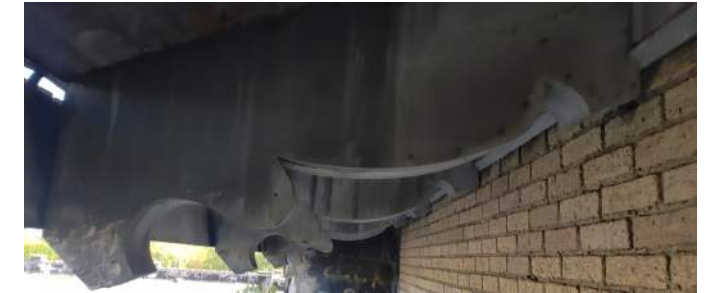
FIGURE 4.2 DECORATIVE WOOD EAVE, SIDE ELEVATION APPROX. LENGTH 3'-4"; IN FAIR CONDITION

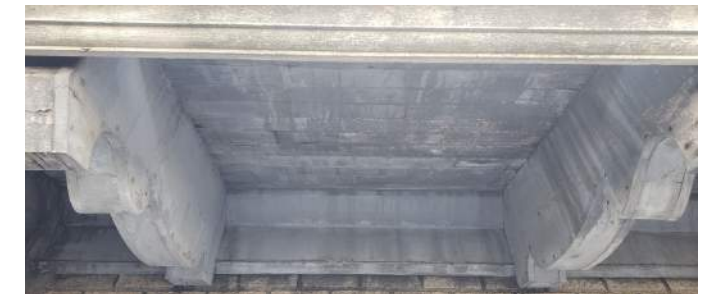
FIGURE A4.3 DECORATIVE WOOD EAVE IN FAIR CONDITION; (NORTH ELEVATION)

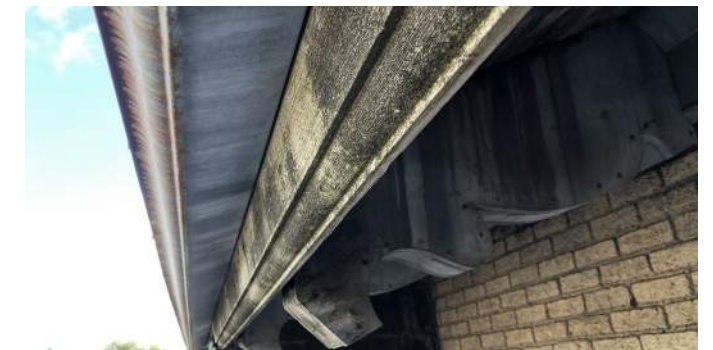
FIGURE A4.4 WEATHERED FASCIA BOARD WITH ATTACHED METAL GUTTER

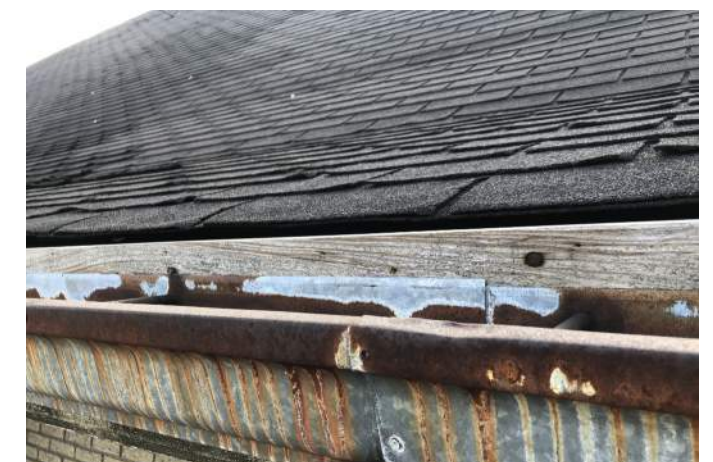
FIGURE A4.5 RUSTED GUTTER, CURLLED AND FRAYED ASPHALT SHINGLES

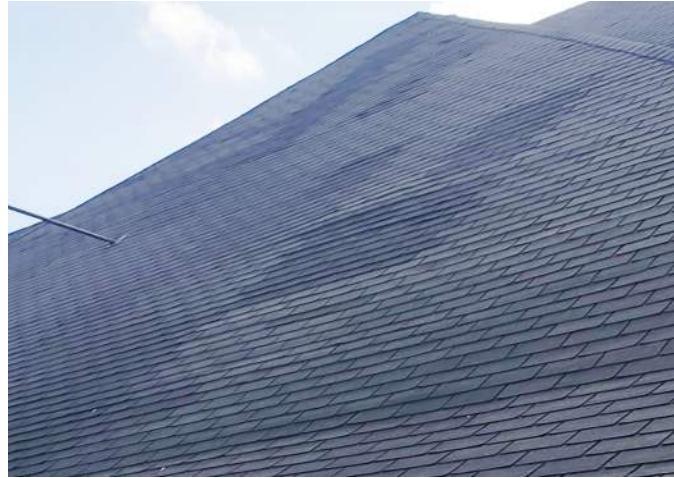
FIGURE A4.6 OVERVIEW OF NORTHERN ROOF; CURLLED, DISCOLORED, AND FRAYED ASPHALT SHINGLES; SHOW SIGNS OF DEPRESSIONS AND UNEVEN SURFACES ALONG THE ROOF

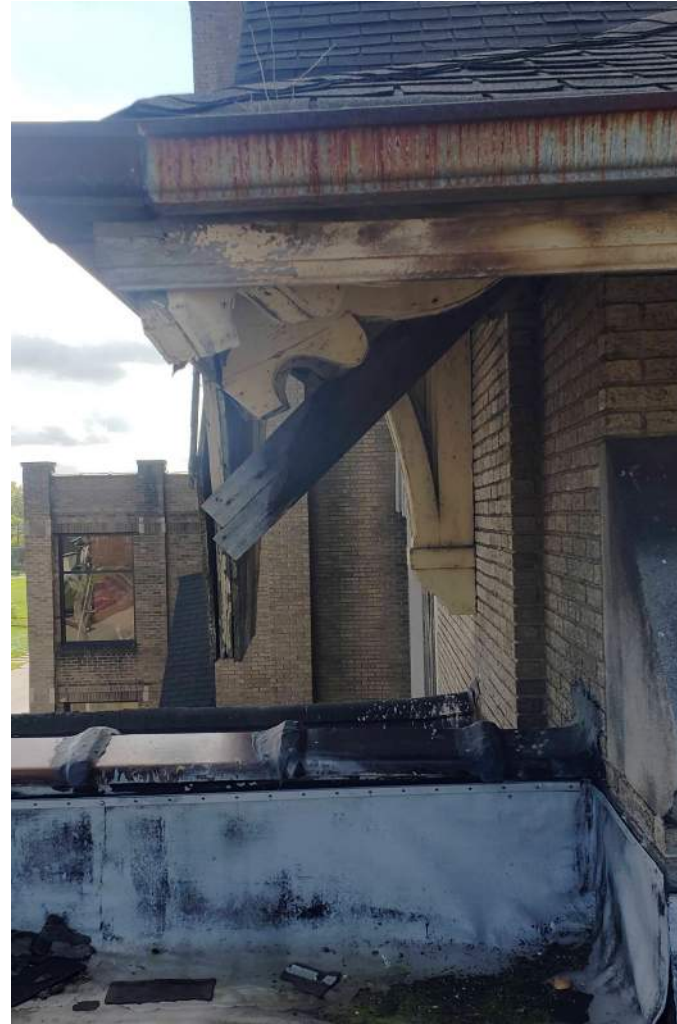
FIGURE A4.12 WEATHERED, FADED EAVES; RUSTED GUTTER (EAST ELEVATION)

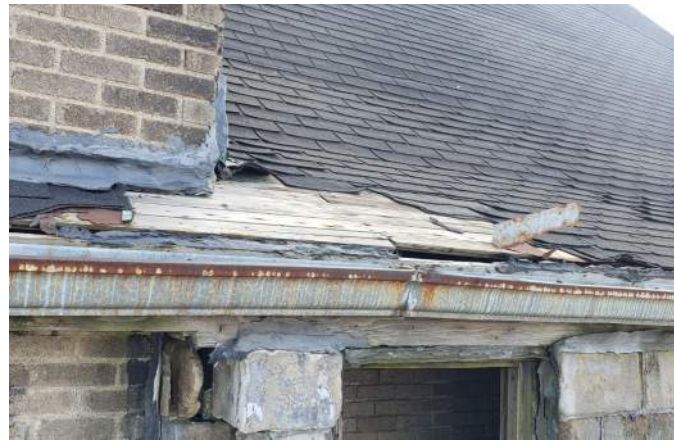
FIGURE A4.9 WEATHERED FASCIA BOARD; DECAYED WOOD DECKING; CURLLED, FRAYED AND MISSING ASPHALT SHINGLES ABOVE ROOFTOP STAIR ENTRY.

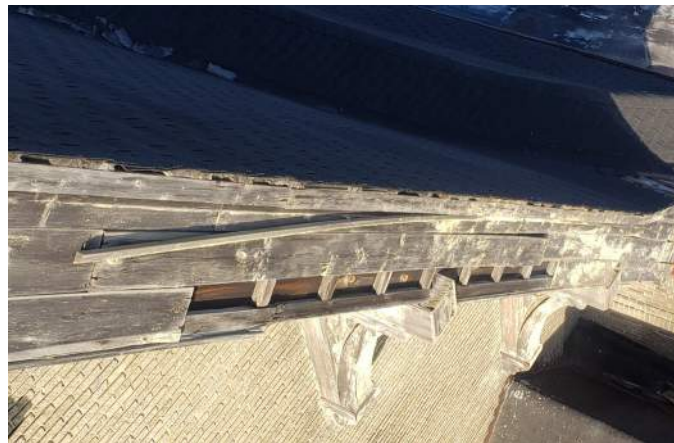
FIGURE A4.14 MISSING WOOD FASCIA BOARDS AT EAST ELEVATION

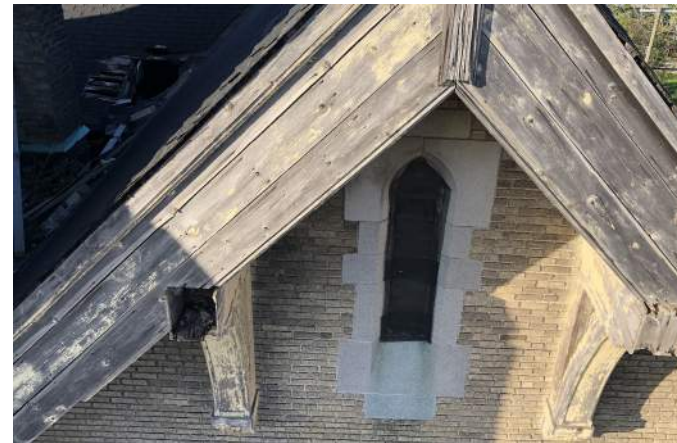
FIGURE A4.24 WEATHER AND FADED FASCIA BOARDS; DECAYED HOLLOWED WOODEN SUPPORT BRACKET

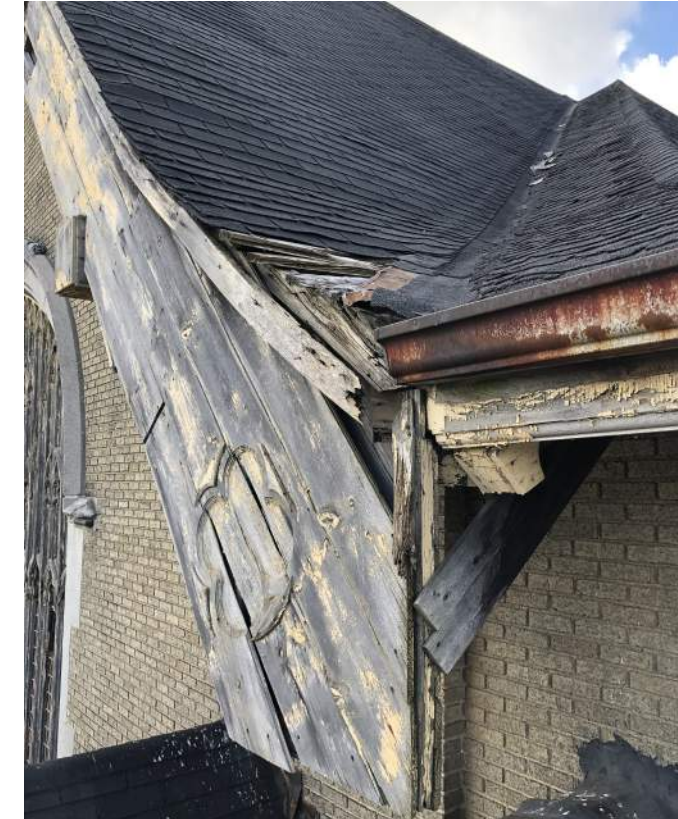
FIGURE 4.13 DECORATIVE FASCIA BOARDS ARE WEATHERED AND FADED; THEY ARE DETACHING FROM THE SUBSTRUCTURE. WOOD DECKING AT VALLEY TERMINATION IS EXPOSED, DECAYED WITH MISSING SHINGLES

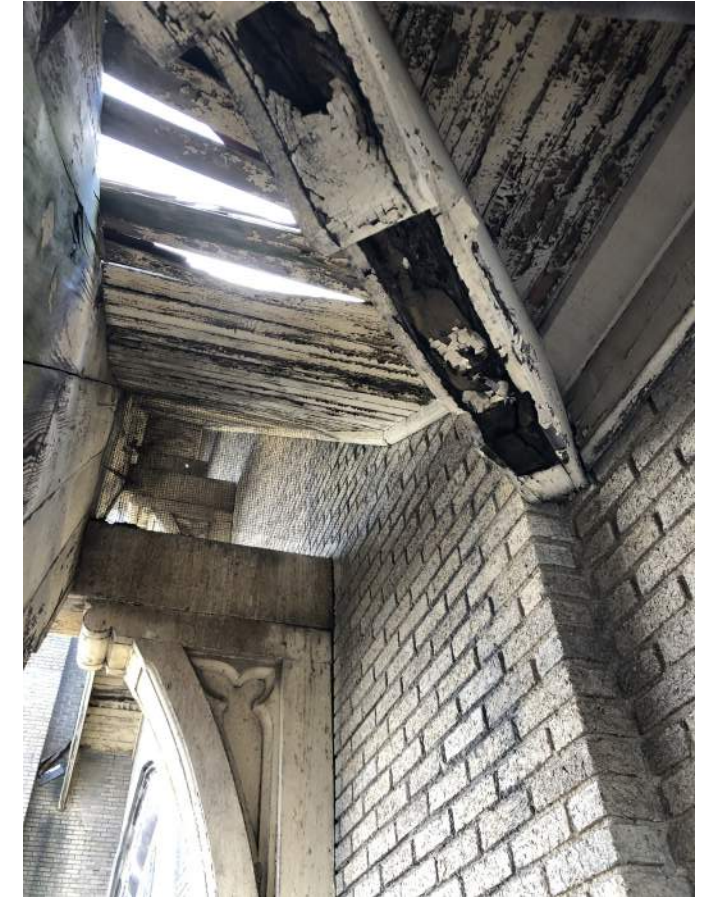
FIGURE A4.16 UNDERSIDE OF EAVES ON THE EAST ELEVATION AT THE MAIN ENTRANCE; WOOD DECKING IS DETERIORATION AT THE EAVE; MISSING WOOD DECKING; WEATHERED AND DECAYING SUPPORT BRACKETS

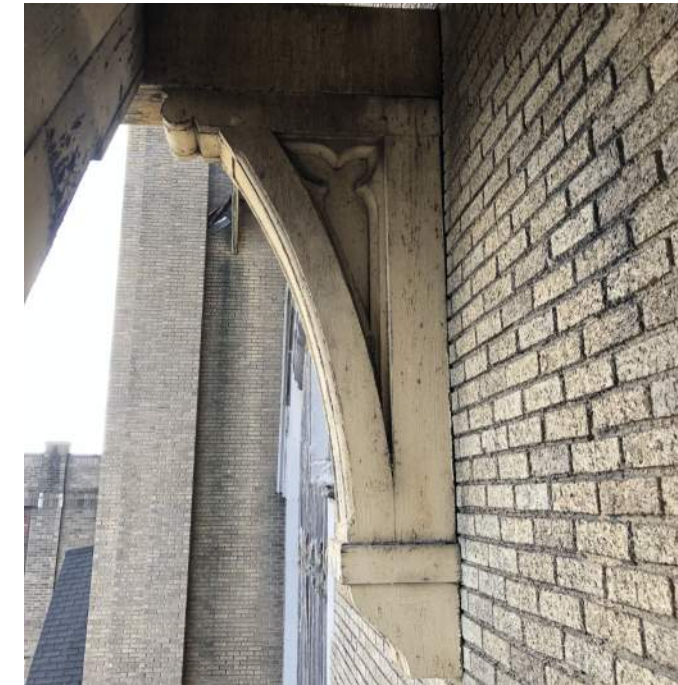
FIGURE A4.15 UNDERSIDE OF THE EAVES; PAINTED WOODEN BRACKET EAVE SUPPORT; (EACH BRACKET SHOULD BE INDIVIDUALLY EVALUATED)

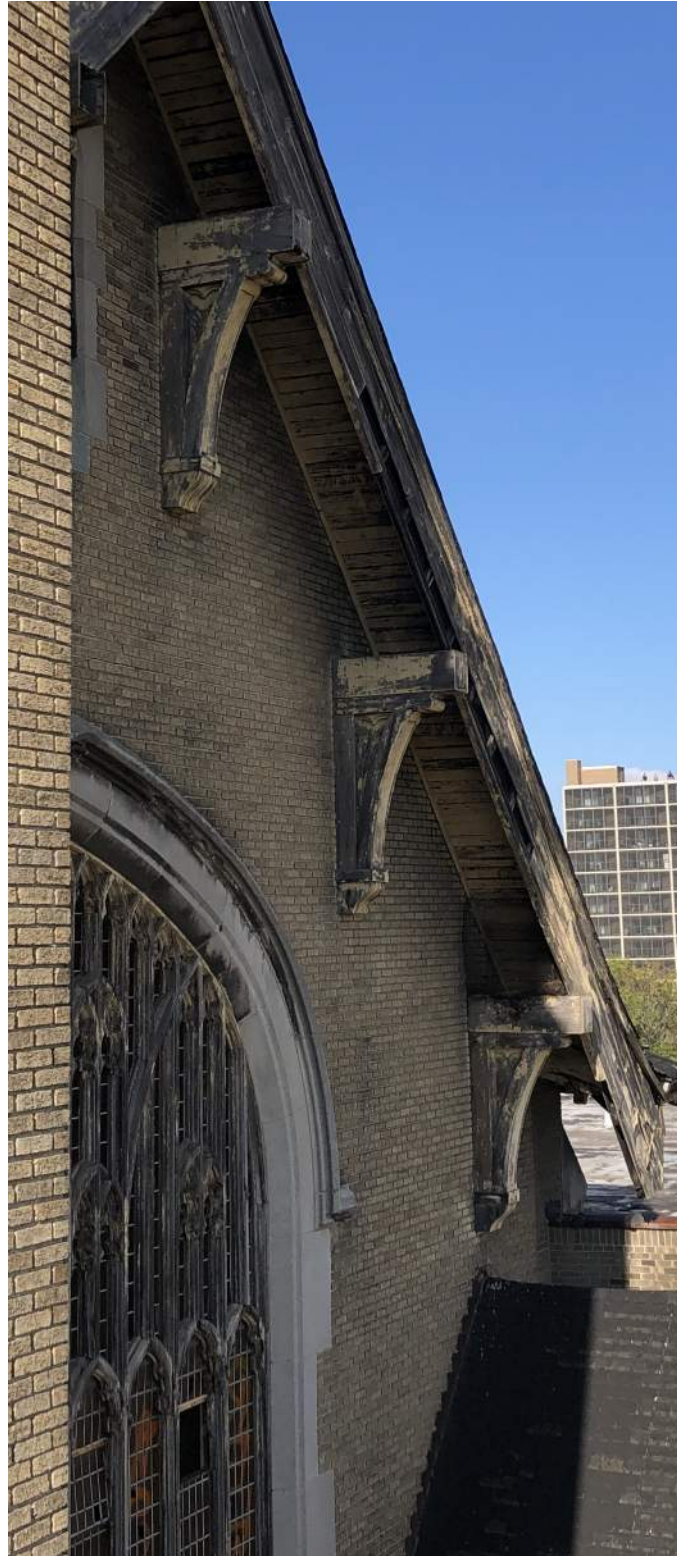
FIGURE 4.22 WEATHER AND FADED FASCIA BOARDS, FADED WOOD DECKING AT THE UNDERSIDE OF THE EAVES ON THE EAST ELEVATION AT THE MAIN ENTRANCE

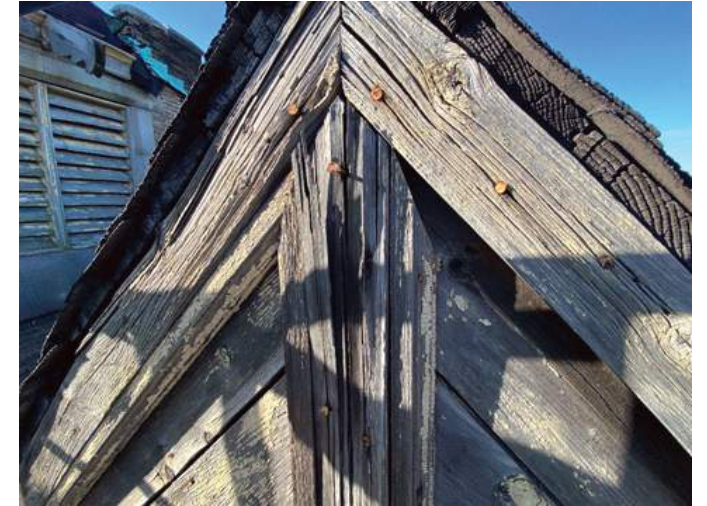
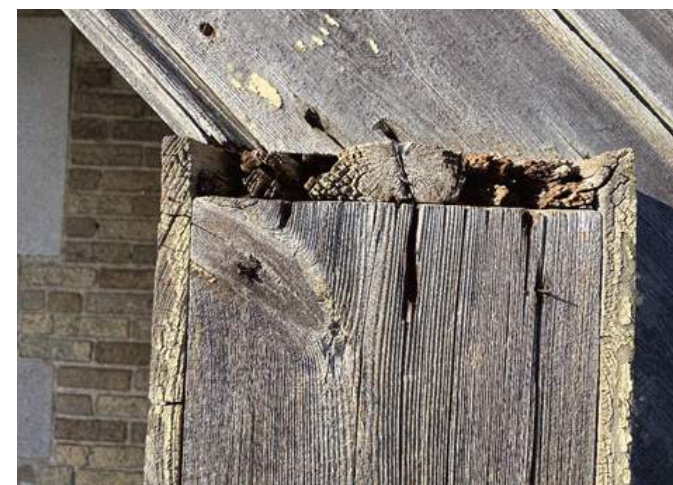
FIGURE S4.1

- The condition of the east overhang varies. The sheathing and a sloping beam that appears to be in moderate condition. The top members and inside structural members within the decorative brackets are in poor condition due to water leaking into the top of the brackets. (see figure S4.1)
- The main roof structure beyond the east overhang appears in moderate condition at the north and southeast slopes. The area at valley between the sloped roof and the bell tower is damaged, the structural members below the roofing may show some level of deterioration. (see figure S4.2)
- The southwest slope of the main roof area is in poor condition with many holes and areas of deteriorated sheathing and rafters. (see figure S4.3)
- The west overhang is in poor condition. The decorative support varies in condition. (see figure S4.4)
