# HISTORIC DISTRICT COMMISSION PROJECT REVIEW REQUEST

ADDRESS(ES): 603 East Milwaukee AKA: Peerless Building

# EXTERIOR RENOVATION FOR PROJECT PEERLESS

**RE: 603-609 E. Milwaukee, Jam Handy/North End- East Grand  
Boulevard Historic District Window Replacement Request:  
Replace existing steel and wood windows**

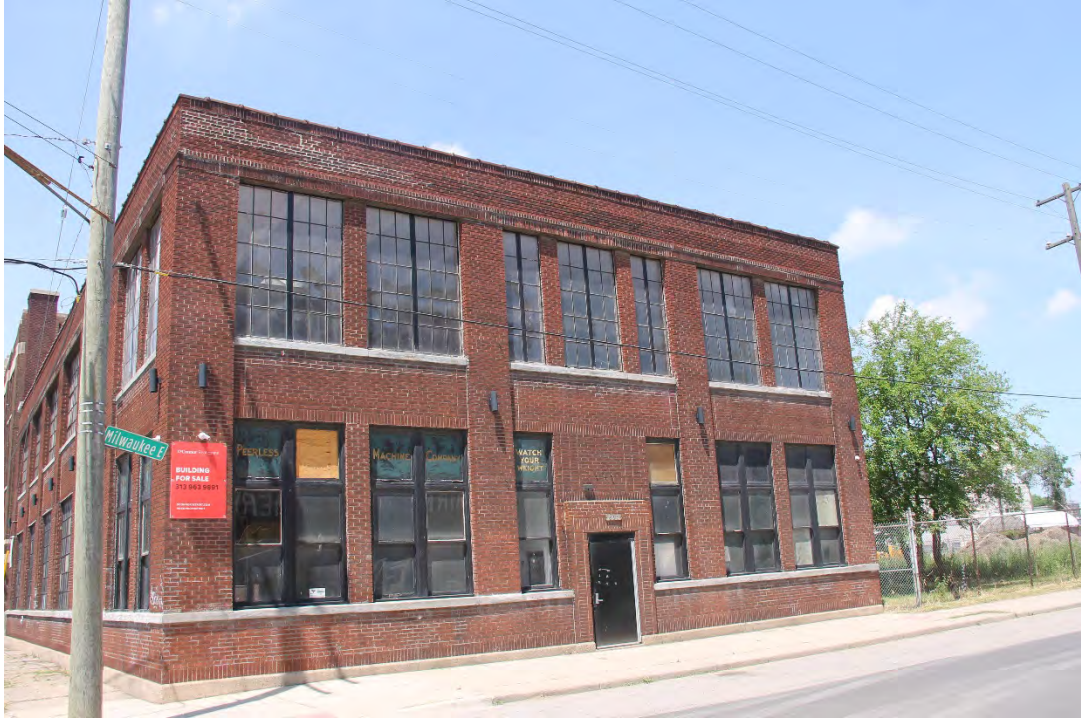
*South Elevation*

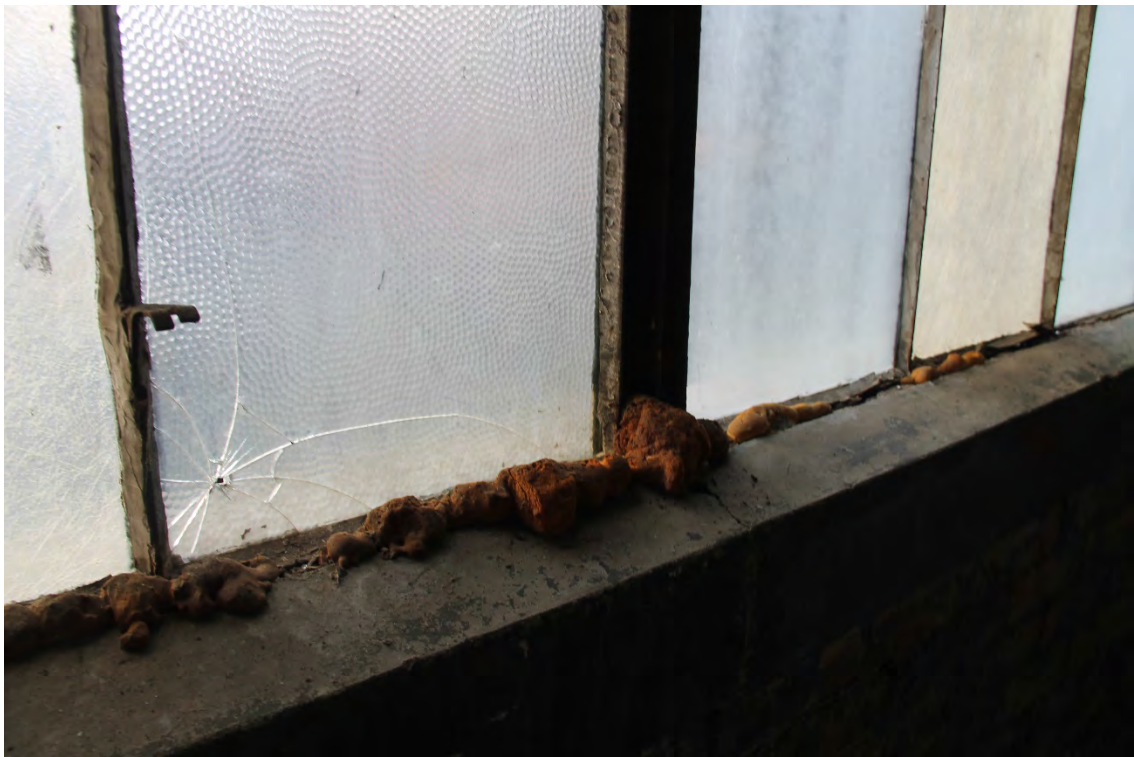
- **Structurally failed vertical “T” mullions. Over 80% of these mullions which support adjacent window sections have corroded to the point that at the intersection with the masonry sill the material is no longer continuous the full length, from the steel lintel header and the masonry brick and concrete poured sill. Steel is gone and daylight is open from the exterior to the interior. Foam has been sprayed to fill the voids; but all structural support is gone. To**

*Typical Mullion and Bottom Rail Condition of Existing Steel Window, Interior View*

repair this, , all window sections would be removed as well as the entire concrete sill would be removed and replaced. New mullions would have to be set in place prior to the new sill being poured.

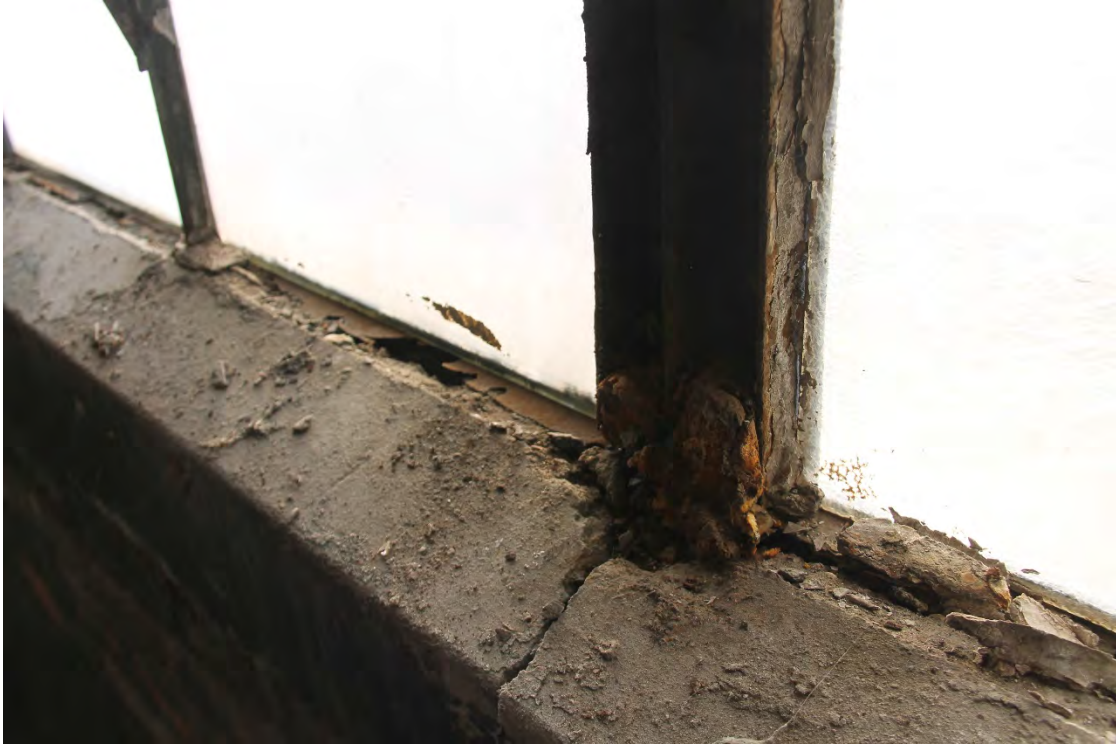
*Typical Mullion and Bottom Rail Condition of Existing Steel Window, Interior View*

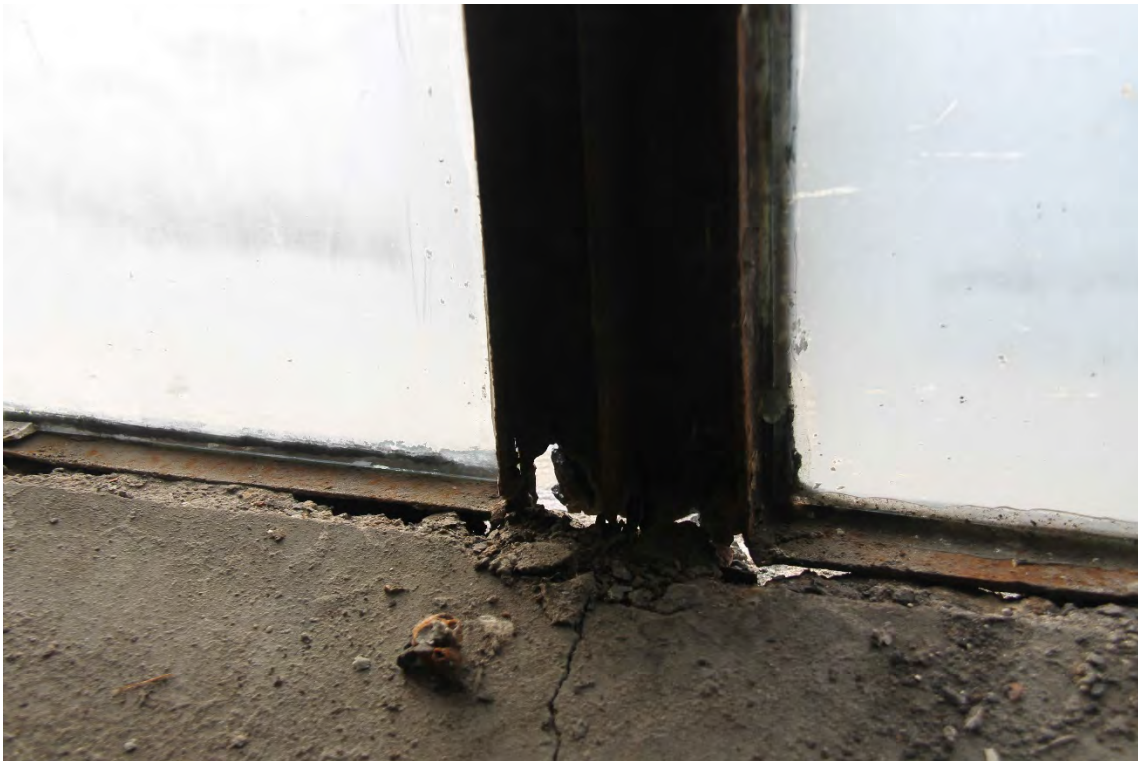
*Mullion Condition of Existing Steel Window, Interior View*

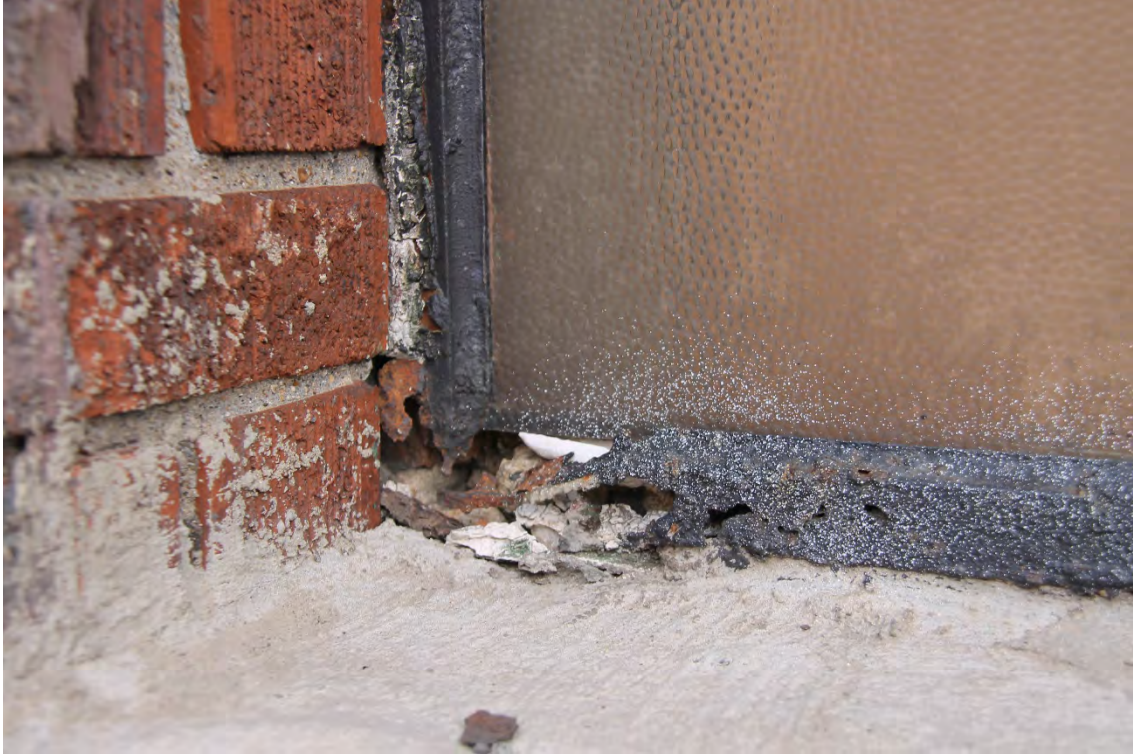
- Structurally failed bottom horizontal sill members. Over 70% of these bottom rails are fully or partially corroded with the original hot rolled steel material missing, these are best viewed from the exterior since a masonry cap was laid on the brick and poured flush with the bottom rails on the interior side. This material buried the sill and has allowed water to collect and corrode the metal. To replace the bottom rail sections the interior masonry cap must be fully removed and all windows sections must be removed. New matching material would have to be welded on all the window sections, first, all the vertical muntins would have to be cut at the top of the bottom rail to remove all the corroded material.

*Typical Bottom Rail Condition, Exterior View*

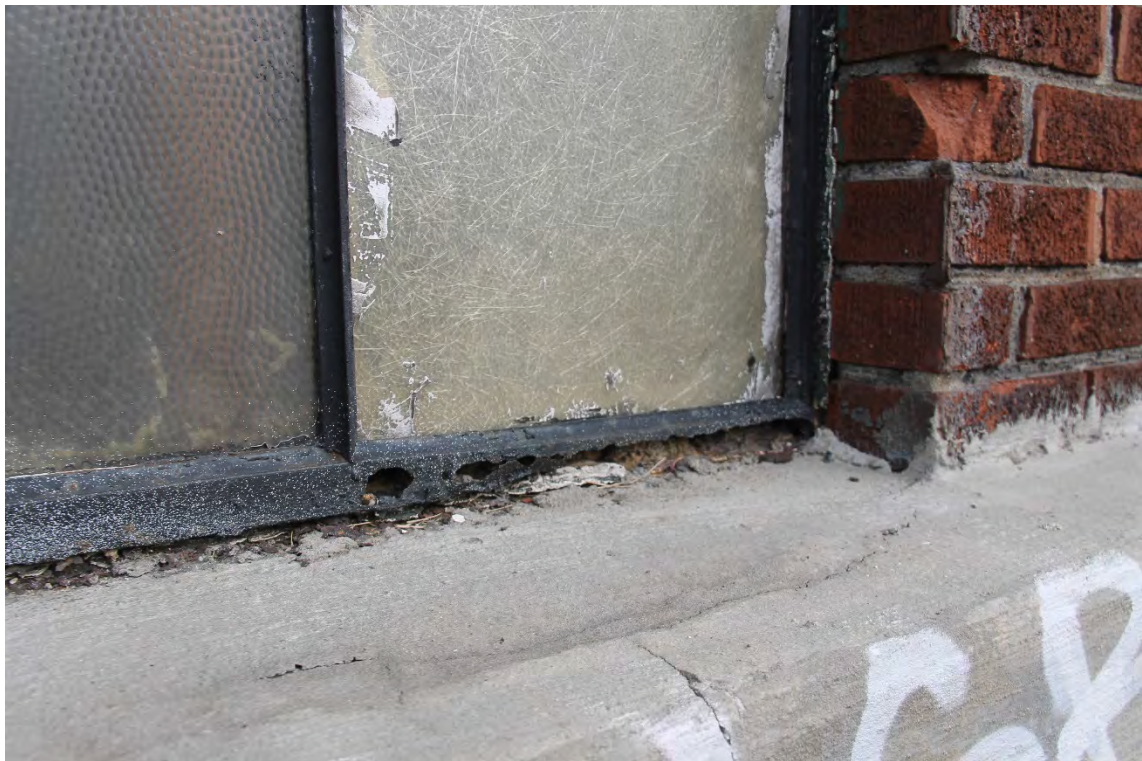
*Typical Bottom Rail Condition, Exterior View*

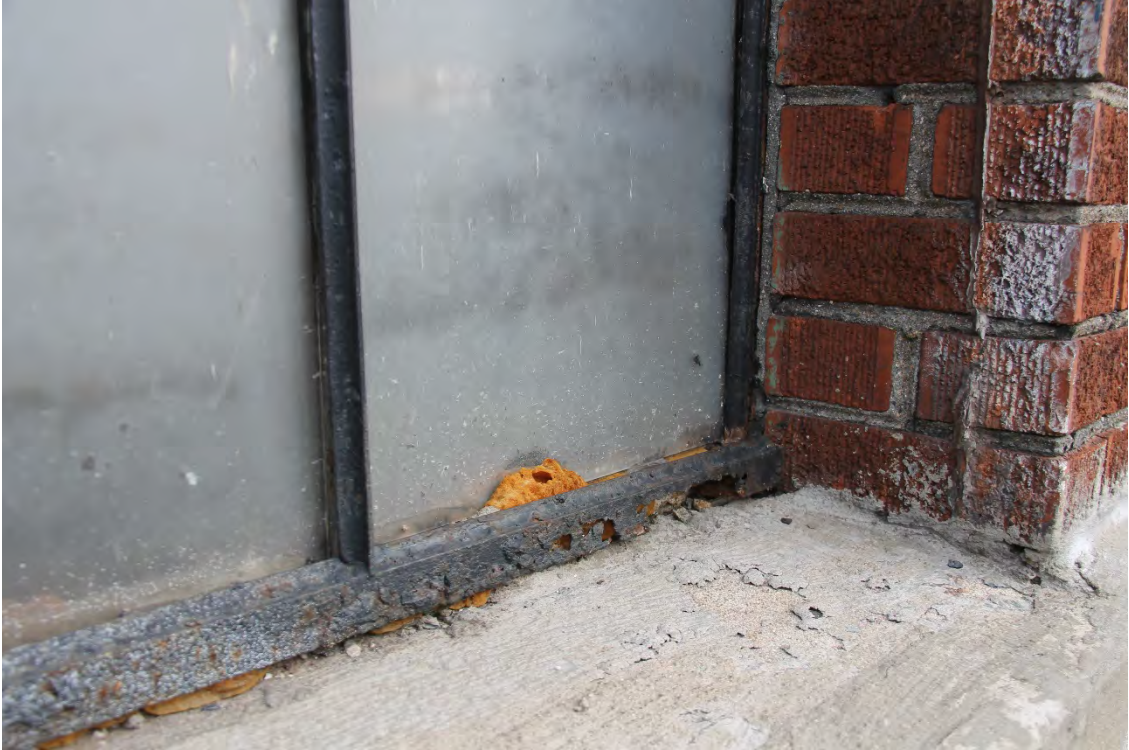
*Typical Bottom Rail Condition, Exterior View*

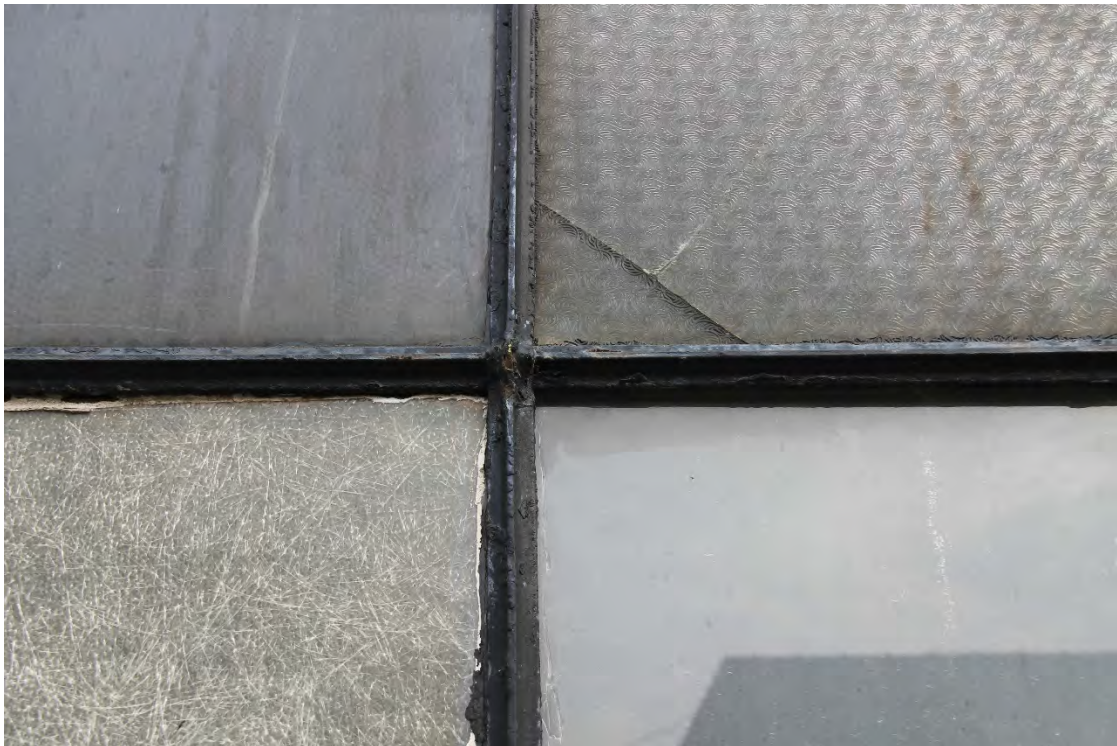
- Glazing is all in need of replacement since there is no consistency, the current glazing includes clear annealed, acrylic sheet, polycarbonate sheet, and fiberglass reinforced sheet. All glazing compound is failed and is likely containing ACM that would require abatement, as well as the exterior perimeter caulking. These compounds need to be tested prior to any work.

*Typical Muntin Original Steel Window and Example of Four Types of Glazing Existing*

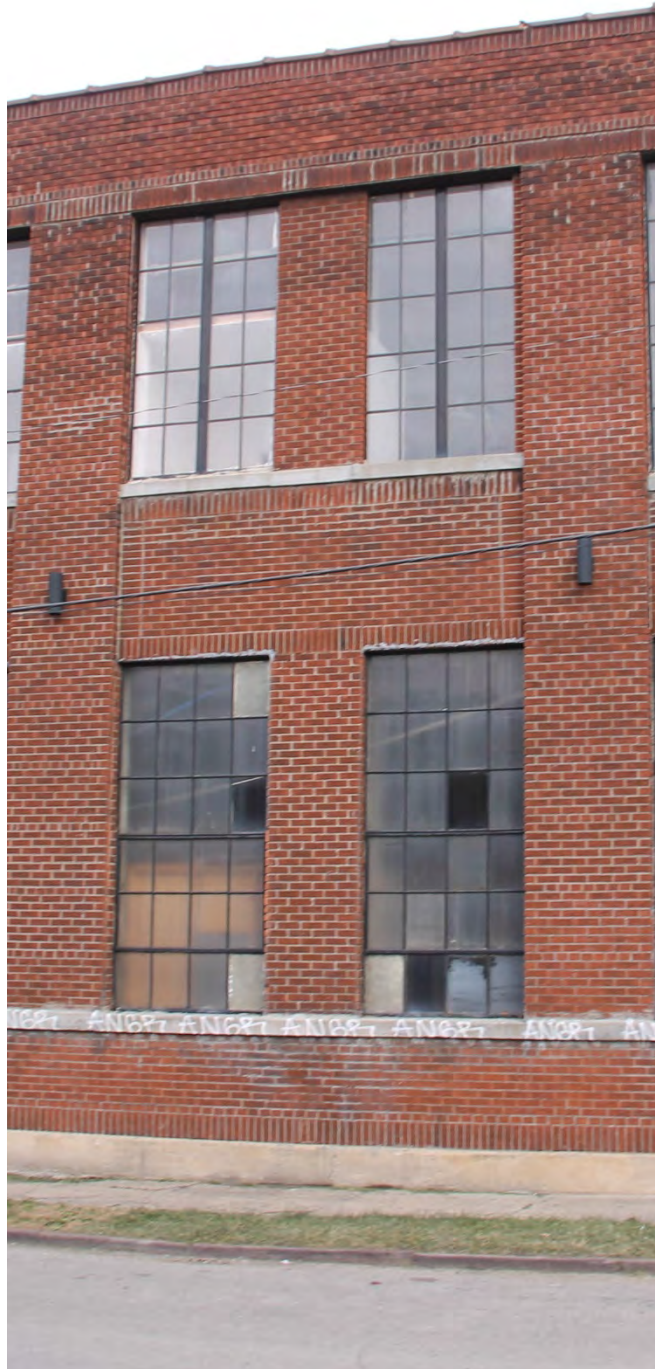
*Example of Incorrect Replica of Steel Windows. Existing Original Window on 1st Floor.  
Incorrect Replication on 2nd Floor.*

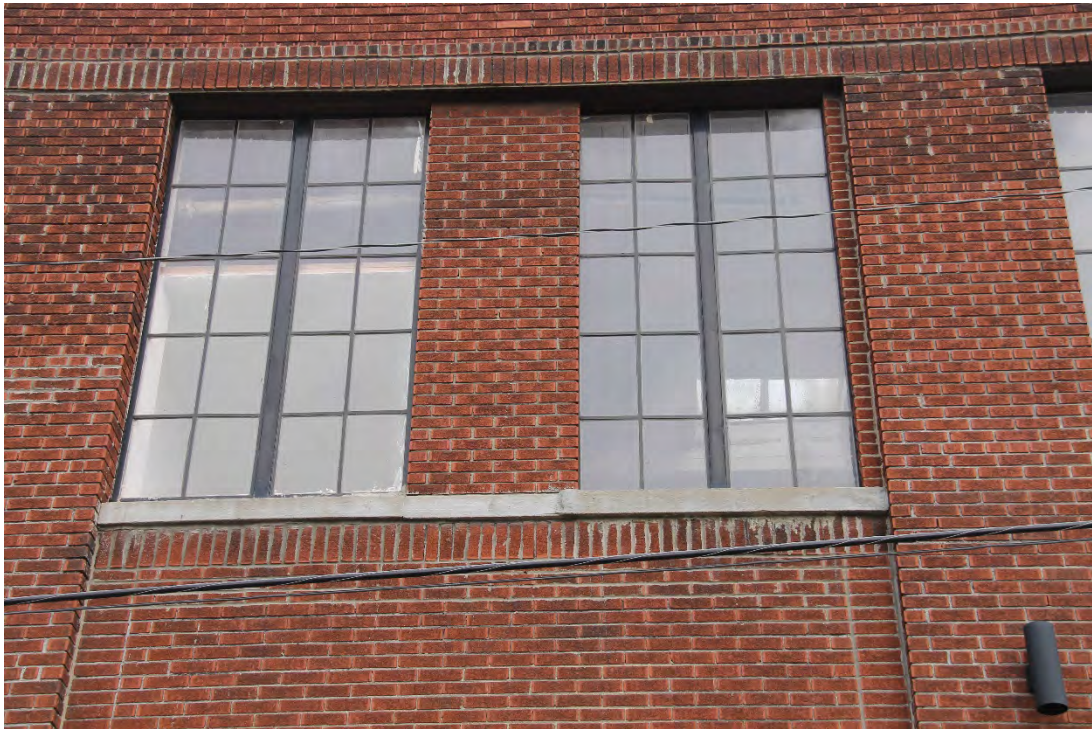
The newer, previously replaced (13) openings are in good condition, they have moderate rust and corrosion. But the replication product and installation is poorly done in regard to incorrect configuration, not matching profiles and dimensions, as well a poorly done installation. The common issues seen throughout these openings are as follows:

*Exterior of Replica Steel Windows*

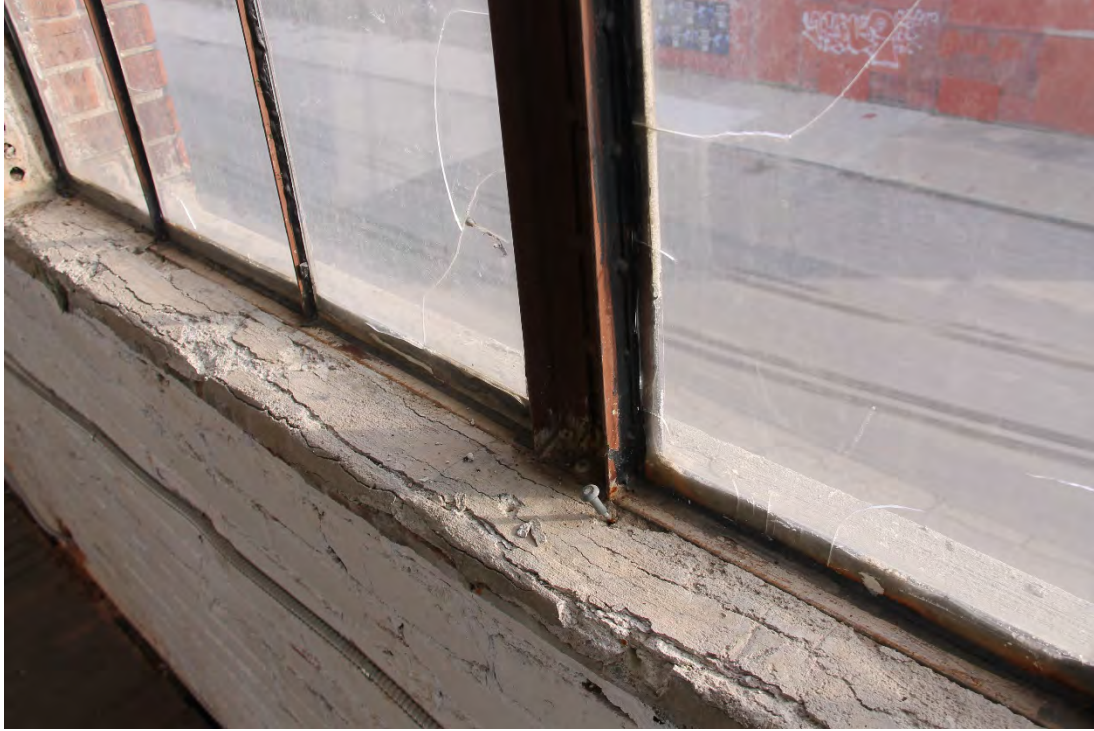
*Interior View of Replica Steel Windows, Mullion, and Glazing with Incorrect Glazing Install*

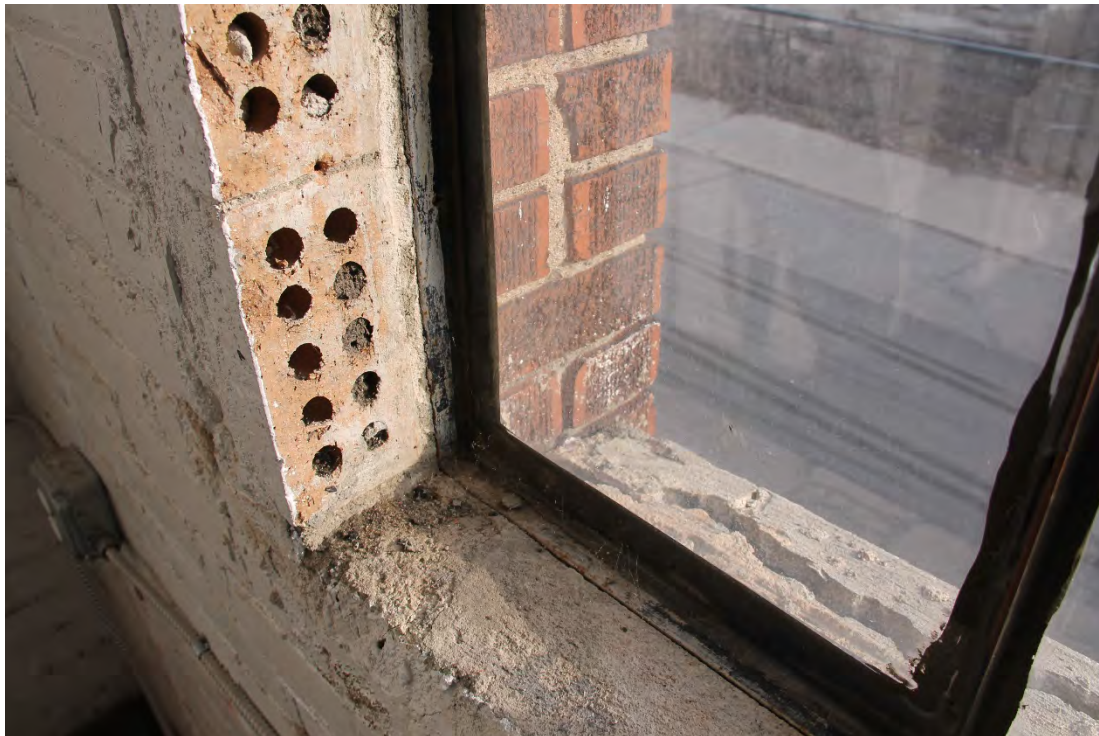
*Interior View of Replica Steel Window, Shows Altered Masonry Opening Changing Window Size*

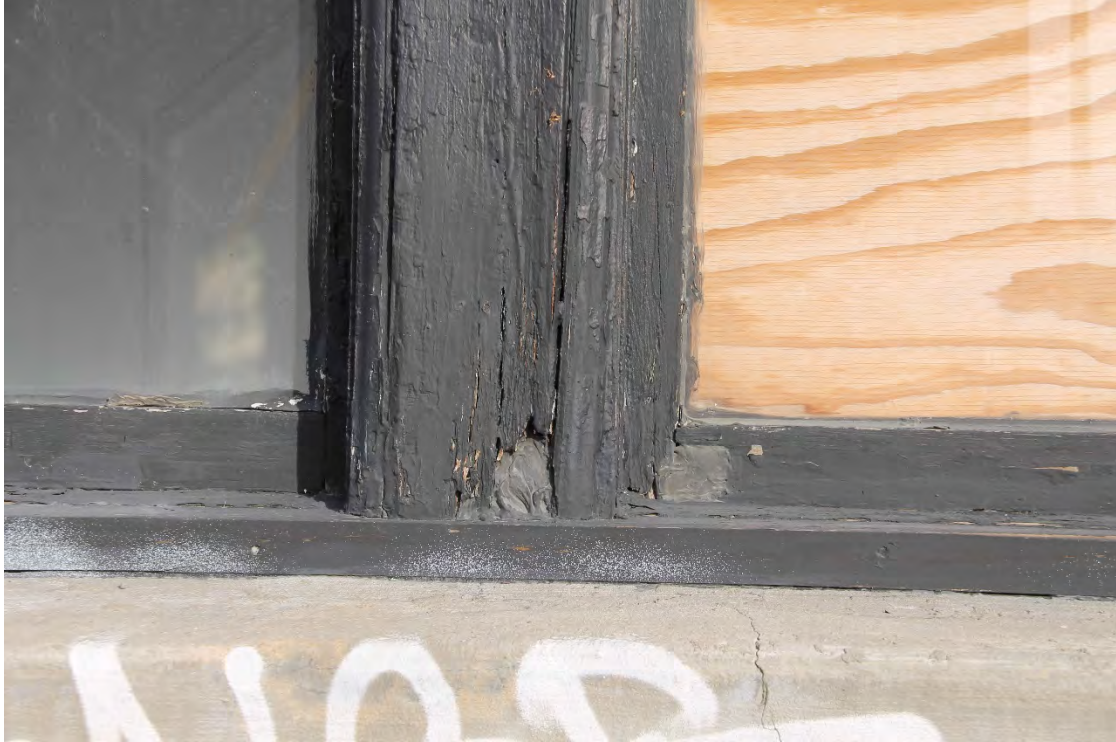
*Exterior View of Failed Mullion Assembly and Bottom Sash*

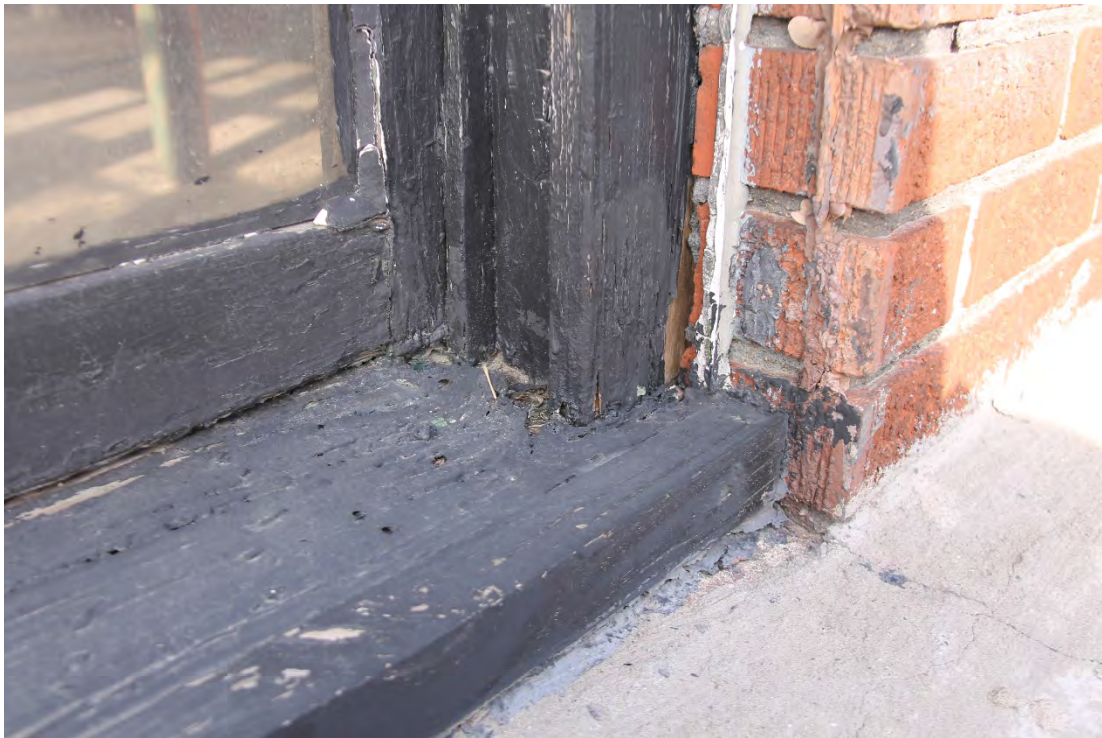
- All exterior sills are split through, running the full width of the opening. In the past, work was done to repair by cutting back the sills and face screwing a 2 x 2 wood piece to replace the rot and decayed face edge. Water is penetrating the attachment and allowing the damage to continue. Many of the existing sills have continued to decay and dry rot is present.
- The intersection of the exterior sill and weight boxes joinery is failed because of water penetration. Once this takes place a window unit is usually
- considered needing full replacement.
- Bottom rails on 30 % of the windows exterior side have failed corner joinery.
- 70% of the brickmould has been removed and no longer on site.
- Some of the mullion covers are split and missing allowing water penetration.

*Exterior View of Failed Sill; Completely Rotted Through with Paint Covering. Example of 2x2 Added to All Windows Covering Rotten Sill, As Well As Missing Brick Mould.*

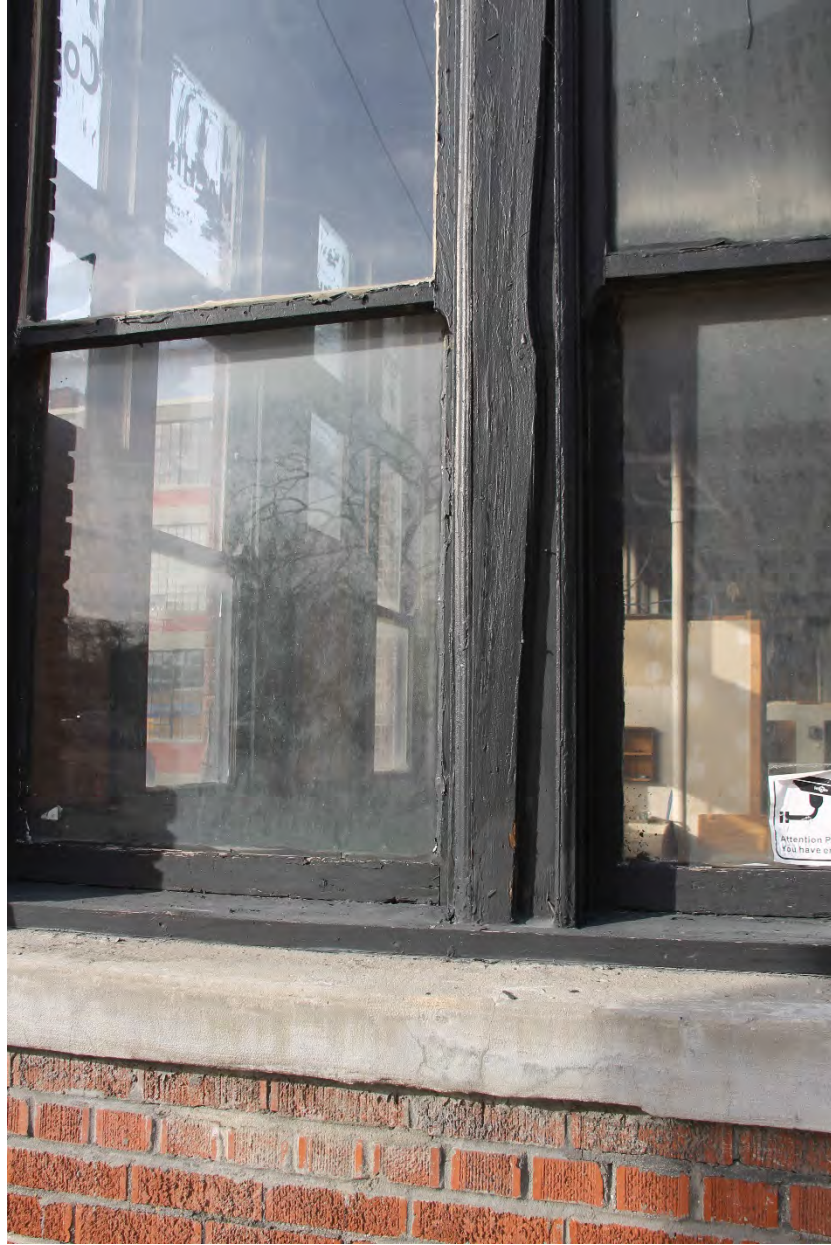
*Exterior View of Broken Mullion Cover Allowing Water Penetration*

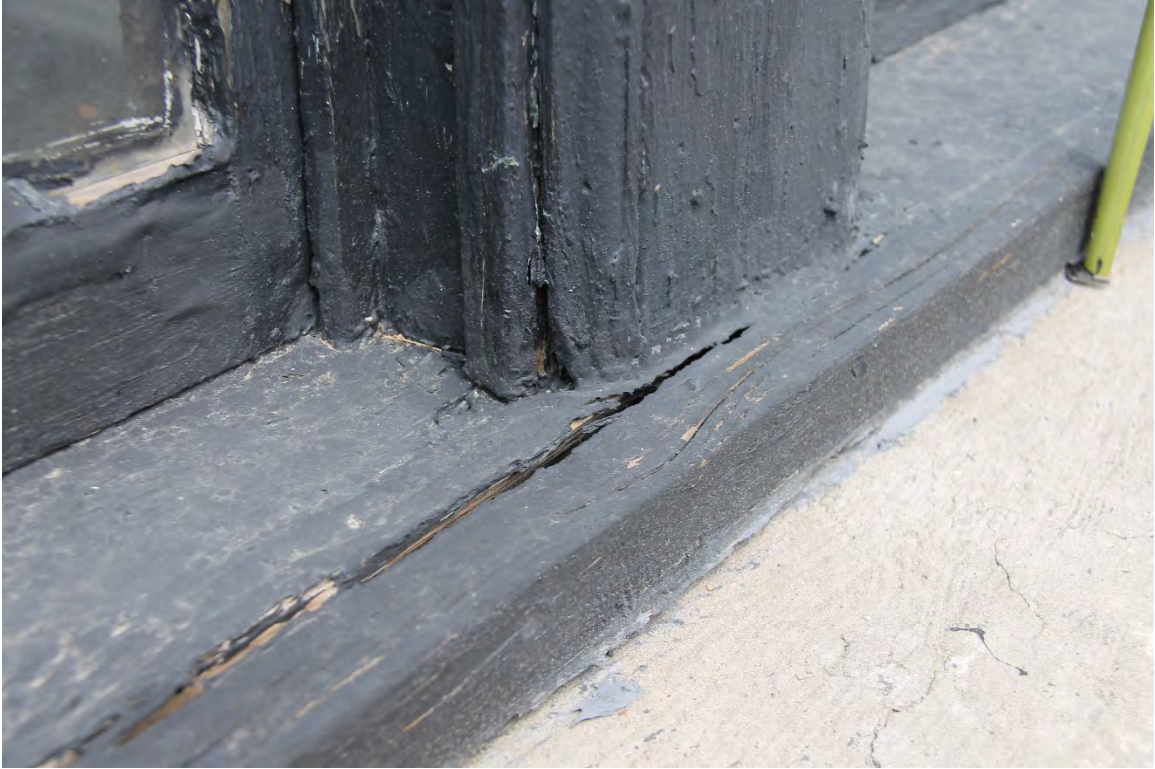
*Exterior View of Split Sill*
