Historic District Commission Project Review

## 92 Forest (Phase 2)

92 E. Forest Avenue, Detroit, MI 48201

Date: May 16, 2022

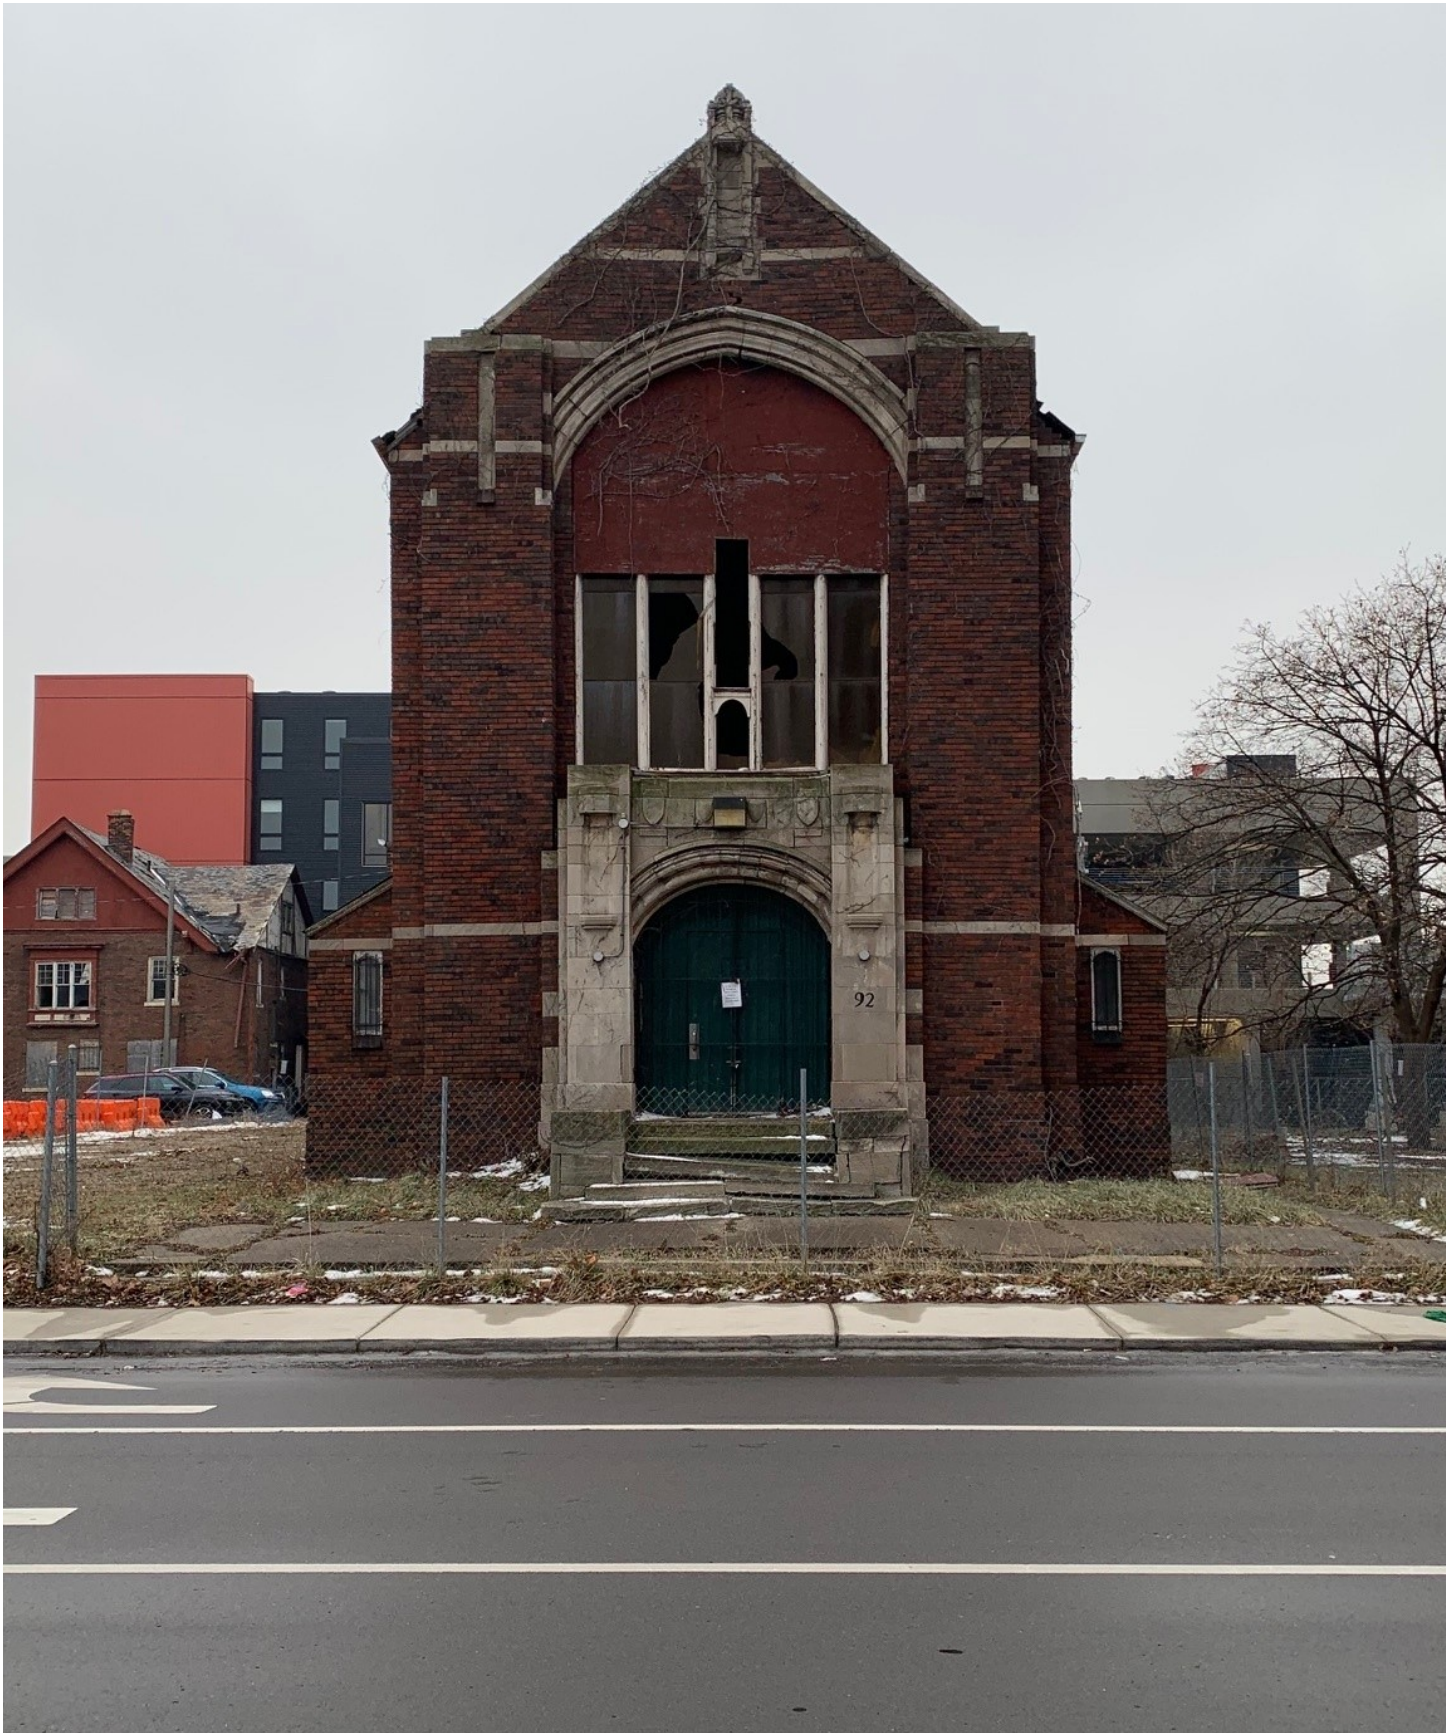
Front façade— Full View ( Note plywood is still in place at upper section of windows). Stone surround to be repaired

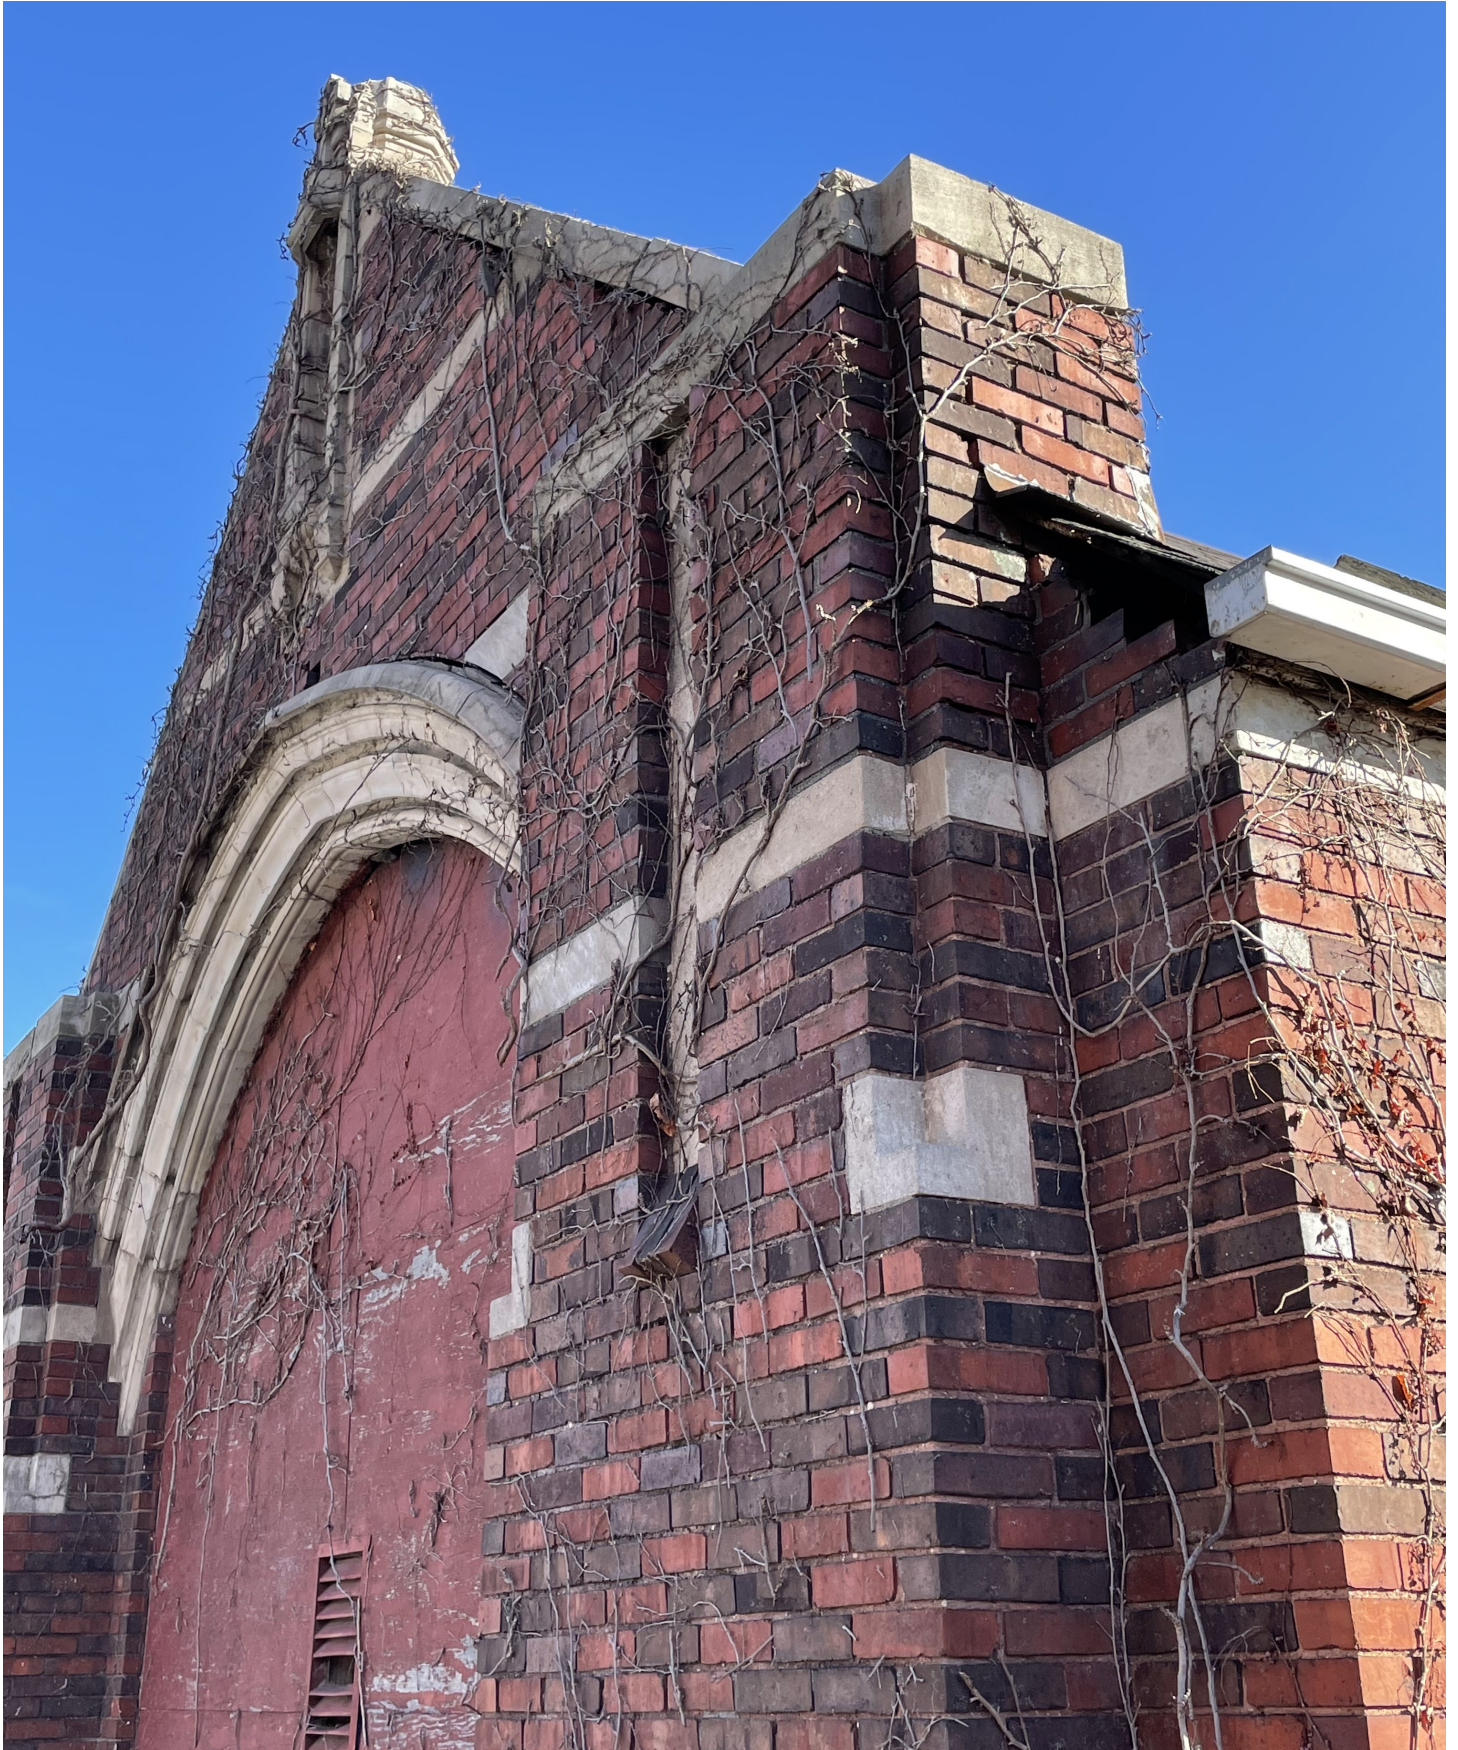
Detail at upper gable section (Note protective plywood still in place at upper portion of glazing)

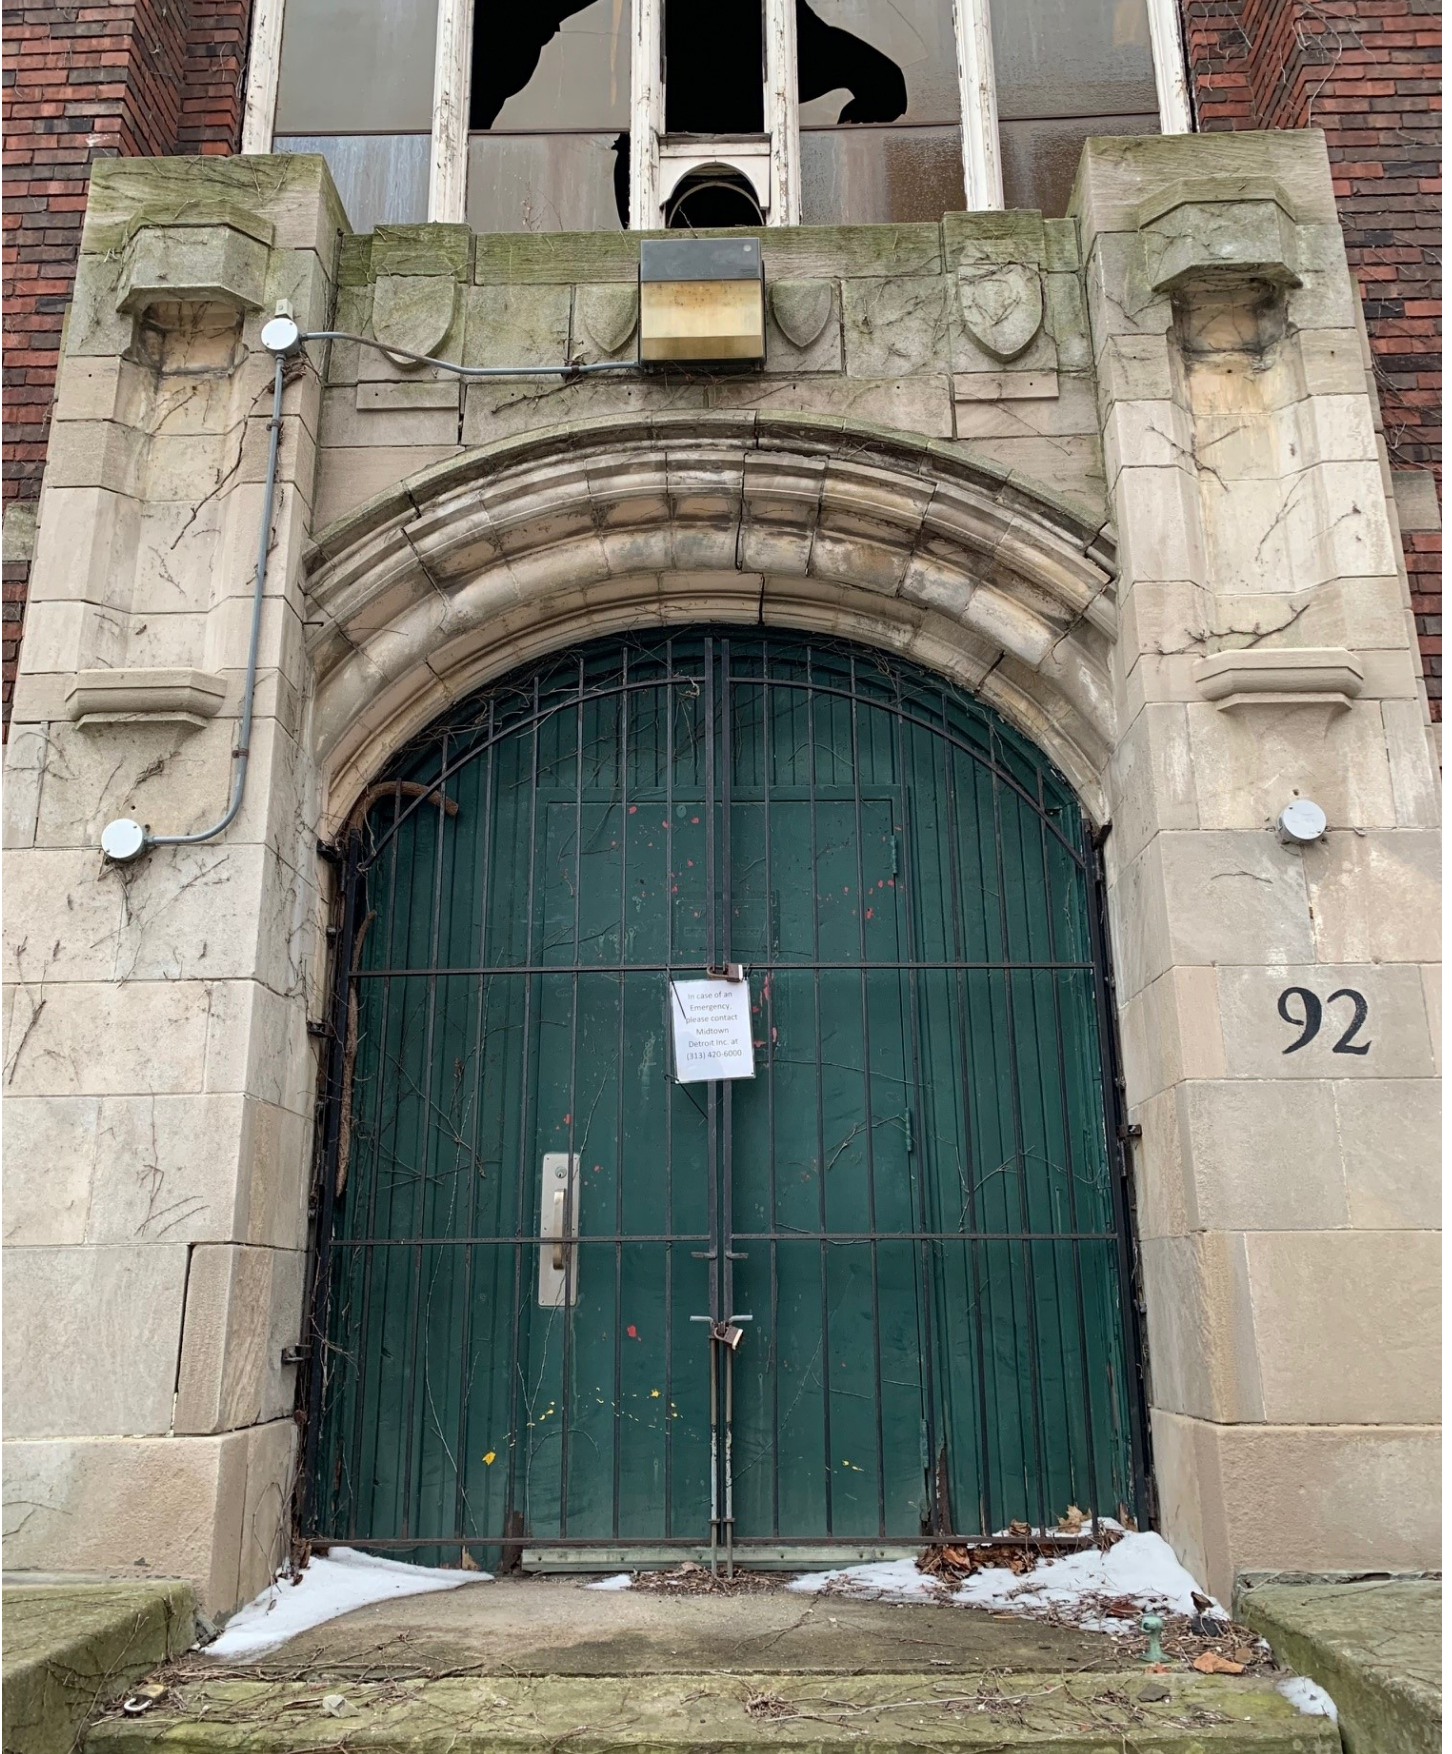
Detail at top of stone surround, security bars to be removed from doors

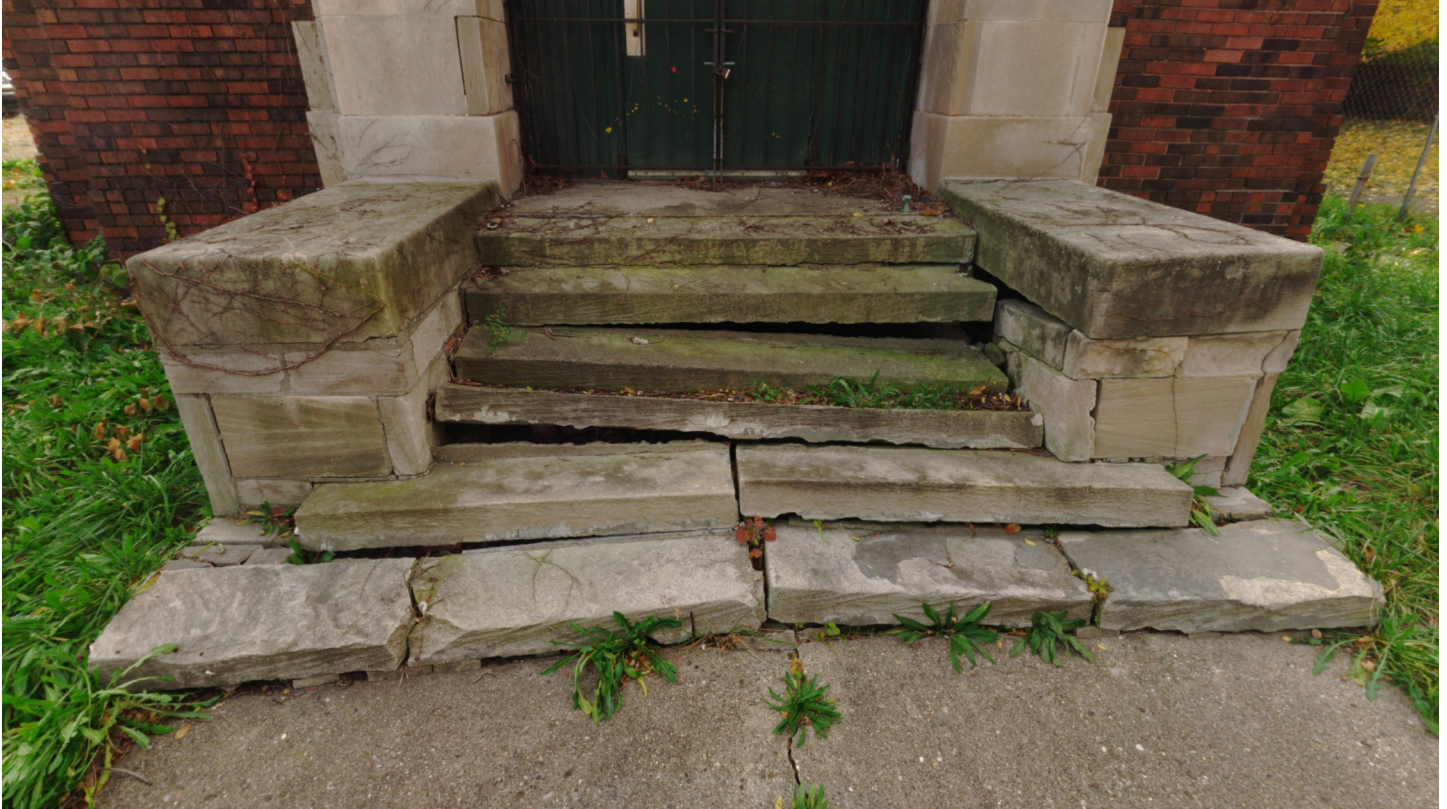
Detail at porch cap, steps and side walls. Stone to be removed, repaired, and replaced .

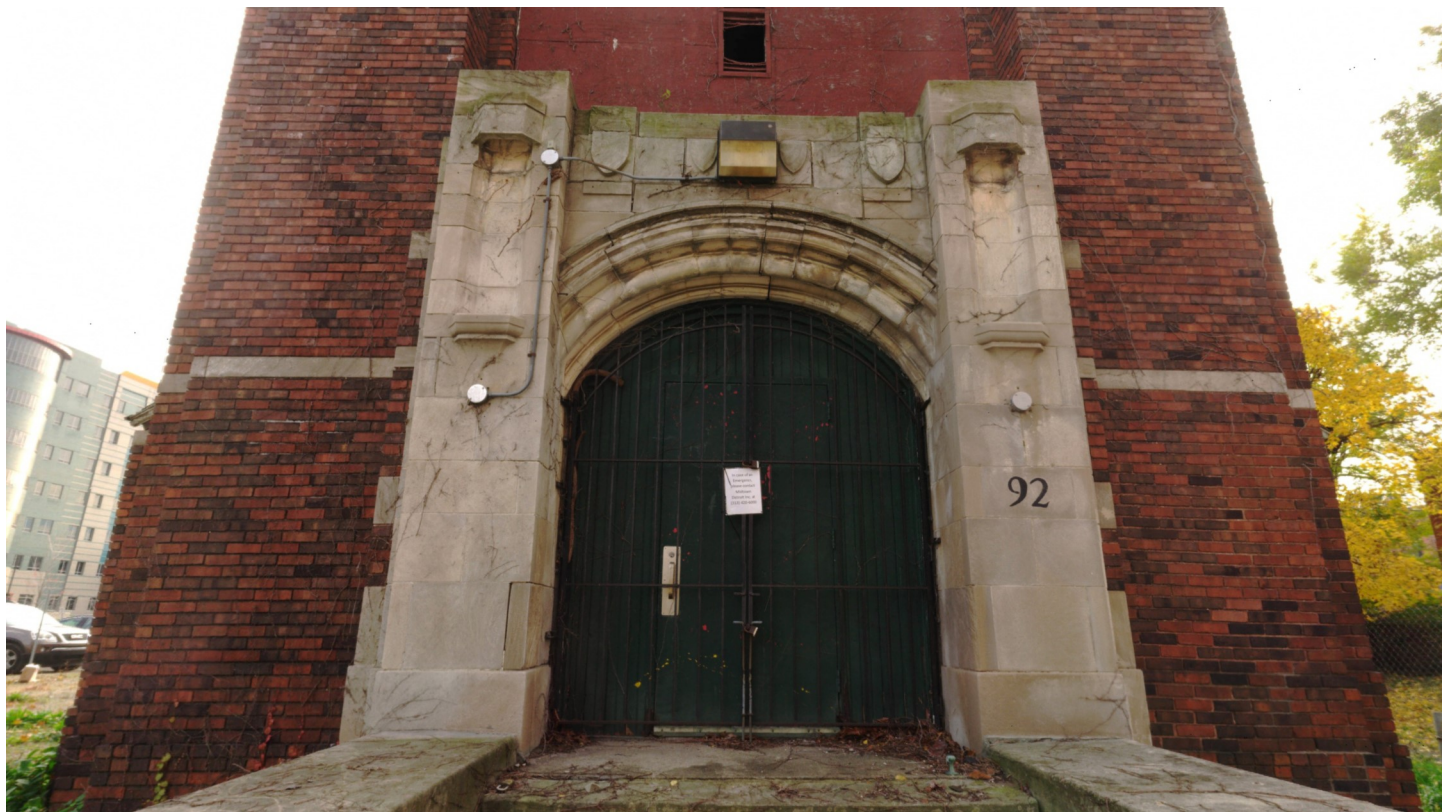
Grade level view of stone entrance surround. Stone to be removed, repaired, and replaced.

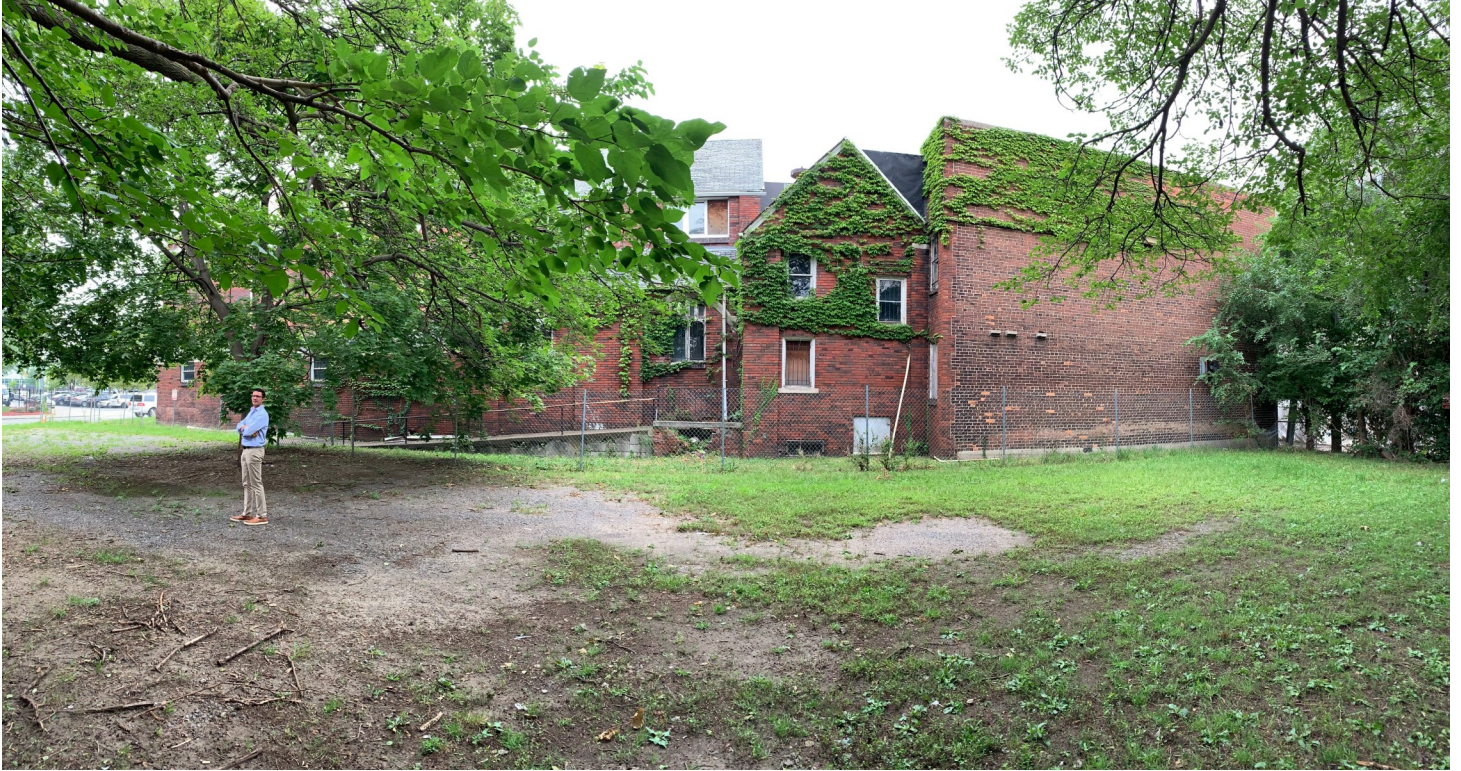
Full Image of West Façade, new basement entry, ramp repair.

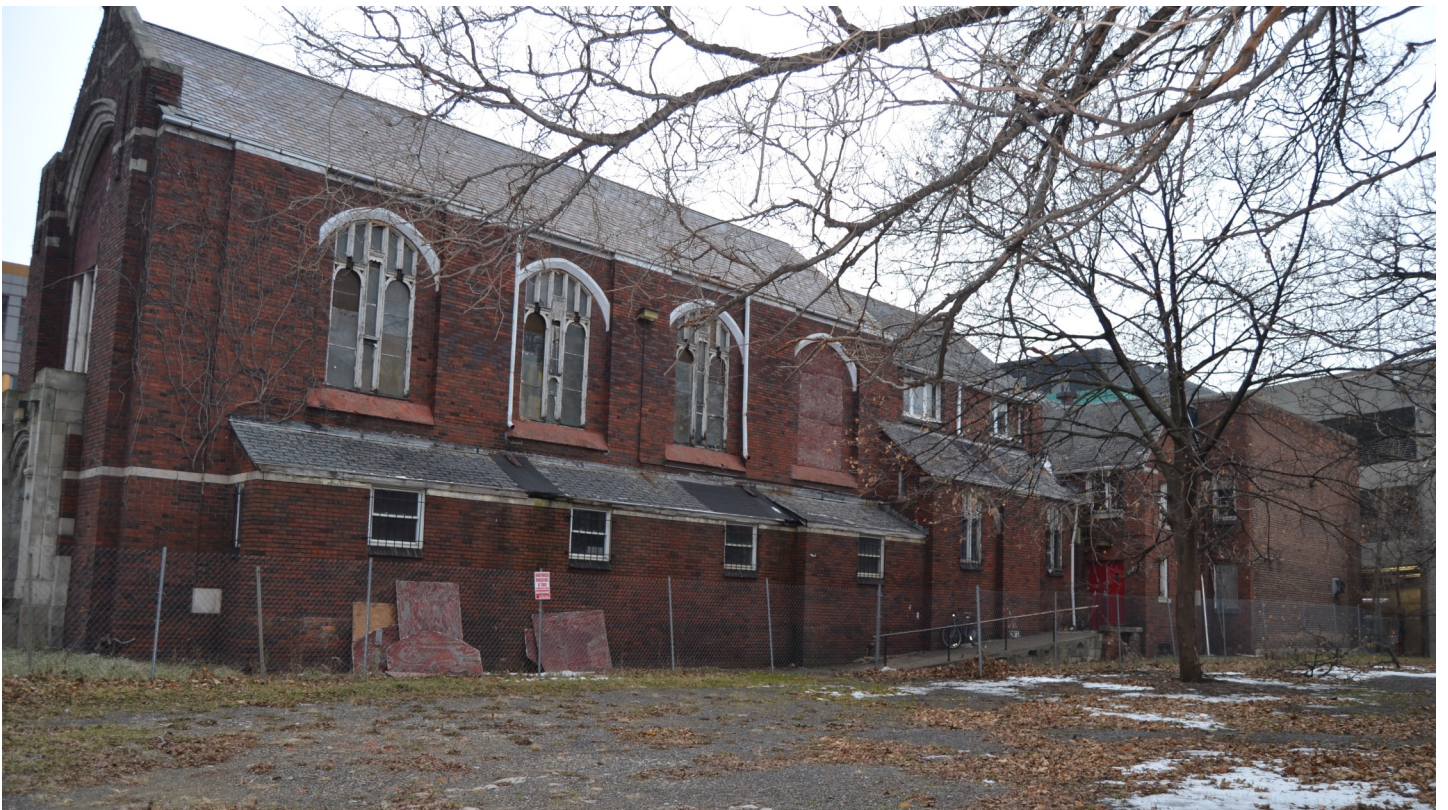
Full Image of West Facade , new site work , ramp repair.

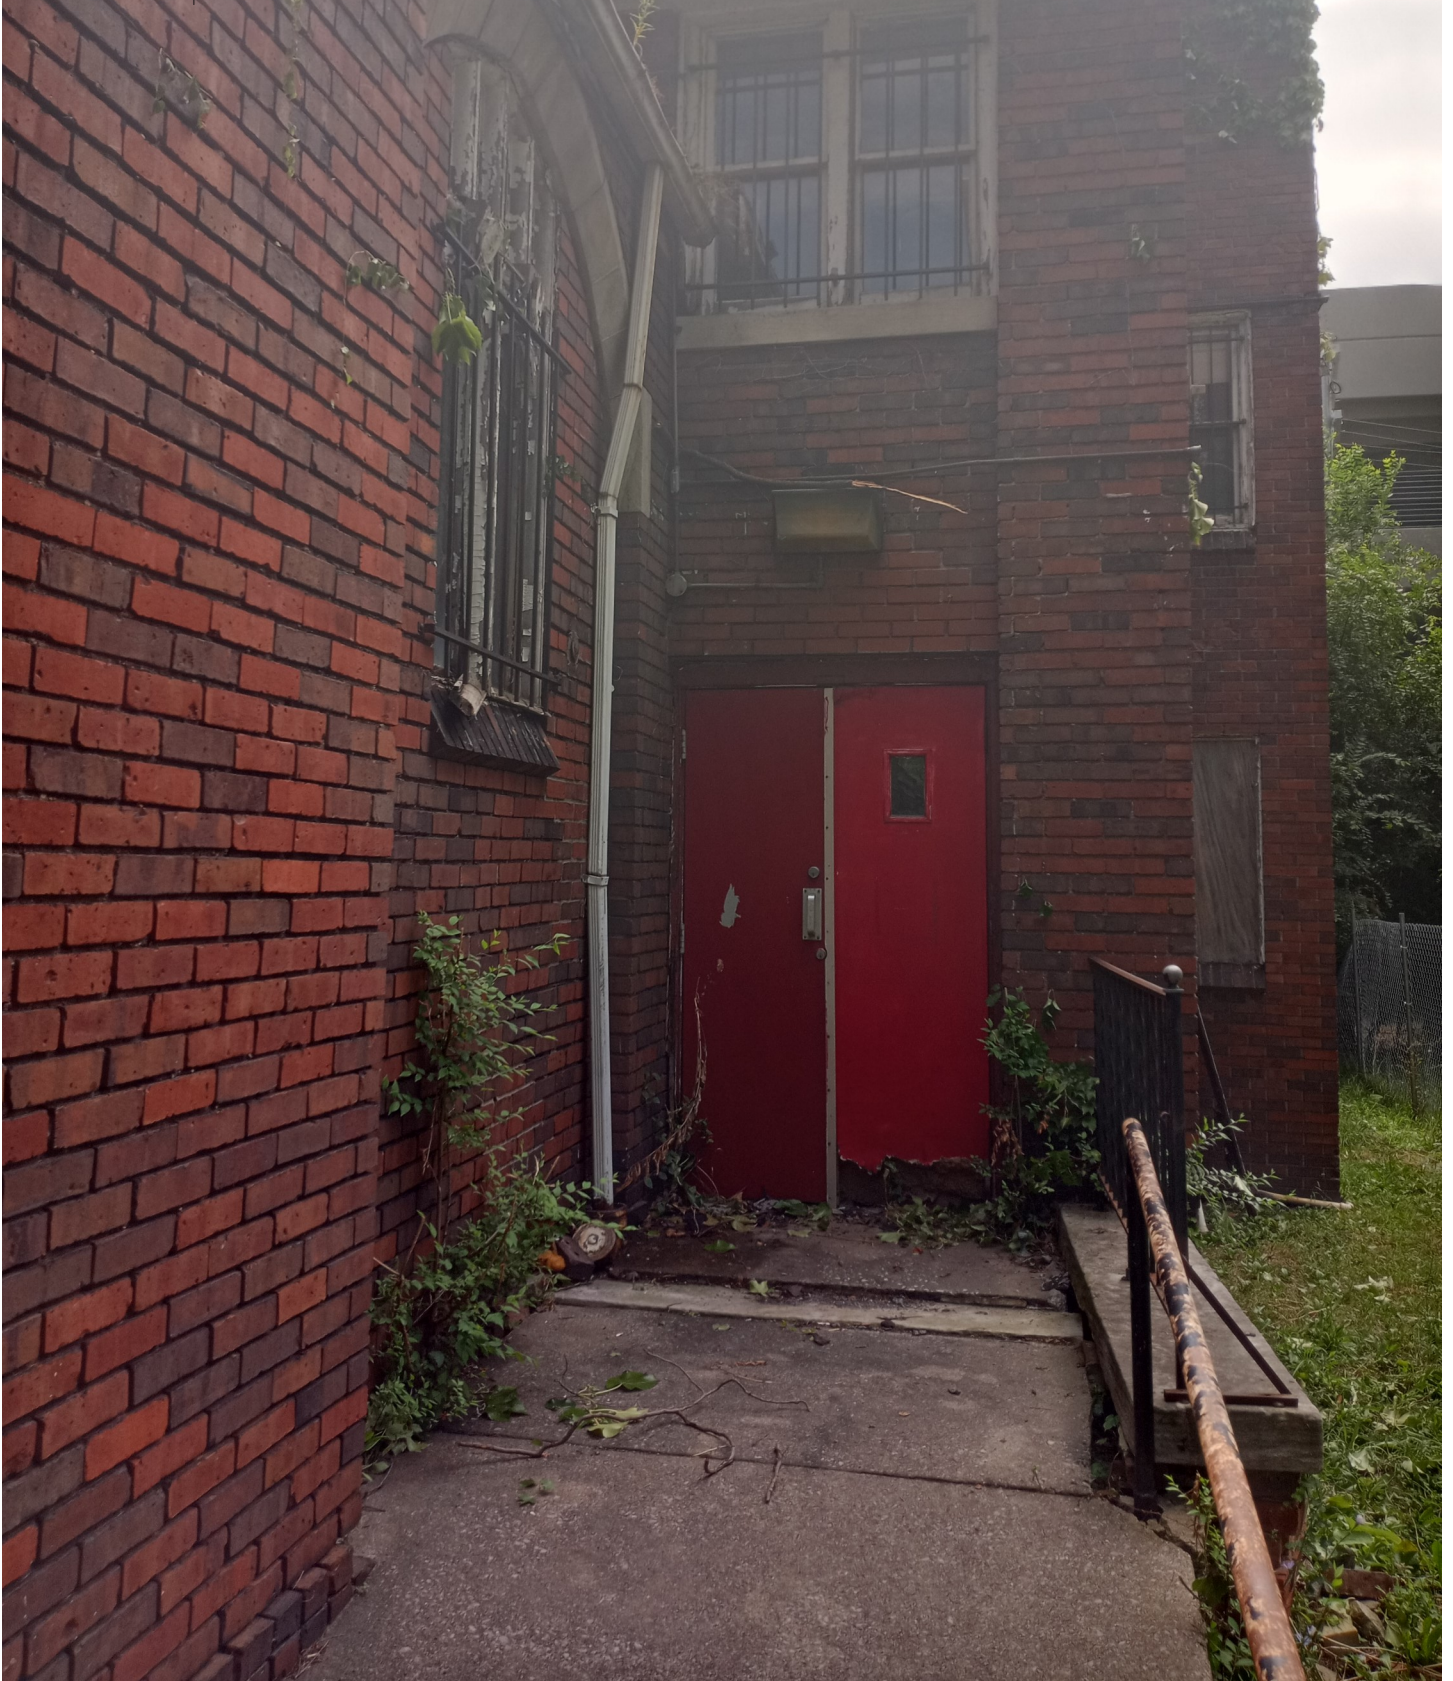
Detail at non-historic pedestrian door and ramp. Ramp to be brought up to code with new rail system, door to be replaced

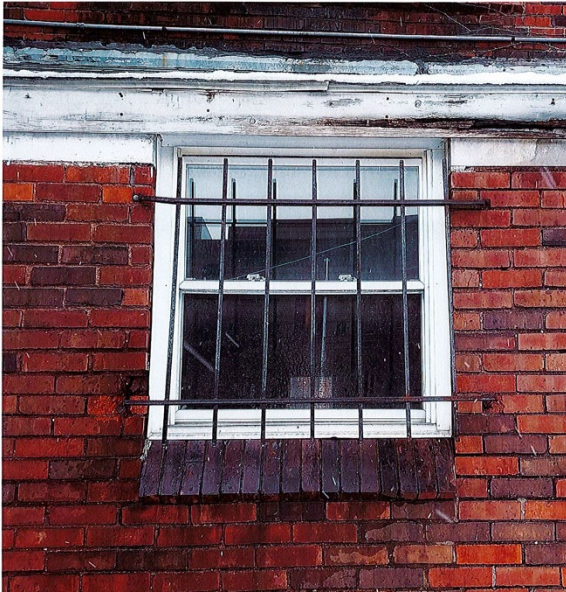
Condition: Fair/Poor

Notes: These windows are non-contributing to the original architecture. They are replacement windows of low quality. Exterior brick molding does not match original. Broken glass and broken window elements visible

1. Non-contributing windows. DW 1-4, DW 24 – 37.
  - a. Not covered in the Secretary of Interior’s Standards for preservation. Possibly Number 3
  - b. Remove vinyl windows back to the rough opening. Replace with new wood windows, 1/1 light, aluminum clad exterior, insulated glass with replicated brick mold. New sills where necessary.

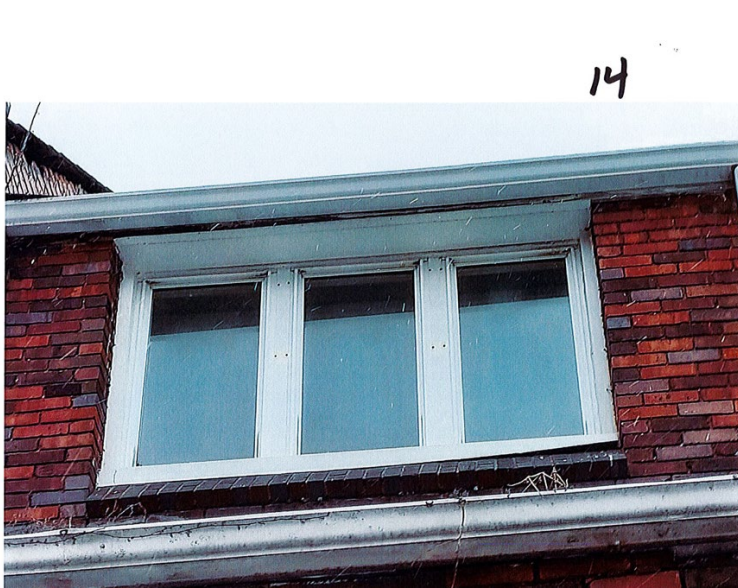
Windows: FW 1-3 (9 Windows)  
Type Vinyl single light non-operable  
Glass: Double pane, IGU  
Condition: Fair

Notes: These windows are non-contributing to the original architecture. They are replacement windows of low quality. Missing sash. Exterior brick molding does not match the original.

2. Non-contributing windows: FW1-3
  - a. Not covered in the Secretary of Interior Standards for preservation. Possibly number 3.
  - b. Remove vinyl windows back to the rough opening. Replace with non-operable wood windows, aluminum clad exterior, single light, Insulated glass & replica brick molding. New sills where necessary.

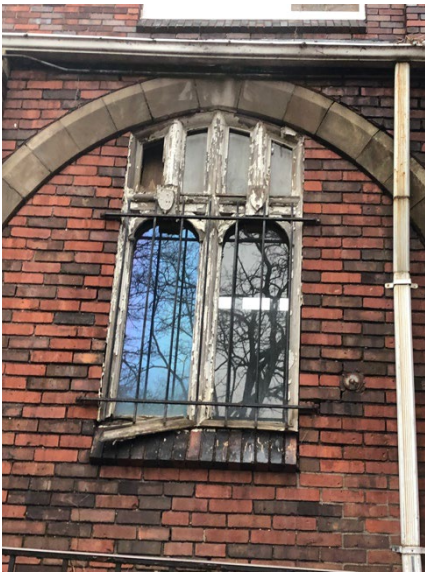
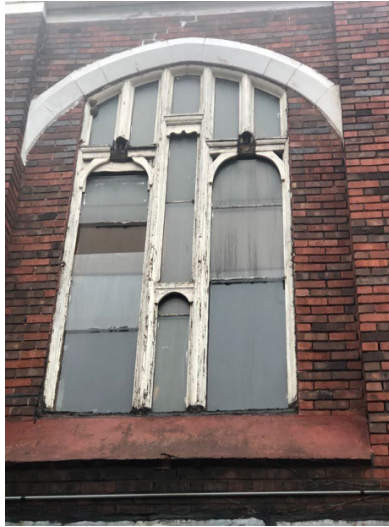
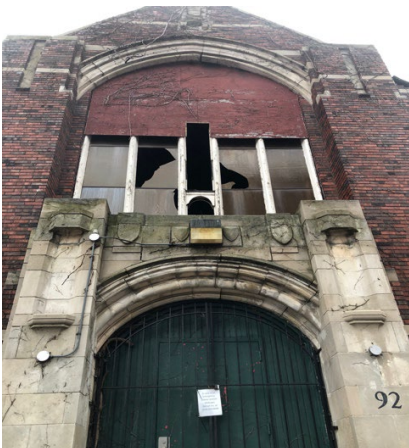
Windows: SW 1 – 11, NW 1-2  
Type: Gothic Arched, Multi-lighted.  
Glass: Single glazed  
Condition: Fair/poor

Notes: These windows are very significant to the original architecture. The wood substrate is in good condition. The Secretary of Interior, National Park service rating for these windows is 2. The paint is failing. The sills are solid, the exception being NW 1-2. The glass appears to be set in a metal frame then inserted against the exterior wood trim and fixed in place with stops on the interior. Most glass is single pieced cut to the opening, the exception being the large side lights on the bottom portion of each window. Bottom 2 openings in the case of SW 2. Each of these openings are metal framed rectangle shaped panels with 2 horizontal muntins. The long slender opening on the bottom between the larger openings also appear to be metal framed with a horizontal muntin, but on some windows this has been replaced with one piece of glass/plastic. The metal frames are in advanced stage of deterioration and non-existent in some openings due to water infiltration. The glass is mostly broken and replaced with a variety of substances, clear glass, plastic, plywood, or nothing at all. (photos) It is unclear if any of the bottom lights open for ventilation. It is unclear if any of the glass is original to the structure. There are missing architectural elements on the exterior woodwork, namely the medallions and in the case of NW 1-2, the sills. Otherwise, the exterior architectural trim is remarkable intact as it had protective plywood covers. The sills have benefitted from being covered with roofing material.

- c. Dutchman/Epoxy repairs where needed
  - d. Replicate missing elements – Medallions & sills.
  - e. Replace glass. Insulated is possible with adjustment made to the inside stops.

These are principally in the sanctuary. These windows should be restored to maintain the church's architecture, historic integrity and place in time. The basic substrate of the windows is in restorable condition. The plywood coverings installed over these windows helped tremendously to slow the deterioration of the wood. The quality of the wood is excellent old growth white pine. The wood is superior to the type of wood available today and it will refinish very well. New pieces will replicate the missing or deteriorated. Thus, the shape, configuration, and scale of these windows as they relate to the building will be preserved.

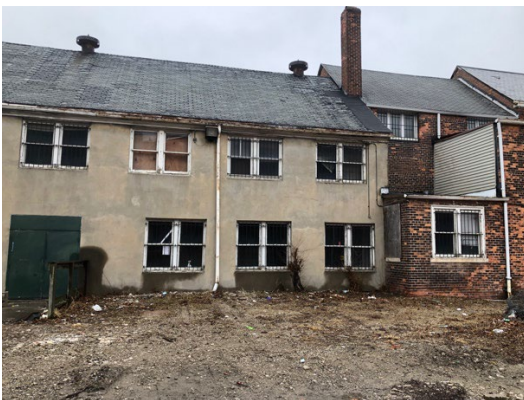
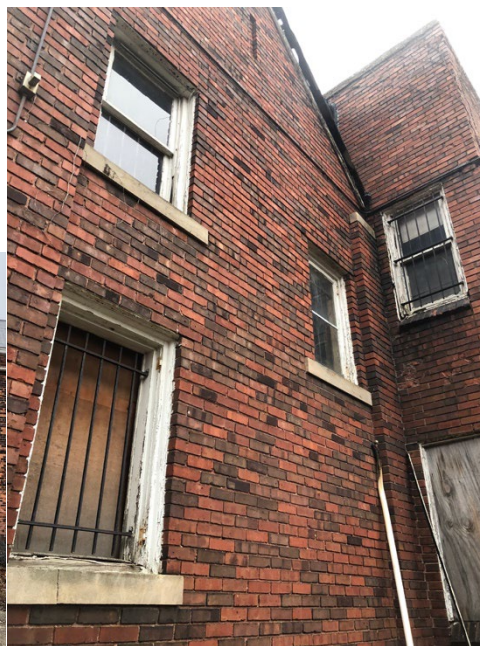
Condition: Fair, mostly poor.

These windows appear to be all the same generation. Perhaps as a result of the addition in the 1940. Many windows are mullioned. Many are separate. These windows would fit into the age determination for historical significance and would qualify as contributing. Rating by The Secretary of Interior, National Park Service would be category 3 for poor, (15 windows) and category 2 for fair (9 windows) These windows are mostly in poor condition and appear to have not had the maintenance and protection of the sanctuary windows. The worst are the windows on the South Façade, followed by the east. The windows in fair condition are on the north and west facades of the nave. These windows appear to have been exposed to the elements with no evidence of recent maintenance. The paint has failed. The glazing has failed. The window sash joinery is loose, and in some instances, deteriorated. The glass needs stained and painted. Lower jambs, brick molding and sills are in poor condition throughout. Sashes missing on the west side windows. All sash ropes are missing. Unable to determine if the windows are single hung or double hung as the top sashes are sealed shut. There appears to be no sash weatherstrips. Existing hardware and pulleys are of a low quality, stamped metal. Most locking hardware is missing. Interior milled profile are deteriorated due to UV penetration. A few storm windows remain. They are in poor condition and low quality. The overall impression of these windows based on the wood, deterioration, hardware, pulleys, joinery and lack of weather seals is that they were not of high quality originally when originally installed.

4. Nave: Contributing Windows DW 5 – 33
  - a. Option 1: Restore Window. Secretary Of Interiors Standards for Preservation 5 & 6
    - i. “Poor” rated windows replaced with replica (15 windows)

- ii. “fair” rated windows refinished, repaired, & restored. (9 windows)
    - iii. New openings to have new windows.

- b. Option 2: Replace windows with new due to deterioration. Secretary Of Interiors Standards for Preservation number 9.
  - i. Old windows removed back to rough opening.
  - ii. New sill installed.
  - iii. New wood windows installed with replicated brick molding. Windows to match the new openings and the non-contributing window replacements. New windows to match the size, shape, and scale of the current windows.

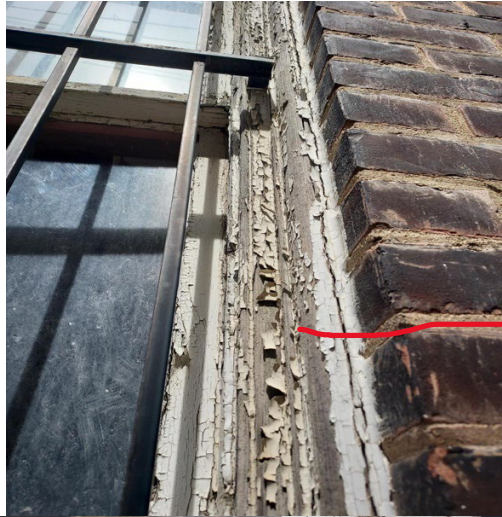
Typical "fair" Condition. DW 5 -10 & DW 26 -29

Paint Failure

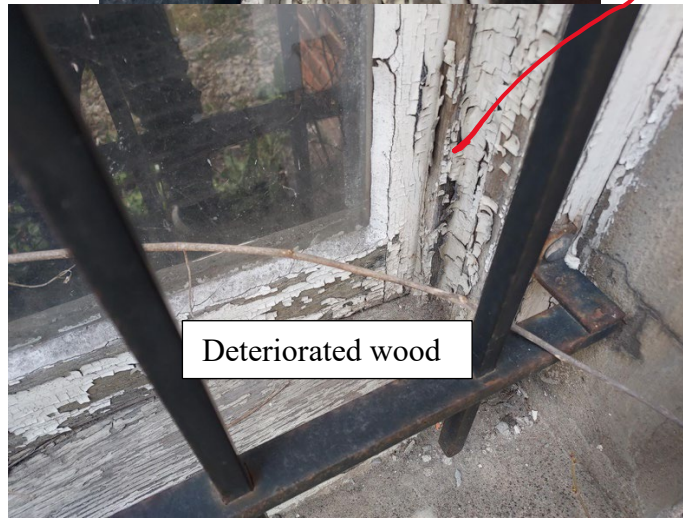
Deteriorated wood

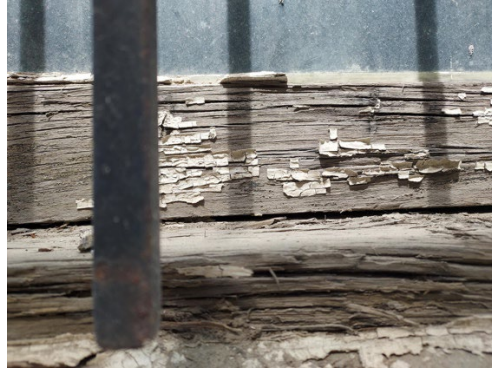
Typical “poor” DW 11-22 & DW 30 -33

Extreme deterioration from exposure

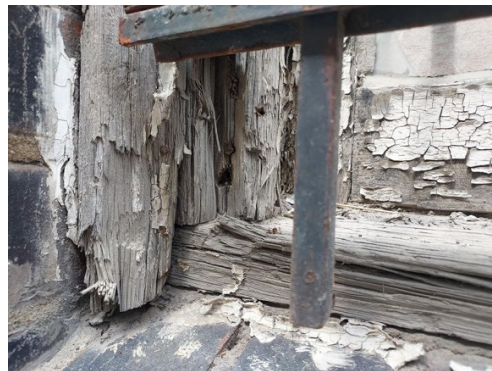
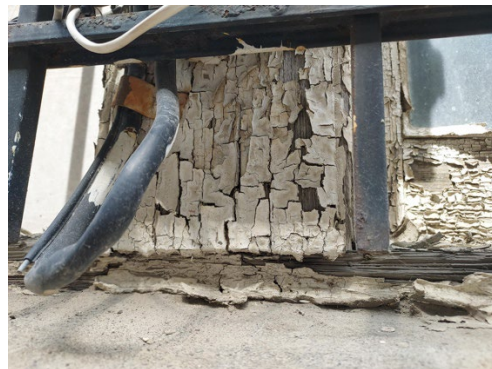
Deteriorated jamb, sill, sash & brick mold

Rotted/Missing sills

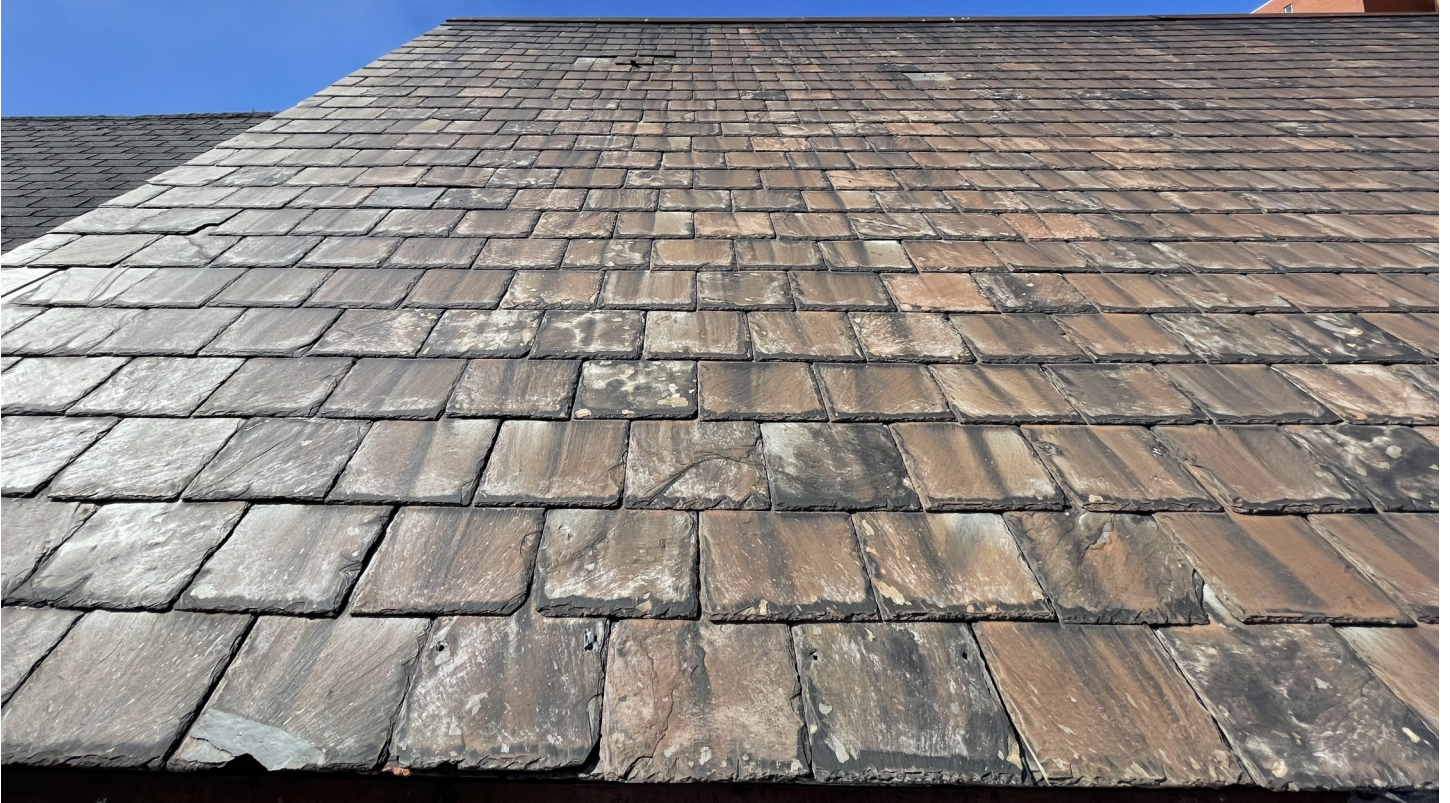
## East Slate Roof

1. The existing slate tiles are degraded beyond a salvageable state, repairing only damaged slate would be extremely dangerous given the brittle, cracking, and thin profile of the existing slate.

View of missing, cracked and delaminated slate tiles, slate that has fasteners corroding through.

Upon a second inspection of the existing slate roof at 92 E. Forest, we have again concluded that the sanctuary roof is beyond repair and that the best course of action for the longevity of the project and preservation of the roof structure below is to remove the deteriorated slate roof and replace the roof and rotted deck boards with a new roof.

It is our recommendation that the replacement roof consist of an insulation underlayment and the Slateline Shingle. The Slateline Shingle will give the appearance of real slate while matching the shingles on the remainder of the sloped roofs and will be a much safer process of repairs in the future.

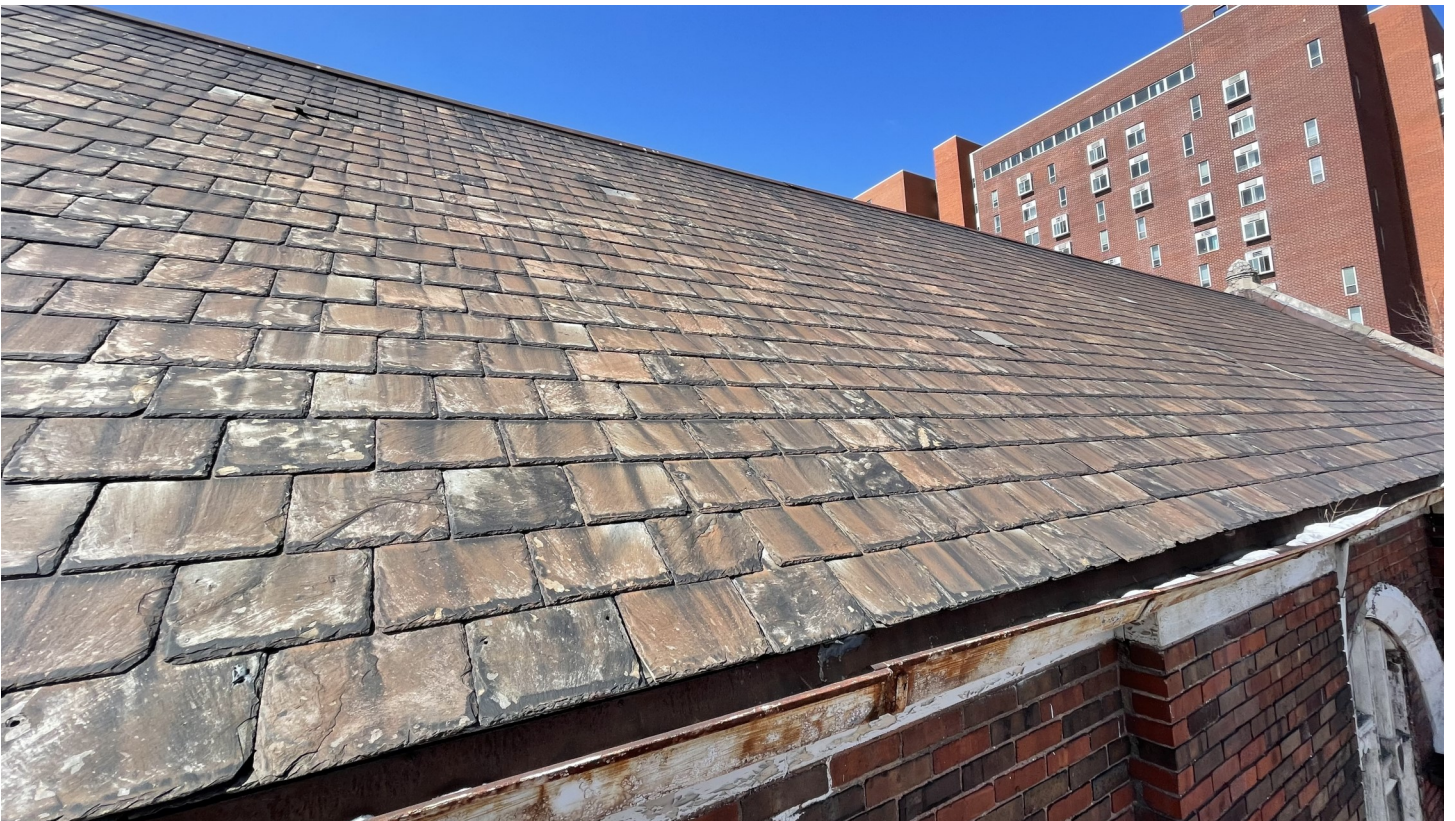
## East Slate Roof

View of missing, cracked and delaminated slate tiles, slate that has fasteners corroding through.
