Historic District Commission Project Review

## 92 Forest (Phase 2)

92 E. Forest Avenue, Detroit, MI 48201

Date: May 16, 2022

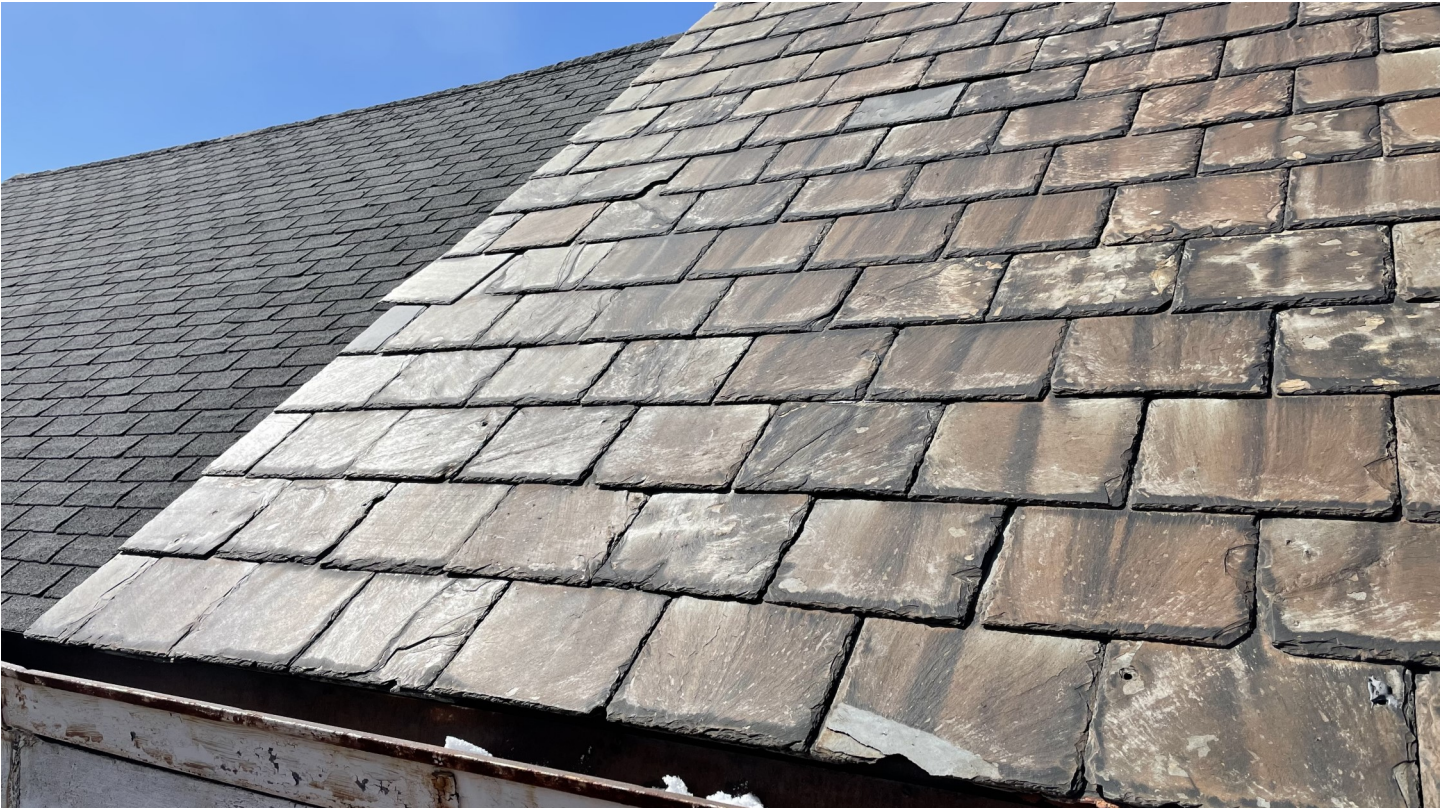
## East Slate Roof

2. In comparing the existing tile thickness, based on tiles that have been damaged from wear and fallen off the roof system and into the gutters, to current slate tile standards the existing tile is more than 1/6<sup>th</sup> of the thickness. This eliminates the ability to repair the damage.

Close-up View of damage showing thinness of existing slate system, new slate will not fit in overall.

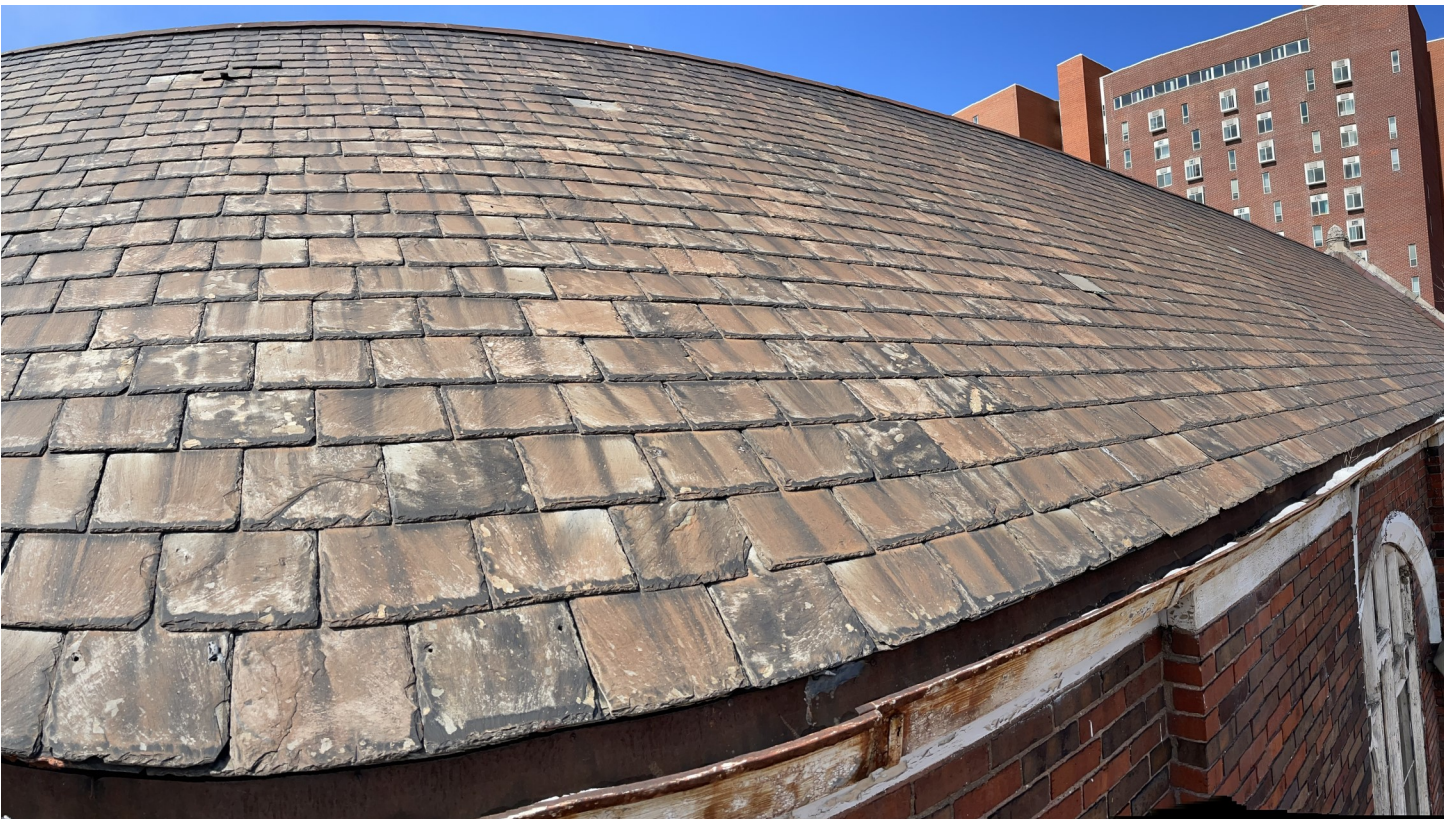
## East Slate Roof

Panoramic View of the East Roof. West Side has additional damage. Refer to Roof Plan for locations.
