# Replacement Window Project Review Request – Current Pictures

1901 Chicago Blvd, Detroit MI 48206

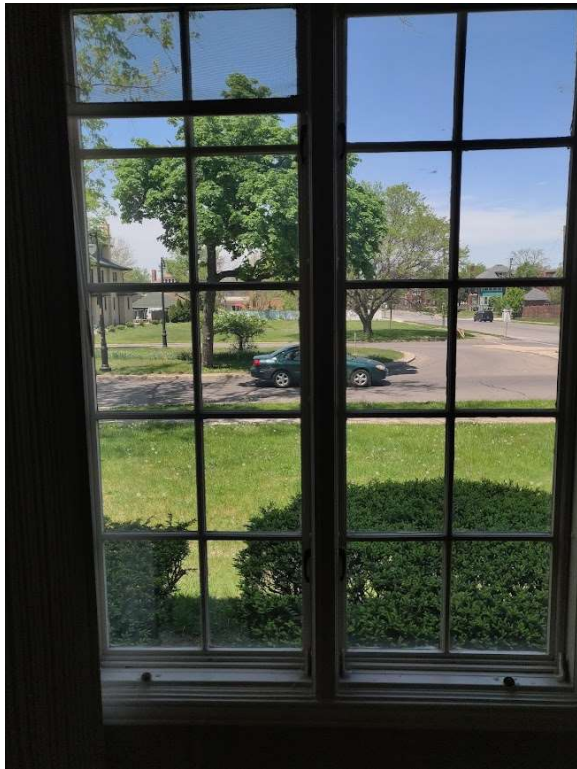
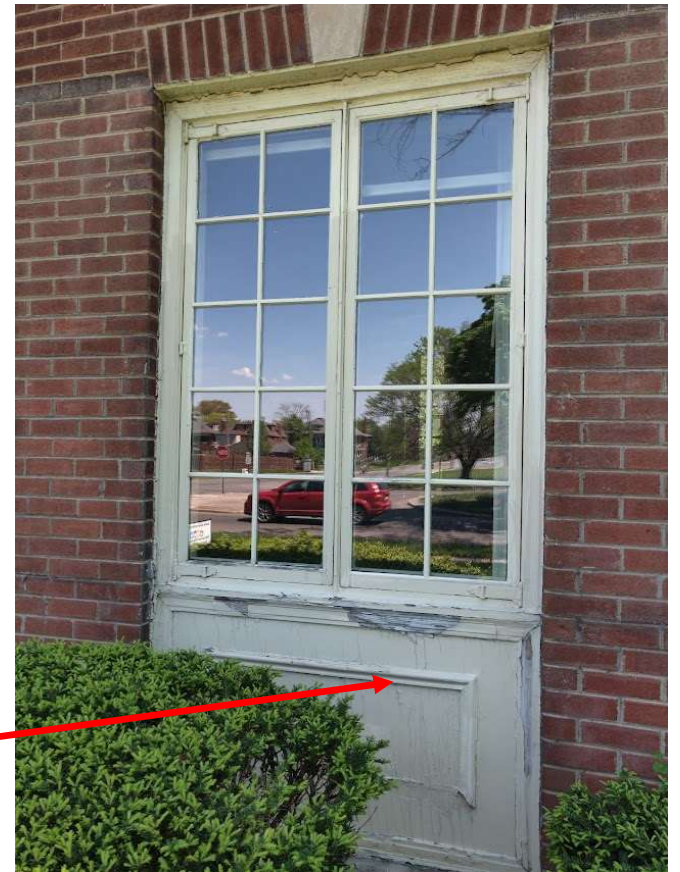
# Livingroom 1 (1<sup>st</sup> floor, north facing, eastern most)

Wood is rotted. To be replaced with window

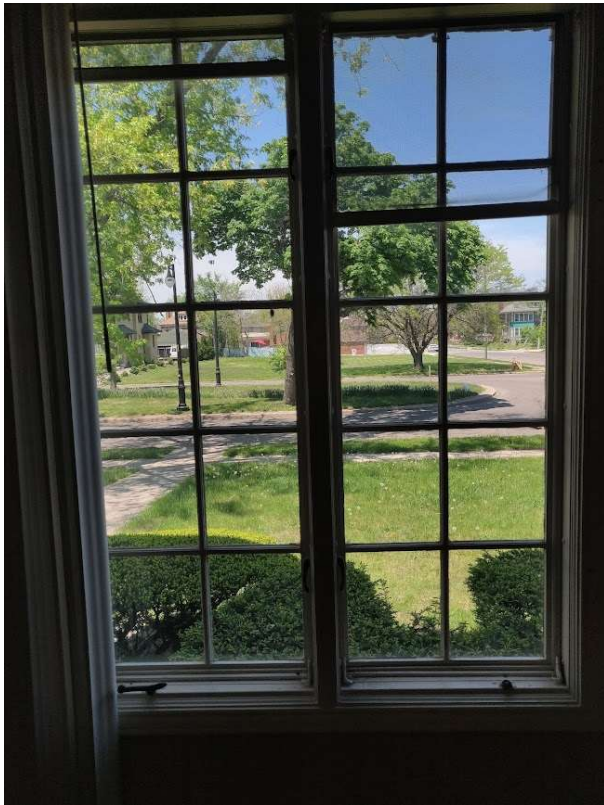
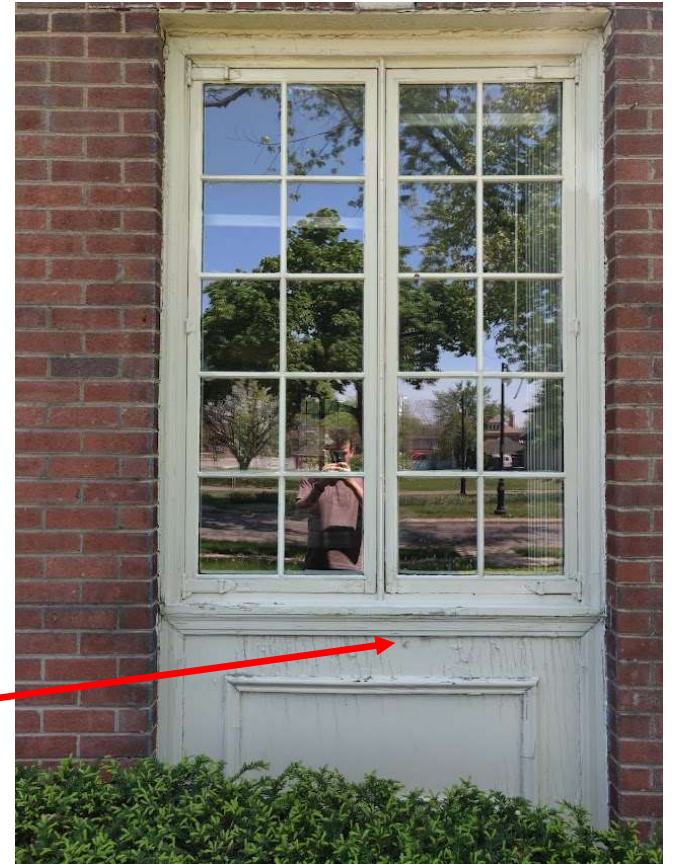
# Livingroom 2 (1<sup>st</sup> floor, north facing, second from east)

Wood is rotted. To be replaced with window

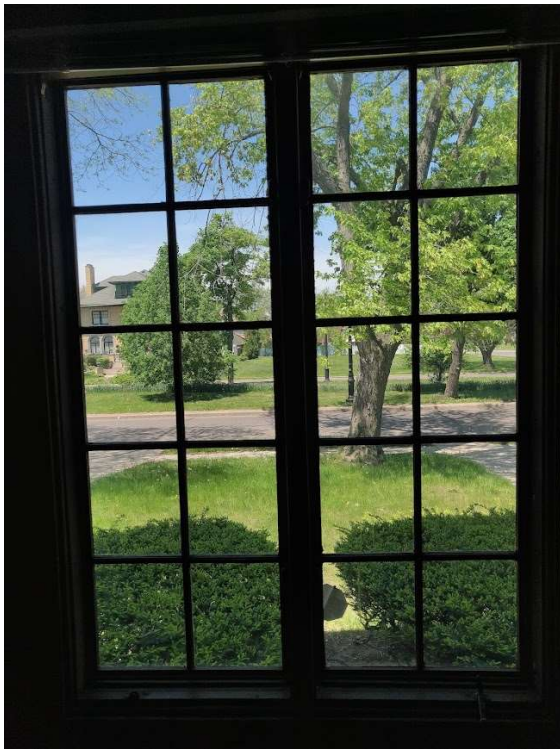
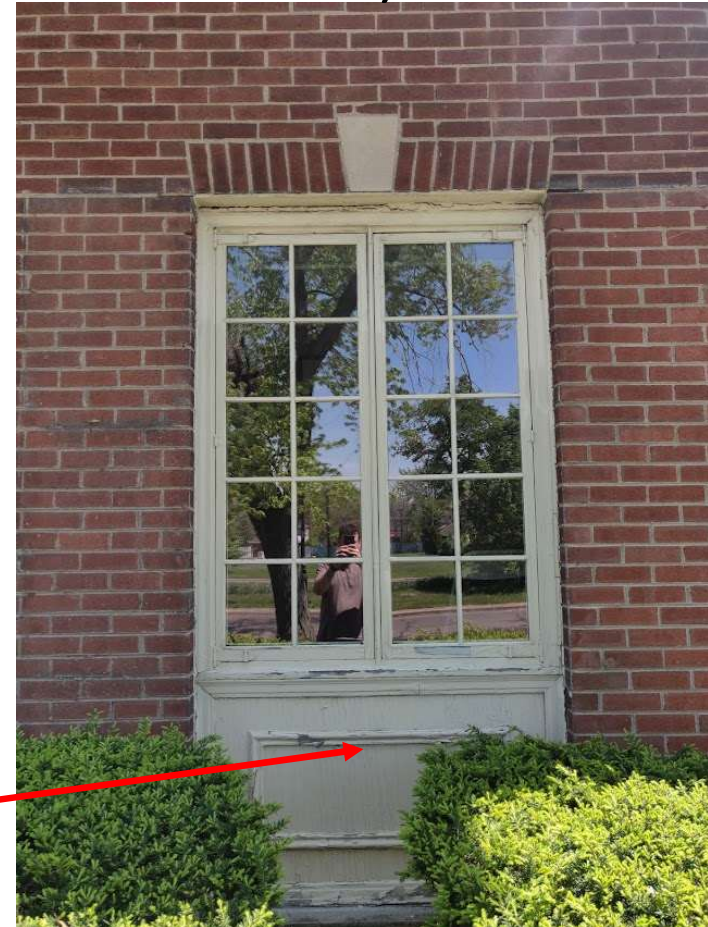
# Den (1<sup>st</sup> floor, north facing, western most)

Wood is rotted. To be replaced with window

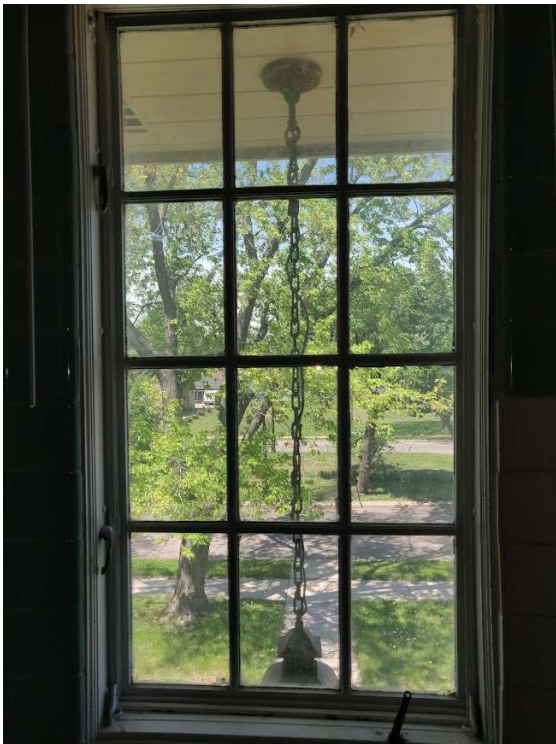
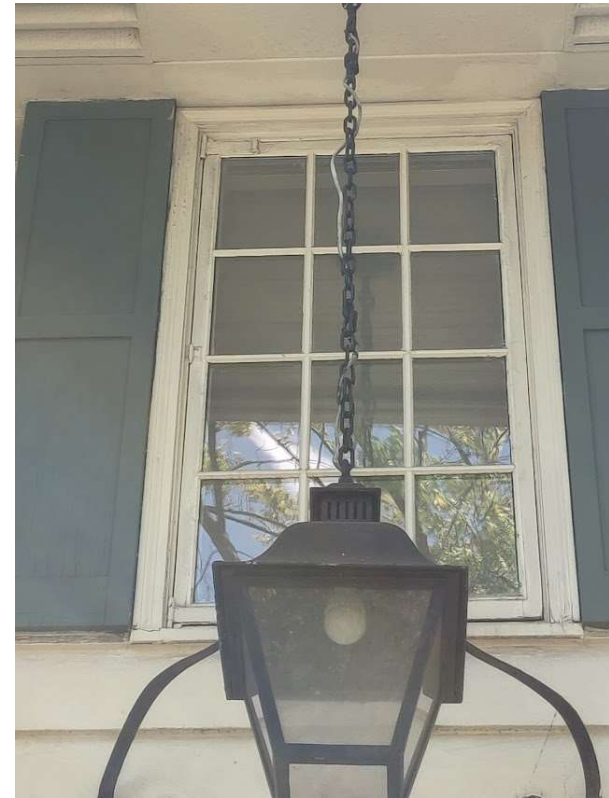
# Master Bathroom (2<sup>nd</sup> floor, northern facing, center)

Current window is clear. Replacement window will be frosted.

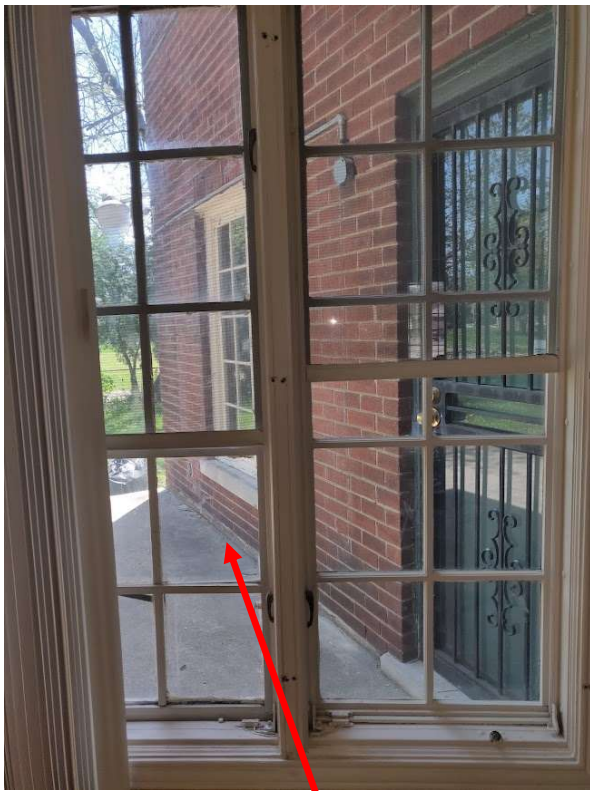
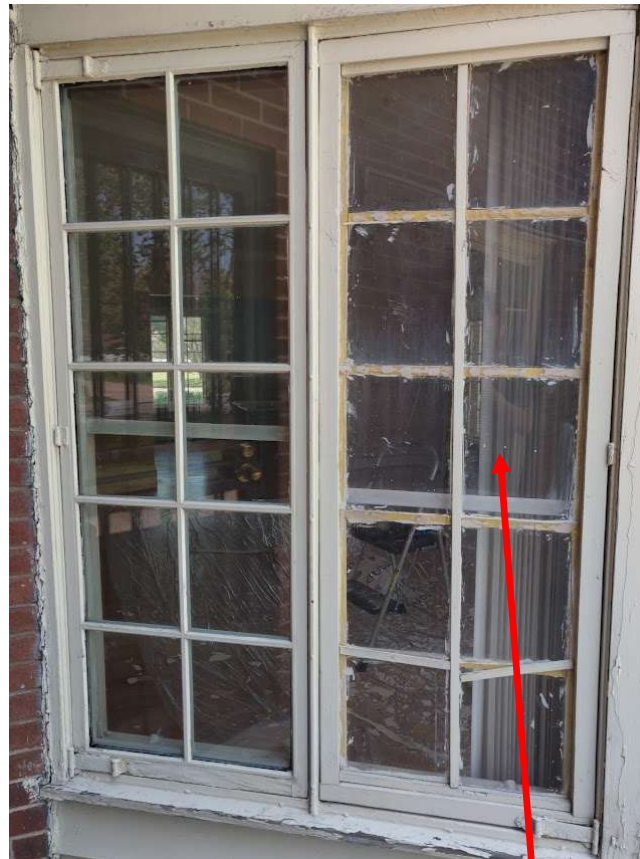
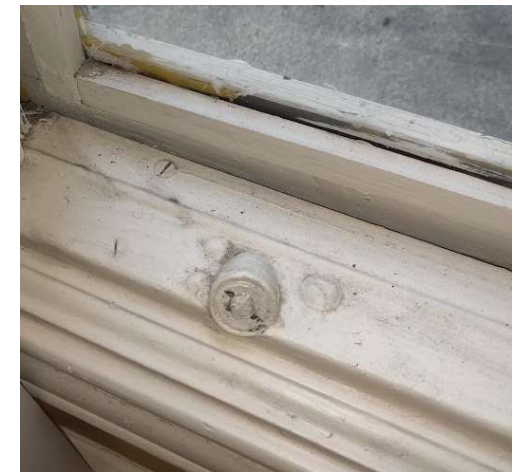
# Bay Window C (southern facing, west section)

This full pane is missing and is just a sheet of plexiglass

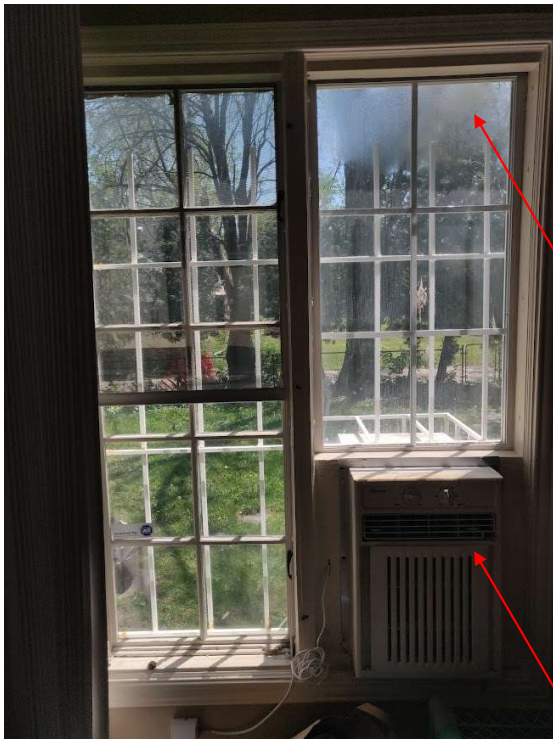
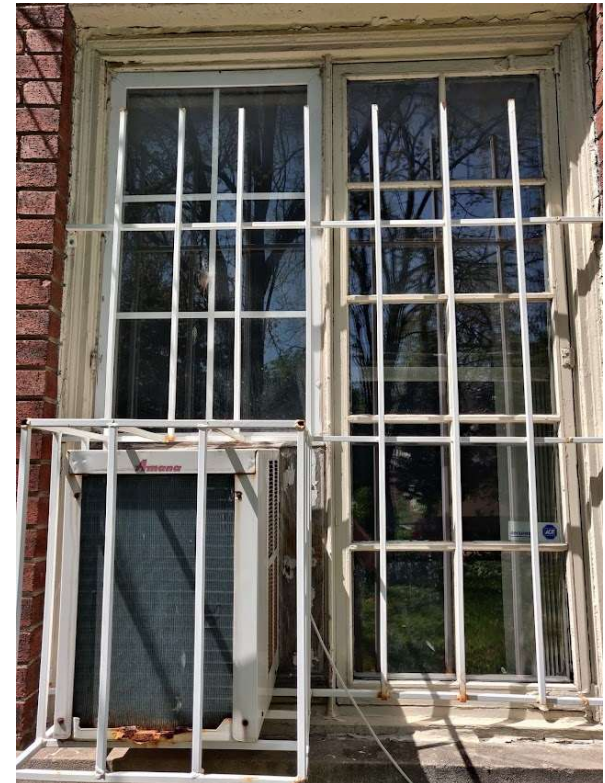
# Breakfast Nook window (1<sup>st</sup> floor, southern facing, center)

Vinyl window. Blown seal.

AC unit not needed.

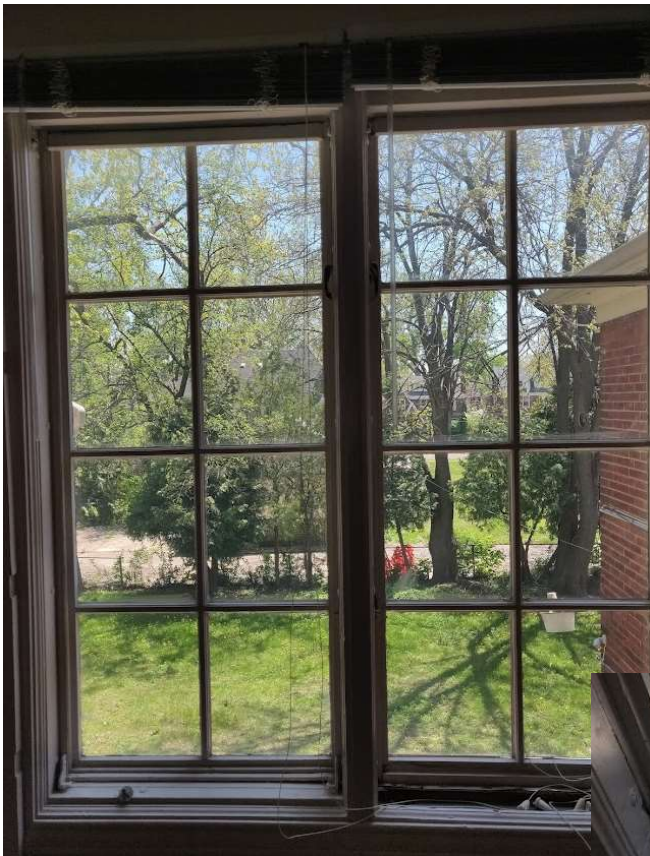
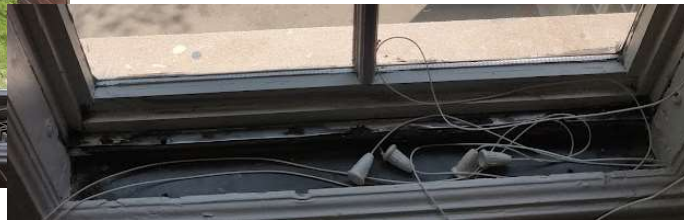
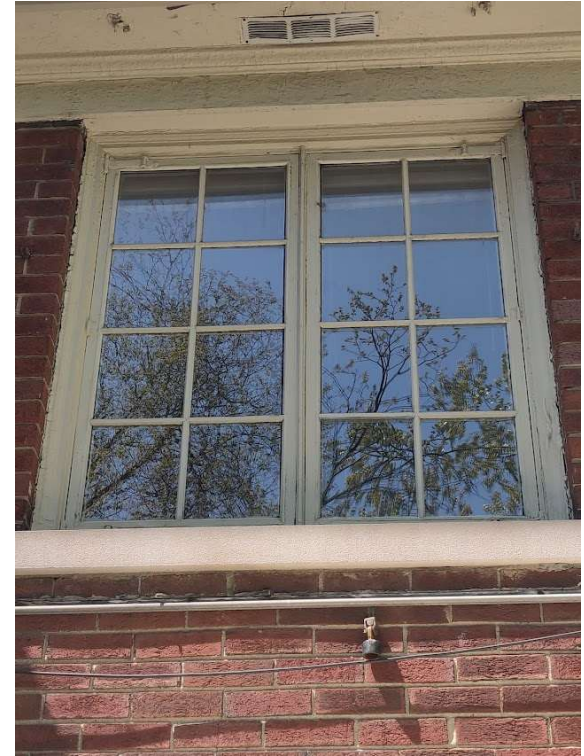
# Bedroom B (2<sup>nd</sup> floor, Southern facing, above Bay)

Rotting at frame is allowing moisture into 1st floor ceiling beneath window
