City of Detroit Historic District Commission

Red Arrow Lofts
1567 Church, Detroit, MI

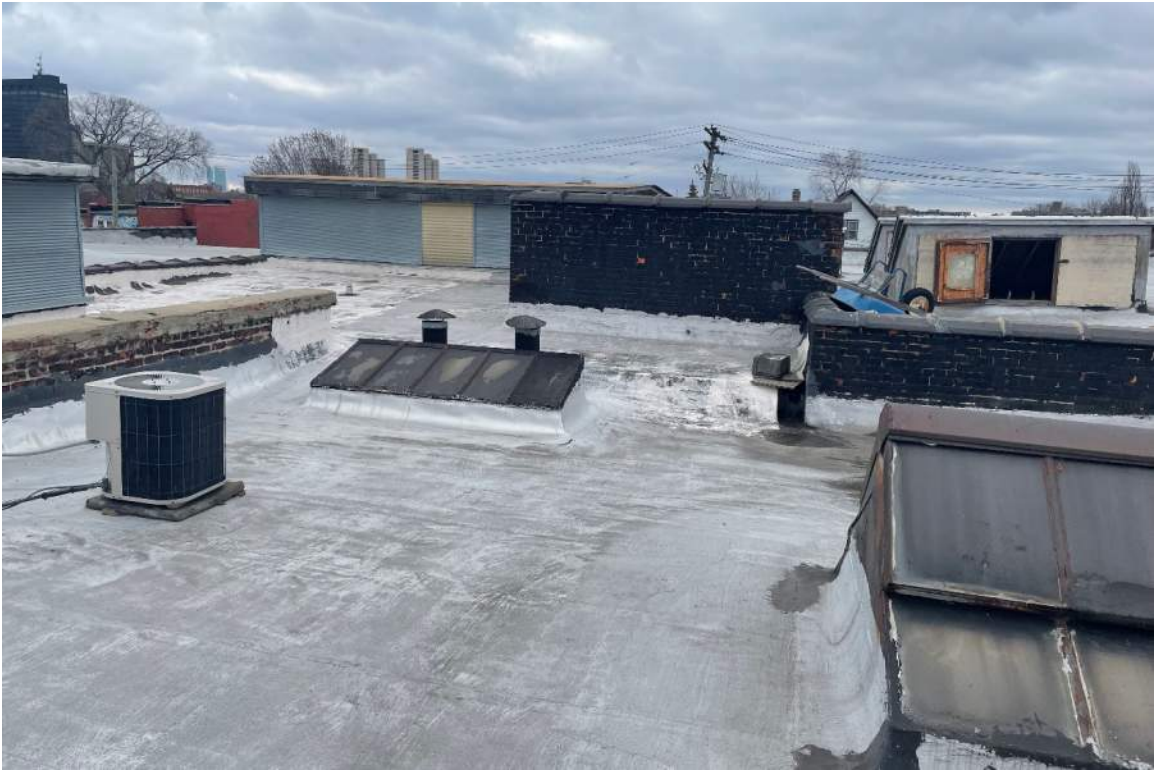
Figure #07: Exterior, Typical Roof Condition, Looking East. 03-31-22.

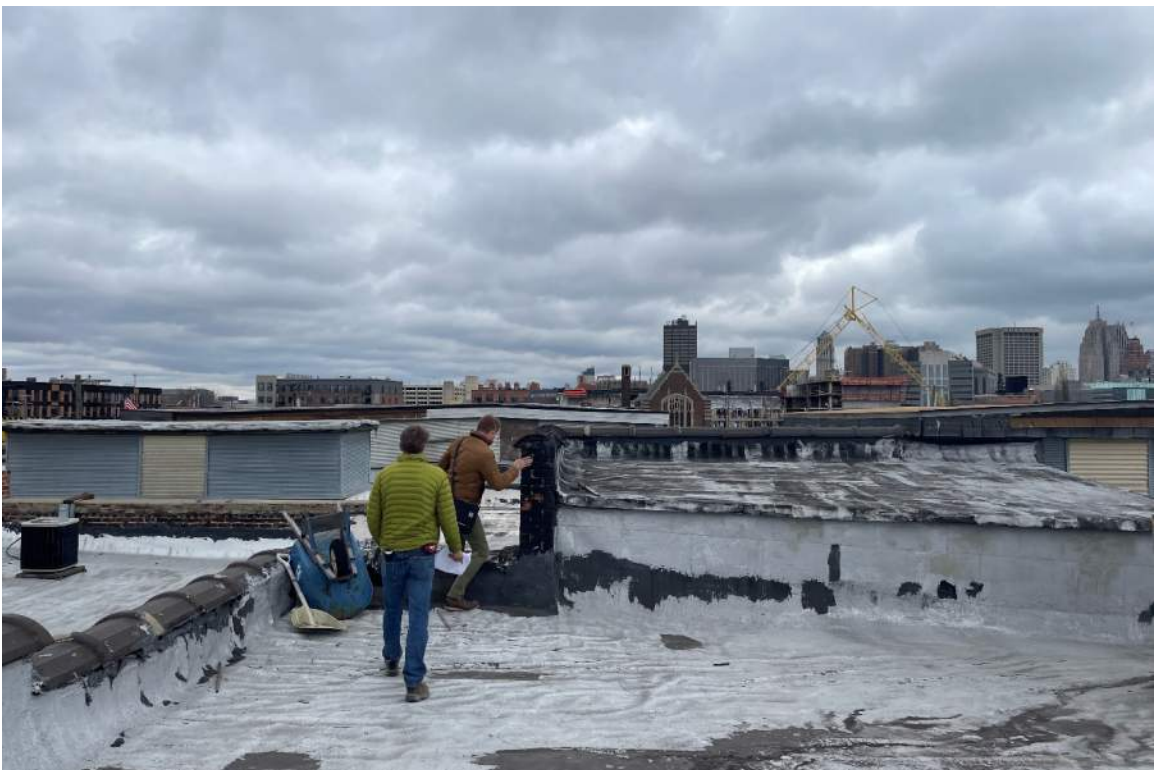
Figure #08: Exterior, Typical Roof Condition, Looking East. 03-31-22.

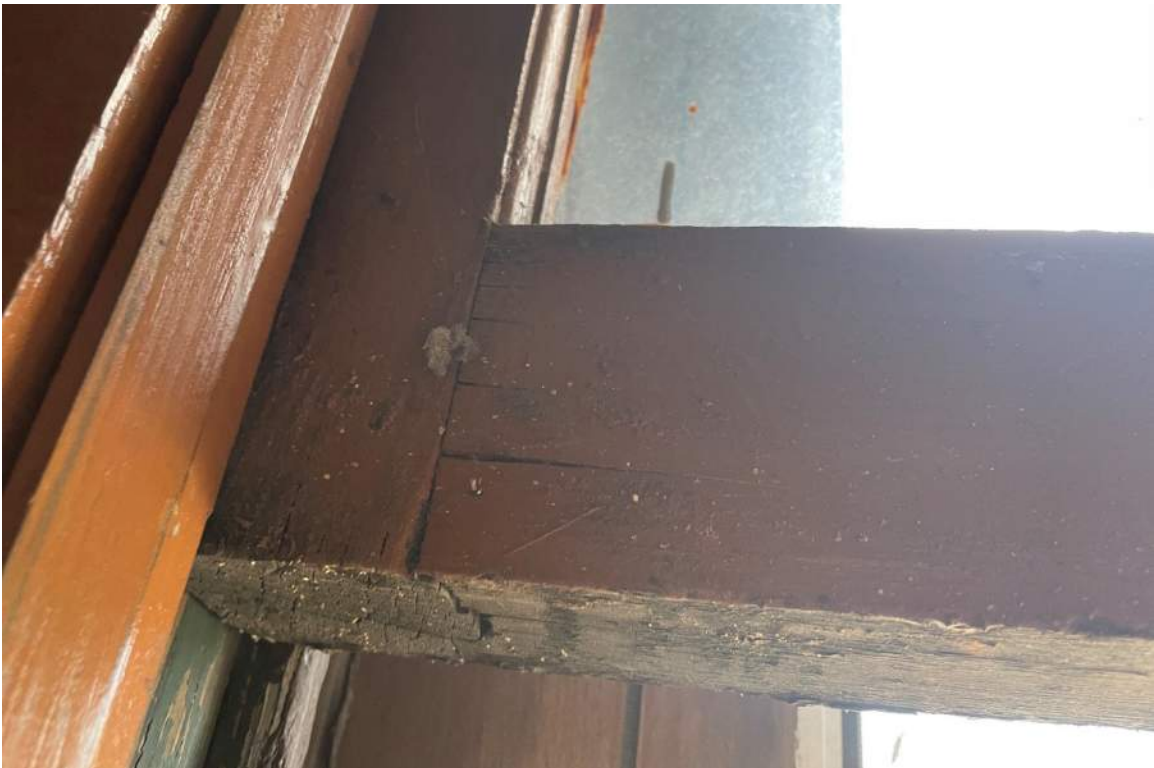
Figure #12: Interior, Typical sash joinery detail on window, Looking North. 06-08-22.

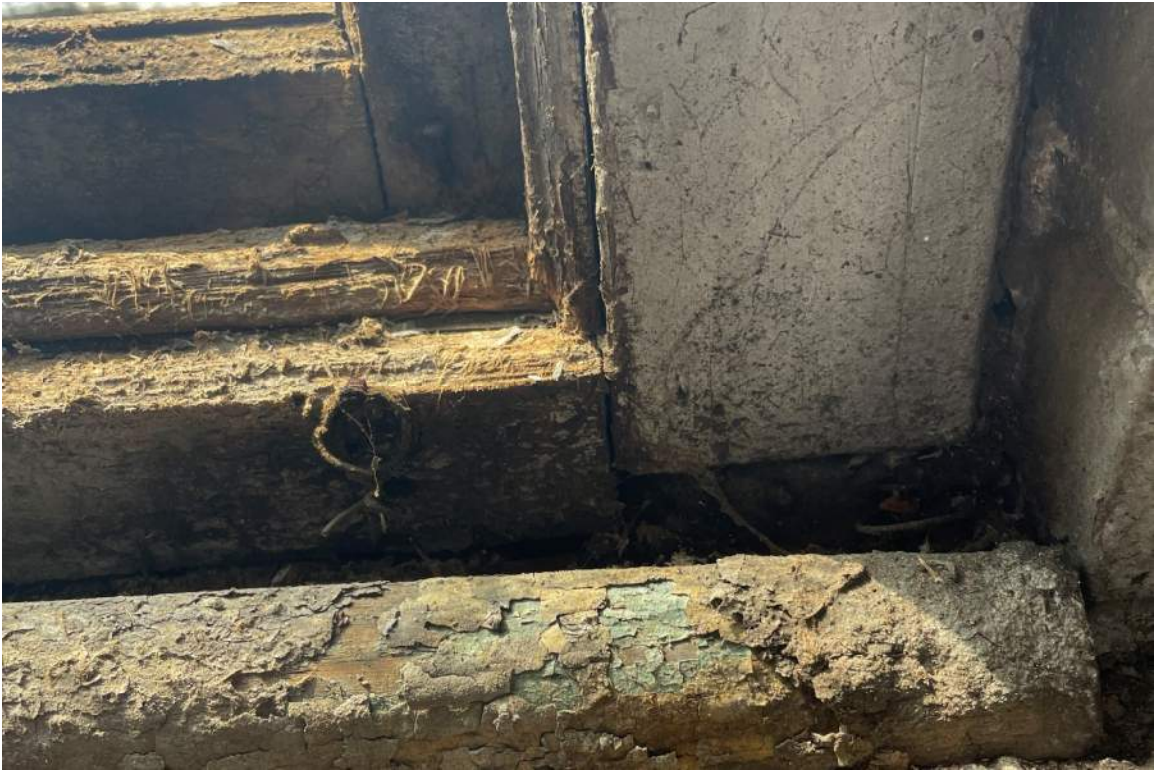
Figure #13: Interior, Typical sill and sash condition on South elevation windows, Looking South. 06-08-22.

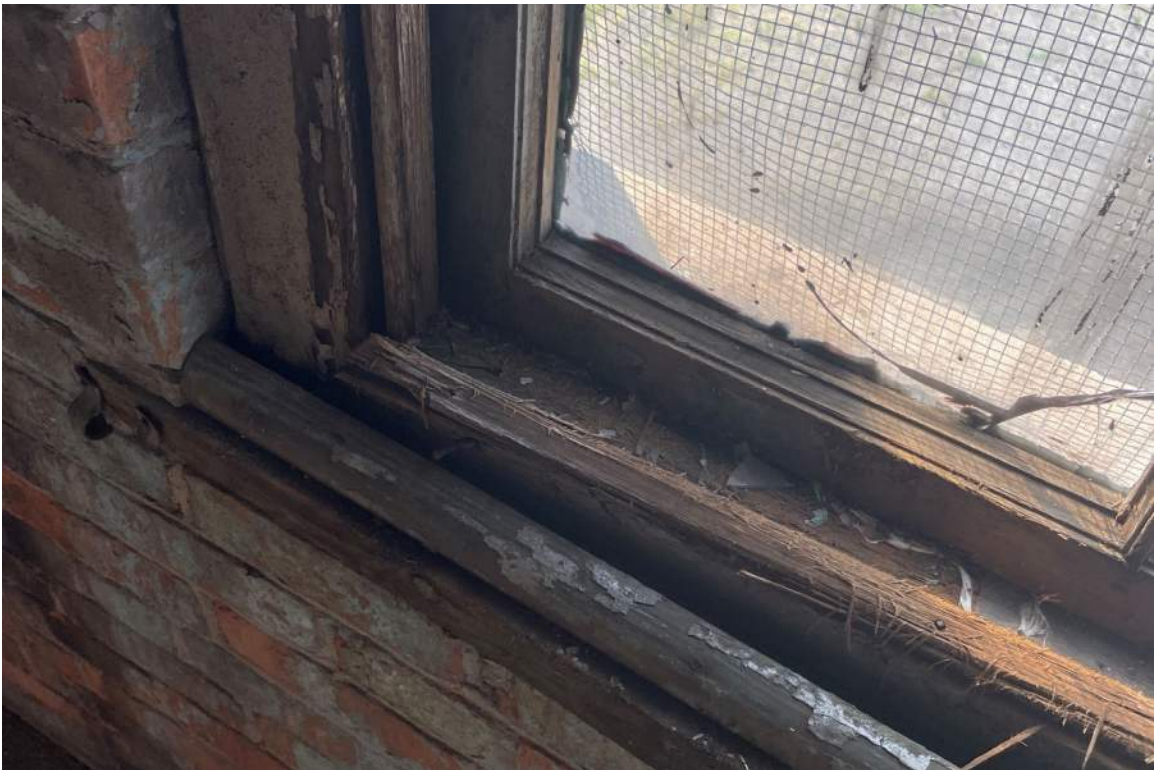
Figure #14: Interior, Typical sill and sash condition on South elevation windows, Looking South. 06-08-22.

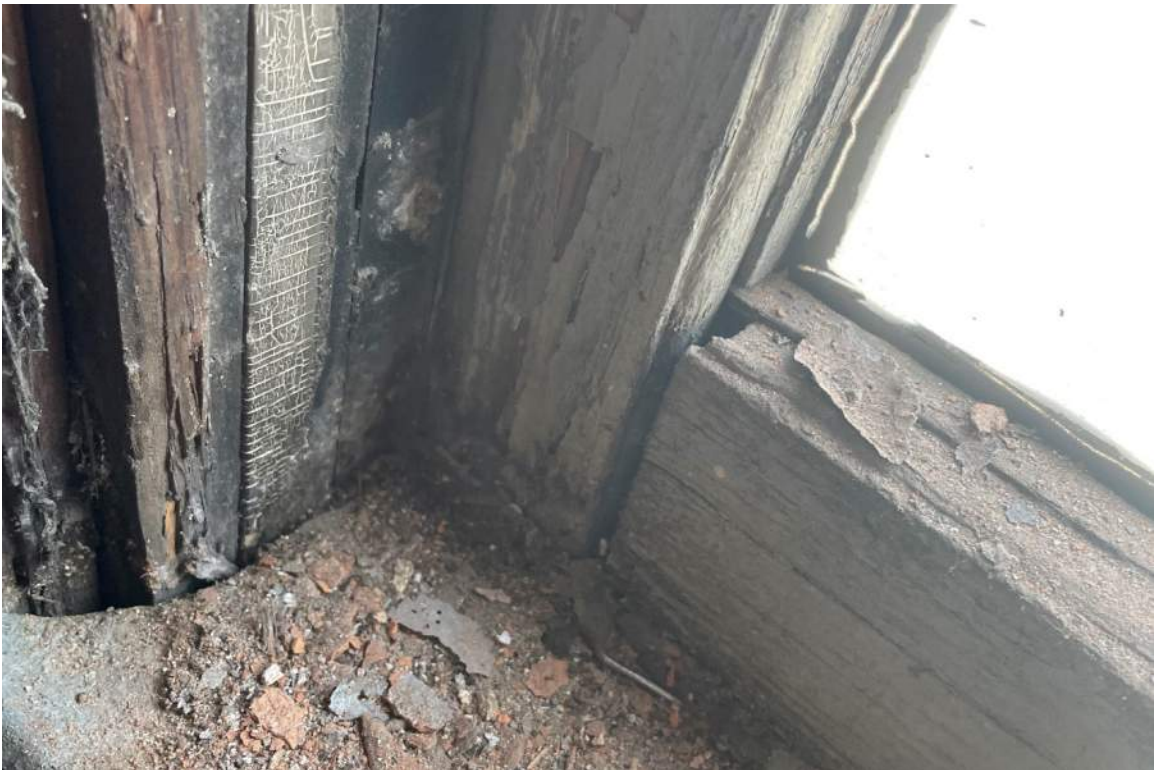
Figure #16: Interior, Typical sash joinery condition on West elevation, Looking West. 06-08-22.

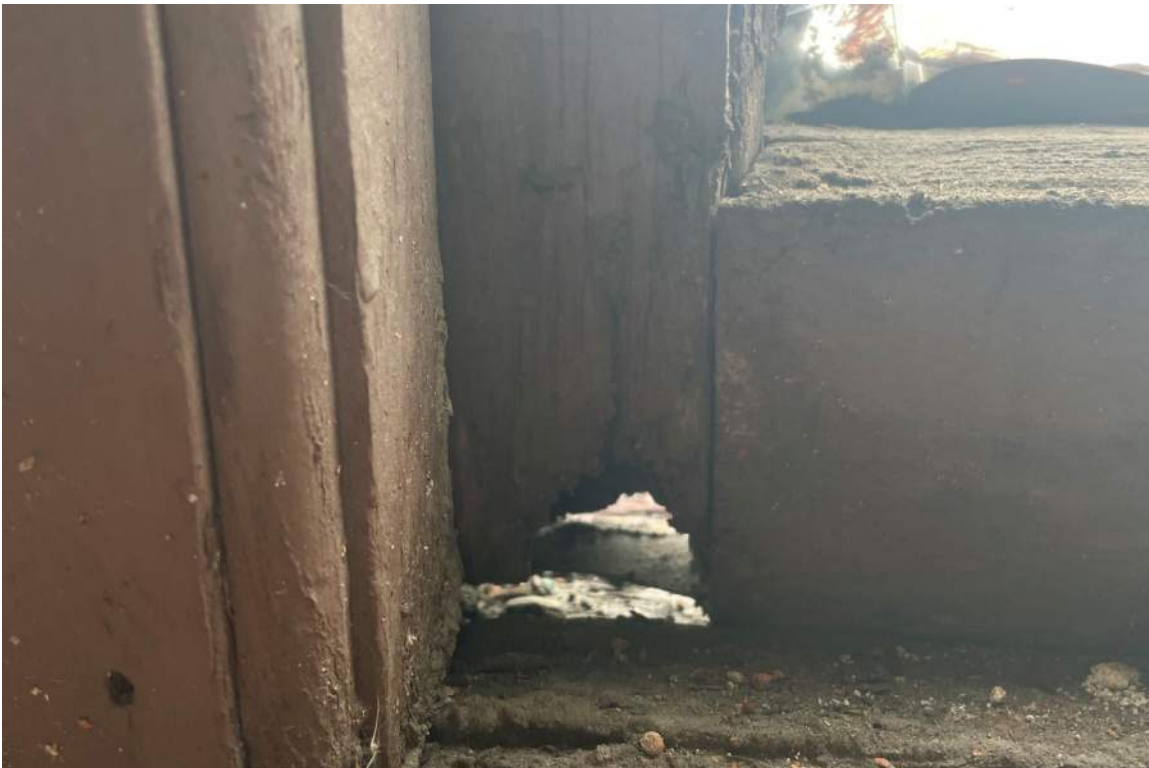
Figure #18: Interior, Typical sash joinery condition on West elevation, Looking West. 06-08-22.

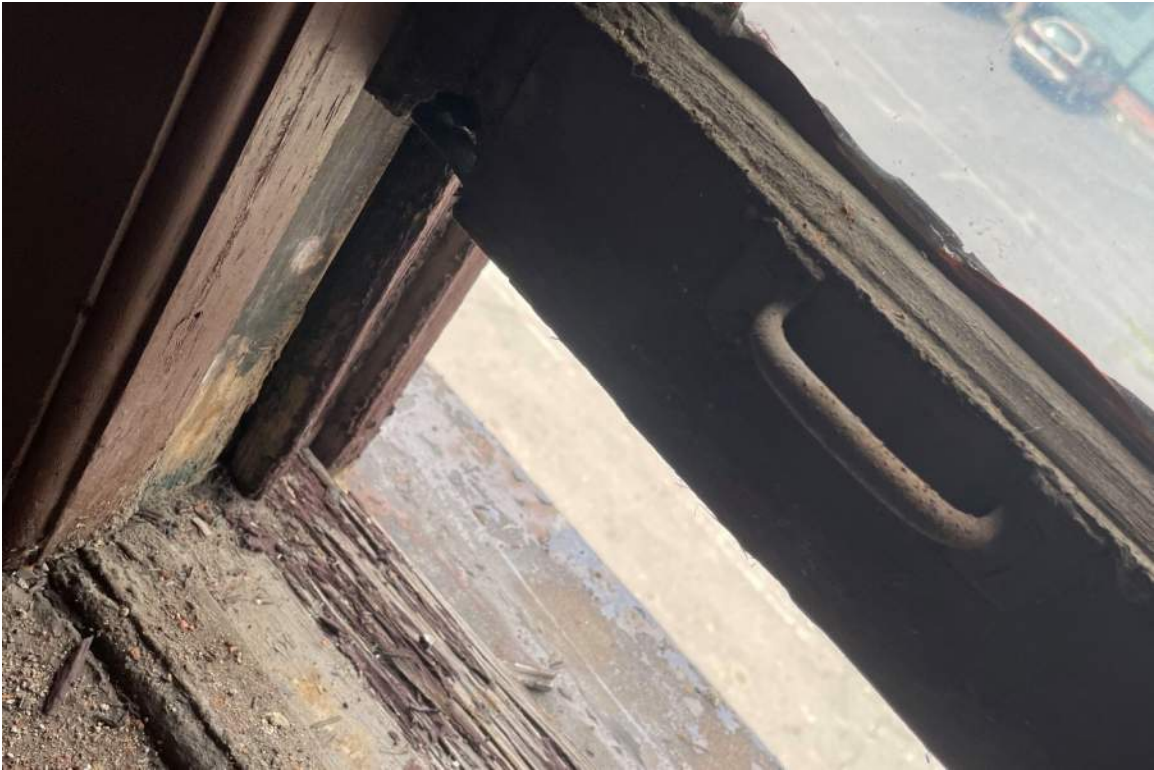
Figure #19: Interior, Typical sash and sill condition, Looking West. 06-08-22.

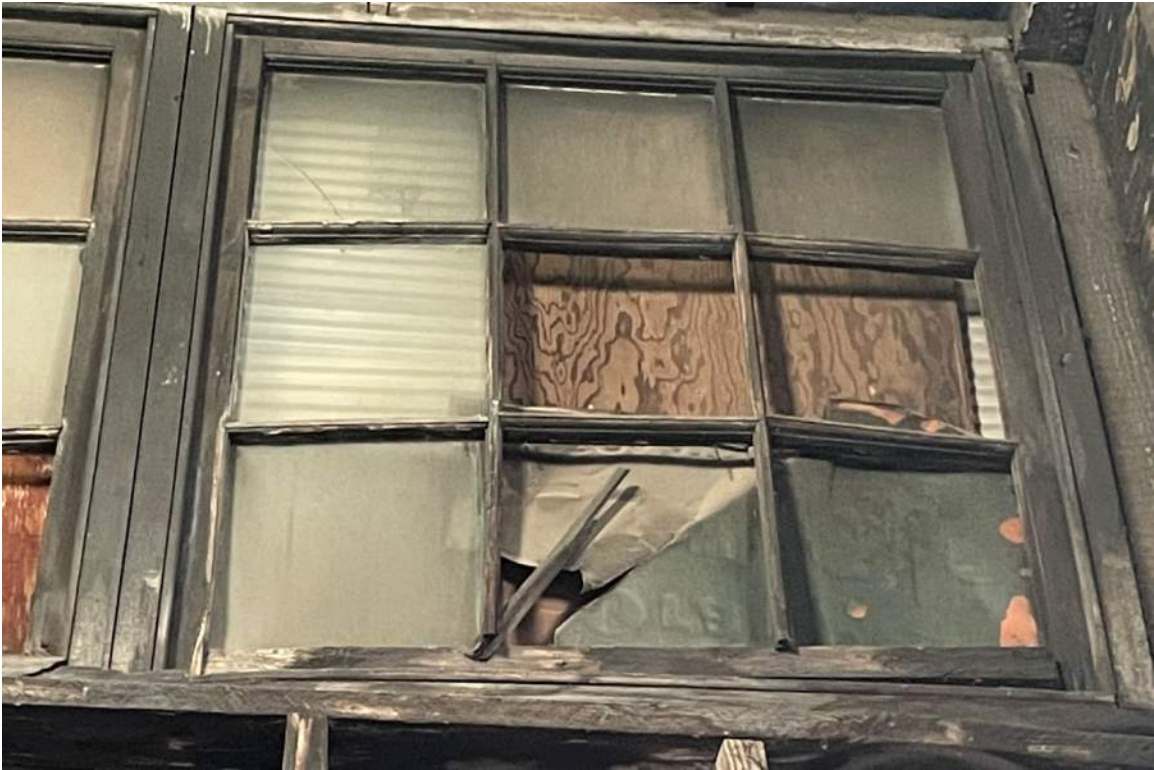
Figure #21: Interior, Detail of Roof Monitor Window Condition, Looking West and Up. 06-08-22.
