# THE CARRIAGE HOUSE

HDC REVIEW // SEPTEMBER 14, 2022

## 2827 JOHN R STREET

Re: Inspection of Brick Structure  
2827 John R St  
Detroit, MI

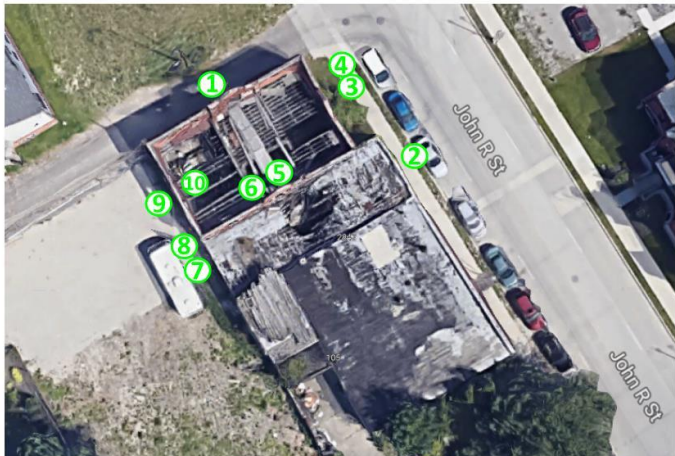
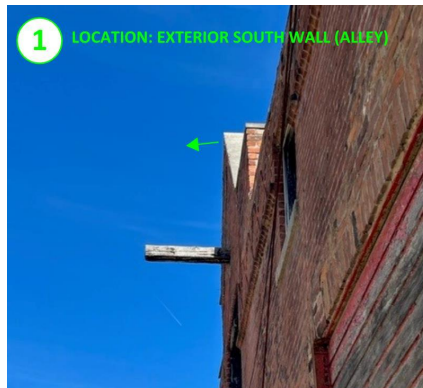
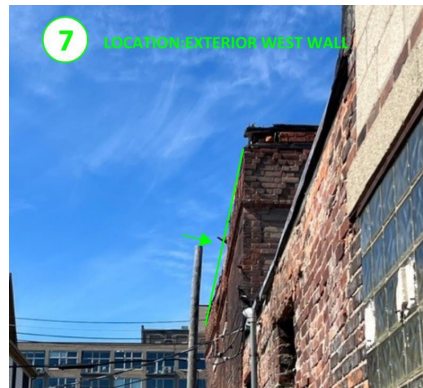
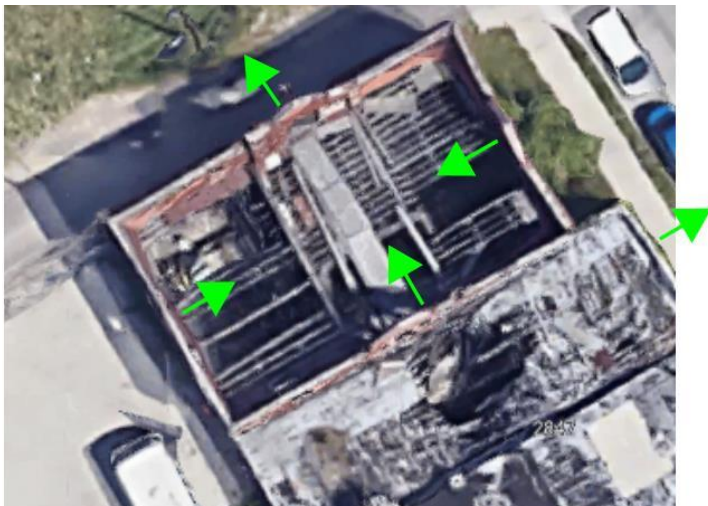
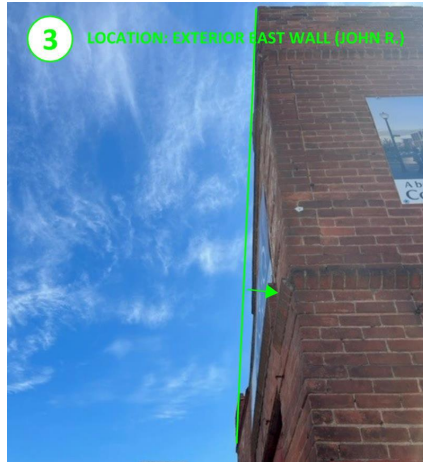
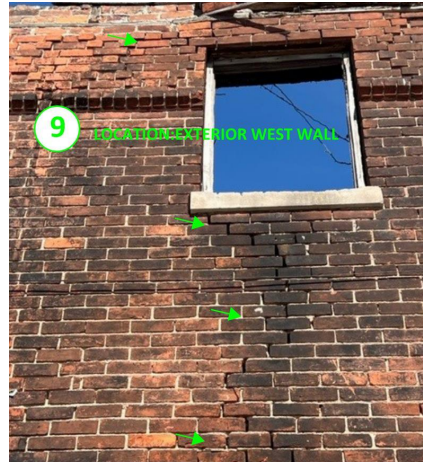
# EXISTING CONDITIONS

The building is in a failed state and should not be entered. With the unreinforced walls cantilevered from the foundation, the remaining structure is unstable. While significant portions of the roof and elevated floor have been damaged and removed, it is possible that the remaining wood joists are providing some support for the walls. Cleaning up the building and removing these pieces, which is required to install bracing, could further destabilize the structure. Additionally, the south portion of the structure is bracing the south wall of the Carriage House. Work to demolish this south portion of the building will impact the south wall of the Carriage House. Further, work to install foundations inside of the Carriage House will destabilize the foundations and the walls. Finally, vibrations related to construction activity north of the alley will likely further destabilize the walls of this structure.

- All four walls are no longer "straight" or Plumb. They have moved significantly since the covid "recess" and the original engineering study and proposed plan. They seem to have moved a considerable amount even since there were photos taken even just this past spring.

- The fire and loss and of the second floor and roof has left the walls unbraced as several lintels were burned which removed significant structural support and integrity.

It is my recommendation that this building be demolished in a controlled manner before it collapses.
