Tuesday, August 30th 2022

Re: Inspection of Brick Structure
2827 John R St
Detroit, MI

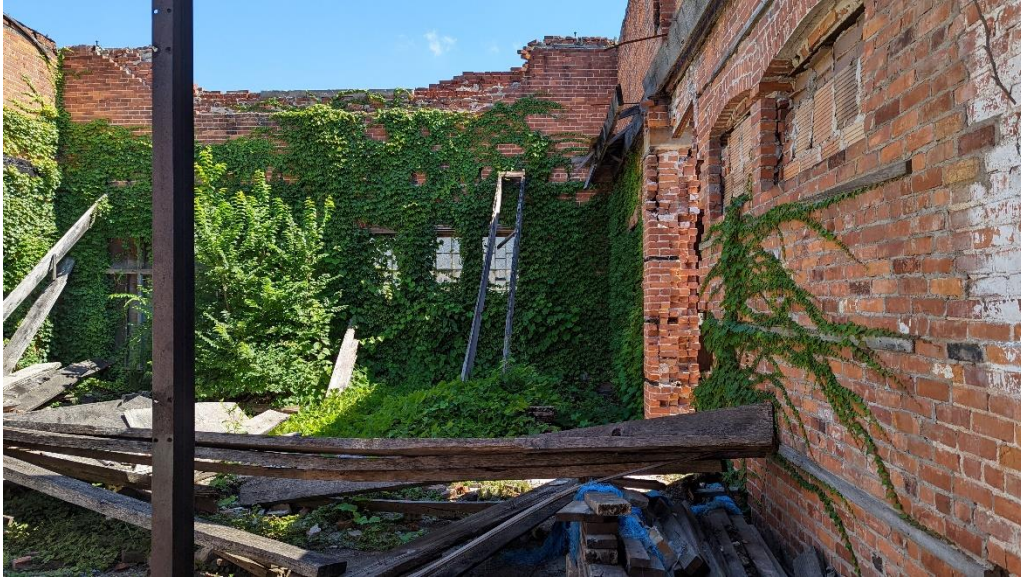
Picture 1: View of the Interior of the Carriage House

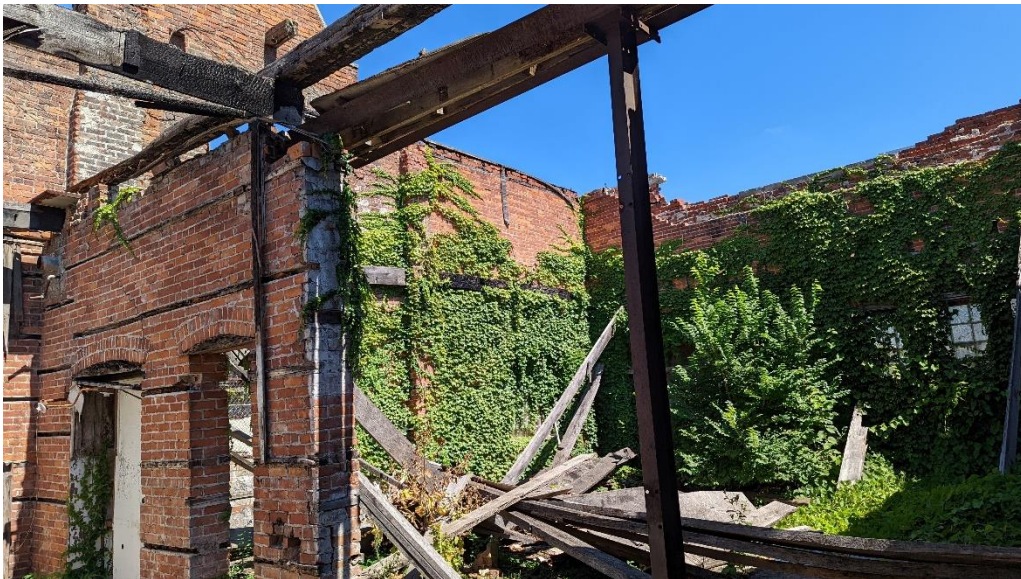
Picture 2: View of Interior of Carriage House

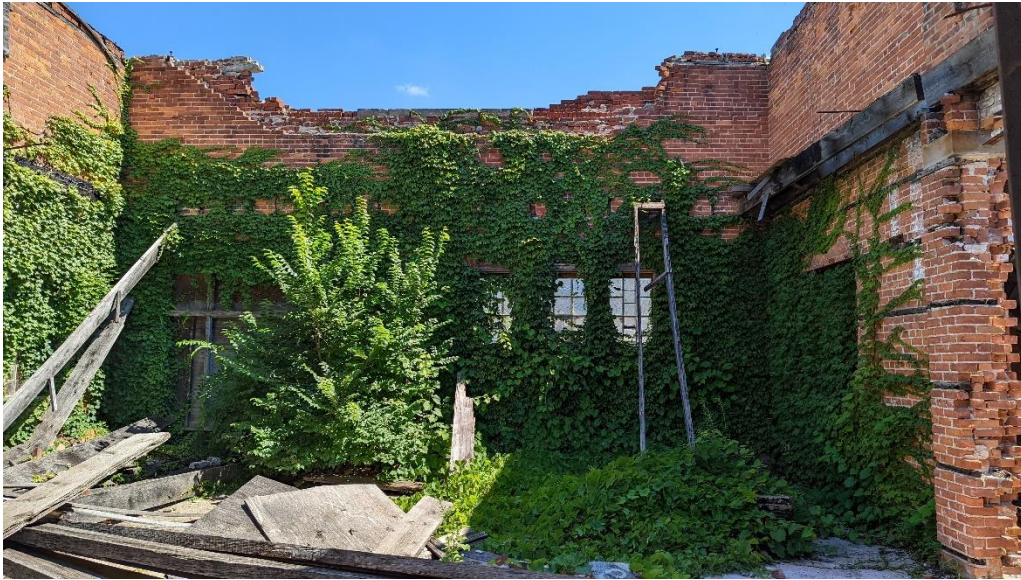
- a. The gable in the North wall is leaning toward the north (exterior of the building).
- b. The gable in the South wall is leaning toward the north (interior of the building).
- c. The gable in the East wall has already collapsed and the remaining portions of the wall lean toward the East (exterior of the building).
- d. The top of the West wall is leaning toward the east (interior of the building).

Picture 3: East Wall of Carriage House with Collapsed Gable

Some of the deterioration of this structure is increasing the exposure to the elements. The collapsed gable on the east wall has caused advanced deterioration of surrounding brick as it opened up the top of the wall allowing water to infiltrate the brick. The continued exposure to the elements are causing the bricks to continue to fall off the wall.

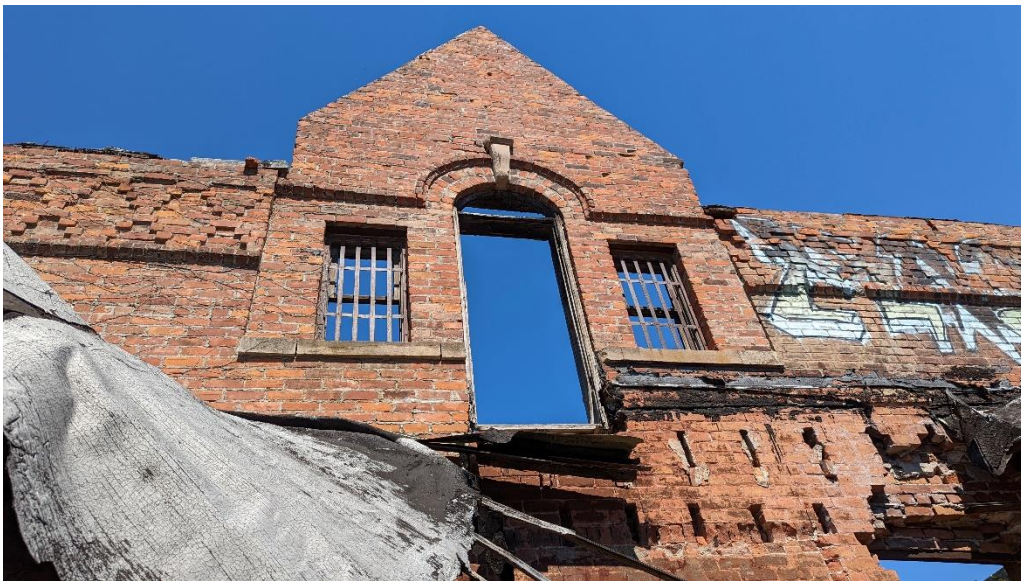
Picture 4: Leaning Gable in South Wall.

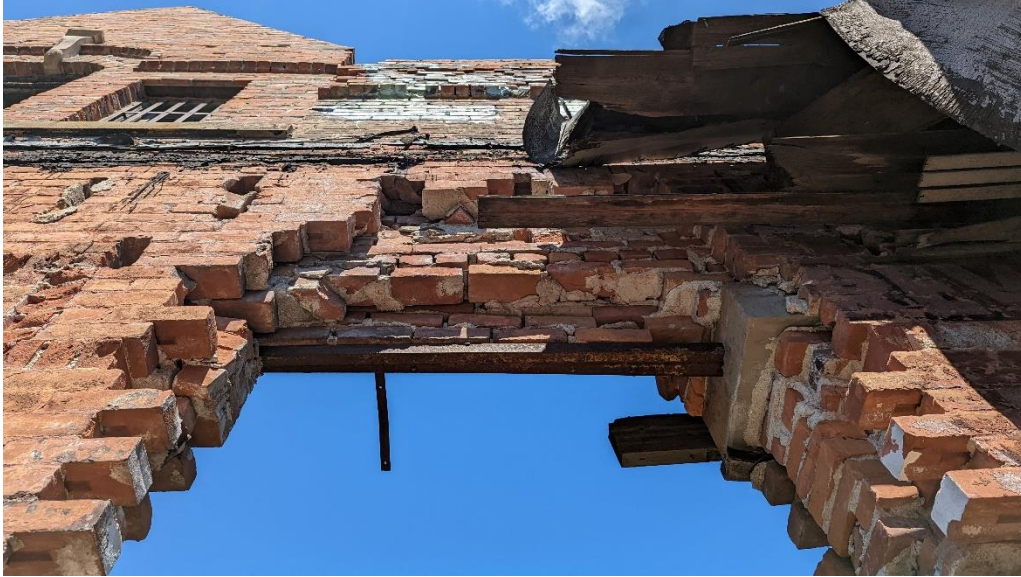
When originally built, the brick above the approximately 26 openings in the walls was supported by solid wood lintels. Of these lintels, all but 3 show extensive damage from either fire, water, or both. The three remaining lintels are in fair condition. Above the windows, the bricks are cracked and the bricks between the top of the opening and the cracks are slowly deflecting, or in the worst cases already falling. Eventually these portions of the wall will collapse.

Picture 5: Missing Lintel at Opening in South Wall.

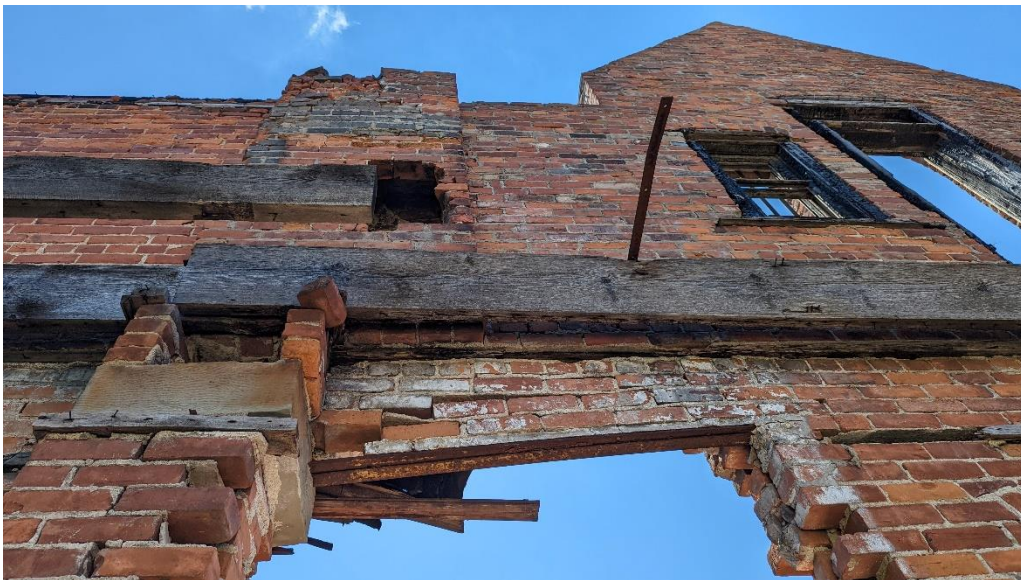
Picture 6: Missing Lintel at Opening in South Wall.

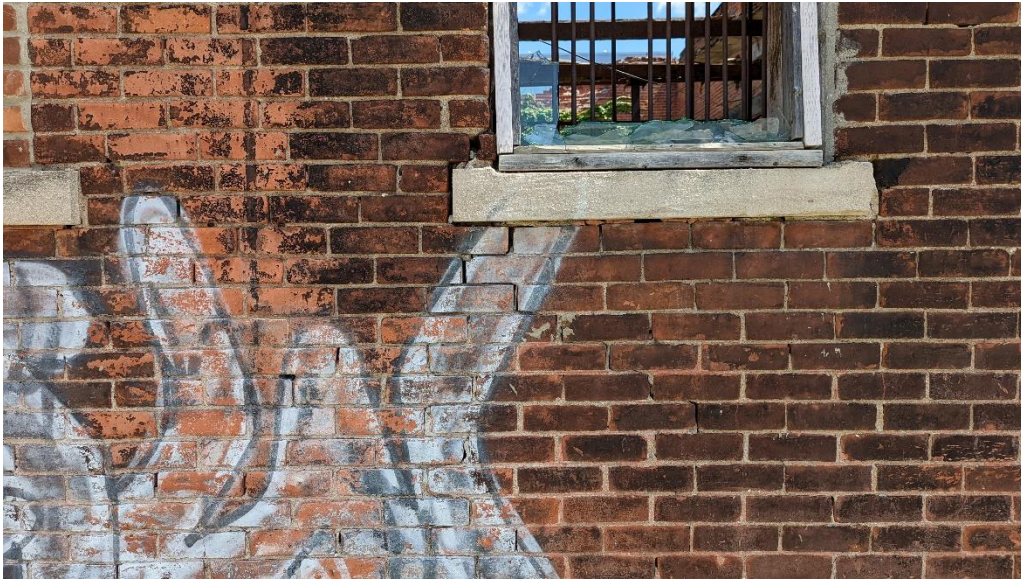
Picture 7: Crack Below Window in West Wall

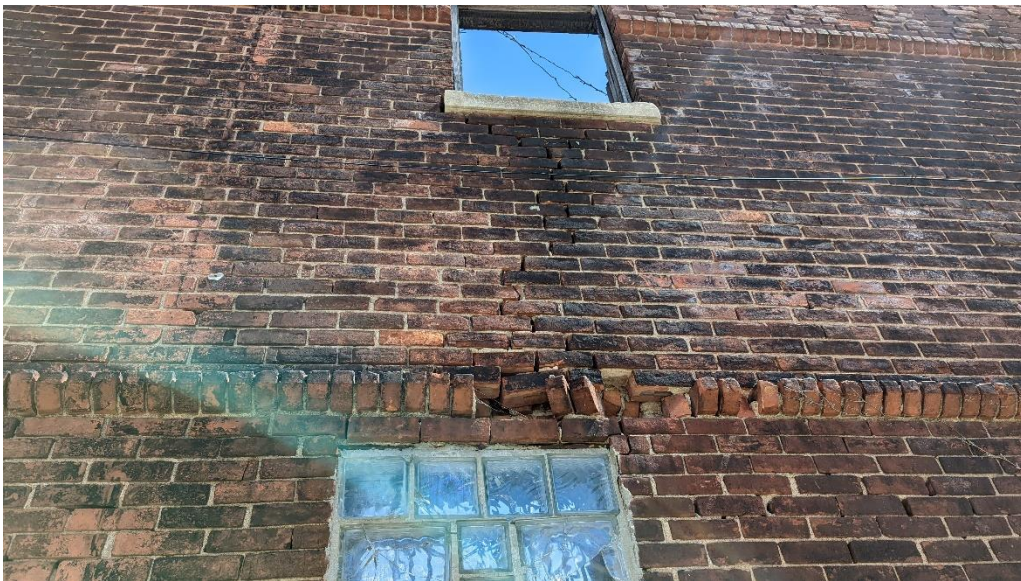
Picture 8: Crack Between Windows in West Wall

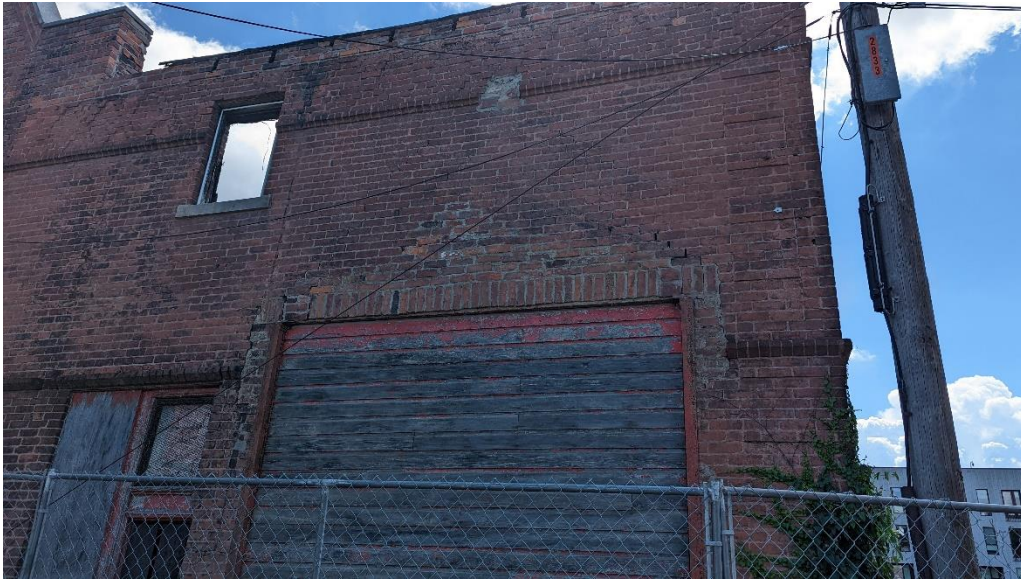
Picture 9: Crack Above Window in North Wall

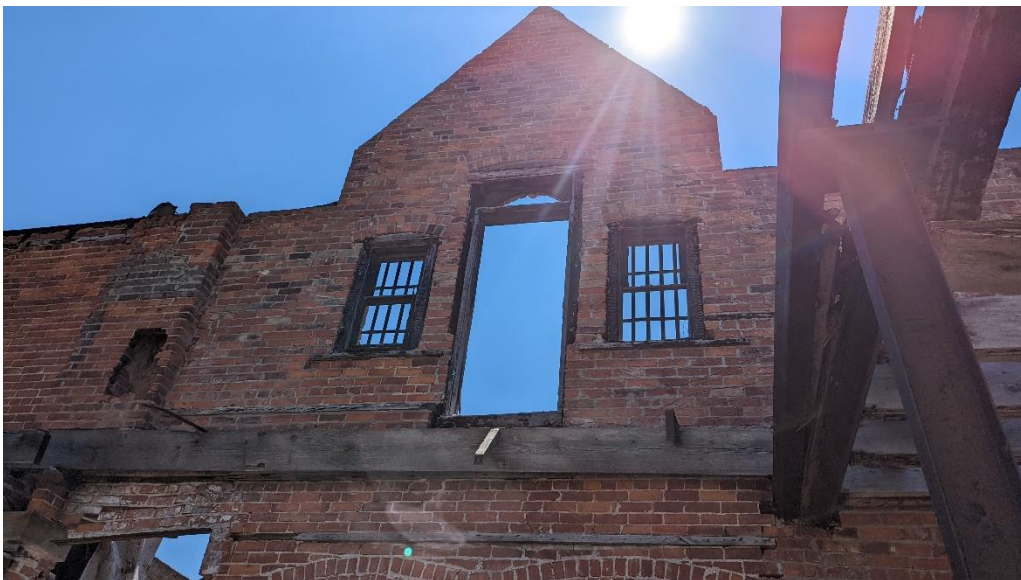
The large number of openings in the walls reduces the stiffness and integrity of the walls and have caused the walls to twist as they move. This is visible in openings that are no longer square and in walls that are moving in different directions at the top and middle of the walls.

Picture 10: View of South Wall with Non Square Openings

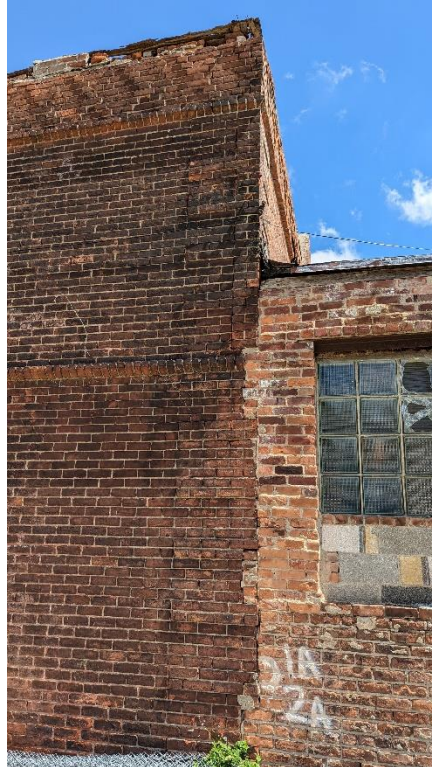
The intersections of the walls at the corners have cracks running vertically along one of the intersecting walls. As the walls move out at the top they pull away from the intersecting wall. These cracks are visible along the full height of the wall.

Picture 11: Crack Along Intersection of Walls at Southwest Corner.

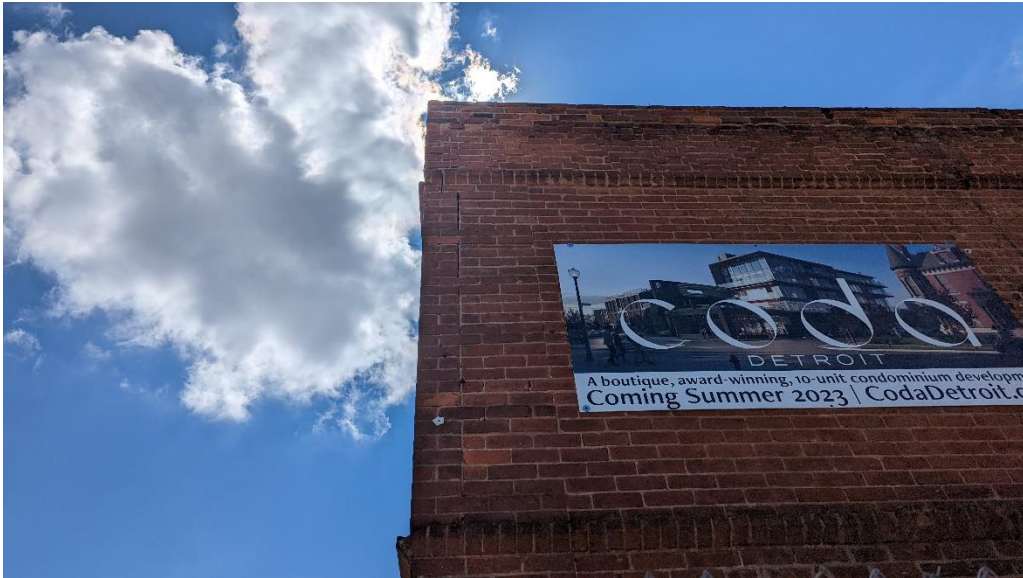
Picture 12: Crack Along Intersection of Walls at Northeast Corner.

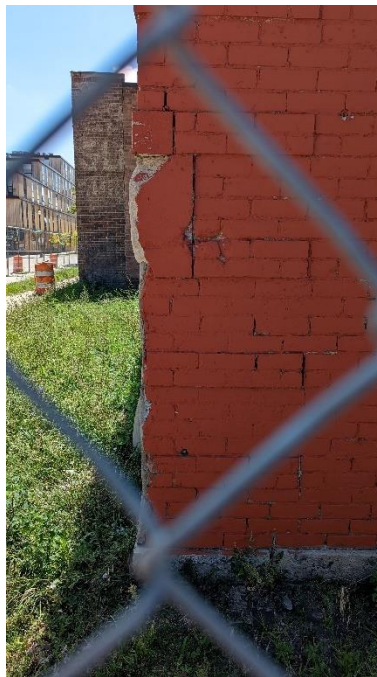
Picture 13: Crack Along Intersection of Walls at Northeast Corner.

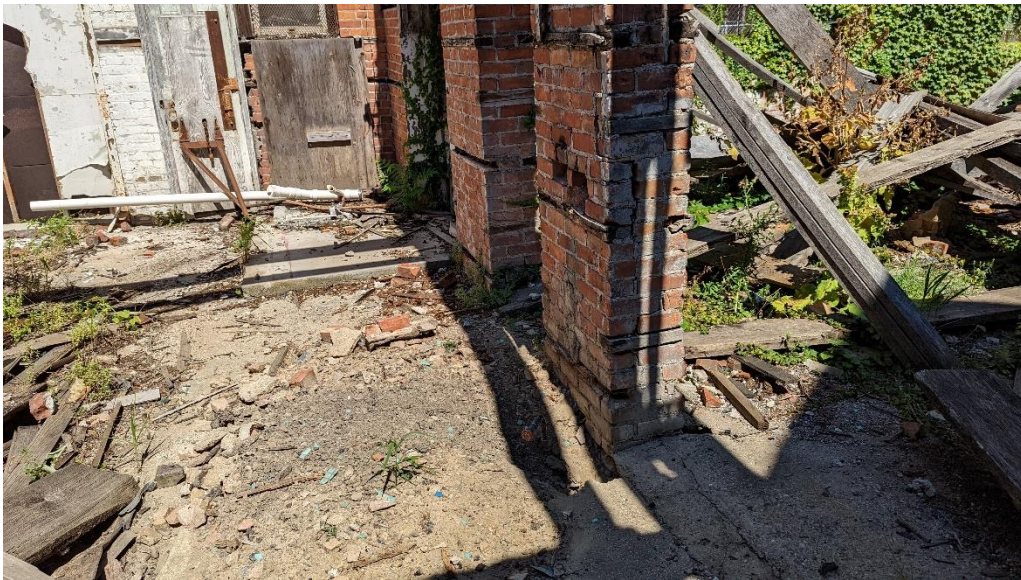
The geotechnical investigation found that the foundations for the Carriage House walls are stacked stone. The owner of the building indicated that for a time a water line was pouring water onto the building floor. A sinkhole is present in the alley north of the building in the vicinity of this pipe. It appears that this prolonged exposure to water has undermined the foundations. Further investigation into the damage to the foundations would require unsafe excavation at the inside and outside of the building walls. This investigative process could lead to further building damage.

Picture 14: Loss of Soil at Foundation of the Center Wall.

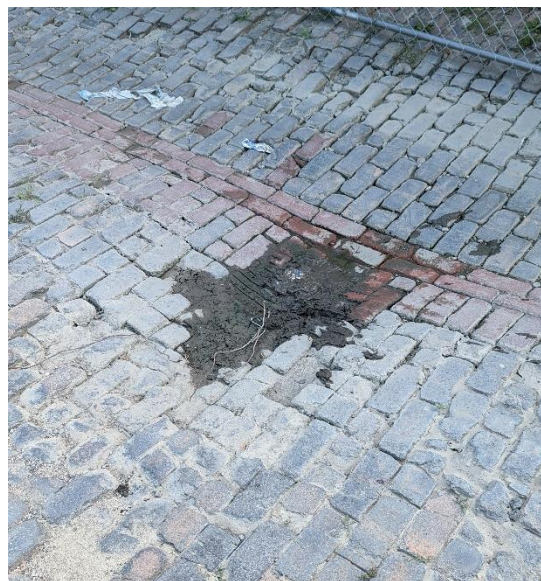
Picture 15: Sinkhole in Alley.

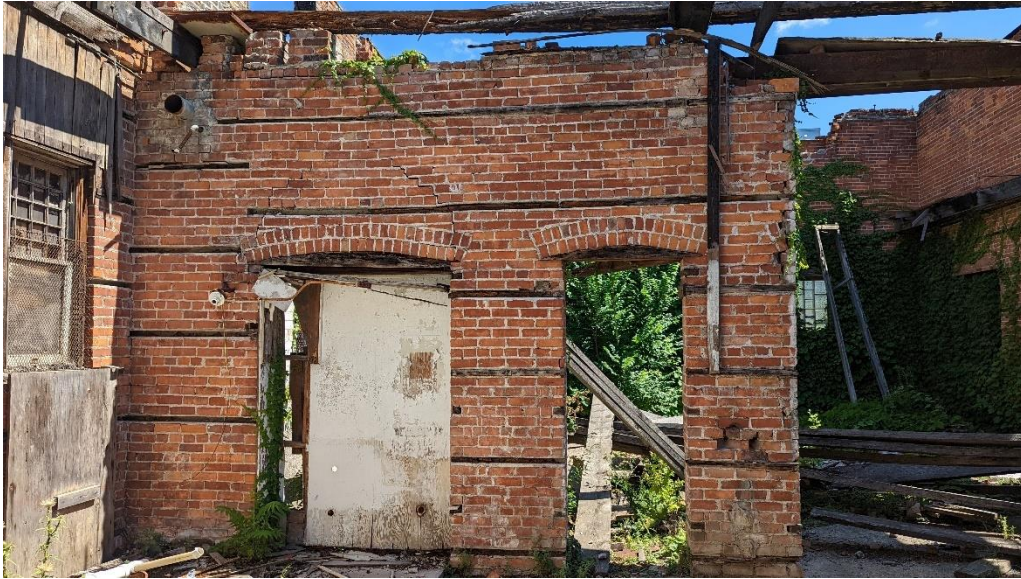
The interior brick wall in the center of the north wall is deteriorated in a similar way to the exterior walls. The lintels have been damaged and have significant section loss. This has led to cracks in the mortar joints above the north opening. The southernmost pier in this wall is deteriorating causing it to lean to the west near the floor and is in danger of collapse. This buckling has caused the wall to move at the top toward the east.

Picture 16: Wall in Center of Building Missing Lintels.

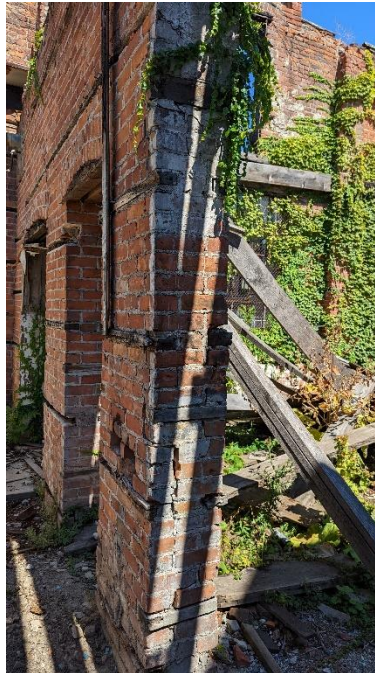
Picture 17: Wall in Center of Building.

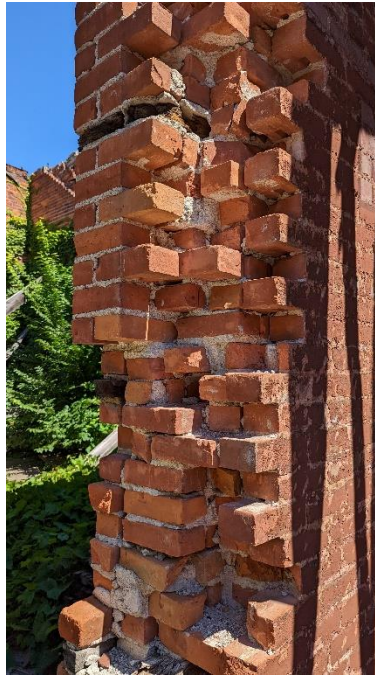
In addition to the damaged location at the east wall, the deterioration is most noticeable at the top of the walls, above openings and along both vertical sides of the opening on the east end of the south wall. Because it is unsafe to climb to the upper elevations of the wall it is not possible to ascertain the condition of these bricks now exposed to weather. It is likely that the infiltration of water and freeze thaw cycles experienced in the winter have caused the brick to deteriorate.

Picture 18: Loose Brick at Opening in South Wall.

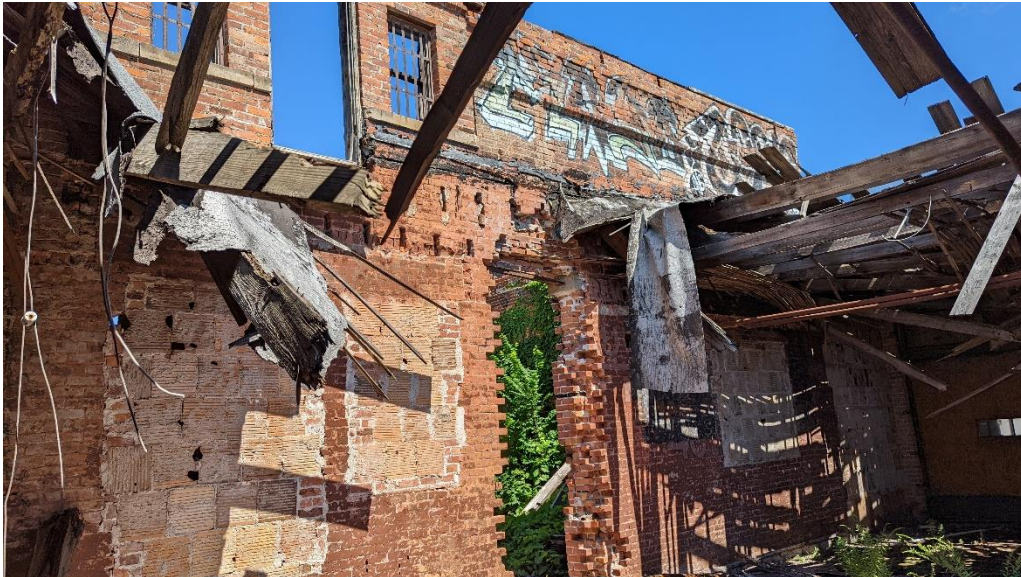
Picture A. 1: View of South Wall.

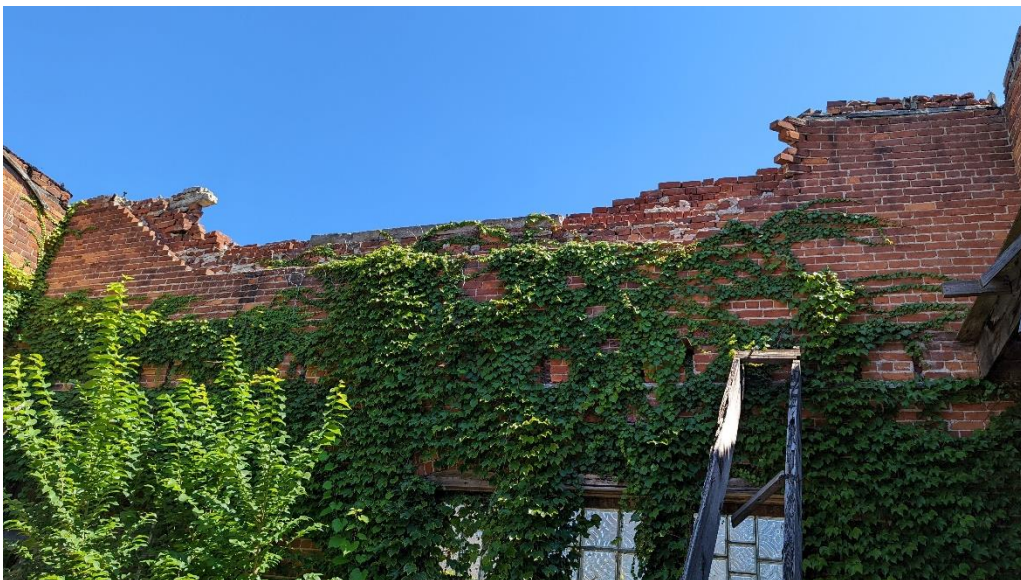
Picture A. 2: View of East Wall

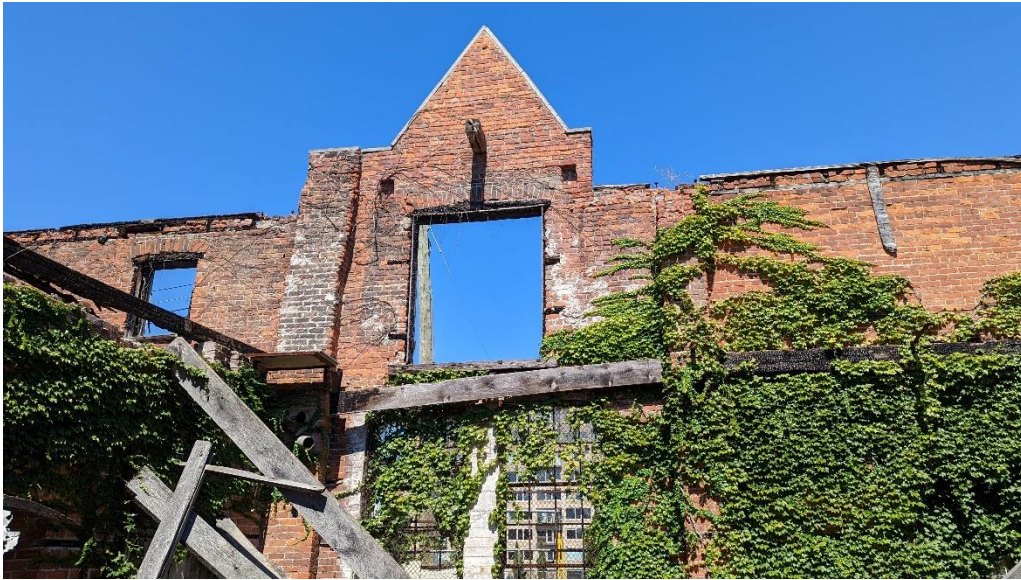
Picture A. 3: View of North Wall.

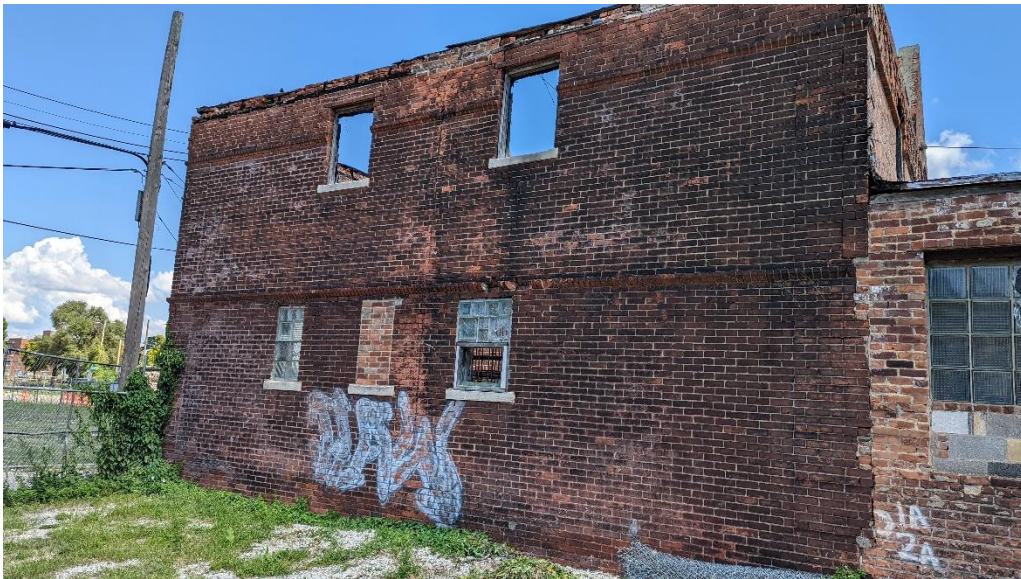
Picture A. 4: View of West Wall.

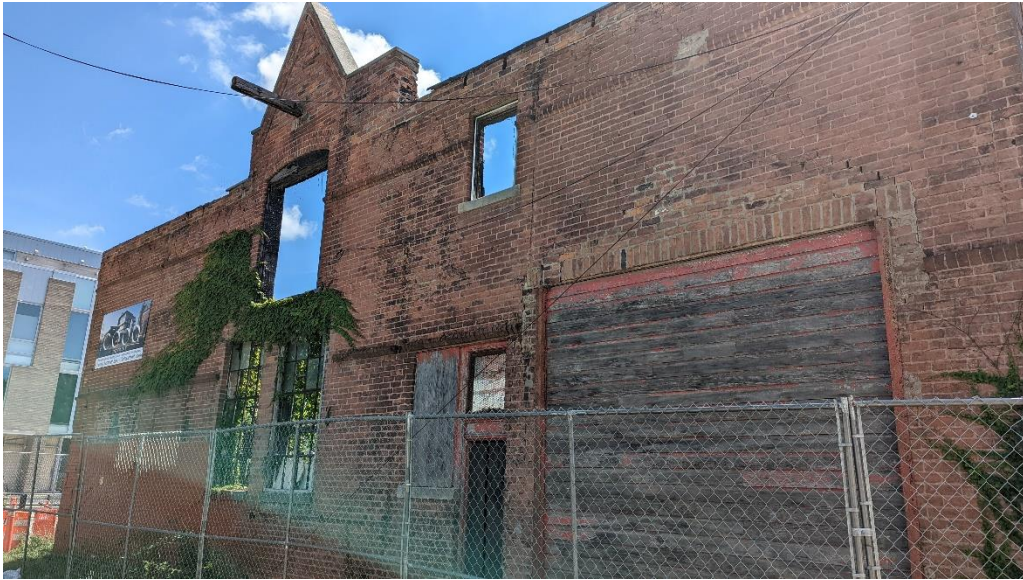
Picture A. 5: Exterior View of North Wall.

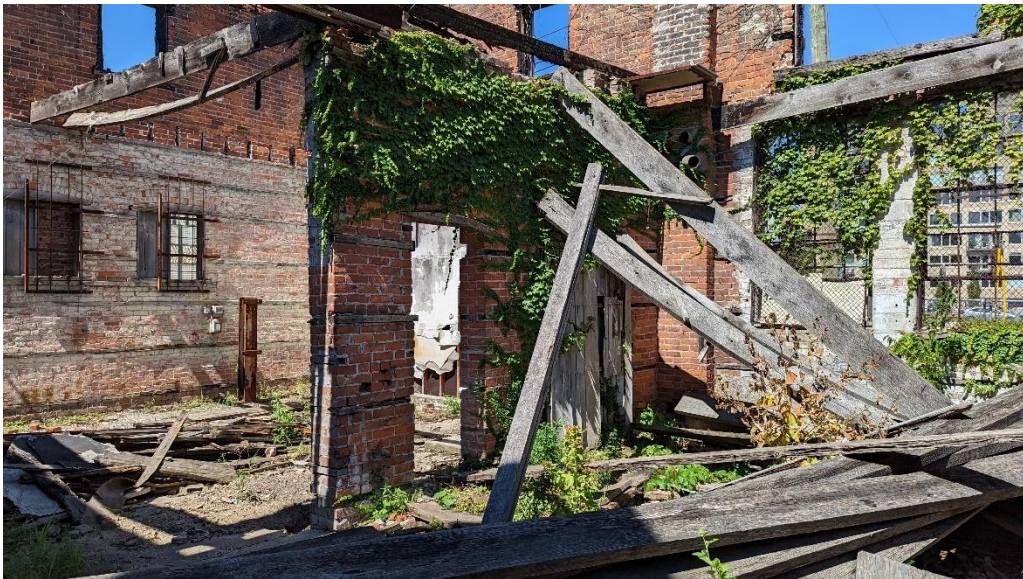
Picture A. 6: Interior View of the Carriage House.

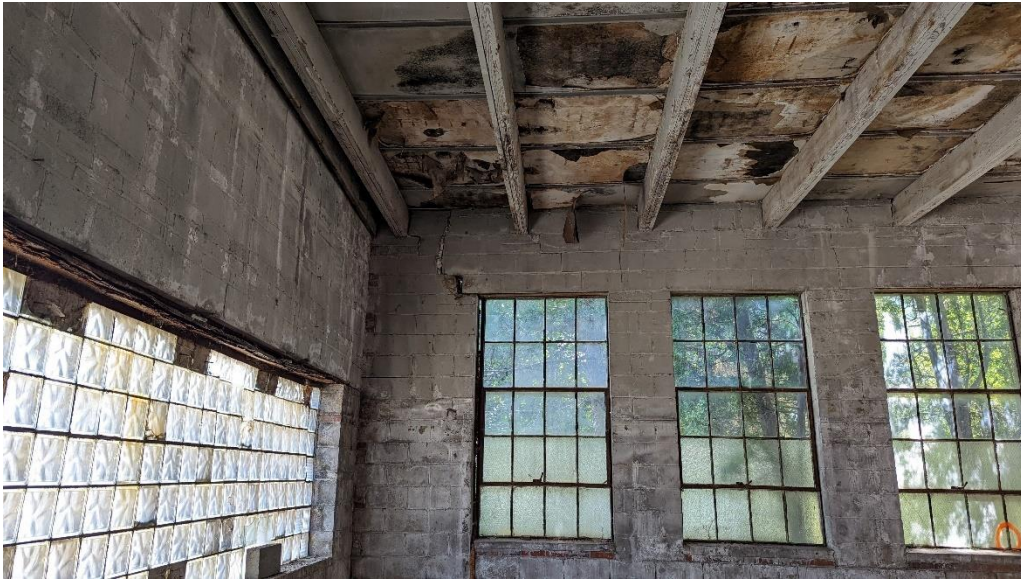
Picture A. 7: Interior View of the South Addition.

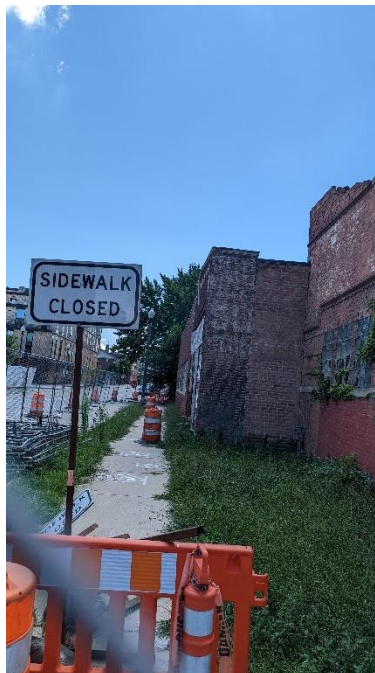
Picture A. 8: Failed Façade of the South Addition.
