Report on the
Assessment of the Historic Murals
at the
R. Thornton Brodhead Armory
Detroit, MI

Executed by Historic Surfaces LLC
July 2022

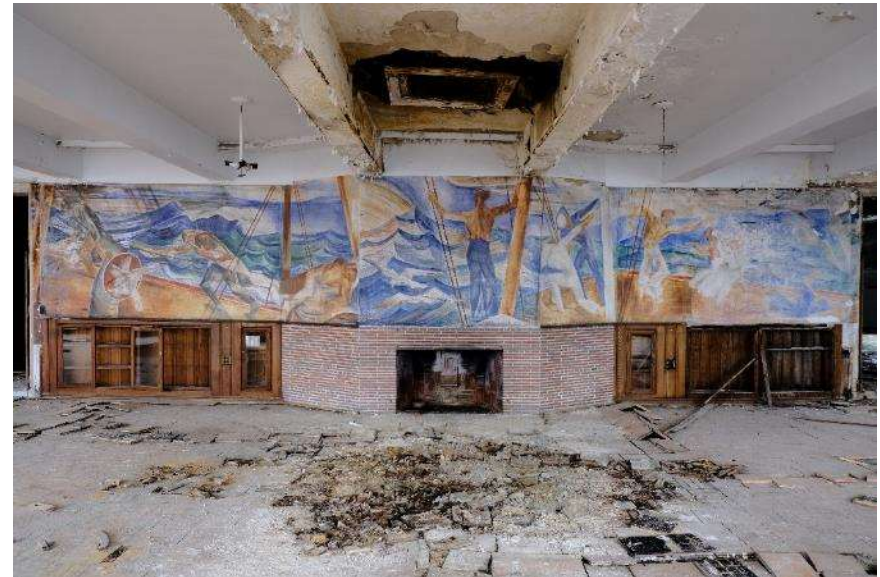
Wardroom Mural Condition

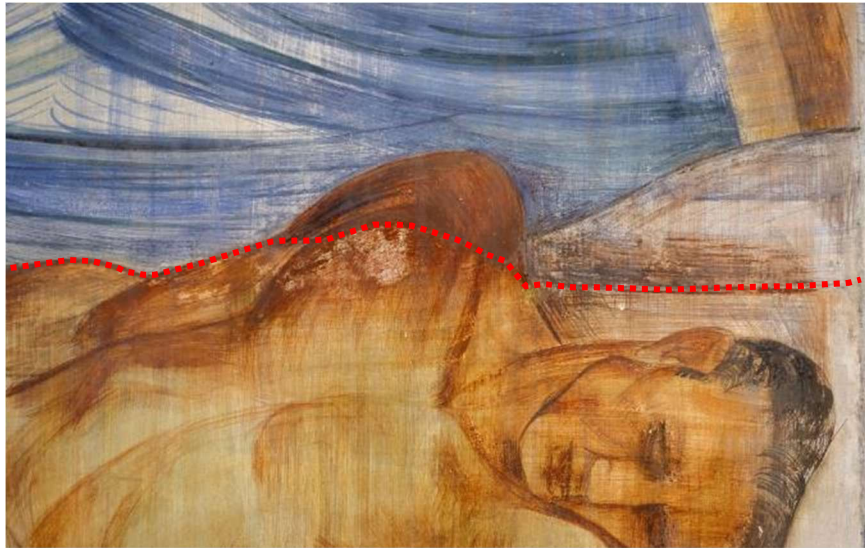
Red line indicates the edge of the 'giornato'

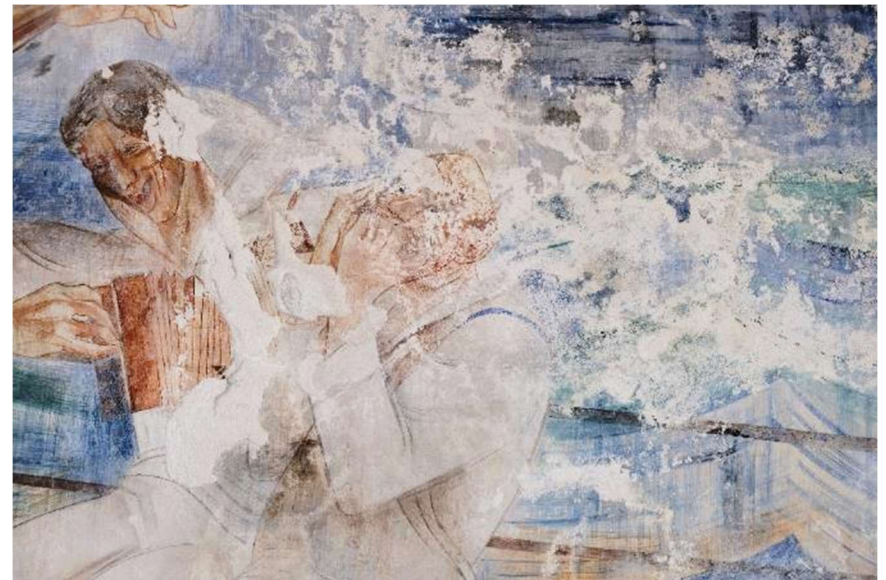
Detail of the significant water damage on the East fresco panel (WN5)

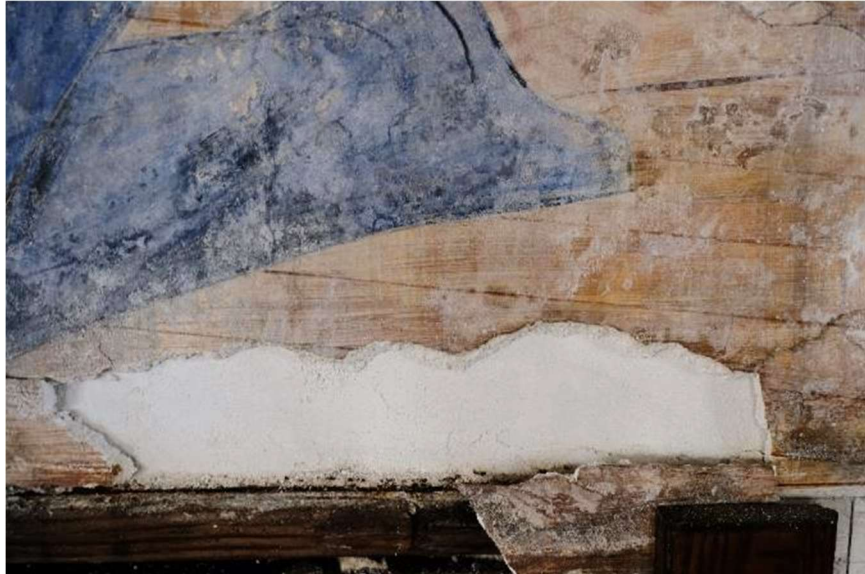
Detail showing the loss at the bottom of panel WN5.

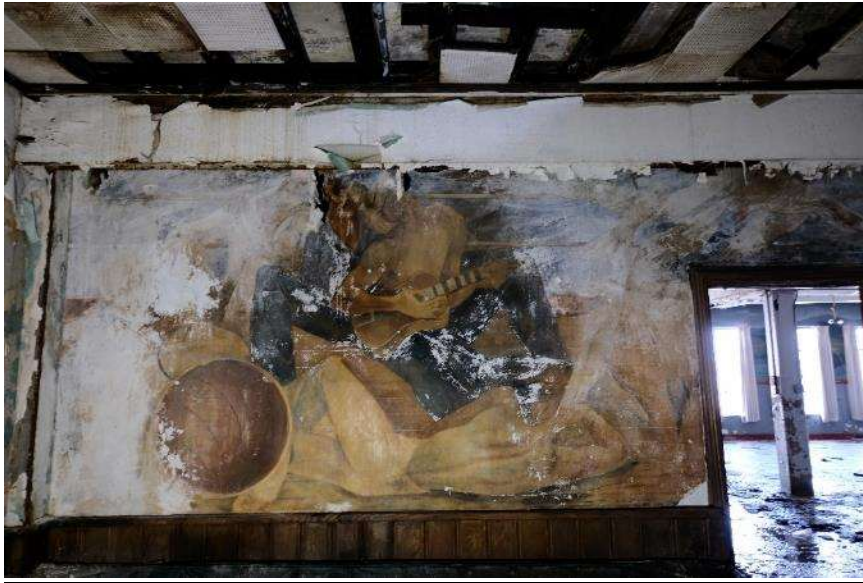
Bar Area Mural Condition

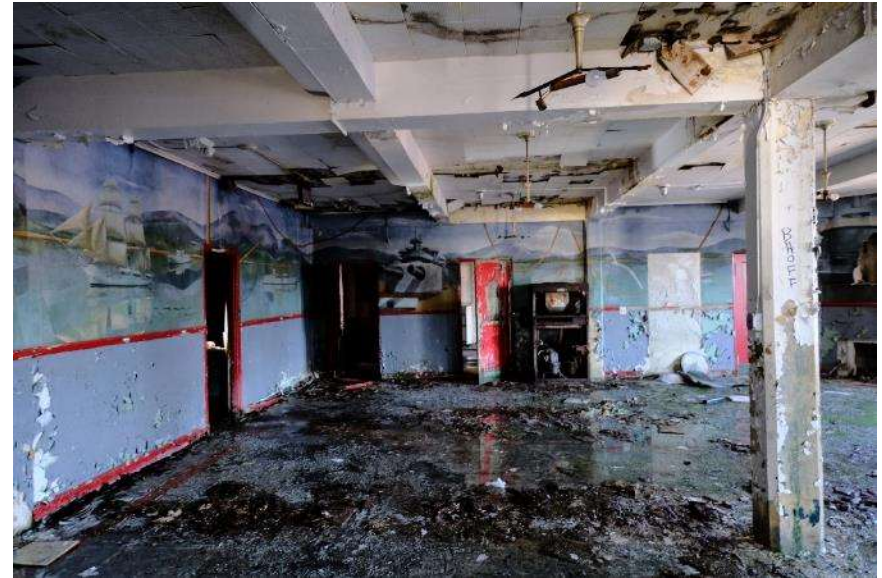
Enlisted Dining Room Mural Condition

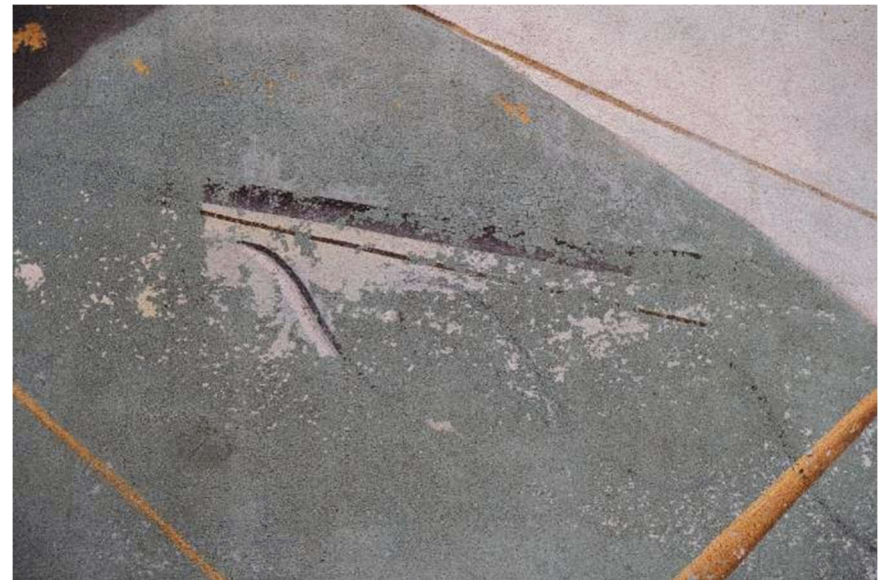
Detail of flaking paint has exposed some of Yaeger's earlier design.

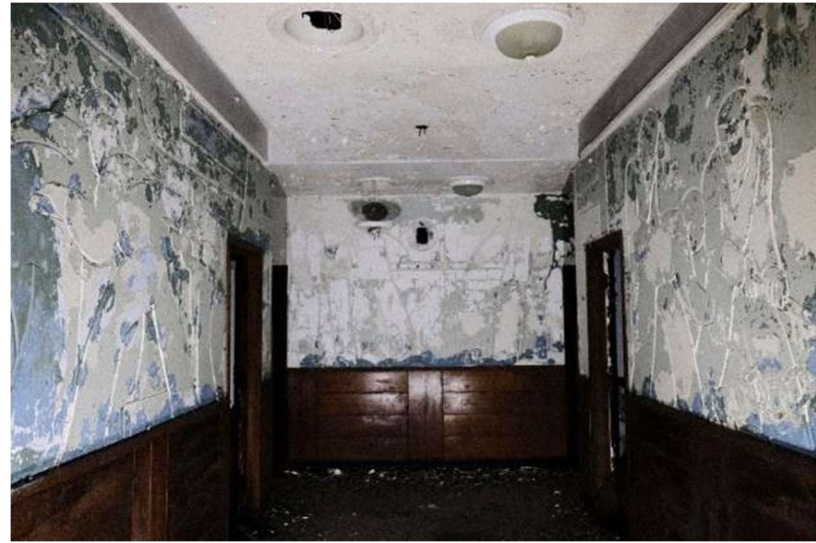
1st Floor Hallway Relief Panels

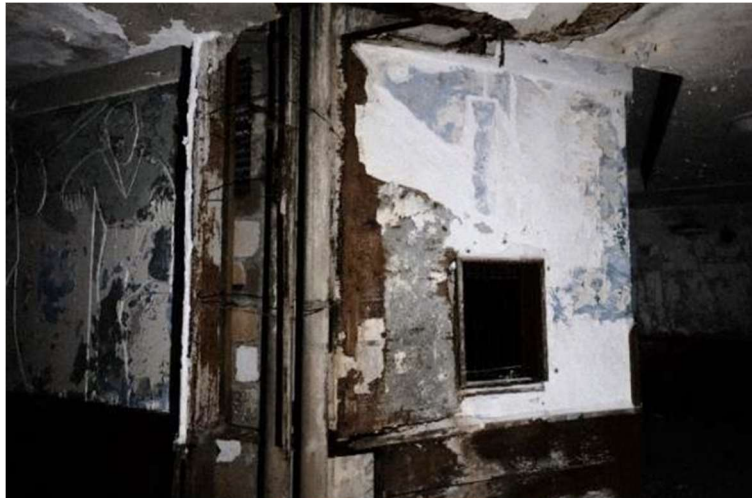
Detail of the eastern wall where relief panel has been removed.

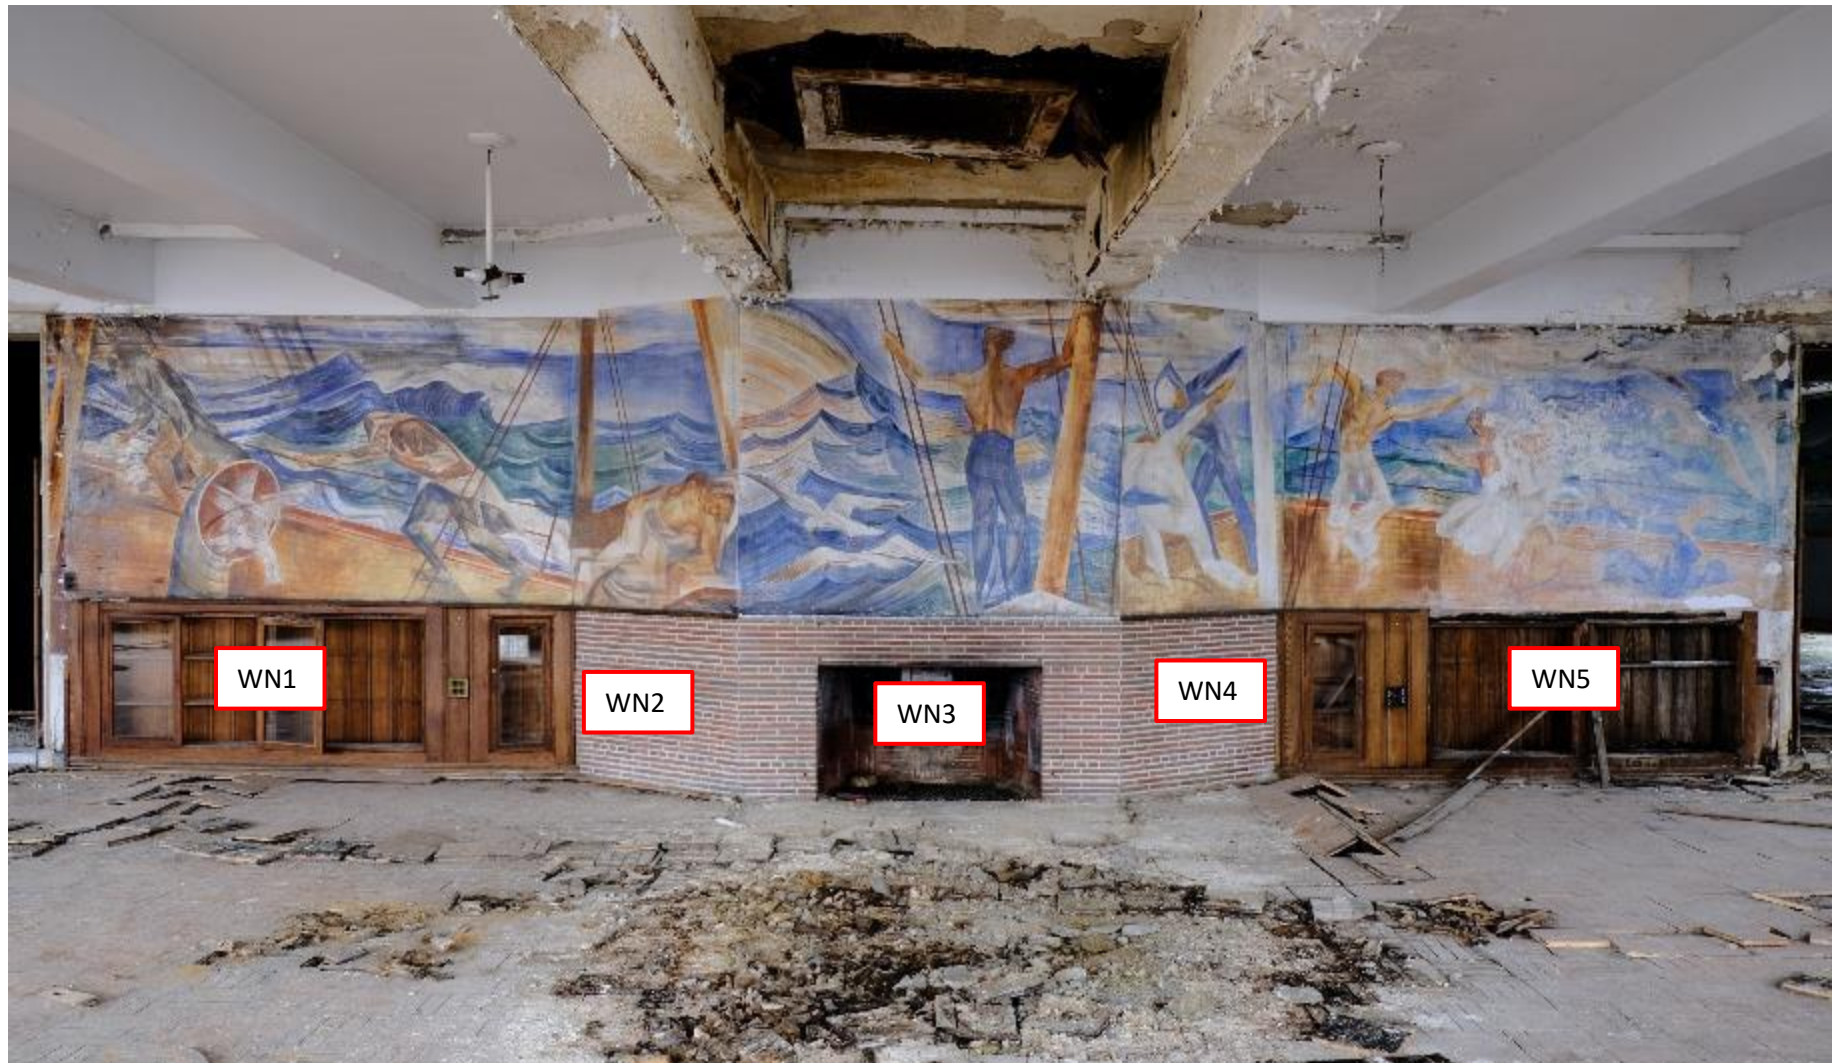
The following are diagrams that attempt to record all the material and surface defects on the murals. The diagrams are meant to graphically represent the quantity and extent of the different defects. The defects that were denoted include plaster delamination, canvas delamination, water damage, flaking paint, non-original paint and touch-ups, surface discoloration, losses, and cracks.

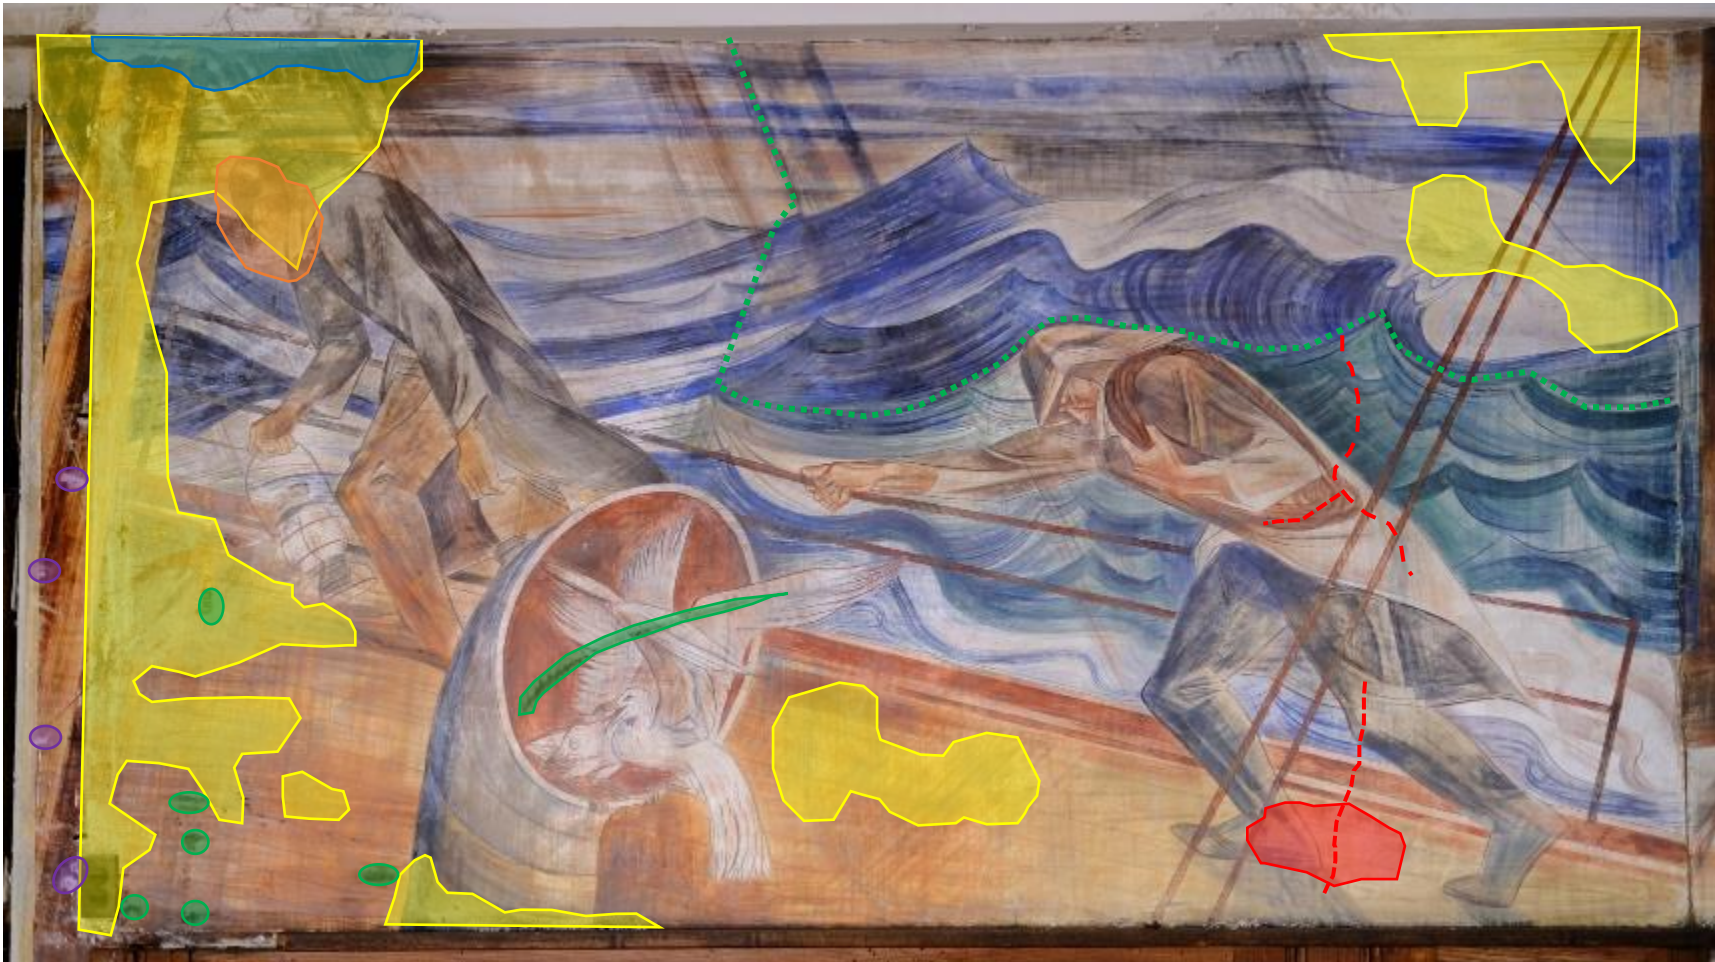
Material and Surface Defects

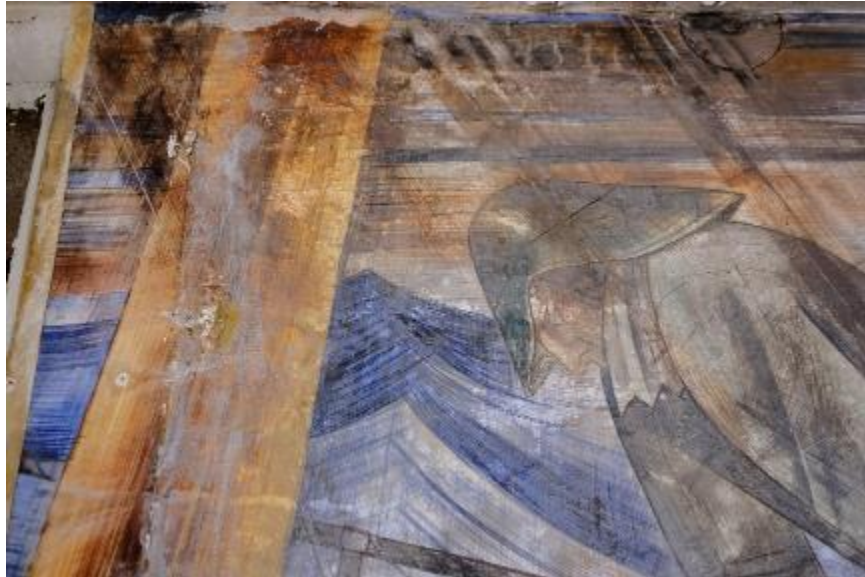
Detail Photo showing the water damage on the upper left corner of the mural. It has caused some losses, surface discoloration and blanching.

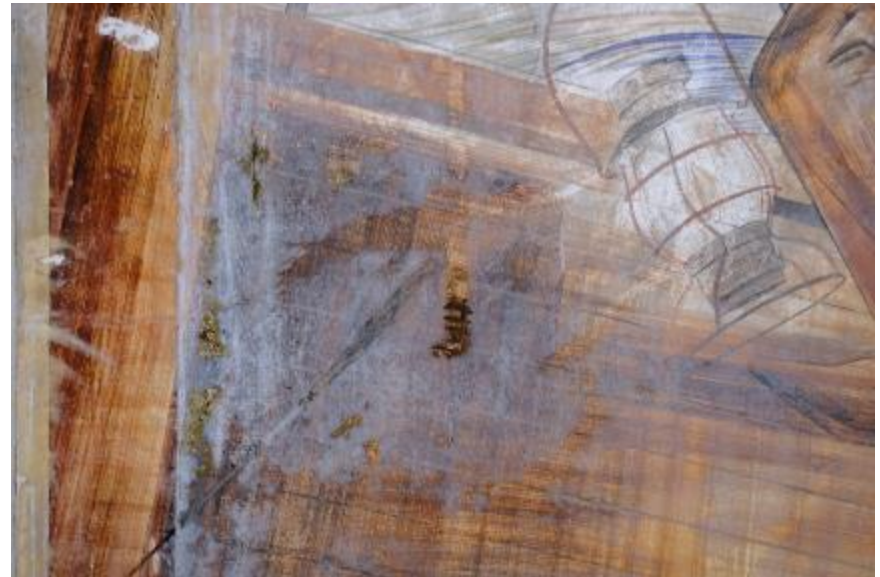
Detail showing the extent of the surface discoloration and blanching.

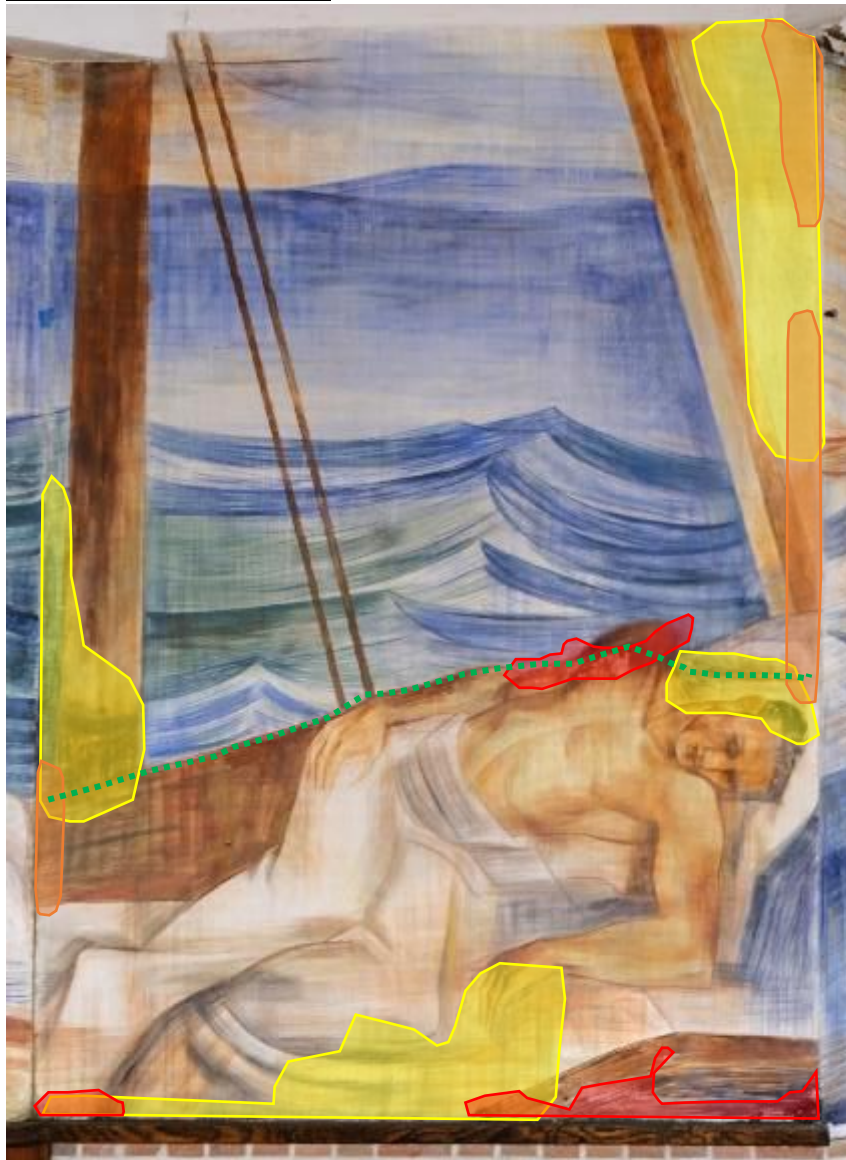
Material and Surface Defects

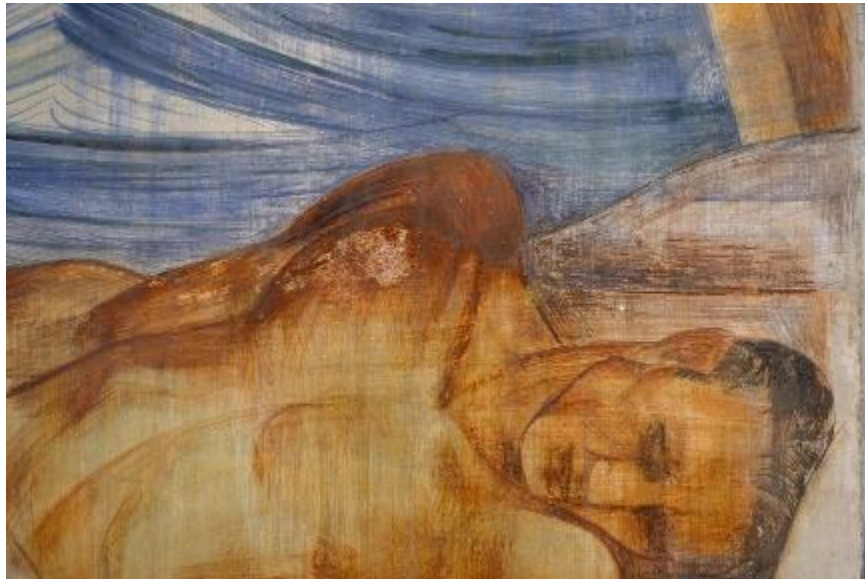
Detail photo of the area above around the line of the giornata. The area above the line is slightly darker and has some flaking paint.

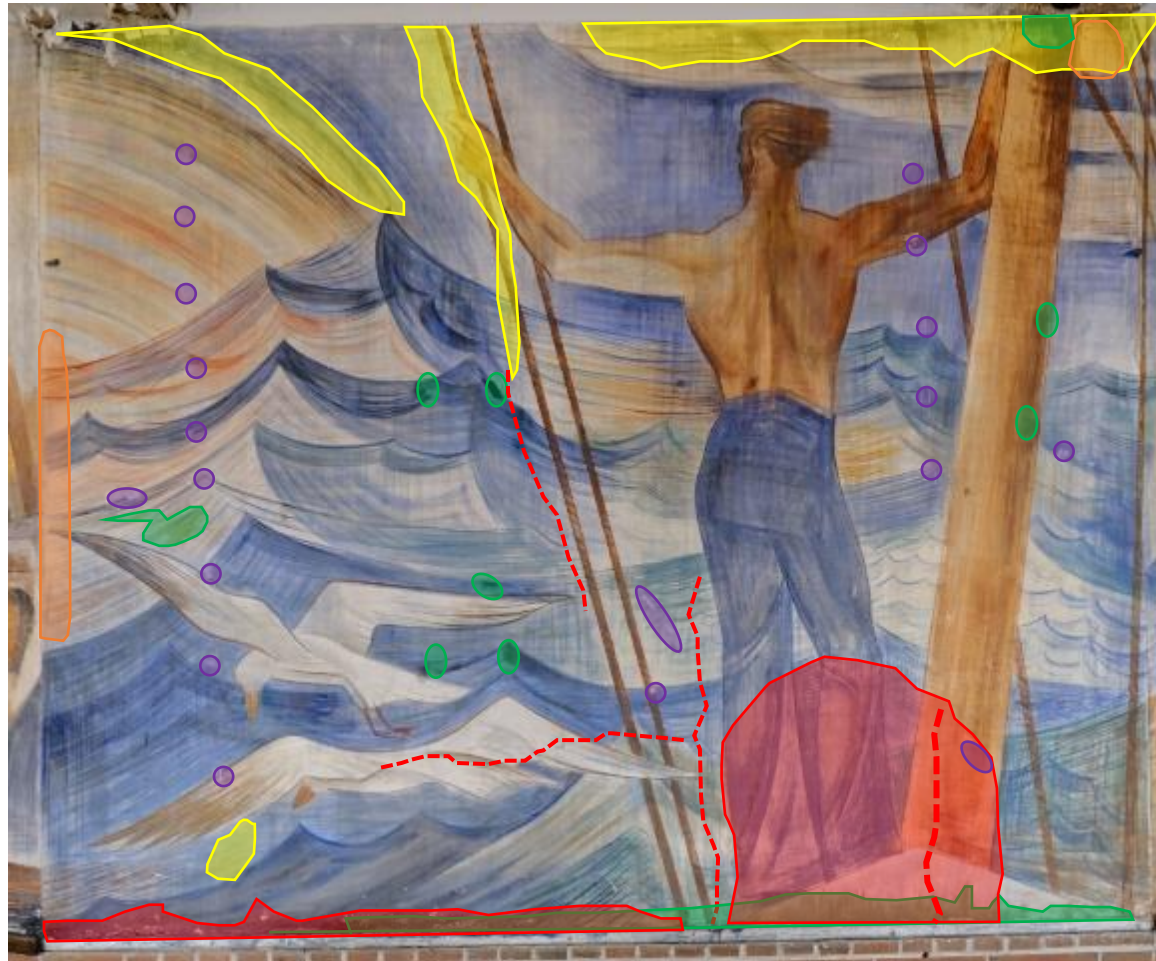
Material and Surface Defects

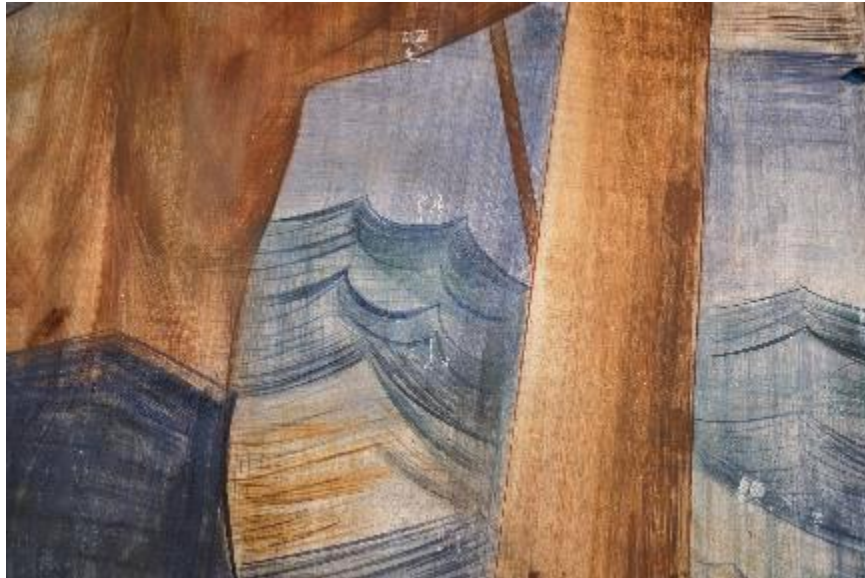
Detail Photo showing the water damage on the upper left corner of the mural. It has caused some losses, surface discoloration and blanching.

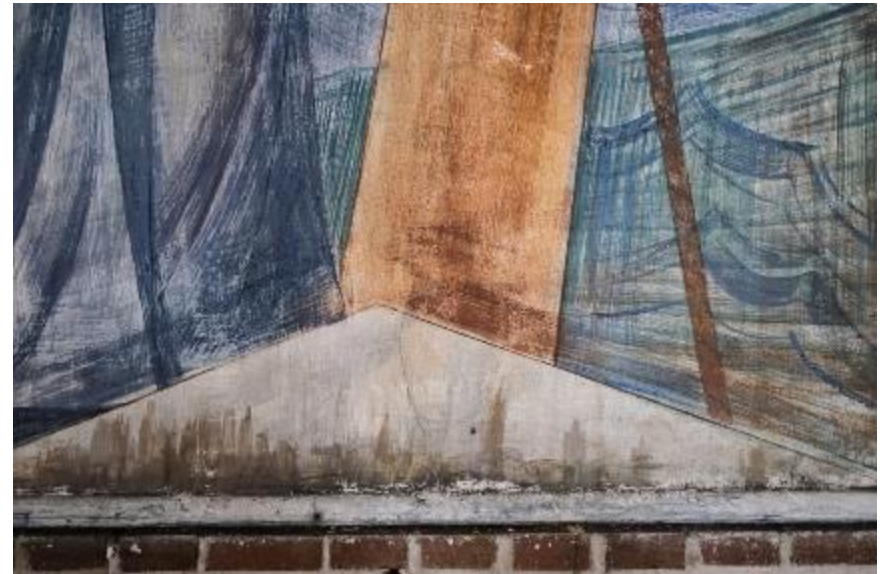
Detail showing the extent of the surface discoloration and touch ups along the bottom edge.

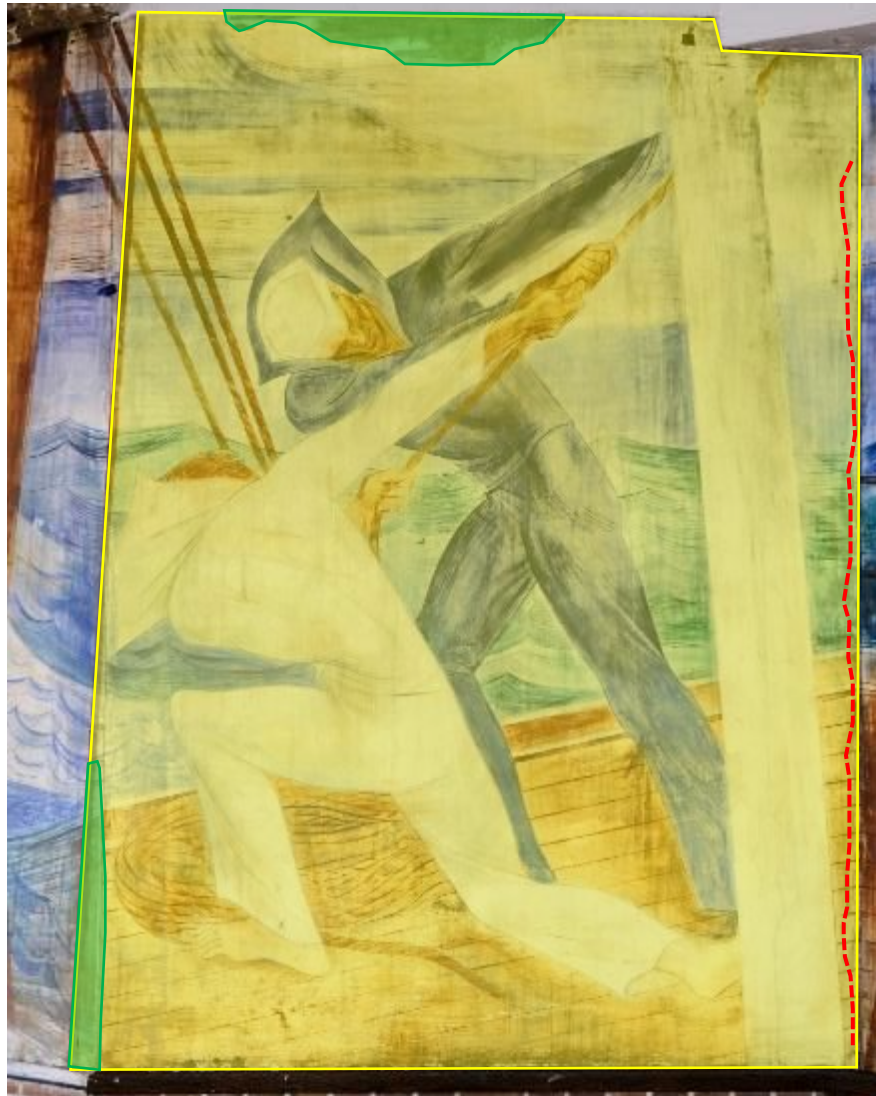
Material and Surface Defects

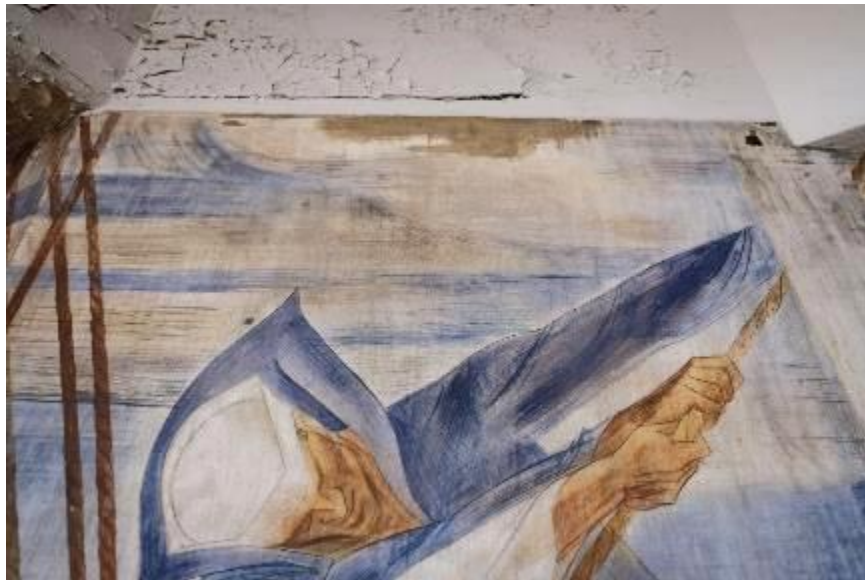
Detail photo of the top edge showing the blanching, tide marks, and excessive touch-ups.

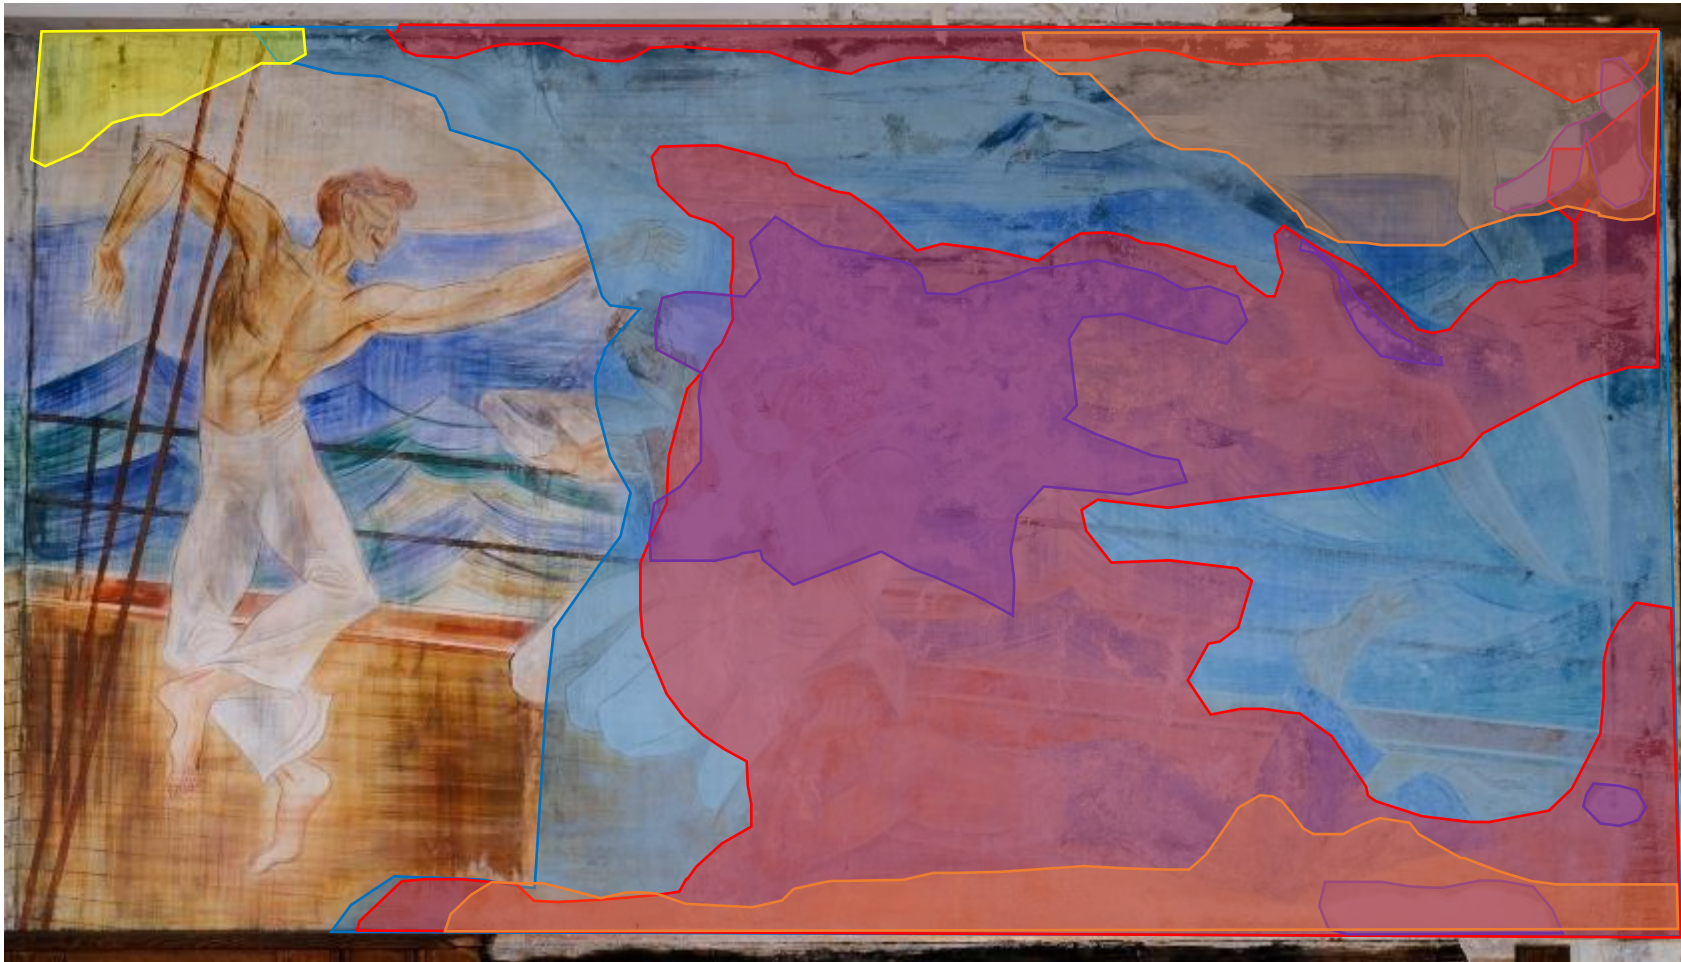
Material and Surface Defects

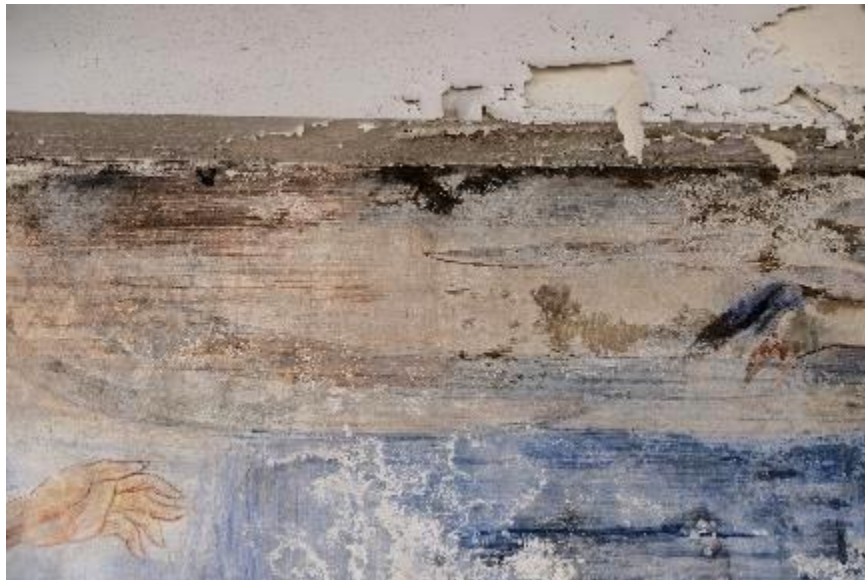
Detail photo of the top edge showing the blanching, losses, and mold.

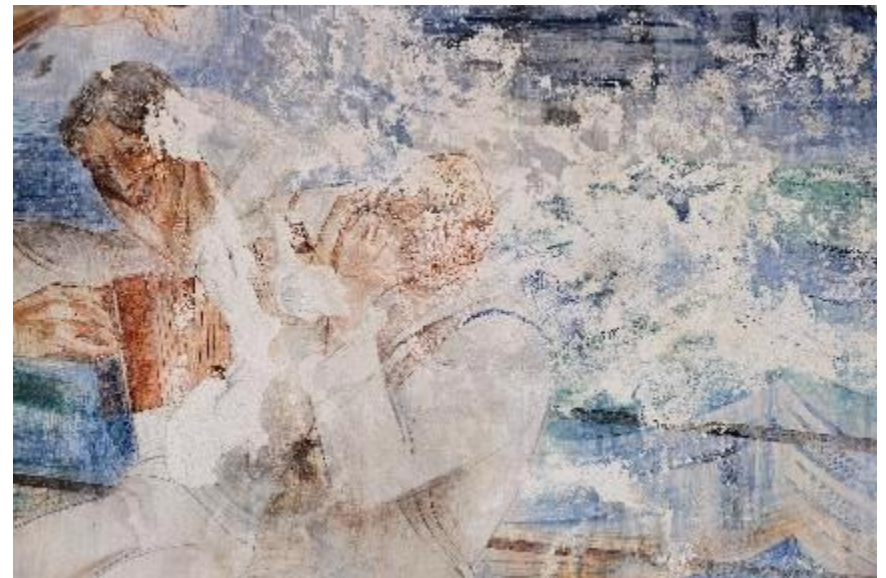
Detail showing the extent of the water damage, causing significant flaking paint and losses.

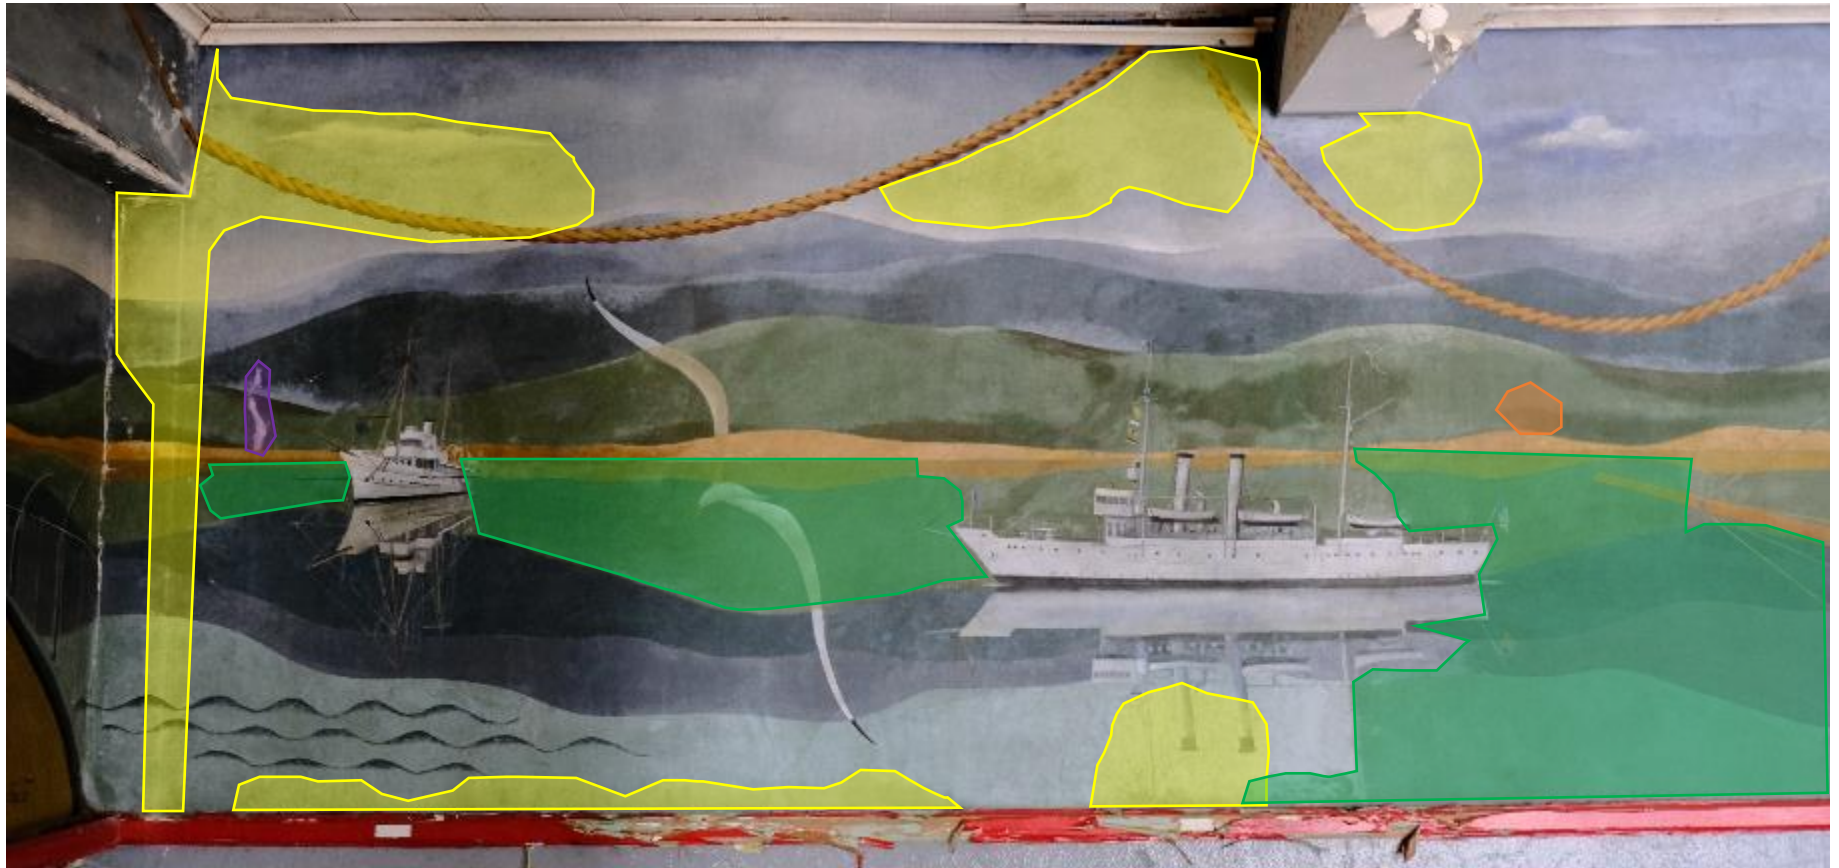
Material and Surface Defects

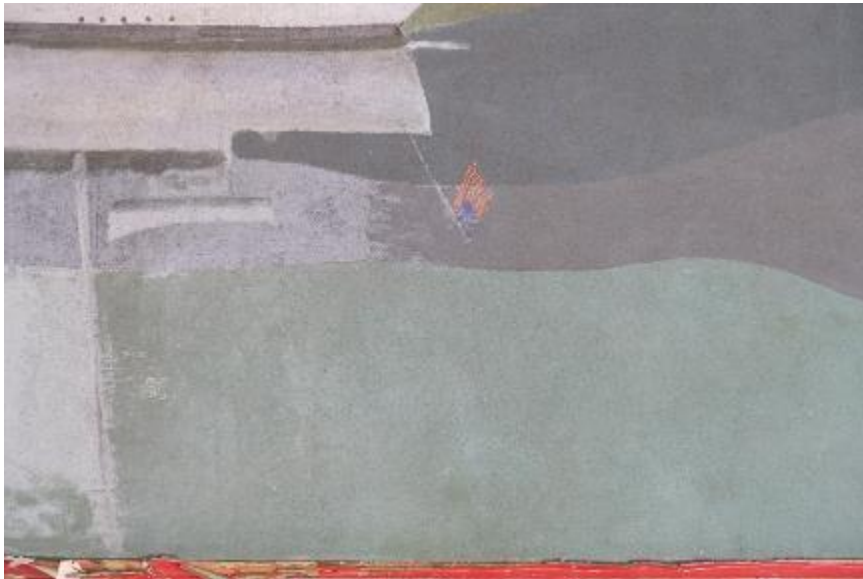
Detail of the right hand portion of the canvas where the dark grey, grey and green field areas are repainted.

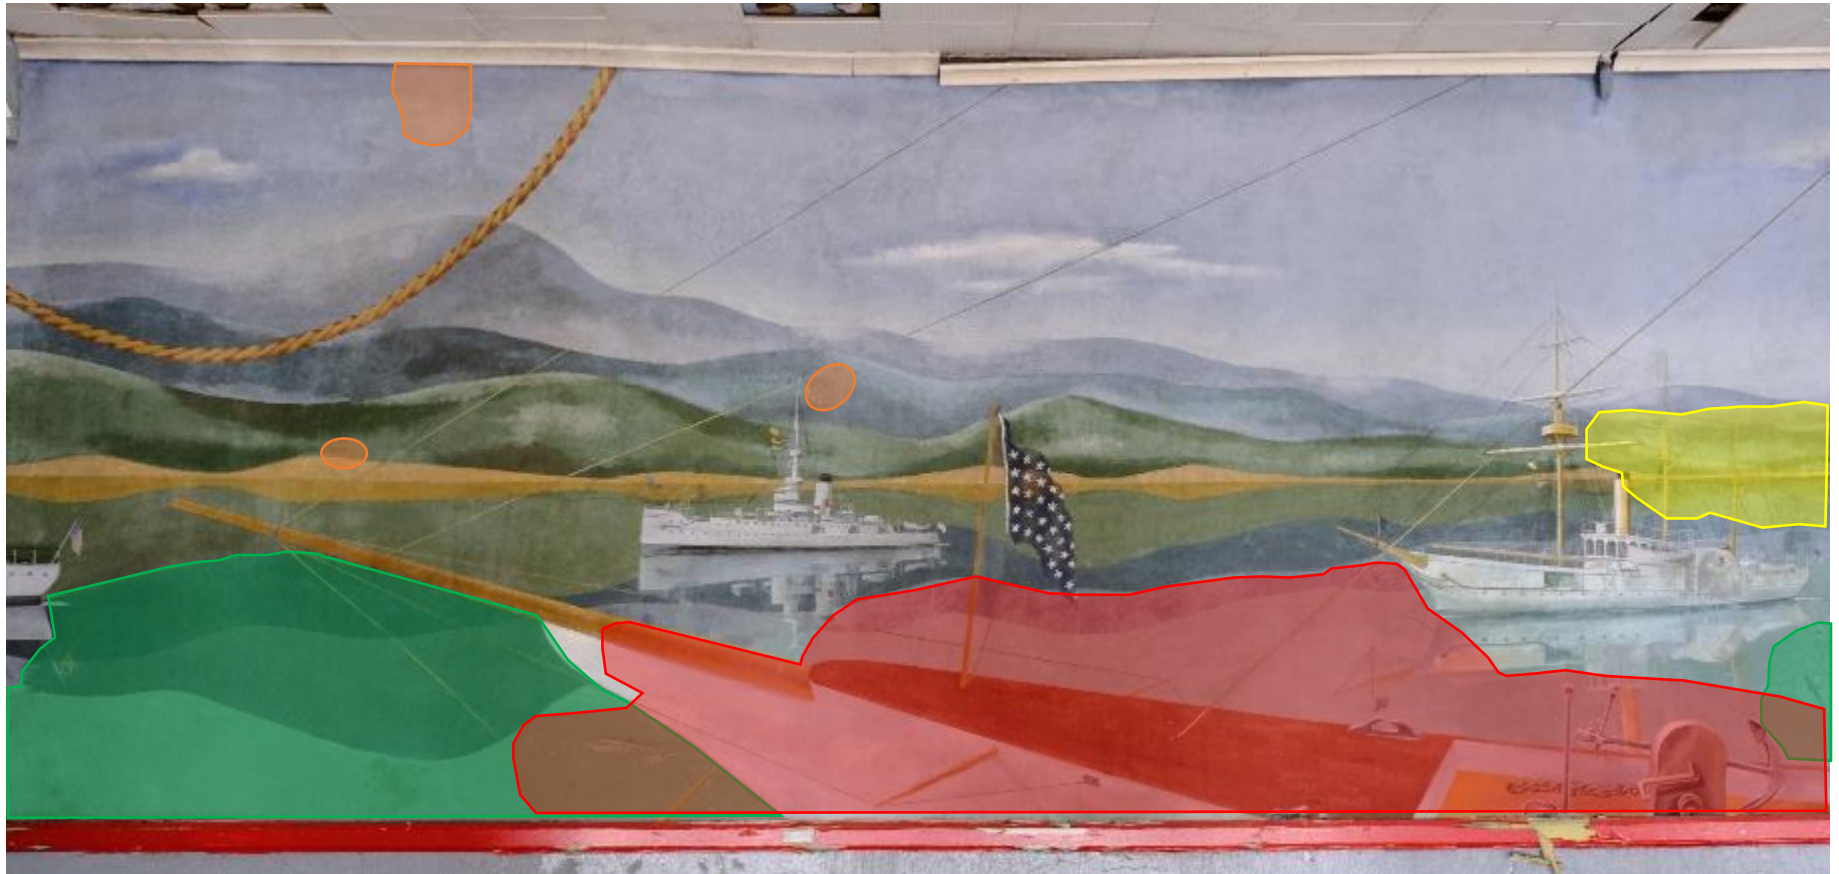
Material and Surface Defects

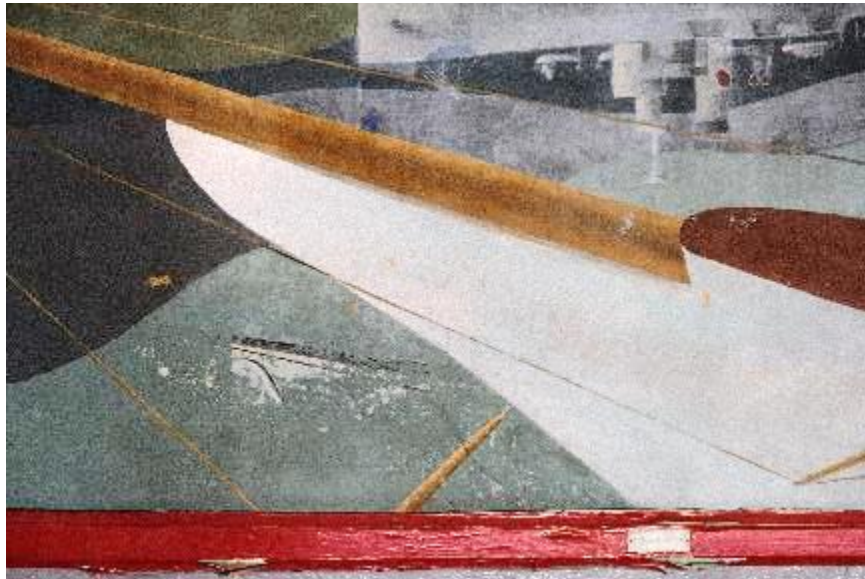
Detail of a repainted area along the bottom of mural. The overpaint is flaking and has exposed some of the earlier design.

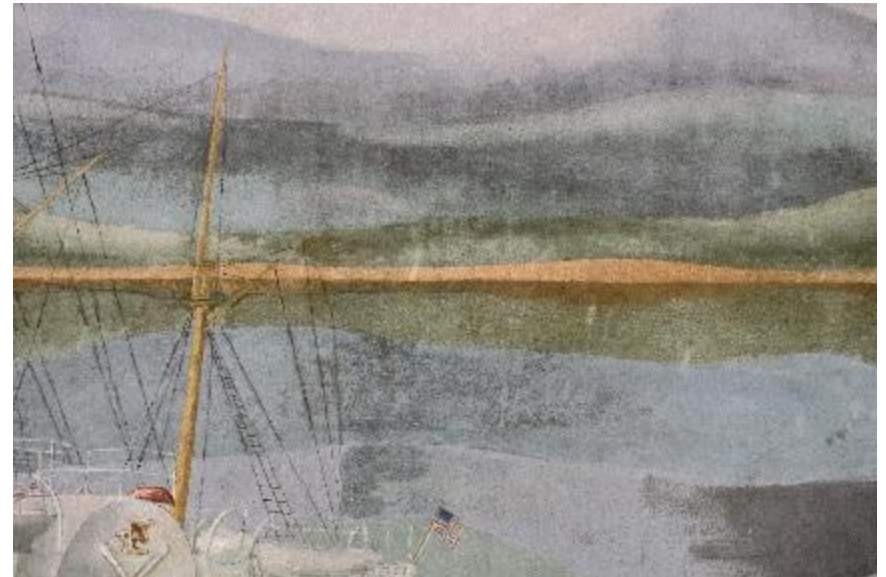
Detail of an area on the right-hand side of the canvas. There is moderate surface staining and discoloration.
