Report on the
Assessment of the Historic Murals
at the
R. Thornton Brodhead Armory
Detroit, MI

Executed by Historic Surfaces LLC
July 2022

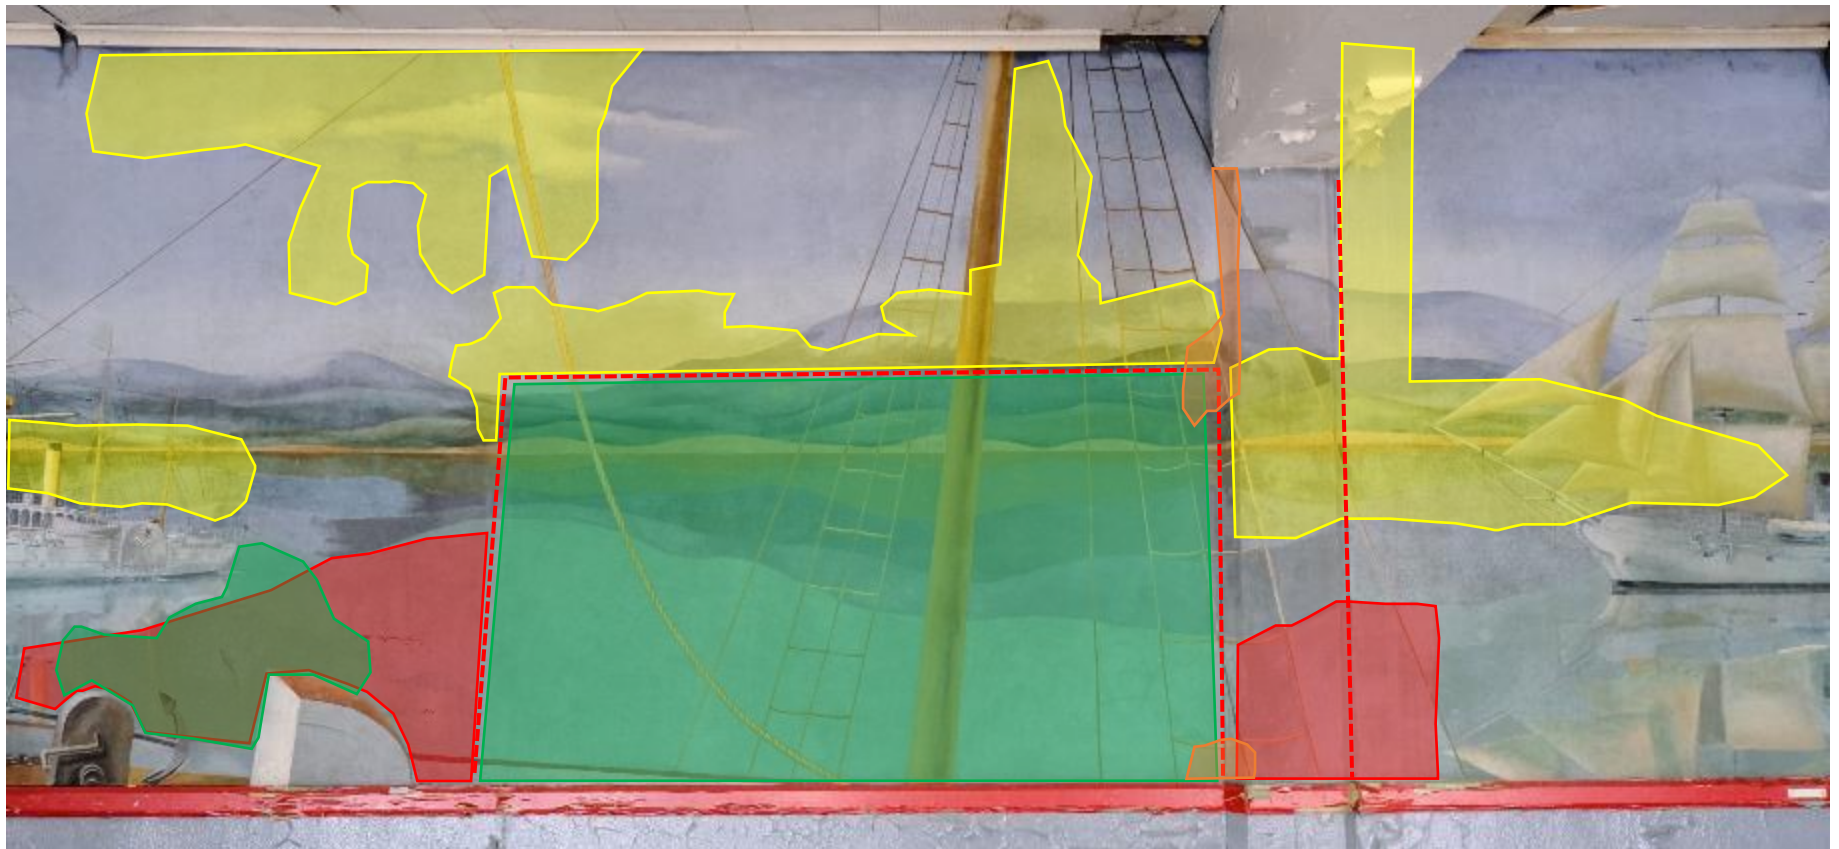
Material and Surface Defects

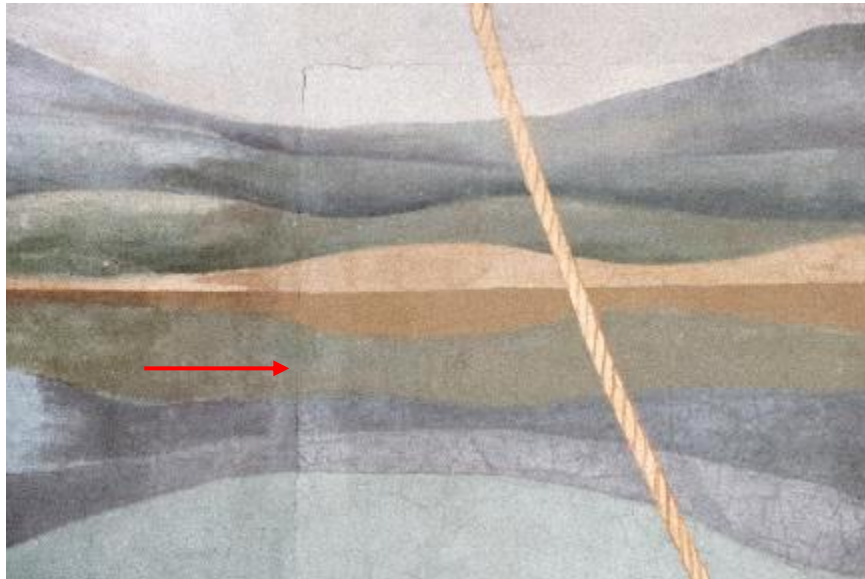
Detail of the canvas infill on the mural. The red arrow shows the canvas edge.

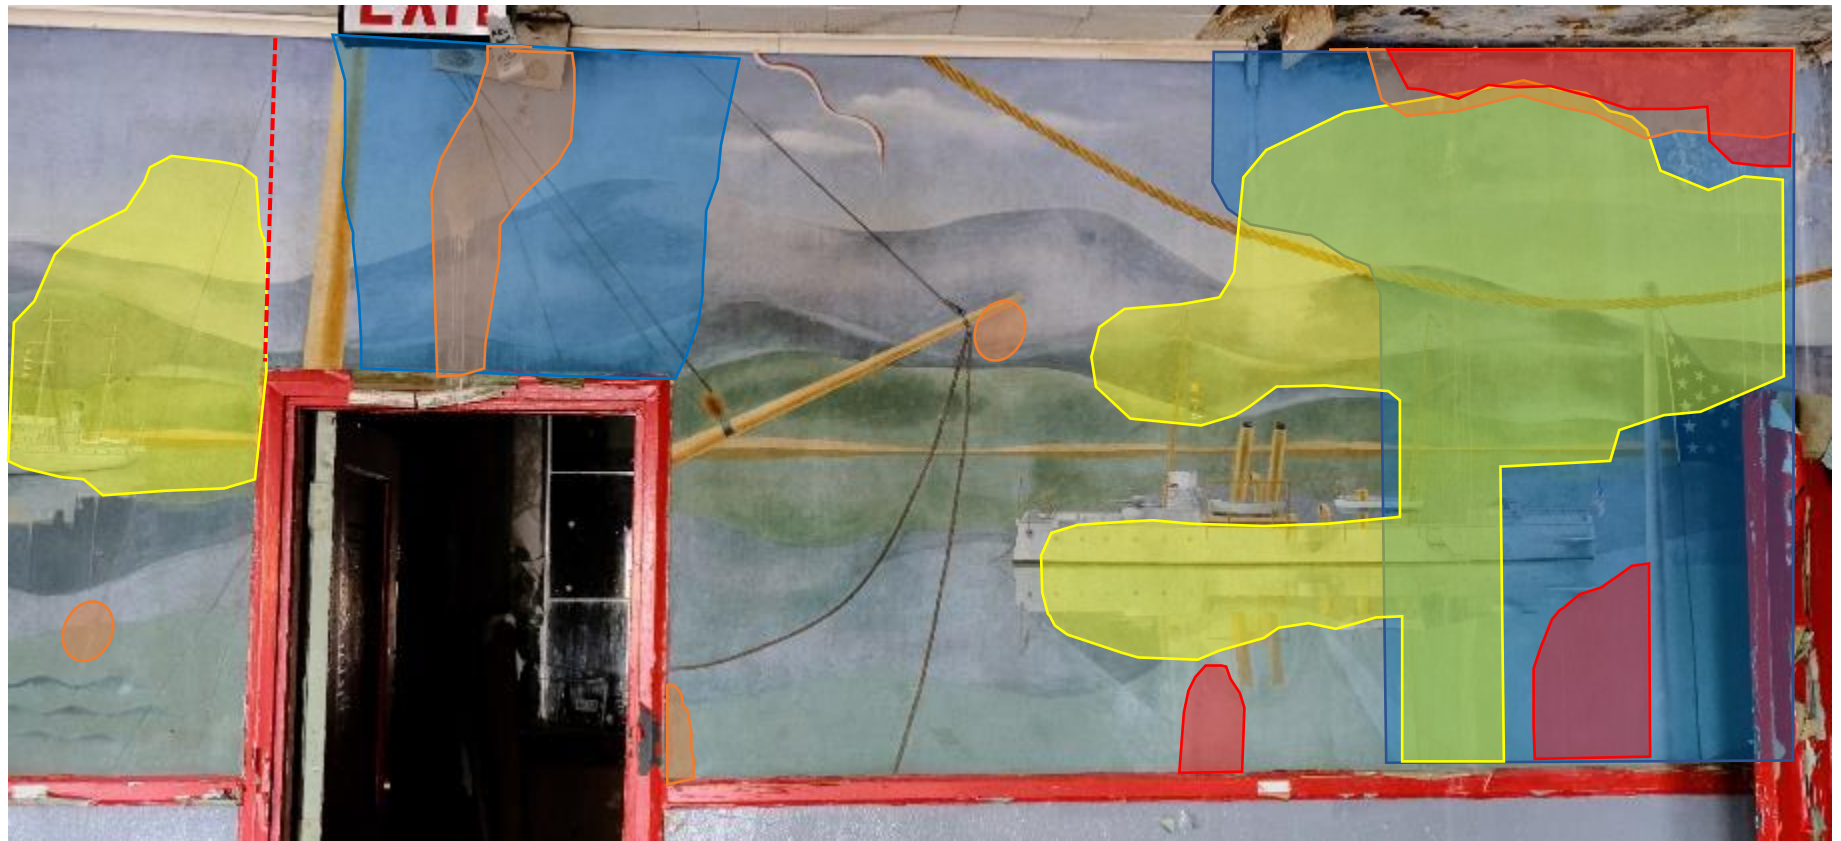
Material and Surface Defects

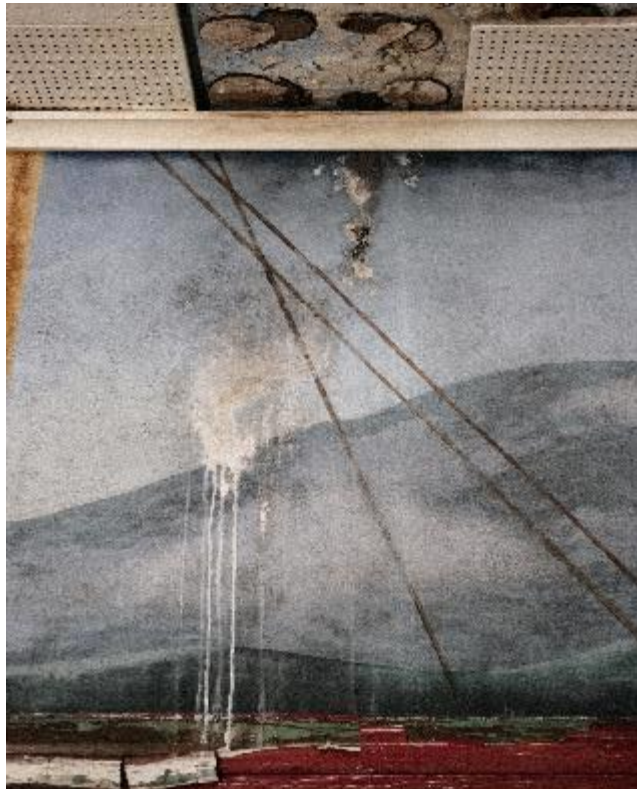
Detail of the area above the door surround. The water infiltration has caused heavy tide marks, efflorescence, and some mold growth.

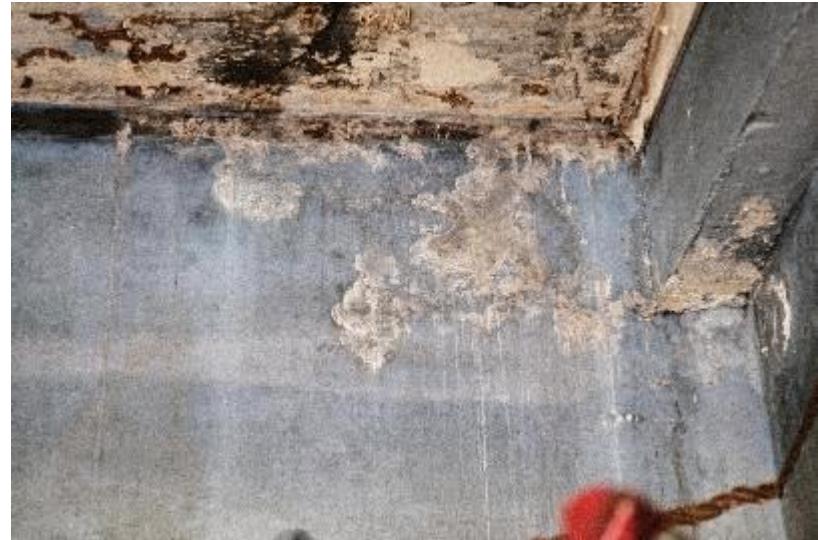
Detail of the upper right-hand corner. The water infiltration has caused heavy tide marks, efflorescence, and some mold growth.

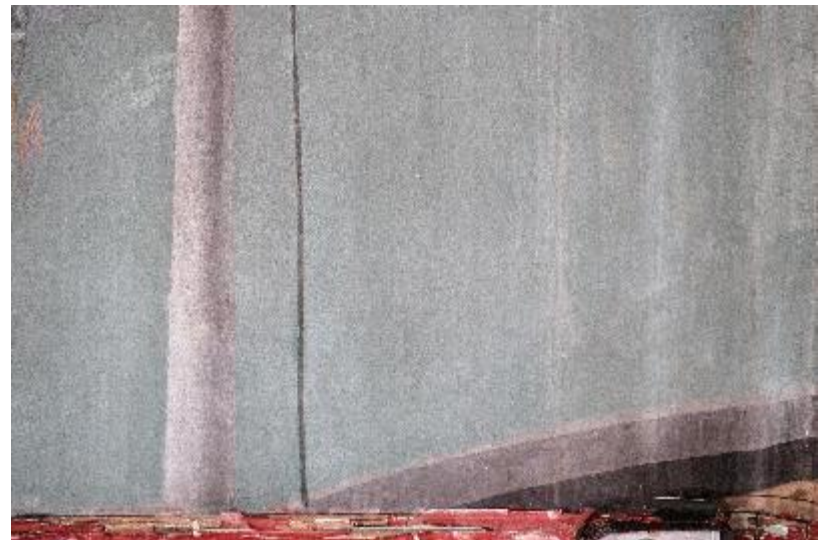
Detail of the lower right-hand portion of the mural. The water infiltration has caused some surface discoloration and active flaking paint.

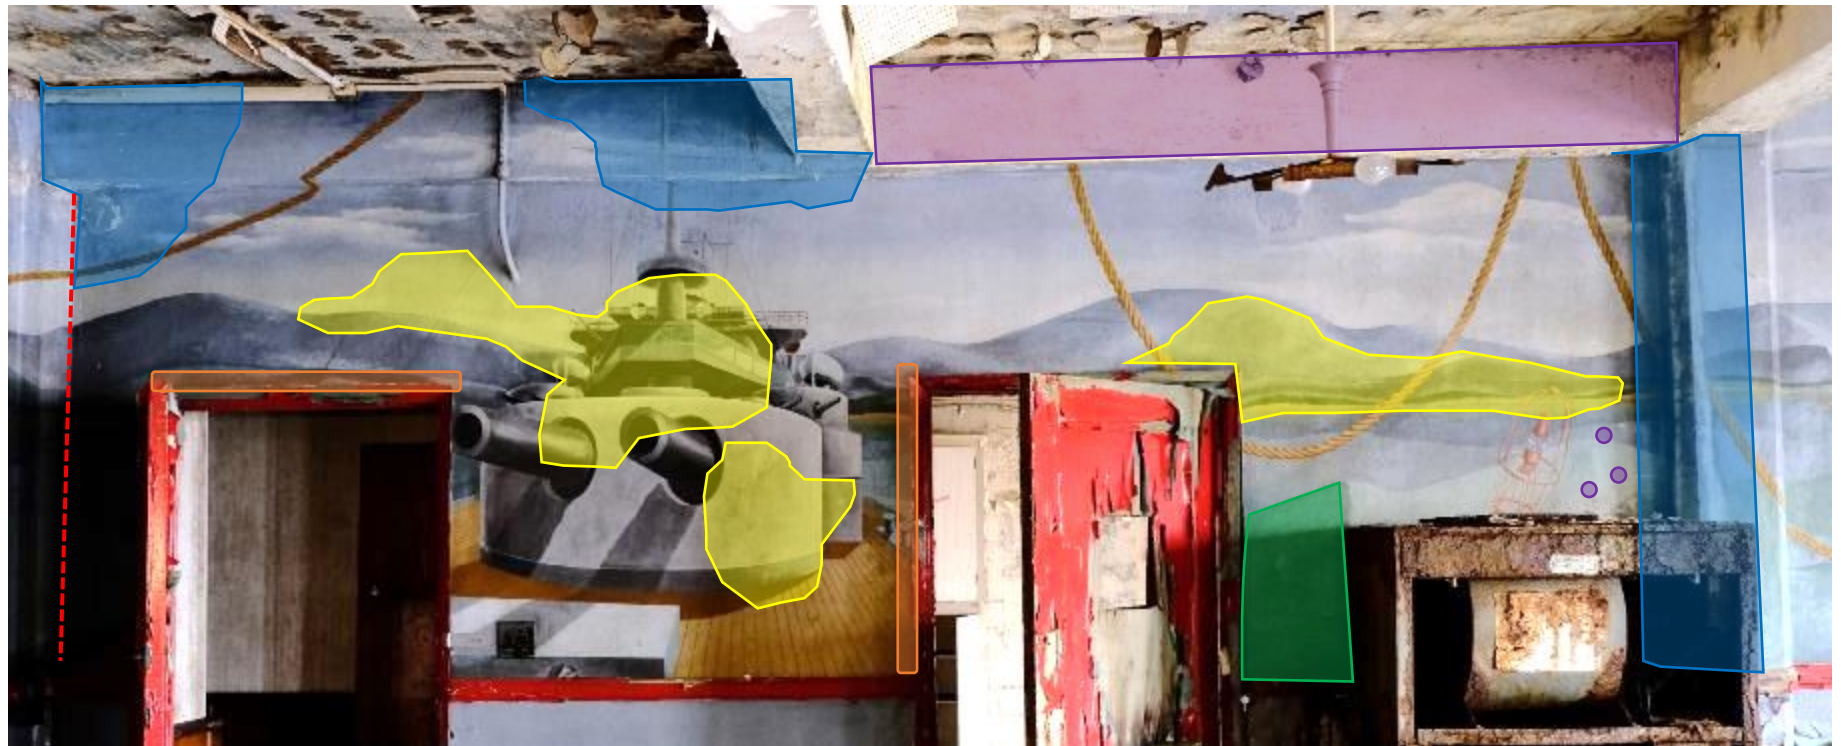
Material and Surface Defects

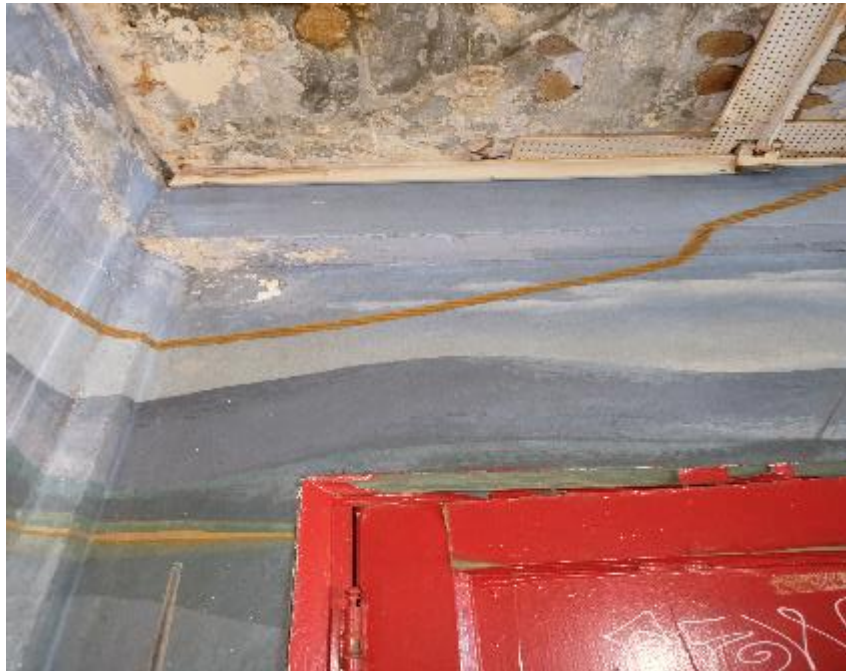
Detail of the upper left-hand portion of the mural. The water damage has caused some surface discoloration, flaking paint, and losses.

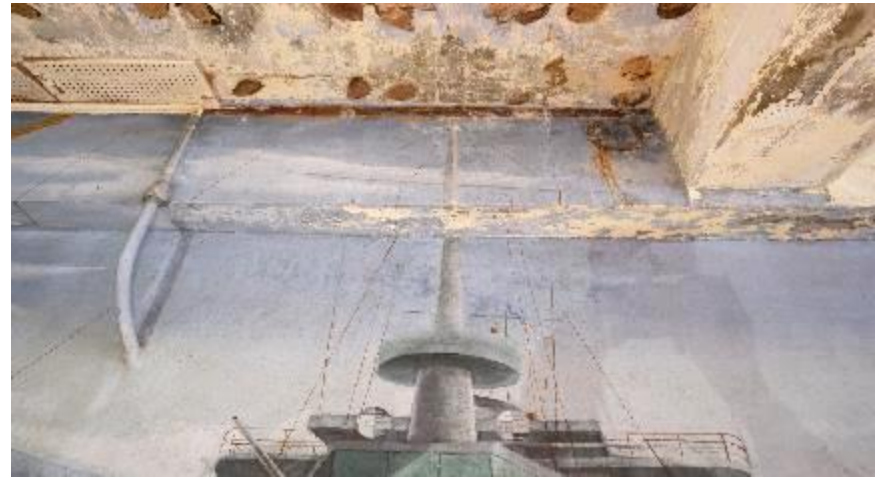
Detail of the center top portion of the mural. The water damage has caused some surface discoloration, flaking paint, and losses.

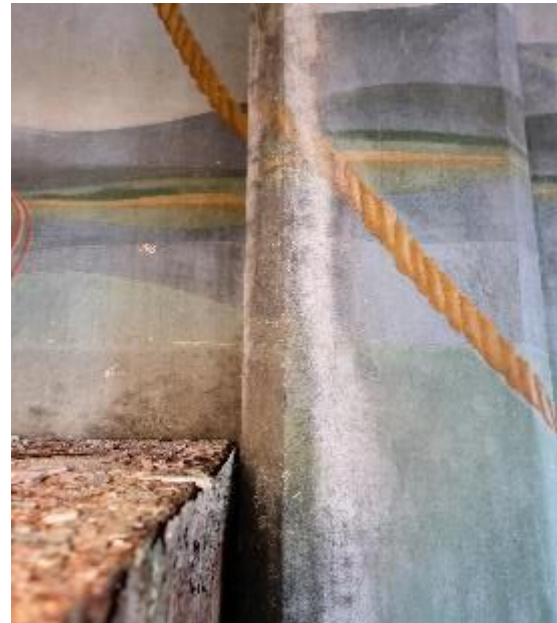
Detail of the lower right-hand portion of the mural. The water damage has caused some surface discoloration, flaking paint, and losses. There also may be some mold growth.

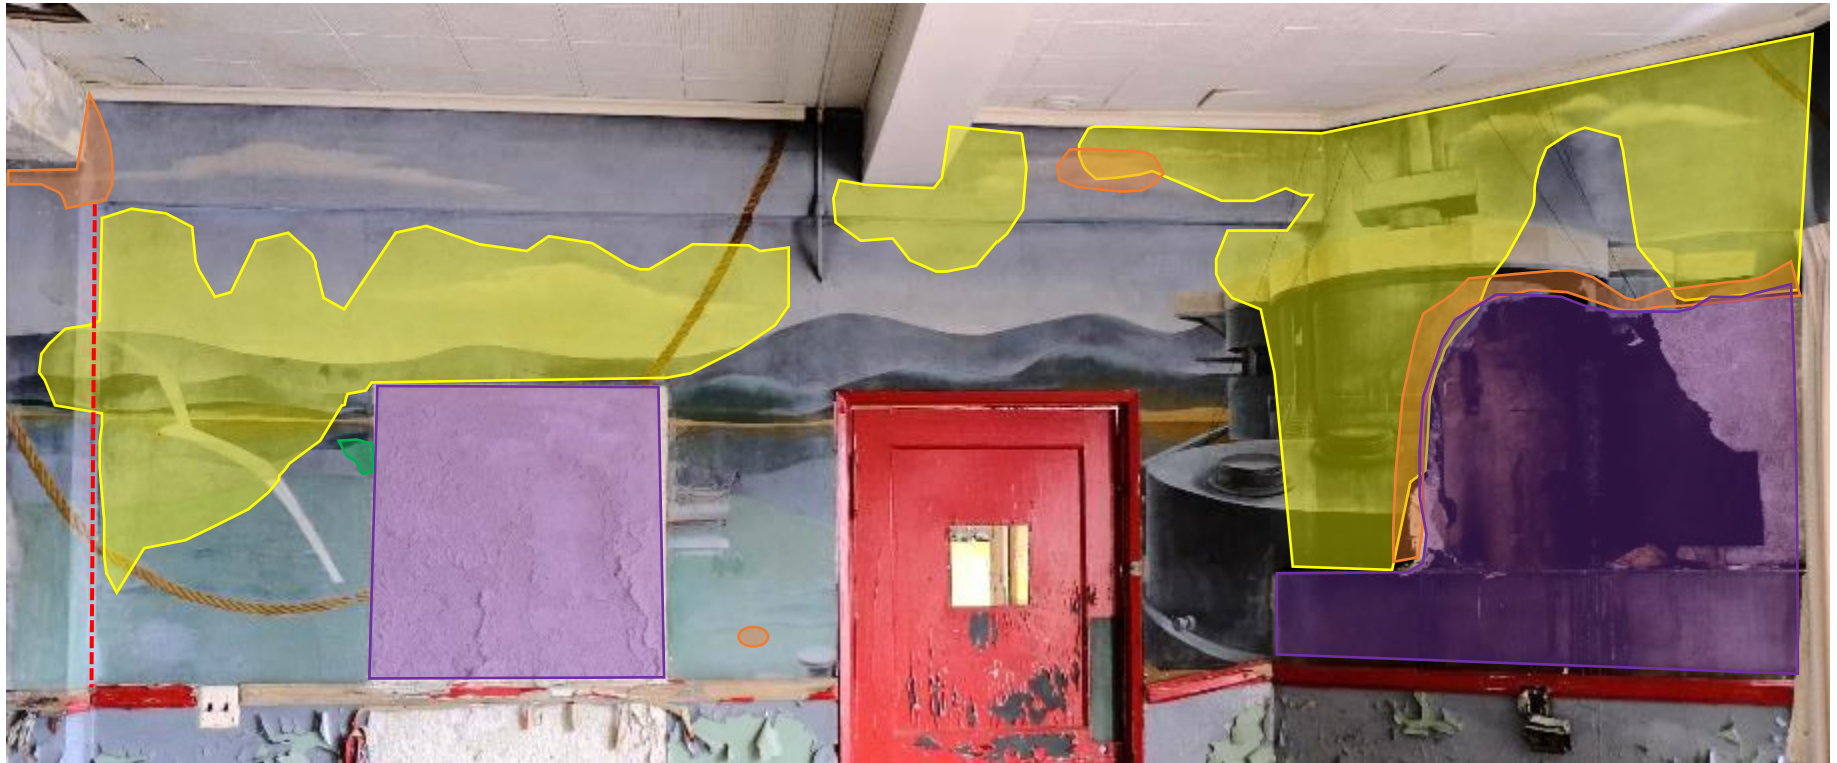
Material and Surface Defects

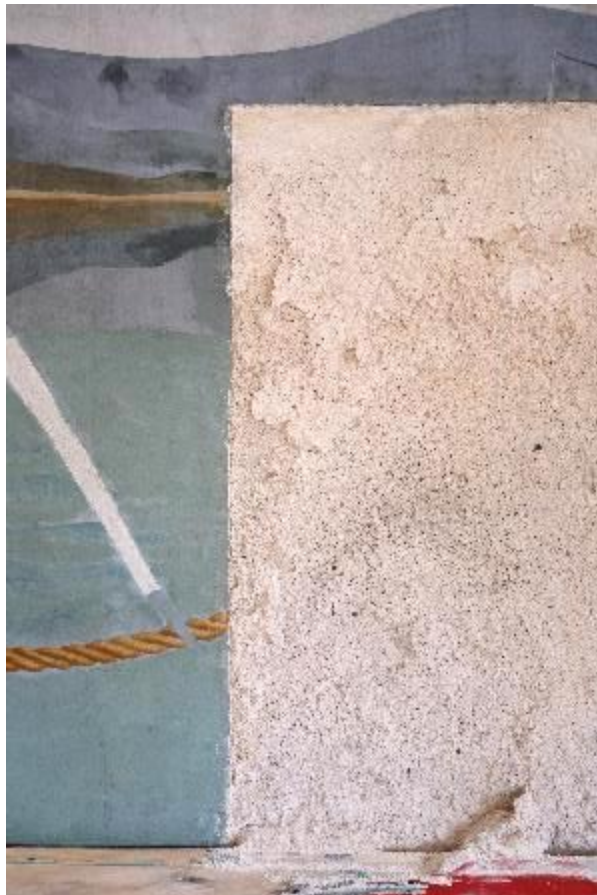
Detail of the center wall where a portion of the canvas has been removed. The piece was found and is in storage.

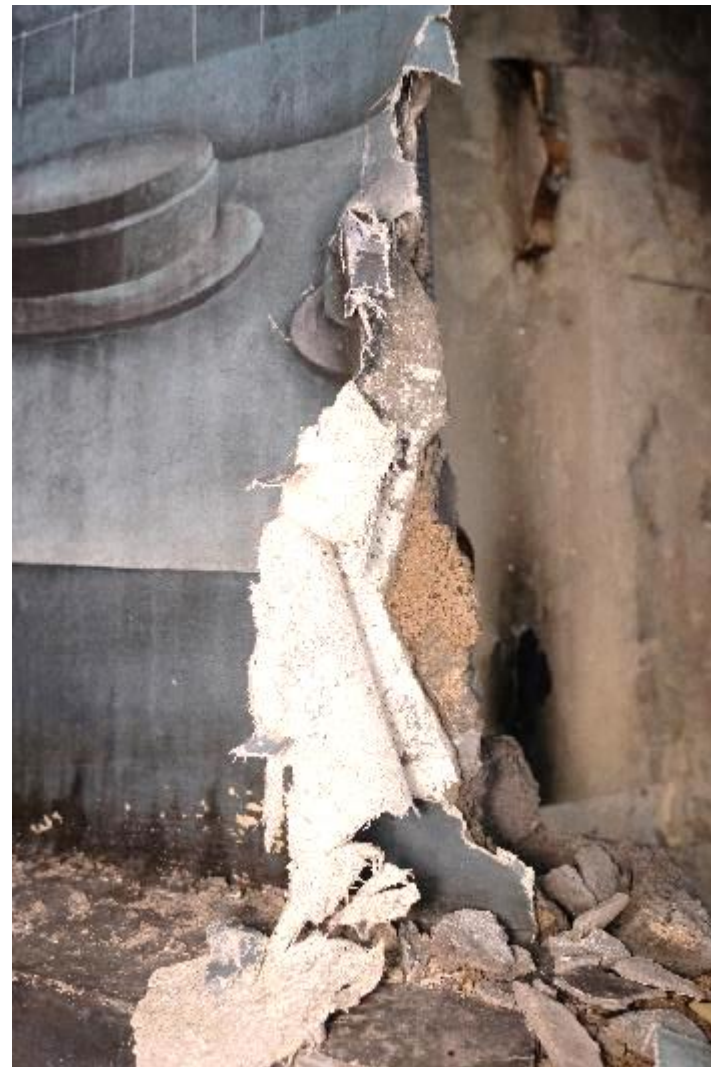
Detail of the damaged canvas on the right side of the mural.

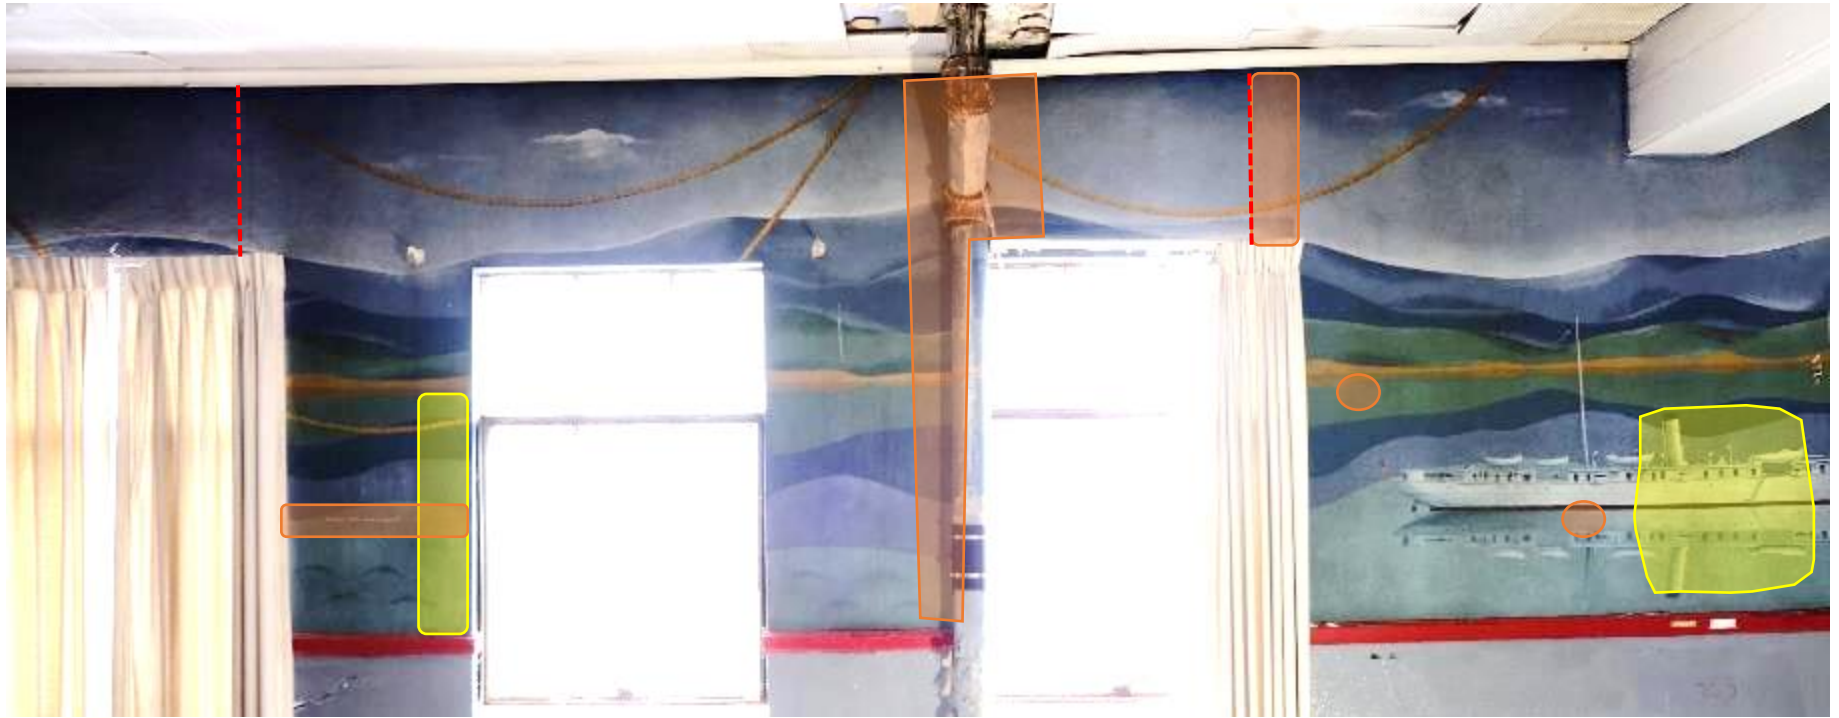
Material and Surface Defects

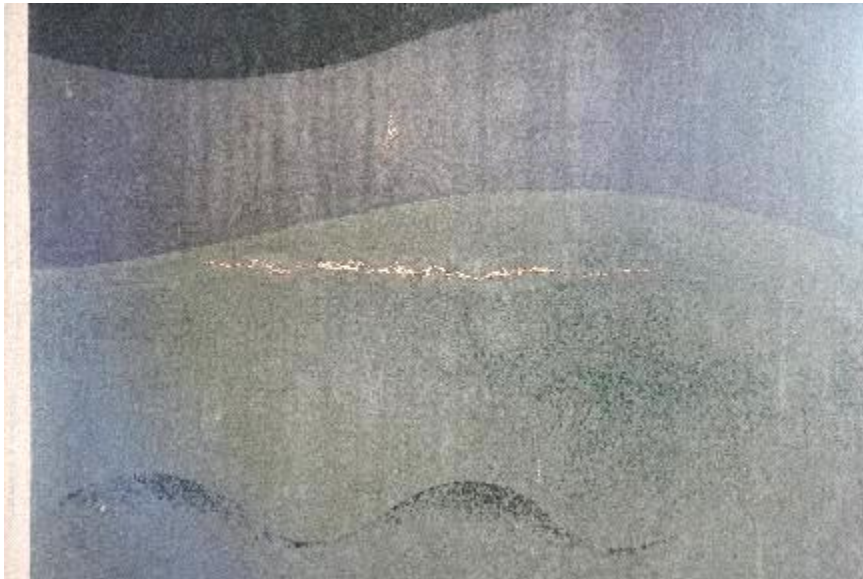
Detail of the left hand portion of the canvas between the windows. The moisture has left tide marks and caused a horizontal crease in the canvas.

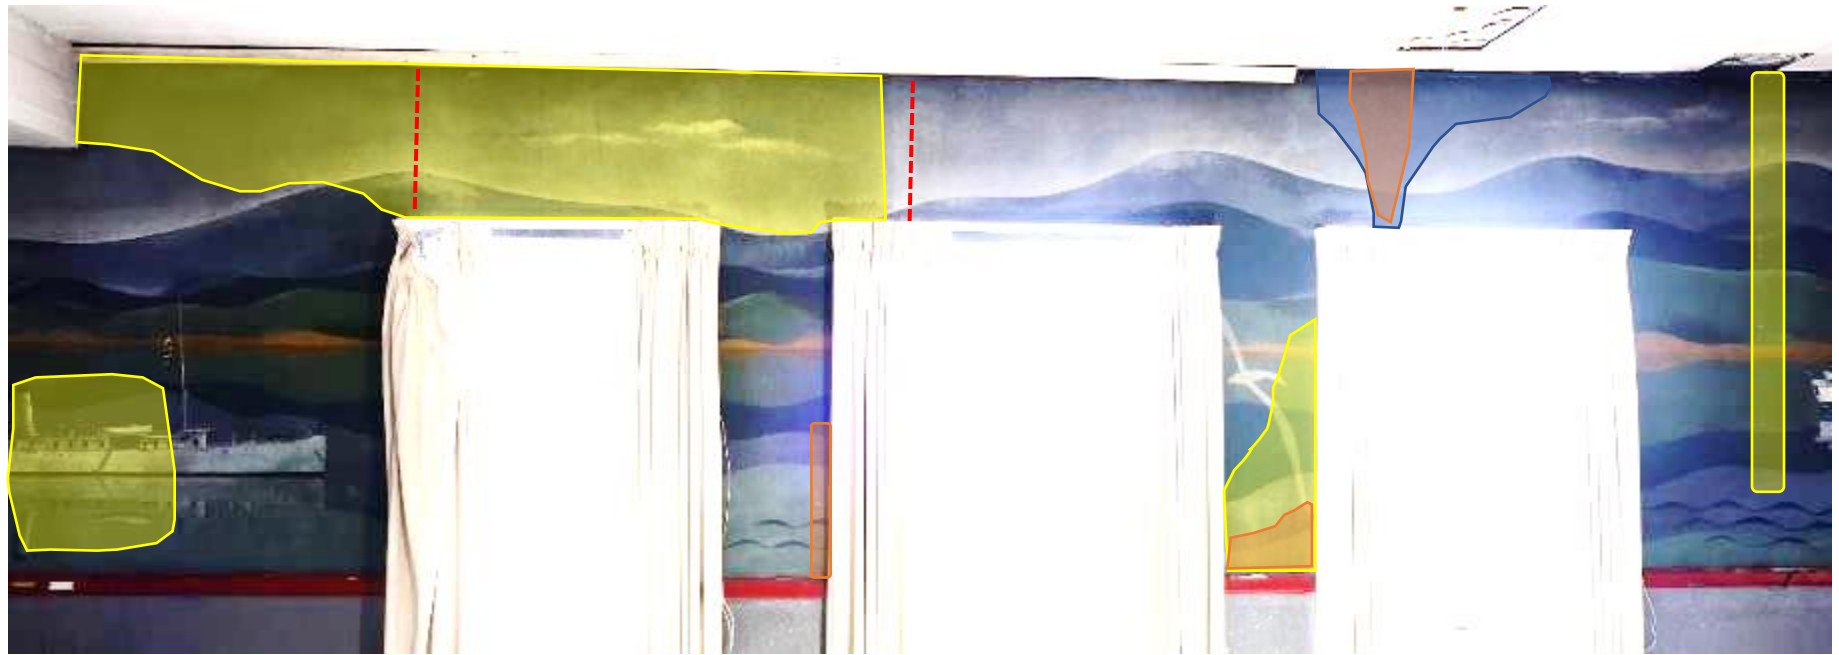
Material and Surface Defects

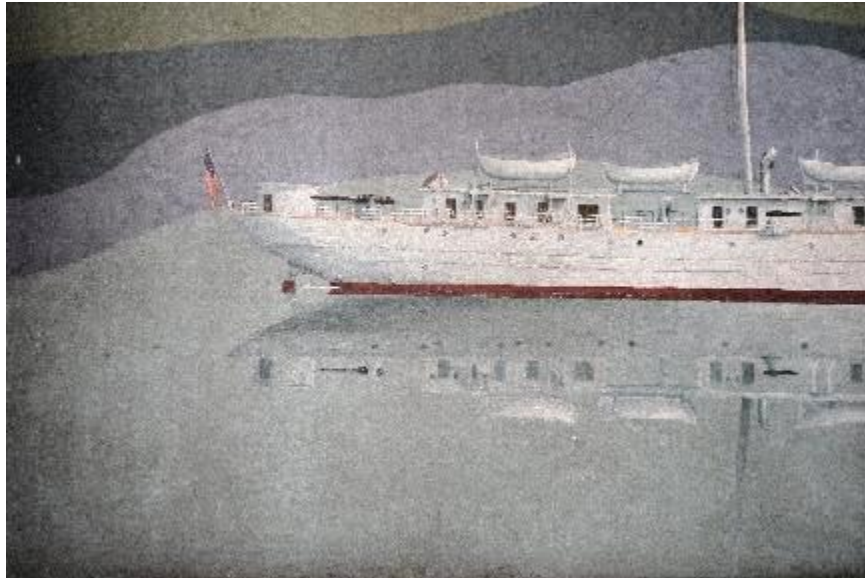
Detail of the left section of the mural. It shows the minor discoloration and tide marks.

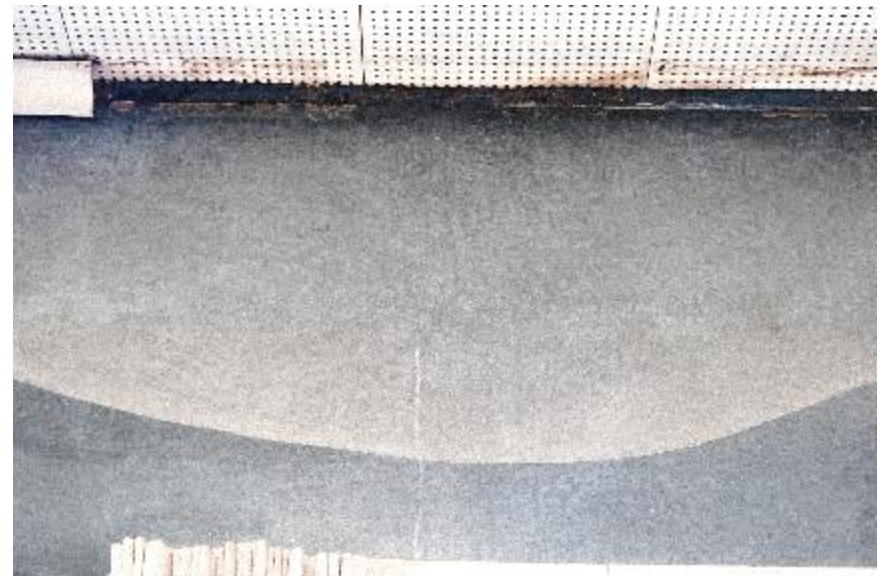
Detail of the upper right-hand section above the window. The water infiltration has caused some surface discoloration. The canvas along the original vertical seam is delaminated.

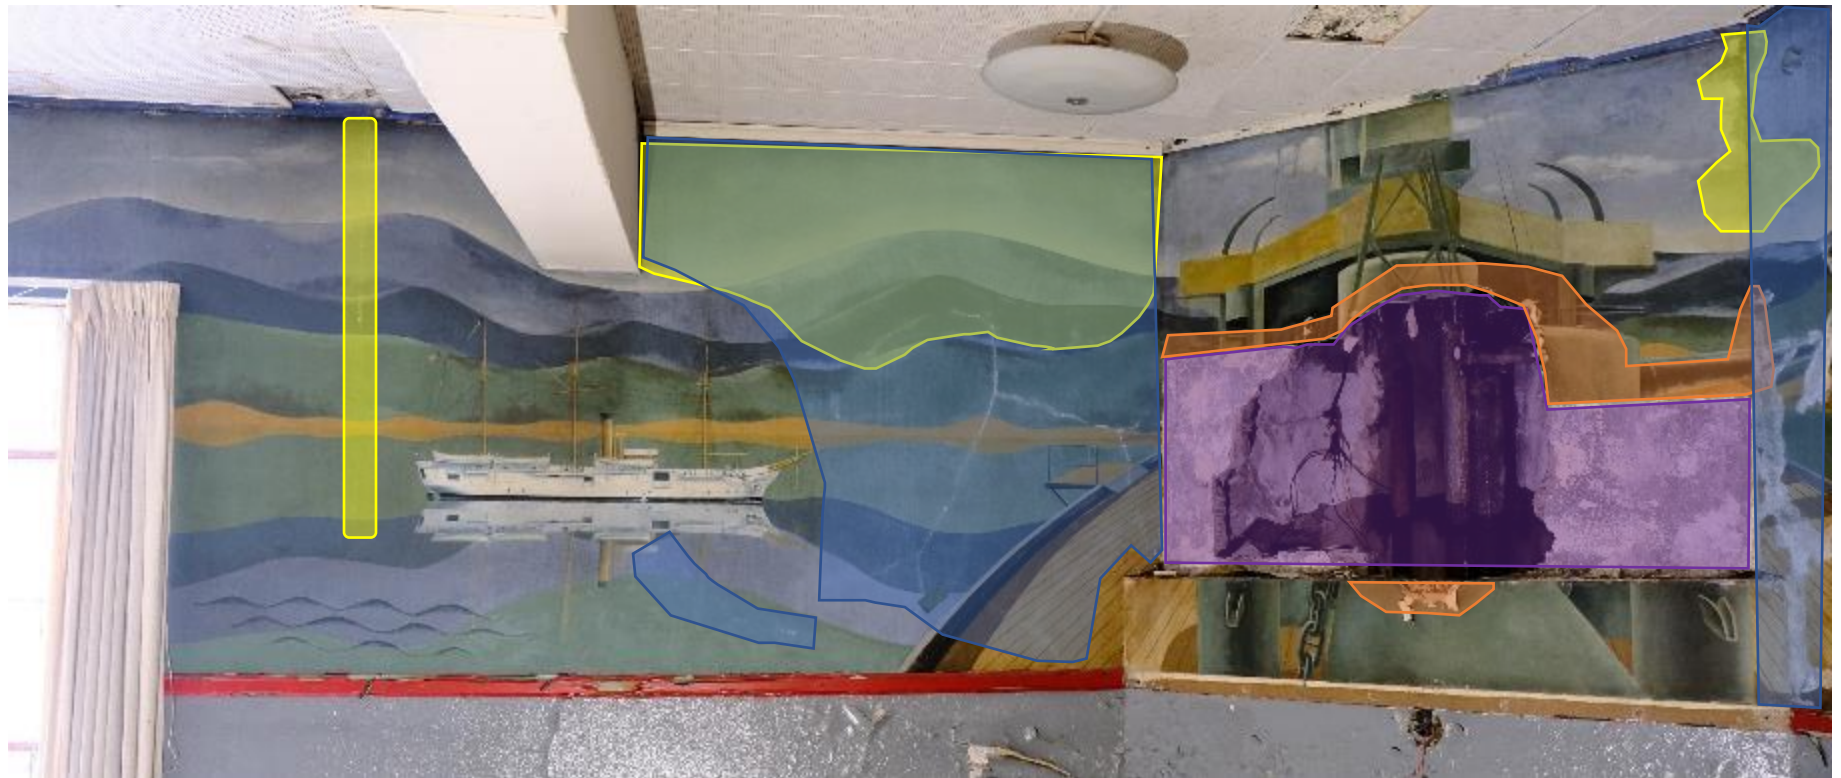
Material and Surface Defects

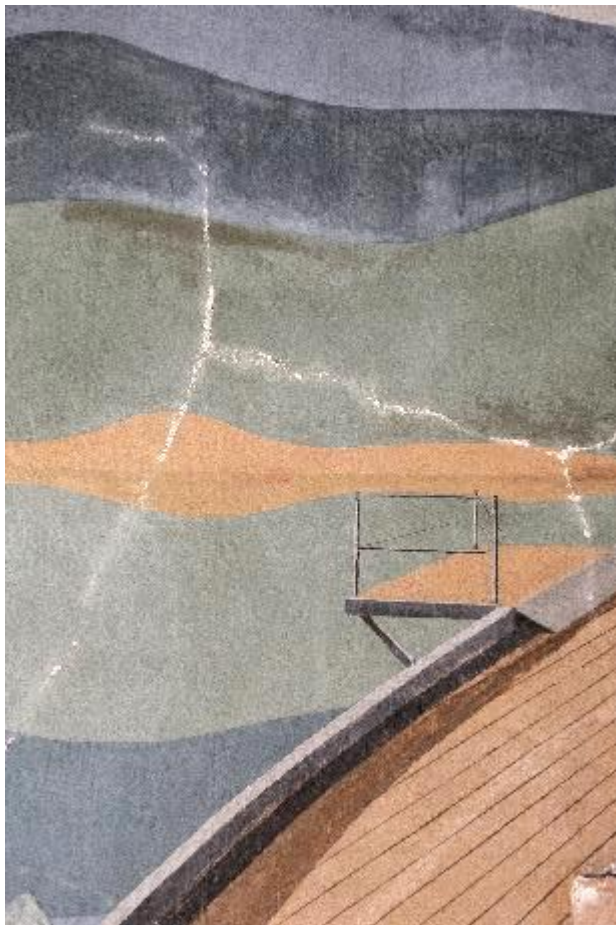
Detail of the lower center portion of the mural. The moisture has caused some creases on the canvas.

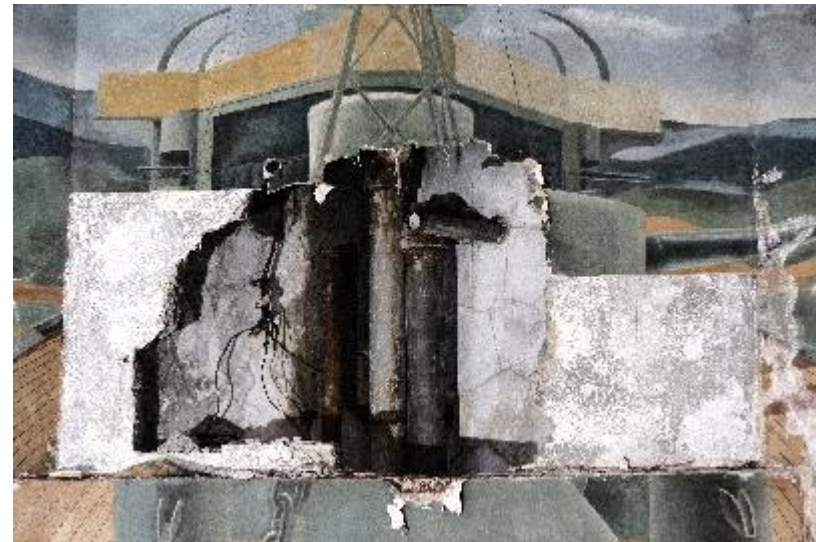
Detail showing the canvas that was cut and removed.

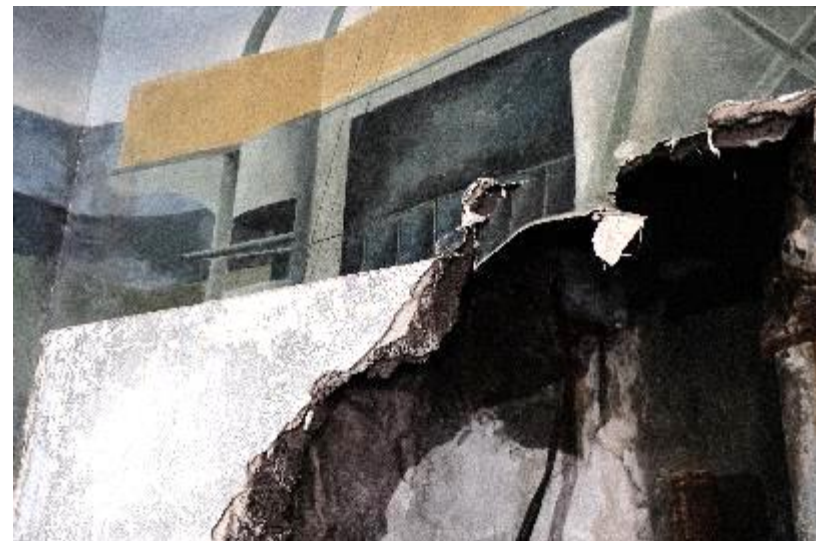
Closer detail of the canvas loss. It also shows the loose edges of the remaining canvas.

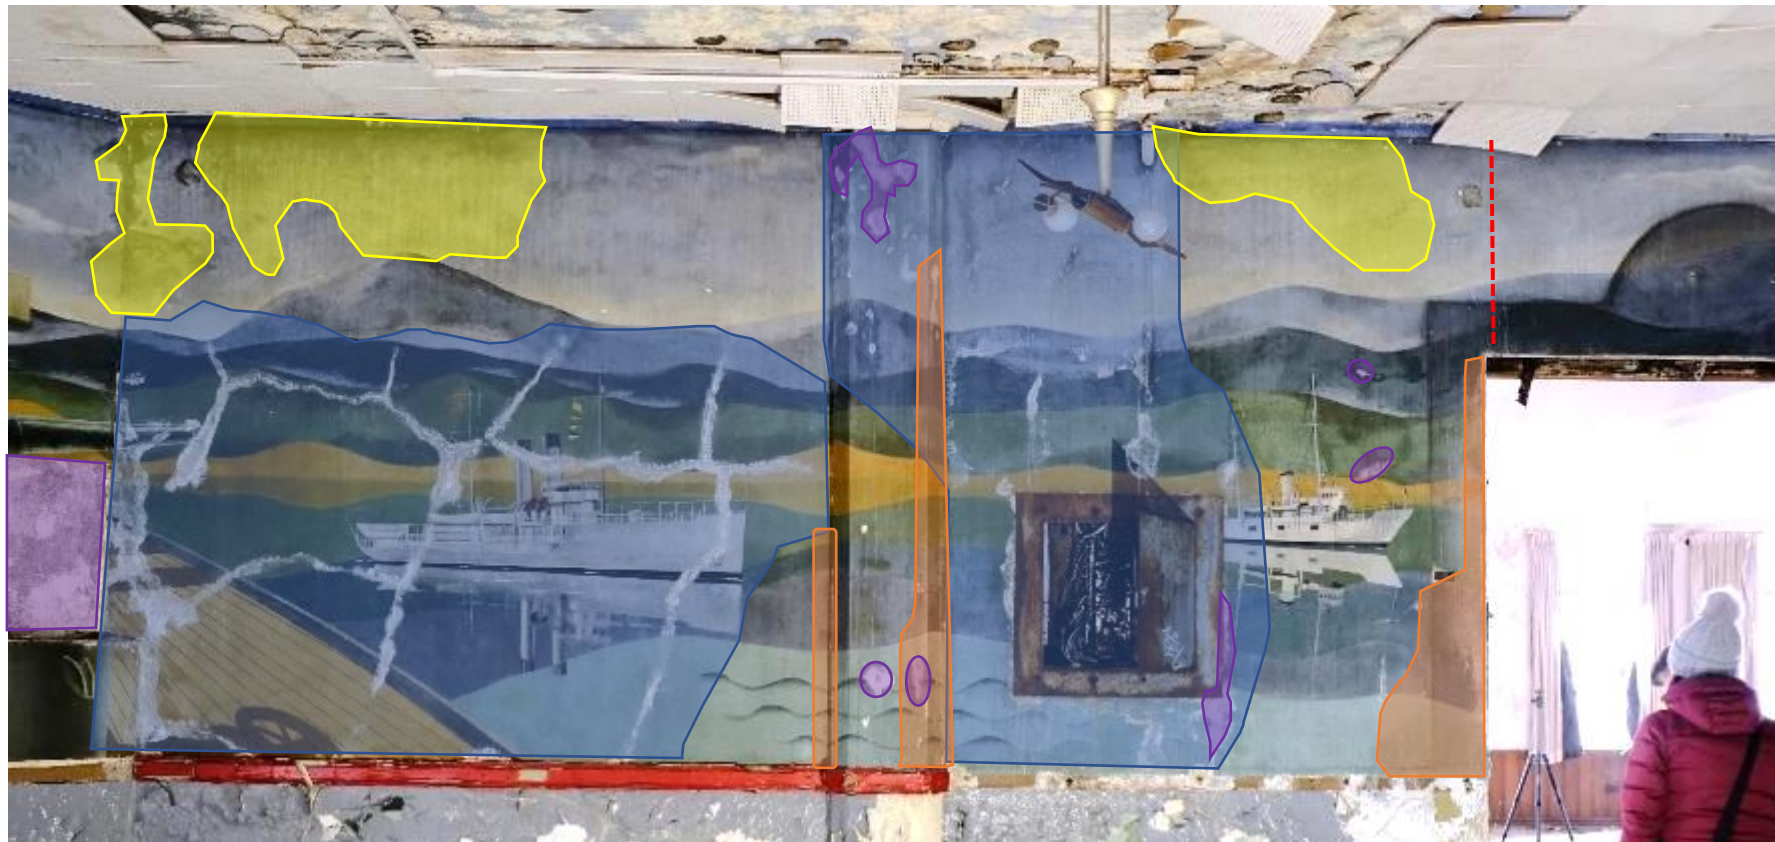
Material and Surface Defects

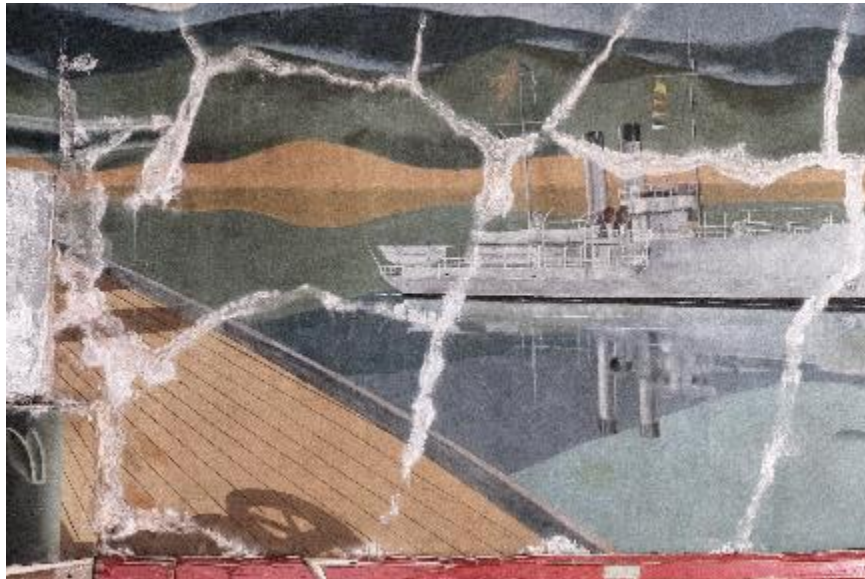
Detail of the left hand portion of the mural. The moisture has caused numerous creases with losses and efflorescence staining.

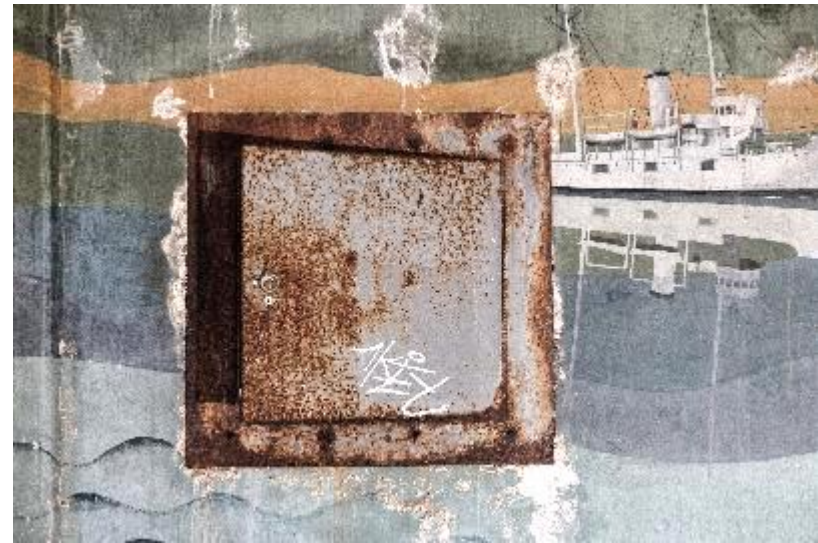
Detail of the right hand portion of the mural. There is moderate water damage and efflorescence from the moisture.

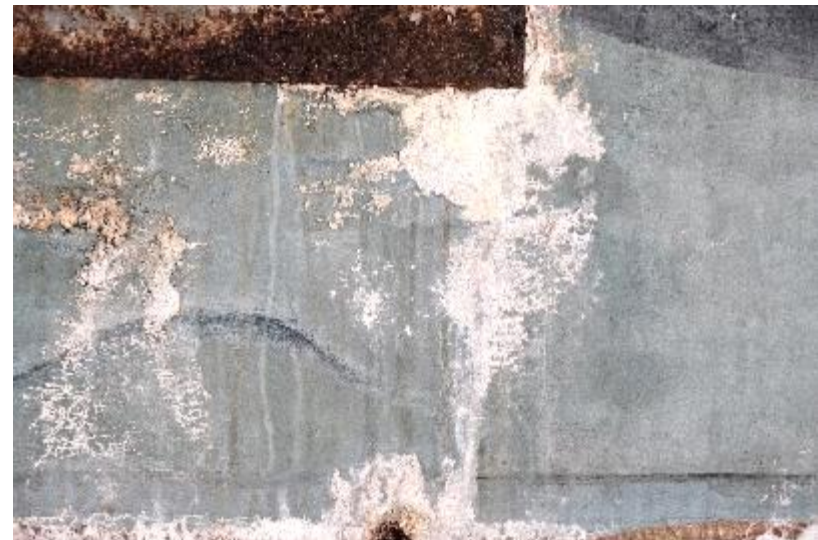
Closer detail below the metal hatch showing the extent of water damage.

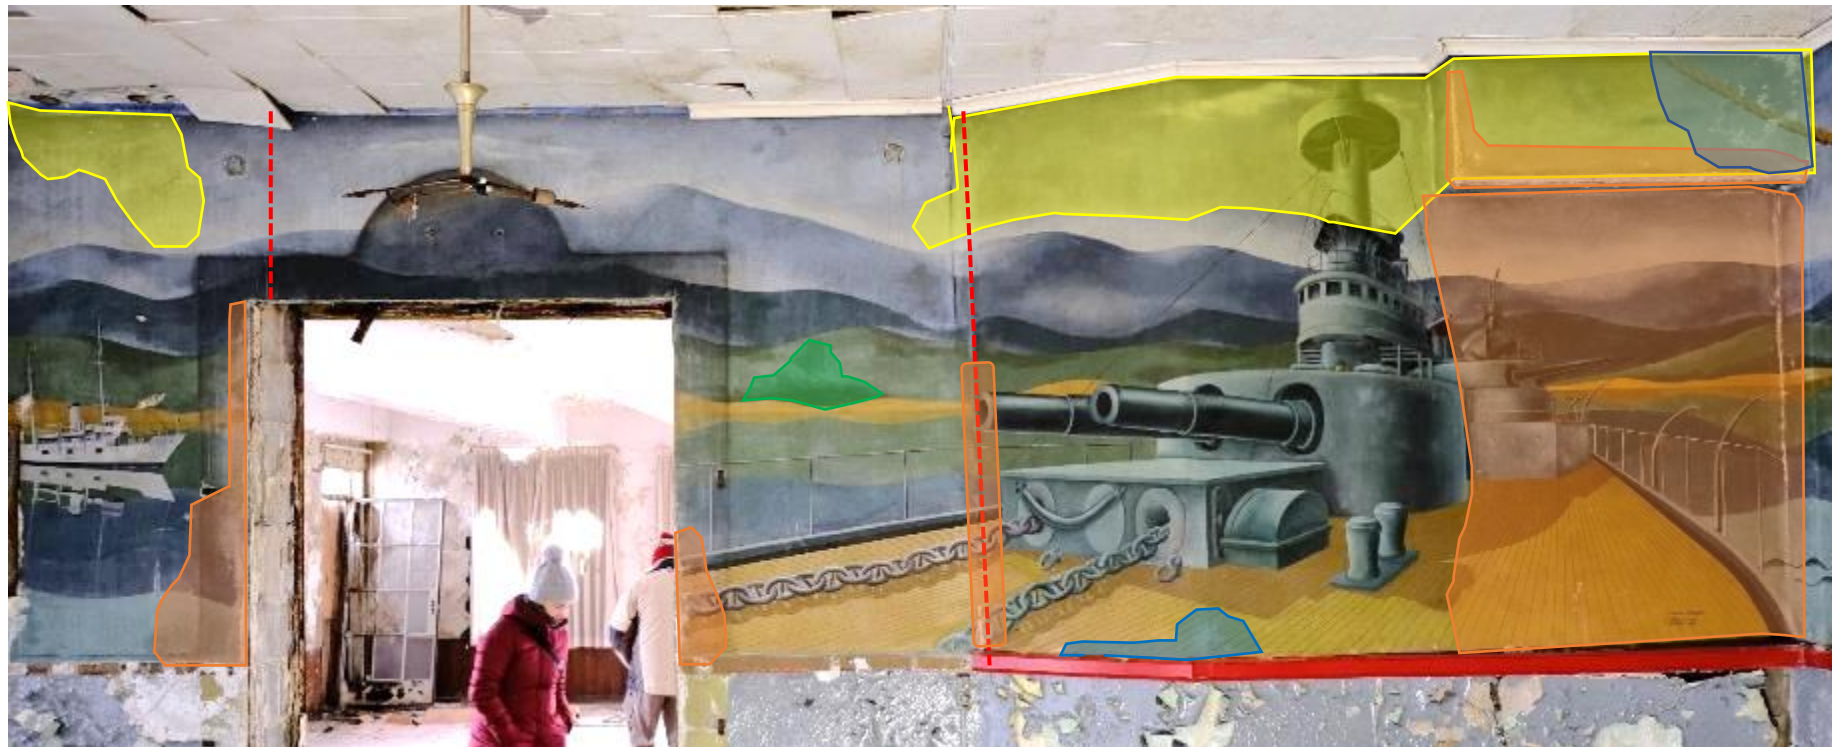
Material and Surface Defects

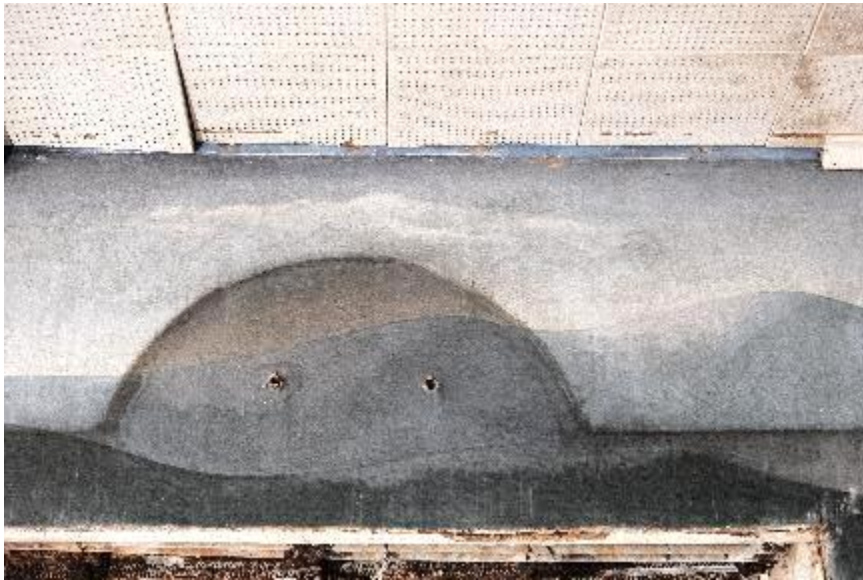
Detail of the upper left hand portion of the mural. The moisture has caused some surface discoloration.
