Report on the
Assessment of the Historic Murals
at the
R. Thornton Brodhead Armory
Detroit, MI

Executed by Historic Surfaces LLC
July 2022

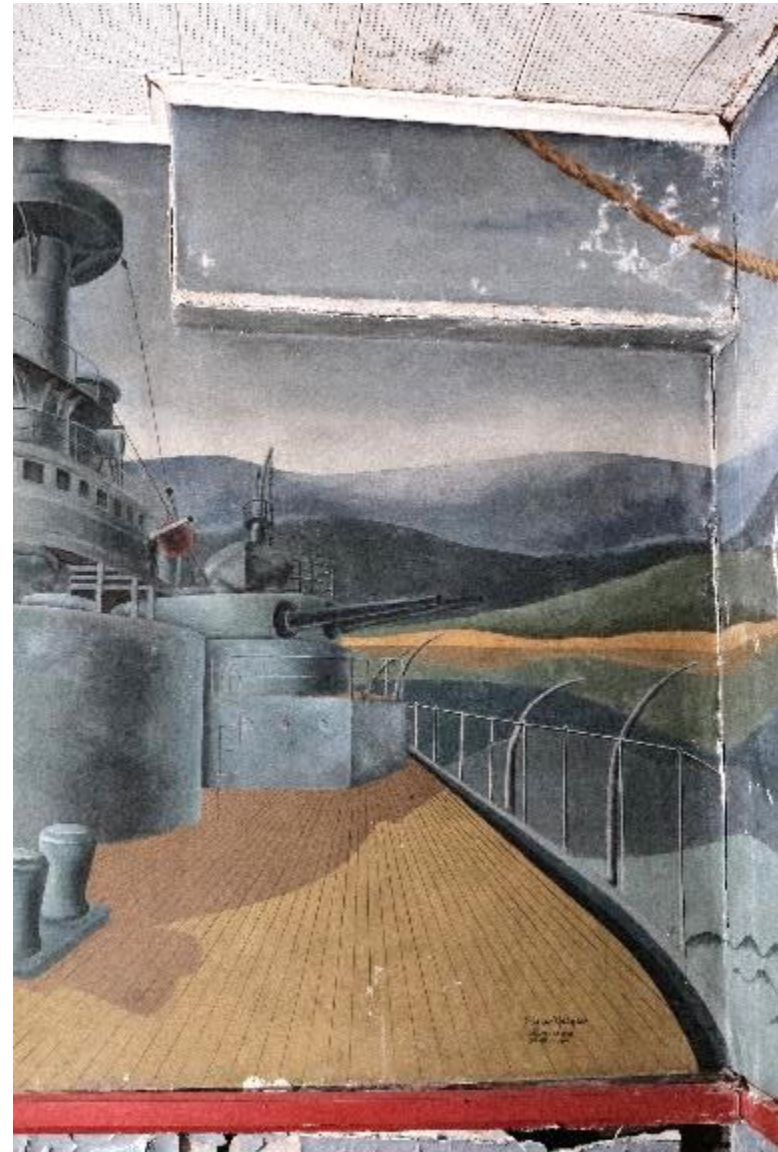
Detail of the right hand side of the mural. The small portion of canvas on the bump out and the entire section of below has delaminated and is loose.

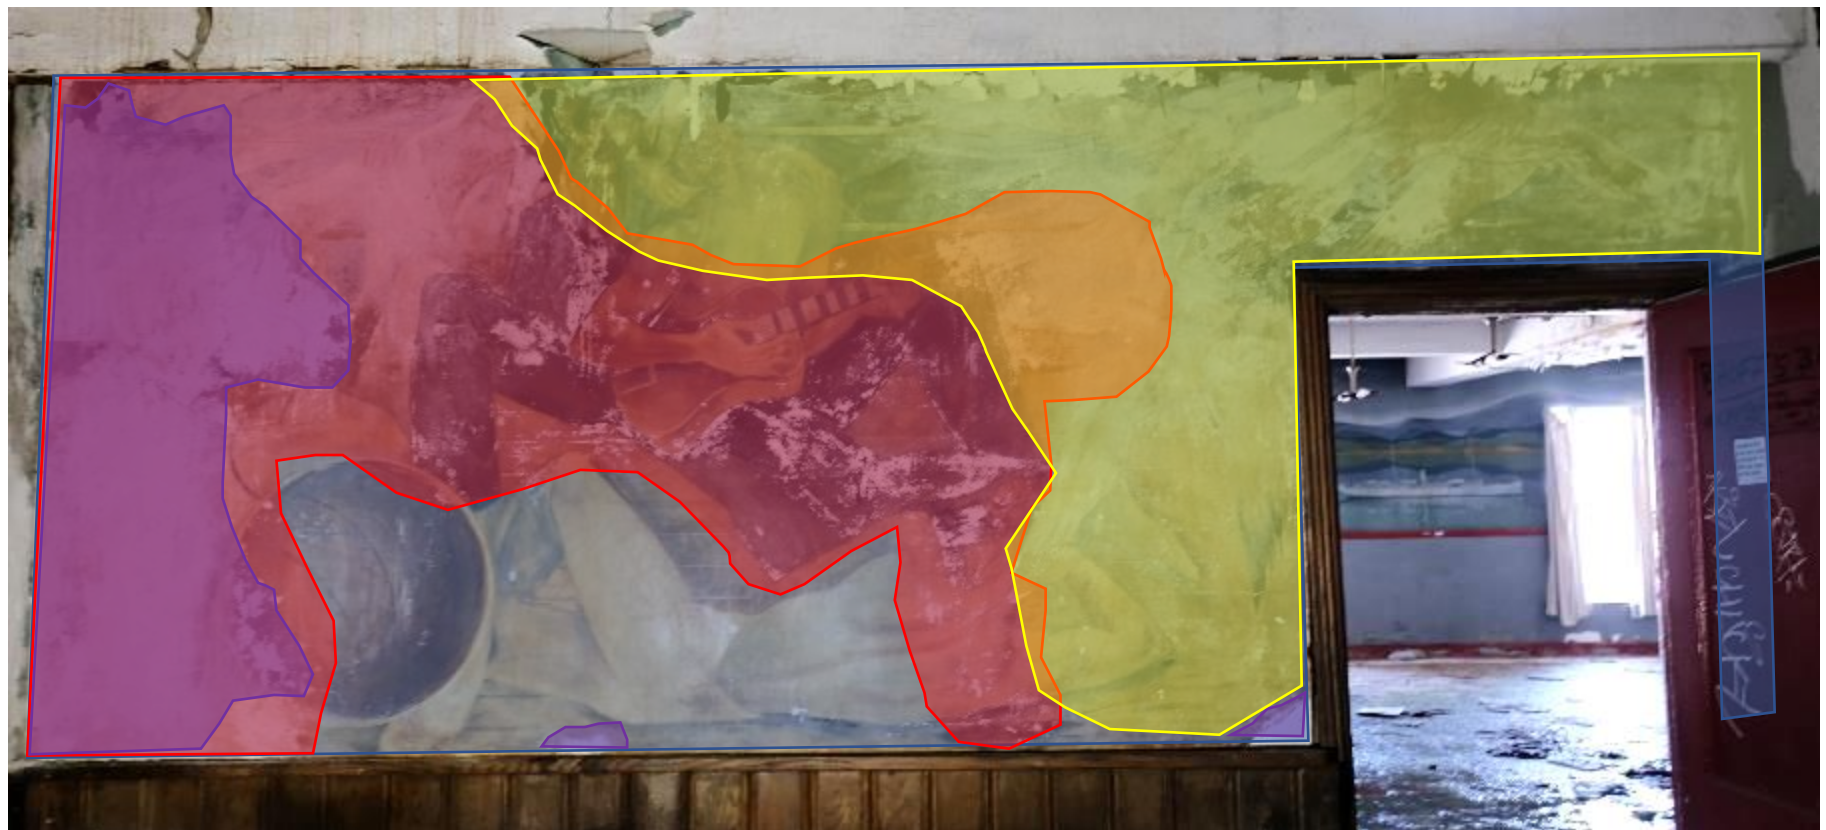
Material and Surface Defects

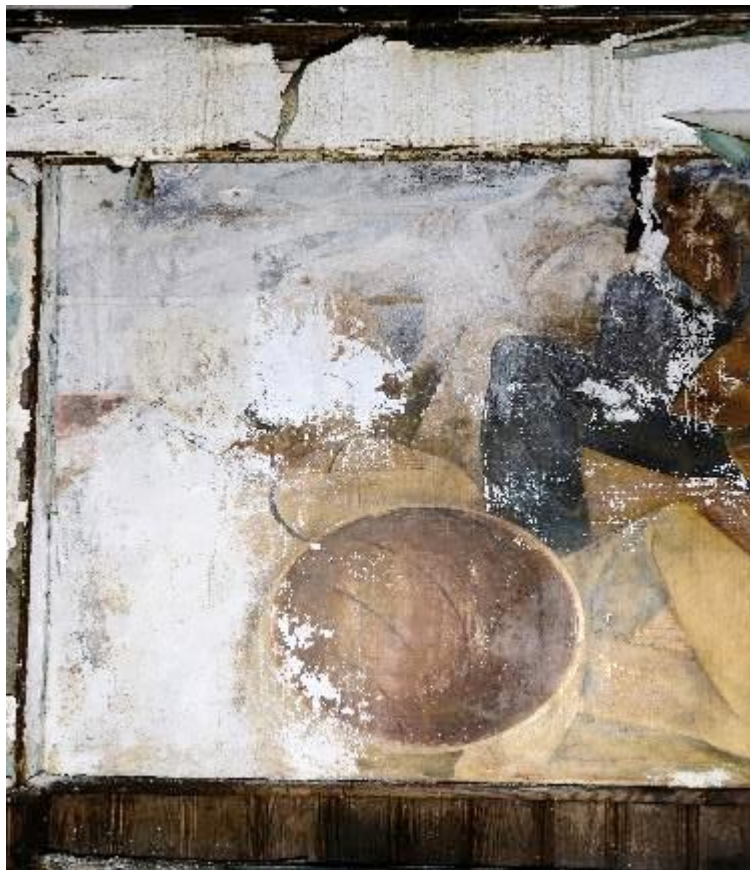
Detail of the left-hand portion of the fresco. Water damage has caused significant damage and loss.

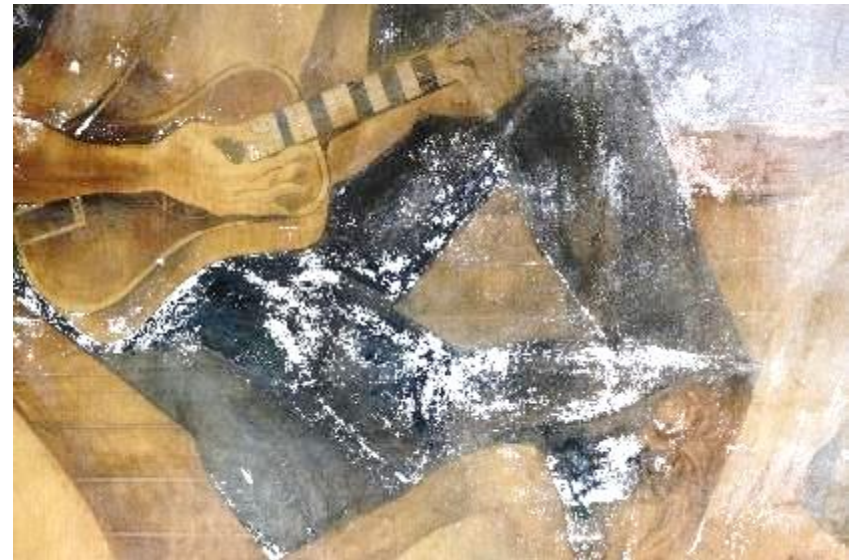
Detail of the center-left portion of the fresco. There is a significant amount of flaking paint and losses.

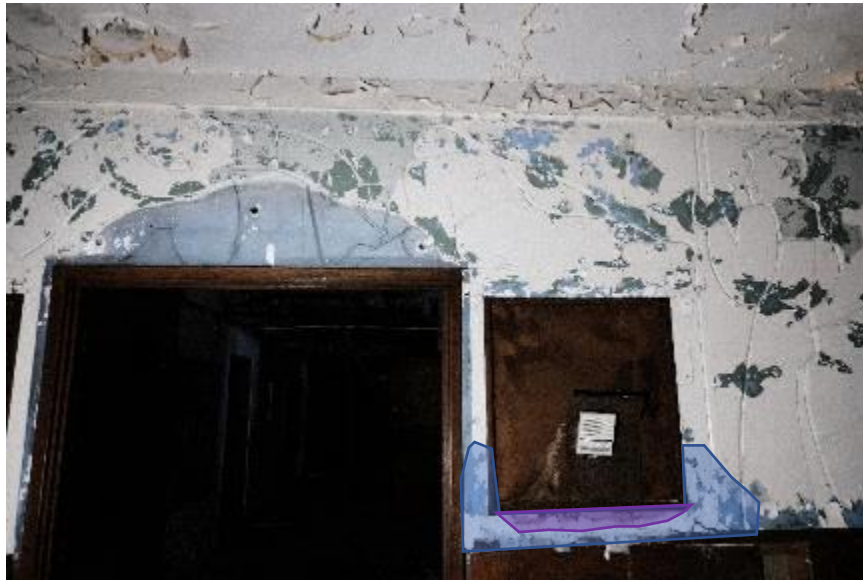
Material and Surface Defects

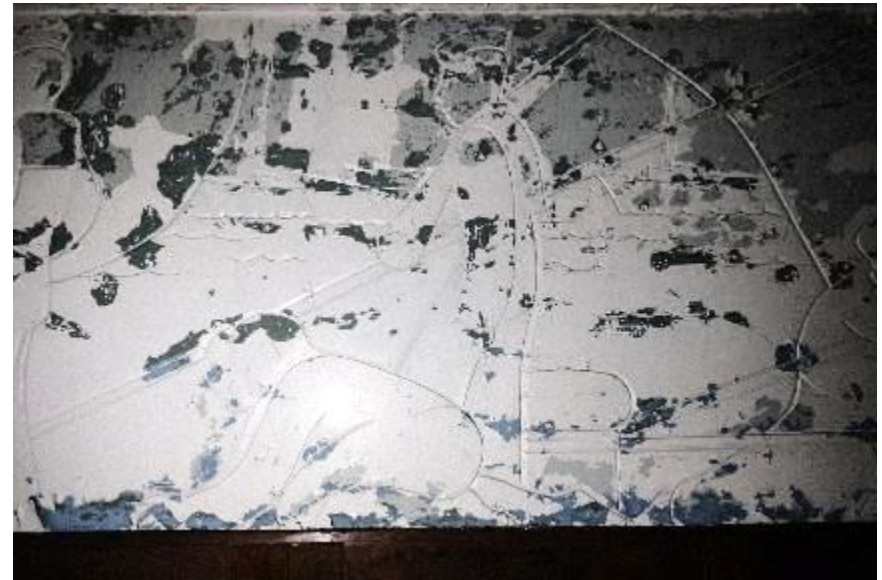
Material and Surface Defects

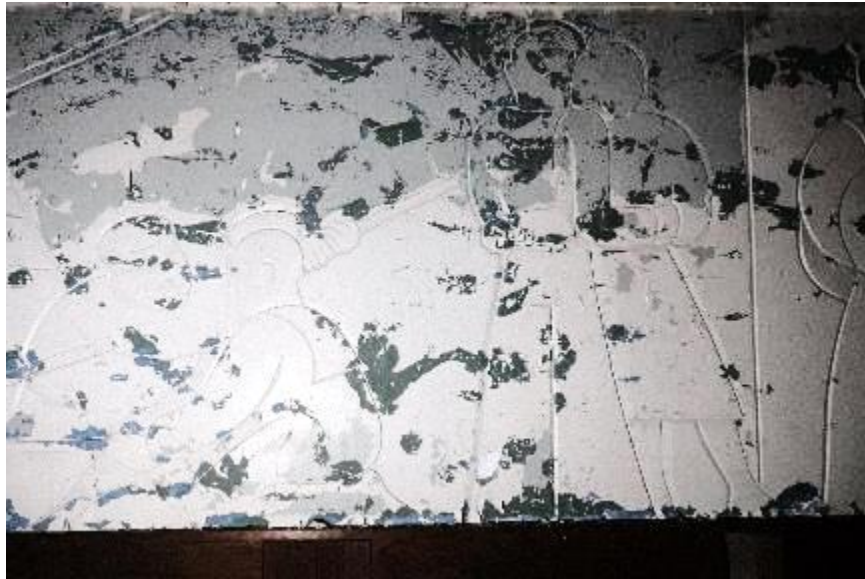
Material and Surface Defects

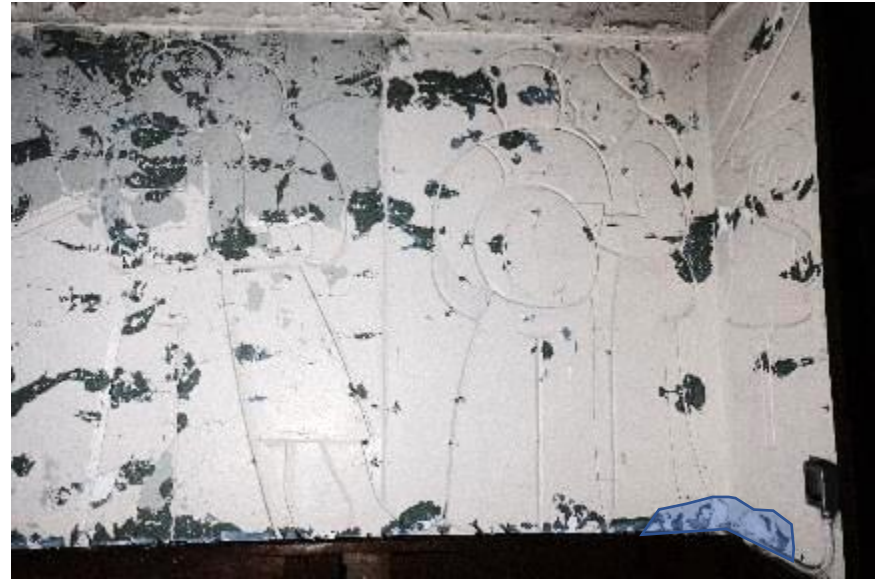
Material and Surface Defects

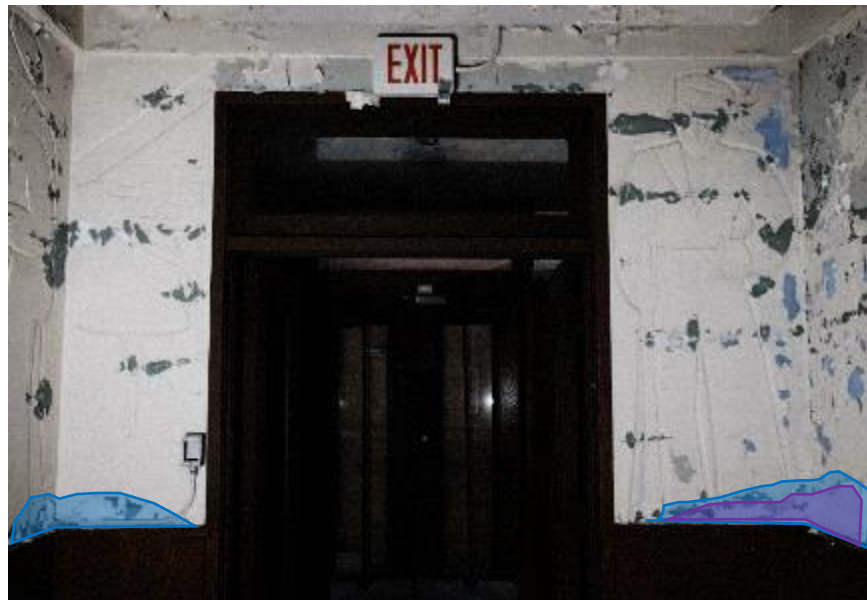
Material and Surface Defects

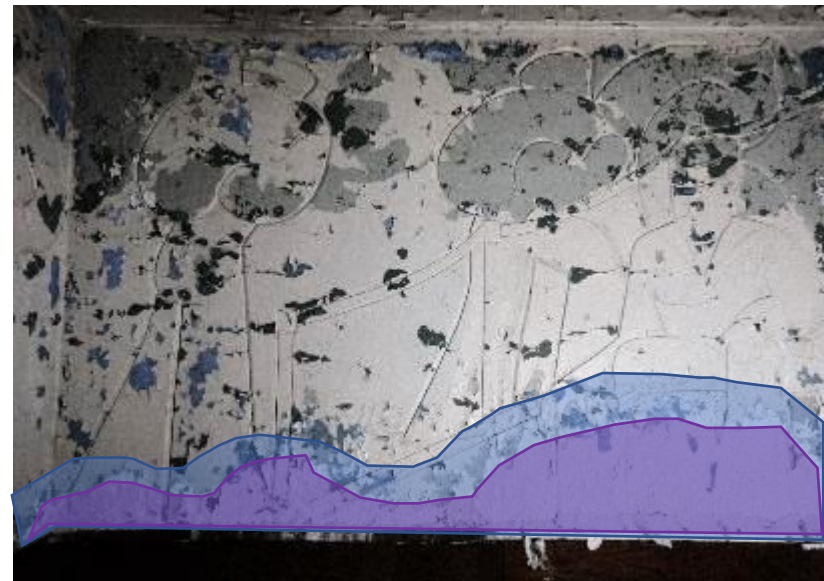
Material and Surface Defects

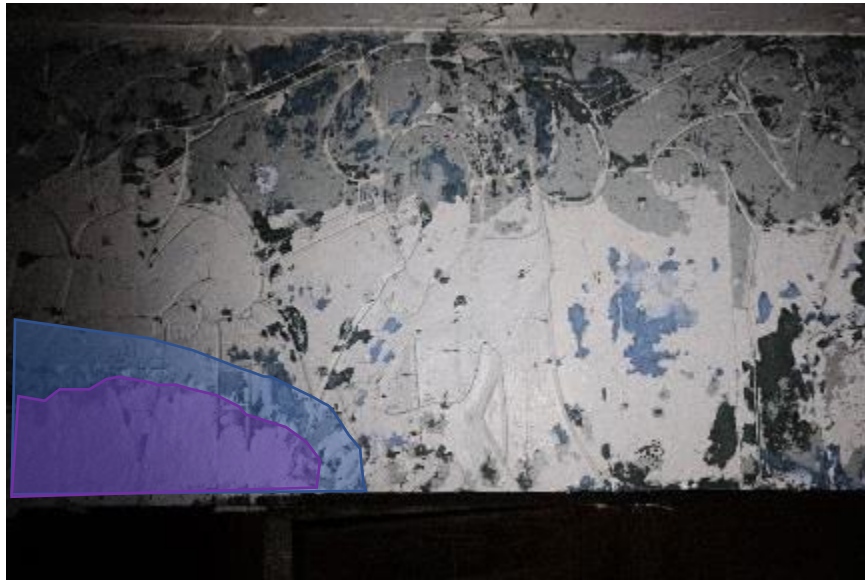
Material and Surface Defects

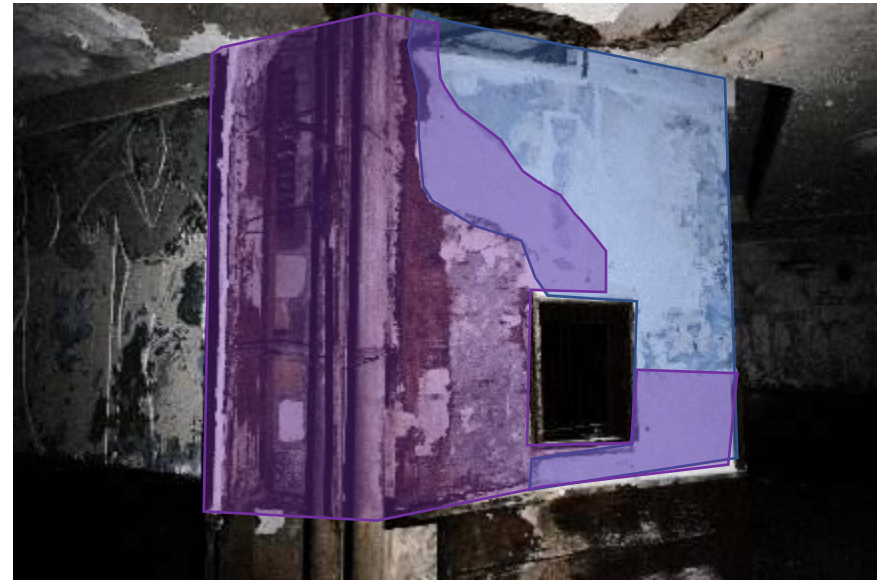
Material and Surface Defects

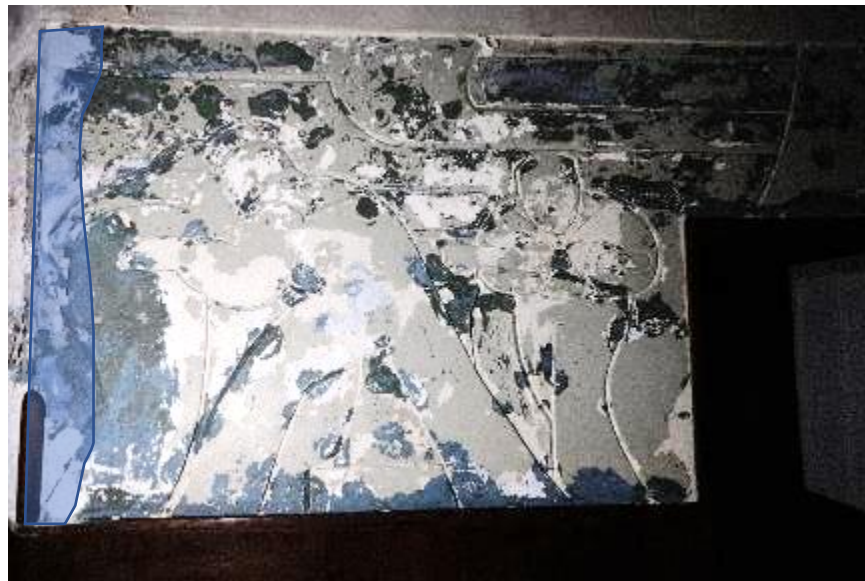
Material and Surface Defects

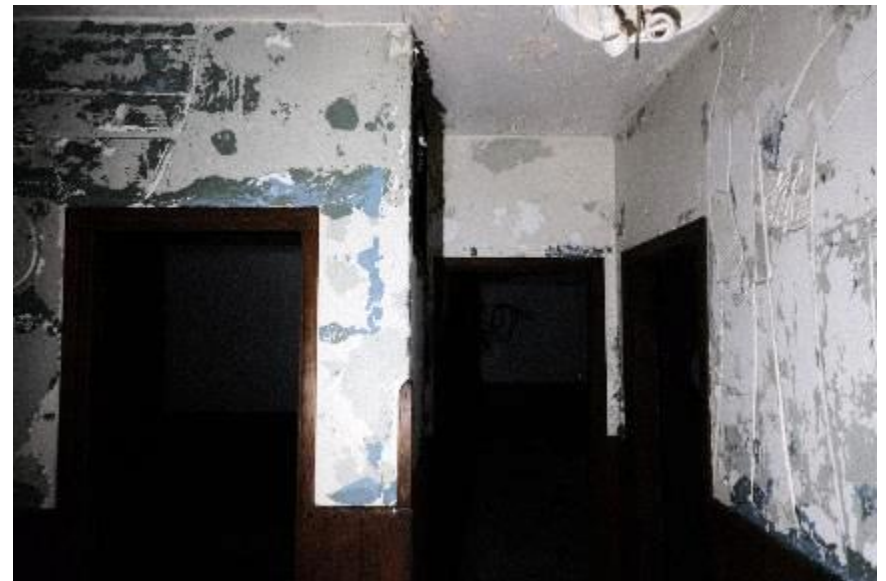
Material and Surface Defects

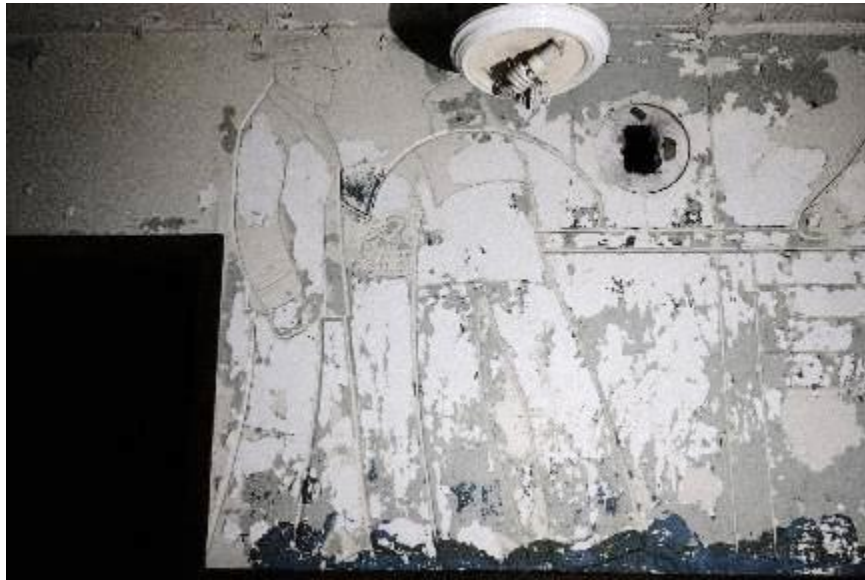
Material and Surface Defects

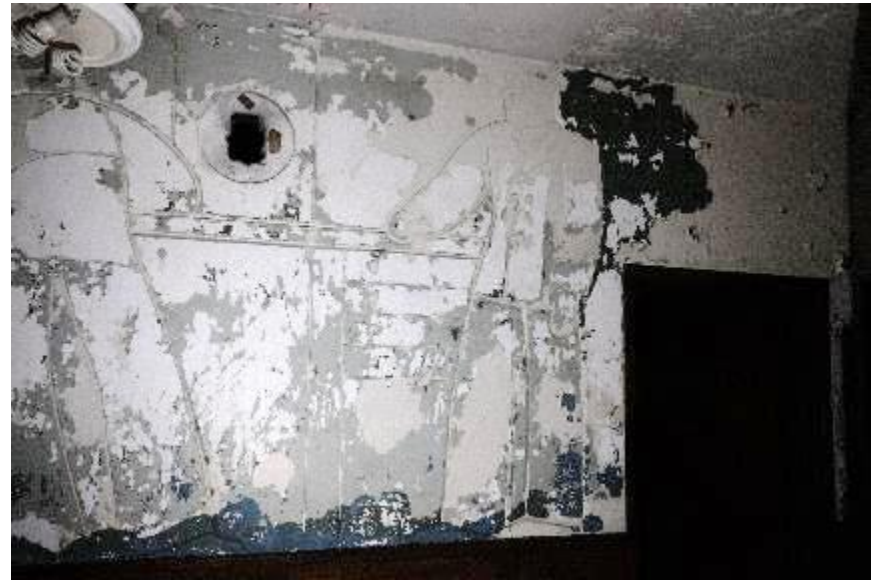
Material and Surface Defects

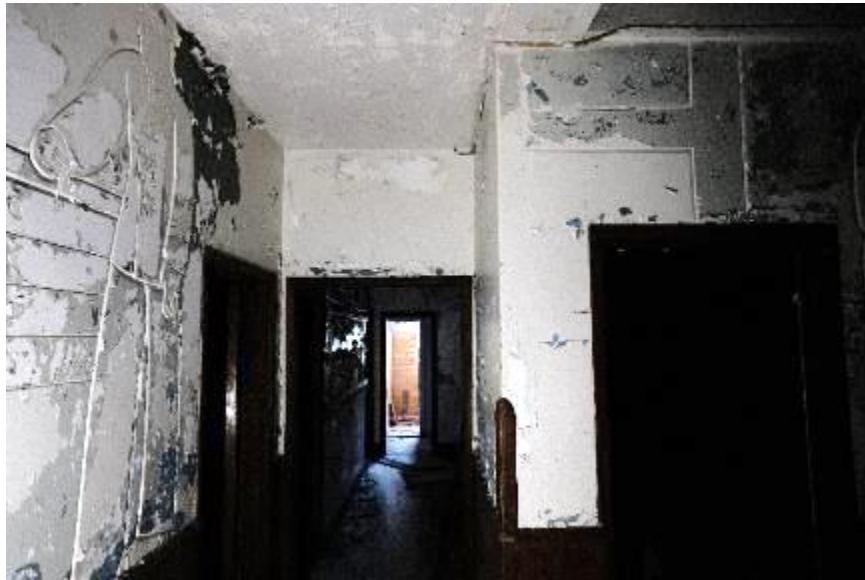
Material and Surface Defects

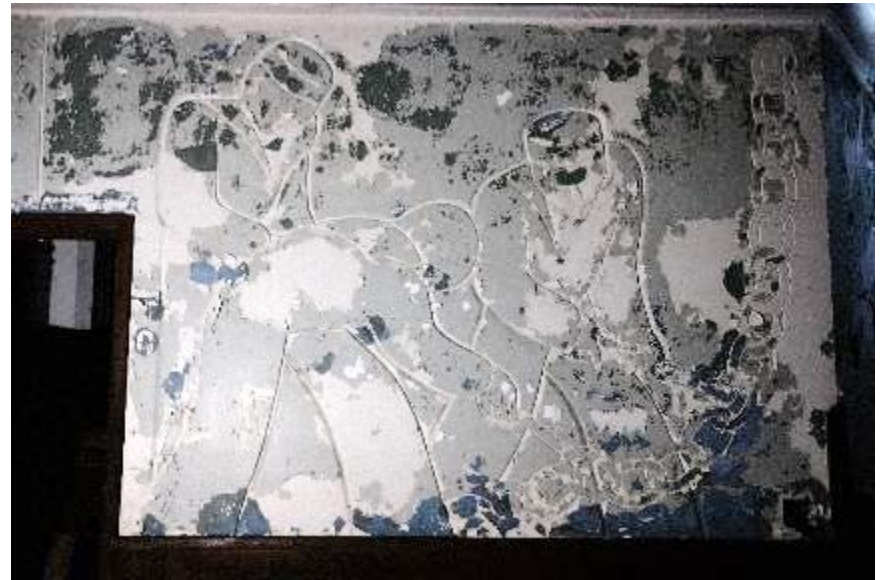
Material and Surface Defects

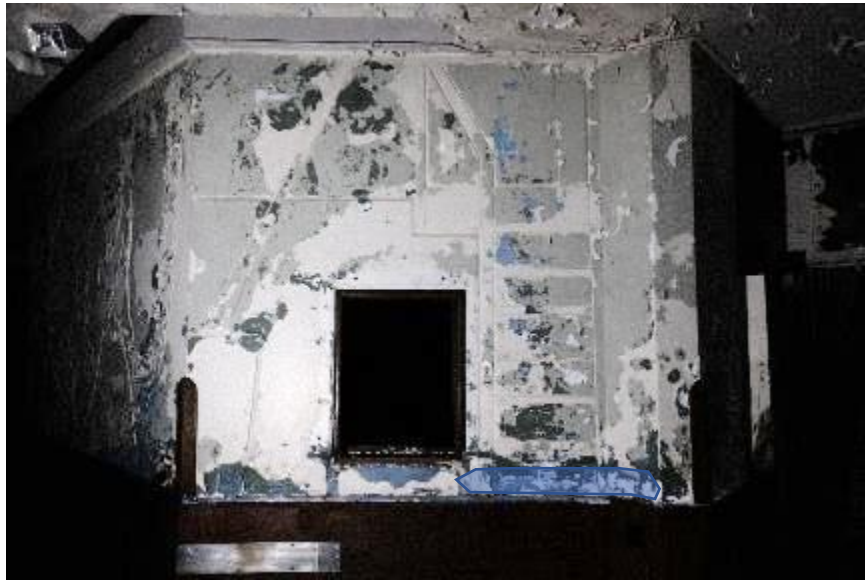
Material and Surface Defects

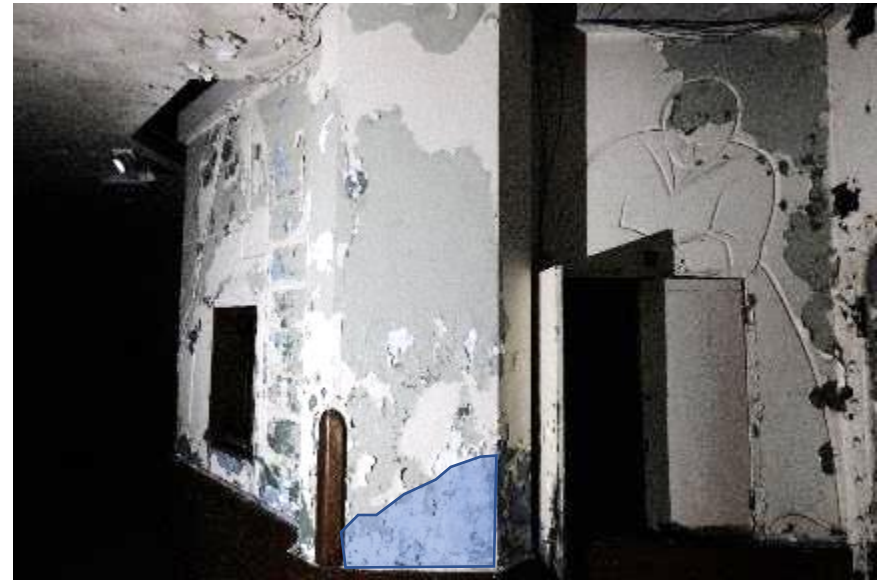
Material and Surface Defects

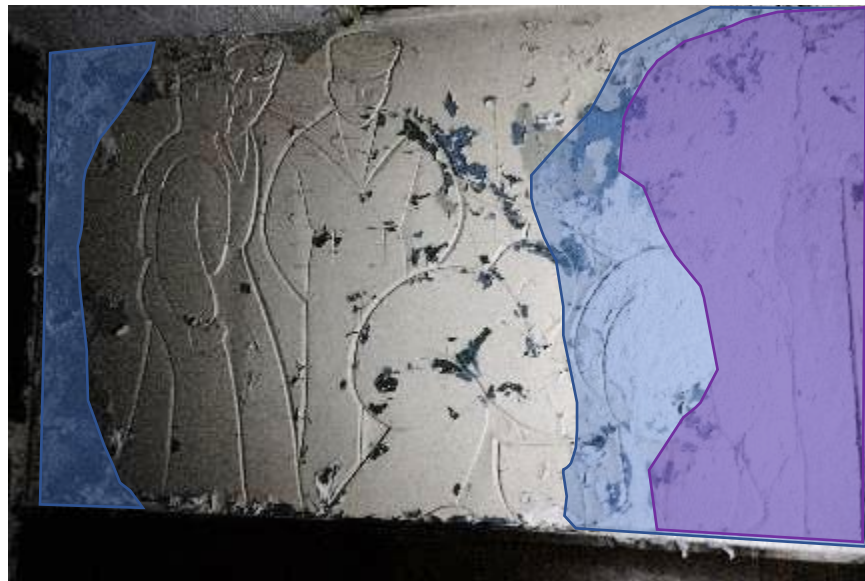
Material and Surface Defects

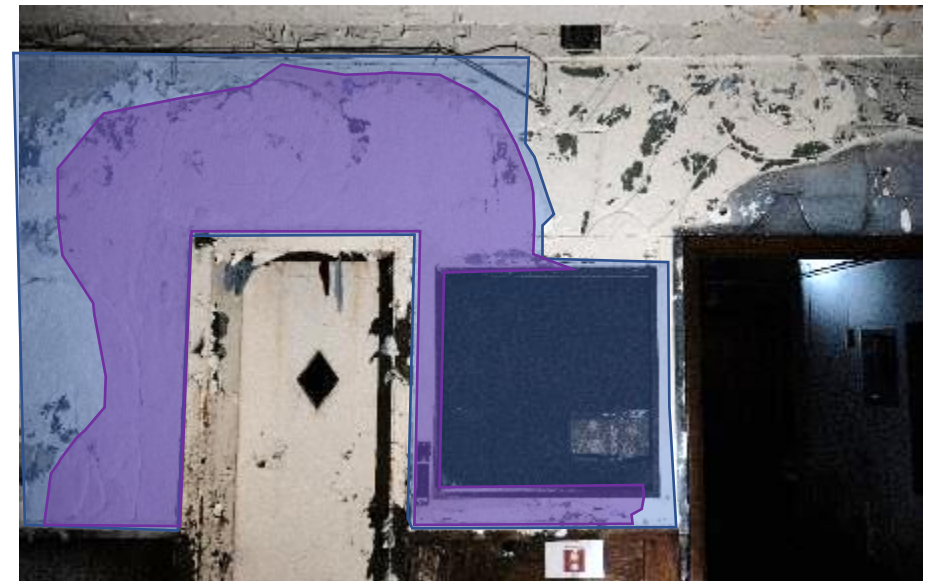
Material and Surface Defects

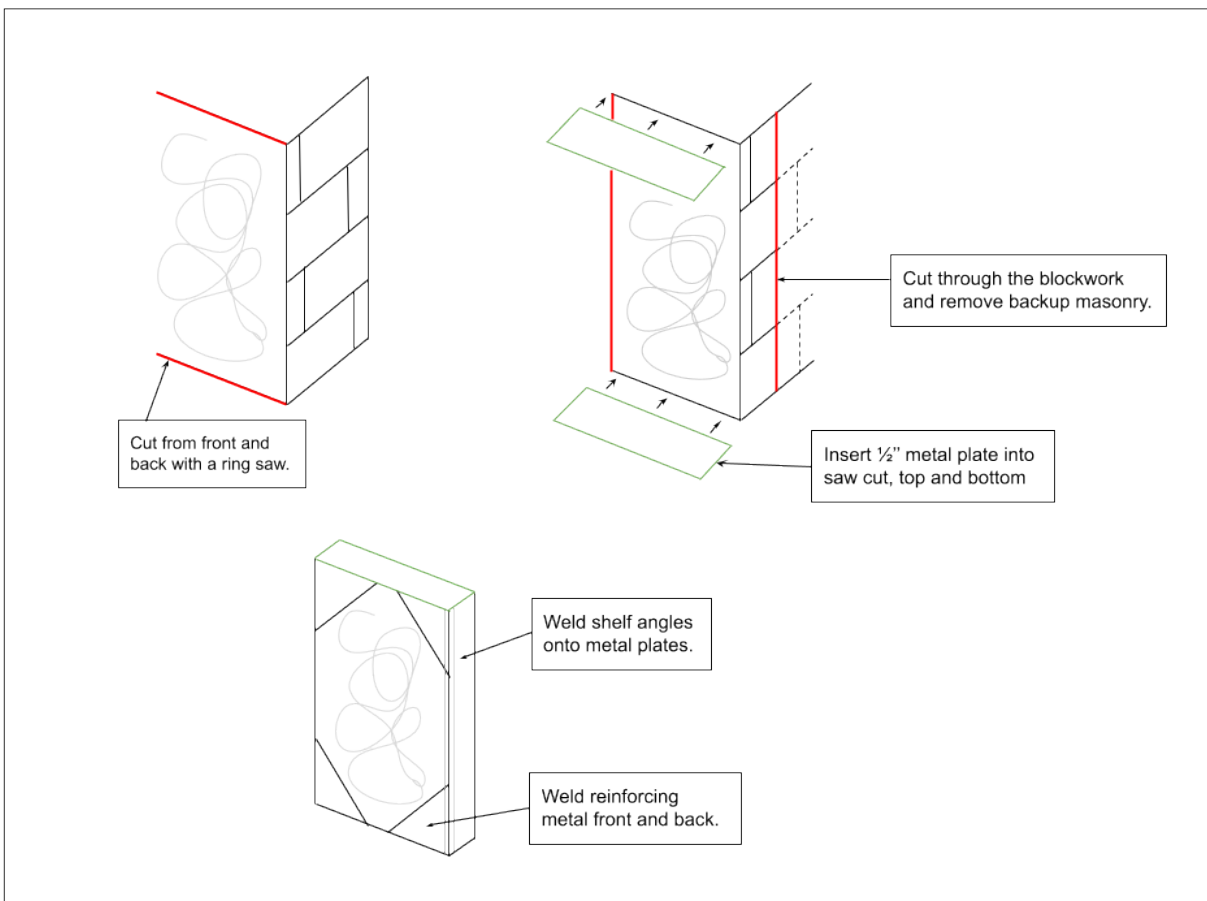
Leverett Masonry Consulting

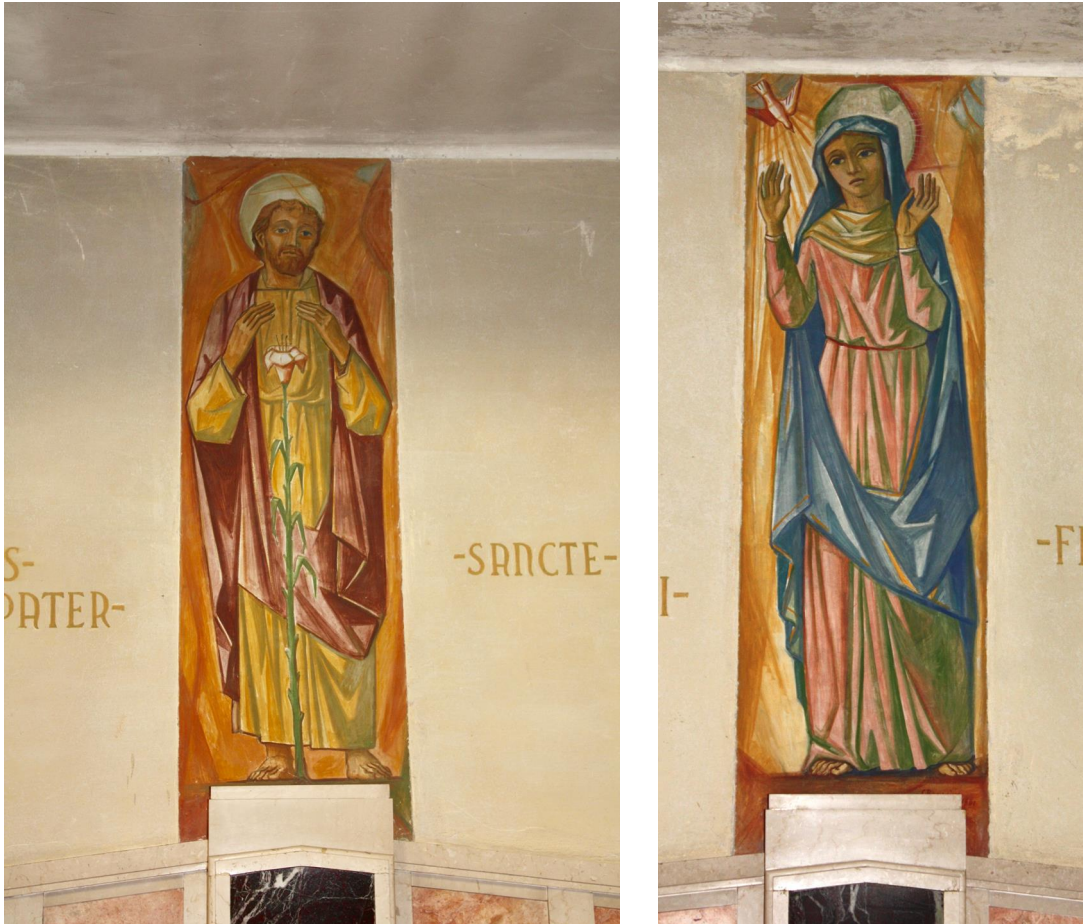
Carlo Bonacina is an artist (Mestrino 09/20/1905, Pergine Valsugana 01/30/2001), working in Verona and Trentino, that belongs to Magic Realism Current and his production counts many frescos because of his contemporary cultural atmosphere, characterized by rediscovery of antique traditional techniques.
