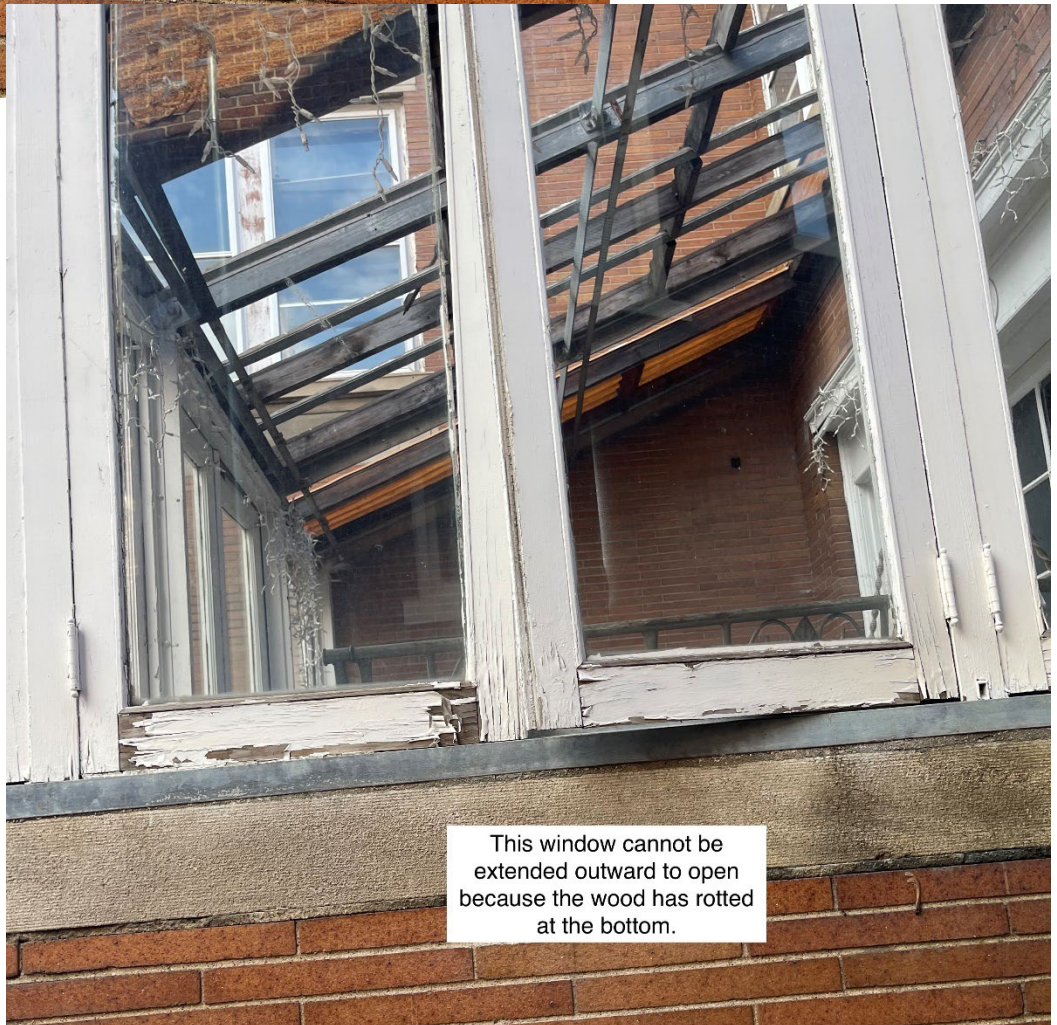
This window cannot be extended outward to open because the wood has rotted at the bottom.

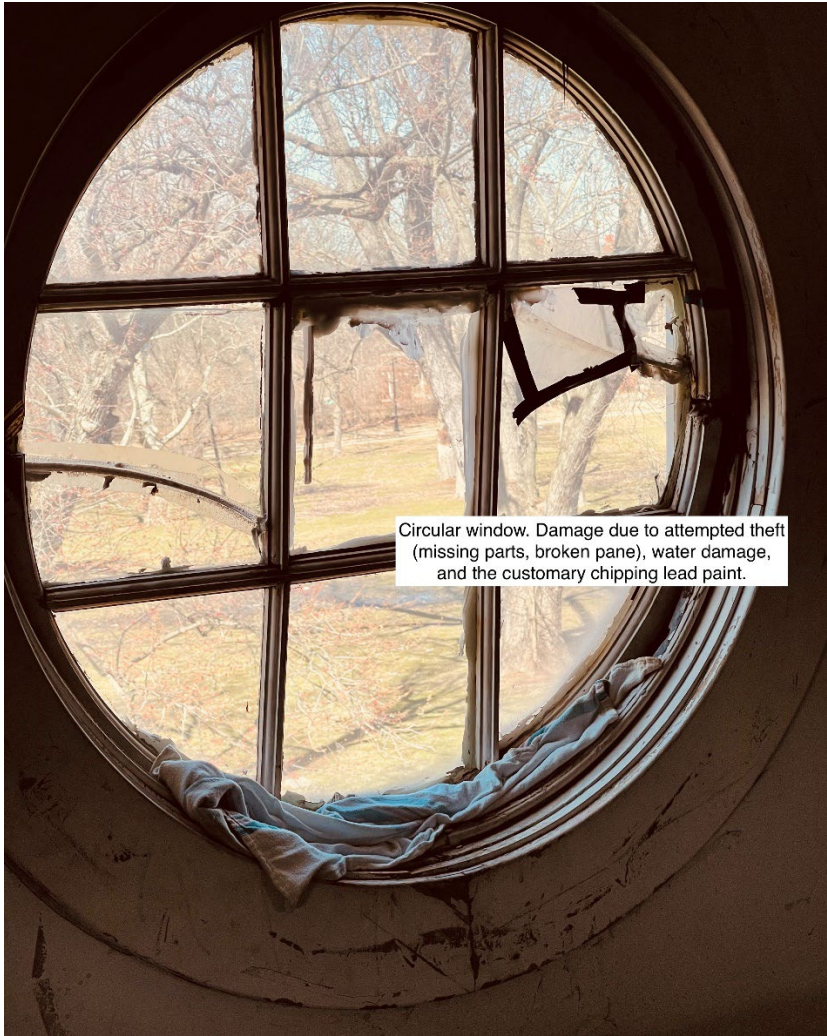
Circular window. Damage due to attempted theft (missing parts, broken pane), water damage, and the customary chipping lead paint.

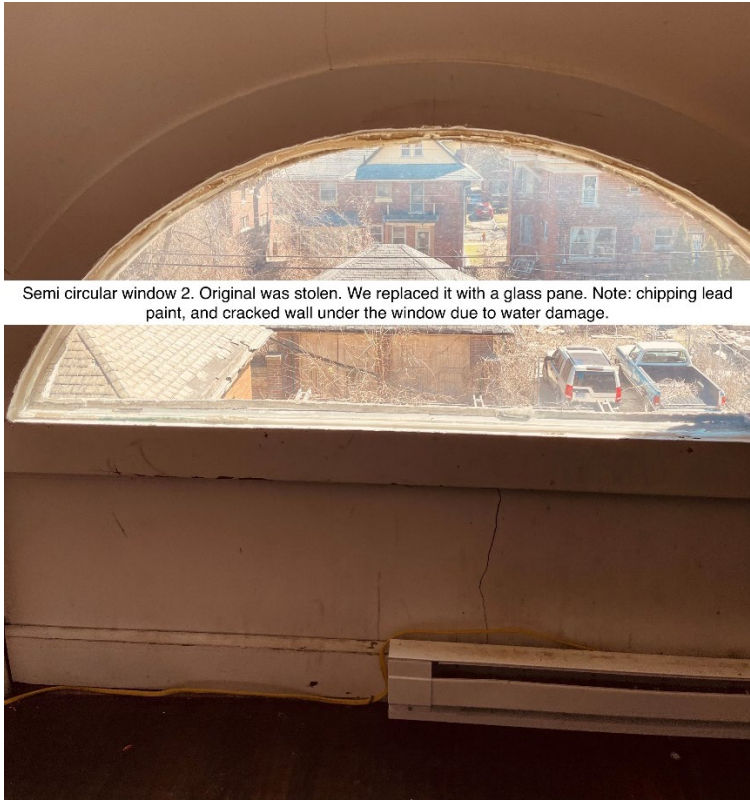
Semi circular window 2. Original was stolen. We replaced it with a glass pane. Note: chipping lead paint, and cracked wall under the window due to water damage.

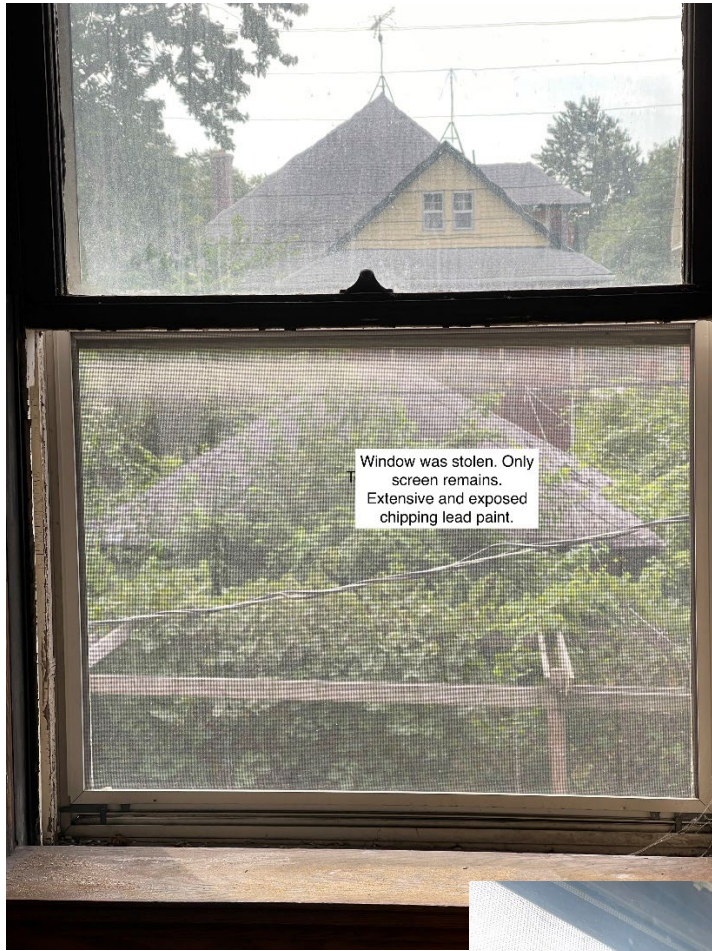
Window was stolen. Only screen remains. Extensive and exposed chipping lead paint.

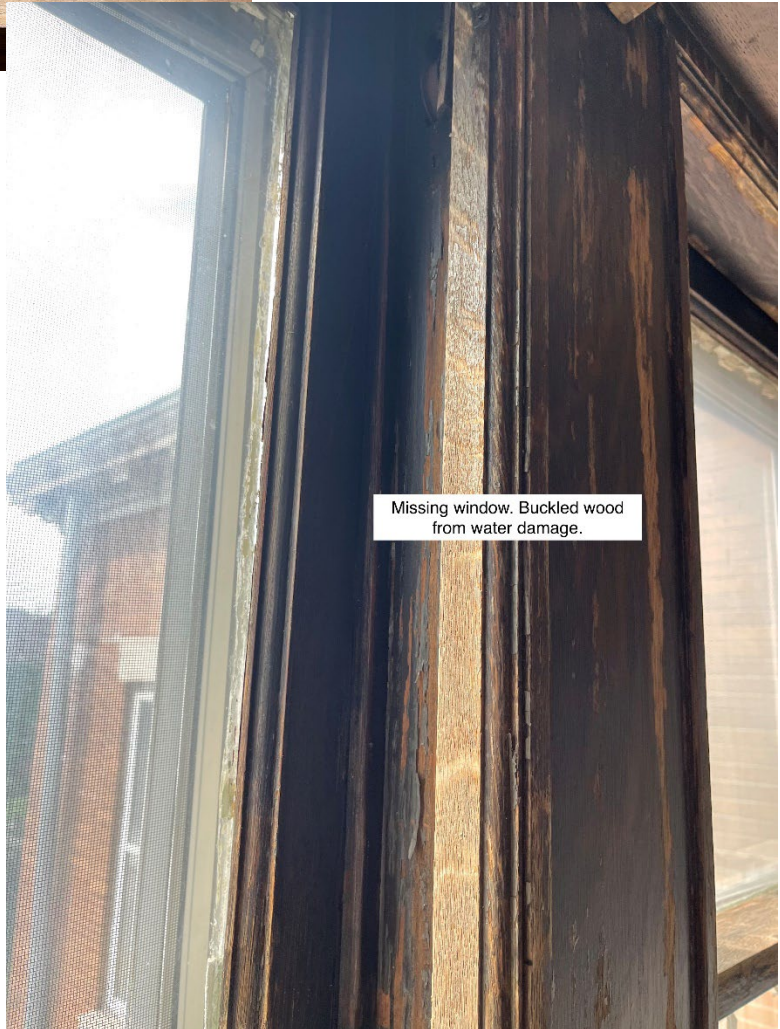
Missing window. Buckled wood from water damage.
