HITSVILLE USA

FRONT PORCH GUARDRAIL

PORIS ASSOCIATES 10.12.22

DETROIT HISTORIC DISTRICT COMMISSION

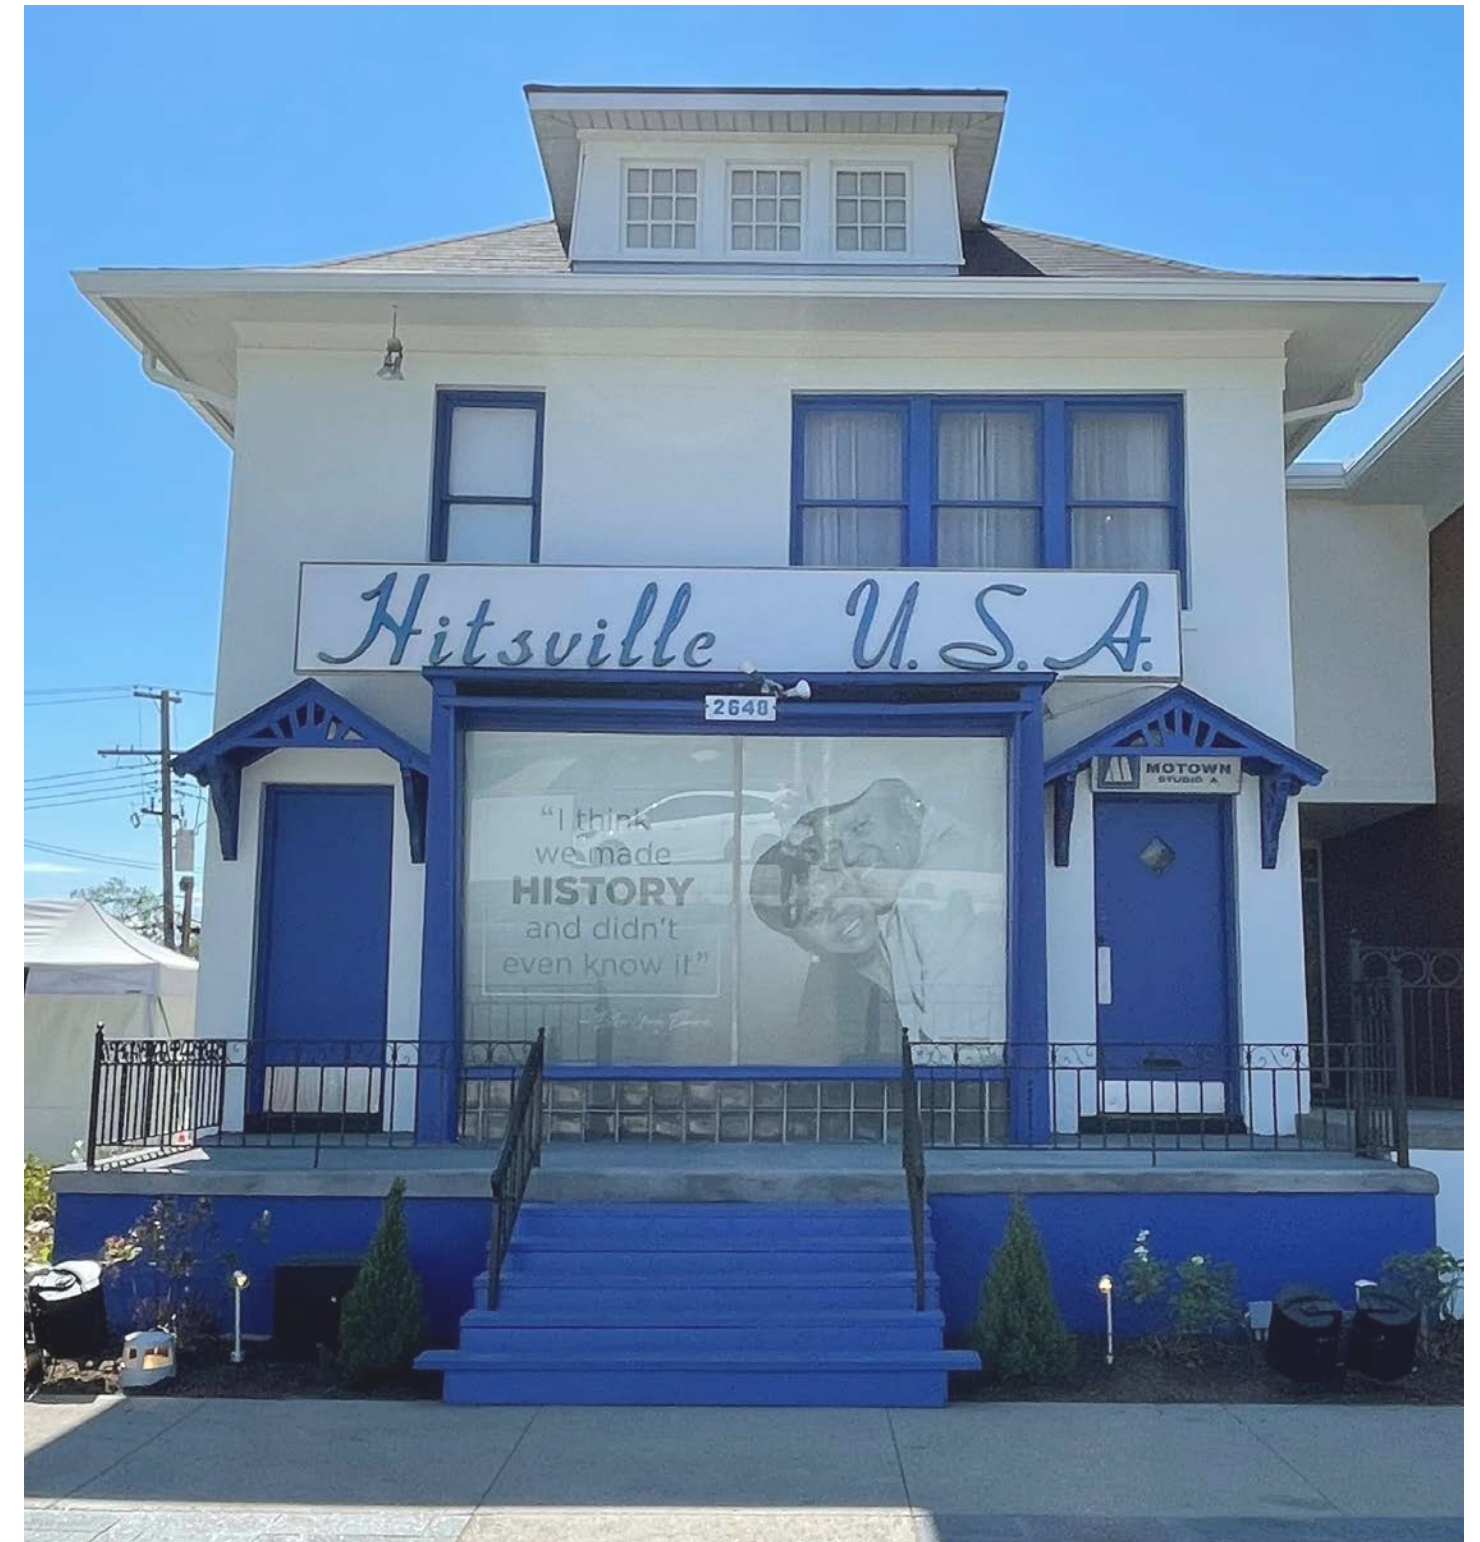
AUGUST 2022

TEMPORARY STEPS, CONCRETE SLAB
AND PORCH FASCIA SHOWN

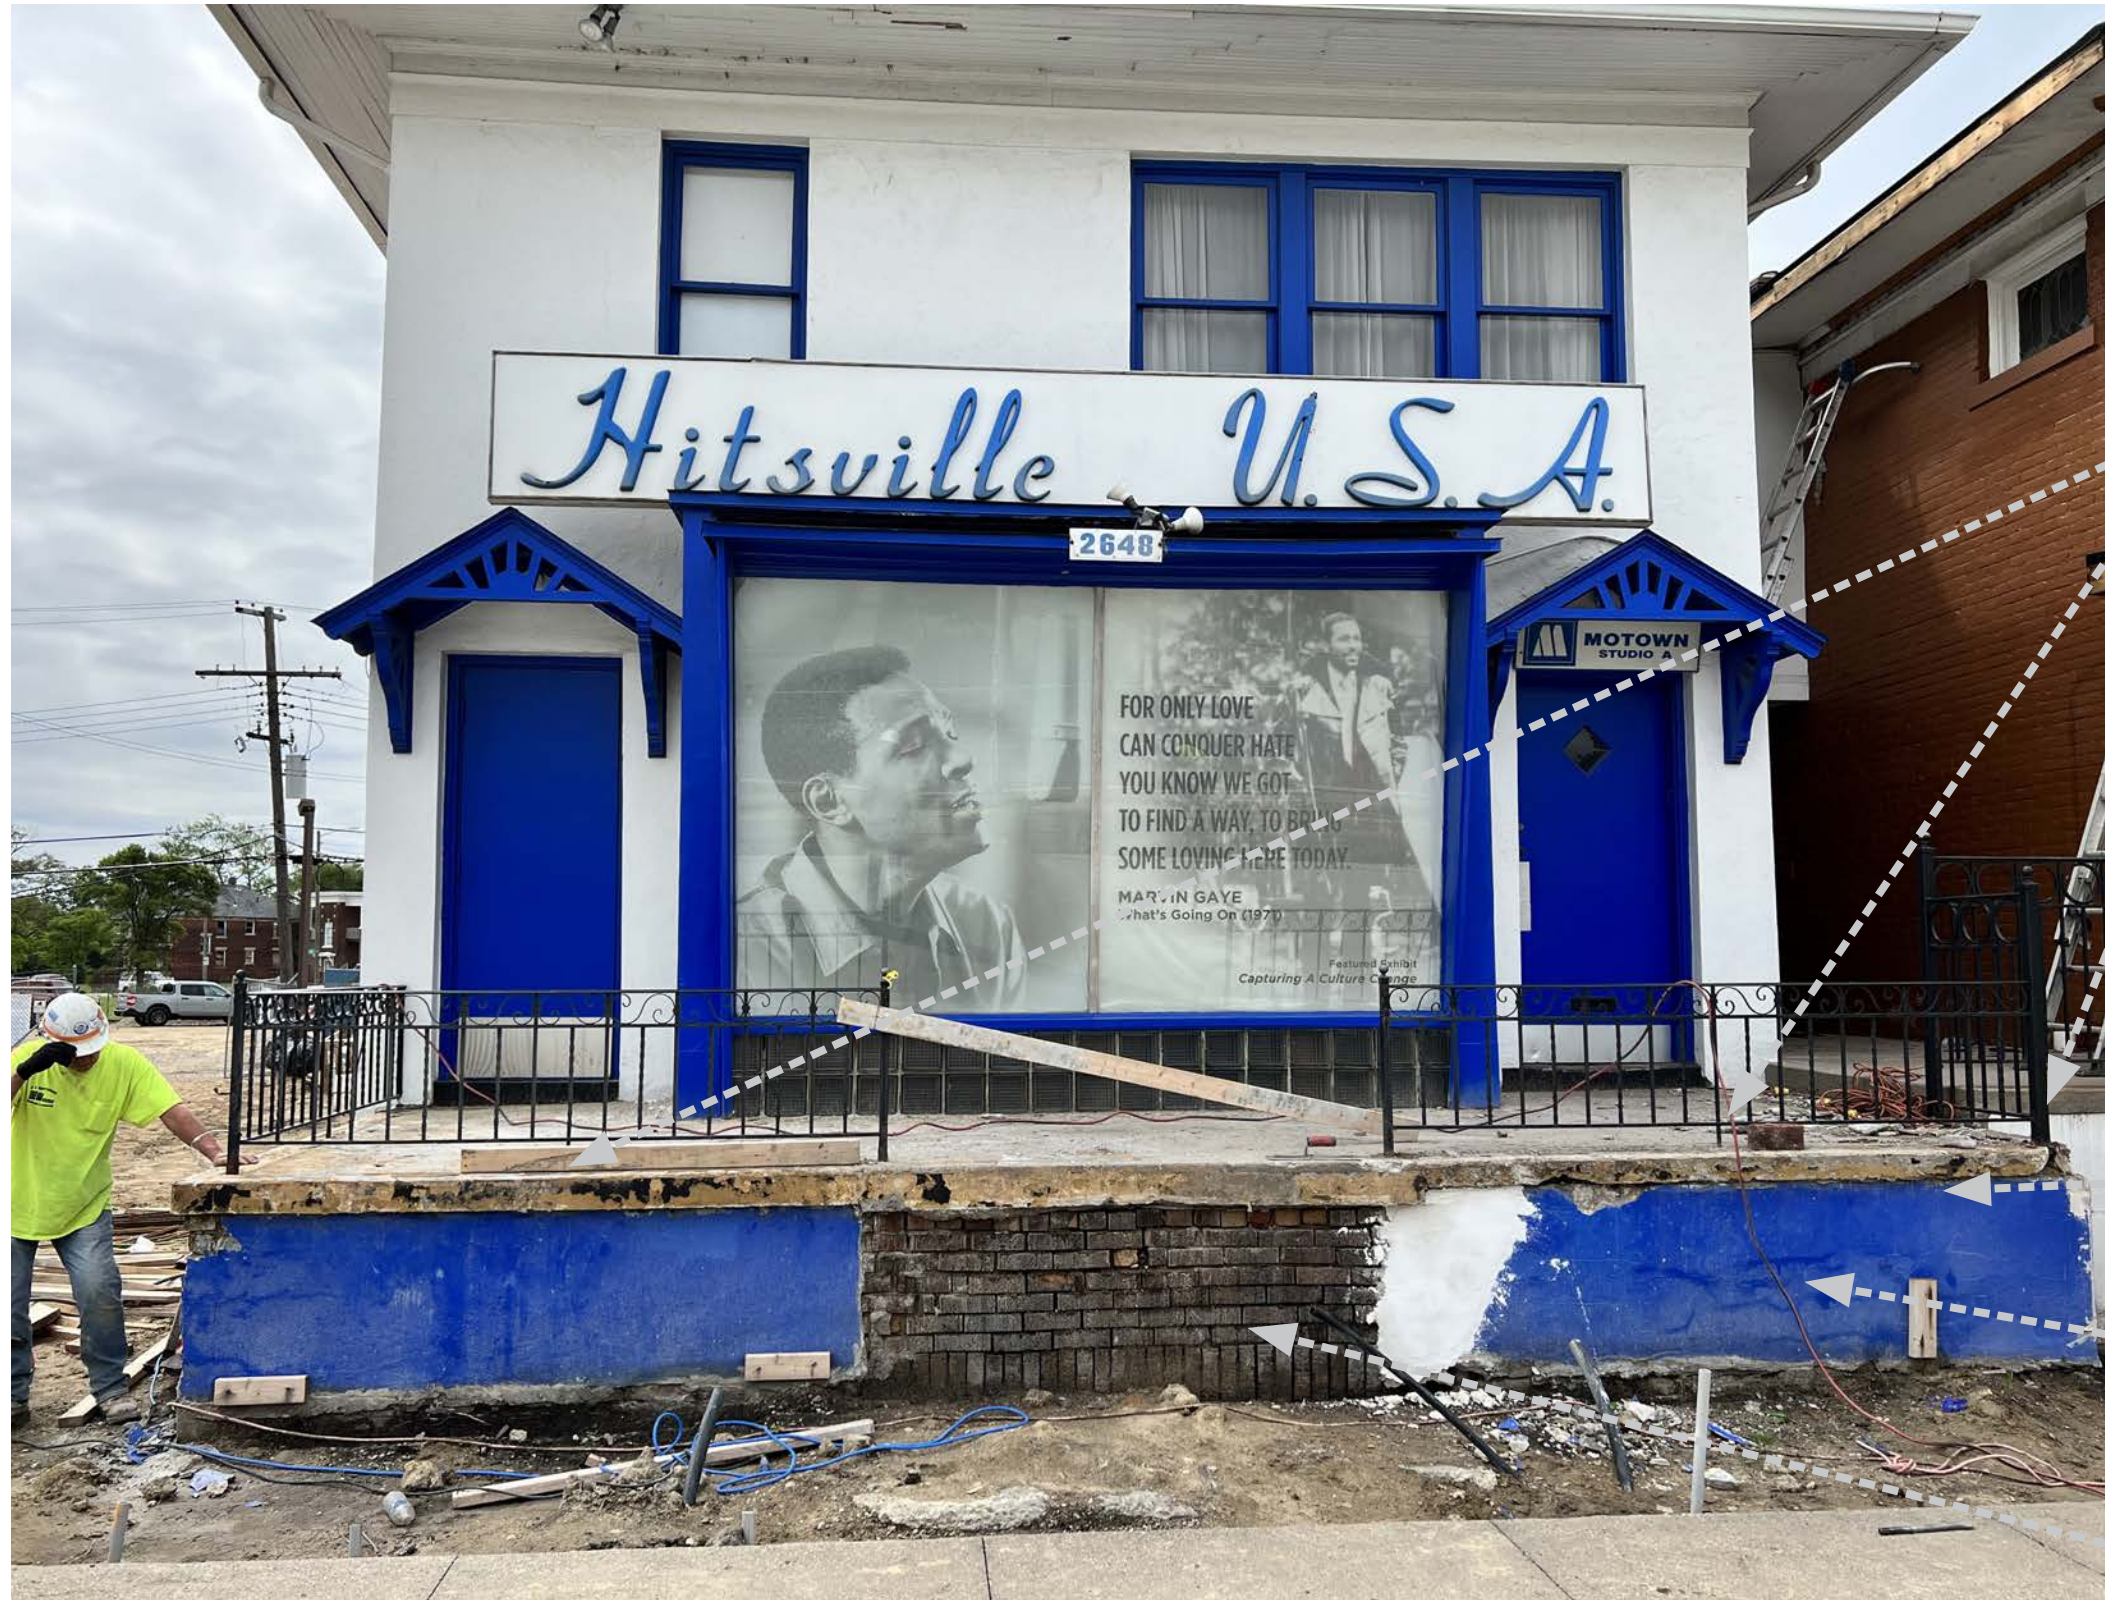
INTERMEDIATE RAILING PEG RUSTED THROUGH AND IS NOT PROVIDING ANY ATTACHMENT

CORNER POST ANCHOR EXPOSED - REPLACEMENT REQUIRED

BOTTOM SLAB SPAWLING AND RE-BAR EXPOSED

CEMENTITIOUS PARGE COAT SPAWLING DUE TO SEVERE WATER INFILTRATION AND SLAB WASHOUT BEHIND

>70% OF MORTAR IS NON-EXISTENT AT ALL EXPOSED PORCH MASONRY

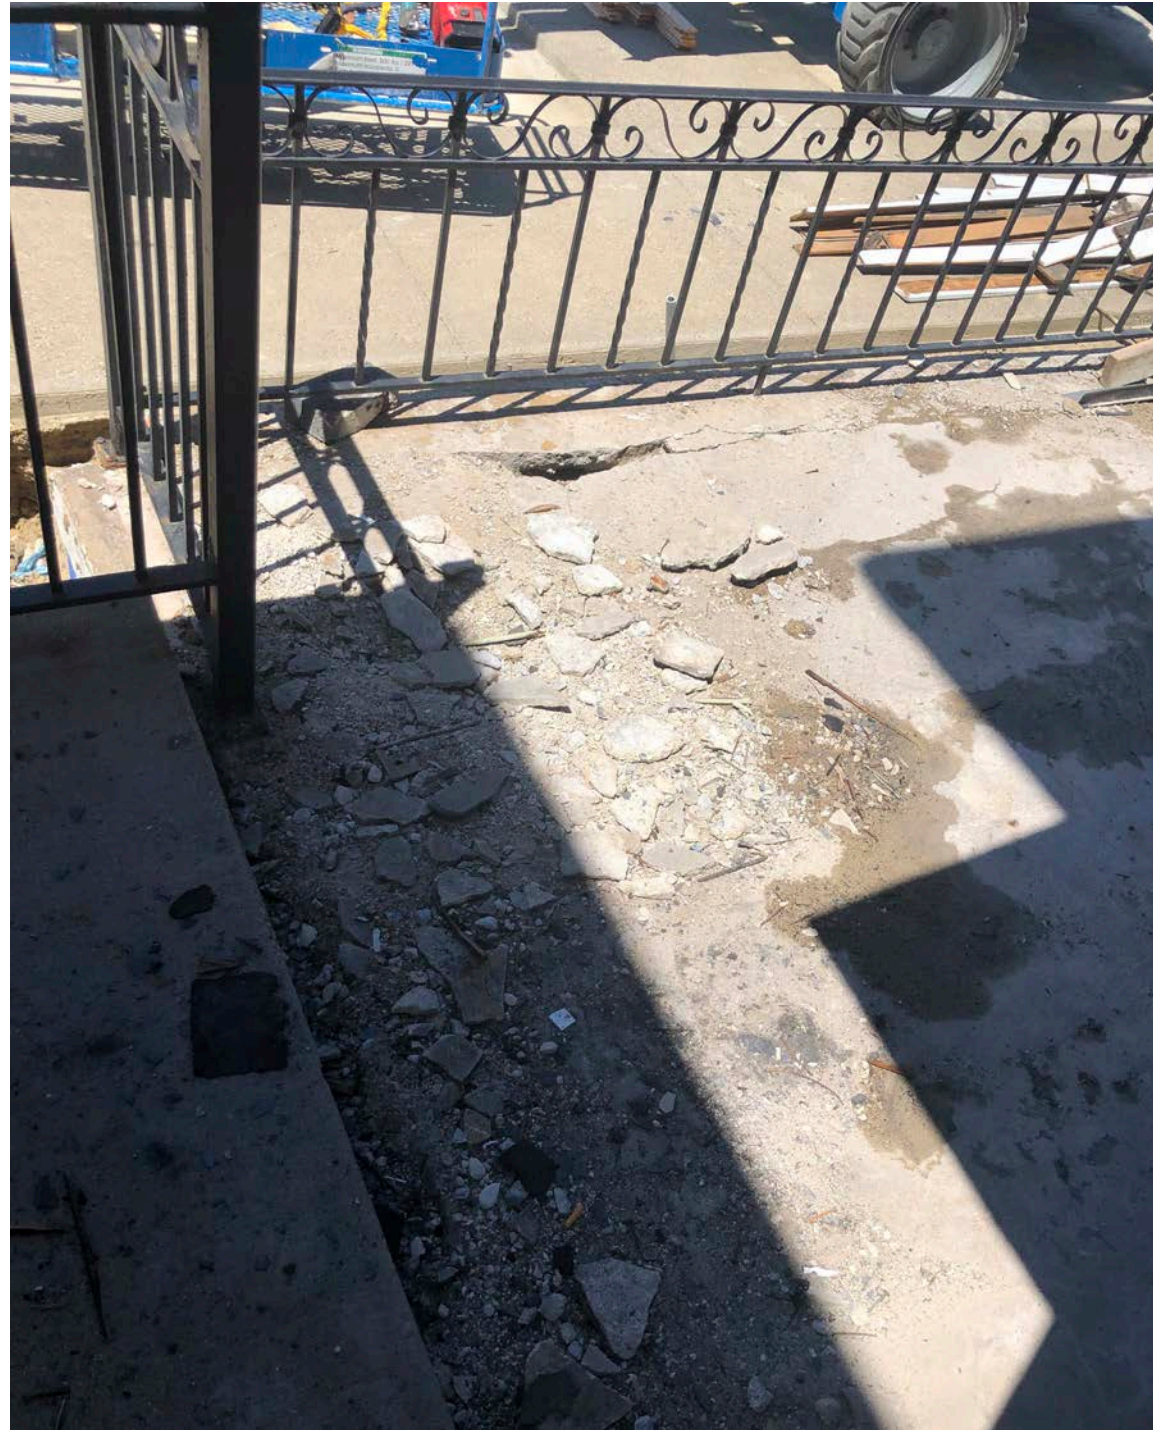
CRACKING AND HOLES AT OF TOP OF EXISTING CONCRETE PORCH SLAB

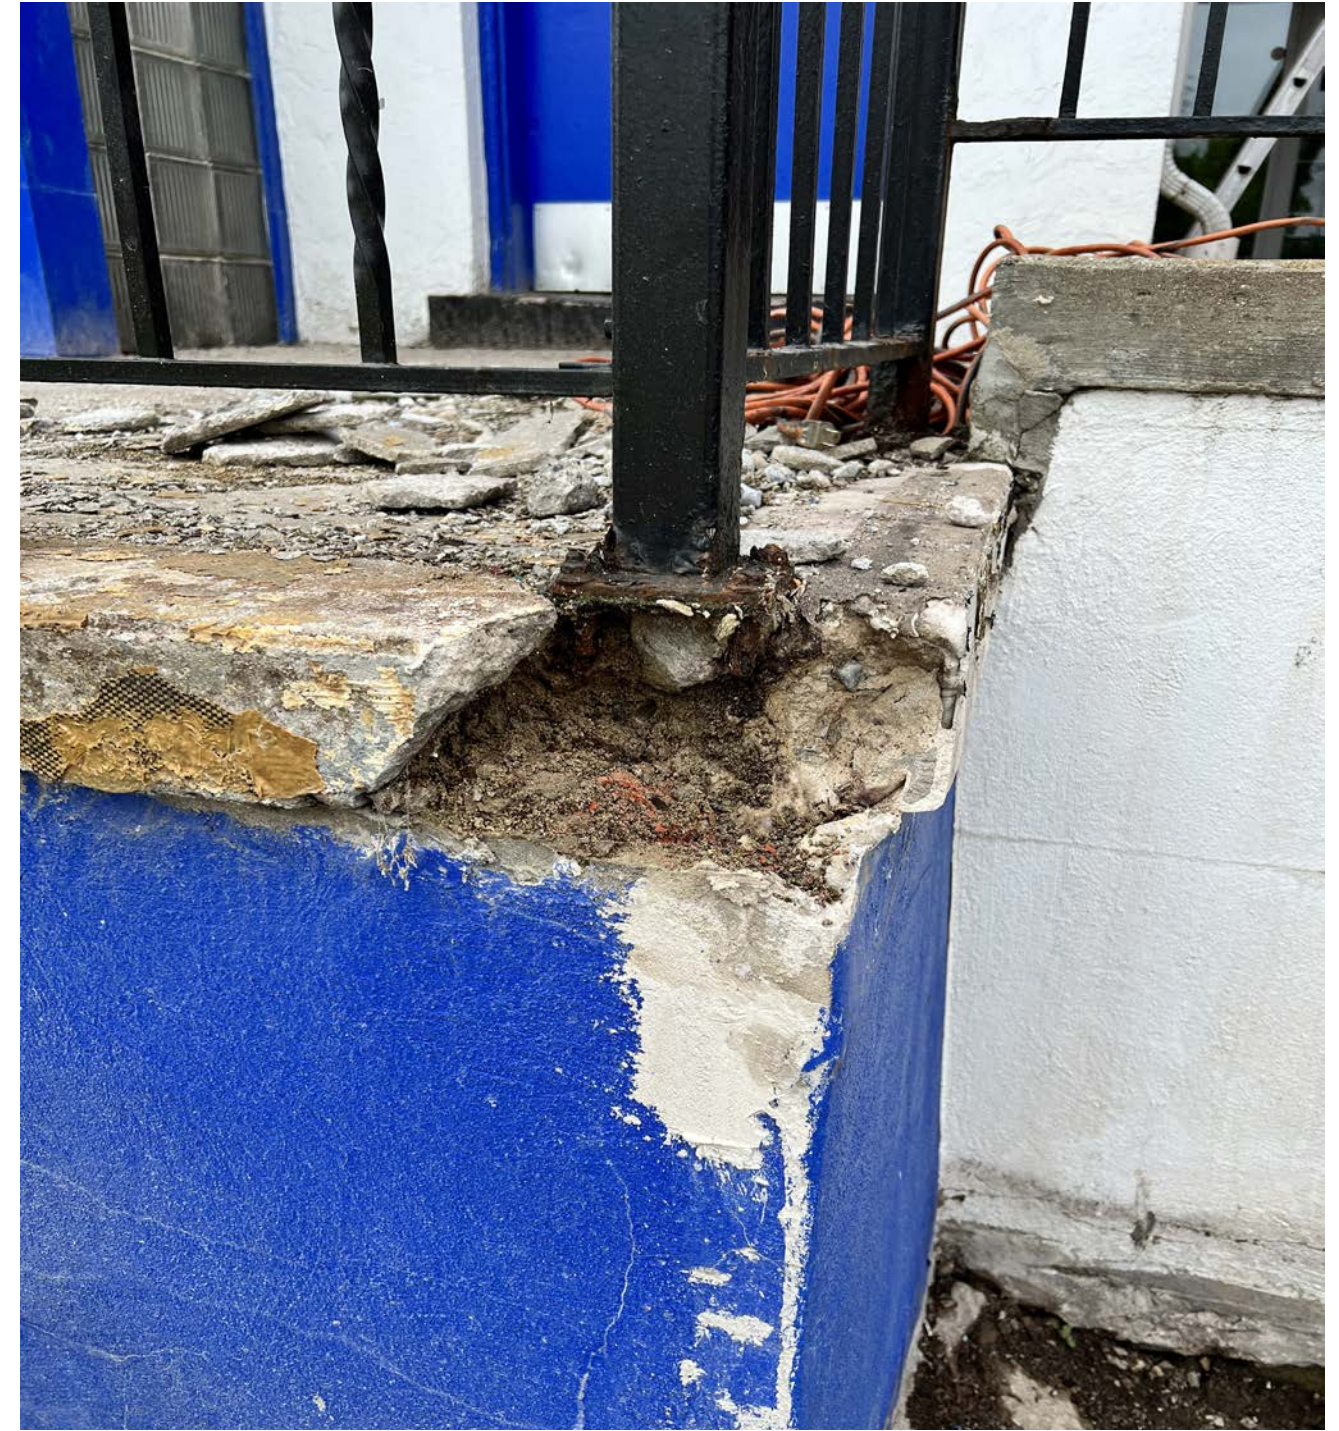
CRACKING AT EDGE OF EXISTING CONCRETE PORCH SLAB, EXPOSING CONER POST OF EXISTING GUARDRAIL

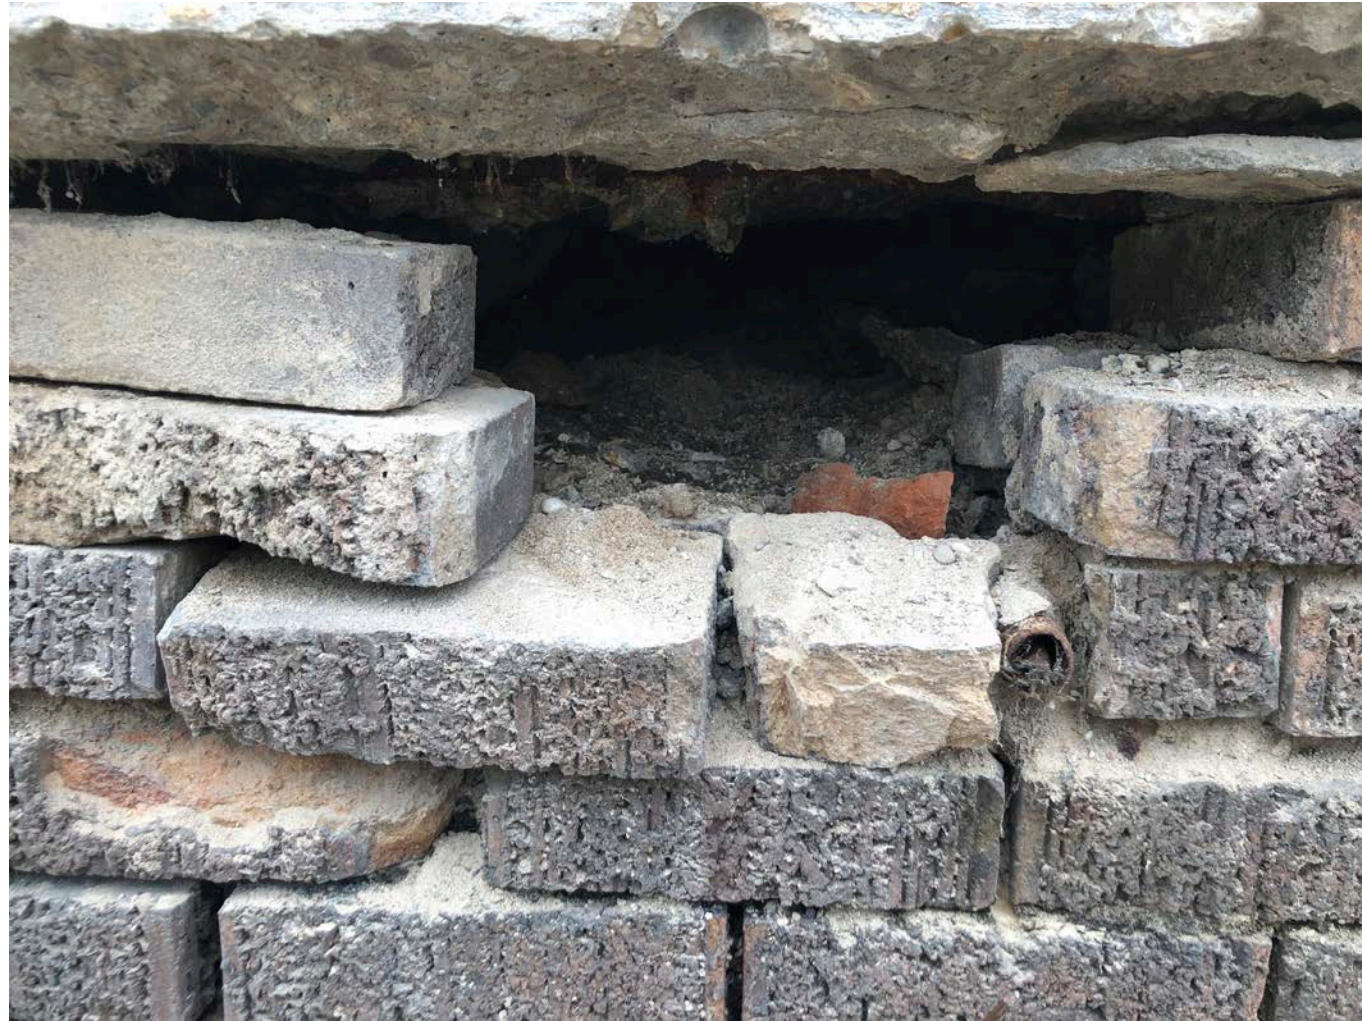
EXISTING MASONRY PORCH WALL EXHIBITING SEVERELY DETERIORATED MORTAR JOINTS, SETTLED FILL BELOW PORCH SLAB.

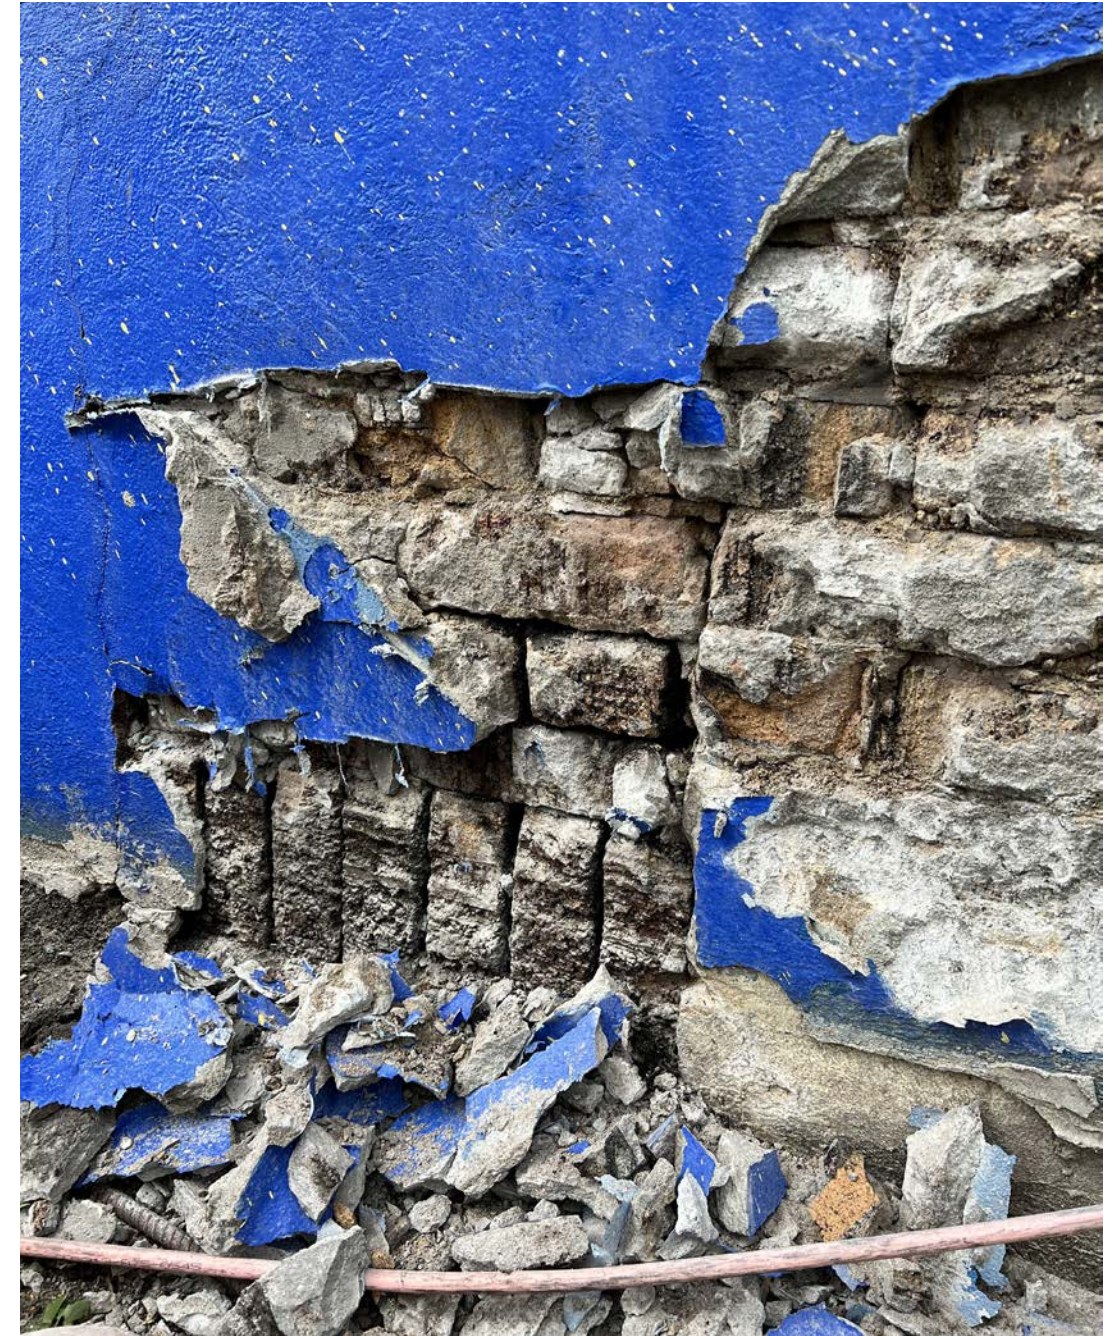
EXISTING MASONRY PORCH WALL EXHIBITING SEVERELY DETERIORATED MORTAR JOINTS, SPALLING BRICK AND PARGE COAT.
