HamiltonAnderson

**Re: Detroit Midnight Golf- 7441 Second Ave Detroit
Existing Building Windows replacement, removing existing roofing and installing
new roofing.**

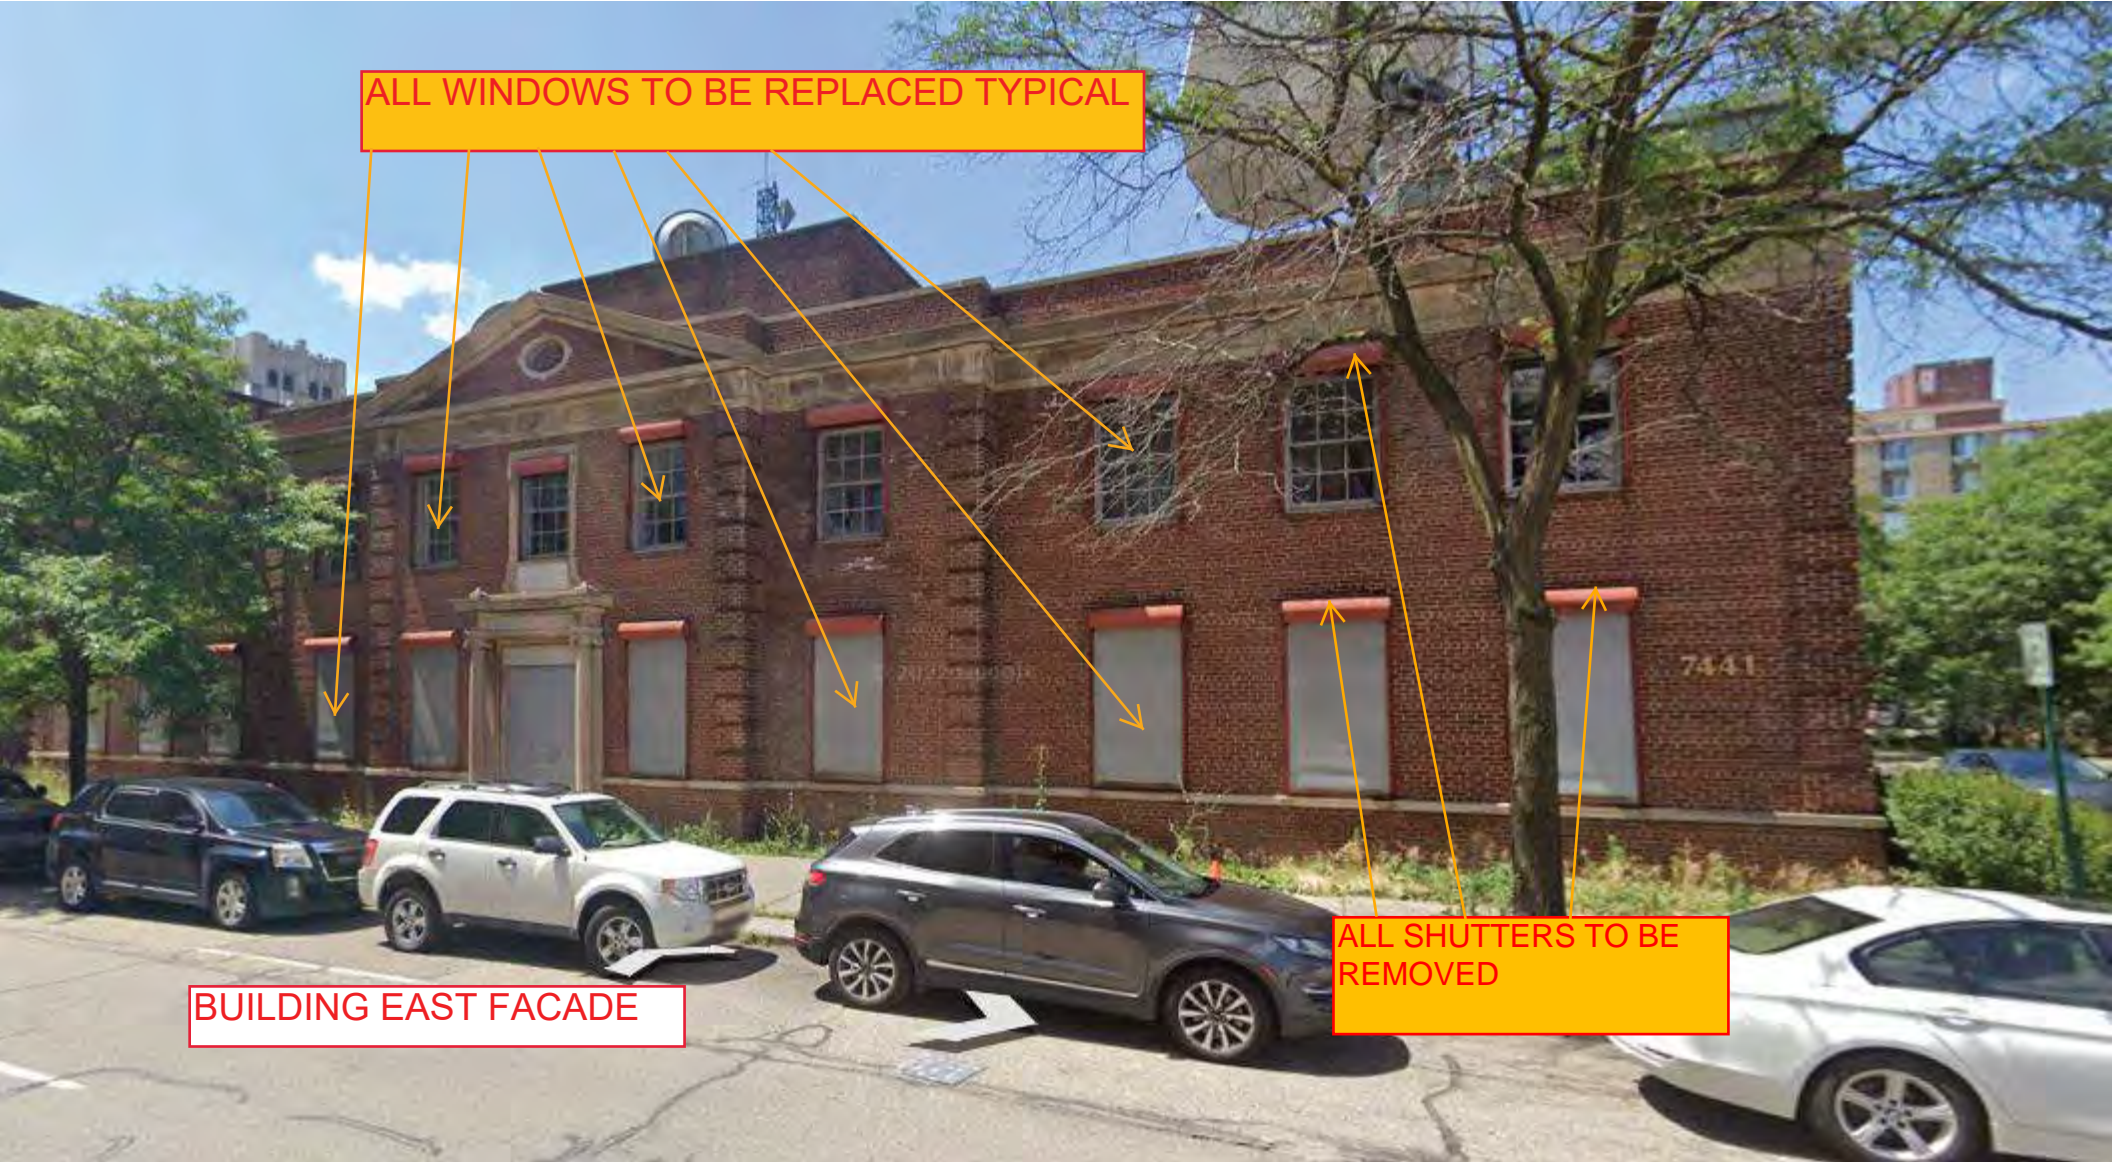
PHOTO (1)

ALL WINDOWS TO BE REPLACED TYPICAL

BUILDING EAST FACADE

ALL SHUTTERS TO BE REMOVED

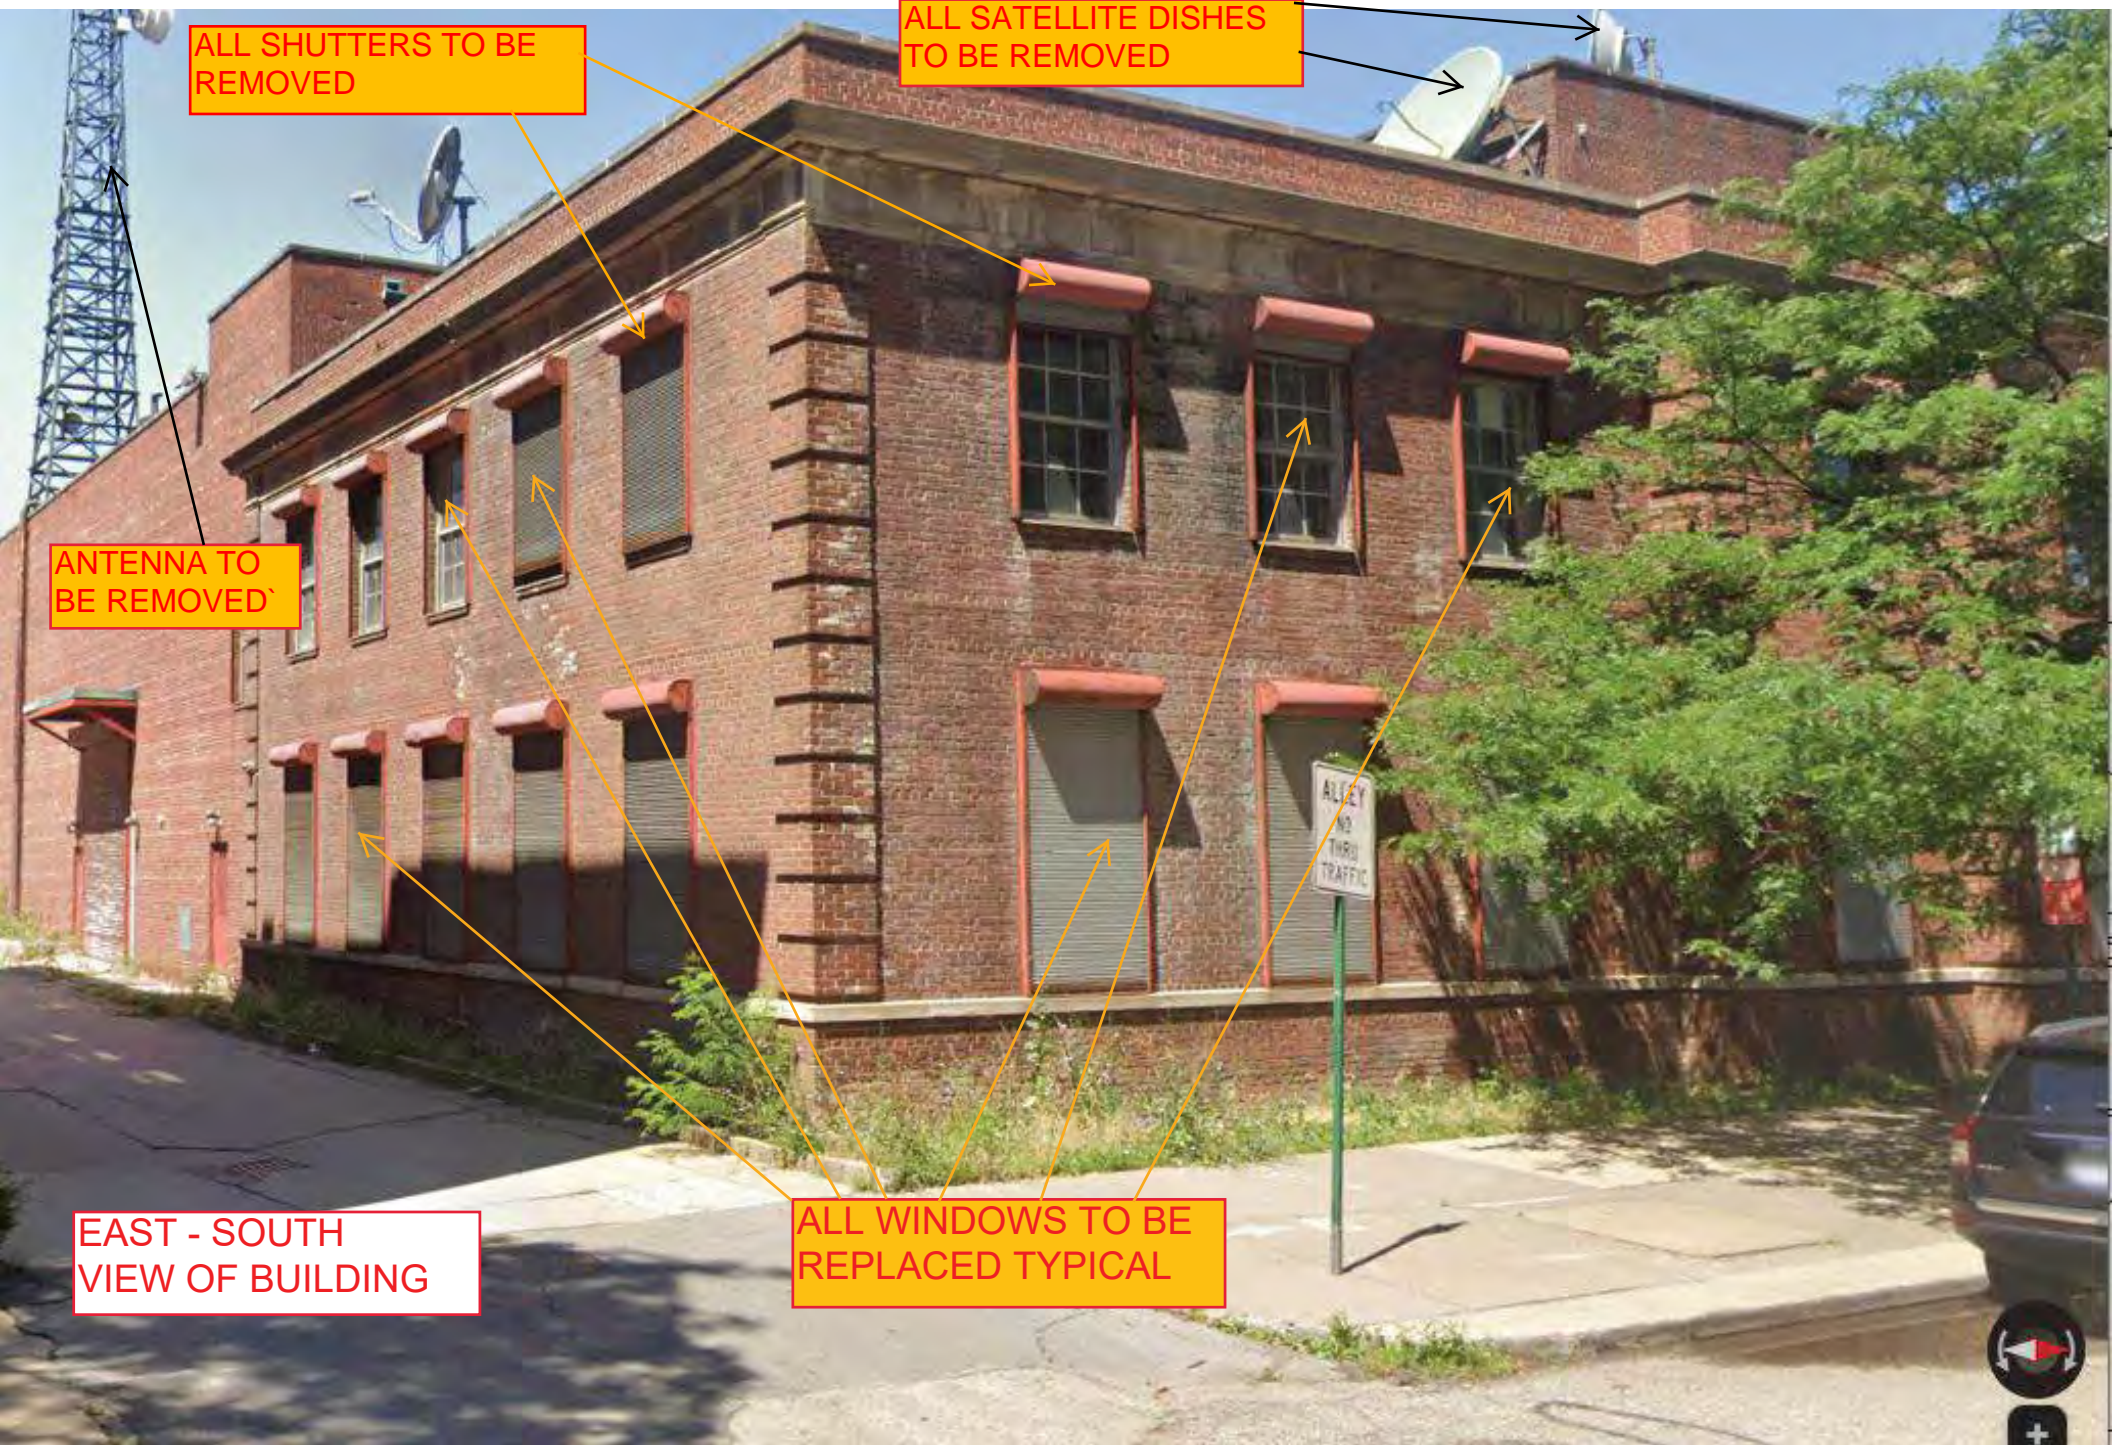
EAST - SOUTH VIEW OF BUILDING

ALL SHUTTERS TO BE REMOVED

ALL SATELLITE DISHES TO BE REMOVED

ANTENNA TO BE REMOVED

ALL WINDOWS TO BE REPLACED TYPICAL

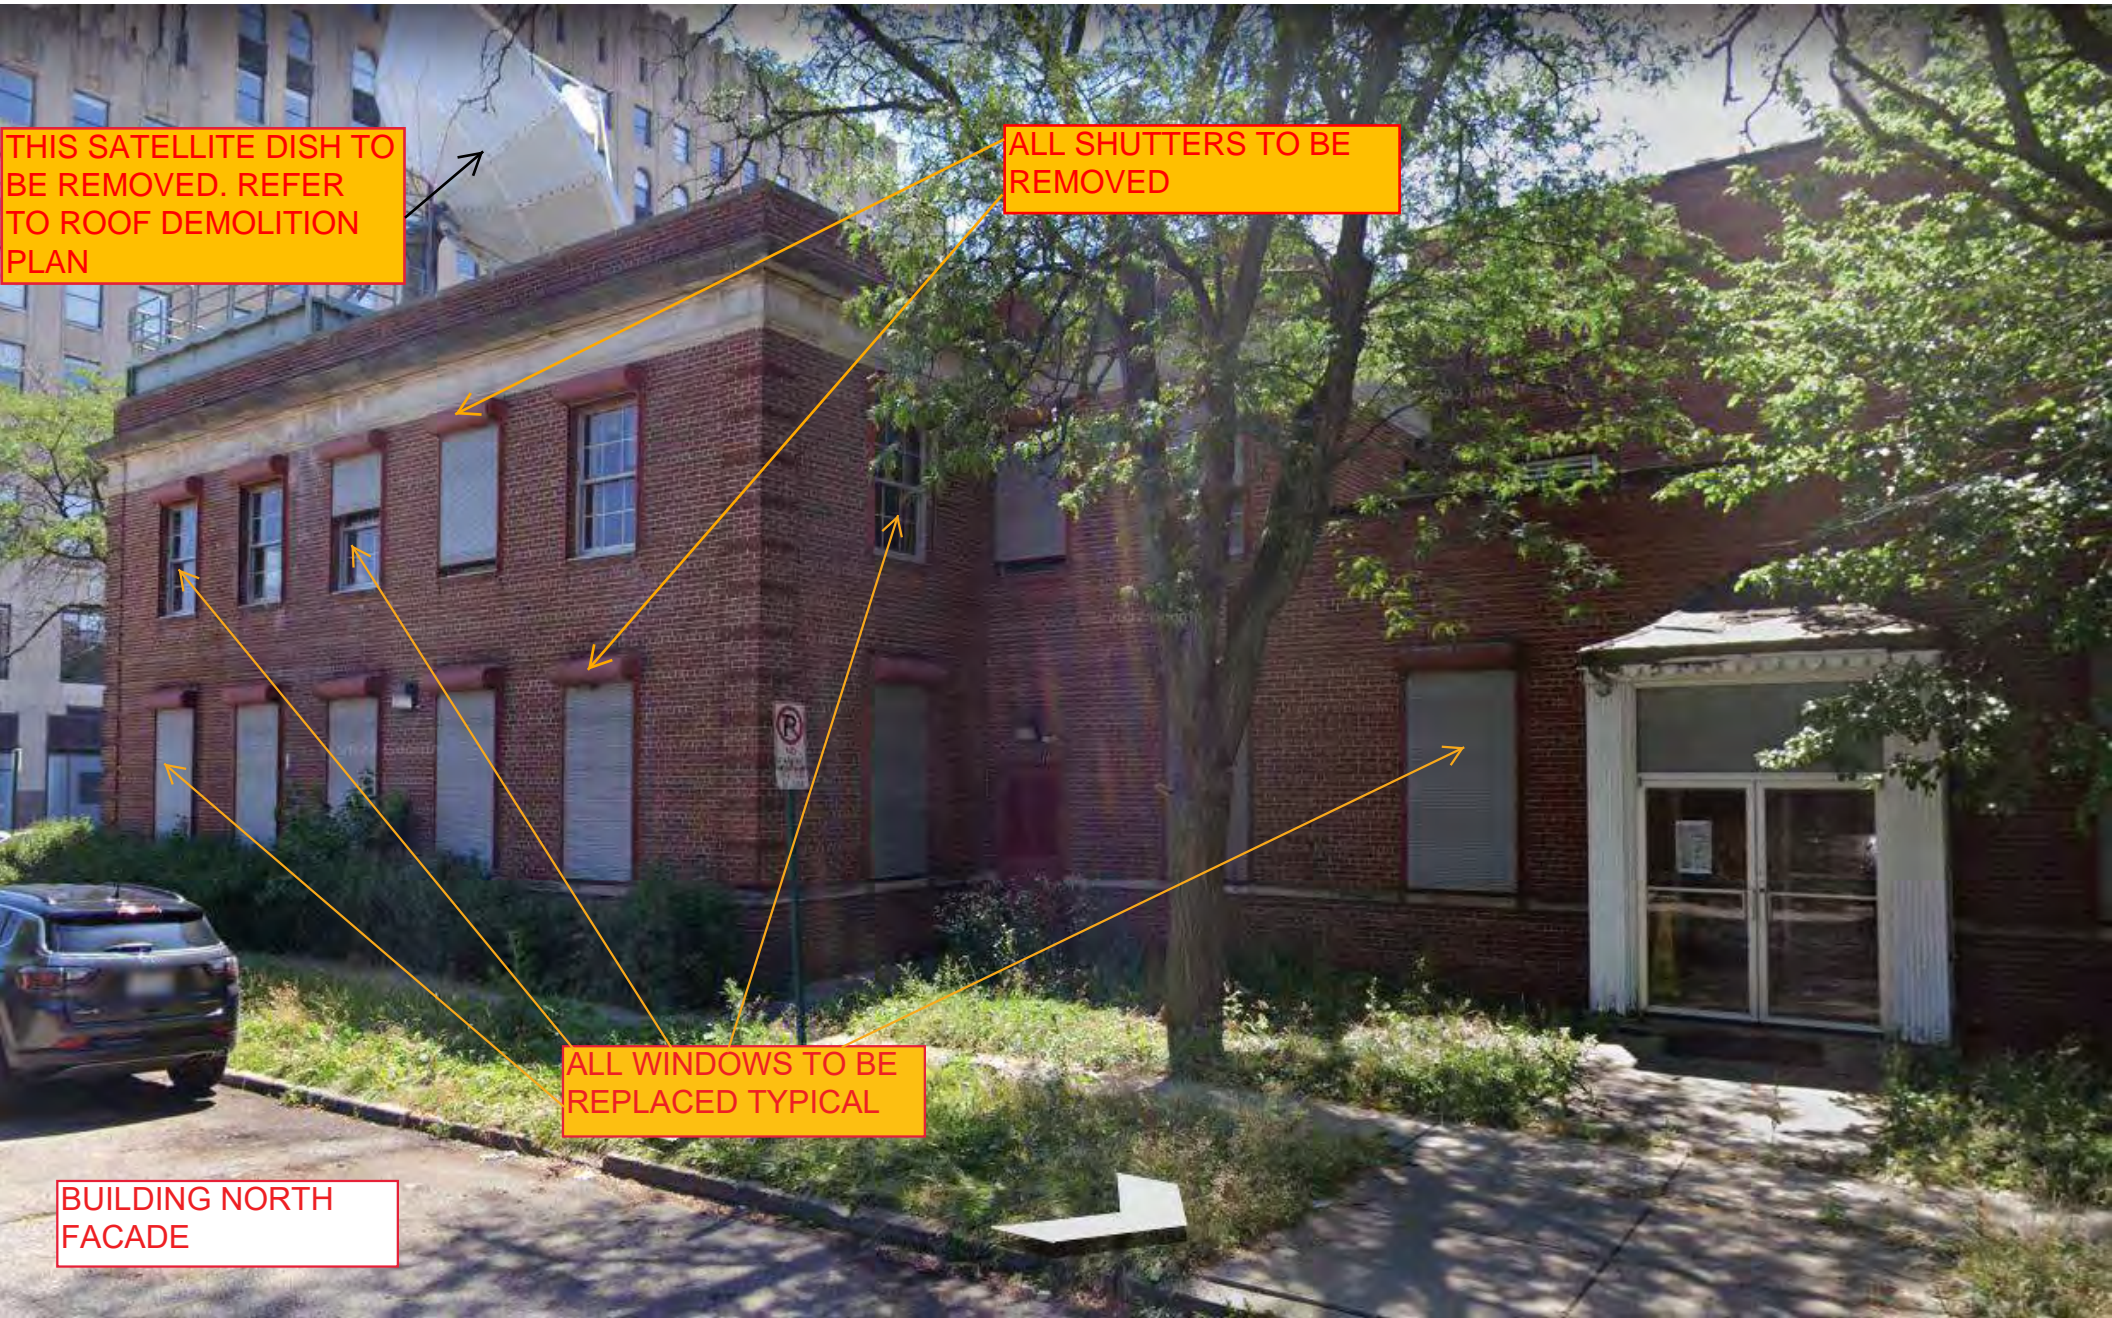
BUILDING NORTH FACADE

THIS SATELLITE DISH TO BE REMOVED. REFER TO ROOF DEMOLITION PLAN

ALL SHUTTERS TO BE REMOVED

ALL WINDOWS TO BE REPLACED TYPICAL

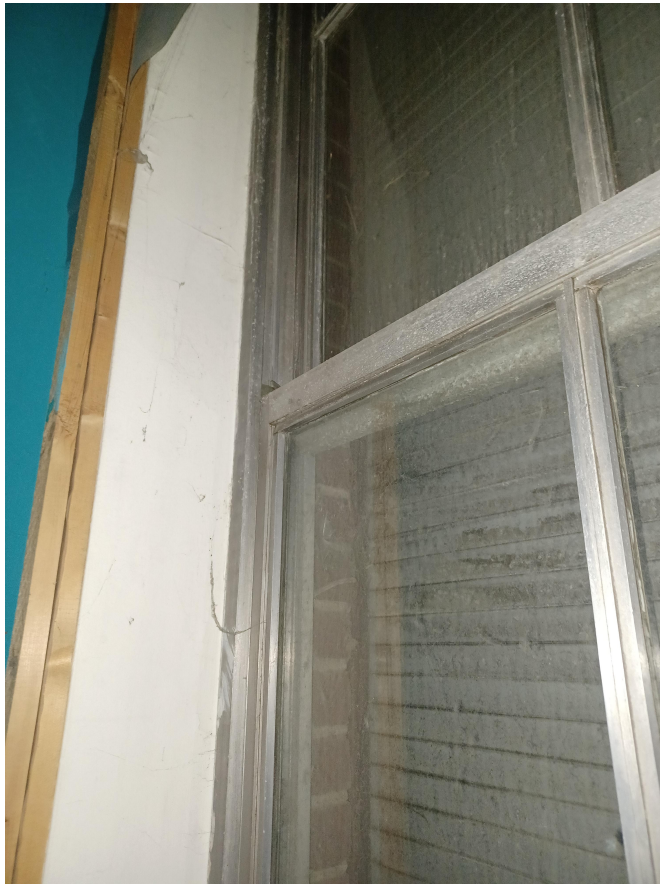
CLOSE VIEW OF ALUMINUM WINDOW (W3) ON THE FIRST FLOOR SHOWING ADVANCED STAGES OF OXIDIZATION. THE WINDOW IS NOT OPERABLE BECAUSE OF THE RUST

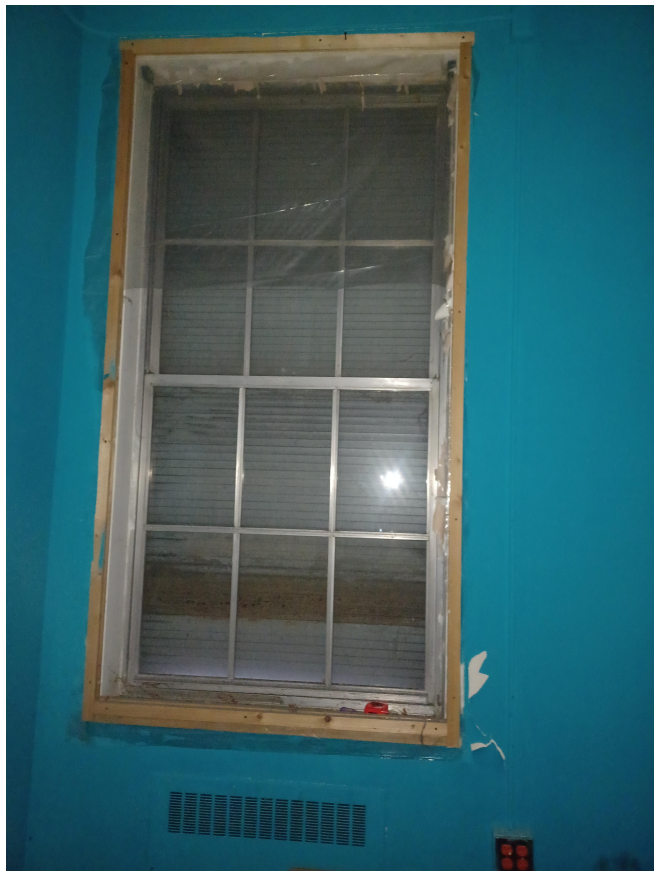
INTERIOR VIEW OF (W3) ALUMINUM WINDOW ON THE FIRST FLOOR

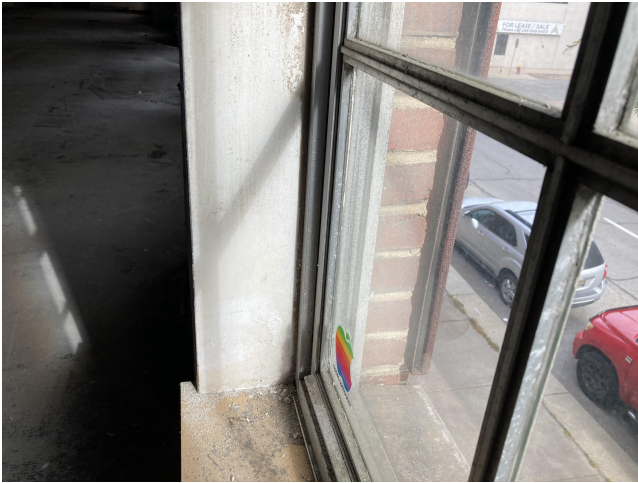
INTERIOR VIEW OF ALUMINUM WINDOW (W2) SHOWING THE INEFFICIENT SINGLE GLAZING

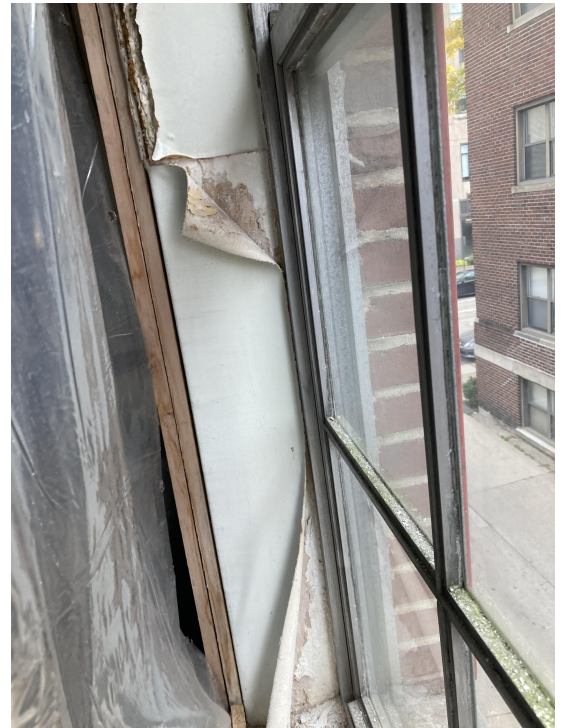
INTERIOR VIEW OF ALUMINUM WINDOWS (W3) SHOWING ADVANCED STAGES OF OXIDIZATION

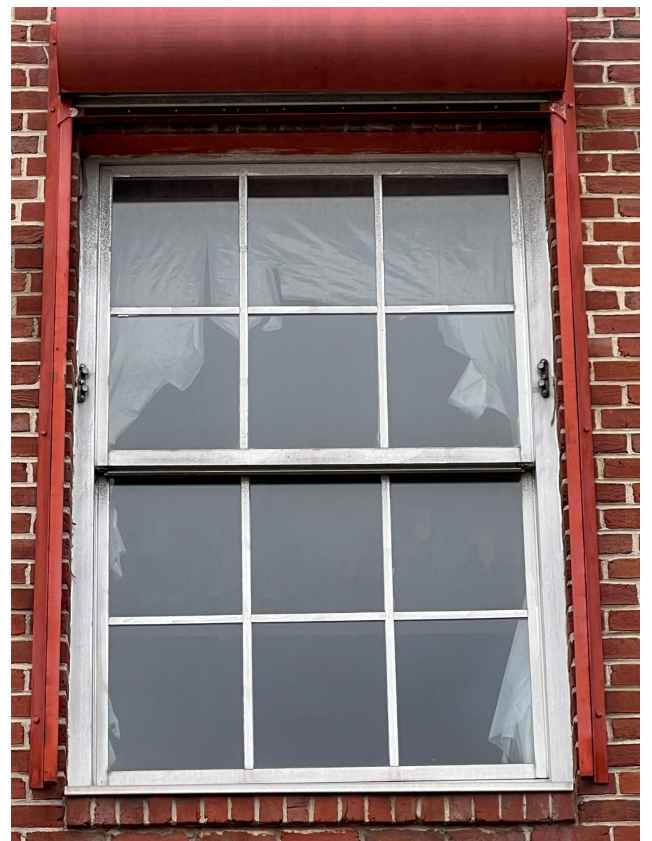
(W1) EXTERIOR VIEW EXISTING ALUMINUM WINDOW

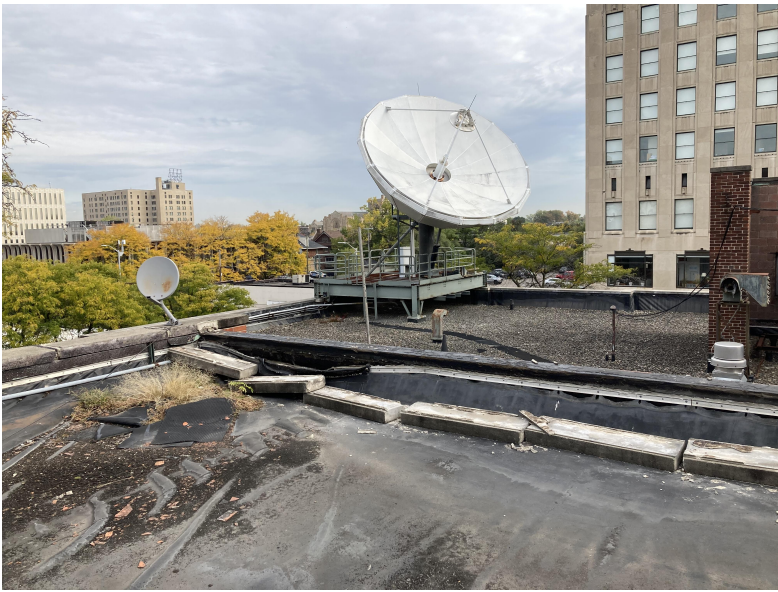
Existing Roof – The existing roof has failed in many places and will be replaced with new tapered insulation and a new membrane roof. The roof leaks have damaged the exterior walls and interior finishes and has caused flooding in the basement.

View (A) : existing roof deterioration

The new roofing system will be comprised of a single-ply roofing membrane (TPO) and rigid insulation that meets Michigan Energy Code requirements. Slopes will be provided to drain water to a set of existing and new roof drains with over-flow roof drains. Refer to attached sheet A1.5 roof plan.

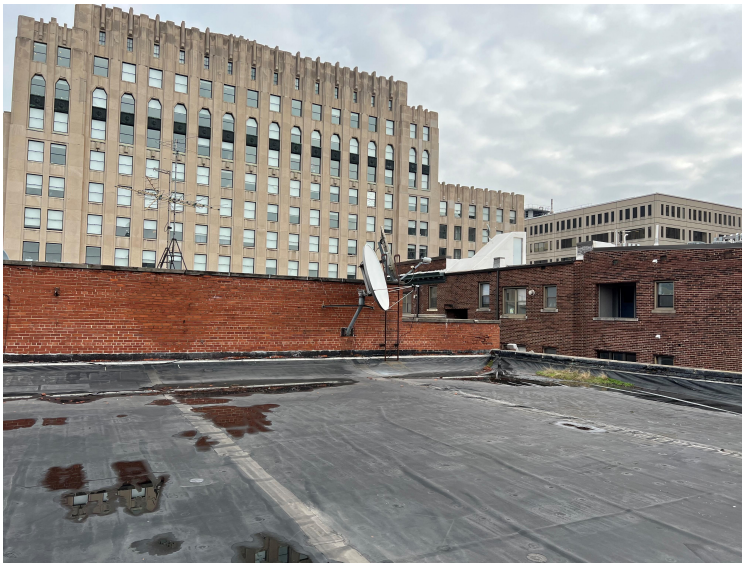
View (B): existing roofing membrane wears away of back of parapet

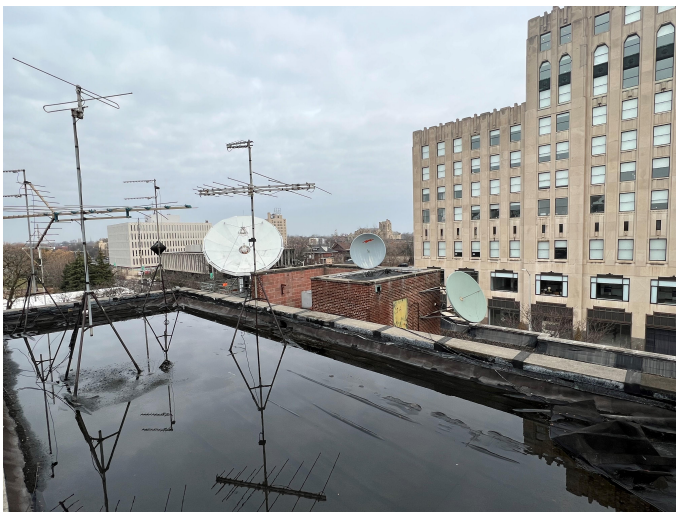
View (C): Water ponds on roof for lack of appropriate slope to drainage

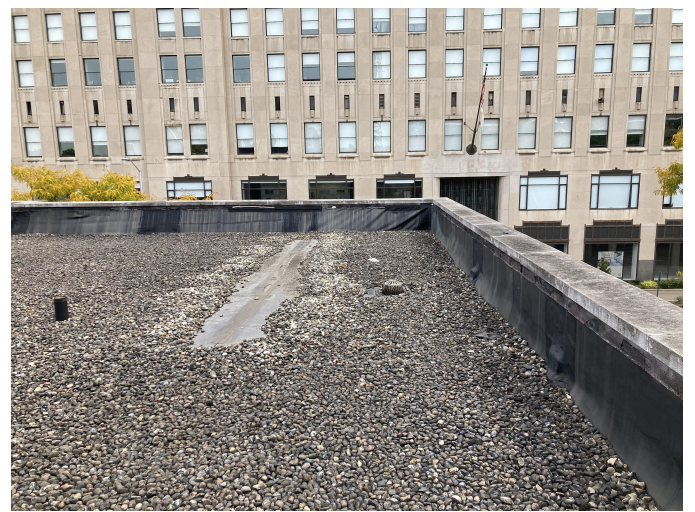
View (D): exposed membrane due to missing gravel protecting layer.

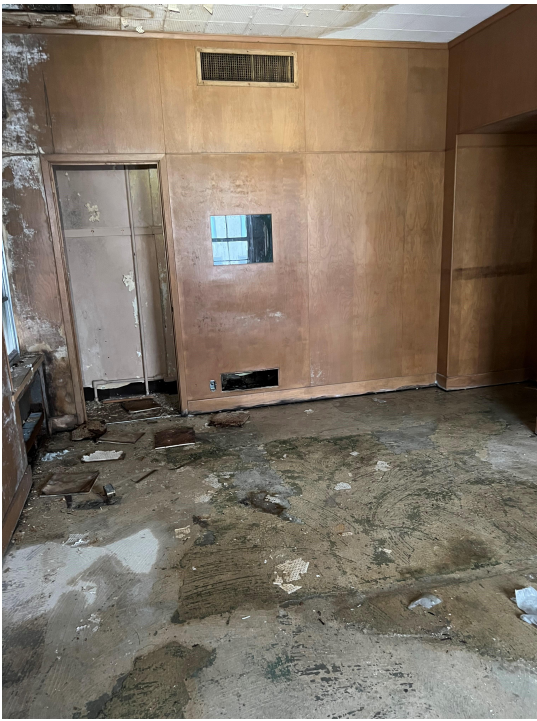
DAMAGED CEILINGS AND WALLS ON THE SECOND FLOOR BECAUSE OF ROOF LEAKS

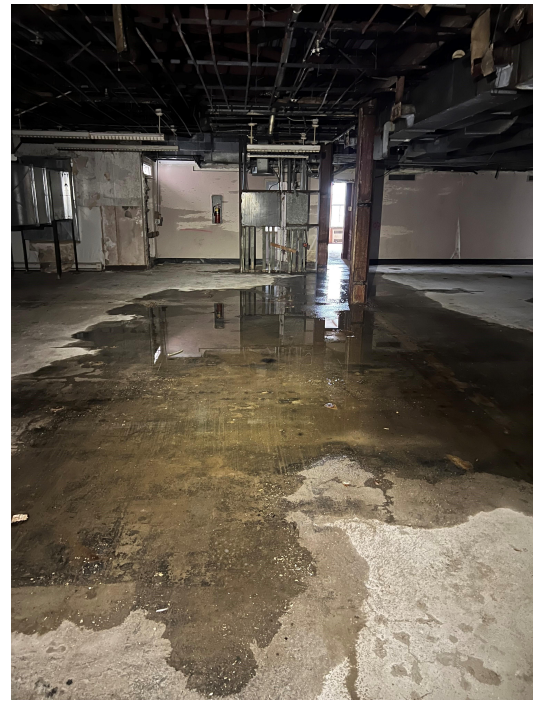
ROOF WATER LEAKS ON THE SECOND FLOOR DURING THE RECENT RAIN

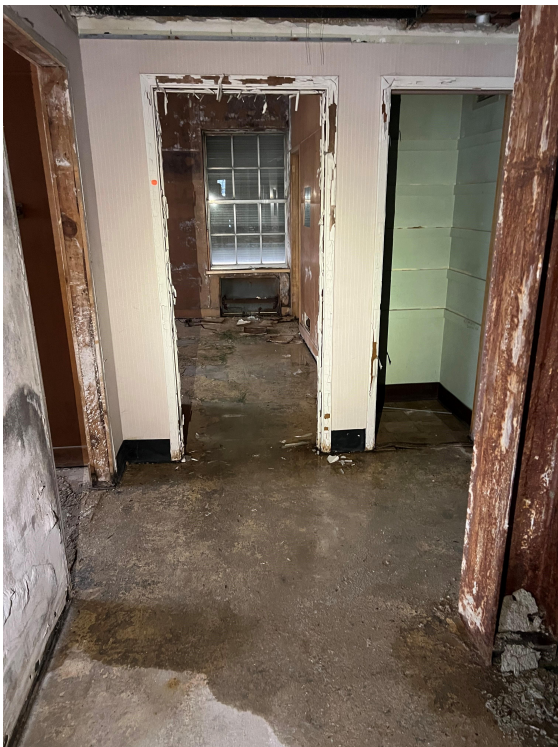
INTERIOR DAMAGES ON THE FIRST FLOOR BECAUSE OF THE LEAKING ROOF

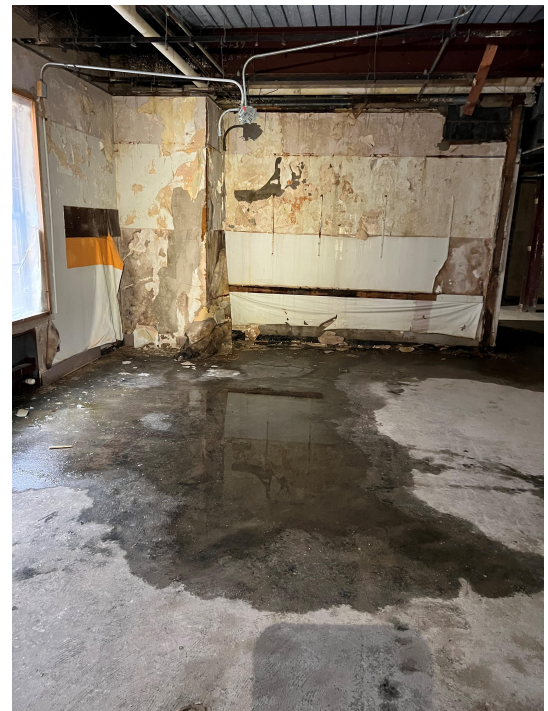
INTERIOR DAMAGES ON THE SECOND FLOOR AS A RESULT OF ROOF WATER LEAKING
