# Historic Structures Report for the Dr. Ossian H Sweet House

Conducted by:  
Kraemer Design Group LLC  
1420 Broadway  
Detroit, MI 48226

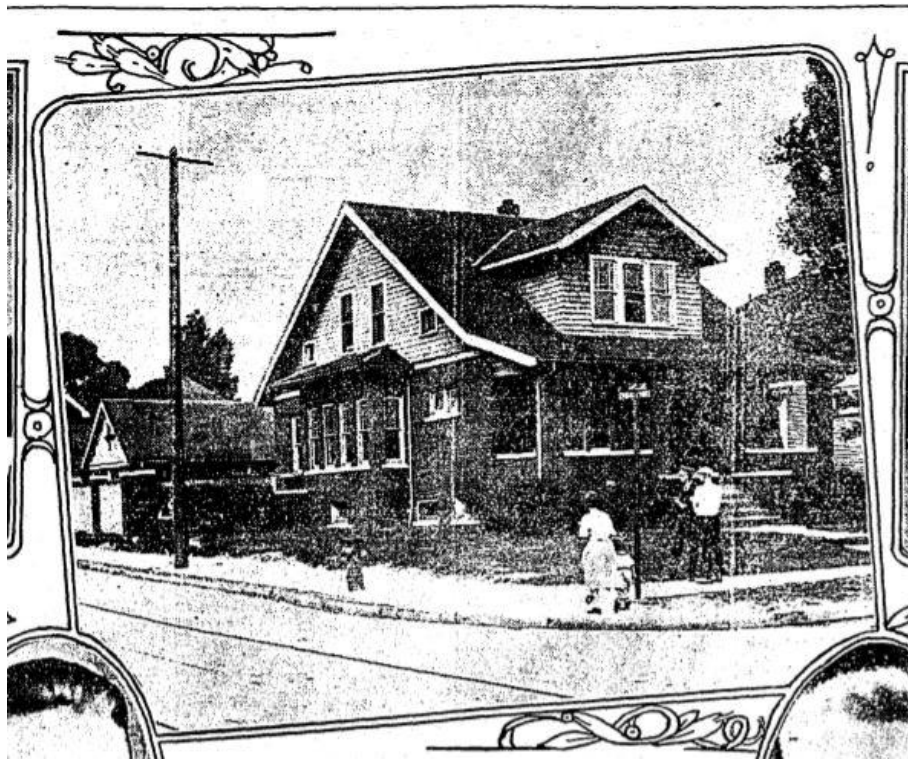
Fig 1: Photograph of 2905 Garland circa 1925, *Chicago Defender* 11-14-25

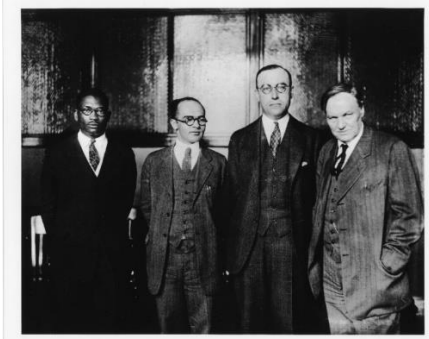
Fig. 3: Henry Sweet and Clarence Darrow, 1926

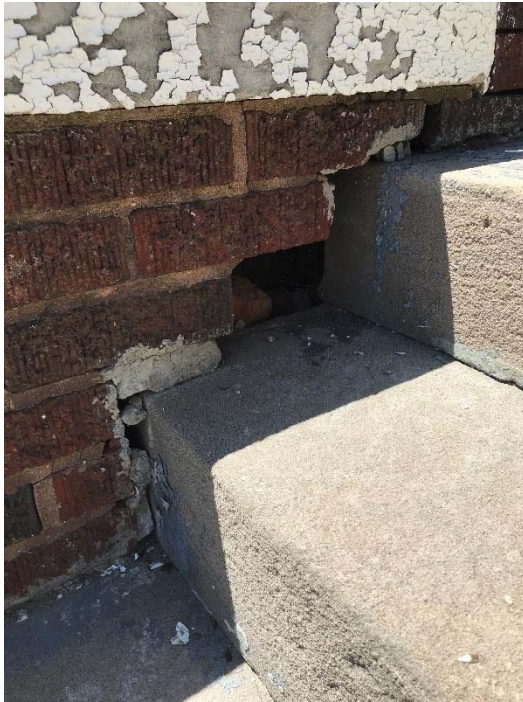
*Fig 05: Dislodged masonry units adjacent to the Side Entry stair along south elevation (Charlevoix)*

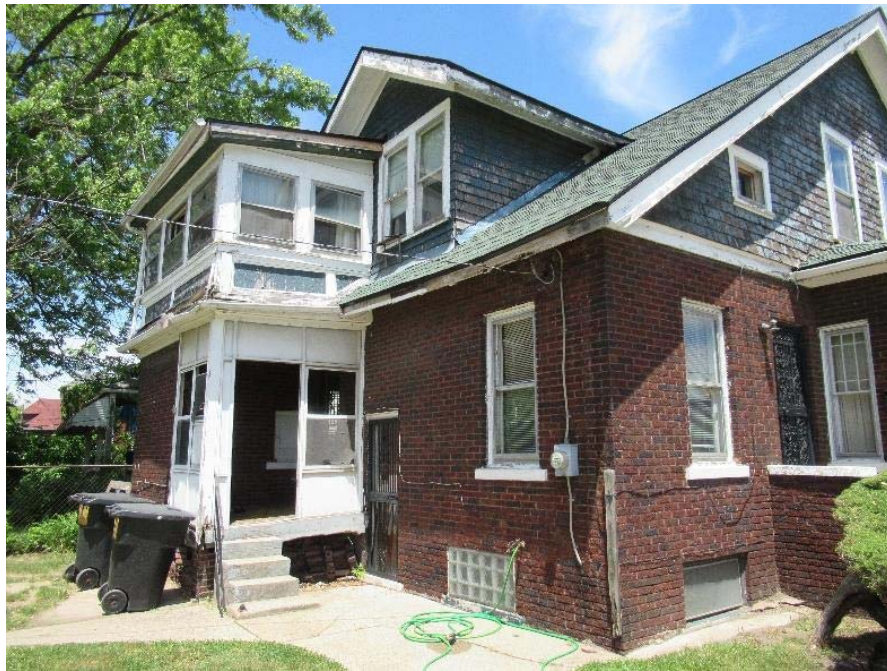
*Fig 08: Wood shakes cladding the second story and vertically oriented wood siding on the enclosed second story rear porch*

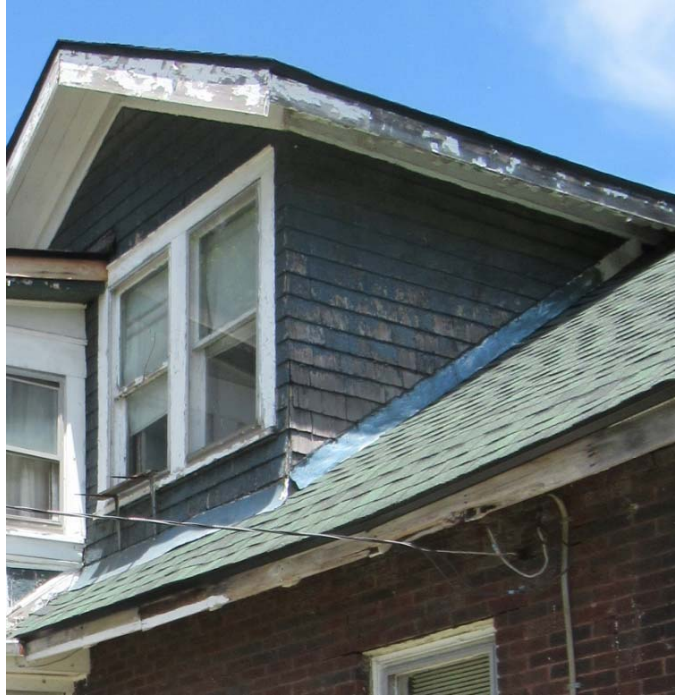
*Fig 09: Weathered original fascia board along eave of second story dormer and non-original unpainted replacement fascia board in poor condition along roof eave line*

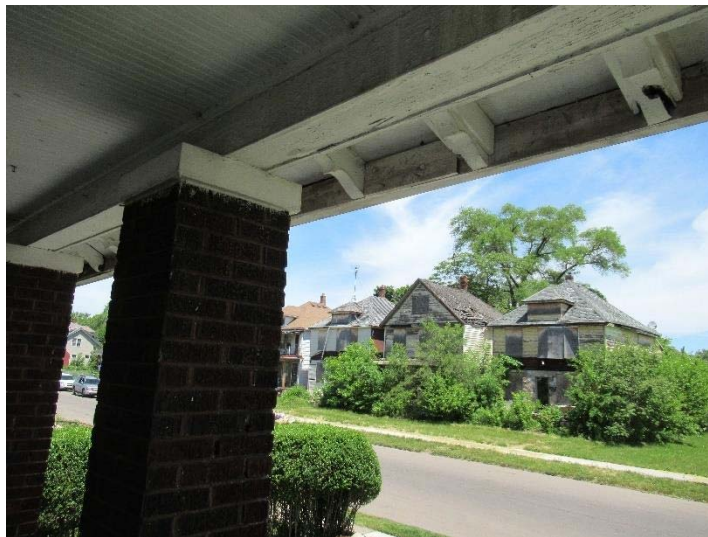
*Fig 10: Looking out from front porch at false decorative raking eaves, some of which have been reinforced with additional wood*

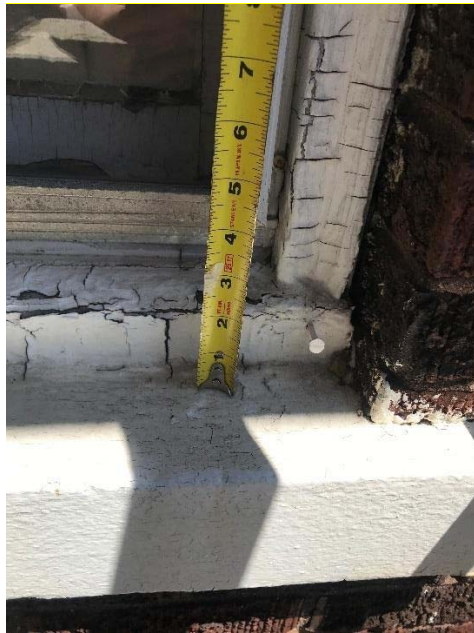
*Fig 11: Typical signs of flaking paint and wood decay as well as miscellaneous nails in wood frames*

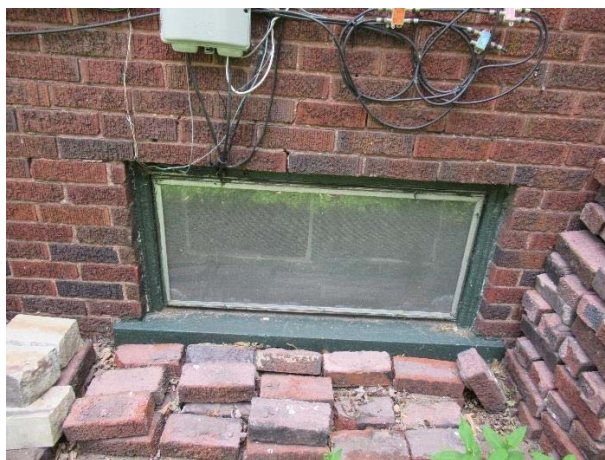
*Fig 12: Typical original basement window*

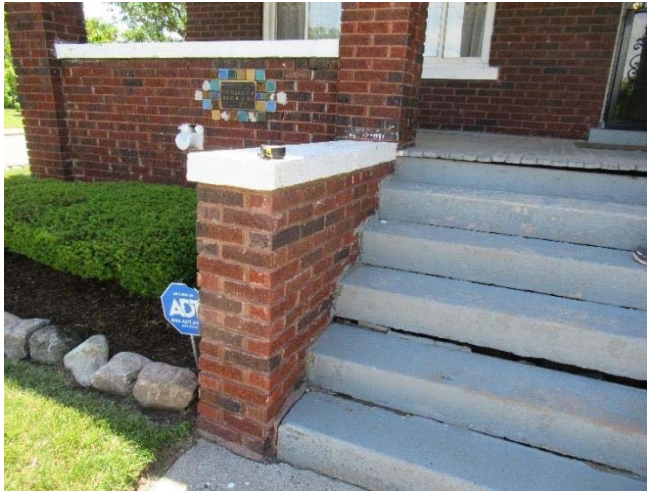
*Fig 15: Front stair with large joints due to settlement*

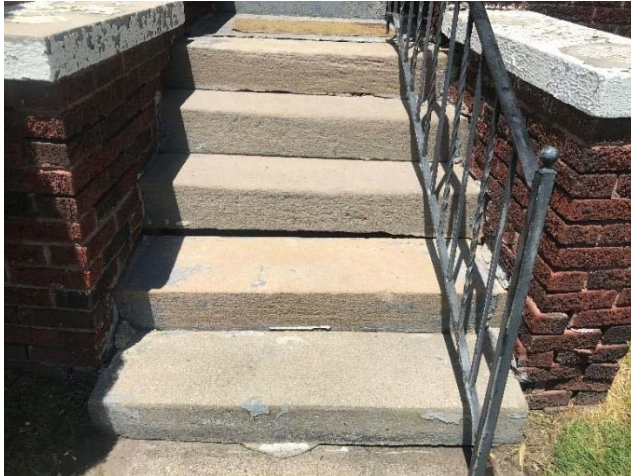
*Fig 16: Side entry stair with large joints due to settlement and wrought iron railing in fair condition*

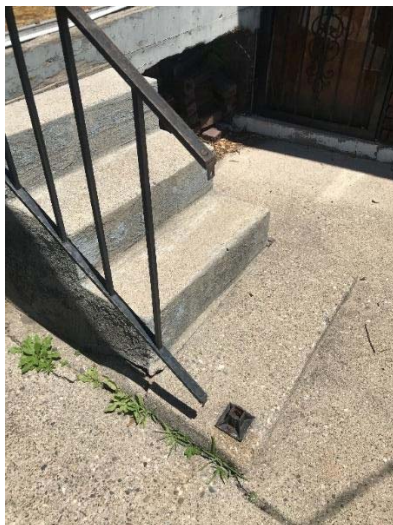
*Fig 17: Stair to enclosed rear porch with small concrete pad and railing in poor non-functional condition*

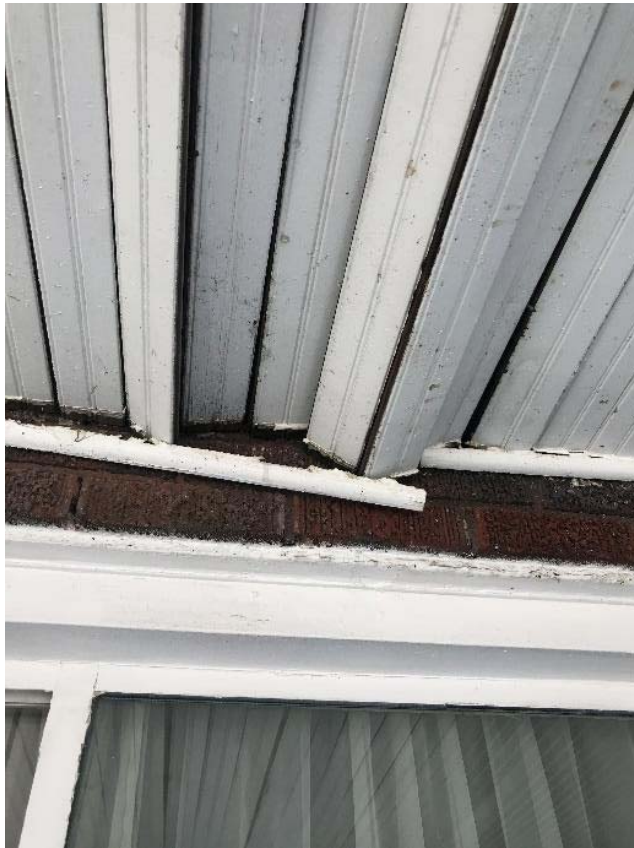
*Fig 18: Typical example of beadboard ceiling condition and broken quarter round crown molding*

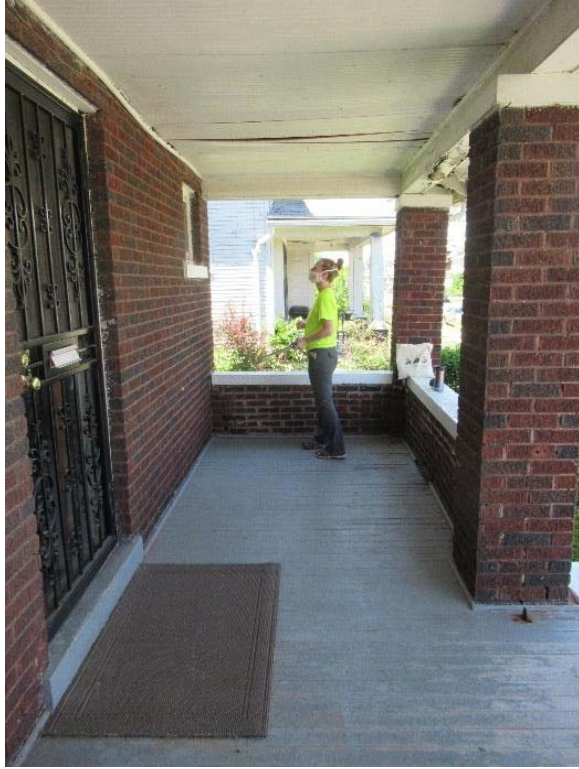
*Fig 19: Front porch including wood plank flooring, buckling in beadboard ceiling, and hardware remnant from non-extant historic handrail*

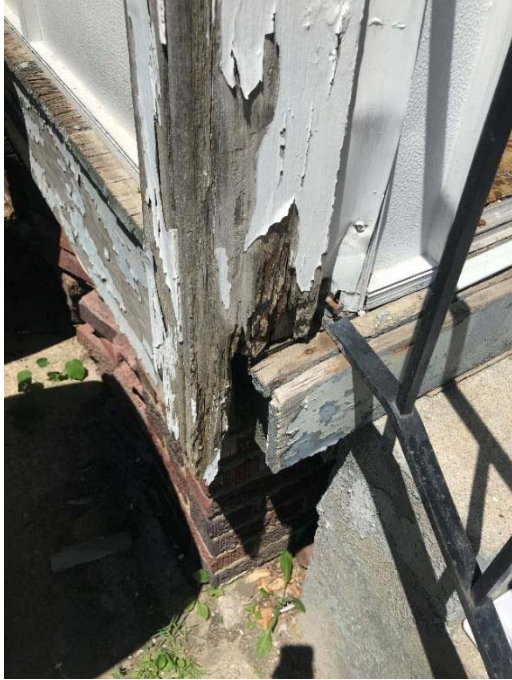
*Fig 20: Wood floor joists and exposed wood column showing signs of deterioration*

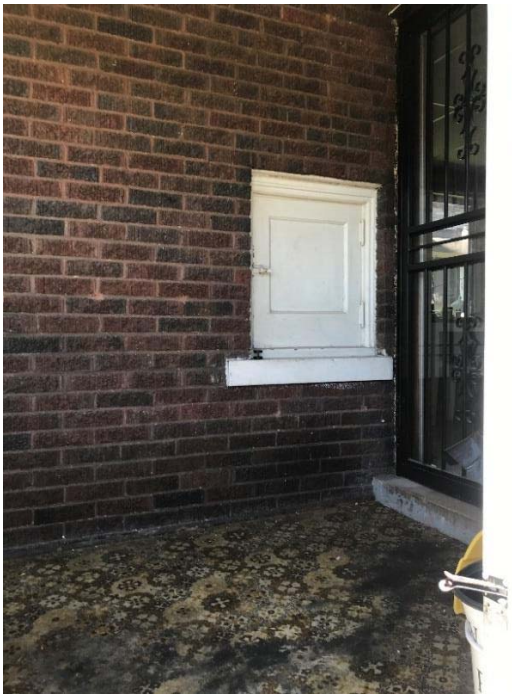
*Fig 21: Interior of first floor rear enclosed porch facing northeast*

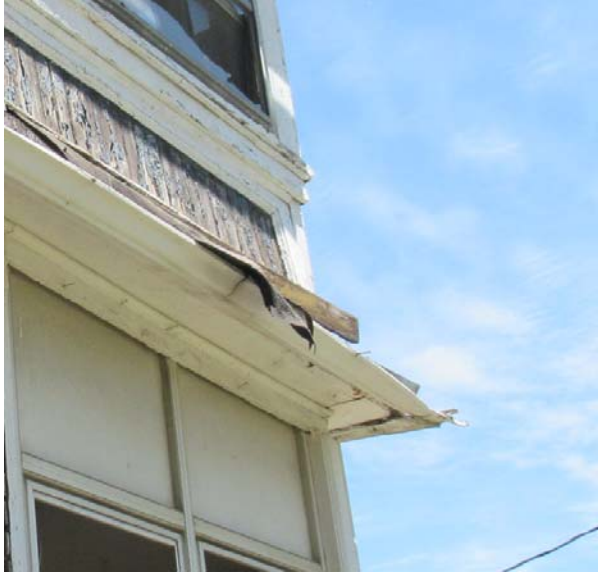
*Fig 22: Loose flashing hanging over gutter edge between first and second story of rear porch*

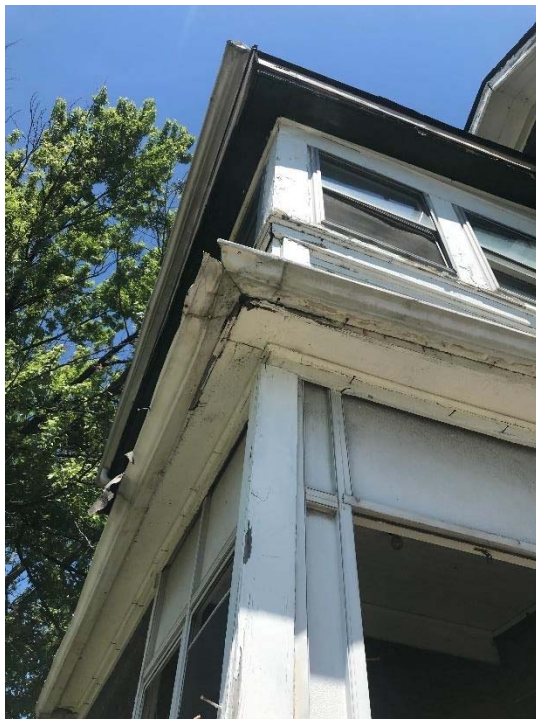
*Fig 23: Typical condition of gutters*

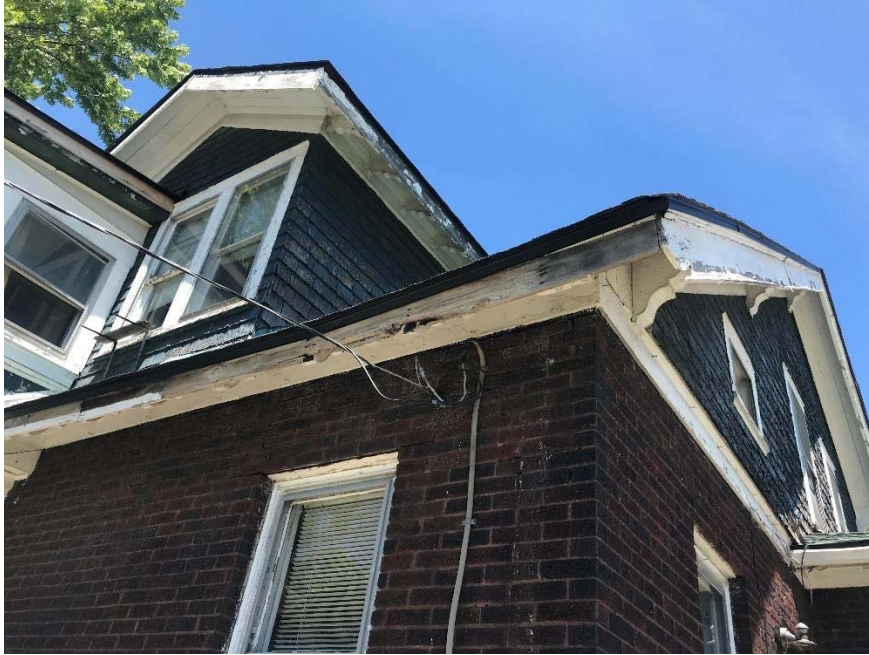
*Fig 24: Missing gutter along roof edge on west elevation*

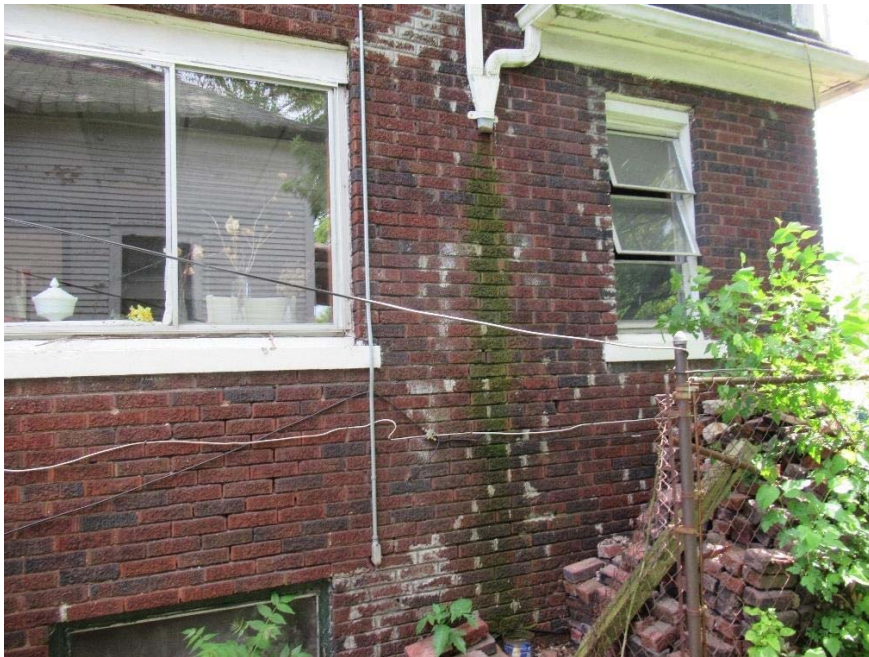
*Fig 25: Missing downspout on southern half of north elevation*

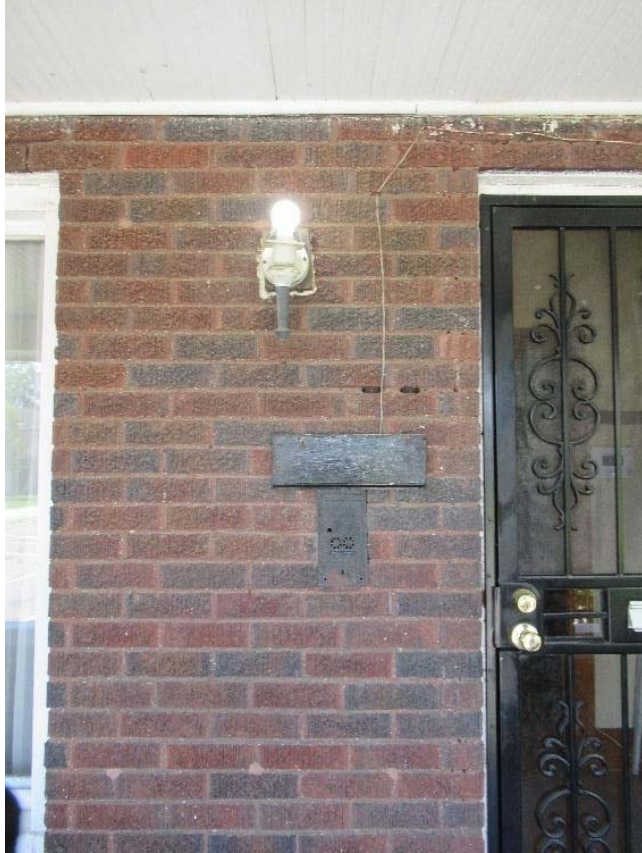
*Fig 26: Exterior light fixture at front entry*

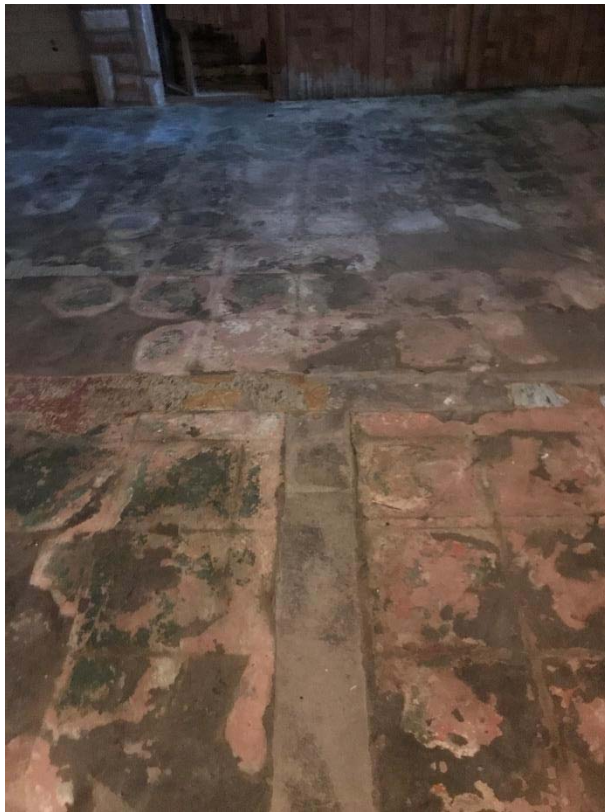
*Fig 29: Remnants of vinyl tile flooring and ghost of previous walls in basement*

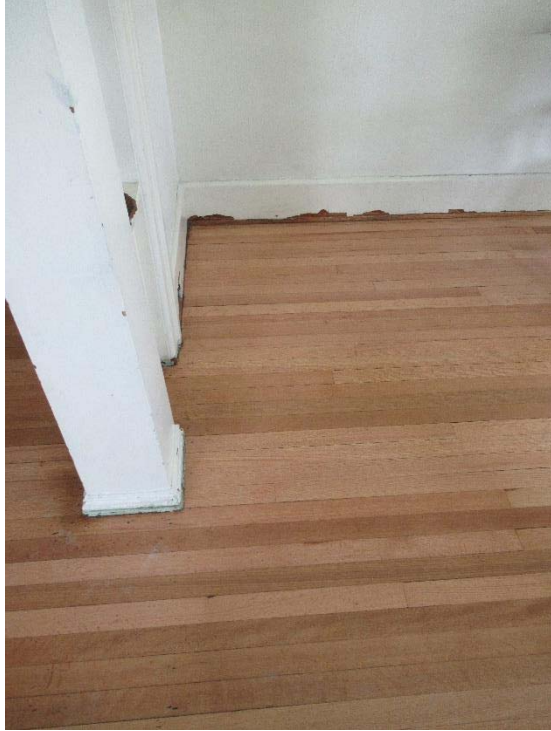
*Fig 30: Typical white oak strip flooring found throughout the house. Photo taken in first floor living room*

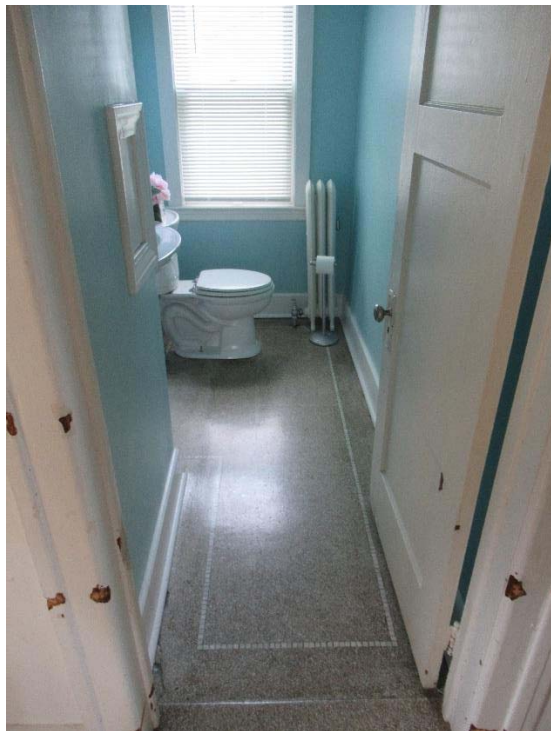
*Fig 31: First floor powder room with original terrazzo and decorative white tile border*

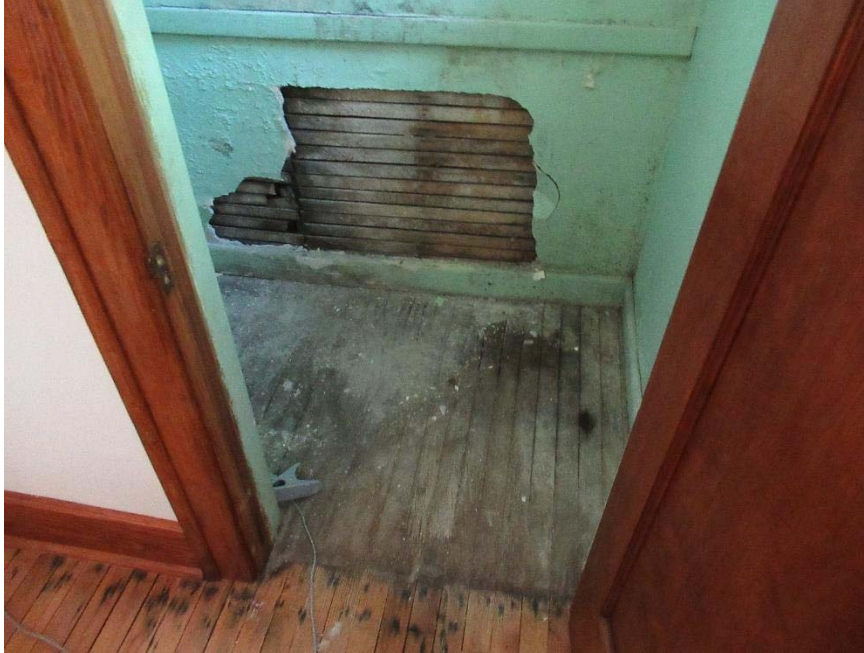
*Fig 32: Exposed wood plank subfloor in closet adjacent to first floor parlor. Floor exhibits signs of water damage*

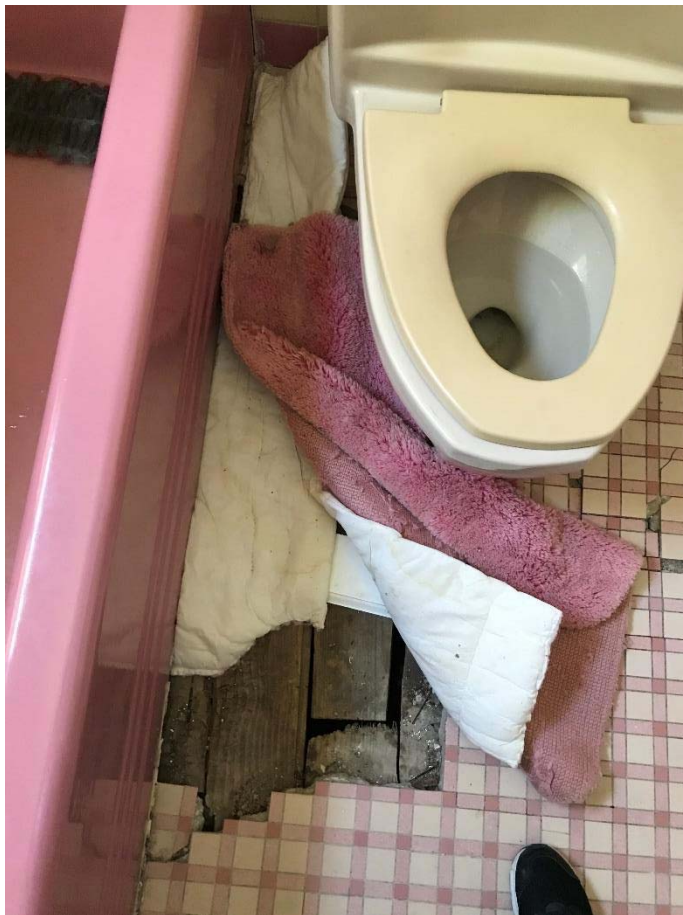
*Fig 33: Missing and damaged tile and damaged wood plank subfloor in second floor bathroom*

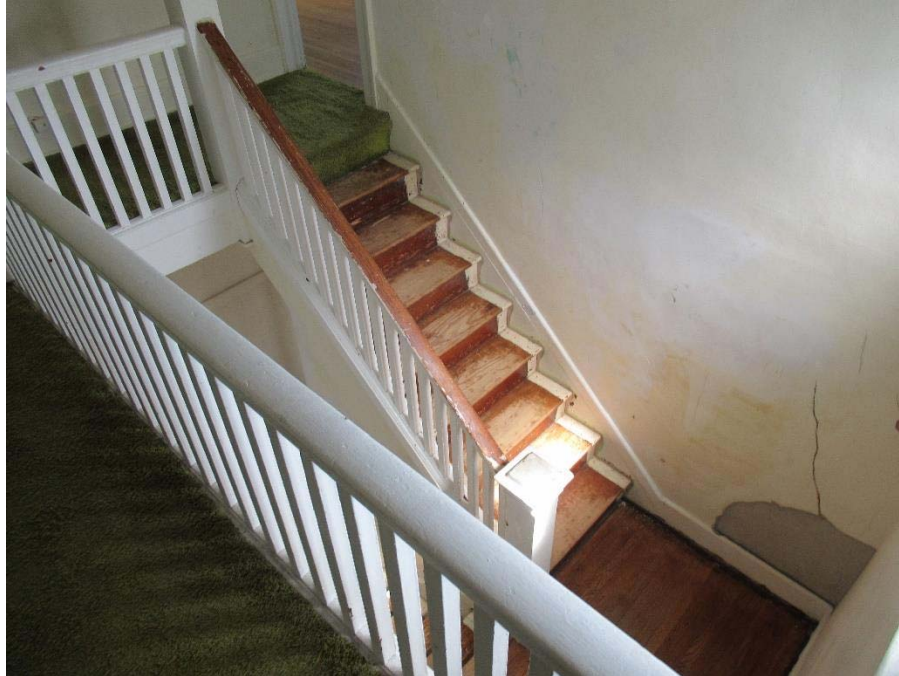
*Fig 34: Second floor corridor carpeting and pine wood stairway*

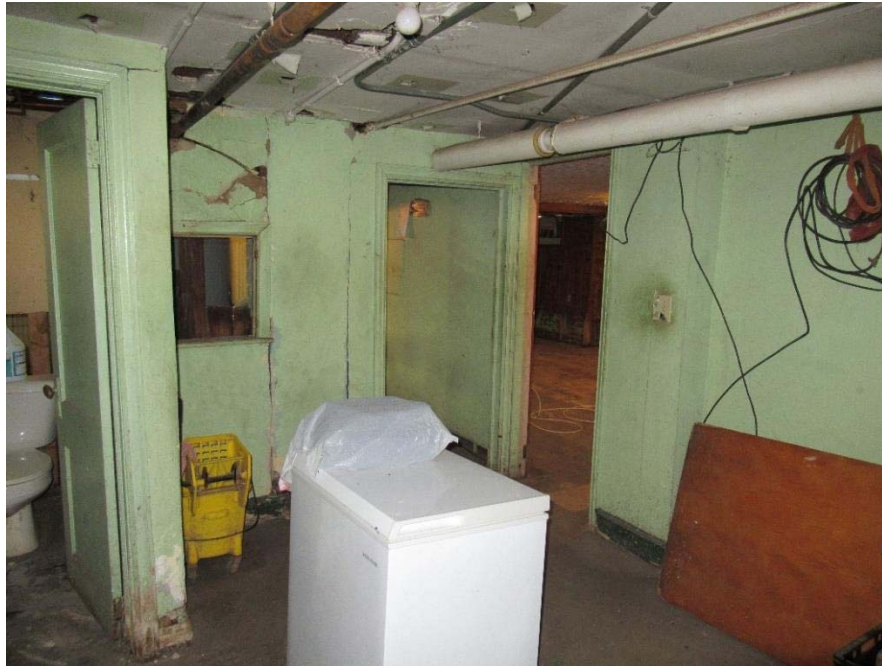
*Fig 35: Finished plaster partition walls in basement*

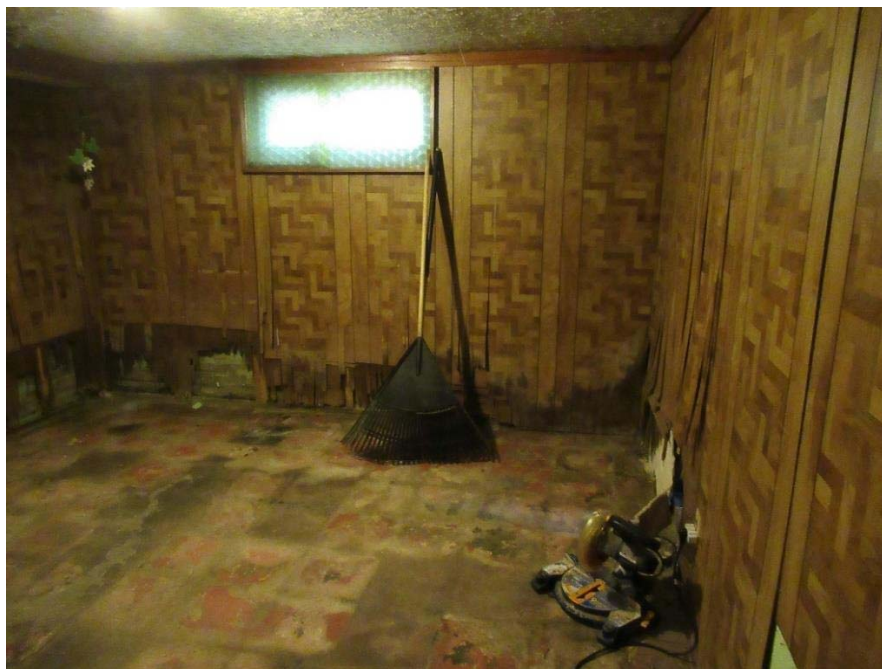
*Fig 36: Typical condition of built out wood paneling in basement*

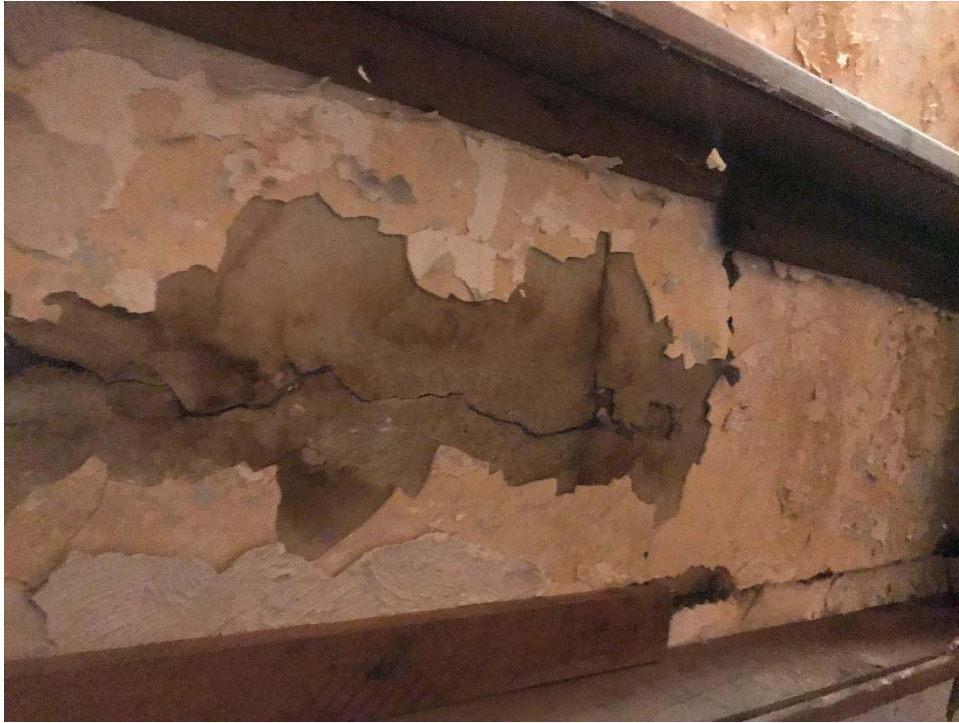
*Fig 37: Basement ceiling beam with visible cracking in plaster finish*

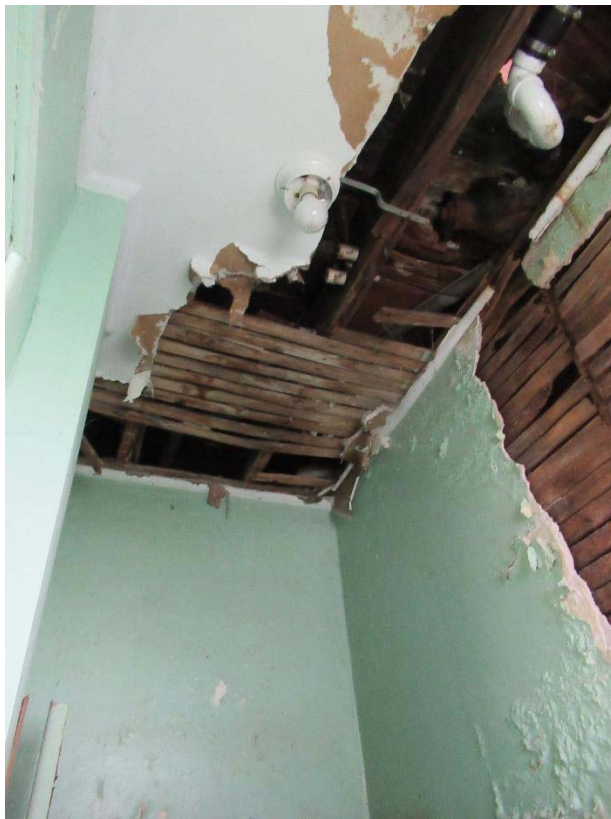
*Fig 38: Water damage and subsequent structural damage in first floor parlor closet*

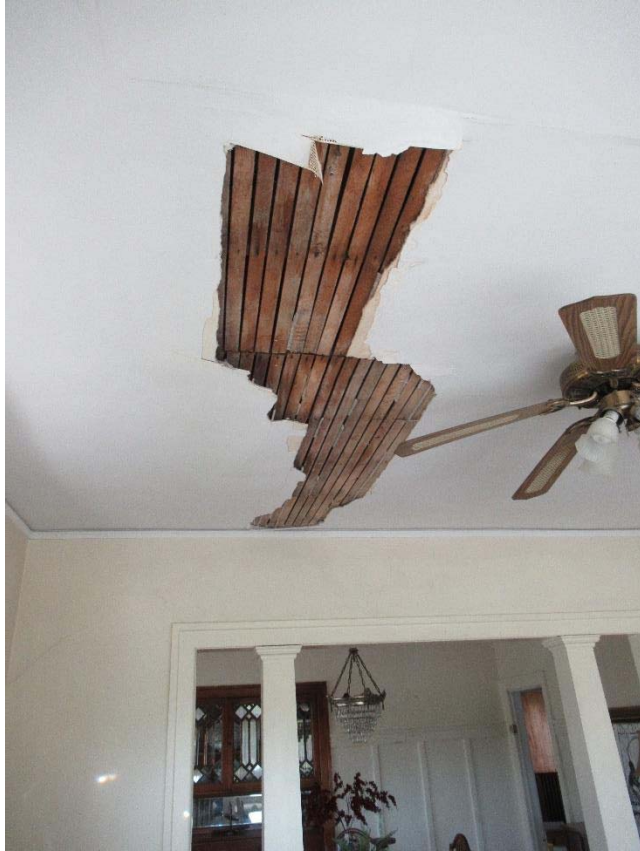
*Fig 39: Plaster ceiling damage in first floor living room*

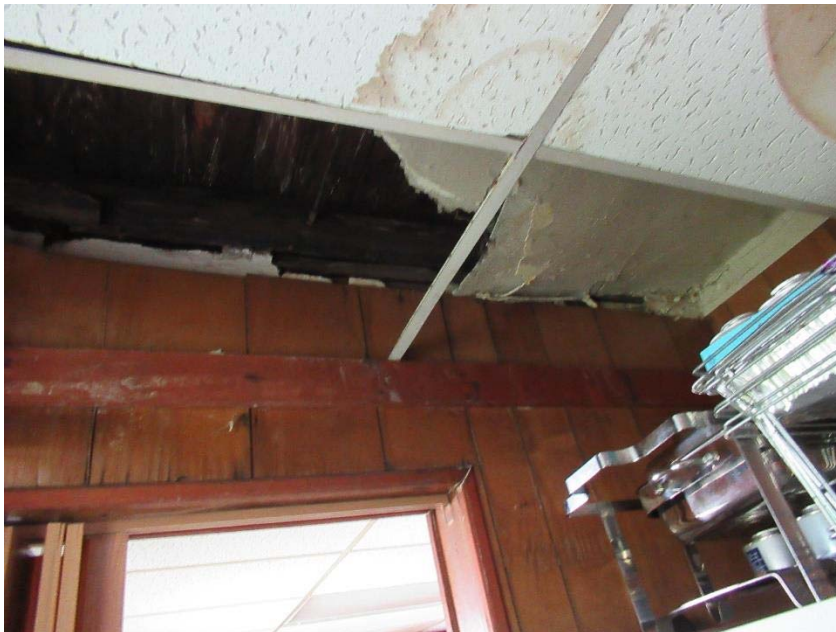
*Fig 40: Damaged plaster ceiling visible above missing acoustic ceiling tiles in kitchen*

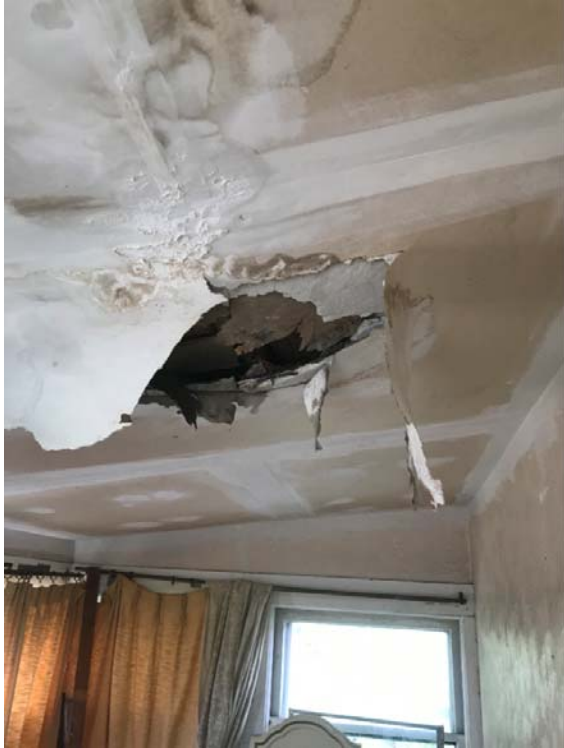
*Fig 41: Extensive water damage to gypsum board walls and ceiling in second floor rear enclosed porch*

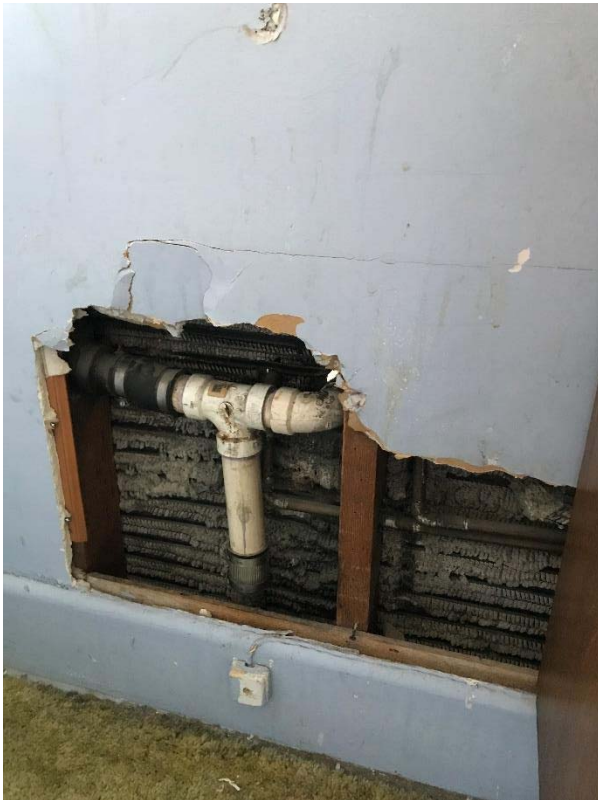
*Fig 42: Missing and damaged plaster in second floor bedroom*

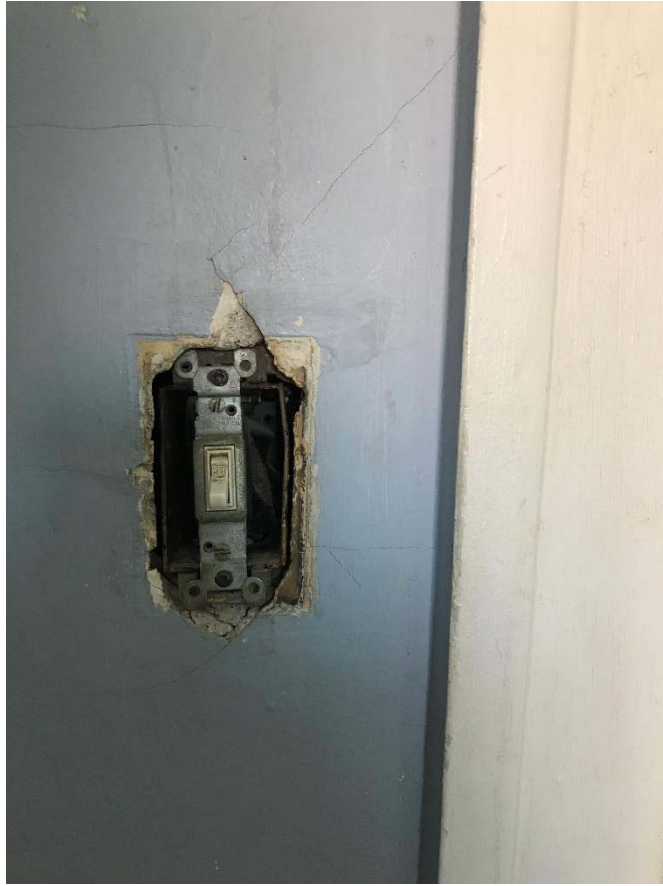
*Fig 43: Typical example of missing switch plates with and adjacent damaged plaster seen throughout house*

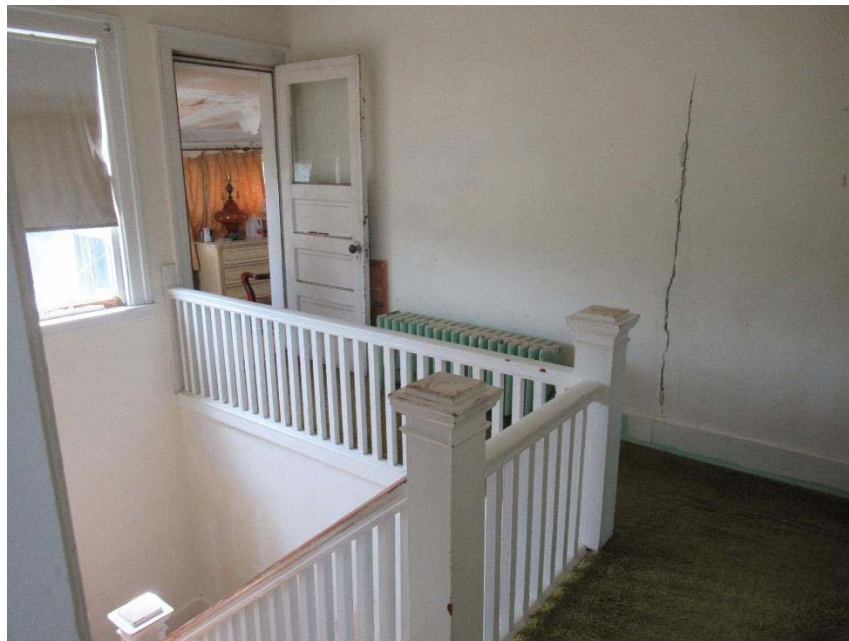
*Fig 44: Cracked and bowing plaster walls visible in second floor corridor*

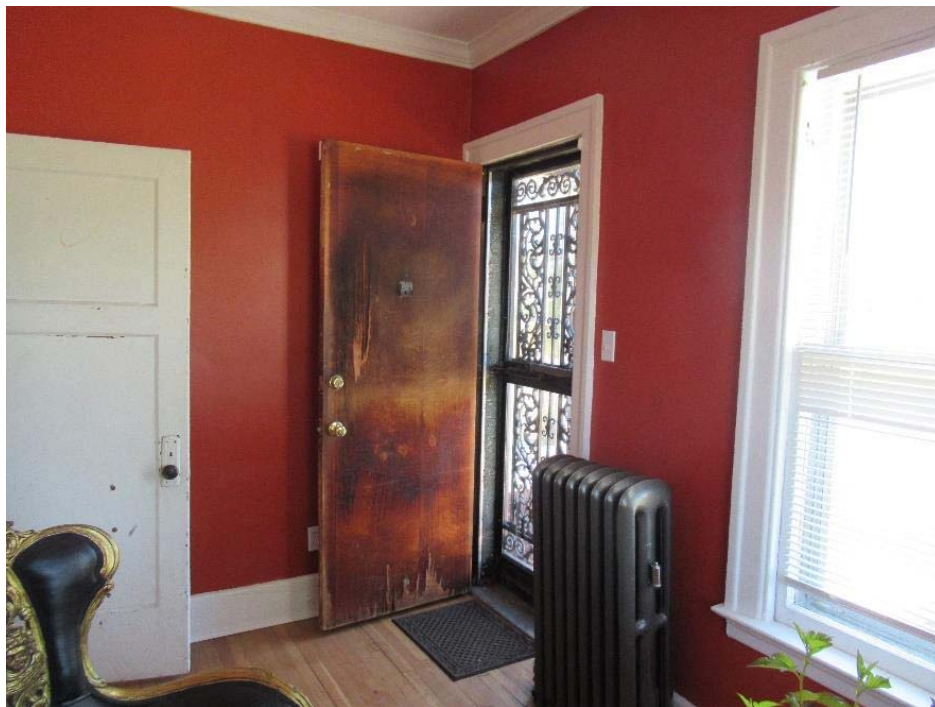
*Fig 45: Exterior door off south elevation into sunroom*

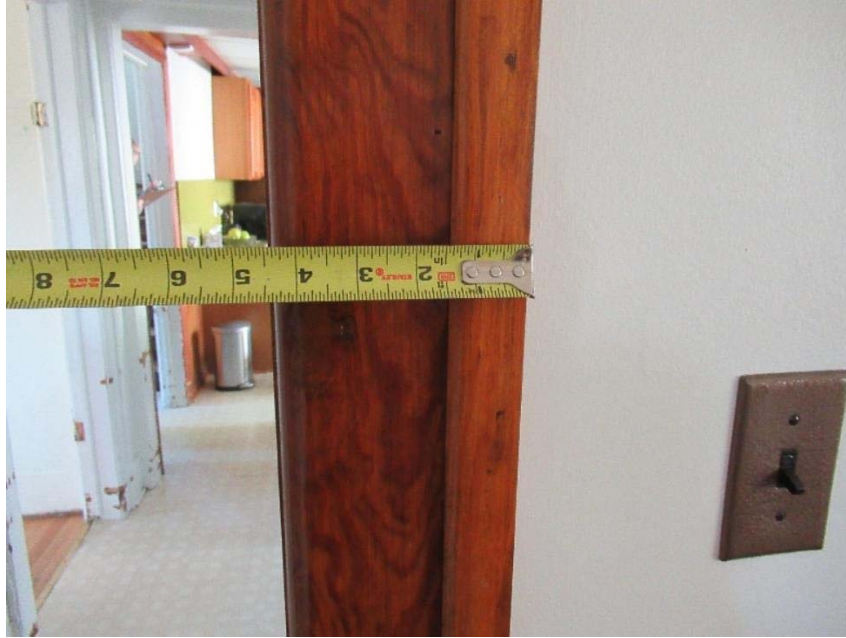
*Fig 49: Typical door trim*

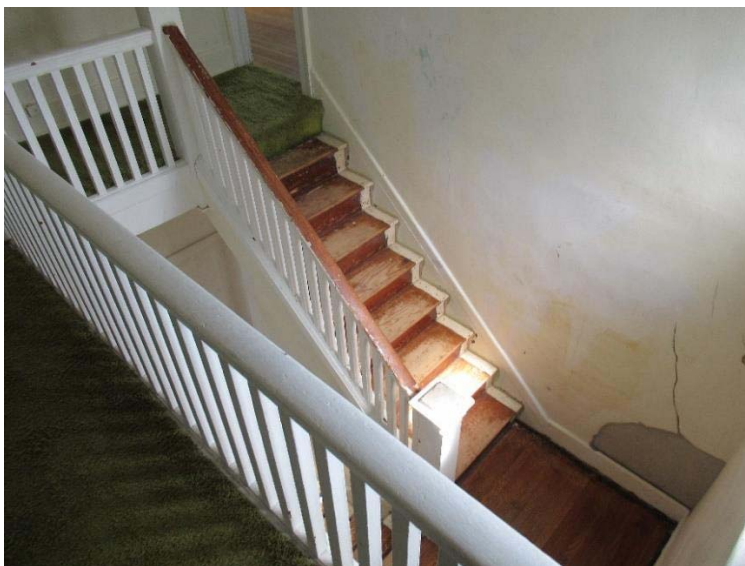
*Fig 54: First floor to second floor stair handrail and skirtboard*

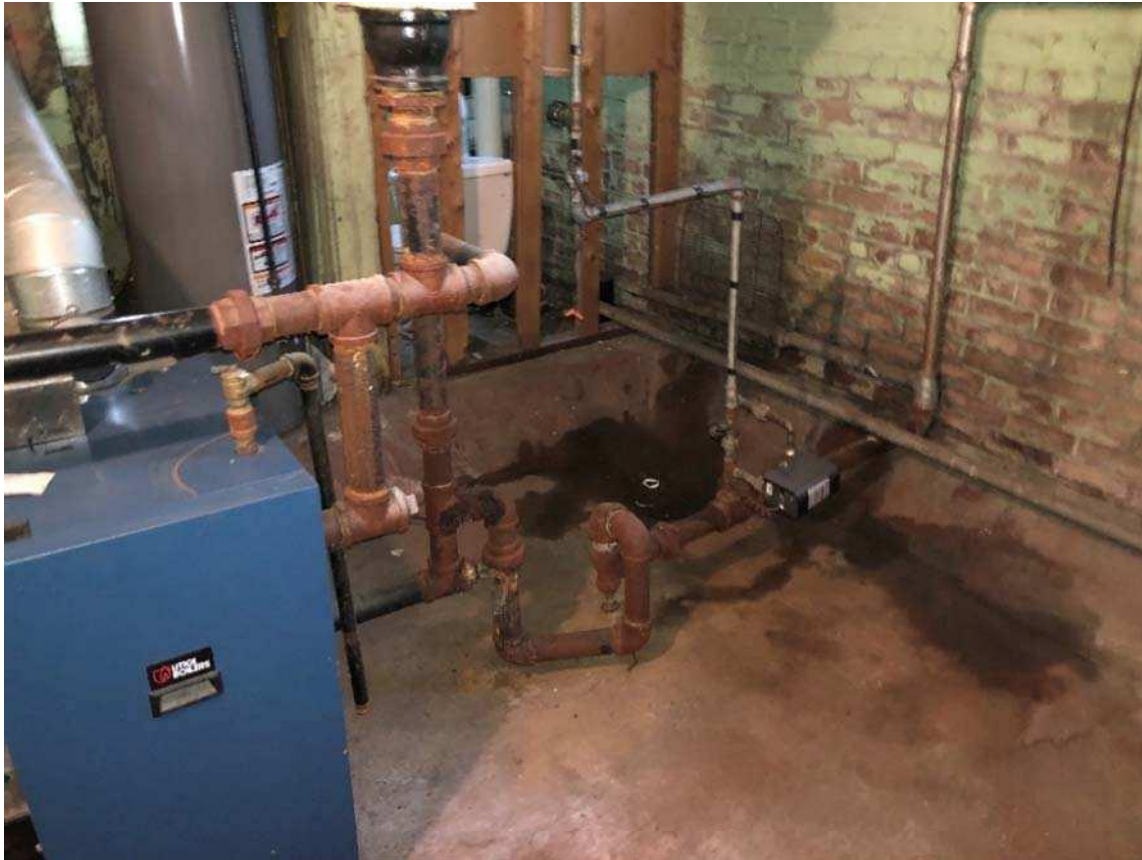
**Figure 3** Shallow pit in basement slab and view of perimeter foundation wall

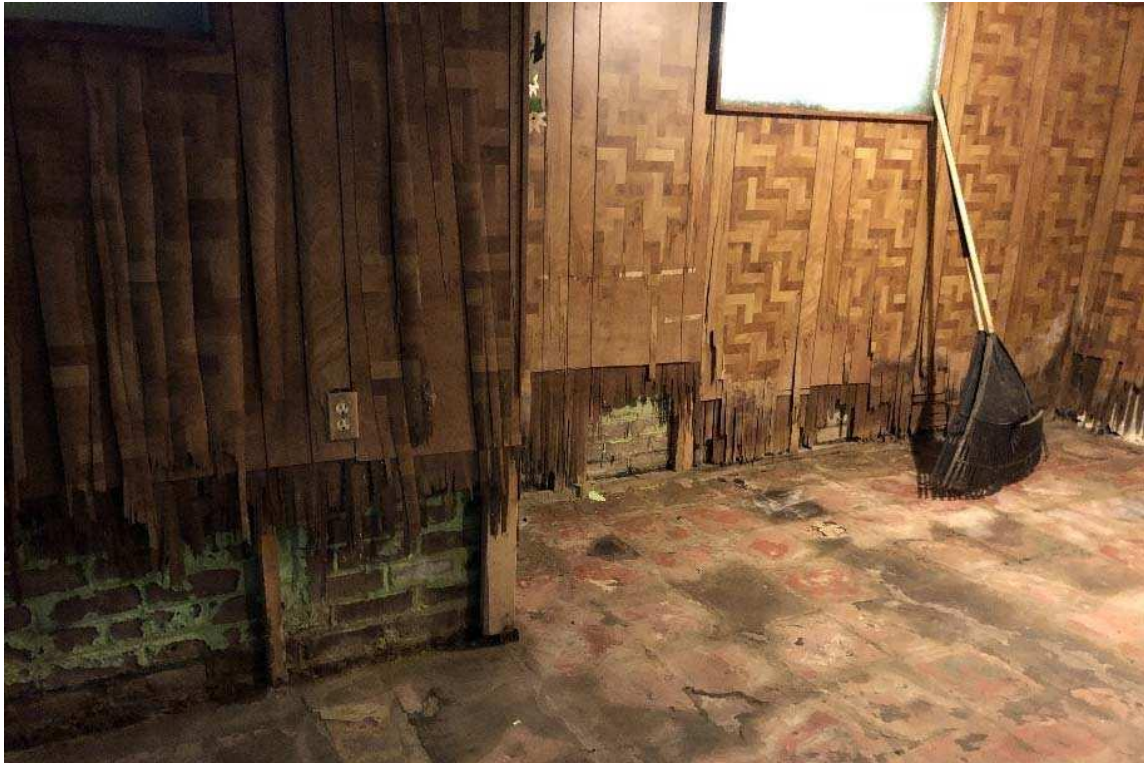
**Figure 6** Basement floor and walls

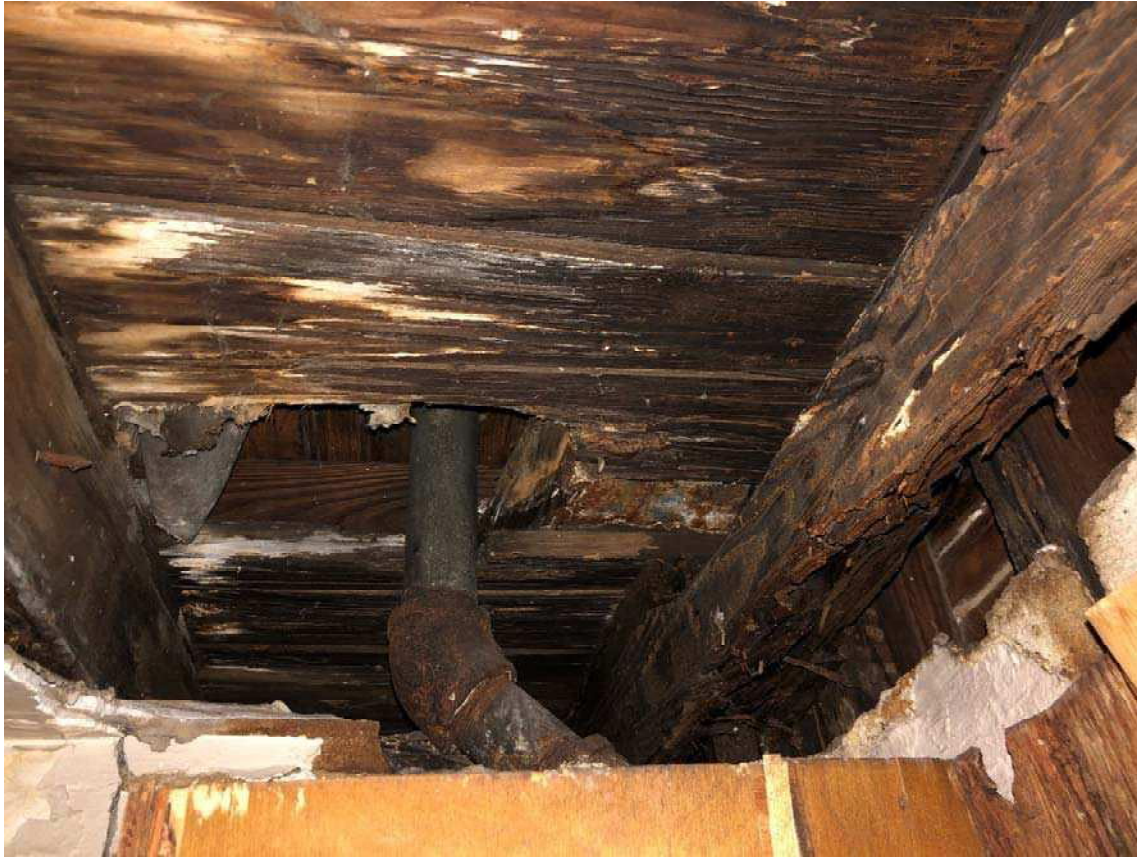
**Figure 7** Water-damaged second floor beams below second floor bathroom

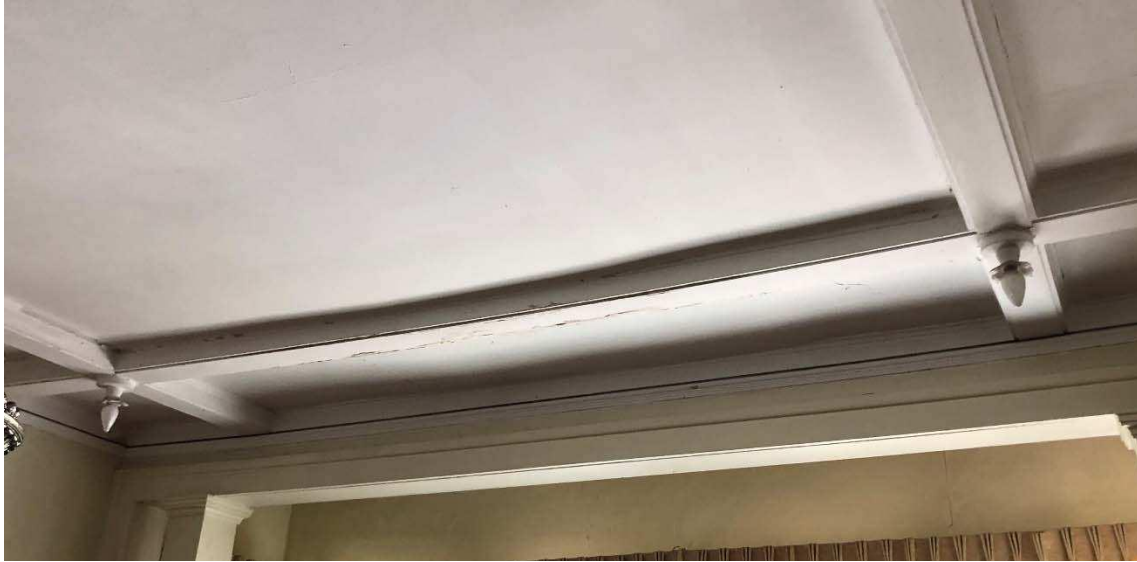
**Figure 8** Sagging of second-floor framing
