# Historic Structures Report for the Dr. Ossian H Sweet House

Conducted by:  
Kraemer Design Group LLC  
1420 Broadway  
Detroit, MI 48226

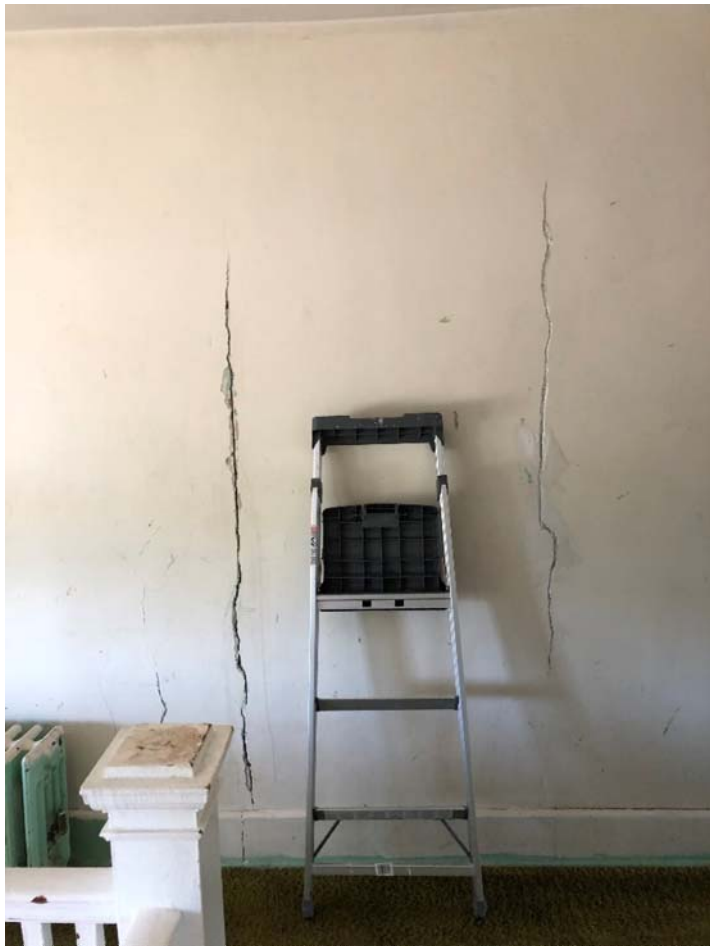
**Figure 9** Vertical cracking in plaster wall behind shower/chimney stack

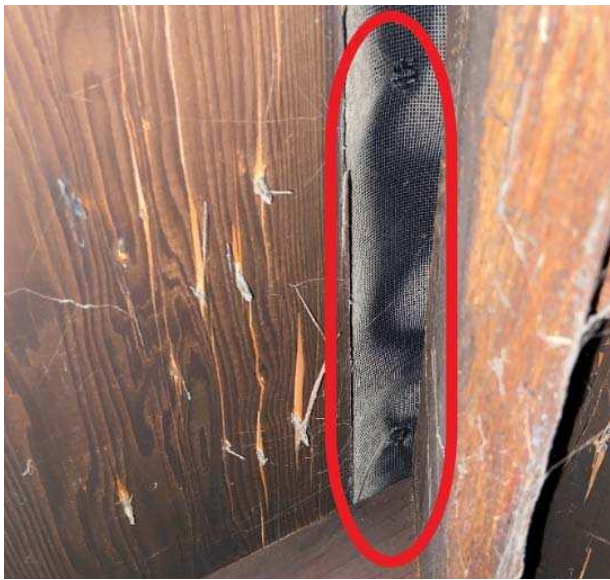
**Figure 10** Unsealed roof apex

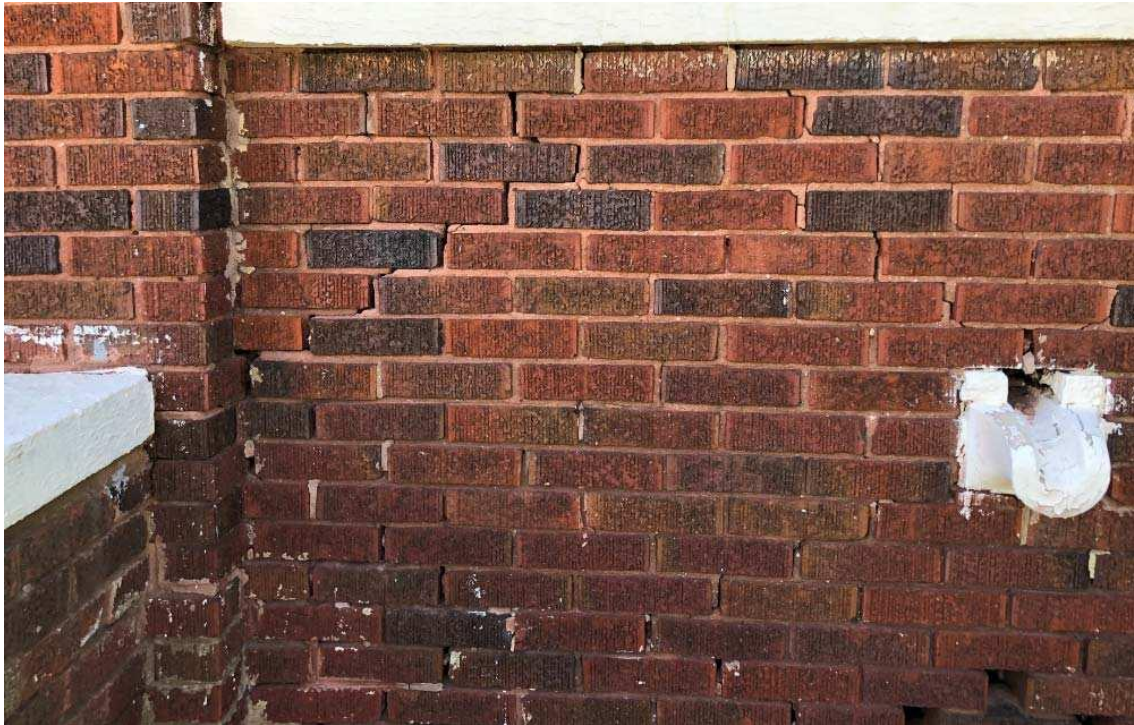
**Figure 12** Step cracking and receded mortar on north porch wall (from the exterior side)

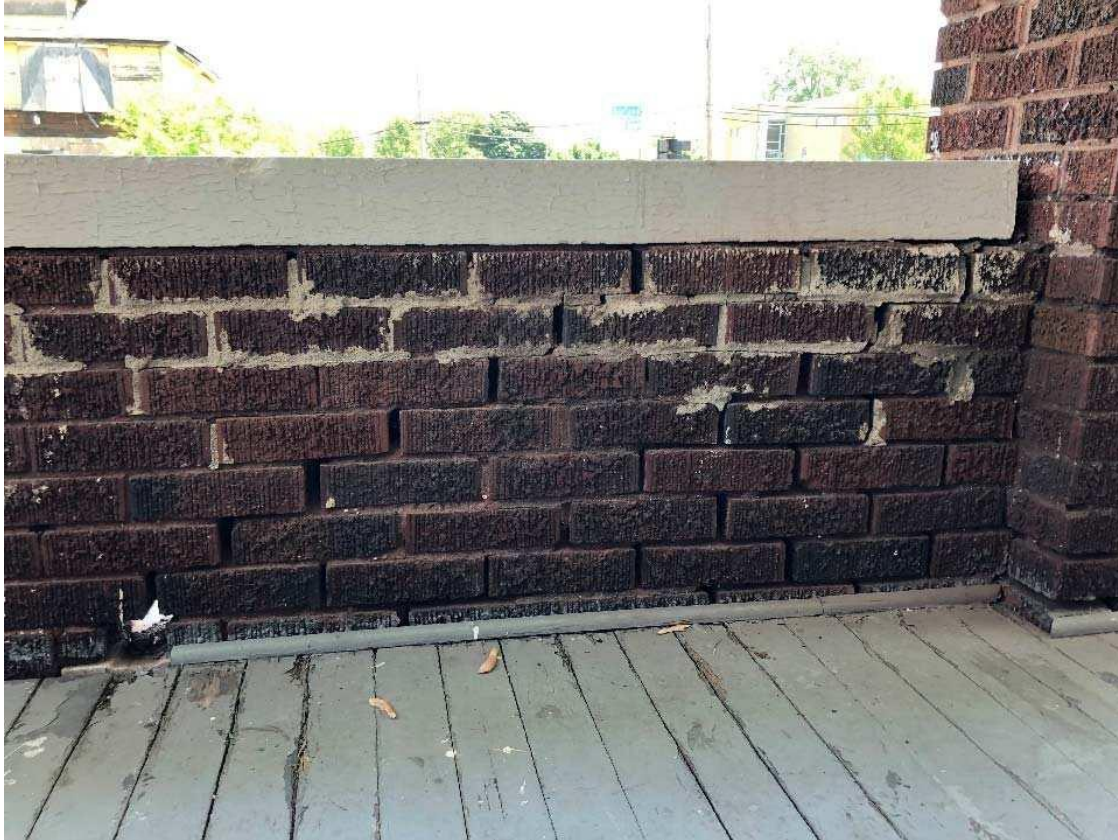
**Figure 13** Step cracking and receded mortar on east porch wall (from the porch side)

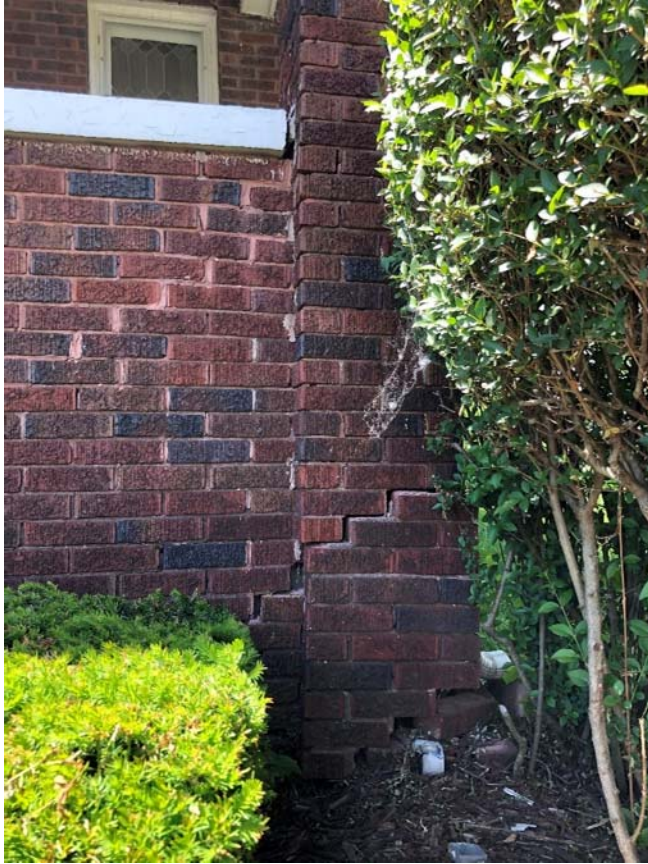
**Figure 14** Northernmost porch column

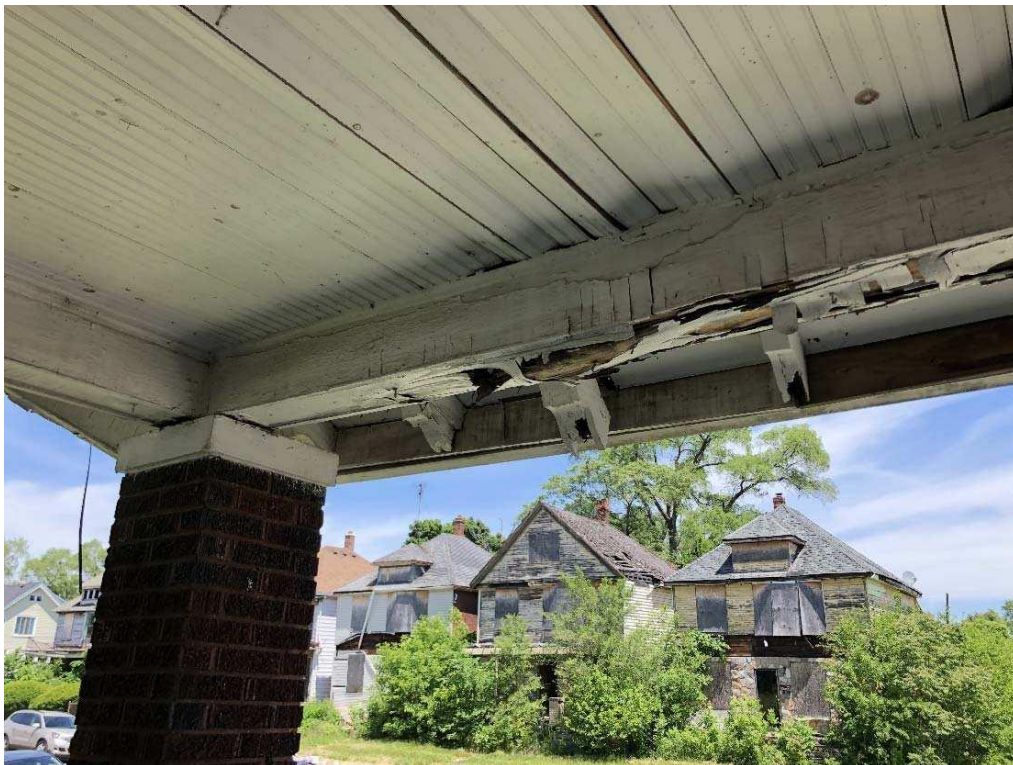
**Figure 15** Deteriorated porch beam

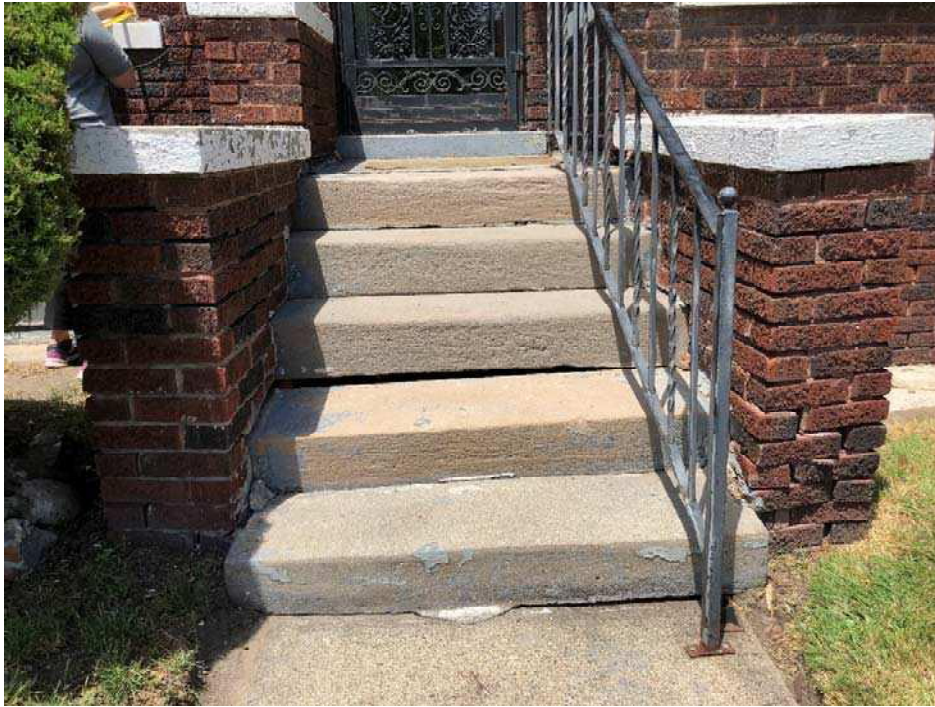
**Figure 16** Side porch showing concrete step cracks and localized brick displacement at each wall.

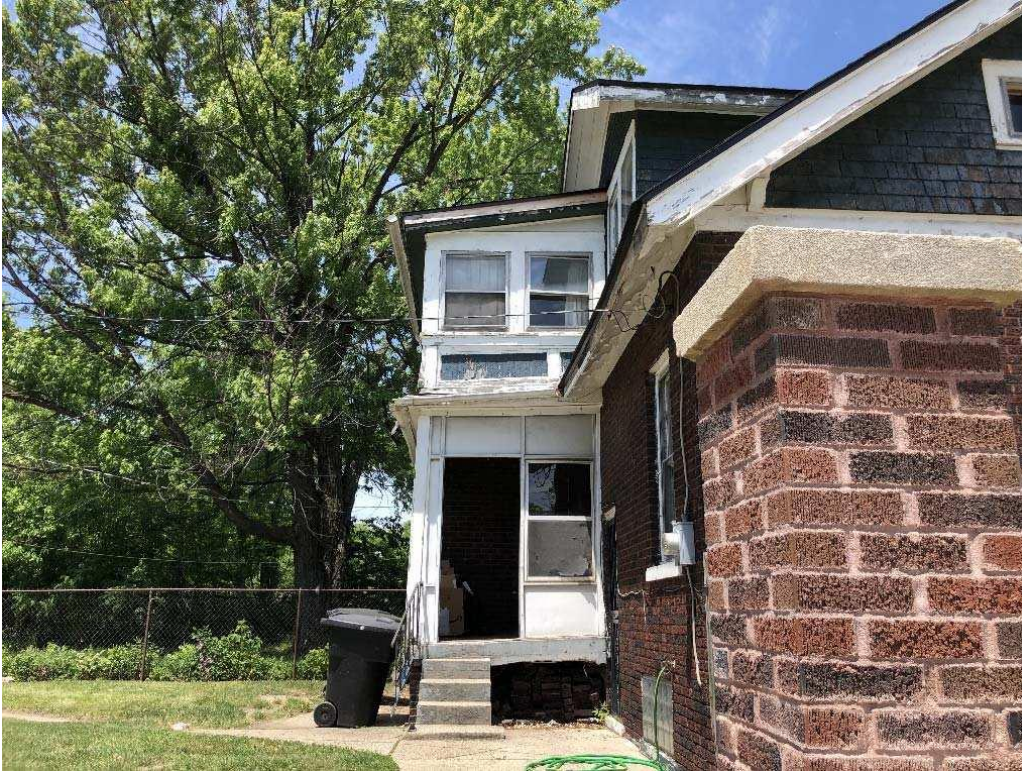
**Figure 17** Back Porch

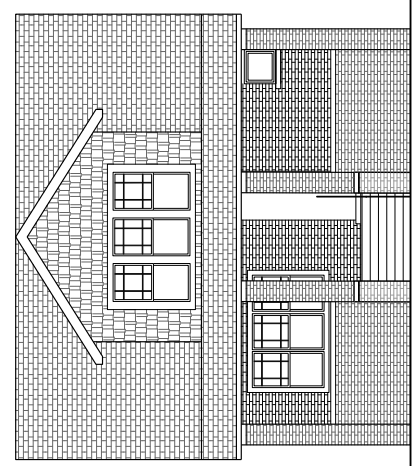
# OSSIAN SWEET HOUSE

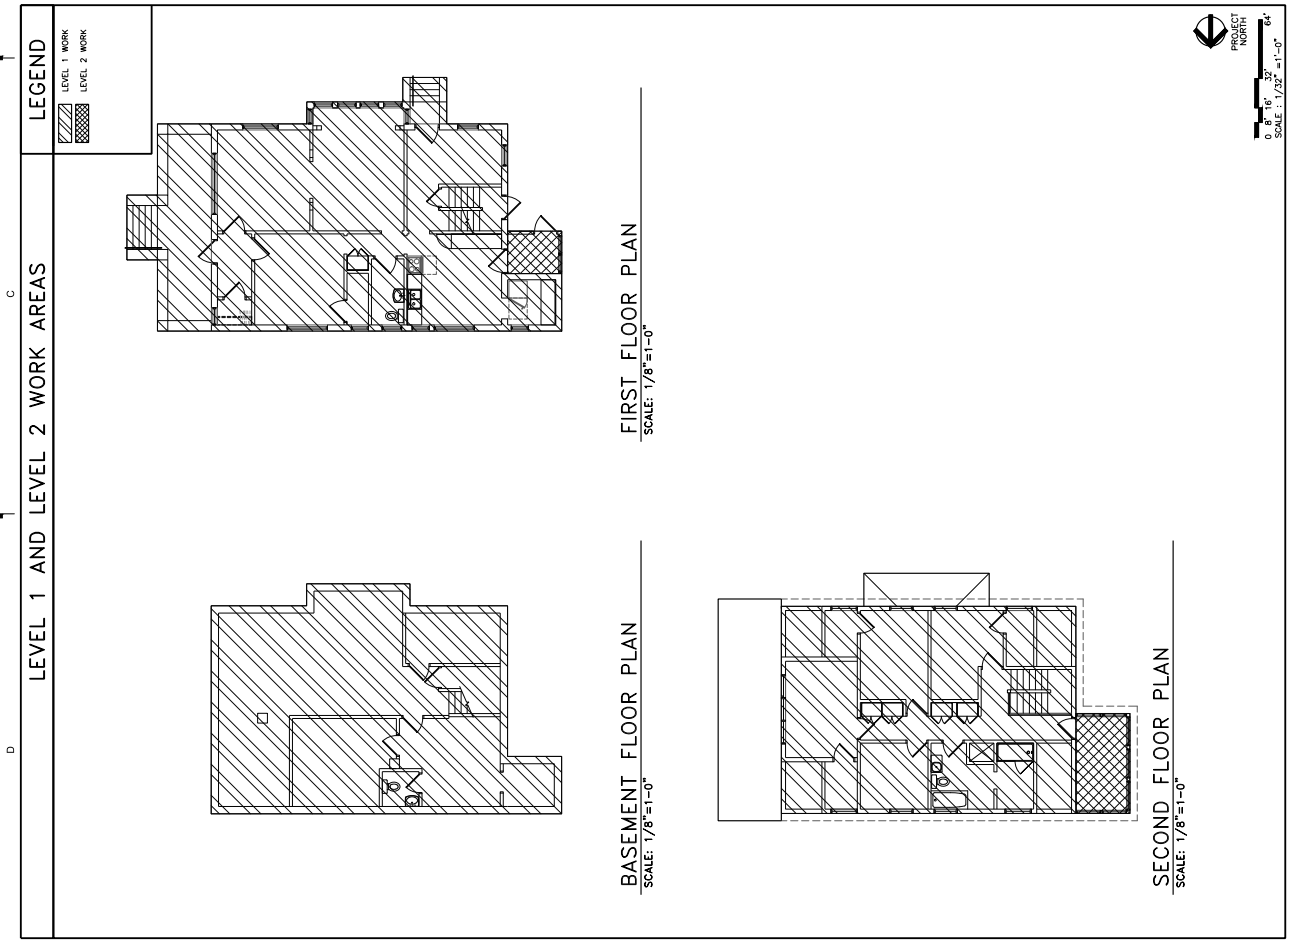
**GENERAL SITE NOTES**

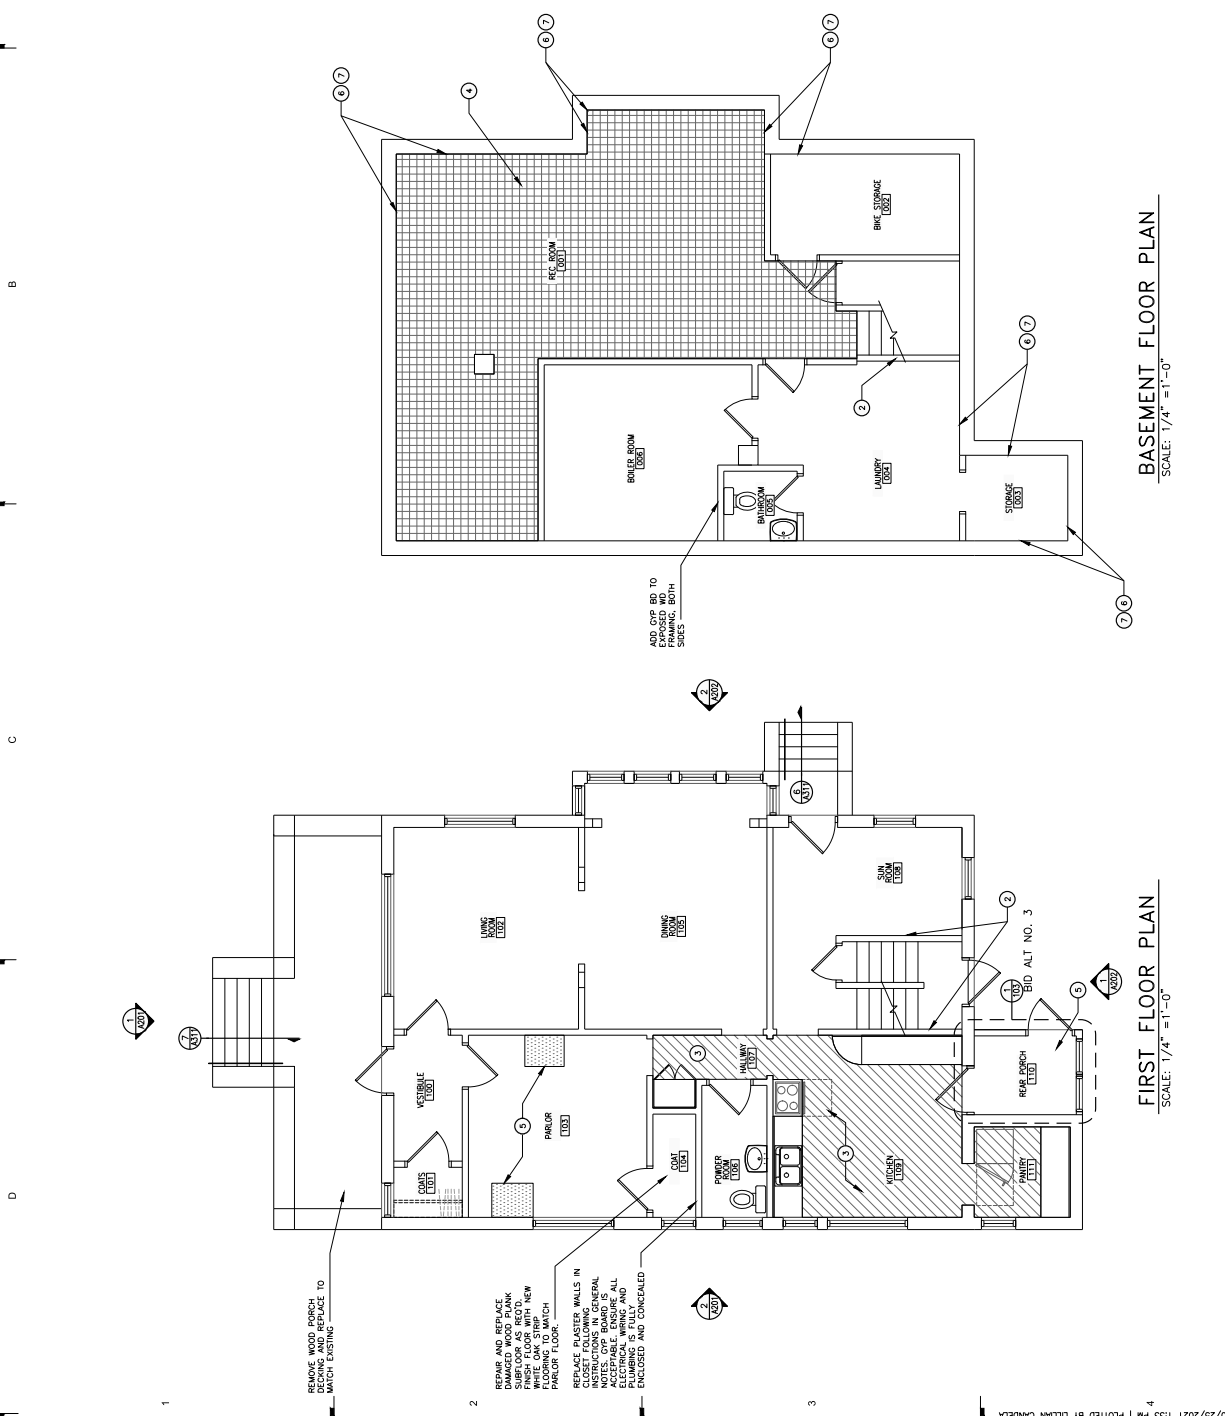
**BASEMENT FLOOR PLAN**  
SCALE: 1/4" = 1'-0"

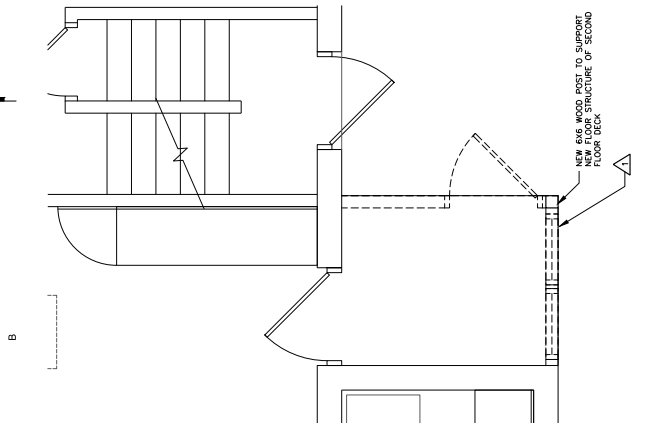
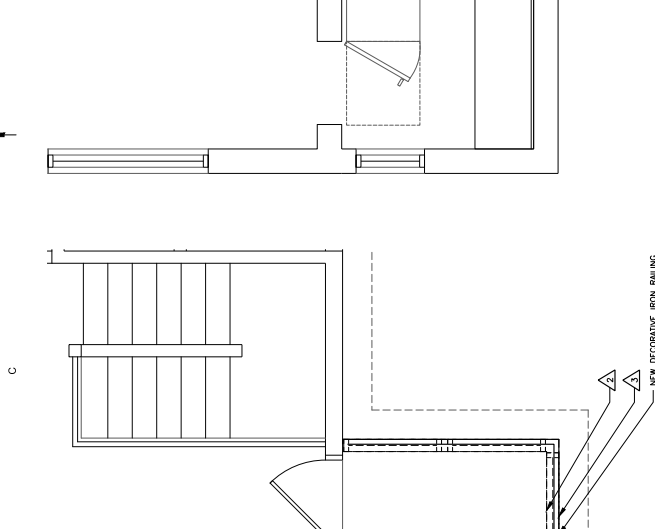
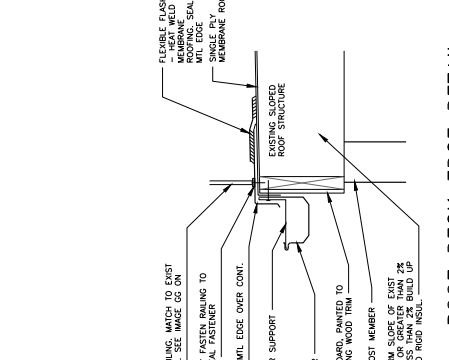
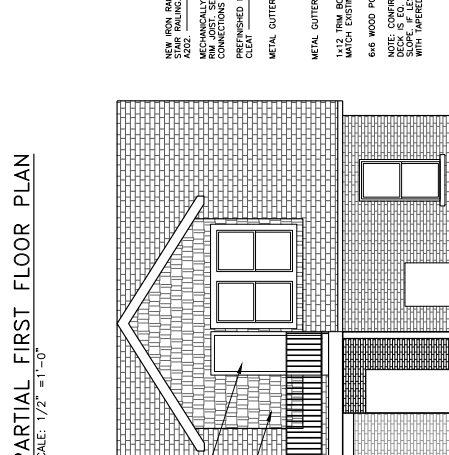
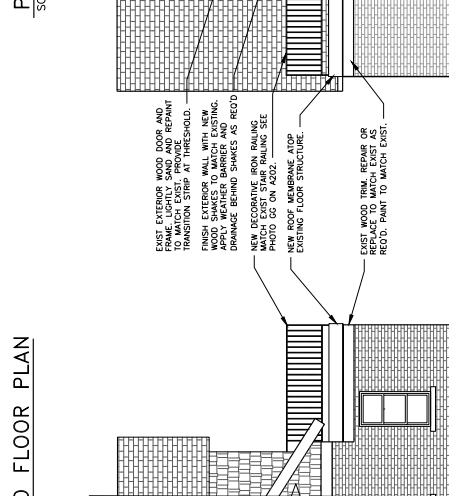
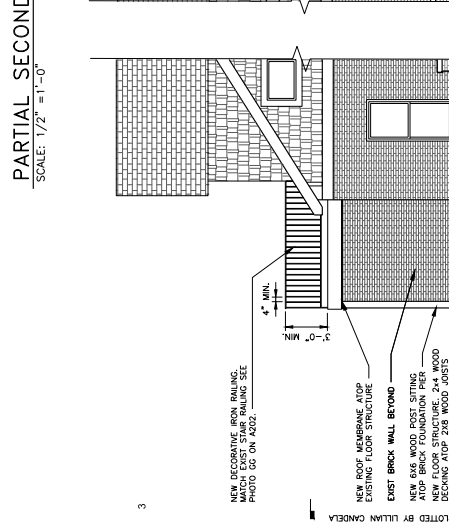
**ROOF DECK EDGE DETAIL**  
 SCALE: 1/4" = 1'-0"

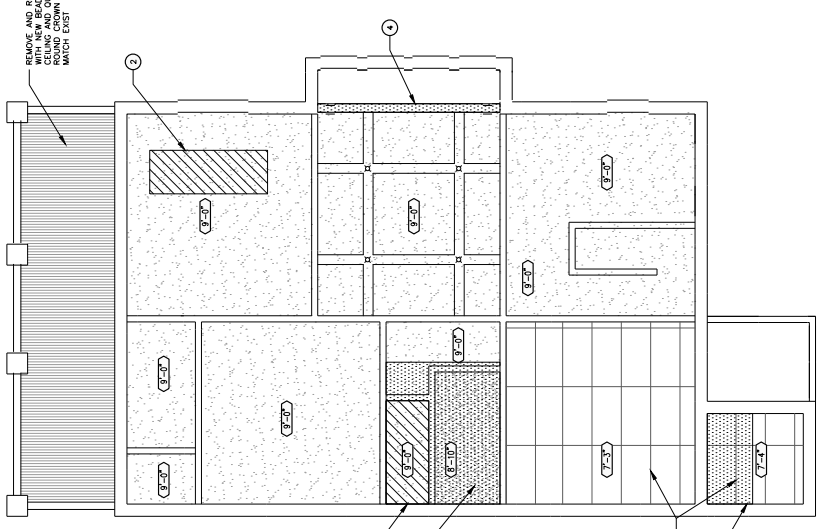
**FIRST FLOOR RCP**  
SCALE: 1/4" = 1'-0"

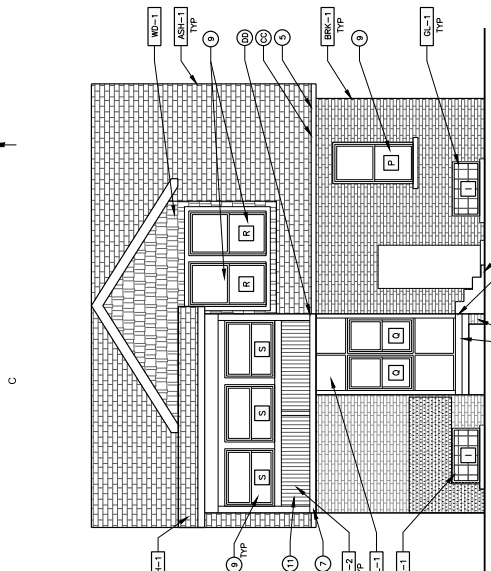
**1 WEST ELEVATION**  
SCALE: 1/4" = 1'-0"  
REFERENCE LOCATIONS: A101, A102

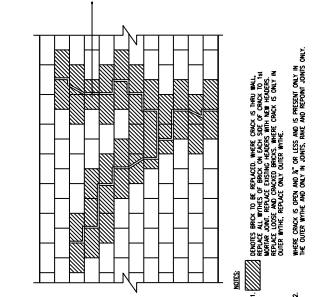
**2 TYPICAL DETAIL REPAIR IN BRICK MASONRY**  
 SCALE: 1/2" = 1'-0"  
 REFERENCE LOCATIONS:

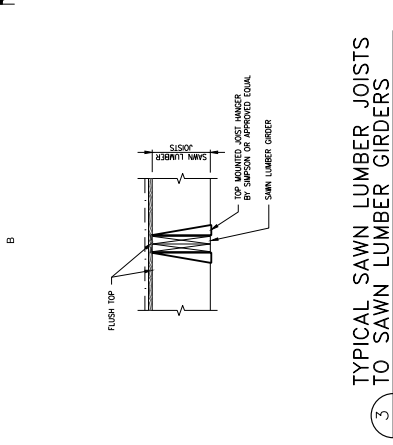
**3 TYPICAL SAWN LUMBER JOISTS TO SAWN LUMBER GIRDERS**  
 SCALE: 3/4" = 1'-0"  
 REFERENCE LOCATIONS:

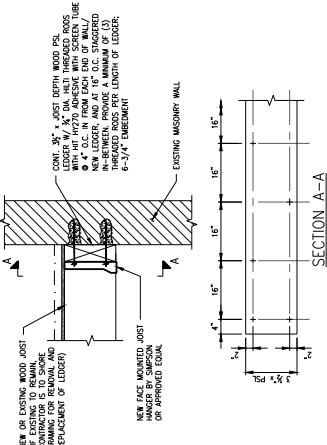
**5 TYPICAL REPLACEMENT OF WOOD LEDGER ON BRICK WALL**  
 SCALE: 3/4" = 1'-0"  
 REFERENCE LOCATIONS:

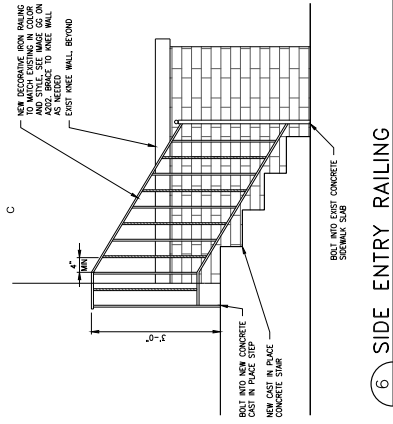
**6 SIDE ENTRY RAILING**  
 SCALE: 3/4" = 1'-0"  
 REFERENCE LOCATIONS: A10

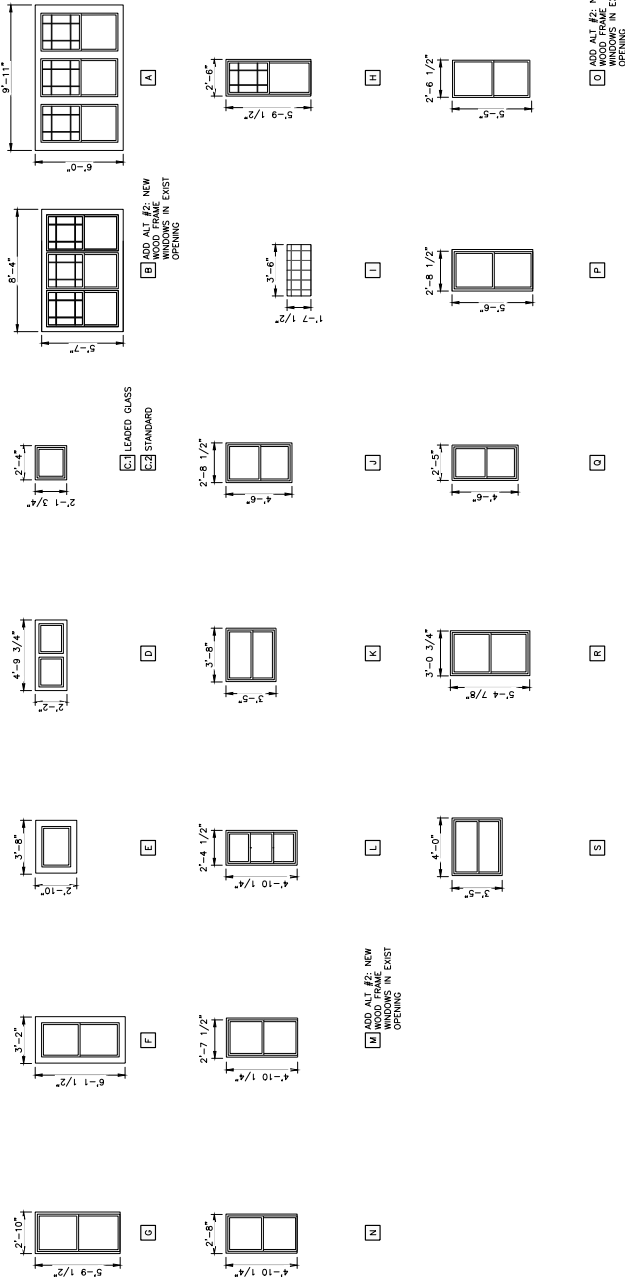
BIG A UPGRADE NO. 2: WINDOWS AND DOORS  
 DAMAGED UNITS AS SHOWN  
 ADD ALT. (1) NON-ORIGINAL WINDOWS TO BE REPLACED WITH FRAME WOOD  
 ADD ALT. (2) NON-ORIGINAL WINDOWS TO BE REPLACED WITH FRAME WOOD  
 COMPART WOODS AND DOORS. CONTACT MANUFACTURER AND WINDOW DESIGN WITH ARCHITECT PRIOR TO CONSTRUCTION.
