Kraemer Design Group, LLC  
Broadway Lofts  
Historic Building Façade Report

Issued | May 30, 2023

Job number 23038

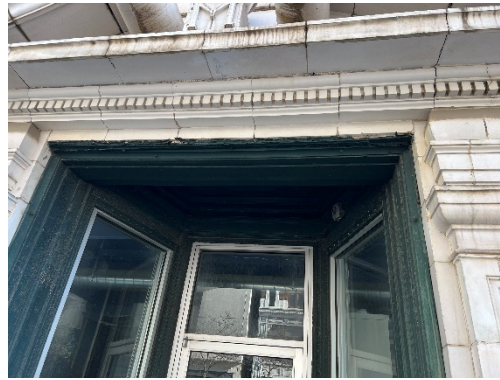
Overall, the terra-cotta façade is in moderate condition. Mortar joints are deteriorated allowing water to infiltrate the facade (P-1).

*P-1 Mortar joints require tuck and re-pointing*

- Extensive tuck and re-pointing of mortar joints required.
- Limited face-shell repairs required at minor cracks and spalls.
- Cope joints repairs and back side waterproofing of parapet wall required to prevent water infiltration into parapet wall.
- Extensive repairs to glazing at parapet wall and water table.

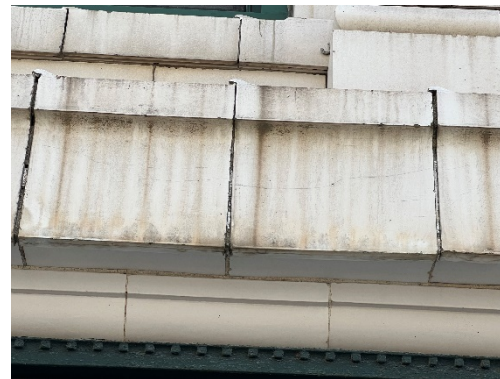
Some minor surface cracking will be repaired at horizontal bands due to water infiltration (P-2).

*P-2 Face cracking due to water infiltration*

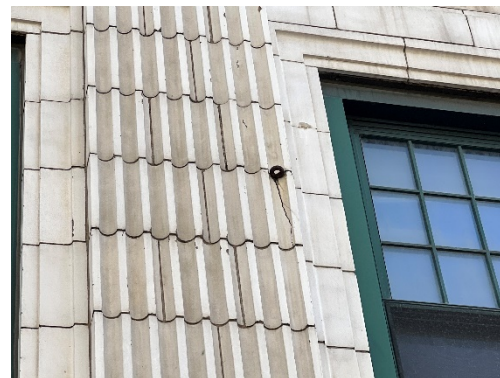
Vertical cracks and minor spalling occurring at steel embed (P-3).

*P-3 Spalling and cracking terra-cotta at steel embeds*

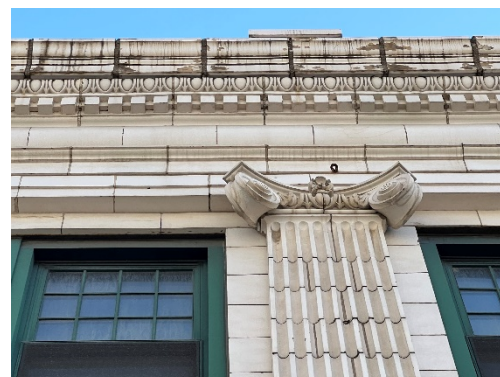
At the upper water tables and parapet, the glazed terra-cotta is showing signs of moderate to severe surface delamination and spalling(P-4).

Delamination occurs overtime as water infiltrating the wall and coping gets trapped behind the glazed surface expands and contracts during freeze/thaw cycles.

*P-4 Delamination of glazing at upper water table*

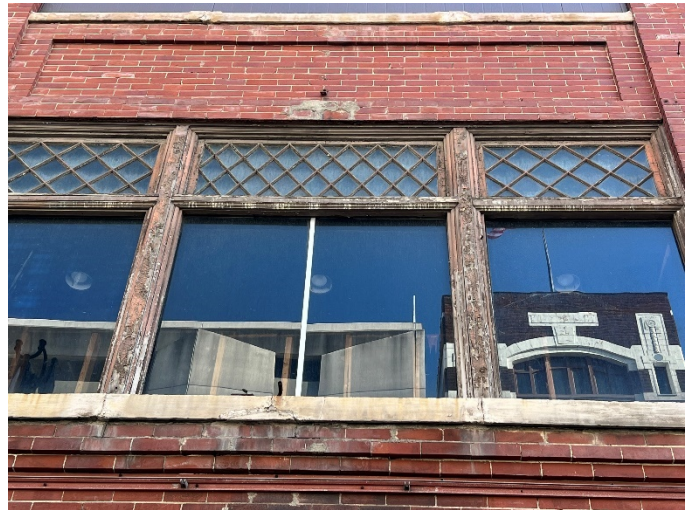
Generally, the red brick is in moderate to good condition. There are areas in the brick that will require repair due to damage from steel anchors and embeds (P-5 and P-7).

Lintel steel above storefront and windows appear in moderate to good condition with no major cracking or spalling of the brick observed (P-5, P-6 and P-7).

Limestone sills show signs of minor cracking and movement that can be repaired in place (P-5 and P-6).

P-5 Red brick and limestone second floor and above

- Tuck and repoint brick and limestone joints.
- Repair cracked limestone sills.
- Remove steel anchor embeds and repair/replace damaged brick.
- Stop water infiltration into parapet wall by waterproofing back side of wall and resetting/resealing coping tiles.

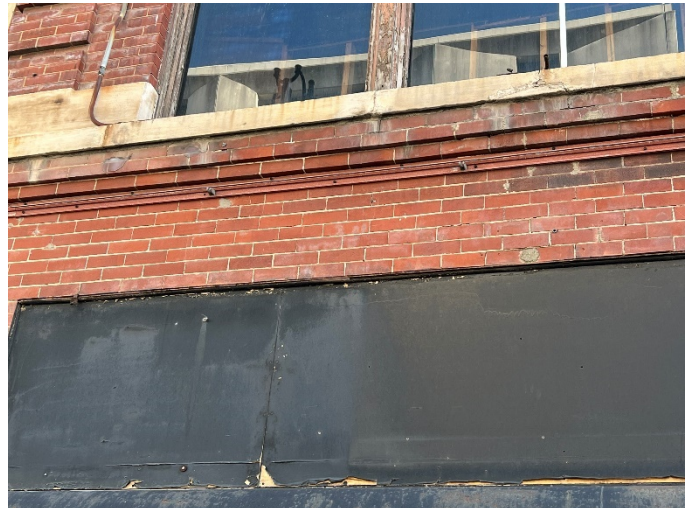
P-6 Metal panel above store front and second floor limestone sill

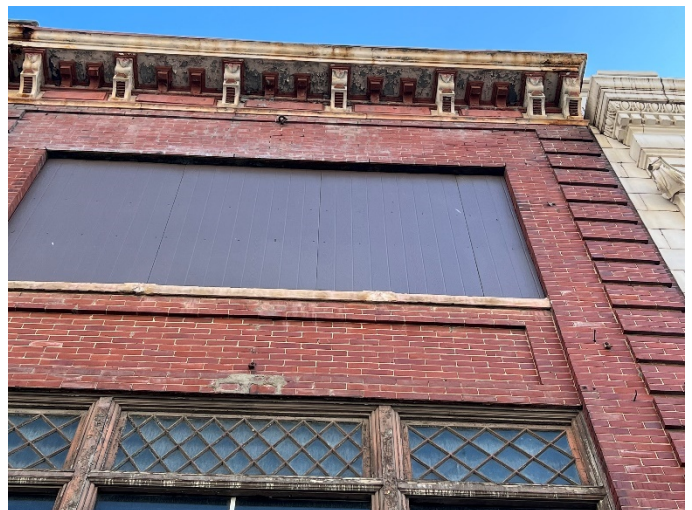
Surface staining and efflorescence visible below water table due to water infiltration through coping and back side of parapet (P-7)

P-6 Red brick below water table

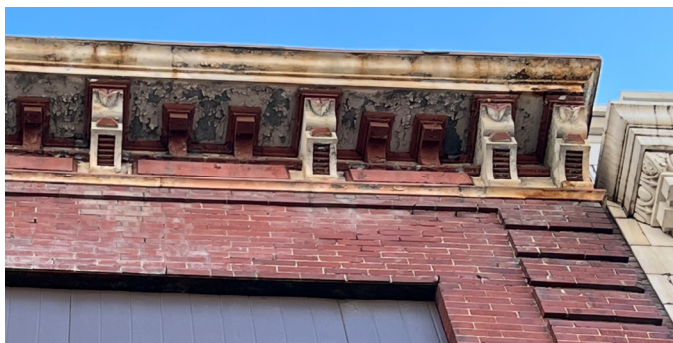
The sheet metal panel water table is in very poor condition and beyond repair (P-8 and P-9).

*P-8 Metal panel water table in poor condition*

- Remove and replicate water table with sheet metal or FRP molding. Replace supports with treated wood or galvanized steel support.
- Remove and reset coping tiles.

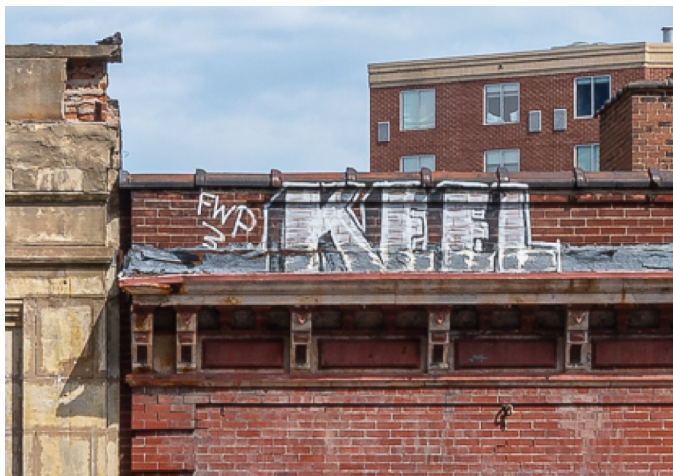
*P-9 Metal panel water table in poor condition*

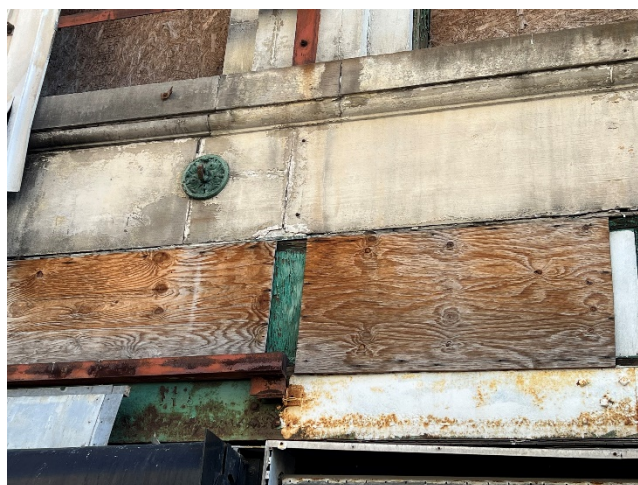
Several decorative cast-iron florets are attached to the limestone and marble panels. The florets are in good condition but require cleaning and painting.

P-10 Cast-iron floret attached to stone

- Remove cast-iron florets clean, paint and re-install.
- Cast iron posts support corroding steel lintels. The steel lintels need to be replaced or completely exposed for repairs. Recommend removing the cast-iron posts for restoration (clean and paint) and reinstall with new steel lintels.

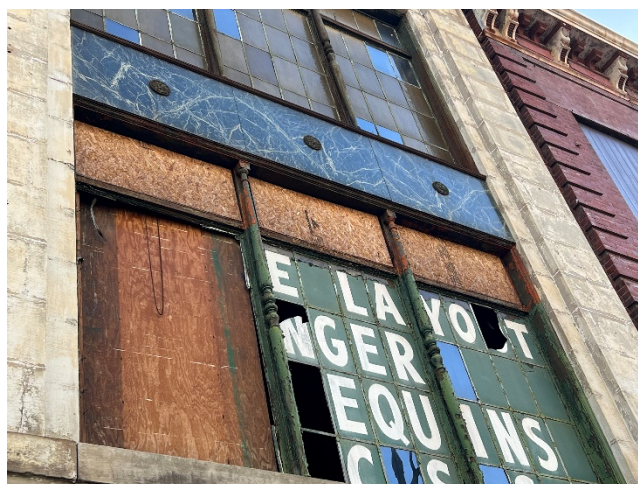
The cast-iron decorative posts appear in good condition but require cleaning and painting. These posts provide support for the steel lintels supporting spandrel panels with marble or limestone.

P-11 Cast-iron floret attached to marble. Cast-iron mullion posts

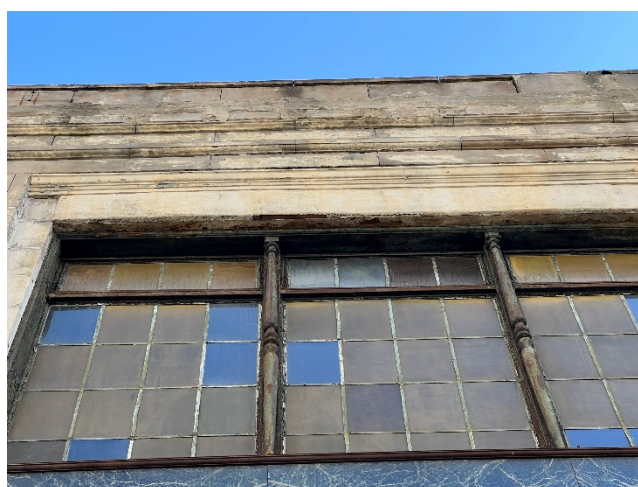
P-12 Cast-iron mullion posts between windows

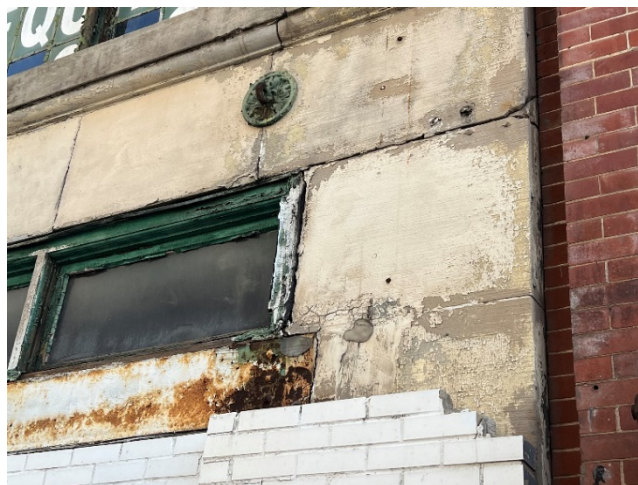
The steel lintels above the storefront and window openings are in poor condition and moderately to severely corroded. Steel corrosion and resulting rust pack jacking forces is cracking and displacing the limestone and marble façade above and at ends (P-13)

P-13 Damage to limestone and windows due to steel corrosion

- To repair the steel lintels beams will require the removal of large areas of limestone, all the marble panels and most of the backup walls and structure, to allow access for repair.
- Access to steel lintel will require removal of most of the historic façade elements.

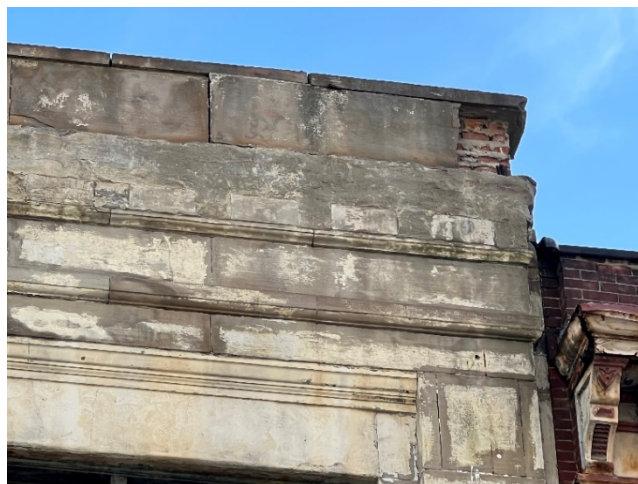
Most of the Broadway façade consists of limestone and marble. The limestone is in poor condition and has been painted over with many cracks and holes due to various modifications in the past (P-14 and P-15).

The original water table below the parapet has been removed and patched with mortar.

There are significant open mortar joints and displaced stone pieces. It appears that most of the steel ties providing lateral support to the backup wall have corroded over time and have failed structurally.

P-14 Loose limestone pieces above patched water table

- All lateral ties connecting veneer elements to the backup wall need to be replaced.
- To replace lateral ties all veneer elements, need to be removed, restored, and reset.
- Due to the overall condition of the backups structure and need to remove all veneer elements for steel repair and installation of new lateral ties it is recommended at the building façade is removed and re-constructed on new backup structure integrated into proposed new building.

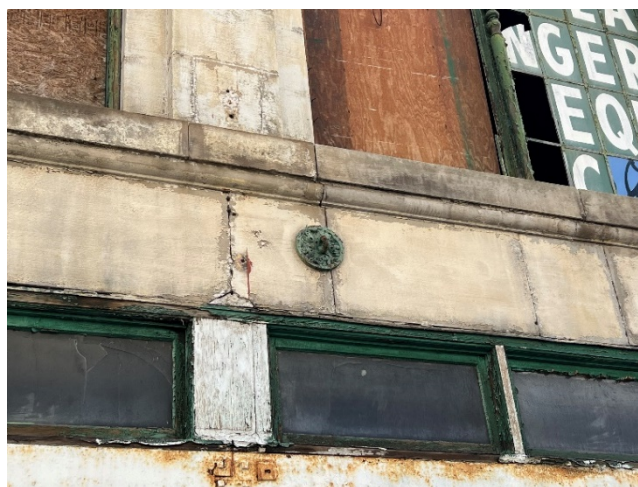
P-15 Cracked and damaged limestone due to steel corrosion and lack of lateral ties

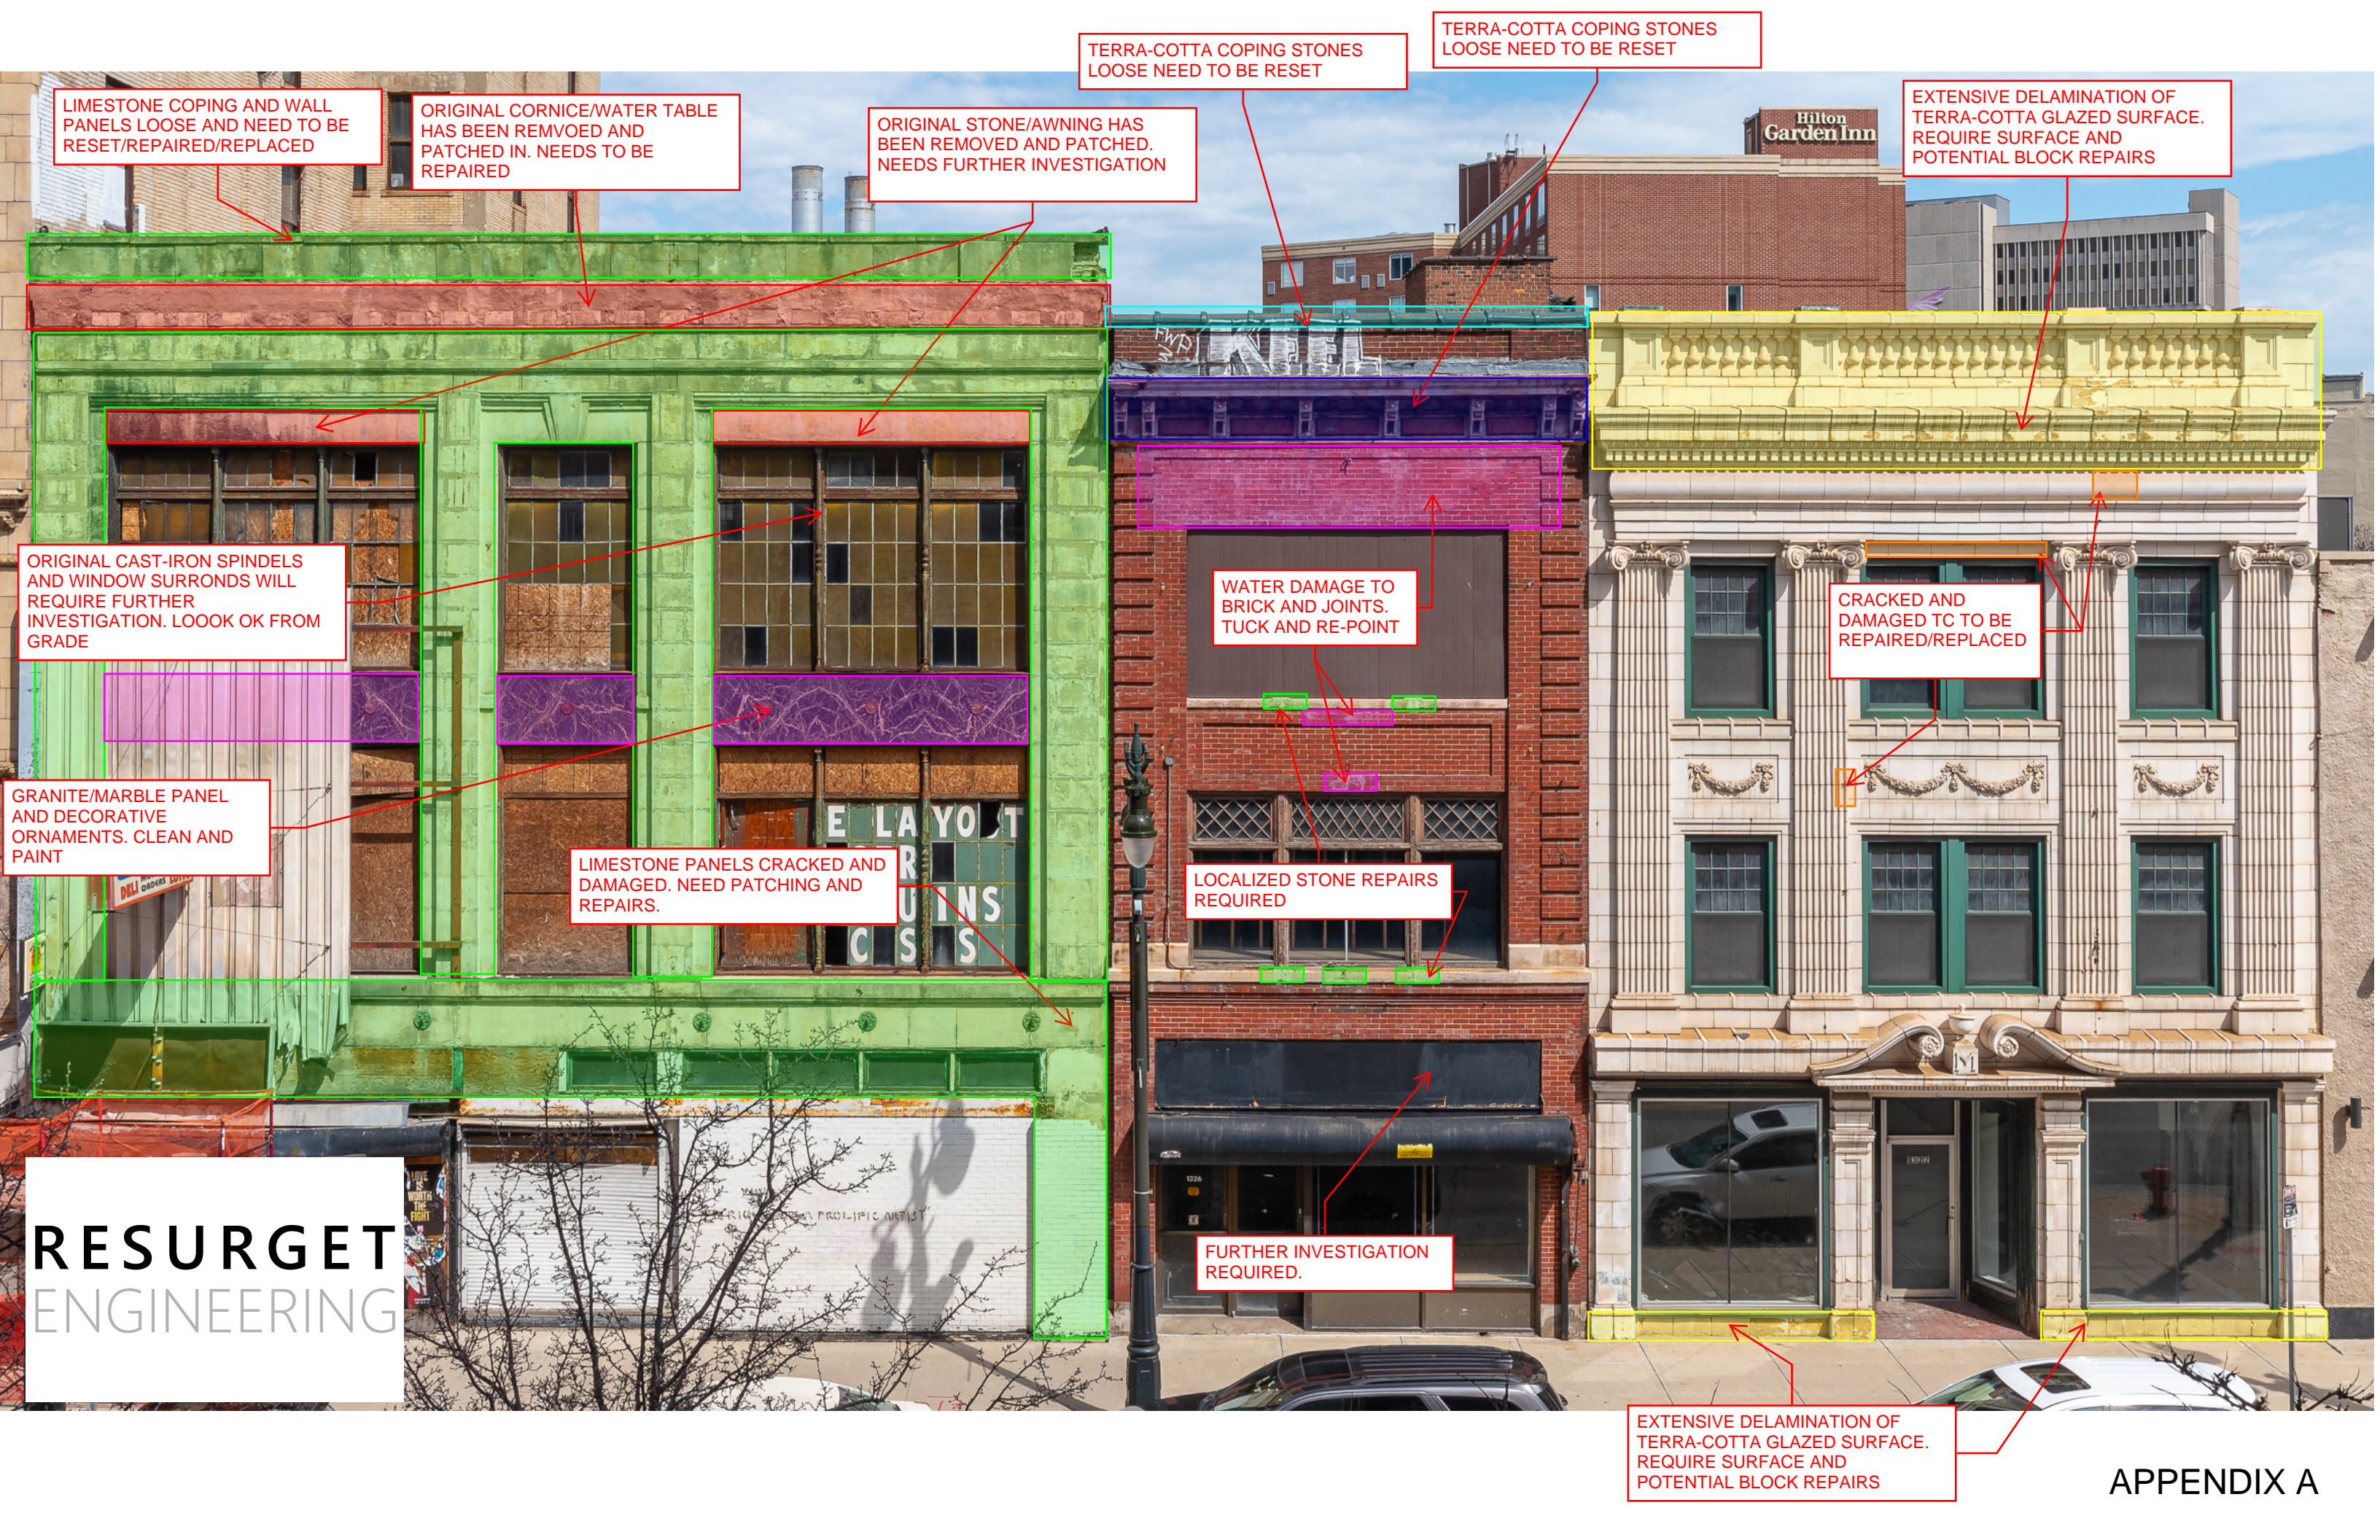
## Appendix A – Marked up Broadway Elevation

LIMESTONE COPING AND WALL PANELS LOOSE AND NEED TO BE RESET/REPAIRED/REPLACED

ORIGINAL CORNICE/WATER TABLE HAS BEEN REMOVED AND PATCHED IN. NEEDS TO BE REPAIRED

ORIGINAL STONE/AWNING HAS BEEN REMOVED AND PATCHED. NEEDS FURTHER INVESTIGATION

TERRA-COTTA COPING STONES LOOSE NEED TO BE RESET

EXTENSIVE DELAMINATION OF TERRA-COTTA GLAZED SURFACE. REQUIRE SURFACE AND POTENTIAL BLOCK REPAIRS

ORIGINAL CAST-IRON SPINDELS AND WINDOW SURROUNDS WILL REQUIRE FURTHER INVESTIGATION. LOOK OK FROM GRADE

GRANITE/MARBLE PANEL AND DECORATIVE ORNAMENTS. CLEAN AND PAINT

LIMESTONE PANELS CRACKED AND DAMAGED. NEED PATCHING AND REPAIRS.

WATER DAMAGE TO BRICK AND JOINTS. TUCK AND RE-POINT

LOCALIZED STONE REPAIRS REQUIRED

CRACKED AND DAMAGED TC TO BE REPAIRED/REPLACED

FURTHER INVESTIGATION REQUIRED.
