BRICK CONDITION OVERVIEW

A. Poor patching of failing bricks at East front entry

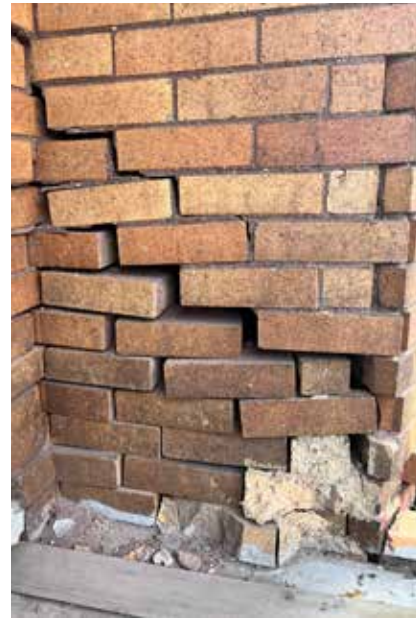
B. Loose and failing bricks at East entry/bay

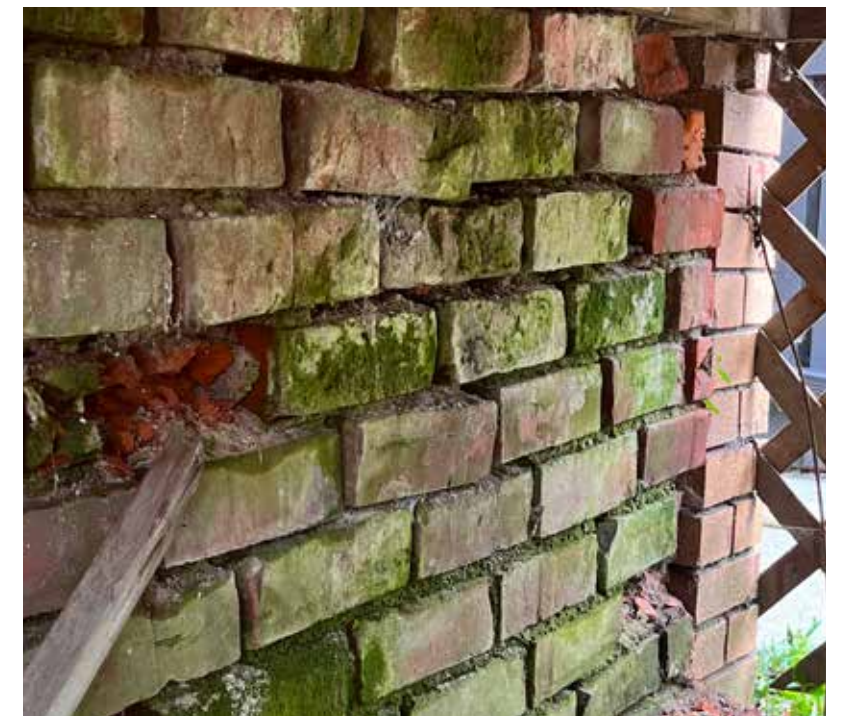
D. Common brick below West front entry porch is bowed with loose bricks and failing mortar

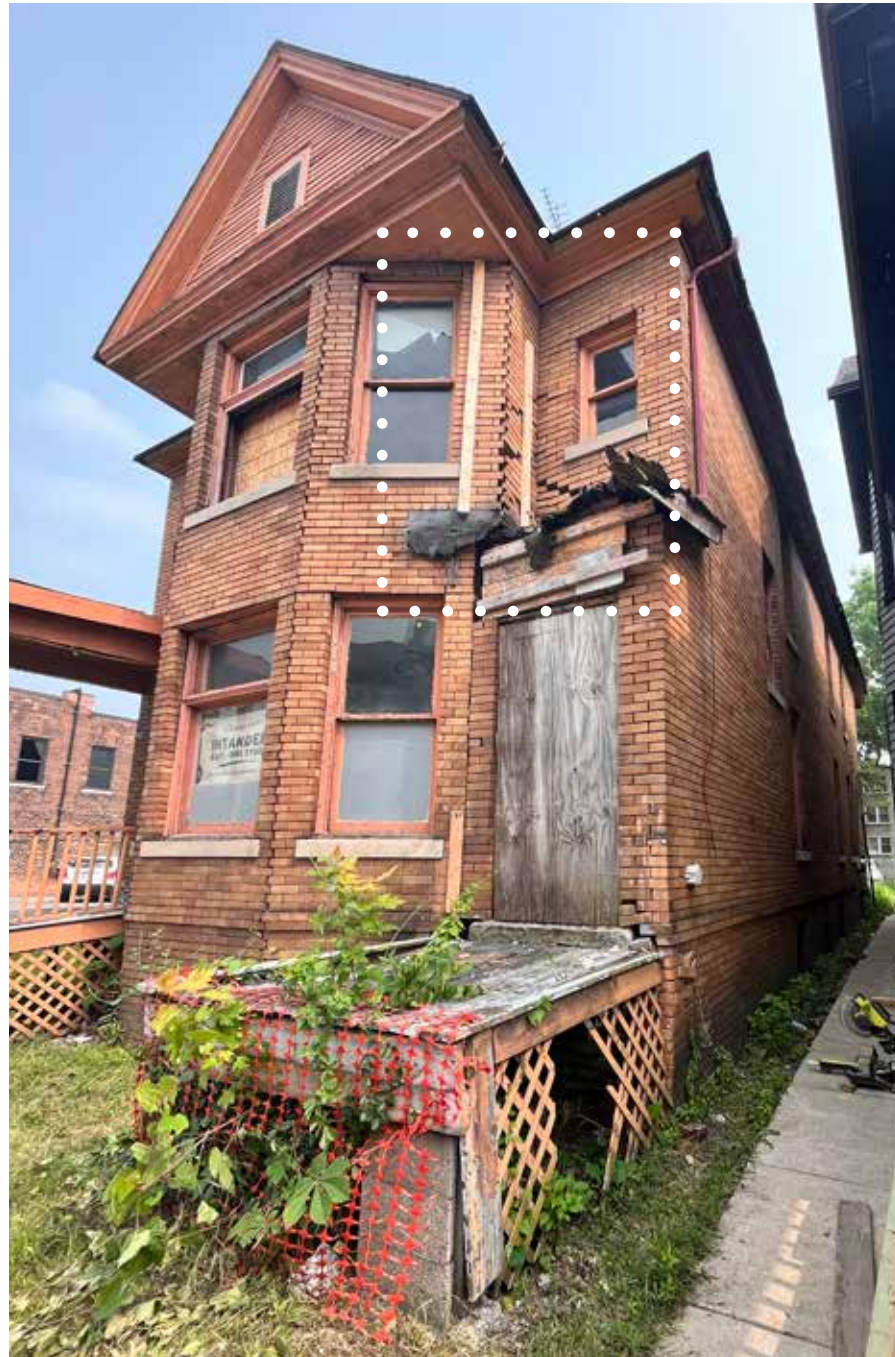
PHOTOS TO THE RIGHT DETAIL THE SECOND LEVEL BRICK CONDITION AT THE WEST SIDE OF FRONT FACADE WHERE THE POINT OF FAILURE BEGAN

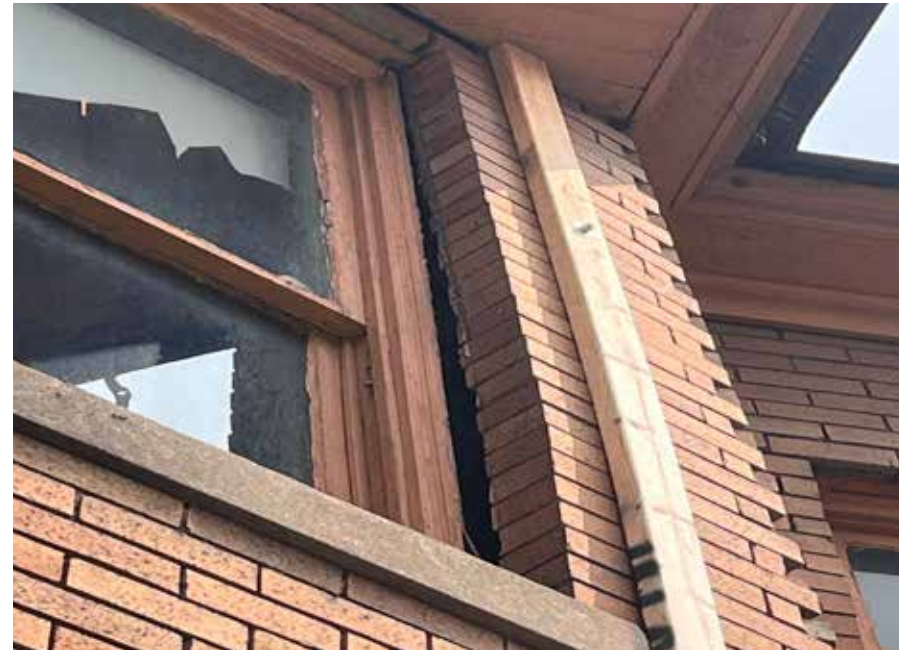
DETACHED BRICK VENEER AT WEST SIDE OF FRONT BAY

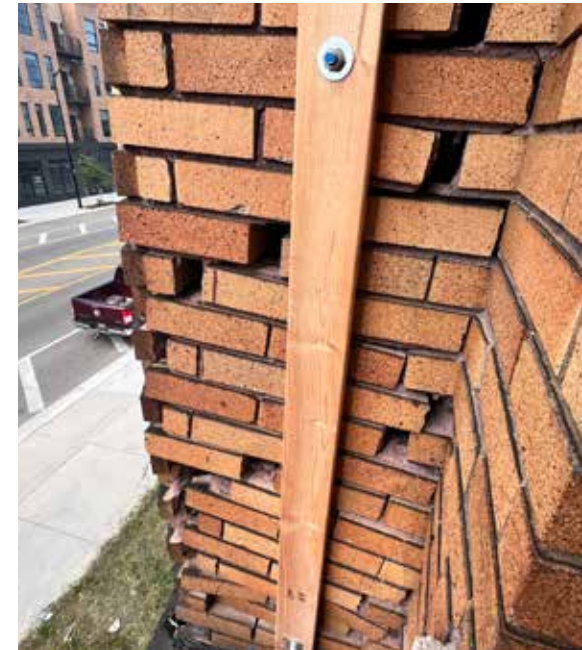
BRACING AT FAILED VENEER

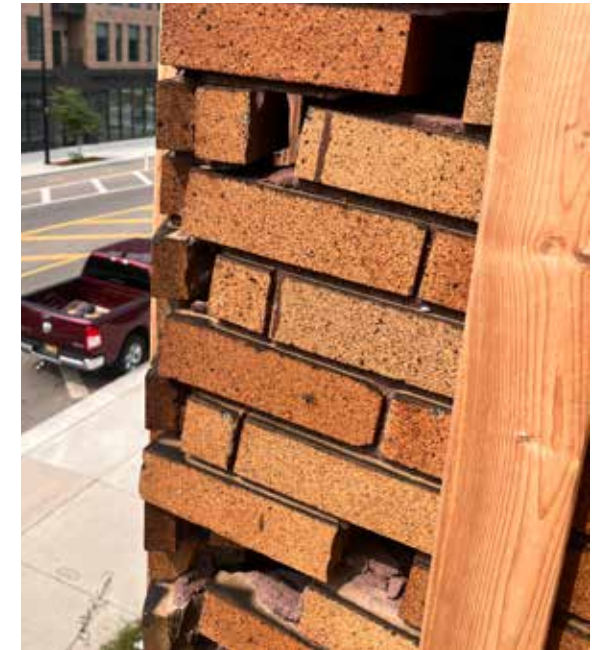
COMPLETE VENEER FAILURE

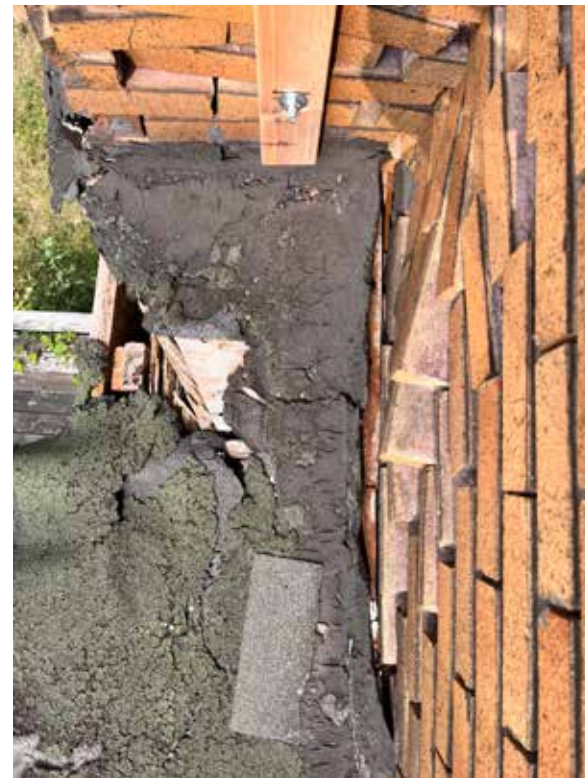
REMAINS OF WEST FRONT PORCH ROOF OPEN TO ELEMENTS

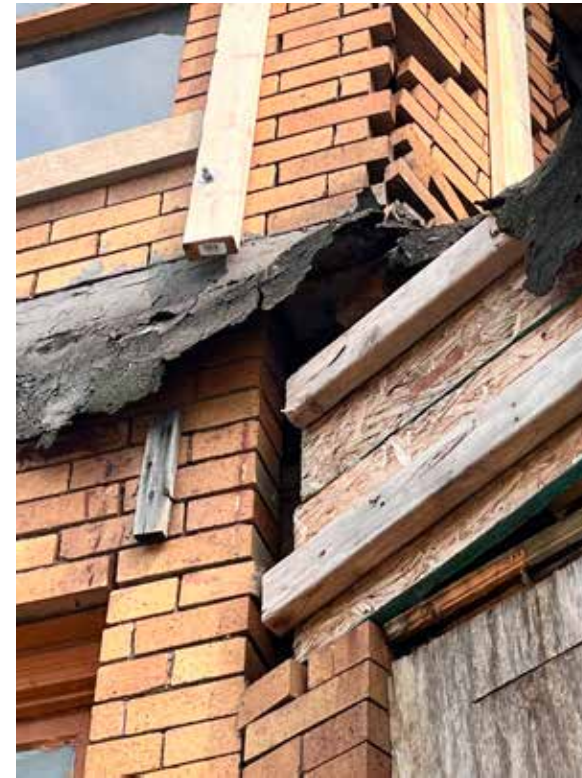
CONDITION ABOVE WEST FRONT PORCH ENTRY

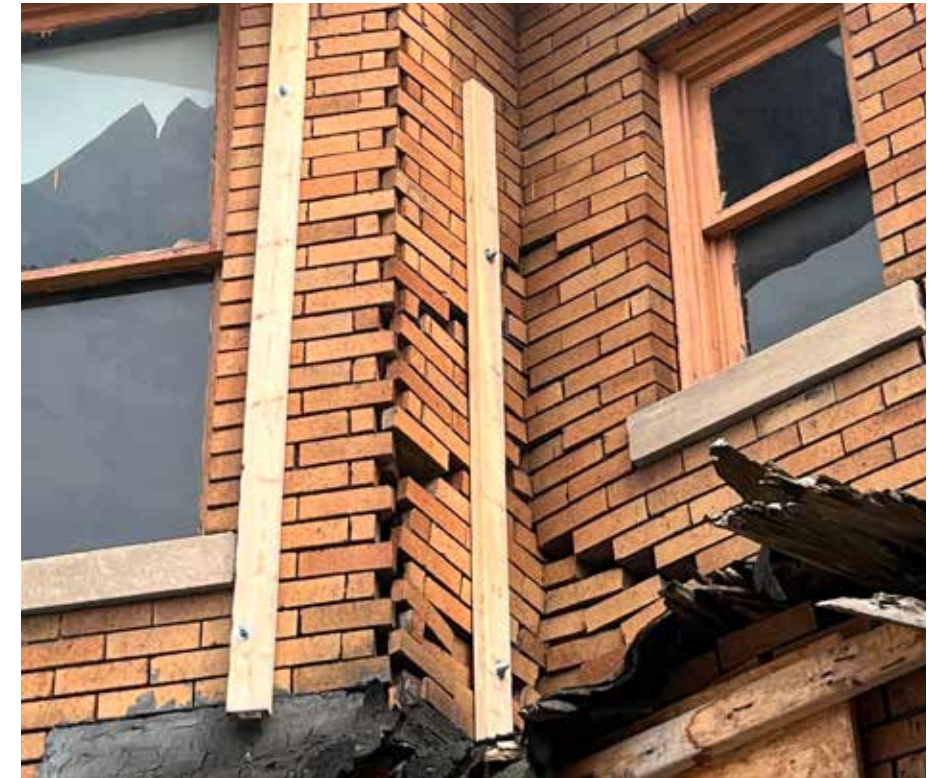
8022 KERCHEVAL RENOVATION

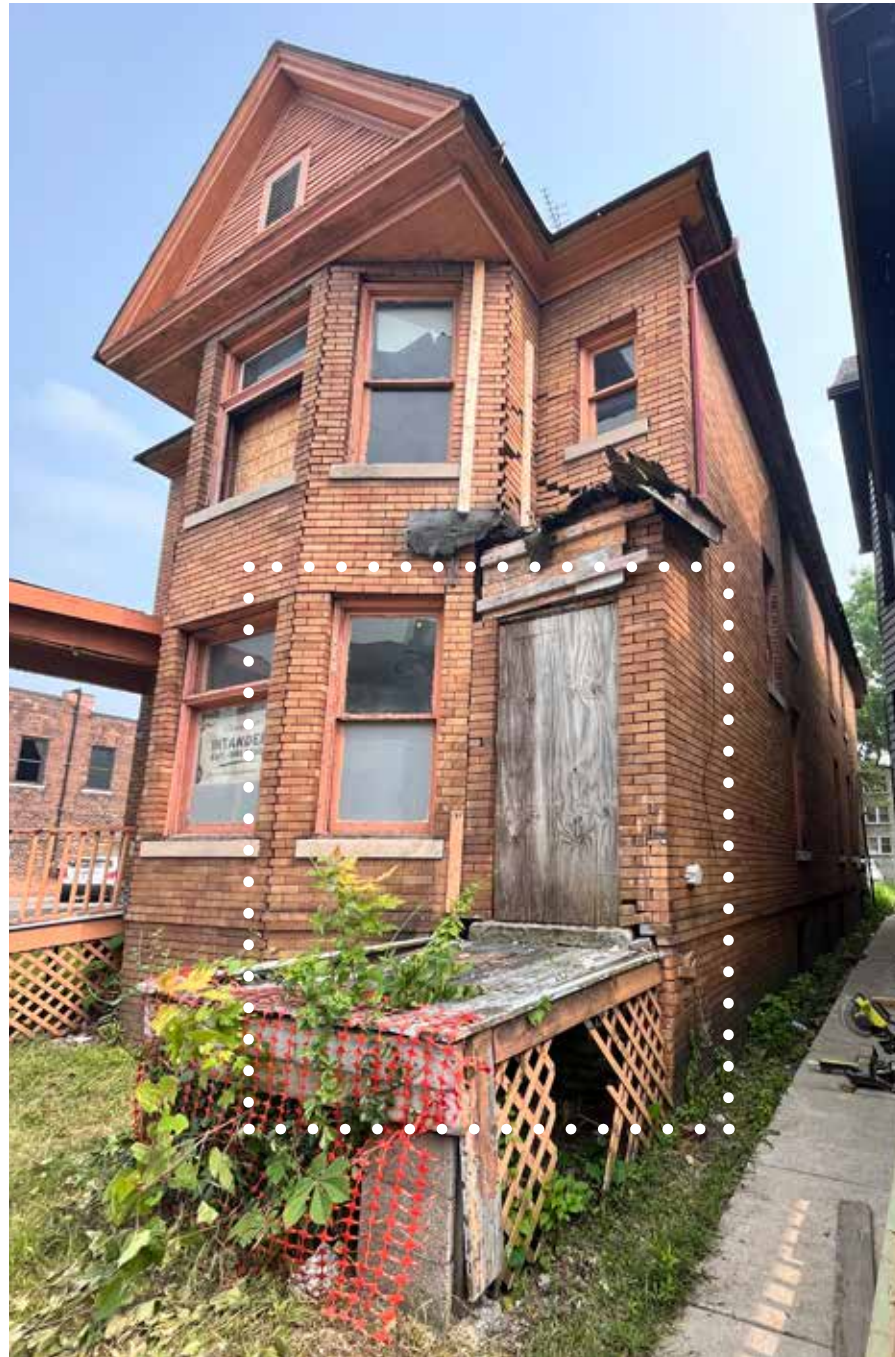
PHOTOS TO THE RIGHT DETAIL THE FIRST LEVEL BRICK CONDITION AT THE WEST SIDE OF THE FRONT FACADE.

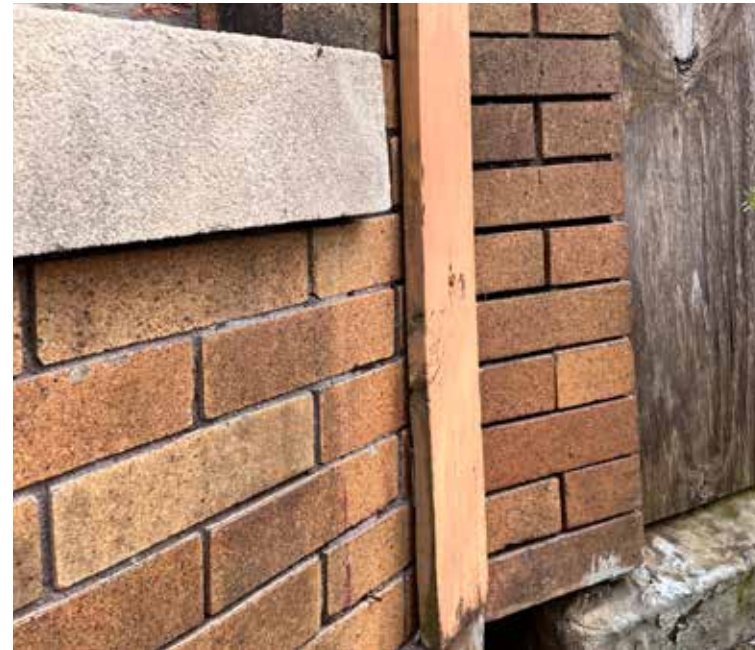
BRACING AT LOWER PORTION OF BAY

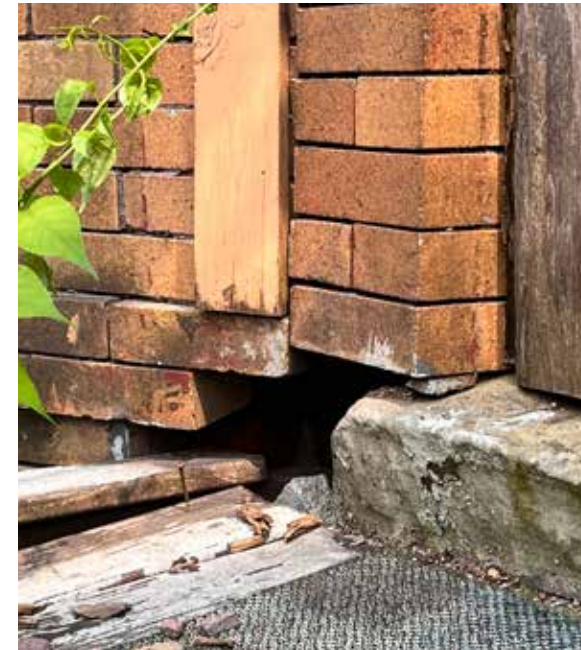
MISSING BRICKS TO LEFT OF WEST ENTRY DOOR

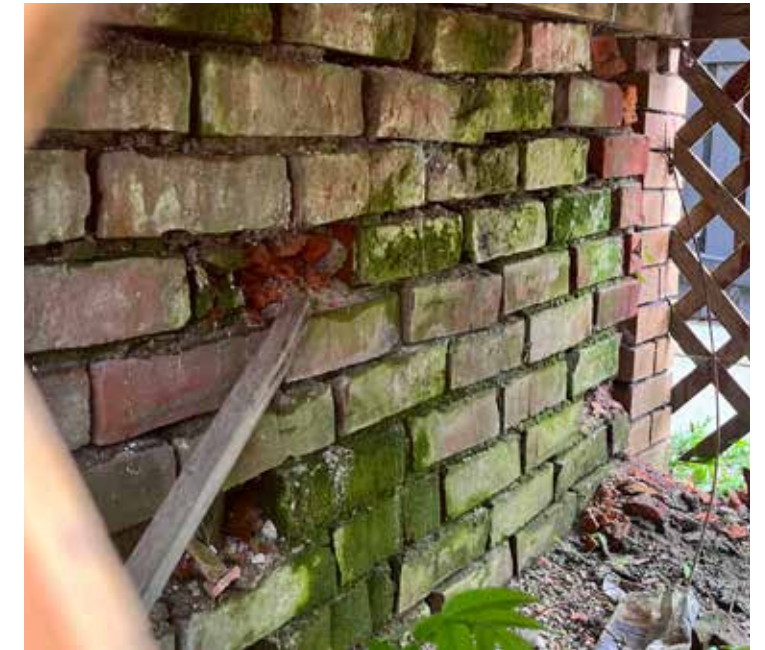
BRICK CONDITION UNDER WEST FRONT PORCH

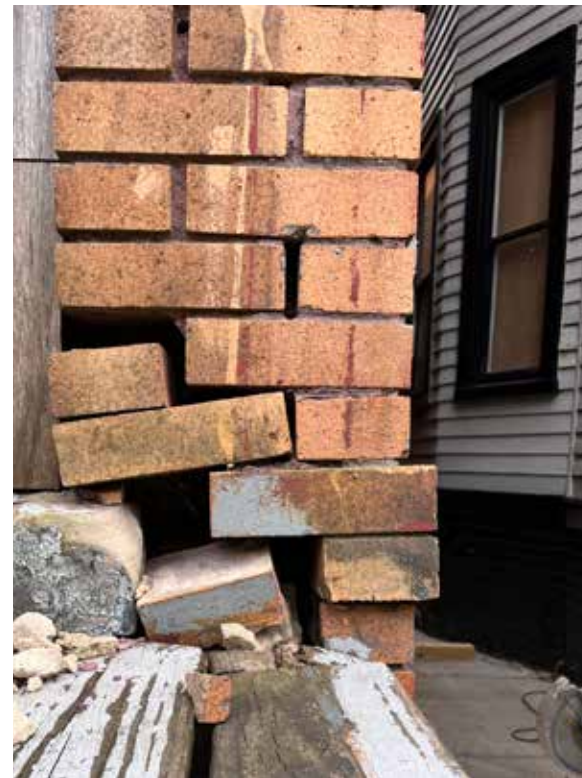
MISSING AND FAILED BRICK AT LOWER PORTION OF WEST ENTRY

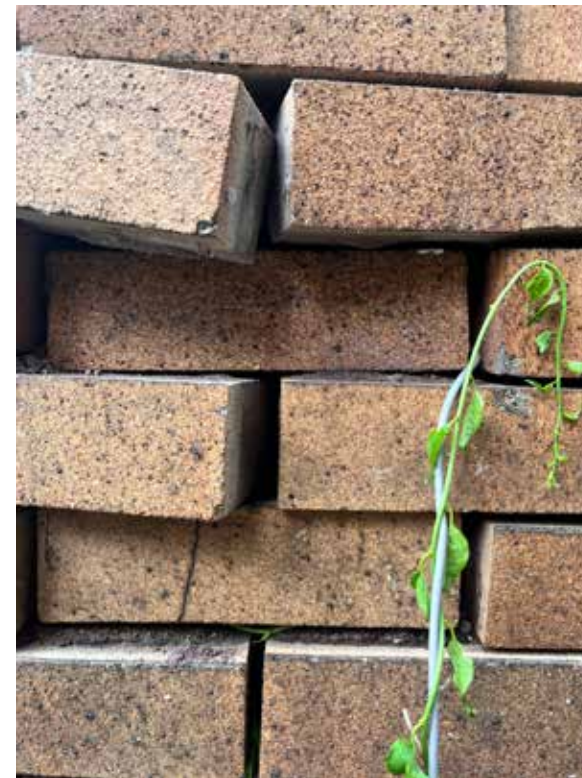
BRICK AT RIGHT FRONT SIDE DETAIL

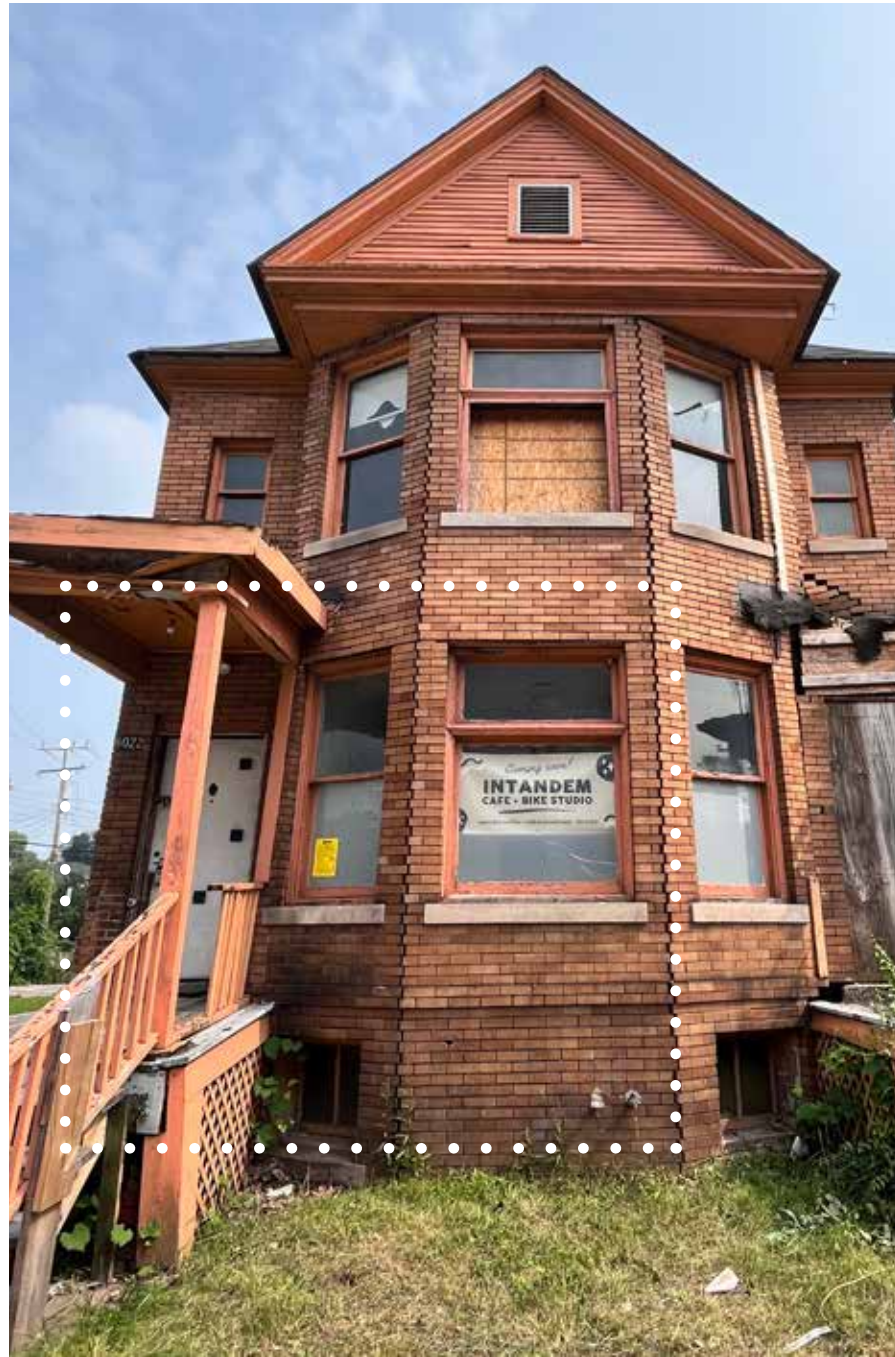
PHOTOS TO THE RIGHT ARE OF EAST SIDE OF THE FIRST LEVEL FRONT FACADE

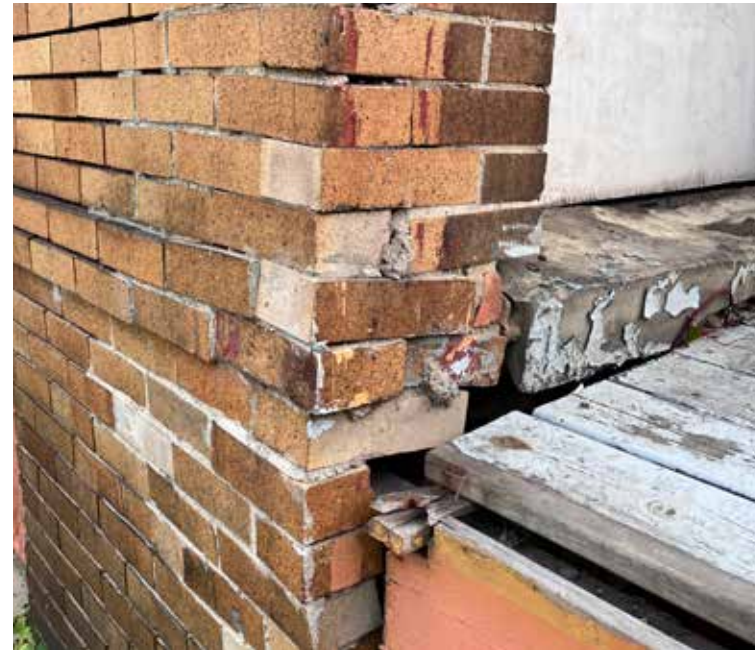
CONDITION AT LOWER PORTION OF WEST FRONT PORCH ENTRY - POOR REPAIR AND BULGING

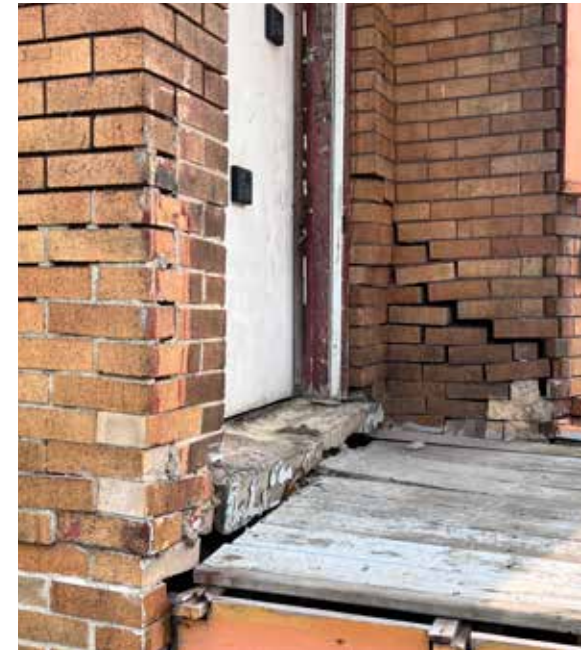
FAILING BRICK VENEER AT WEST FORNT PORCH ENTRY

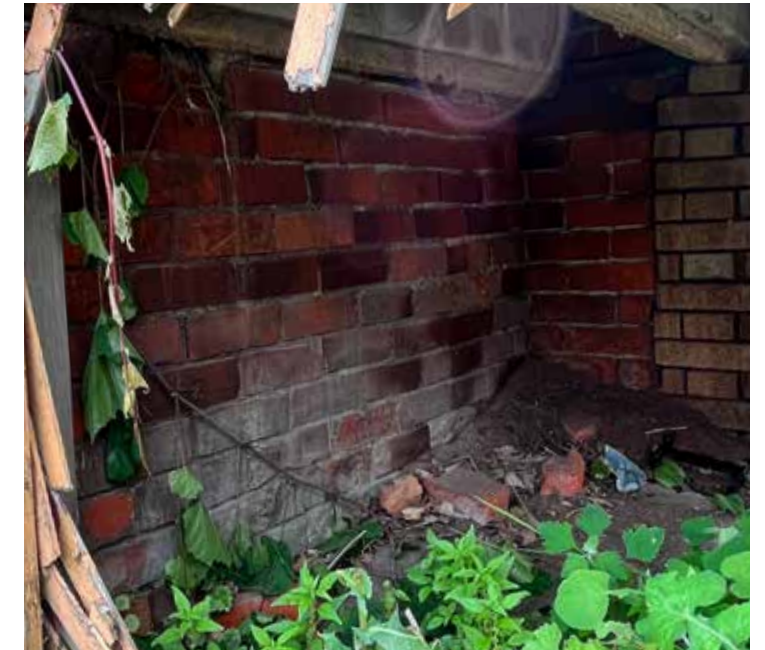
COMMON BRICK BENEATH WEST FRONT ENTRY

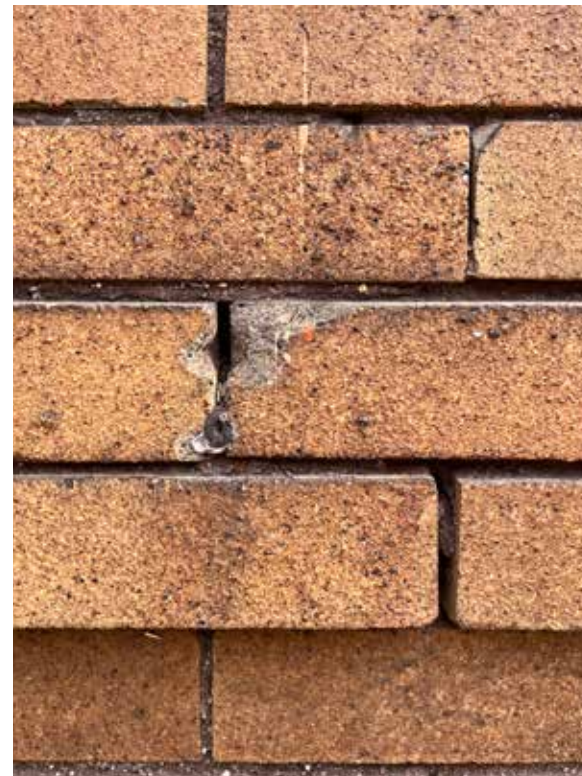
BRICK DETAIL AT MIDDLE OF FRONT BAY WITH MISSING MORTAR

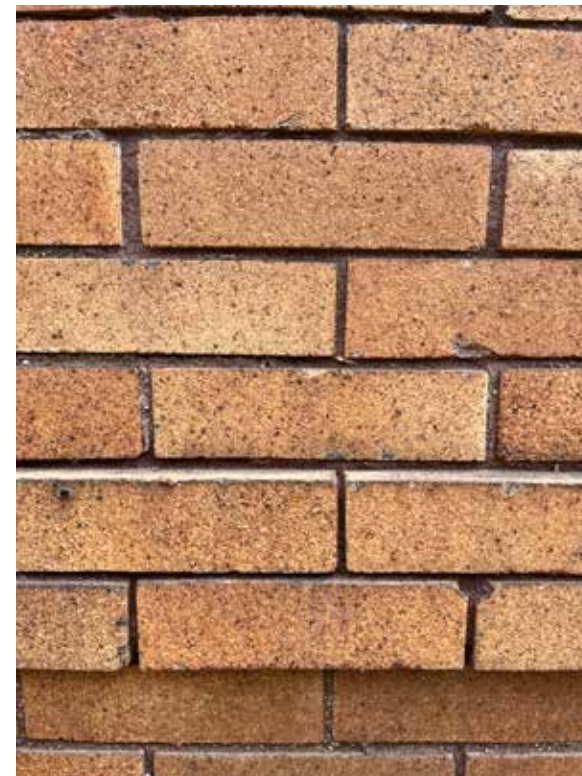
BRICK DETAIL AT MIDDLE FRONT BAY

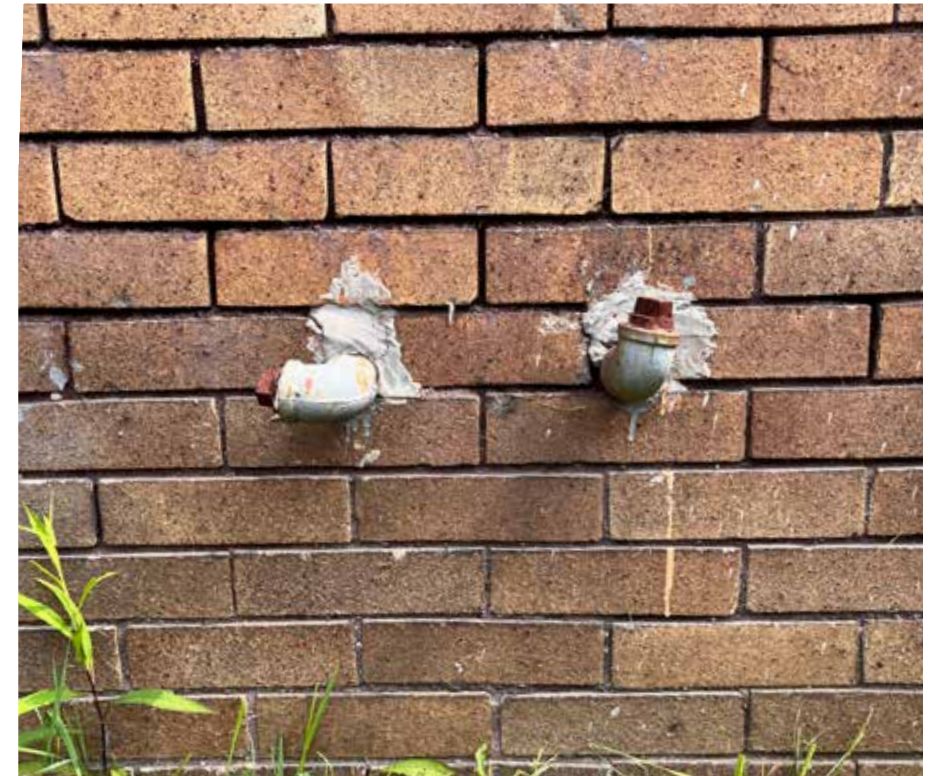
BRICK CONDITION AT MIDDLE FRONT BAY AT OLD GAS CONNECTION POINTS

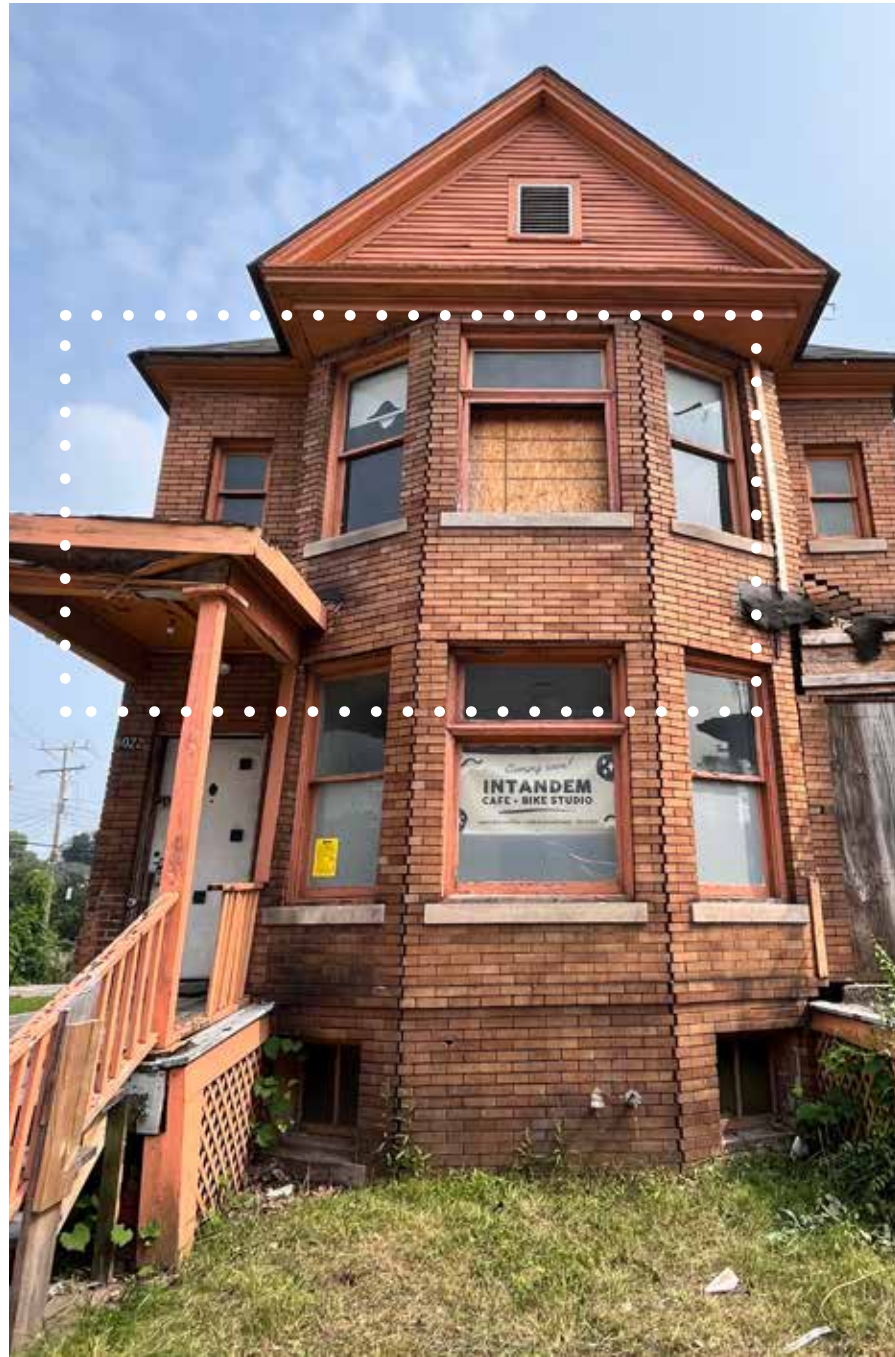
PHOTOS TO THE RIGHT DETAIL THE SECOND LEVEL AND UPPER PORTION OF THE FIRST LEVEL OF THE EAST AND MIDDLE PORTIONS OF THE FRONT FACADE

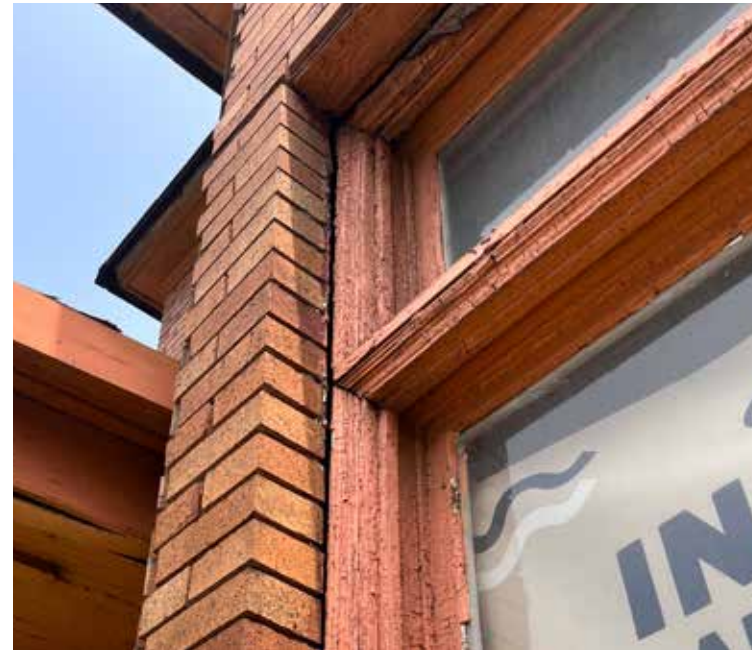
BRICK CONDITION AT SECOND LEVEL EAST SIDE OF FRONT BAY SHOWING BRICK DETACHED FROM STRUCTURE VIA GAP BETWEEN BRICKMOLD

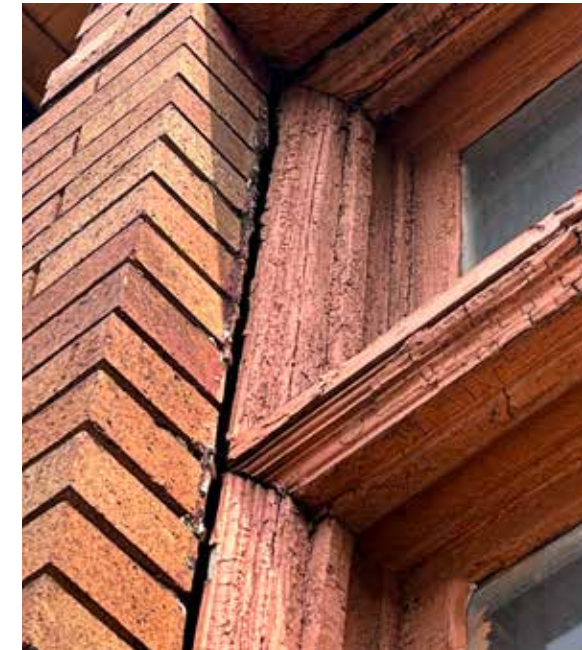
DETAIL OF DETACHED BRICK AT SECOND LEVEL EAST SIDE OF FRONT BAY

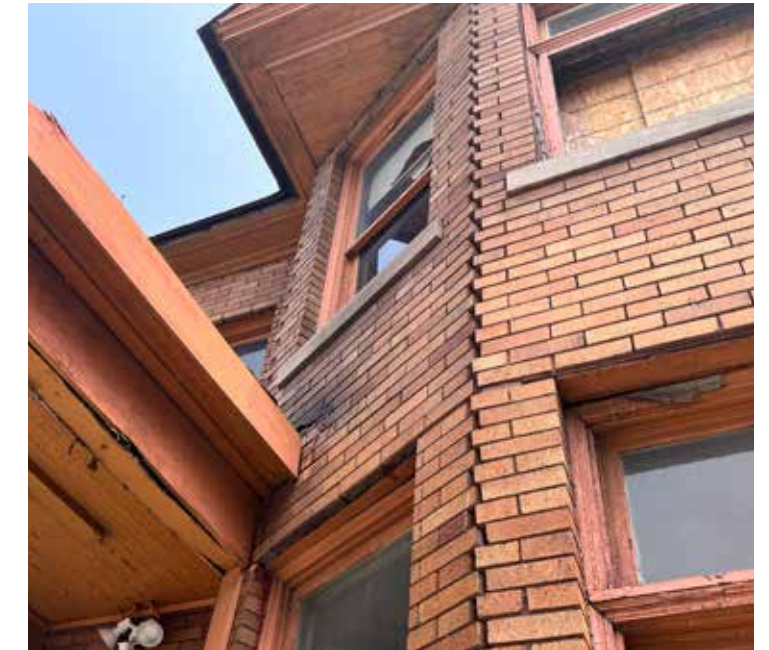
BRICK CONDITION AT UPPER LEFT BAY

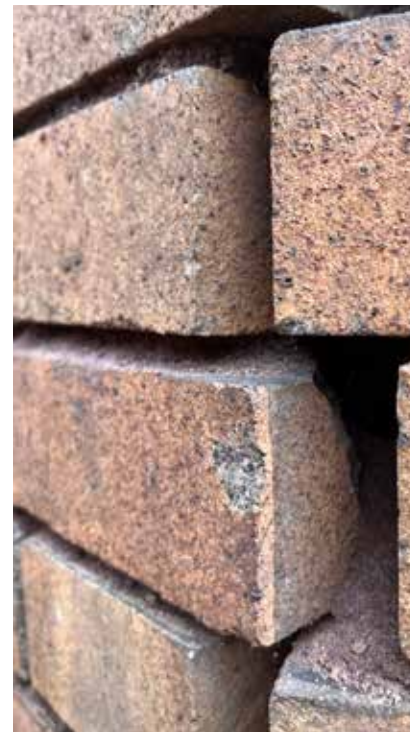
TYPICAL CONDITION AT BAY CORNERS

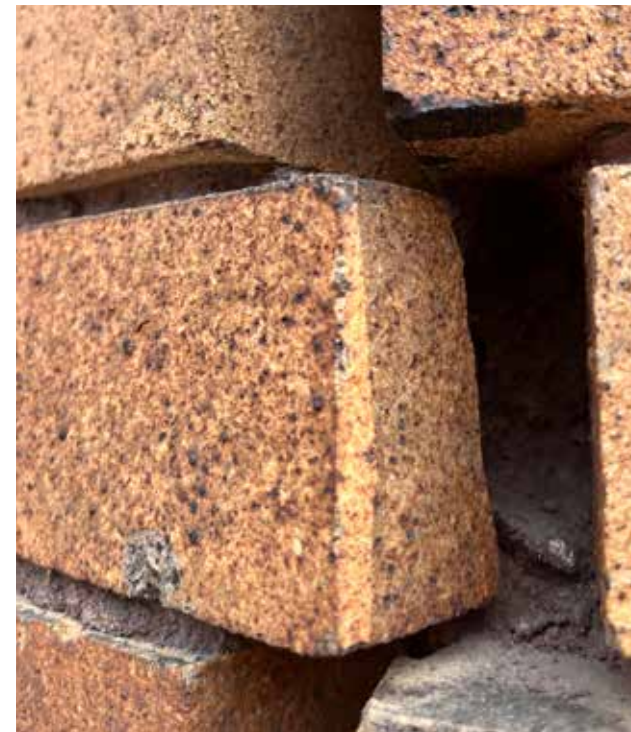
CLOSE UP OF BRICK AT CORNER BAY

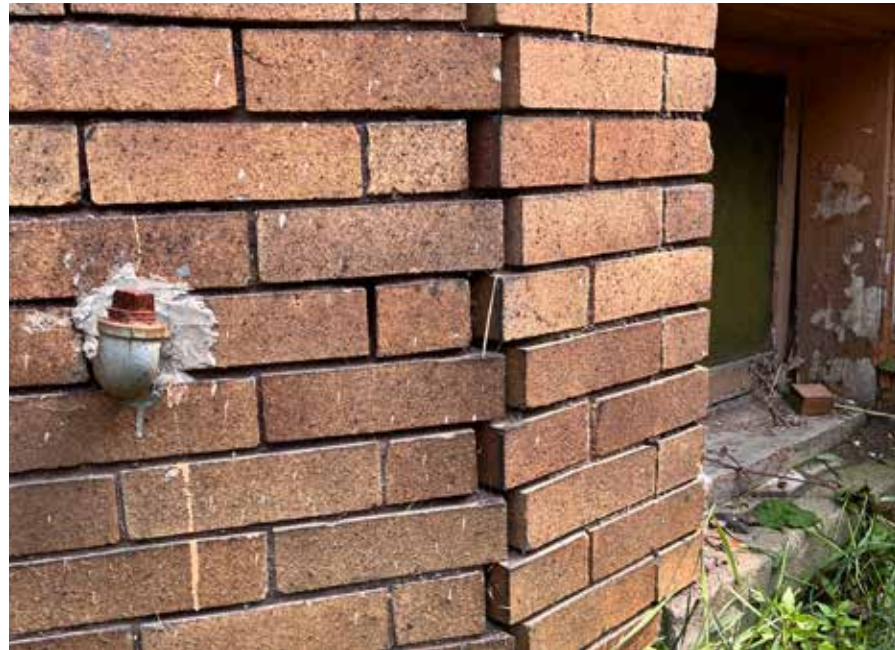
WEST FACE OF FRONT BAY AT GRADE

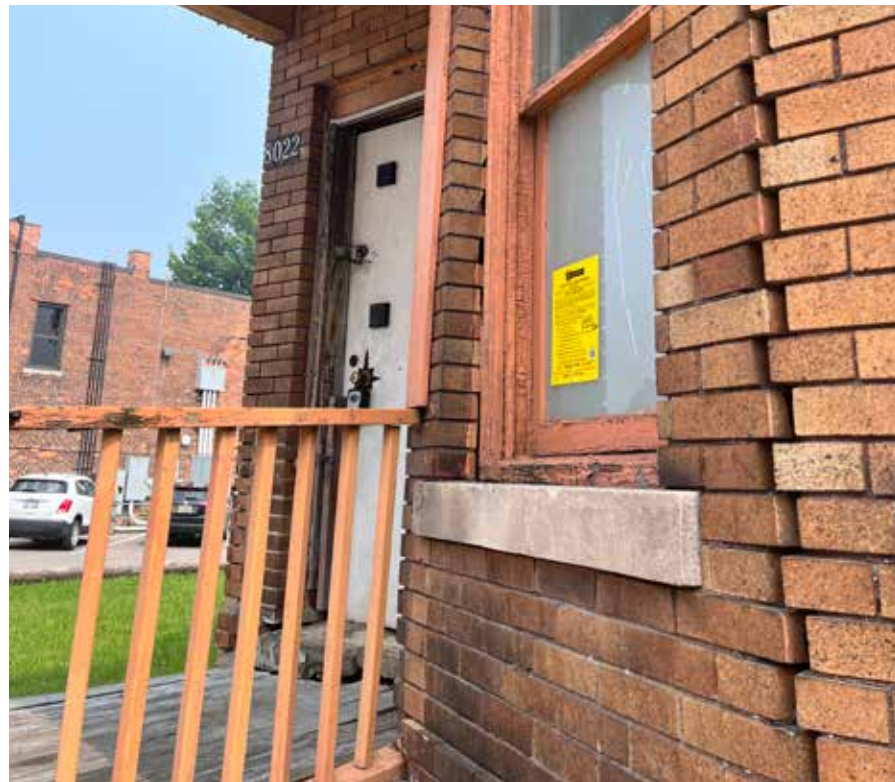
EAST SIDE OF FRONT BAY AT FIRST LEVEL CONDITION

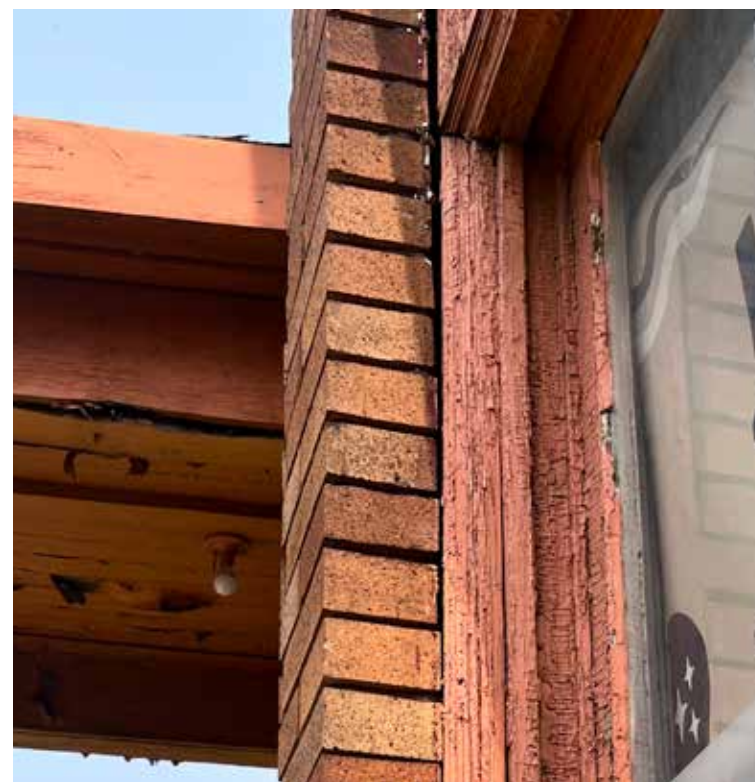
DETACHED VENEER AT EAST SIDE OF FRONT BAY AT FIRST LEVEL

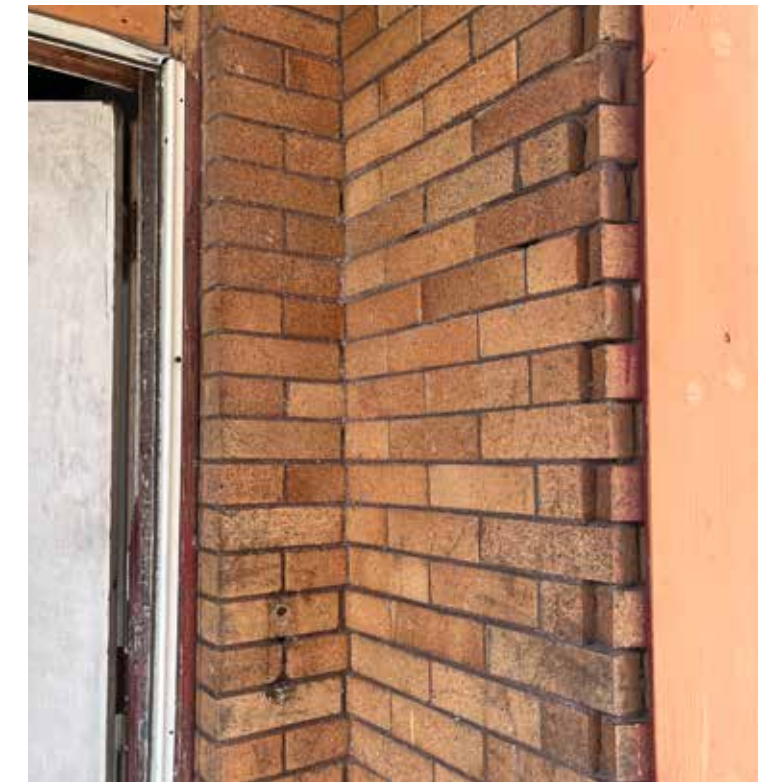
EAST FRONT PORCH ENTRY CONDITION

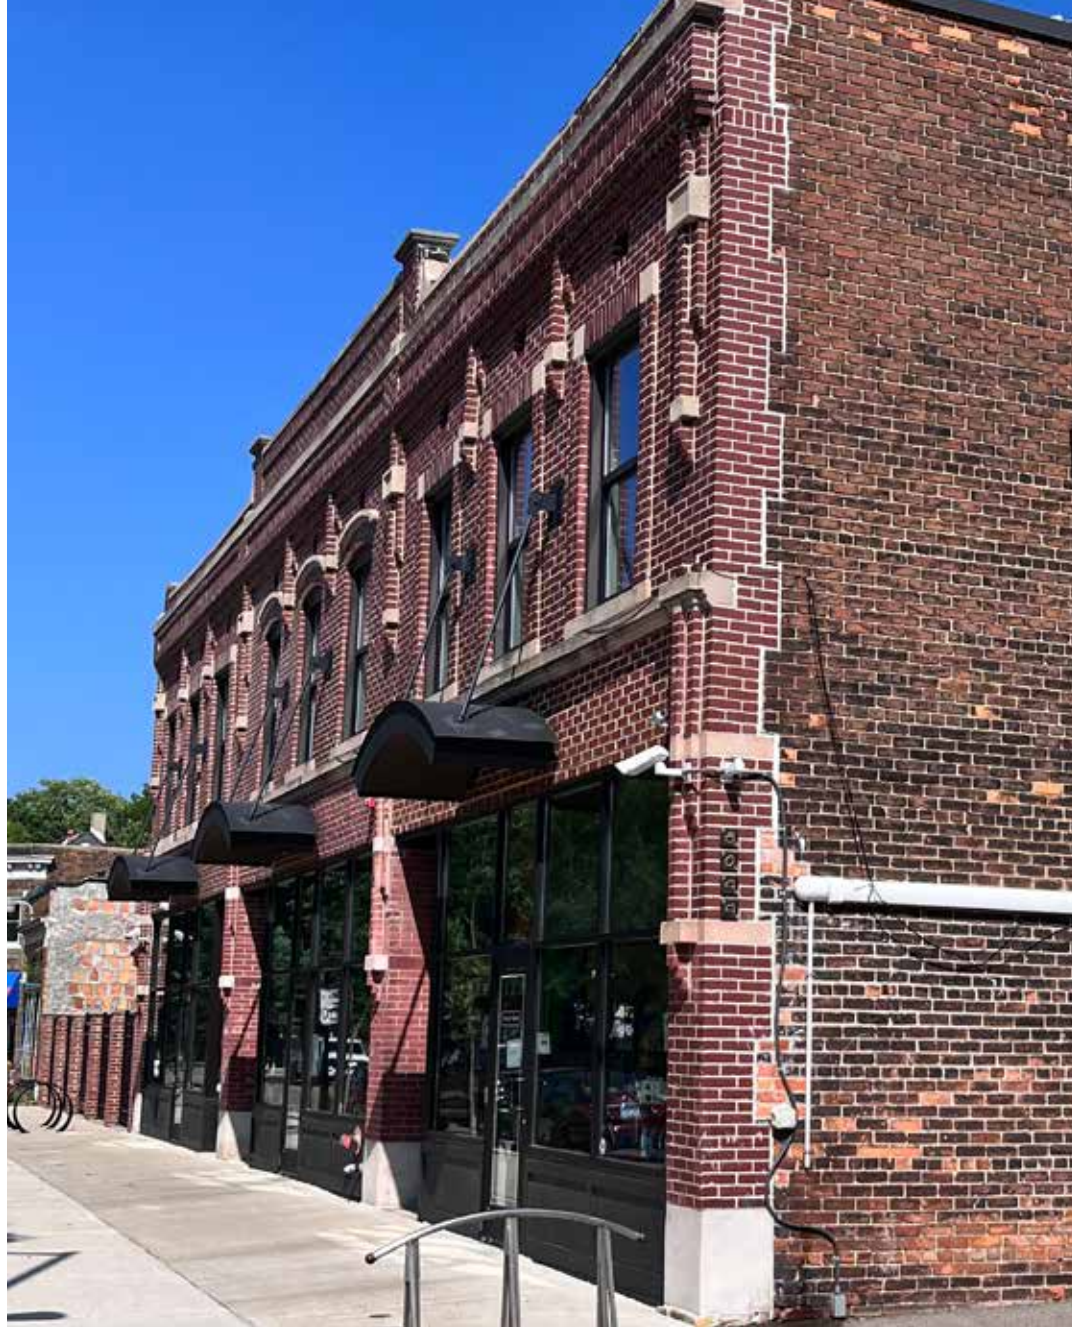
MIXED FACADE BRICK CONDITION AT MIXED-USE BUILDING DIRECTLY ACROSS ALLEY

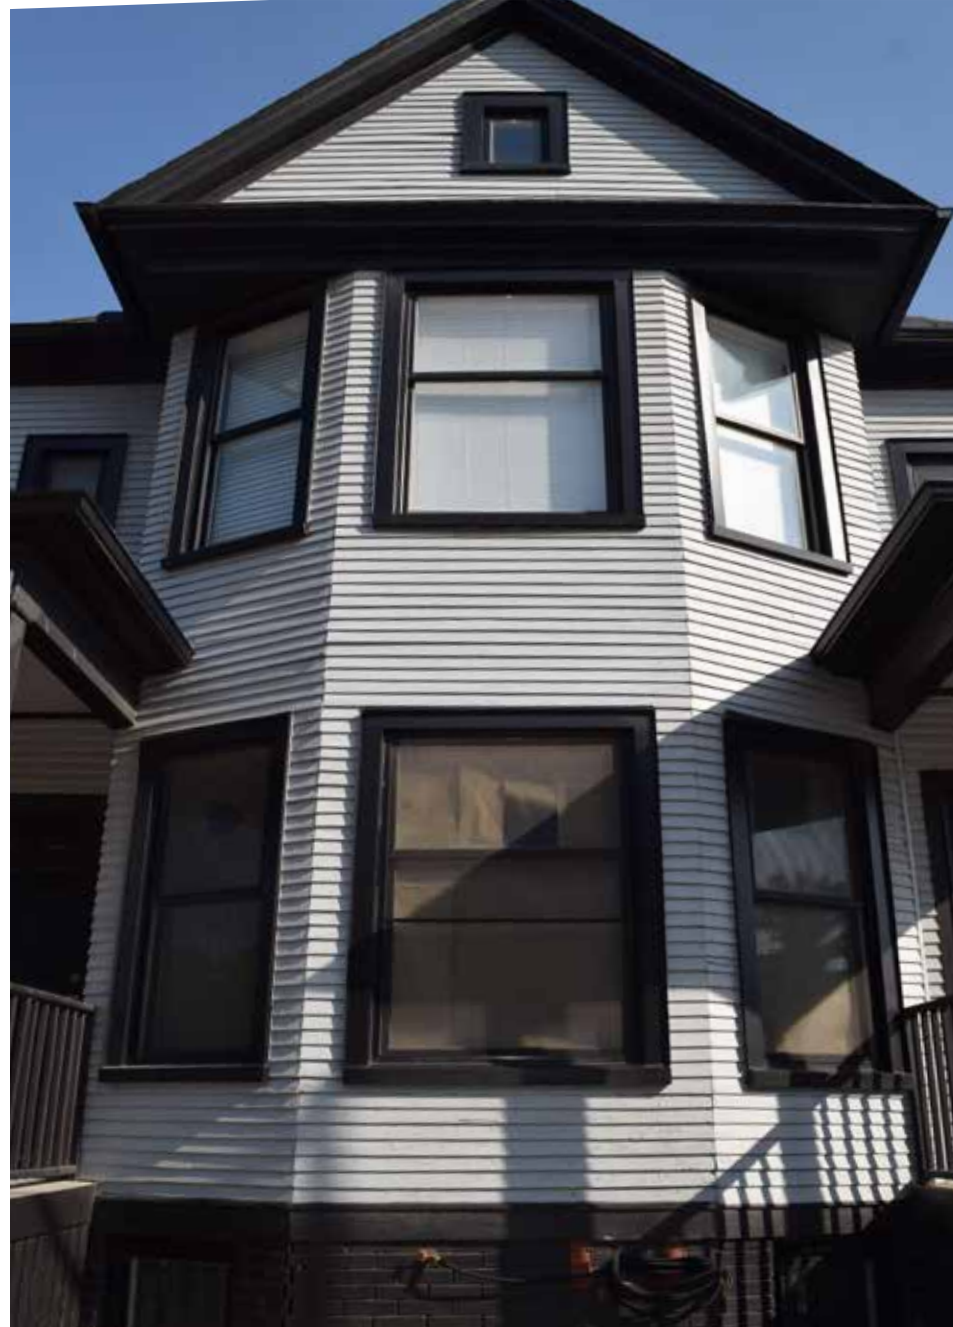
WINDOW CONDITION AT ADJACENT NEIGHBORING BUILDING WITH REPLACEMENT (NOT ORIGINAL) ALUMINUM-CLAD WINDOWS. BOTH BUILDINGS WERE BUILT IN 1907 AND ARE IDENTICAL IN DESIGN EXCEPT FOR THE CLADDING MATERIAL.

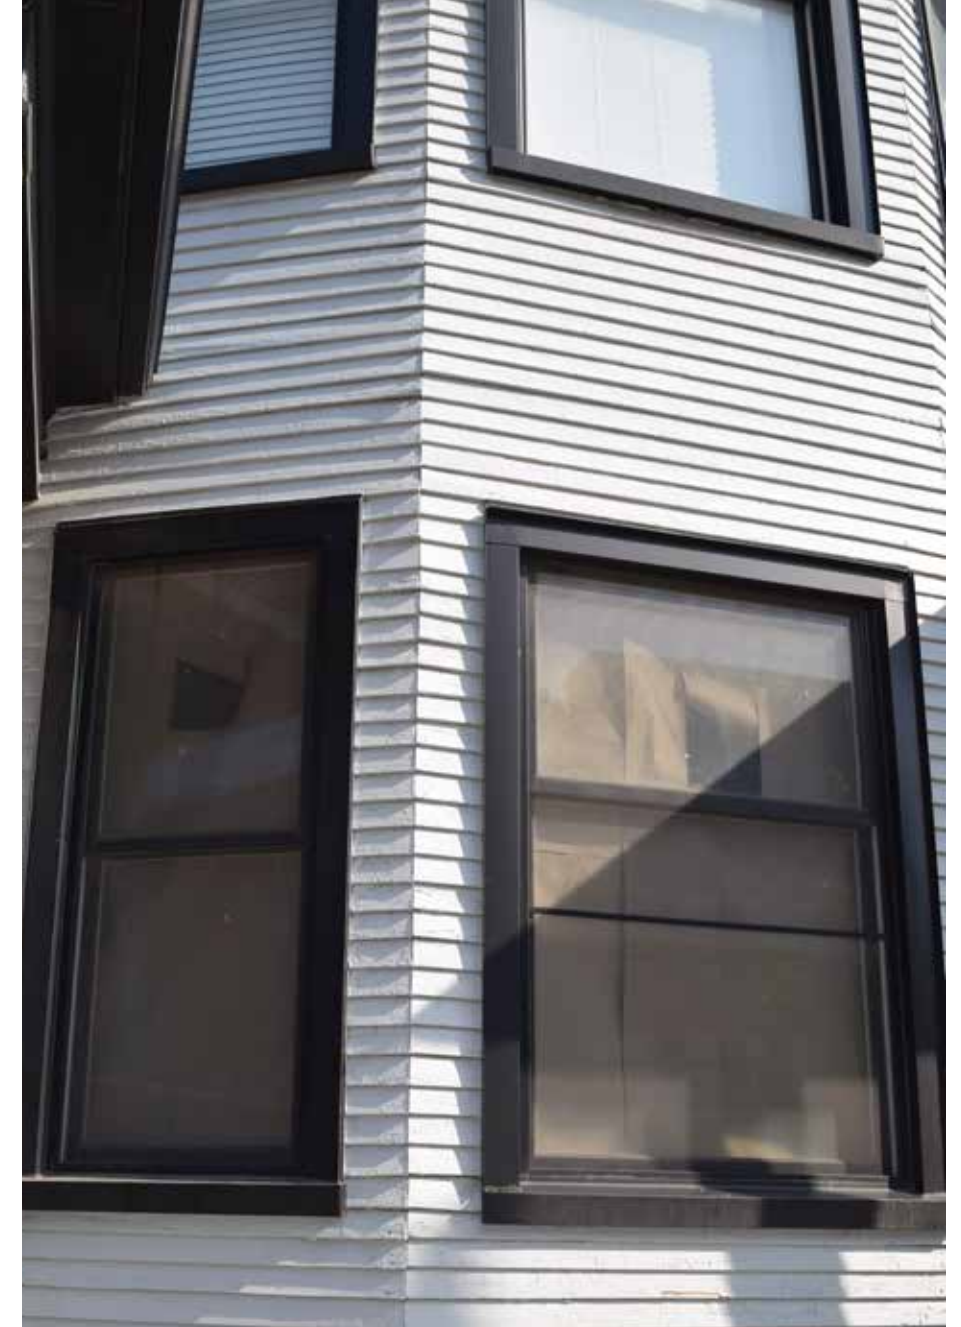
8022 KERCHEVAL RENOVATION
