BRICK CONDITION OVERVIEW

A. Poor patching of failing bricks at East front entry

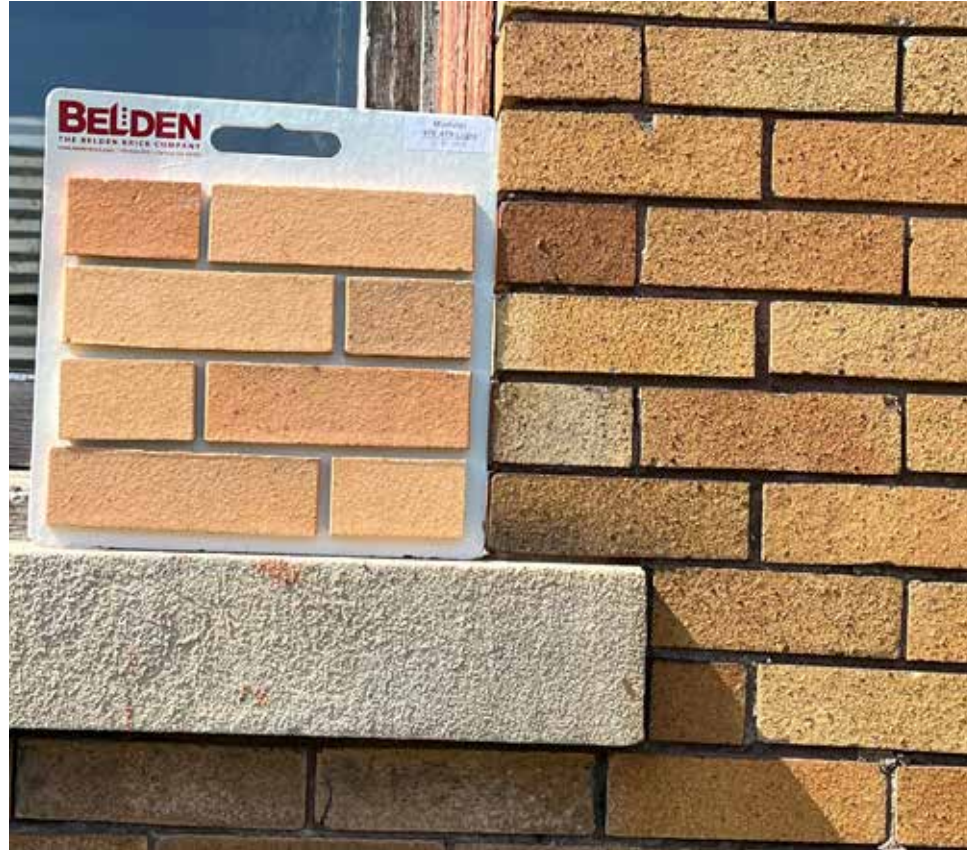
BRICK OPTION #1 **470-479 Light Range**
