6/20/2023 Revised from 5/13/2019

Job Name: 1332-1336 Broadway
Job Location: Detroit, MI

Historic Window Site Review:

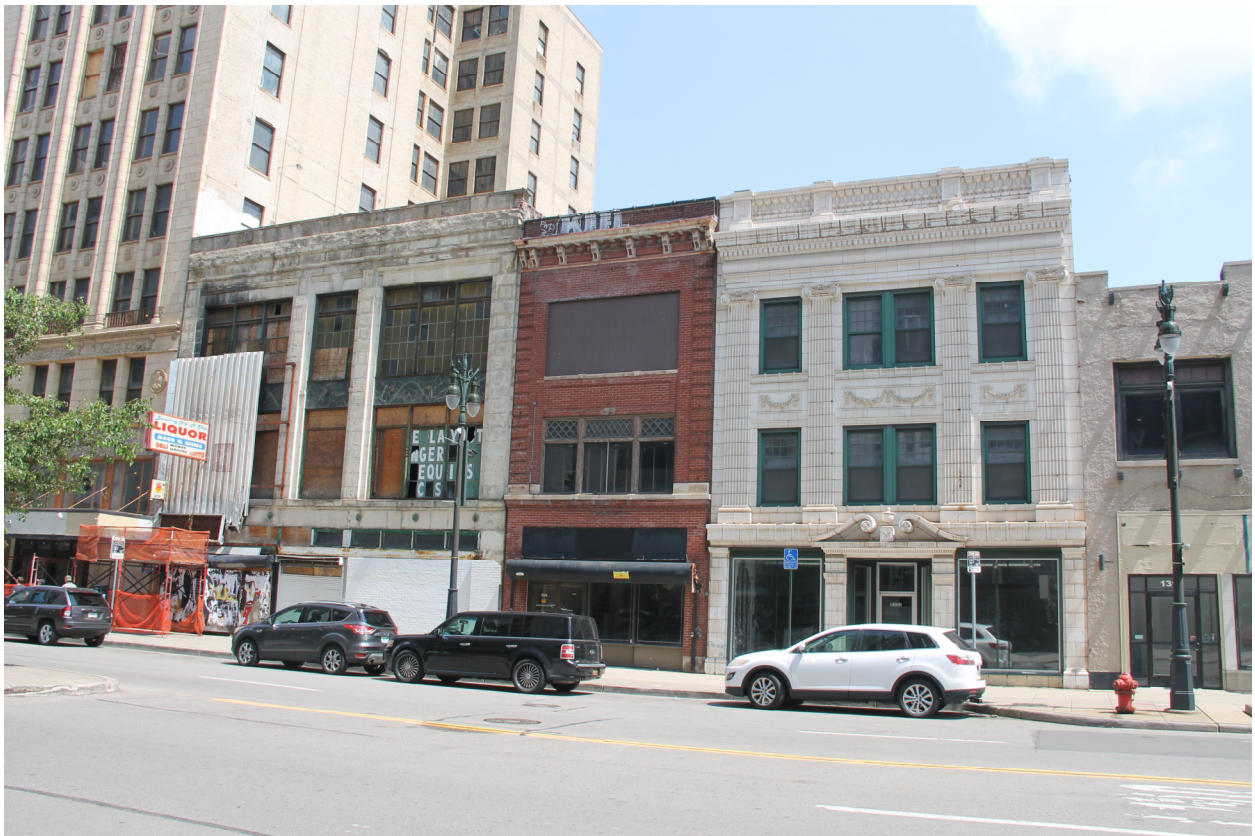
Front Façade 1332-1336 Broadway Left - Center - Right

The following is the Historic Window Site Review for three buildings adjoining at 1332-1336, 1326 and 1322 Broadway. All buildings appear to have been unoccupied for a long period of time, with the window openings partially boarded up and in “poor” condition. The information provided here is based on a site visit and direct discussion with yourself and the Owner Representative. The guidelines BlackBerry follows in evaluating the windows are those provided by the National Park Service for the rehabilitation of wood and steel windows. If the Owner is pursuing Federal Historic Tax Credits or work is required for a review by the Detroit Historic District Commission, make sure that the required products have been approved prior to proceeding with the proposed work. Please note any budget pricing provided is based on estimated costs, to provide accurate pricing BlackBerry requires detailed plans and specifications.

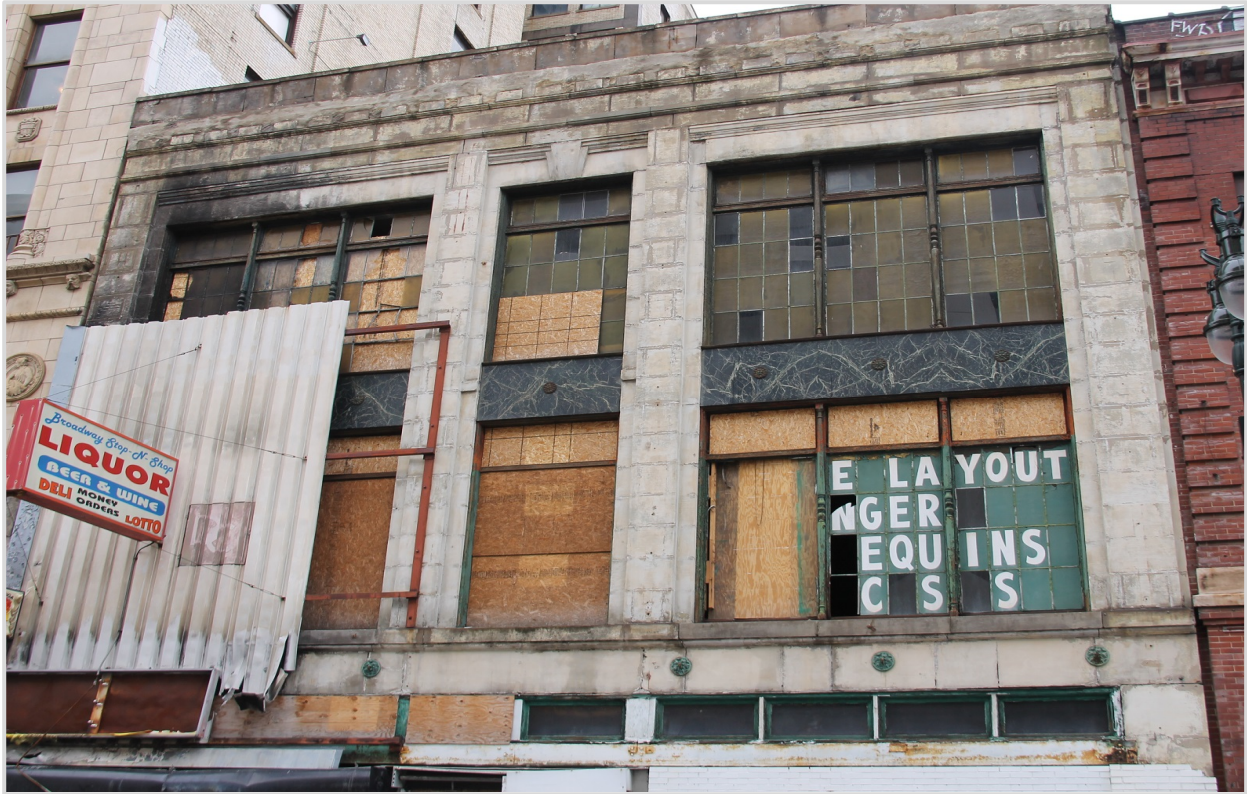
Windows on Front Façade of 1332 Broadway Left Building

1332-1336 Broadway: The front façade of this building group (first one on the left) has two different window types. 2nd and 3rd floors, (6) Openings with Hot Rolled Steel Windows; and Wood Transom Windows above the 1st Floor Storefront. Note a fire severely damaged portions of the front façade including the windows on all three floors

Steel Windows: The hot rolled steel windows on the 2nd and 3rd floors are in poor condition. The sash frames are corroded at the bottom rails, and the top rails and jambs are bent, and joinery is failing on about 50% of the openings. 30% of the frames have been removed and not in the building. The glazing method is unique using a lead

wrap around strips that holds the glass in place but is very weak structurally. I would question if this method would be acceptable per building code in regard to safety issues in case of impact from the interior. The exterior cast frame and ornamental posts and trim appear restorable, but they must be inspected from a lift on the exterior in order to determine if removal will be by individual components one by one; or if the whole assemble will be removed fully intact. Abatement of ACM in the perimeter caulking, as well as the lead glazing strips will be required by a certified abatement contractor.

The steel cast iron post components can be fully restored and reinstalled. It is our understanding that the steel windows will be removed, those that remain will not be replicated or restored but disposed of.

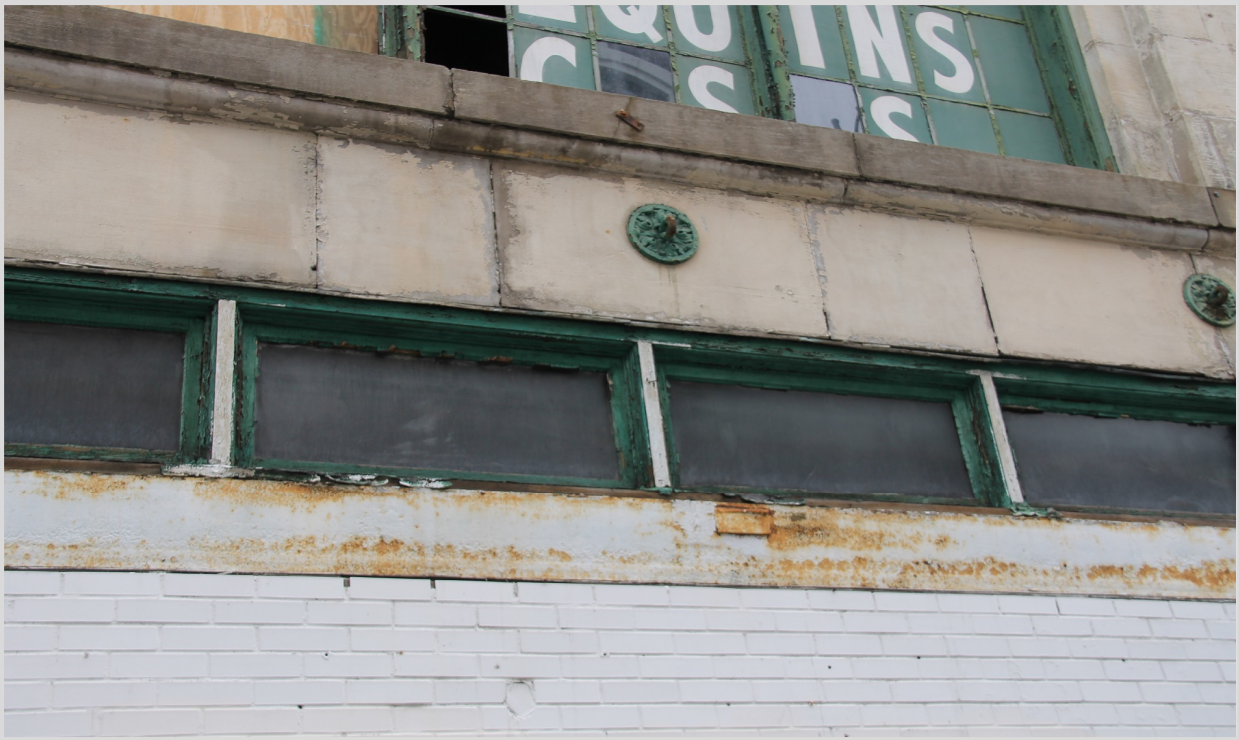
132 Broadway Wood Transoms Left Building

Wood Windows: The wood transoms were heavily damaged by fire and many are missing. The design can be replicated with a thermally broken aluminum system.

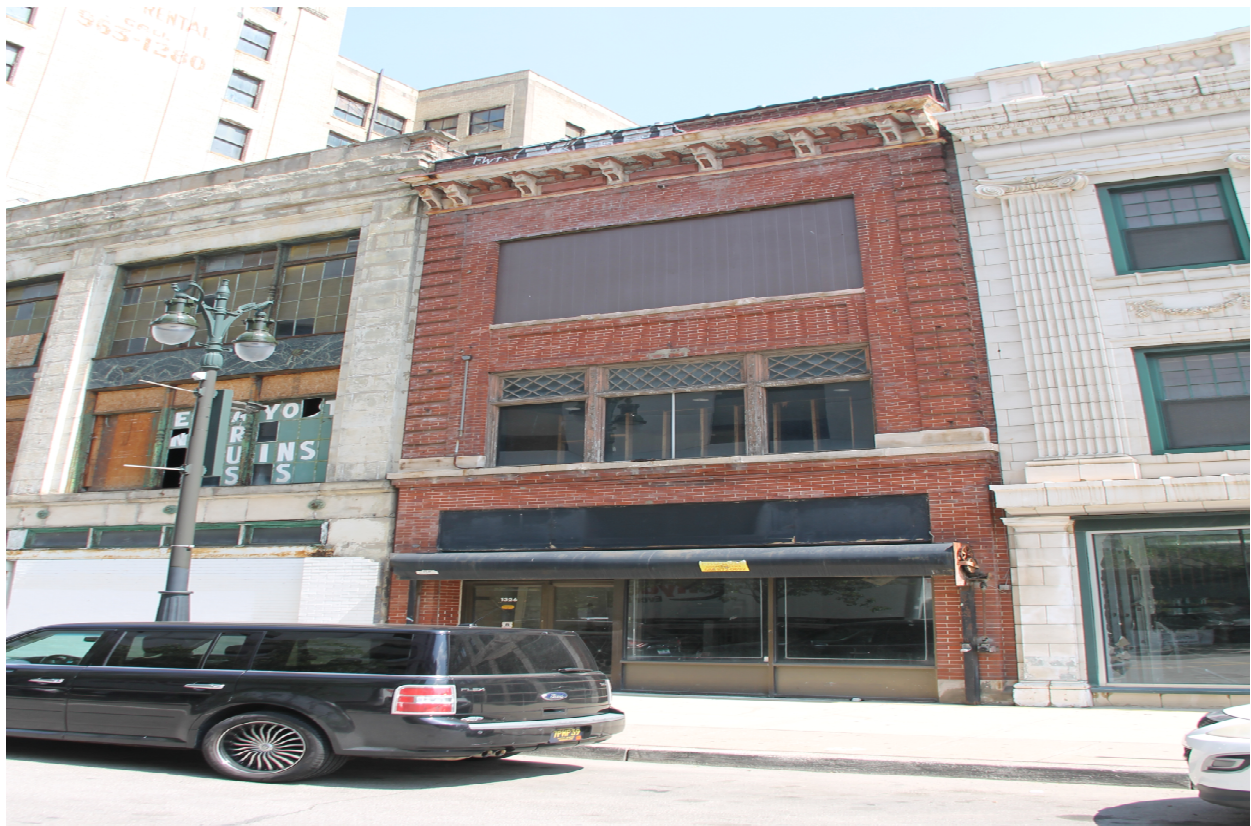
1332-1336 Broadway Center Building

1326 Broadway Middle Building: The front façade of this building has two large openings, one on both the 2nd and 3rd Floors. Both are missing the original lower operating sashes; three fixed upper sashes remain in the 2nd floor openings but all sashes are missing in the 3rd floor openings. All the original frames and sash were wood with typical 1 3/4" thick hung operating sash using , pulley, rope, and weight balance system. The original wood frames are present but only the 2nd floor units are restorable, as well as the existing upper 2nd floor sashes with diamond pattern true divided lites. The 3rd floor frames are too damaged to restore, the sashes were removed with no regard of care for the master frame and mullions. There two potential options; first would be restoration of the 2nd floor master frame and new sashes and new wood replica windows for the 3rd floor. The second option is to replicate both the 2nd and 3rd floor windows with new thermally broken aluminum windows. Abatement of all ACM present in the perimeter caulking as well as glazing compound will be required.

Budget Price: Option 1. Restoration and Full Replication using Mahogany window components. \$35,000.00

Option 2. Full Replication with new historic thermally broken aluminum windows. \$23,000.00

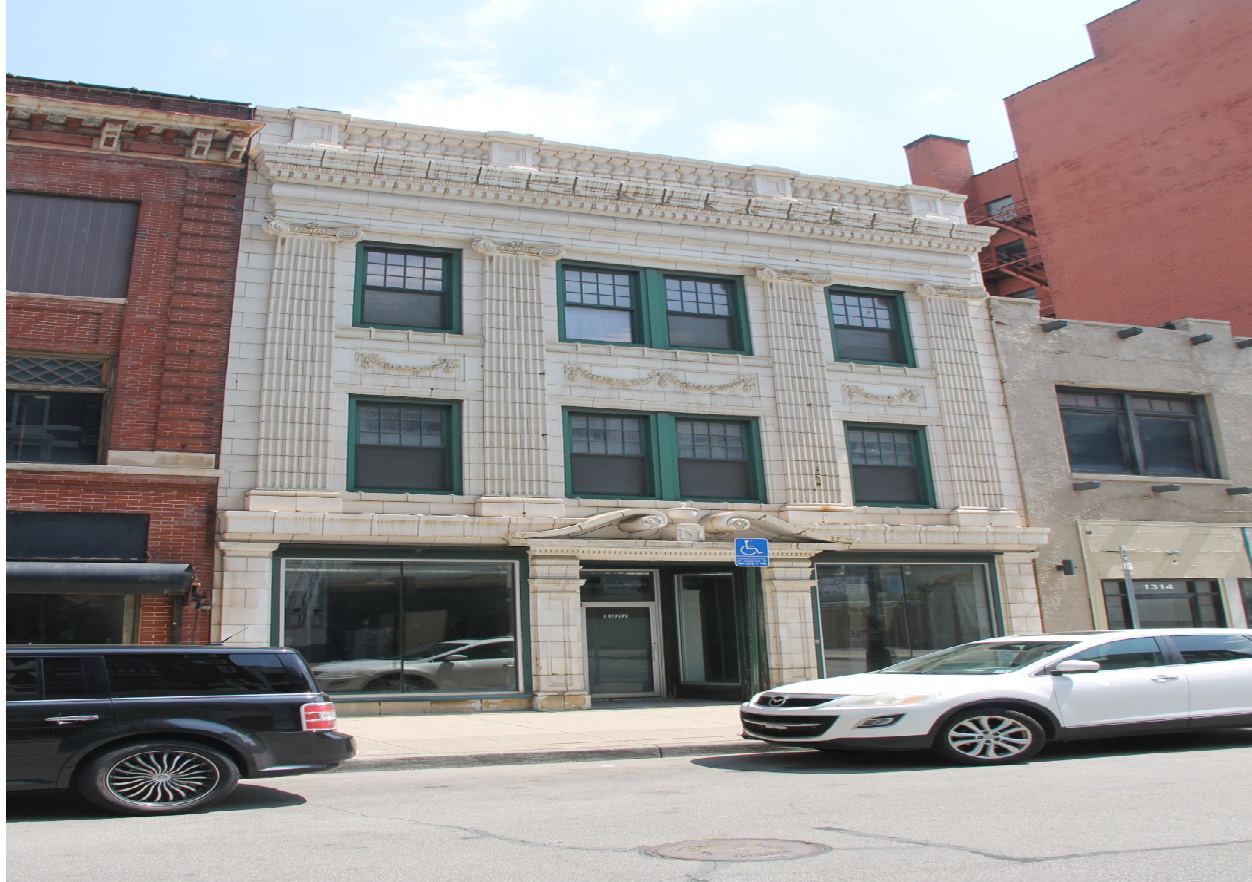
1332-1336 Broadway Right Building

1322 Broadway: First building on the right; has thermally broken aluminum windows that we estimate would have been installed as replacement windows less than 20 years ago. The windows are double hung windows set with an exterior panning and sill assemble. The are in good condition and we would recommend leaving these windows in place.
