1405 Chicago Blvd elevations with windows

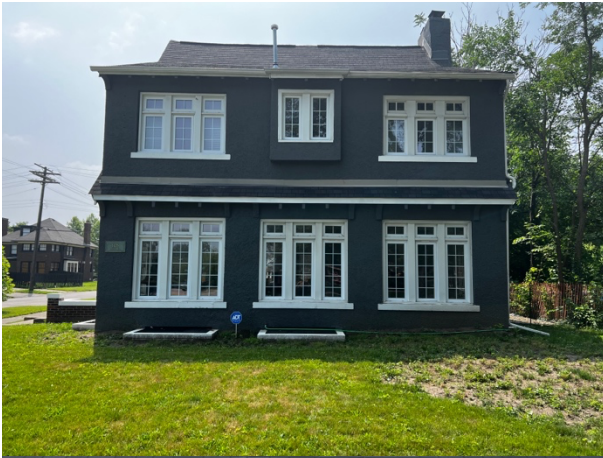
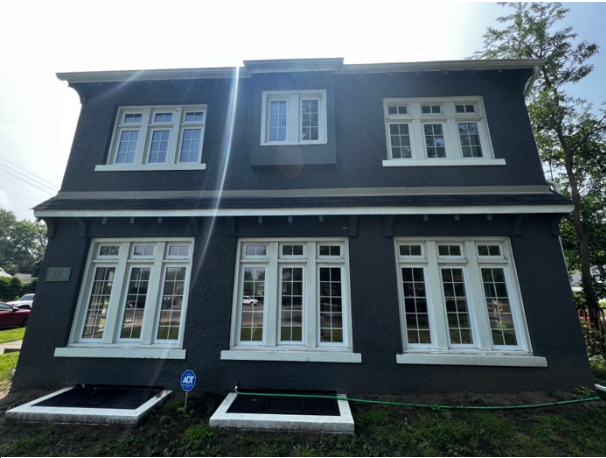
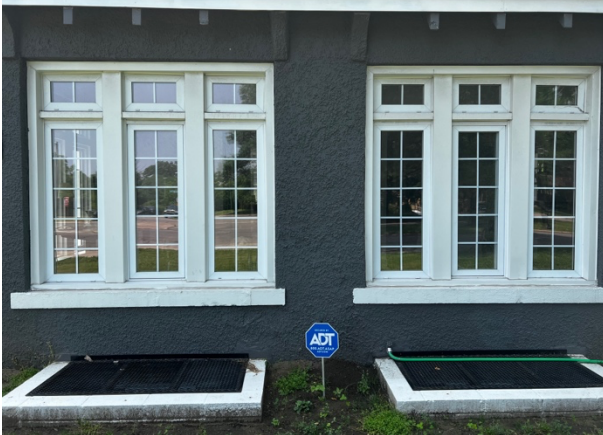
Added a few more photos of the exterior north side, similar windows are also visible in street pictures dated 2011 or earlier, all the windows on this side are same style, material looks like PVC, we found a mark dated 2017 so we are assuming changes happened then for this section.

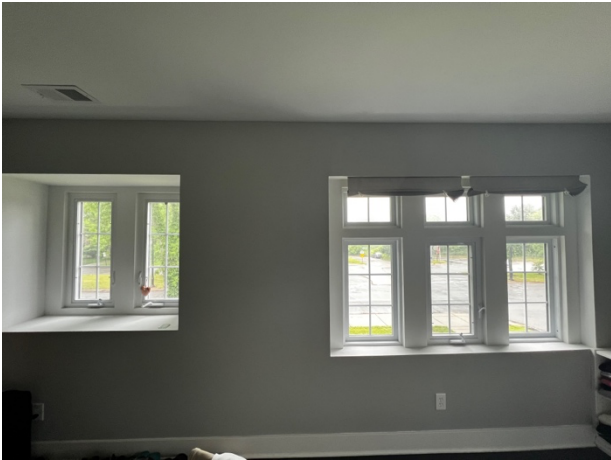
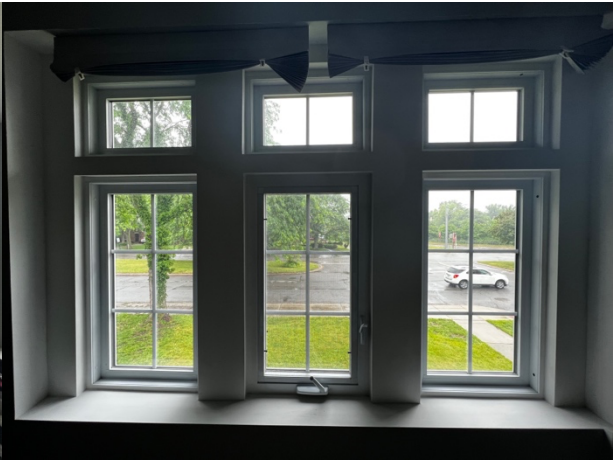
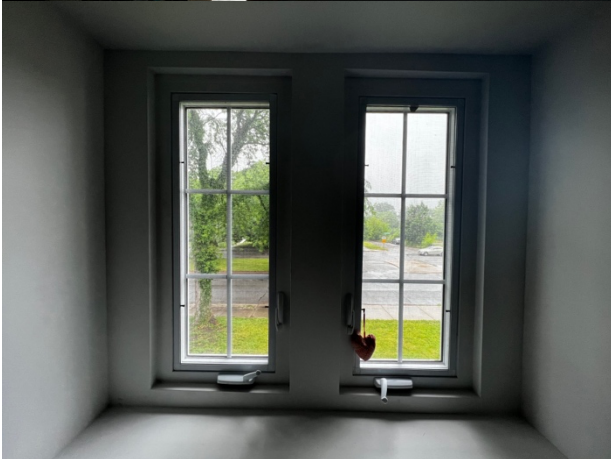
Master Bedroom windows facing North to Chicago Blvd, as all the ones facing North, they look all changed during same time and PVC type material, assuming 2017.

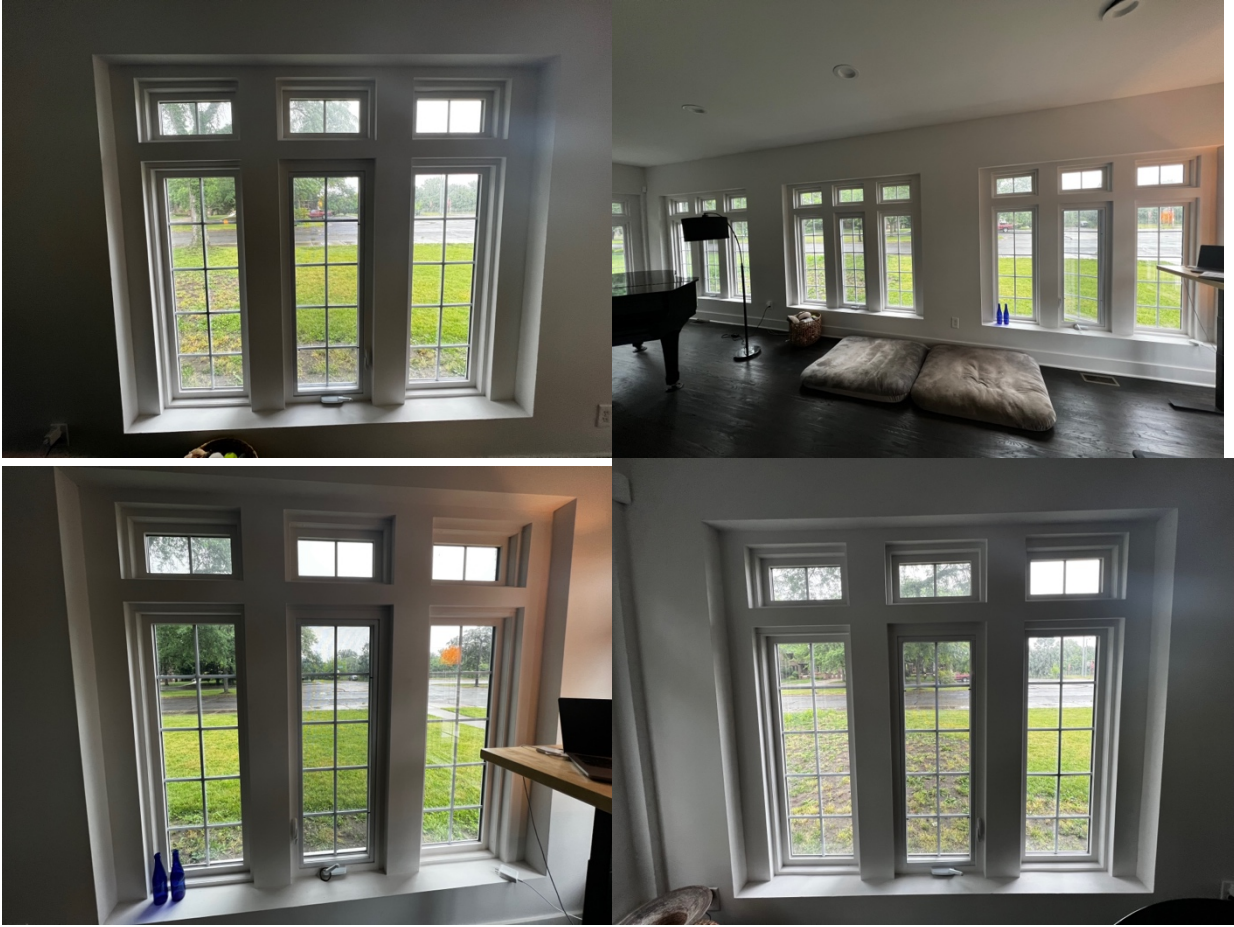
Family room on main floor facing North, same as previous, all same type and kind of PVC material, assuming 2017.

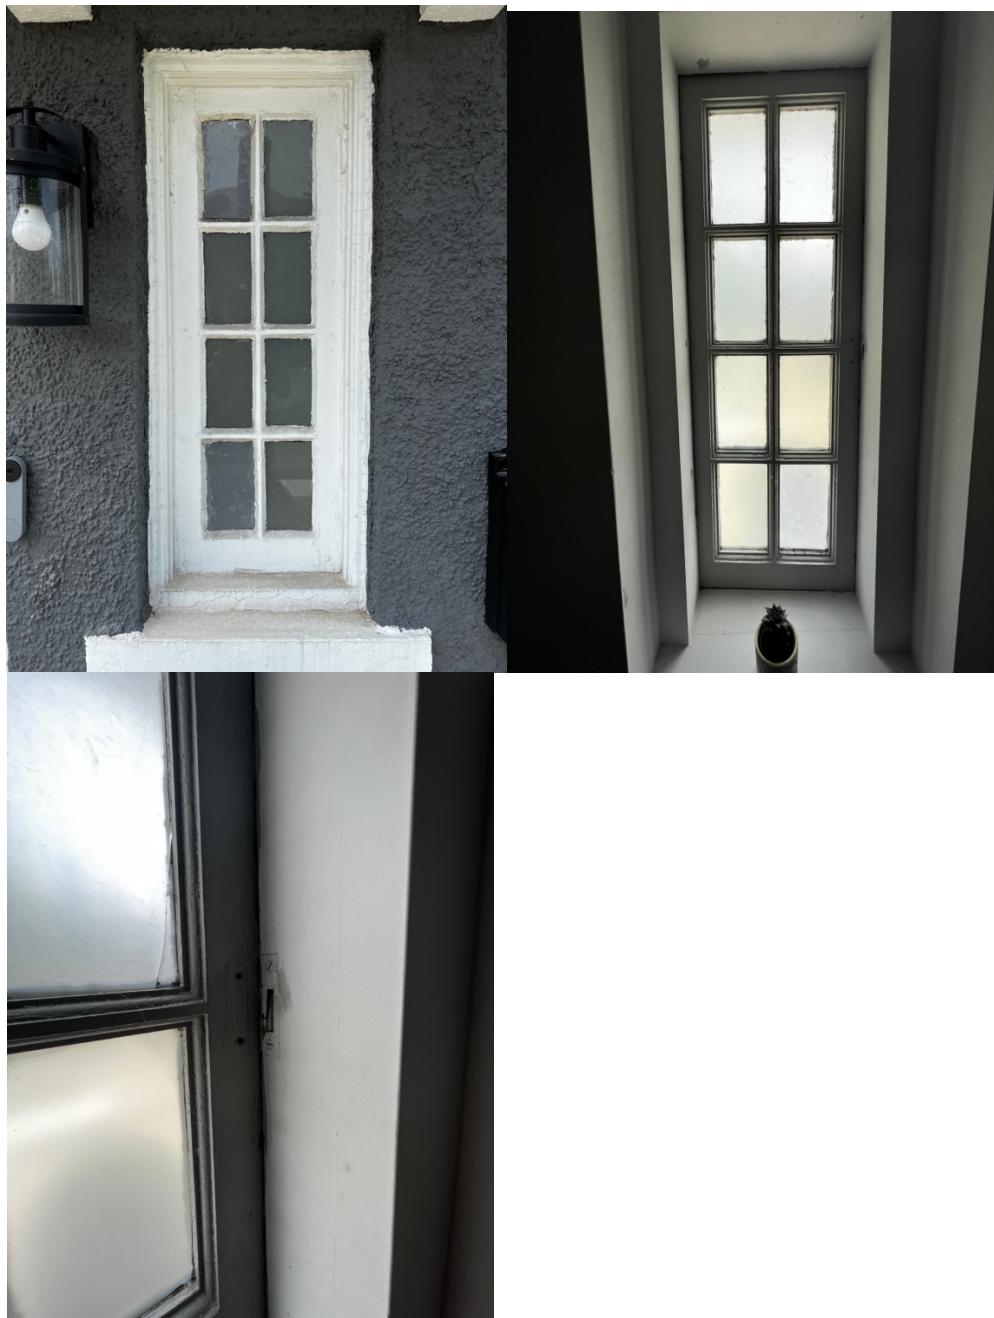
Family room (right side taller window) is the same style as all the ones facing North, and installed clearly at same time, PVC material, assuming 2017.

Main entry, small window to the right of the door is original to the house (see detailed photos attached)

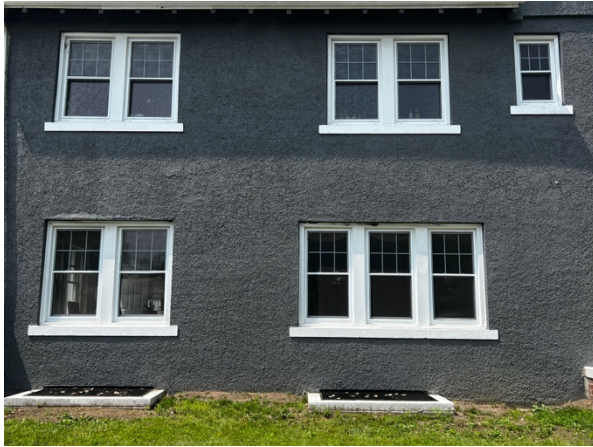
Dining room area on main floor (two windows)

On this section, windows facing Byron St are the same style, they also look like PVC material, and potentially changed around same time than the ones facing Chicago Blvd, assuming 2017.

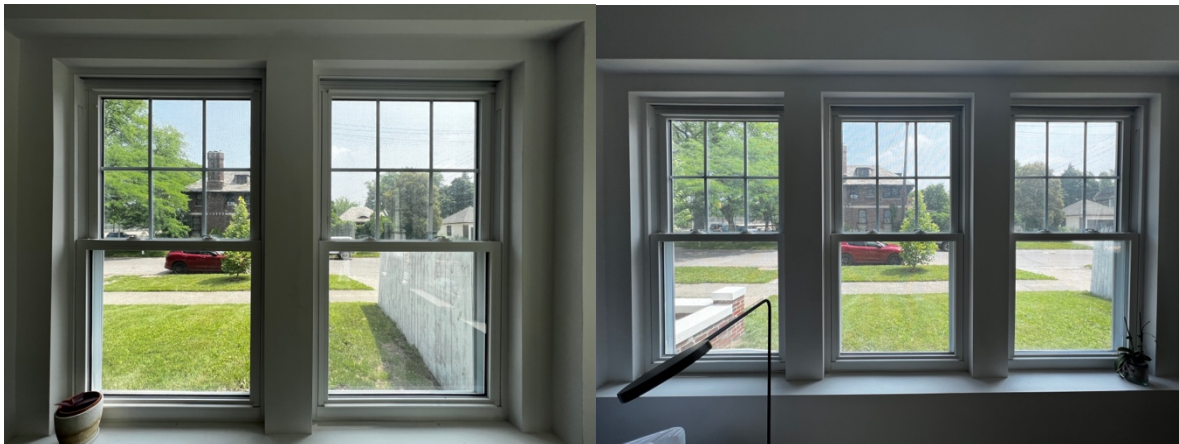
Photos from 2011 show similar windows, but we are assuming changes were made in 2017.

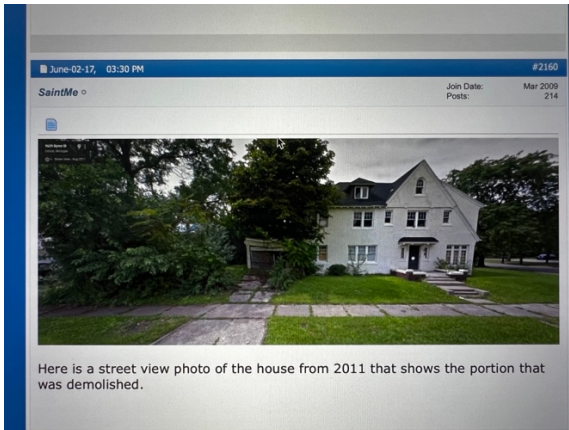
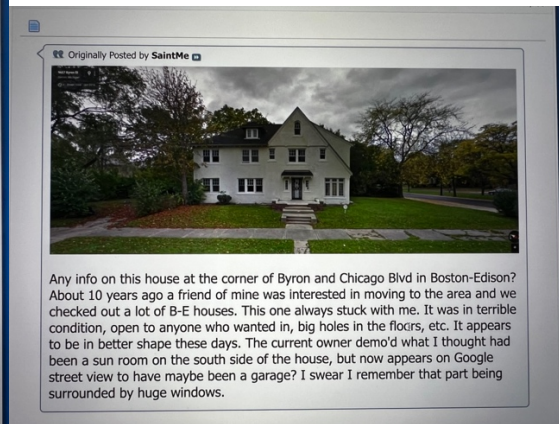
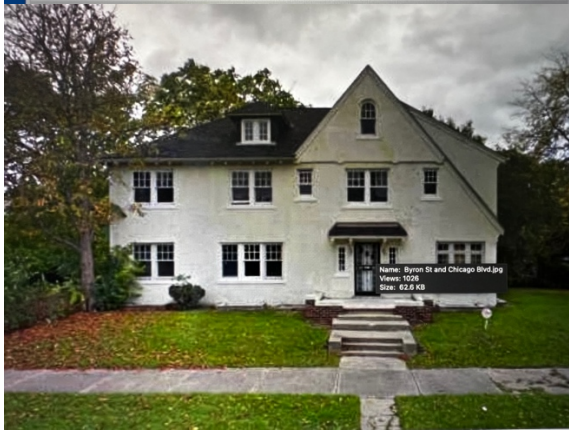
See attached photos from Detroityes.com with comments about 2011, while the windows look like a similar style, we cannot tell they were the same ones.

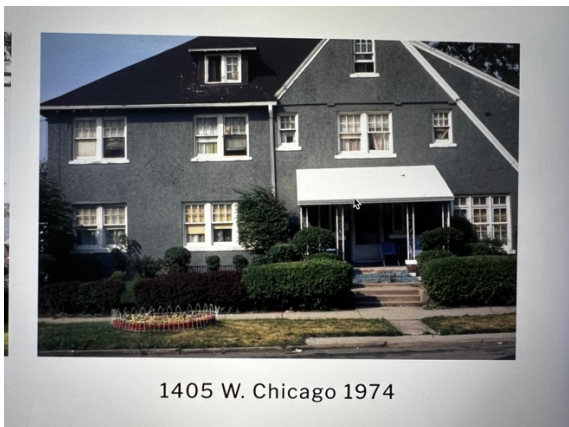
And the only photo from 1974 that we were able to find in preservationdetroit.org showing what we think were the original windows.

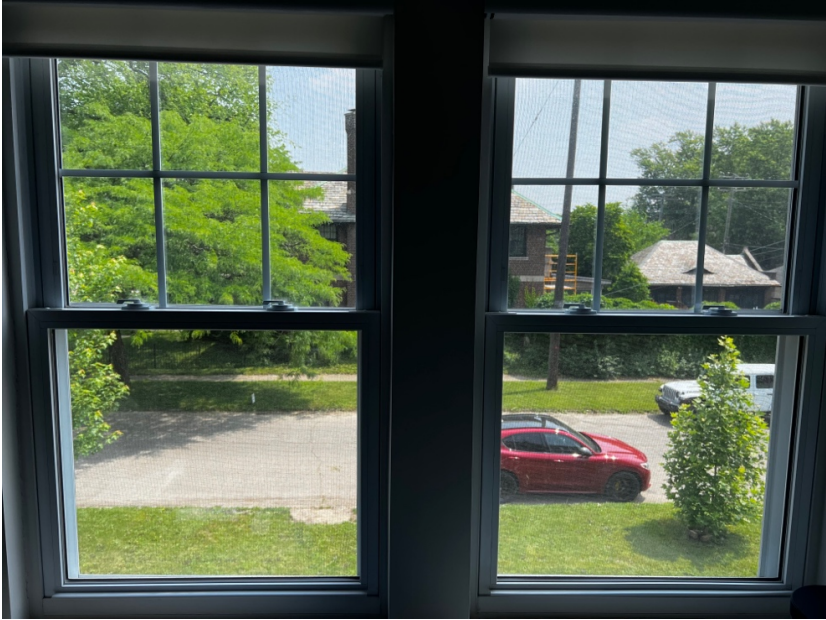
Master windows facing Byron St

On the second floor facing Byron St we have one bedroom, and the master bedroom and bath (right side). On this section, windows facing Byron St are the same style, they also look like PVC material, and potentially changed around same time than the ones facing Chicago Blvd, assuming 2017.

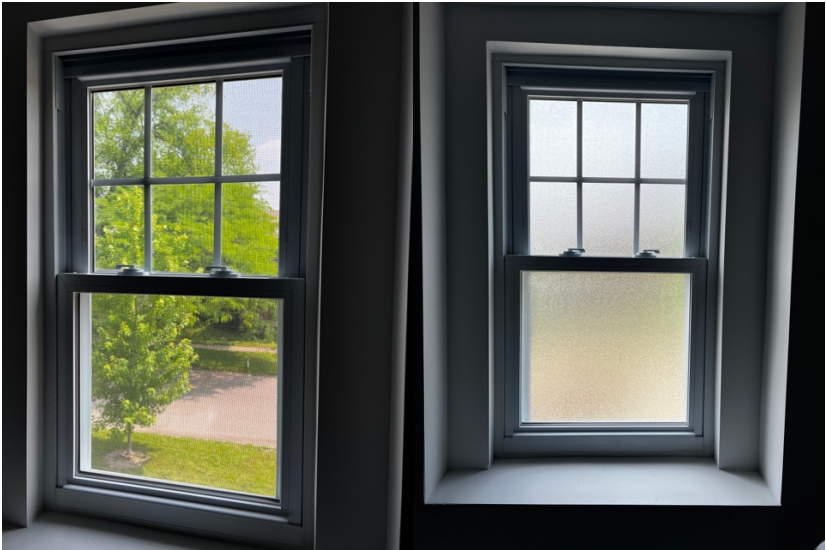
Bathroom window with translucent glass

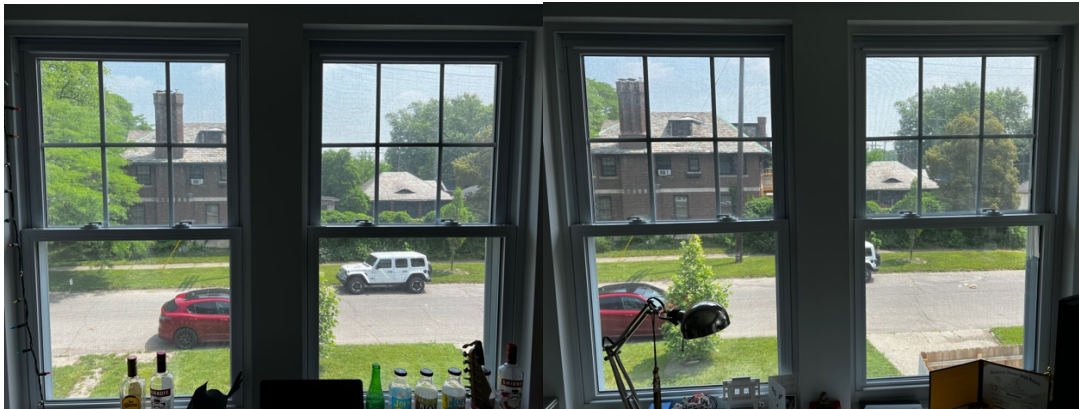
Second bedroom facing Byron with two double windows. Same material, PVC, and assuming 2017 updated.

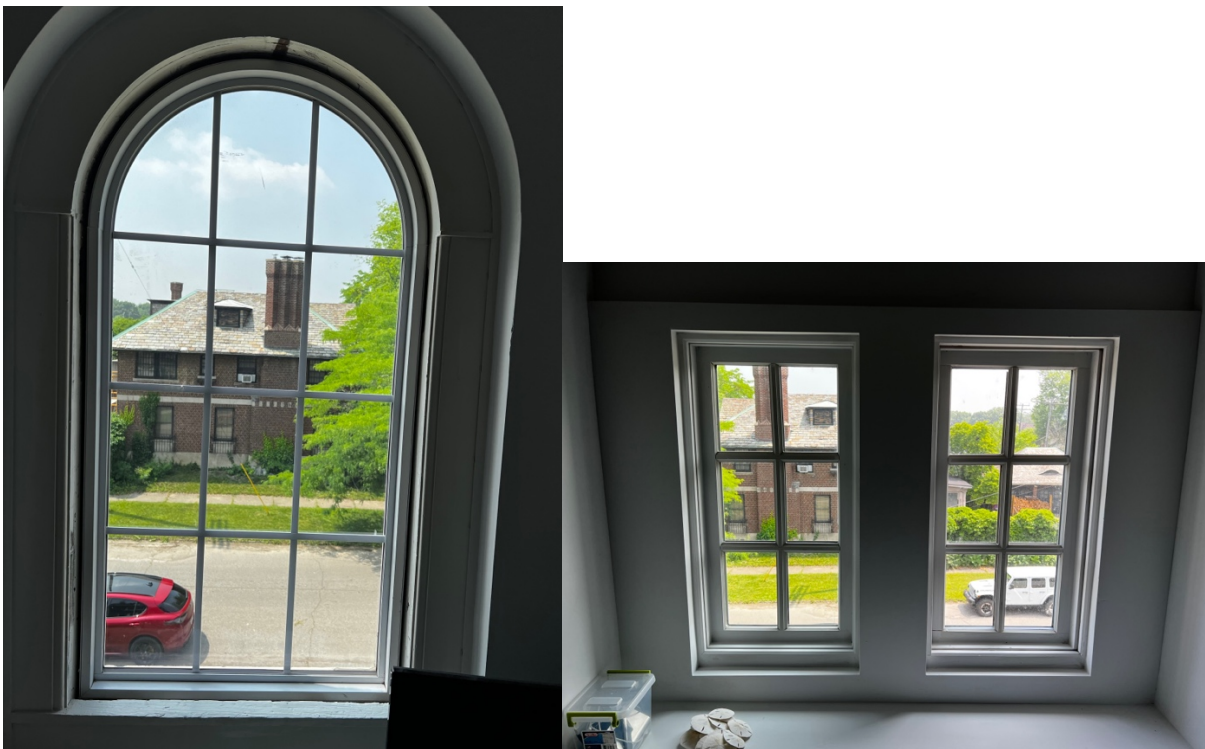
Attic windows material is wood, while they are not original, they don't look as changed at same time than main and 1st floor. Assuming 2010 for a mark on the glass.

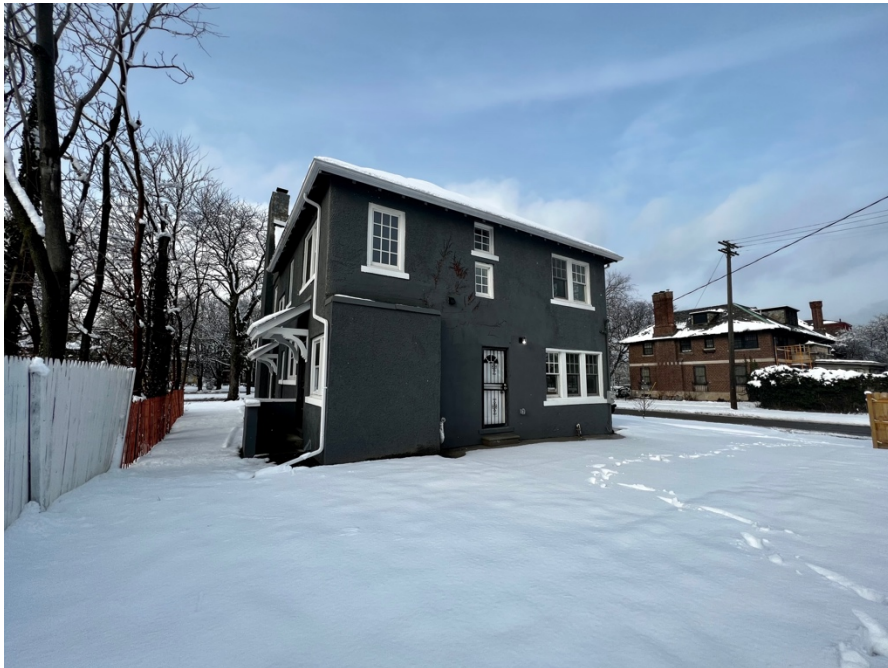
For this back side we have not been able to find any old photo, only one from 2011 shows originally a garage was attached to the house from where today's is the backyard/driveway door.

On this elevation only one window is original (top one on third floor staircase) that on below photo is the top center one.

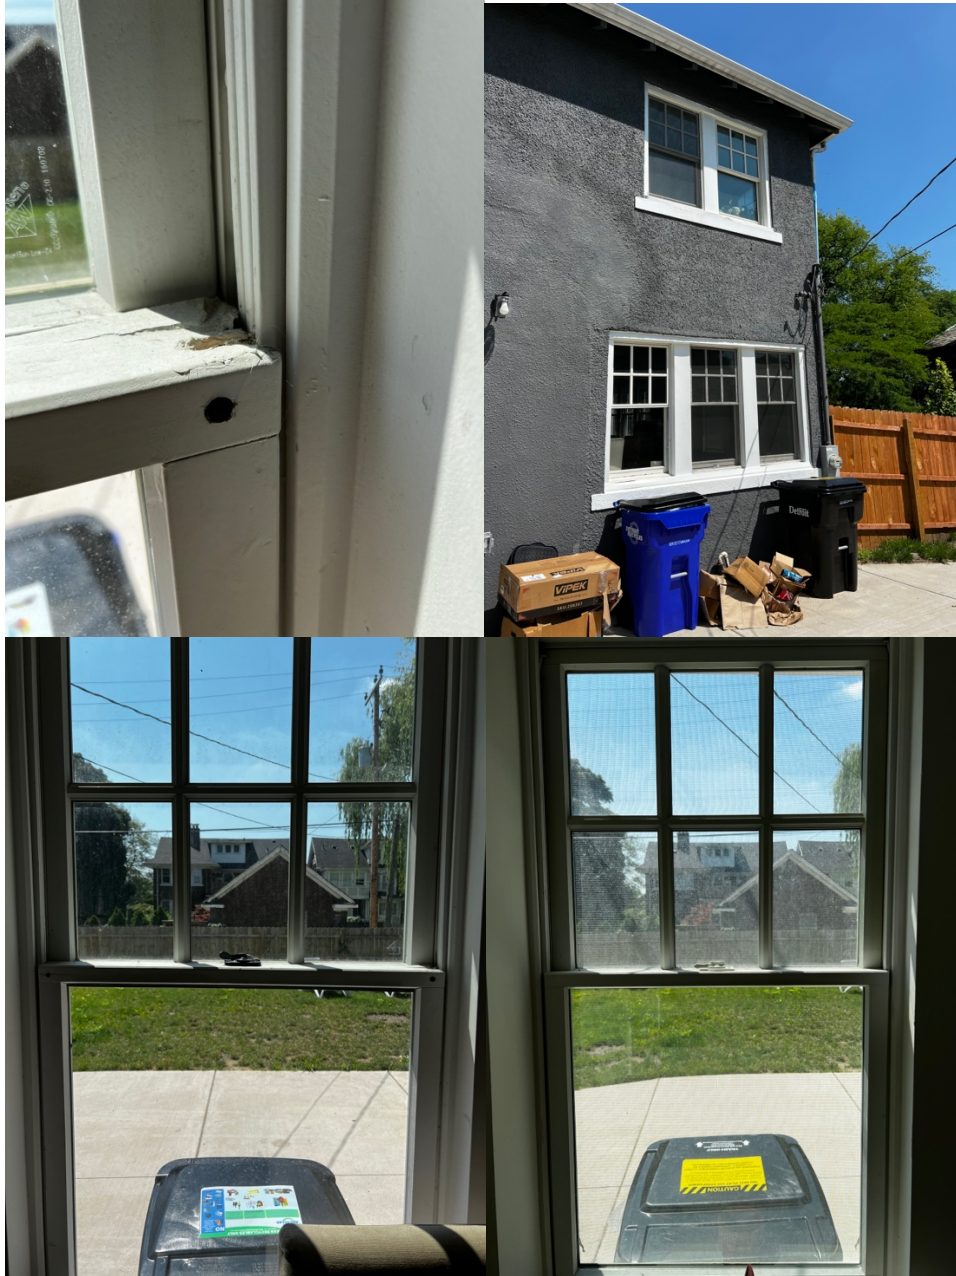
Main floor ones (side of dining room) look like changed earlier than rest of dining room (potentially when garage was demolished) and material is wood, most of them damaged and with some “repairs” on the inside with screws to fix position of window. I was able to find a mark and windows look from 2010.

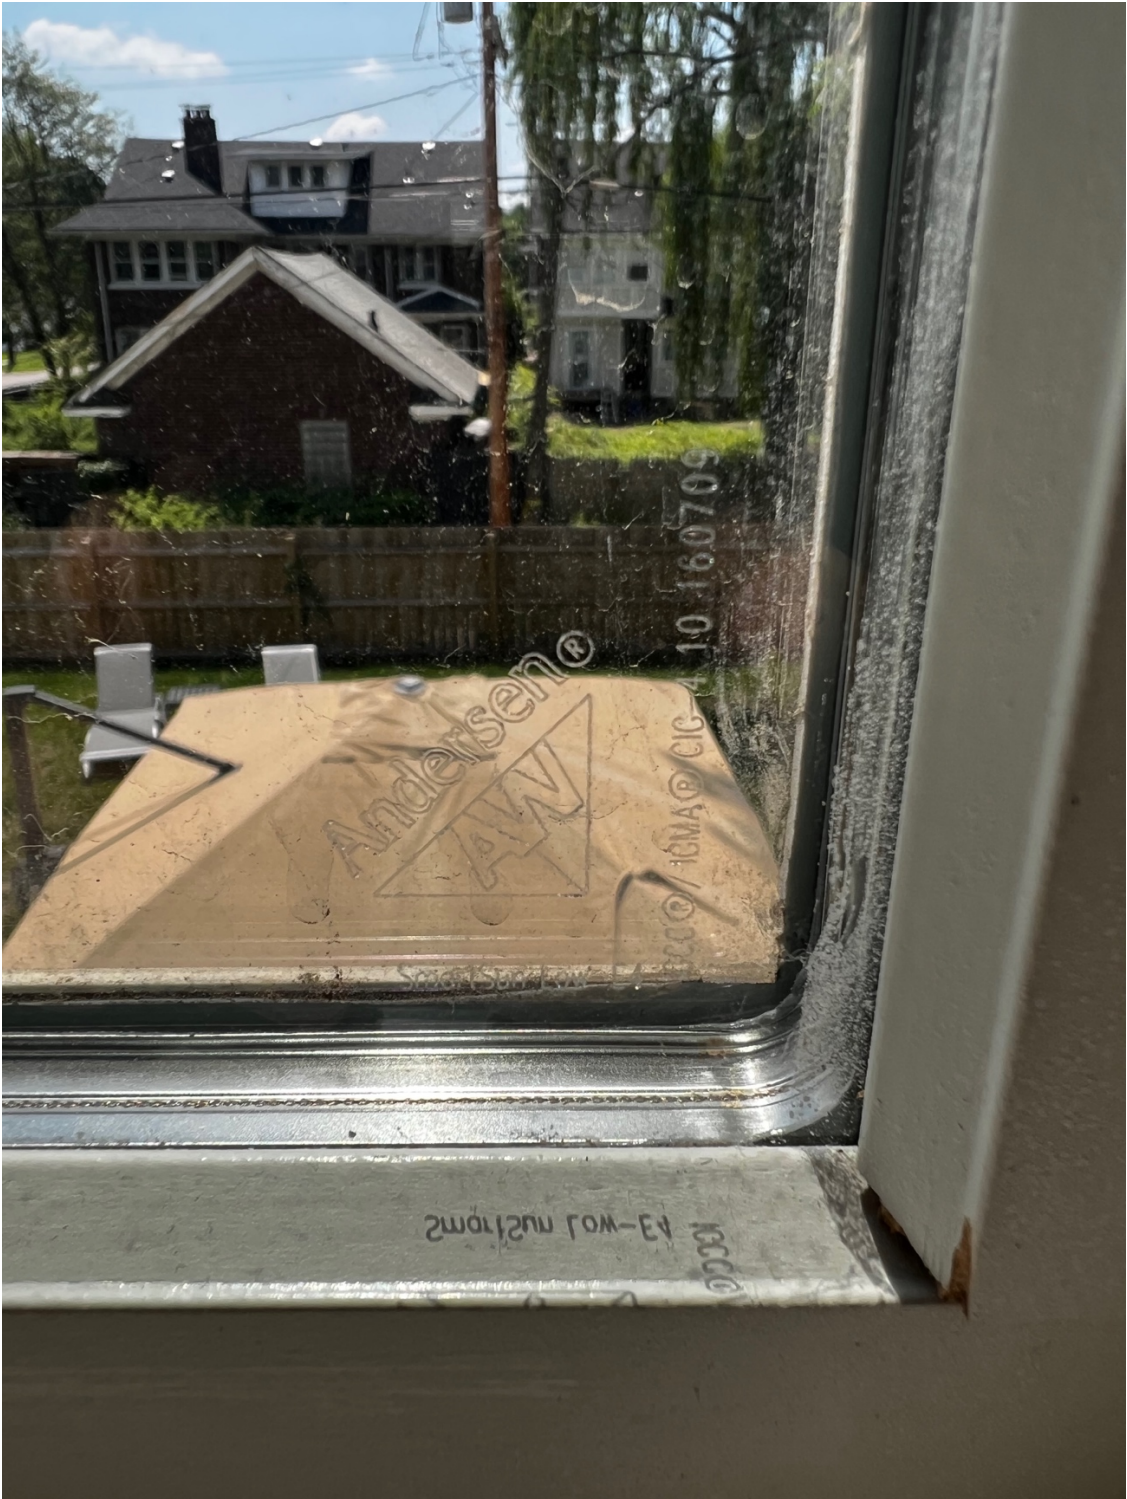
All this windows are from Andersen and built/installed in 2010. They are all the same on south façade (facing alley) ... on the picture is not easy to see the engraving.

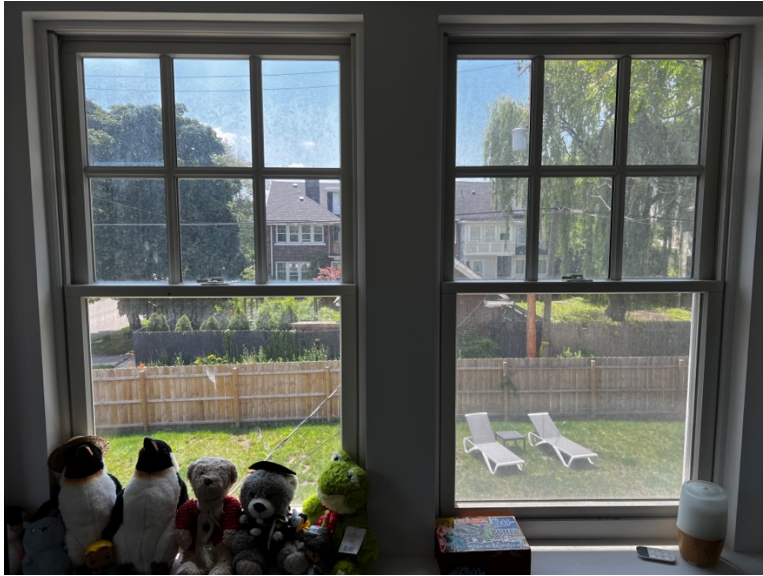
1st floor bedroom

As the other ones facing south, wood material and mark dated 2010.

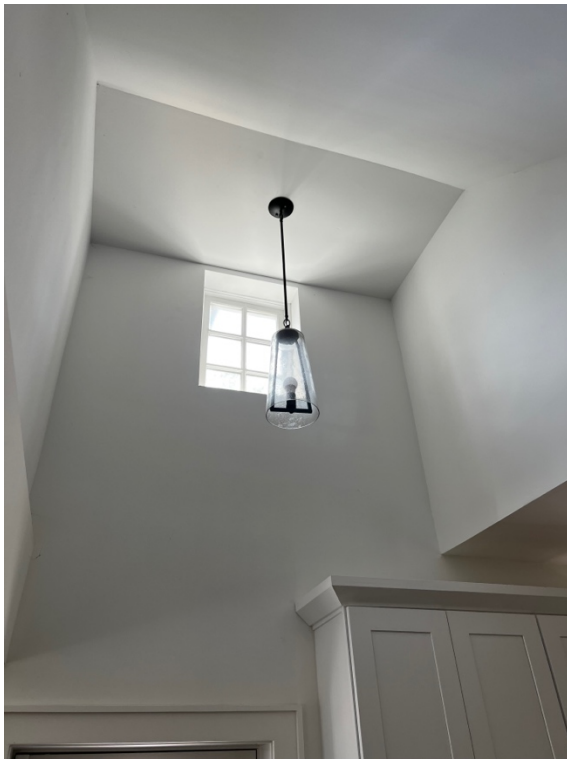
Foyer window seems from same time, but I cannot access to verify.

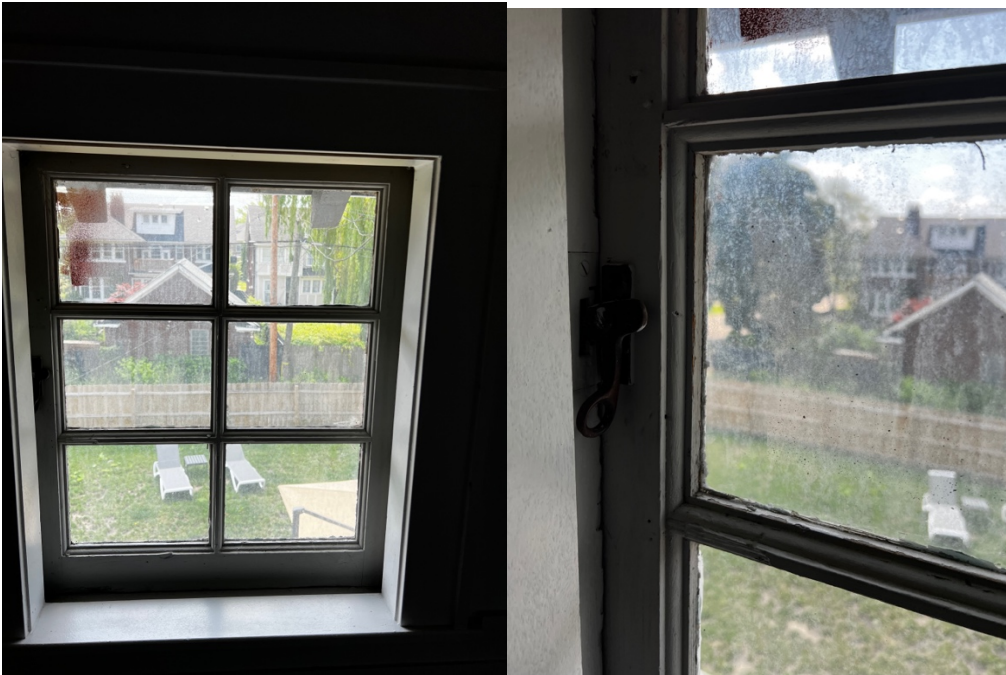
Attic staircase window is original, wood and still in good status

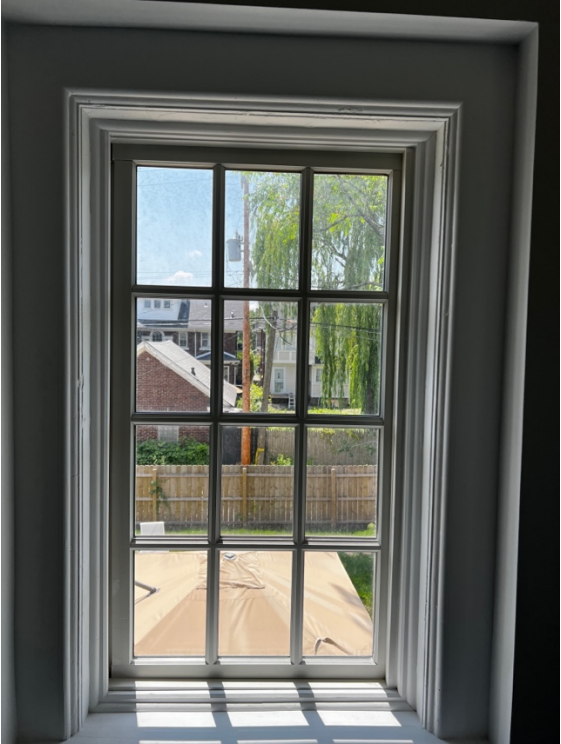
Third room in 1st floor window is one piece, material is wood with window dated 2010.

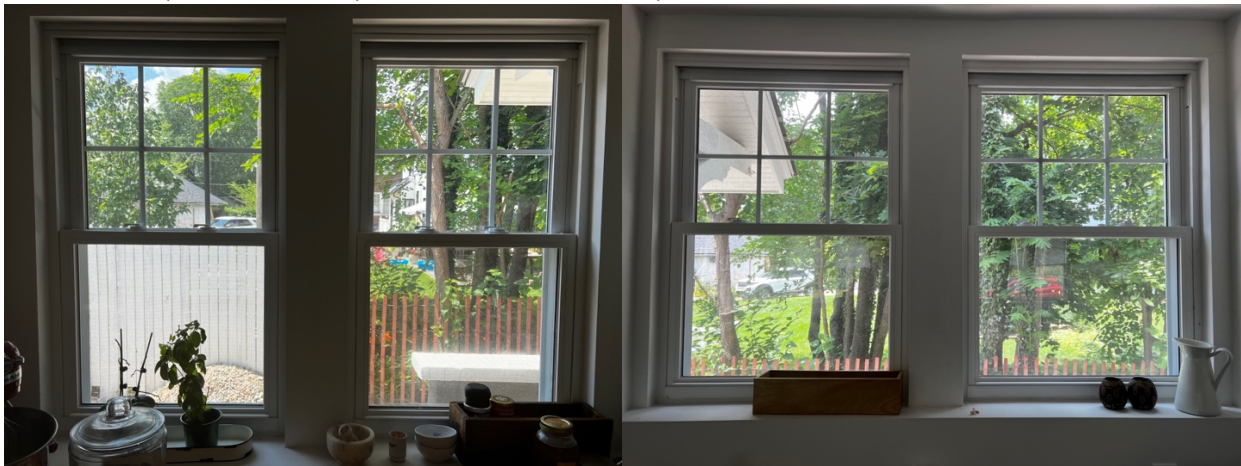
Kitchen area, two windows, both are PVC material, and windows are dated 2017.

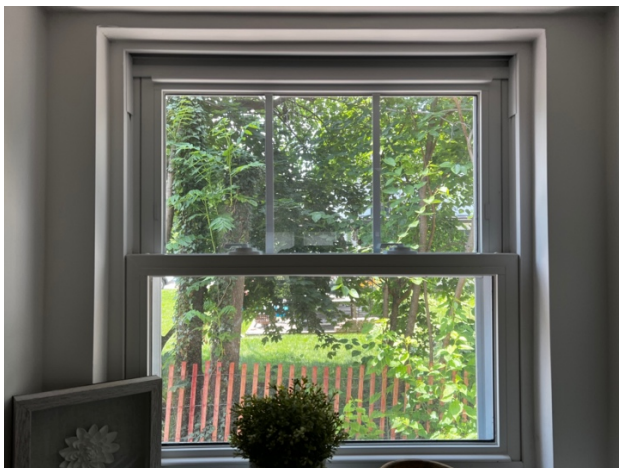
Basement access window, one window, PVC material dated 2017.

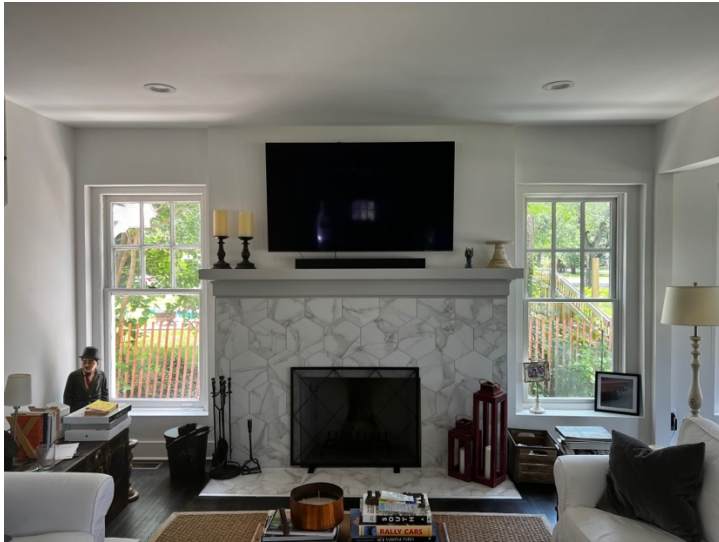
Family room, two windows around fireplace, left one is original, and quite damaged. Right one is wood and dated 2010.

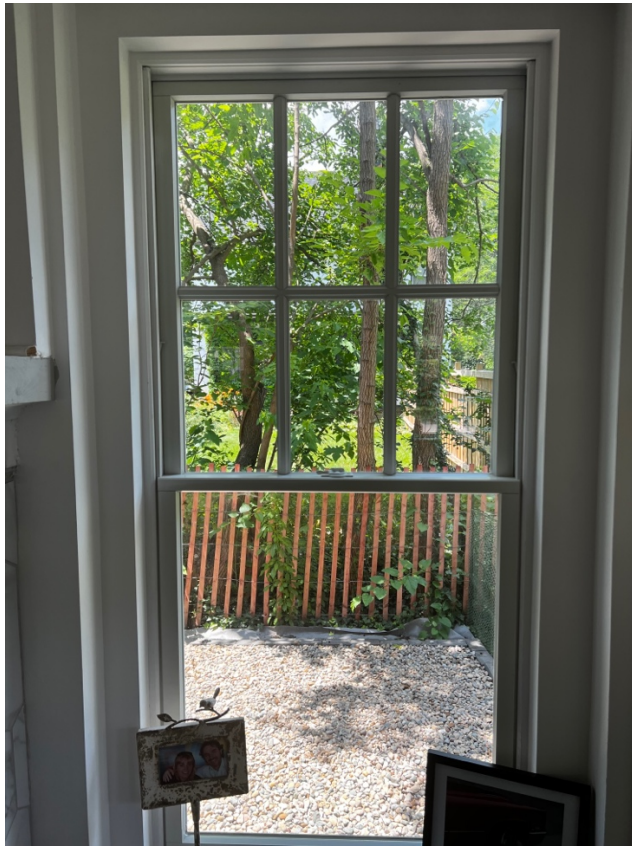
Right window is wood, and dated 2010

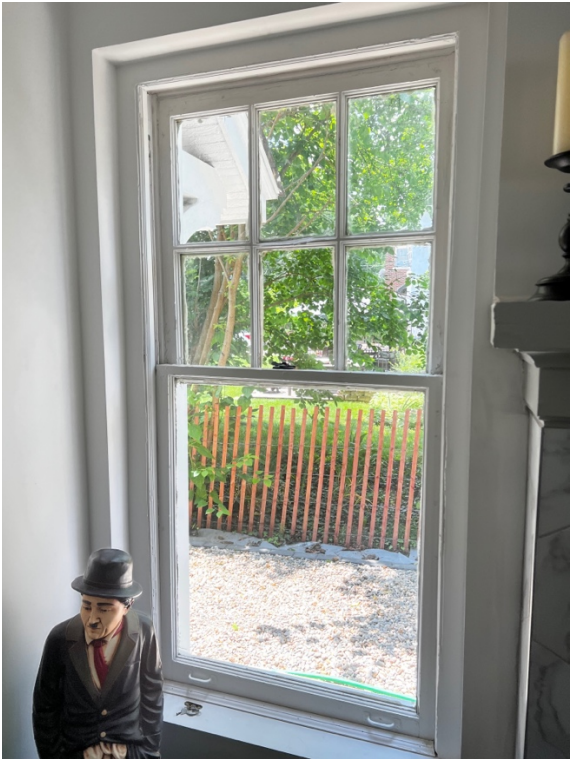
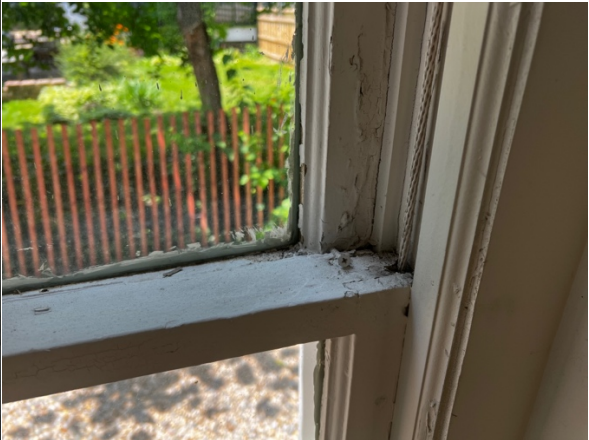
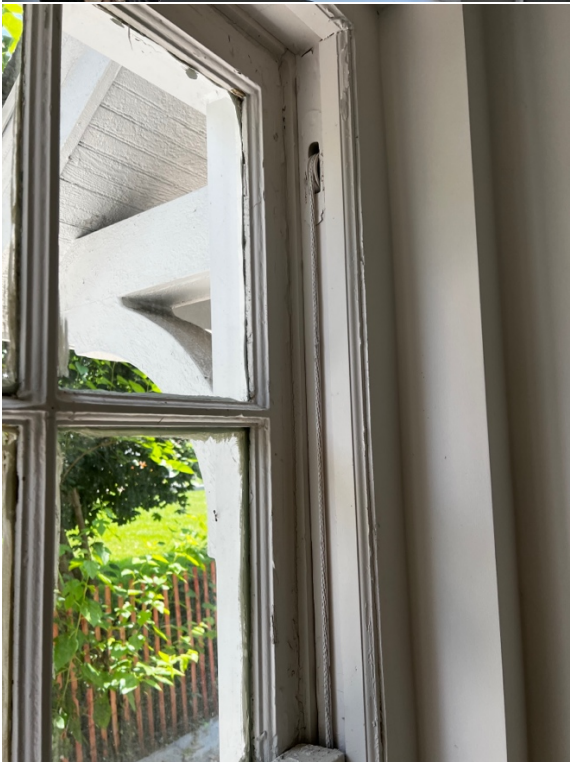
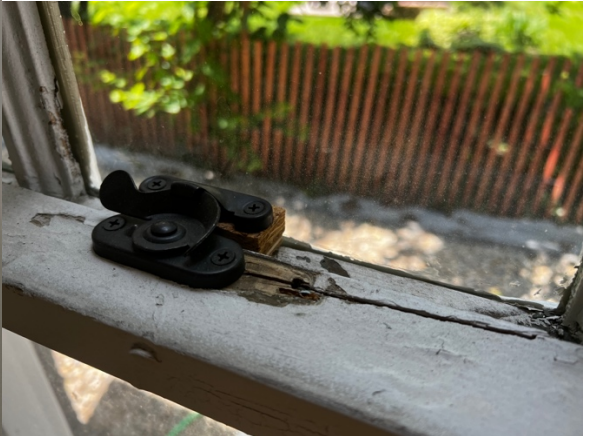
Left window is original one

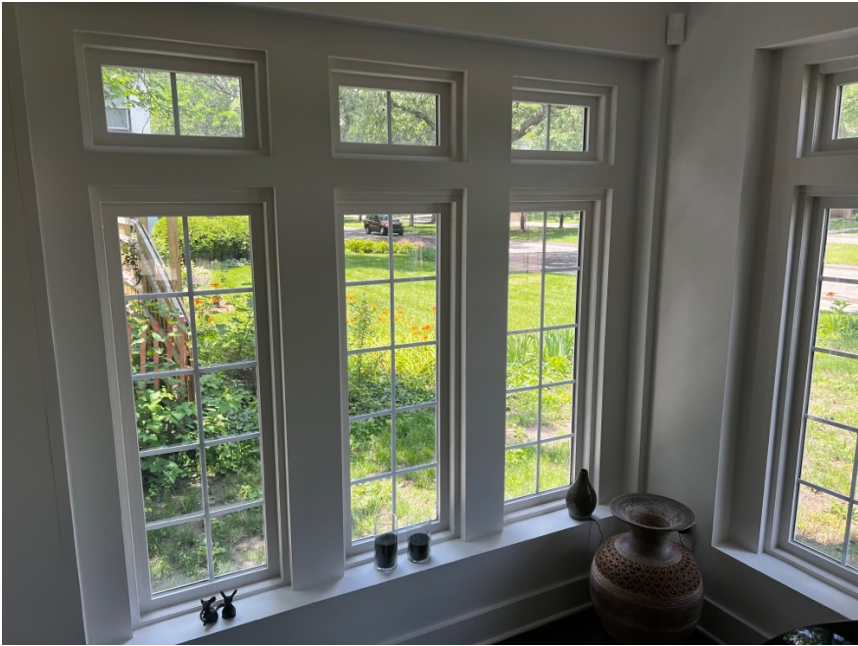
Family room window (old sun room), similar to the ones facing Chicago, material is PVC and dated 2017.

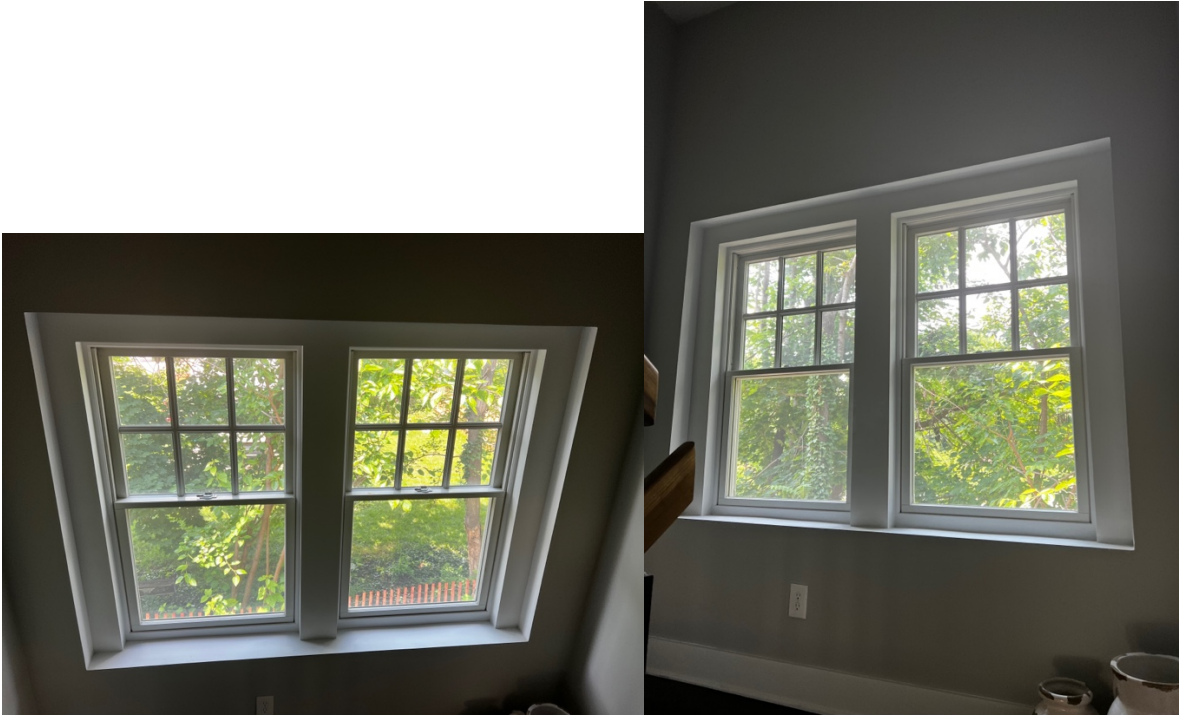
Staircase windows, material is wood and dated 2010

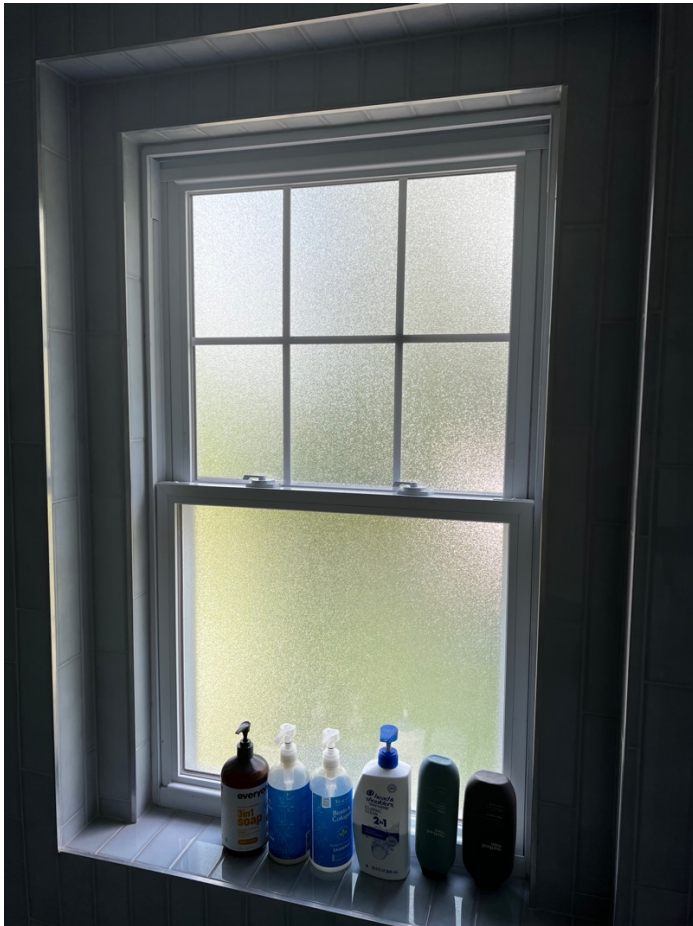
1st floor bathroom, translucent window, material is PVC and seems was changed in 2017

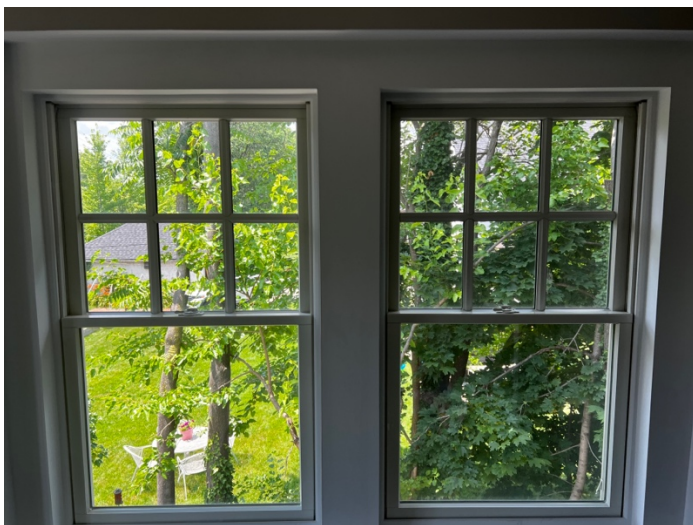
1st floor room, window is wood, dated 2010

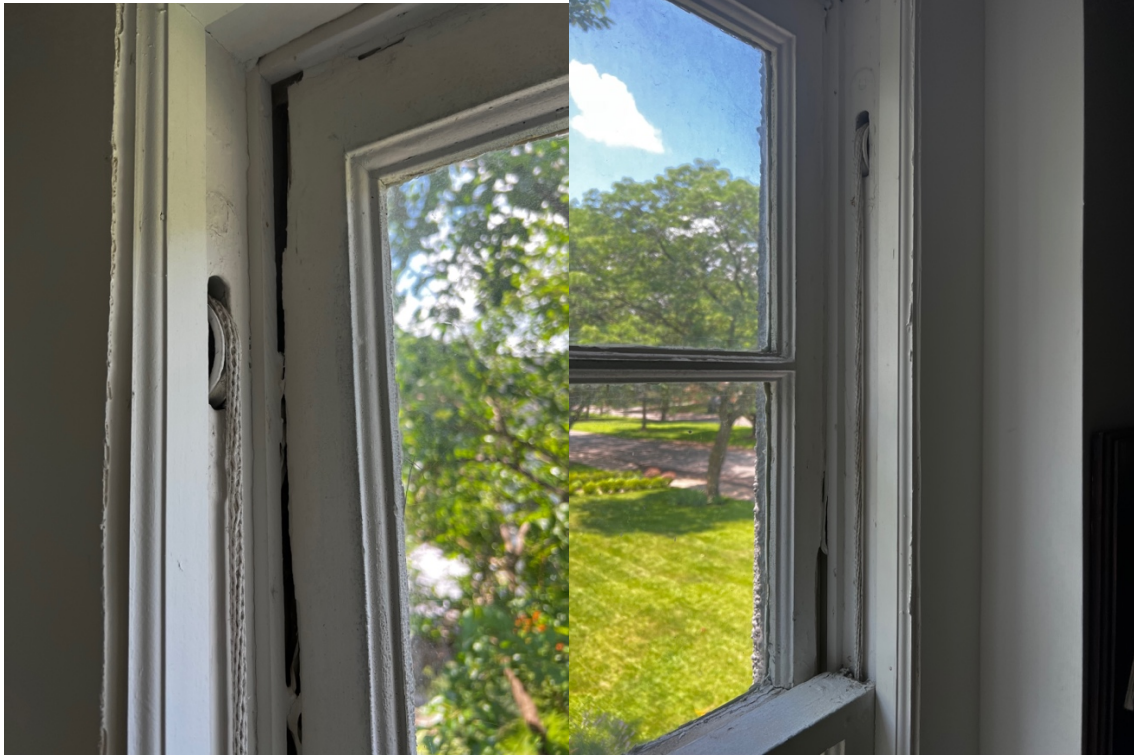
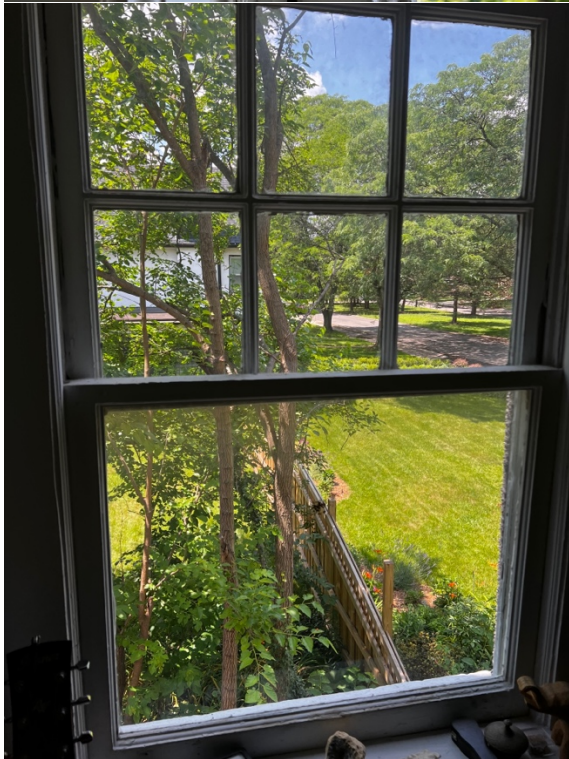
1st floor (second bedroom)

One window is original and in quite a damaged status (right side of fire place)

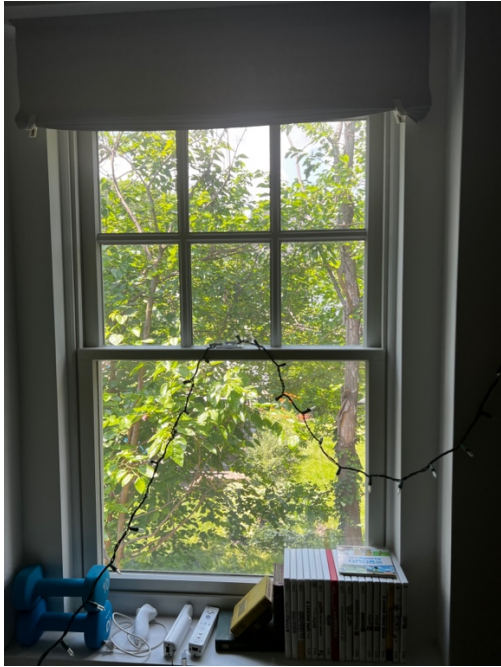
Left side of fireplace is wood, dated 2010

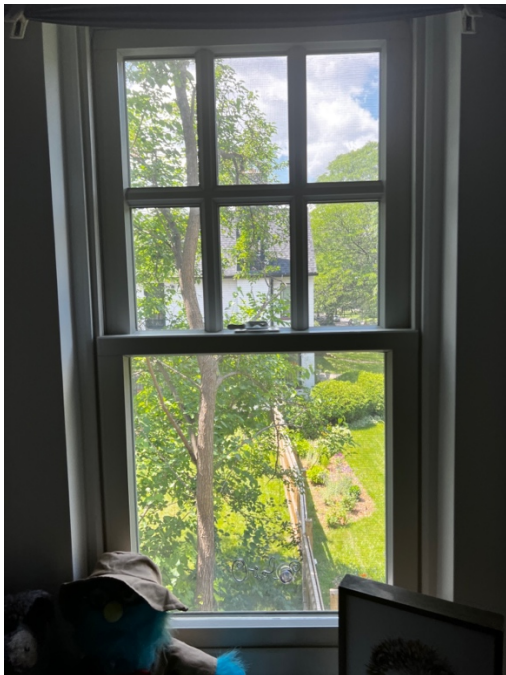
Small window in center of the room, wood window dated 2010

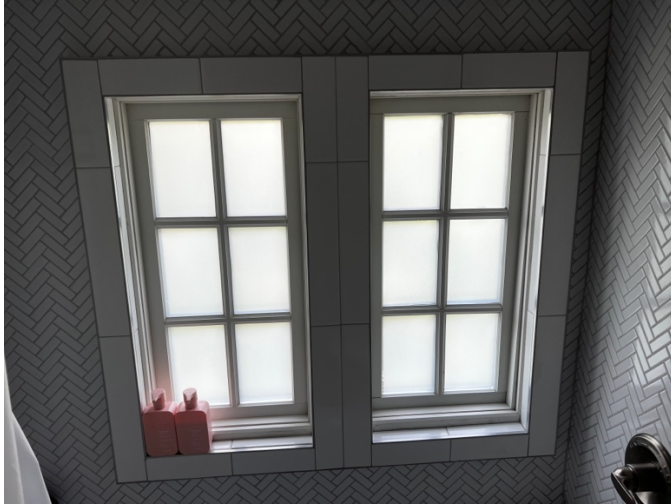
Attic bathroom

Attic windows, all them are wood but I was not able to identify date on glass, assuming 2010 as the other wood ones.
