1405 Chicago Blvd elevations with windows

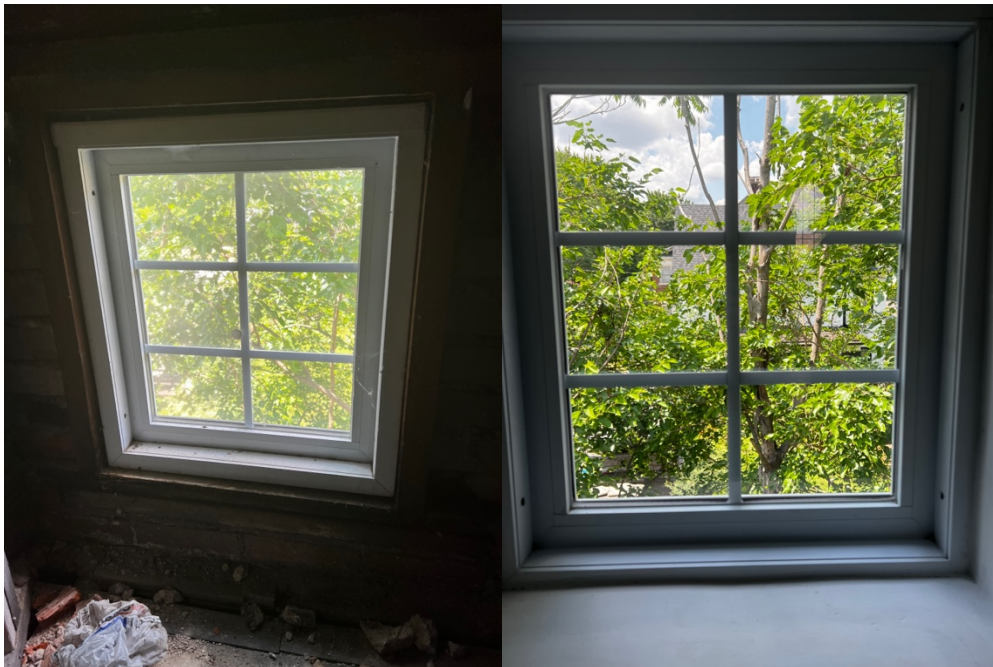
Attic under roof windows, both wood and also assuming dated on 2010
