9/12/23

Job Name: 1315 Broadway
Job Location: Detroit, MI

1315 Broadway HDC Review

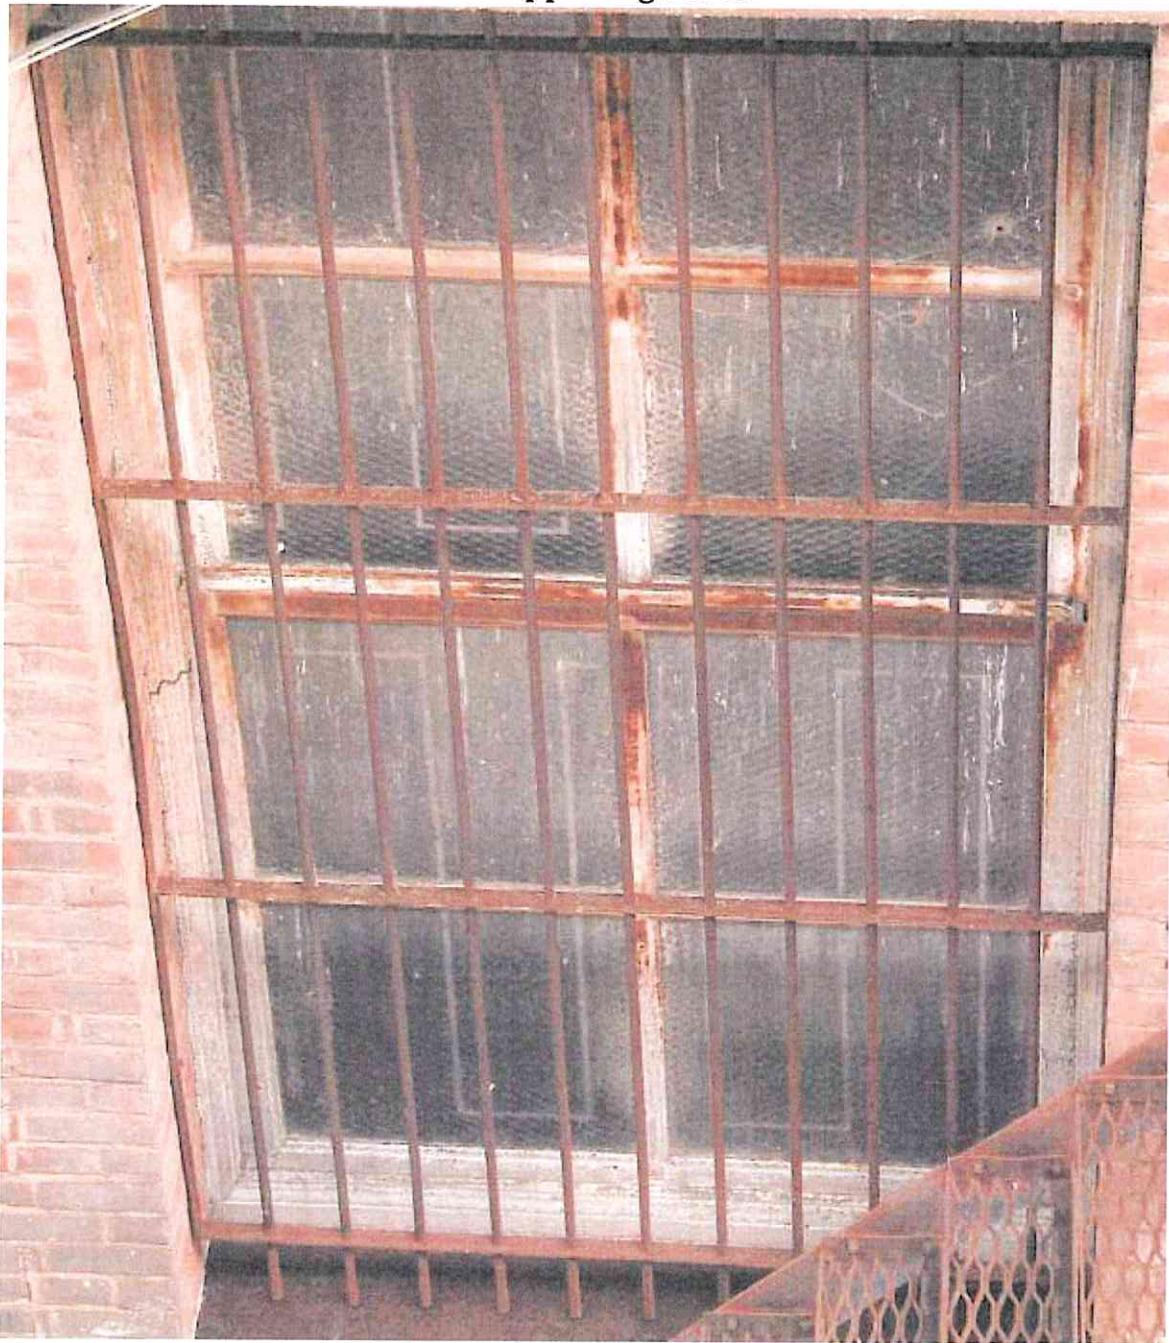
Picture 1. Exterior view of typical steel window with rust/corrosion

- Replacing the existing steel windows with a Quaker H650 Aluminum Single Hung window that matches all visible profiles and components of the windows closely.

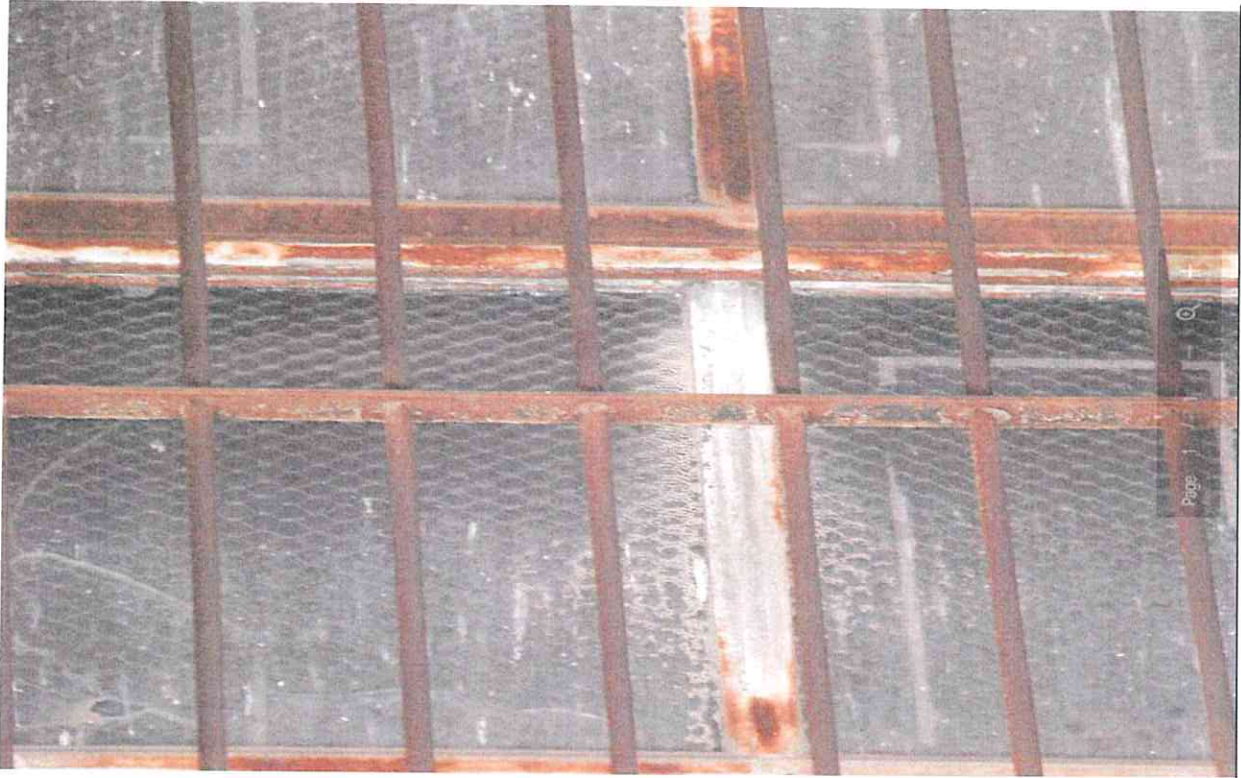
Photo 2. Typical rust/corrosion at exterior window components

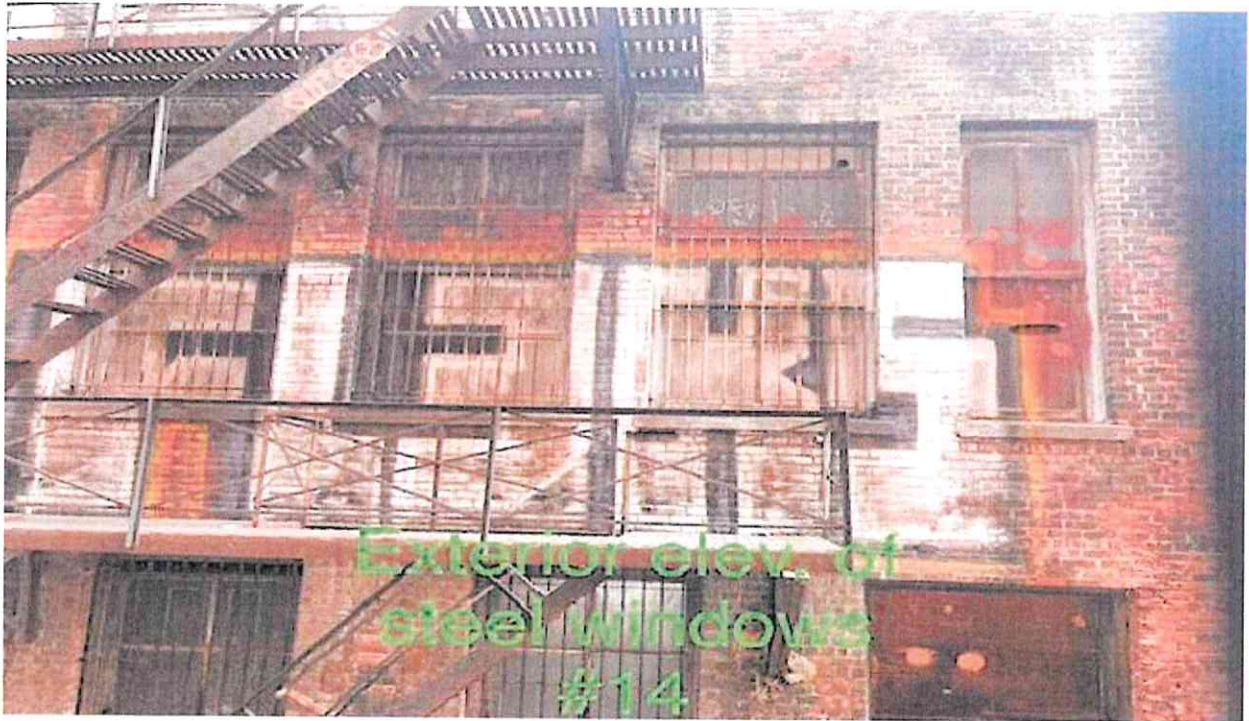
Photo 3. Typical vandalism and exterior conditions of windows

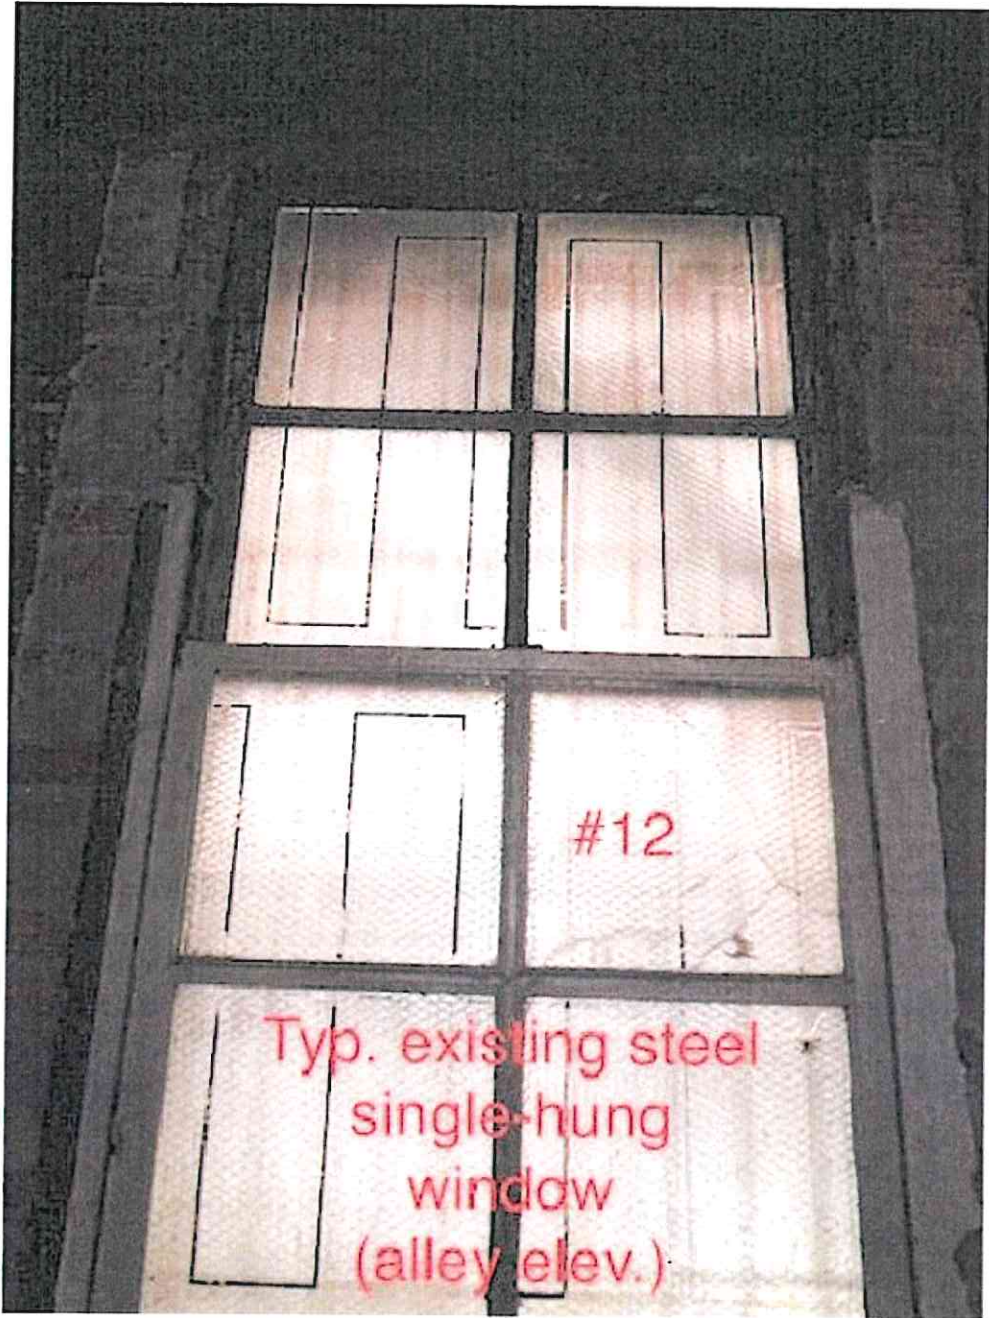
- Corrosion/rust reaching non accessible interior portion of master frame and window sashes/components
- Non-removable sashes hinder the ability to properly restore the windows. BlackBerry would typically remove the sashes and have them chemically dipped to remove all rust/corrosion. Patched wherever necessary, then primed and painted. Operability restored and reinstalled. Replace any damaged sash components. We would be unable to complete all of these steps due to the non-removable nature.
 - See photo (4 & 5)
- Longevity/durability of restored windows will be 5 years or less before corrosion/rust return
- Inability to provide an adequate restoration of this style of steel window to allow for a durable window

Photo 4. Interior view of steel window without stops. (Sashes built into master frame)

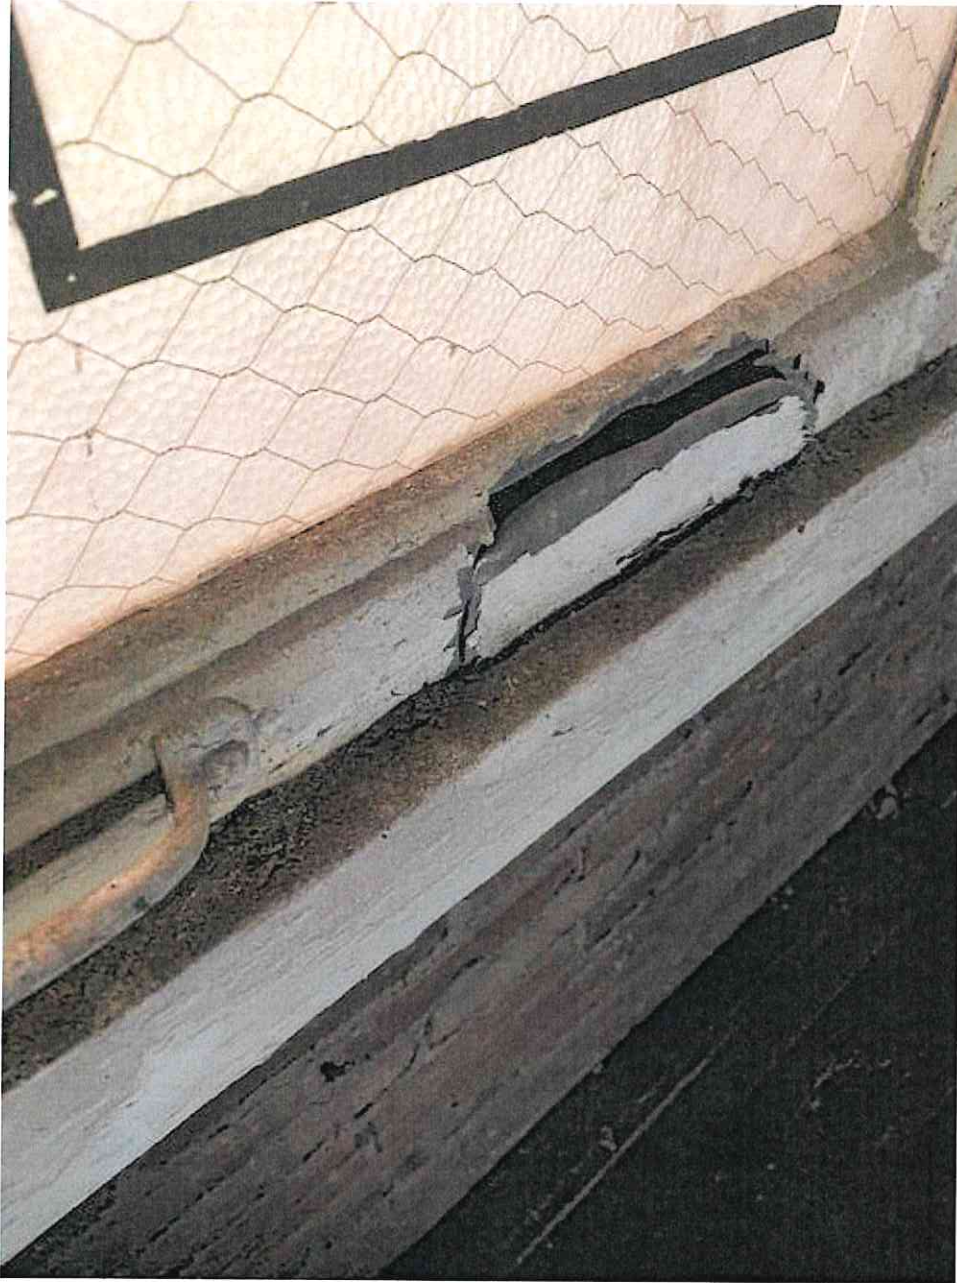
Photo 5. Damaged bottom rail, Also shows “hollow metal” cavity within the steel windows

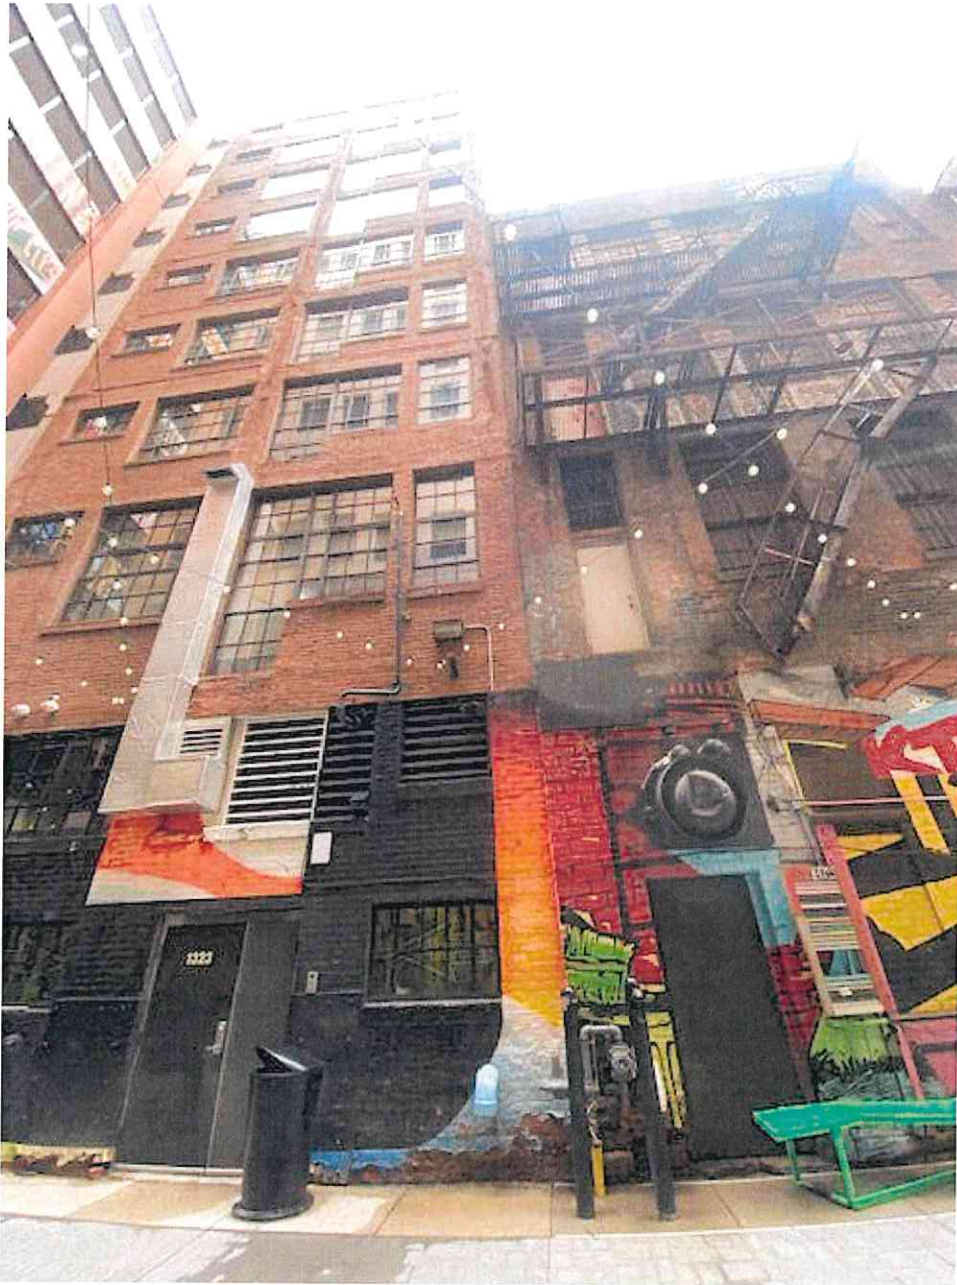
Photo 6. New aluminum replica windows on same elevation as windows in question for 1315 Broadway
