HIGGINBOTHAM SCHOOL WINDOW ASSESSMENT

SUMMARY

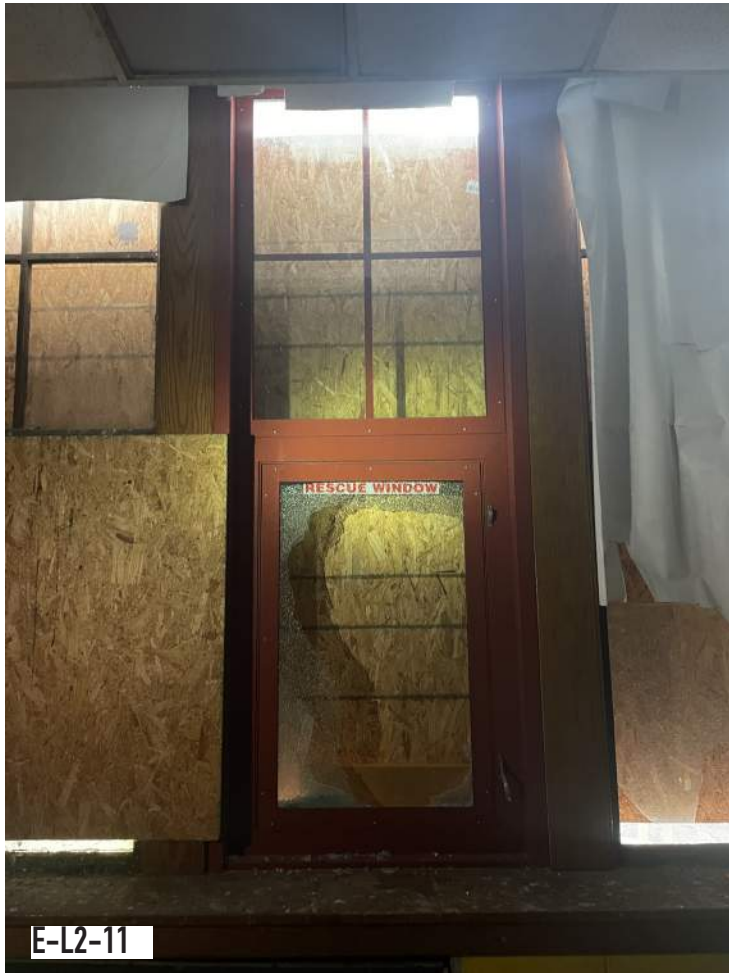
E-L2-11

TYPICAL FIRE RESCUE WINDOW

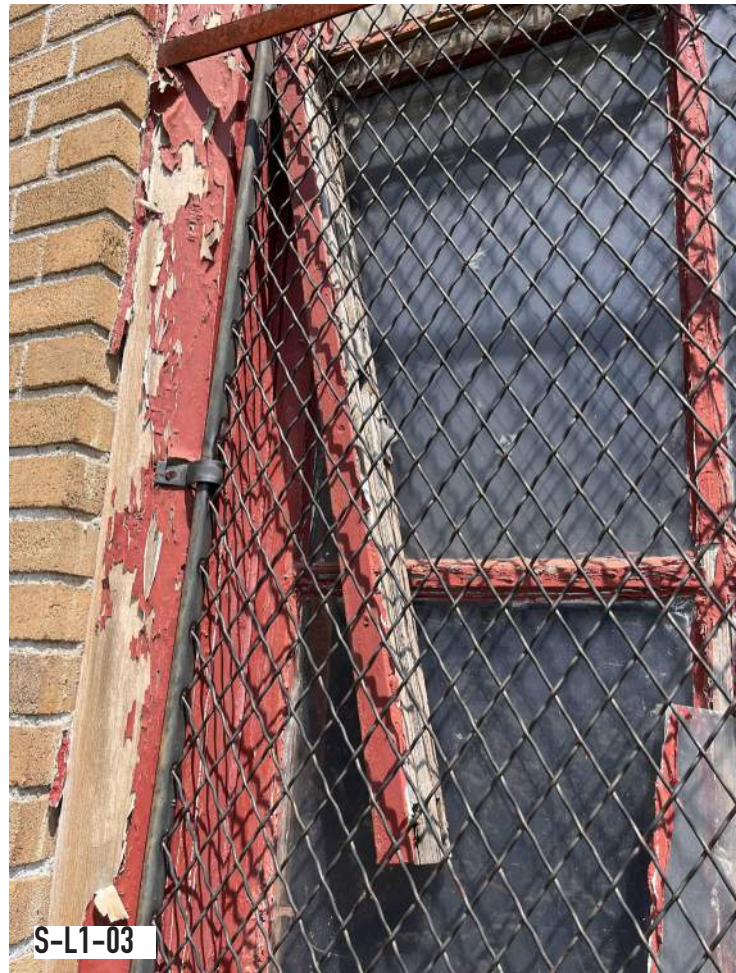
S-L1-03

TYPICAL EXAMPLE OF FAILURE OF FINGER JOINT CONNECTION AT LOWER RAIL OF TOP SASH.

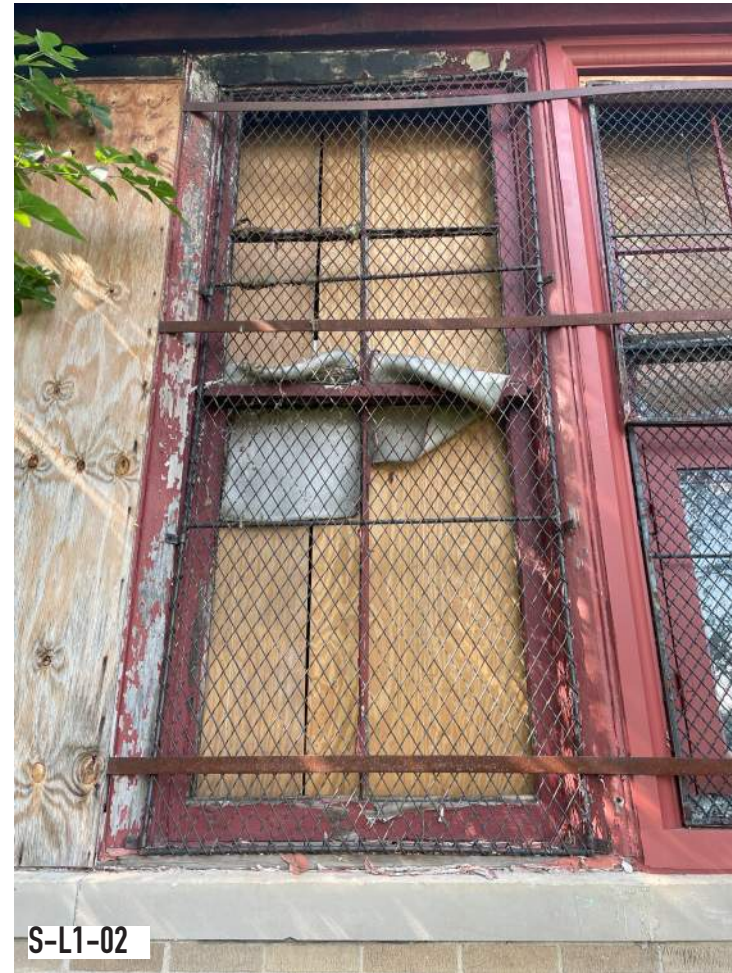
S-L1-02

FIRE DAMAGED WINDOW

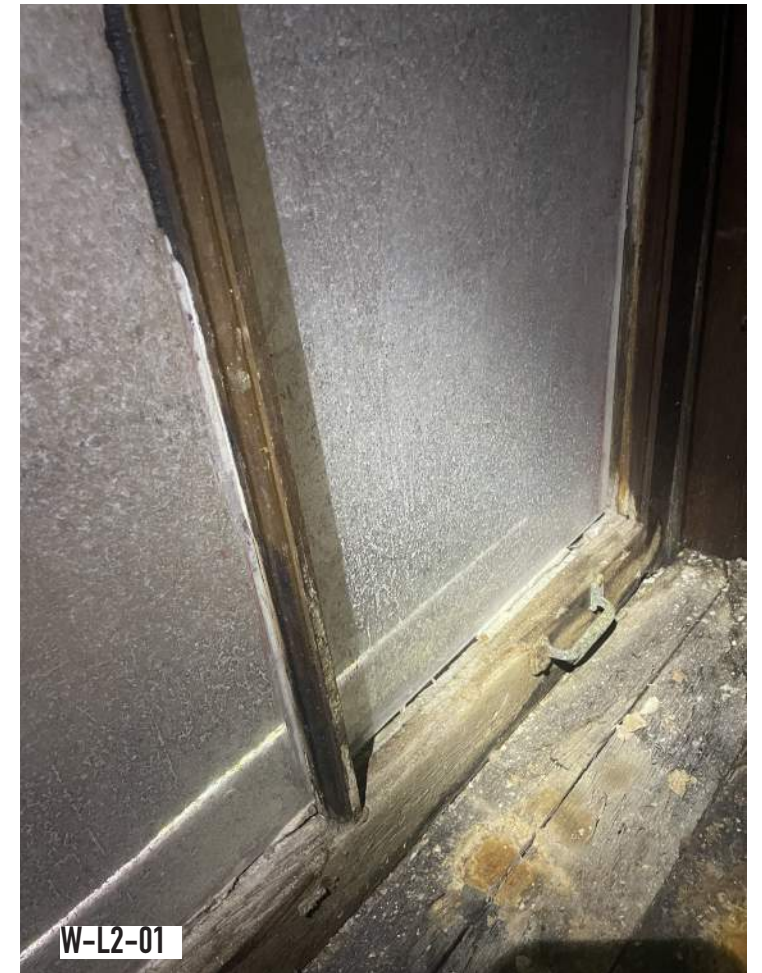
W-L2-01

ROTTED INTERIOR SILL AND SASH DUE TO WATER INTRUSION

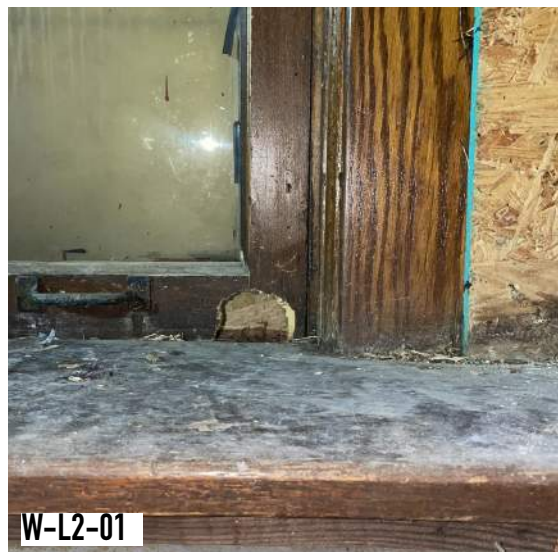
W-L2-01

MOUSE HOLE IN SASH RAIL

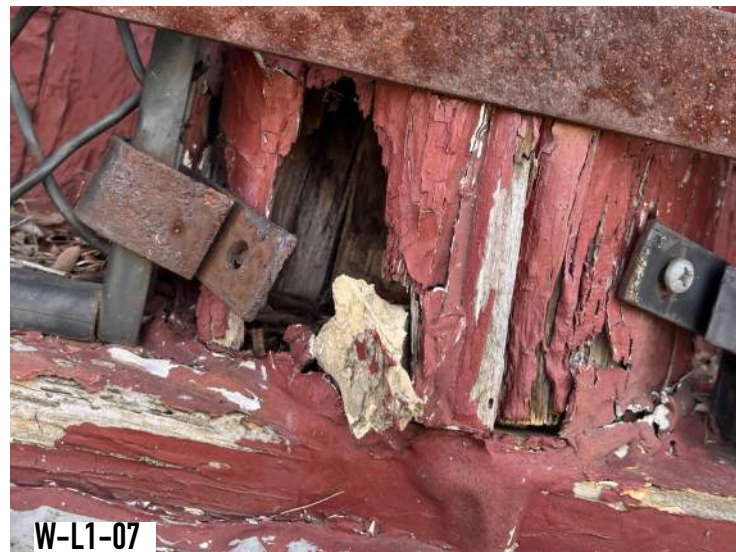
W-L1-07

TYPICAL ROTTED BRICK MOLD AT BASE RESULTING FROM SAFETY SCREEN MOUNTING BRACKETS FASTENERS

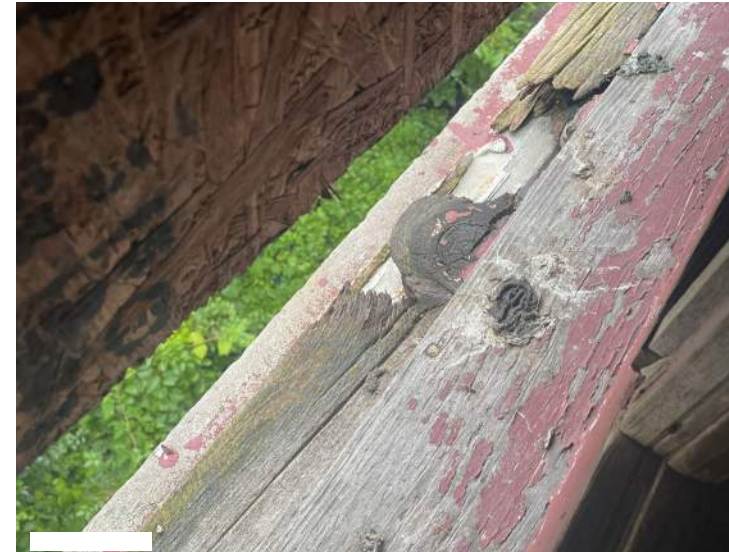
TYPICAL EXAMPLE OF FAILURE OF FINGER JOINT CONNECTION AT LOWER RAIL OF TOP SASH.

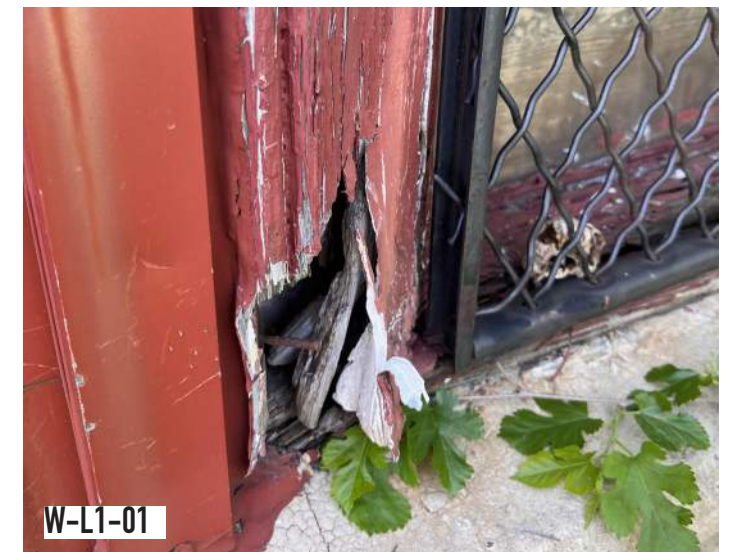
W-L1-01

TYPICAL ROTTED BRICK MOLD DUE TO INSTALLATION OF FIRE WINDOWS

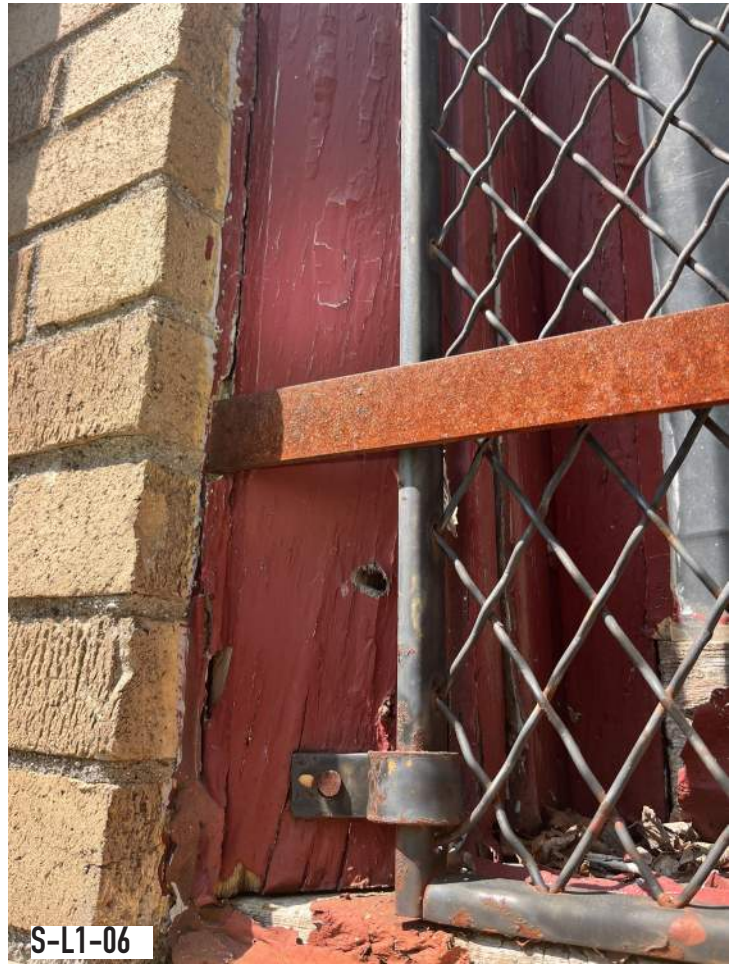
S-L1-06
HOLES CREATED BY SECURITY BAR MOUNTING IN BRICK MOLD

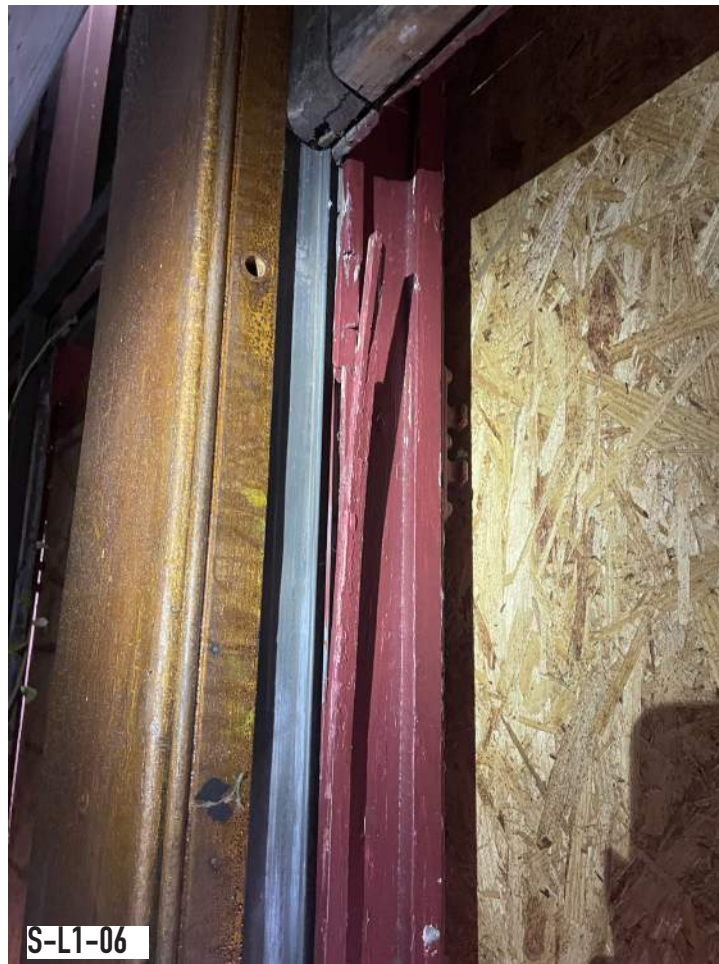
S-L1-06
DELAMINATED FRAME

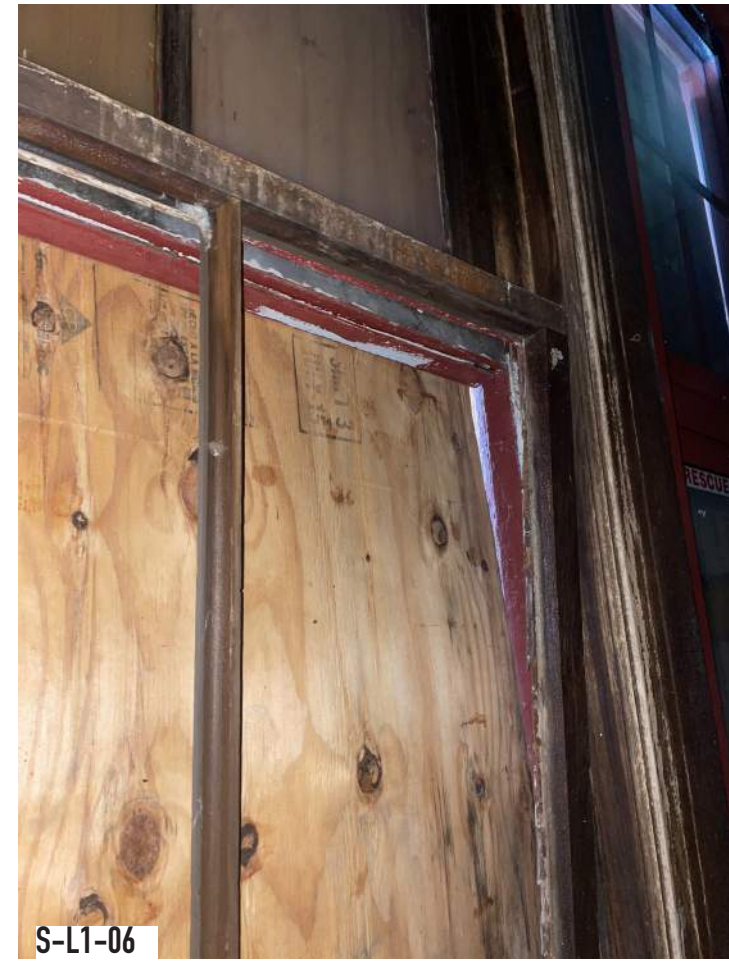
S-L1-06
LOWER SASH OUT OF PLANE

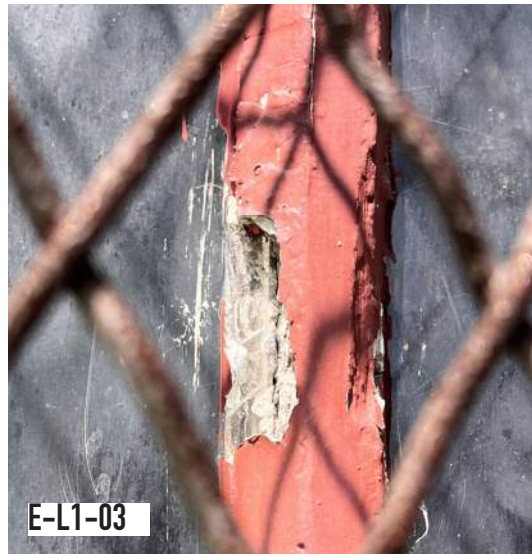
E-L1-03
TYPICAL EXAMPLE OF DAMAGED MUNTIN

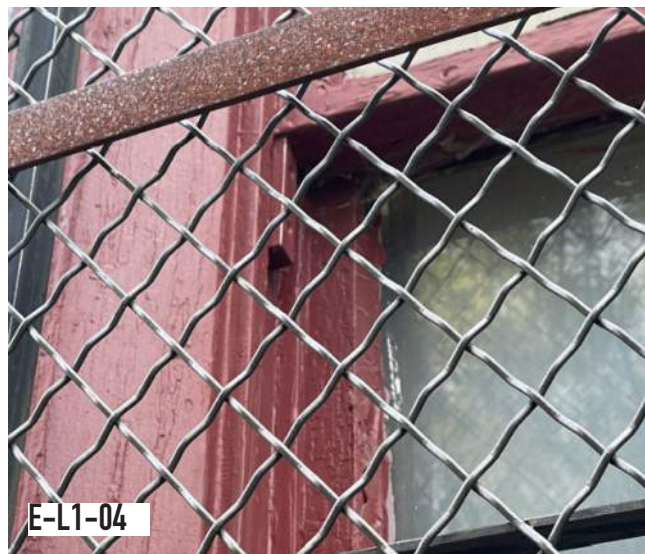
E-L1-04
WEIGHT BOX FAILURE LEADING TO UNSUPPORTED TOP SASH

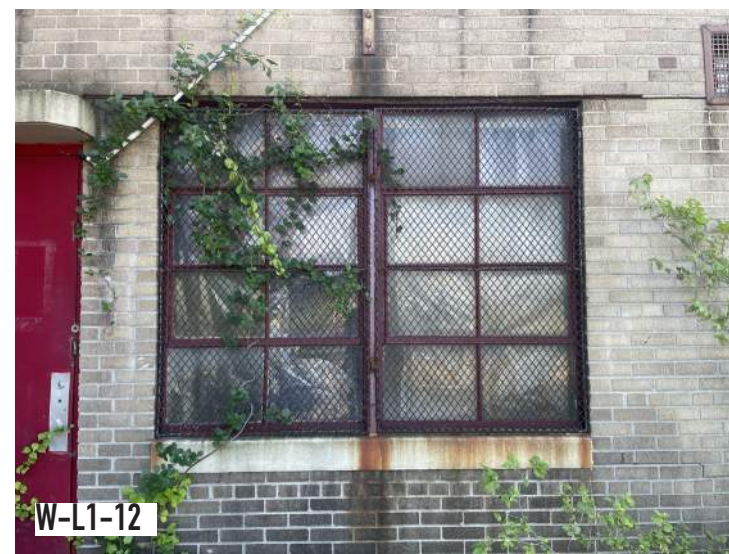
W-L1-12
STEEL WINDOWS WITH MINOR RUST

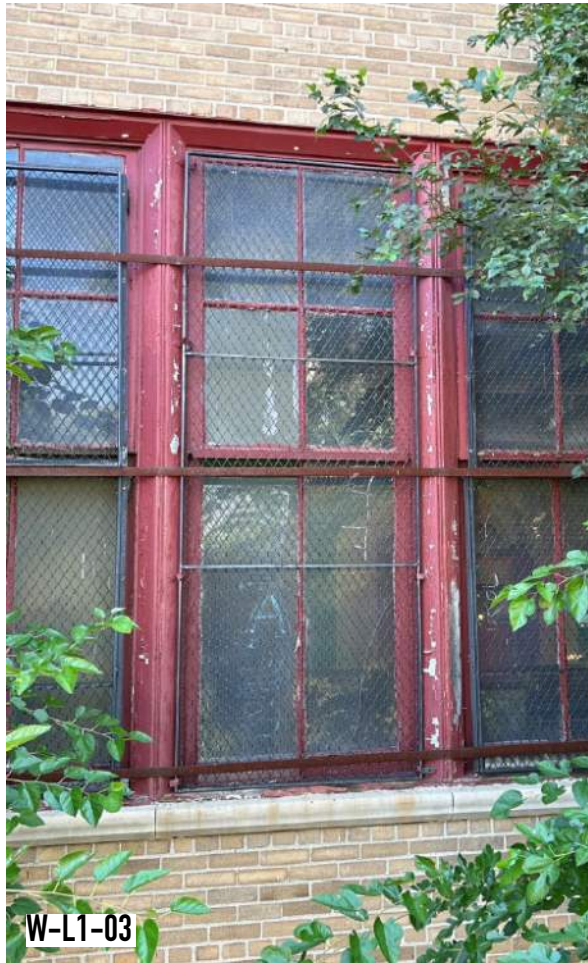
W-L1-03

INTACT BRICK MOLD REQUIRING NEW PAINT AND CAULK ABATEMENT

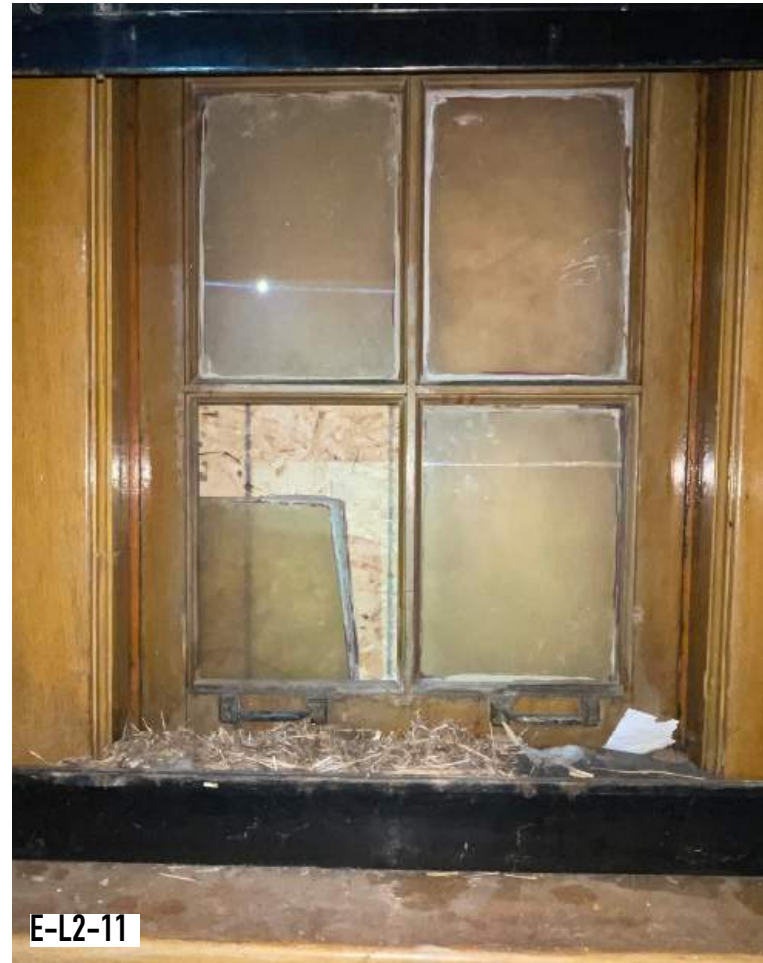
E-L2-11

WINDOW REQUIRING REPLACEMENT GLASS, FINISH IN FAIR CONDITION

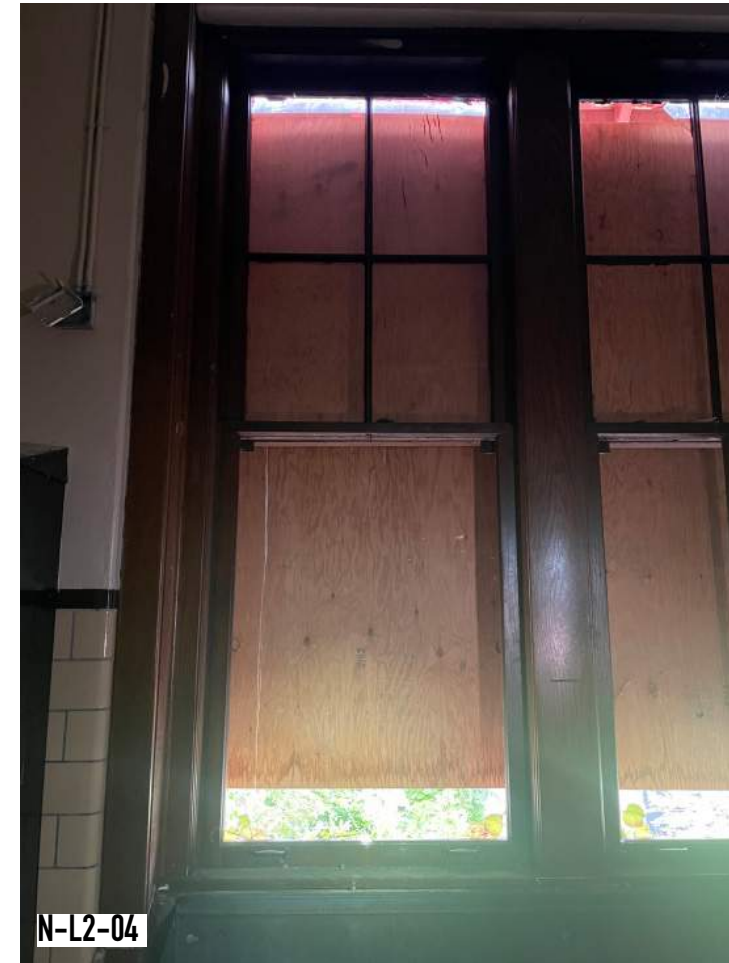
N-L2-04

FRAME, SASH AND GLAZING IN FAIR CONDITION

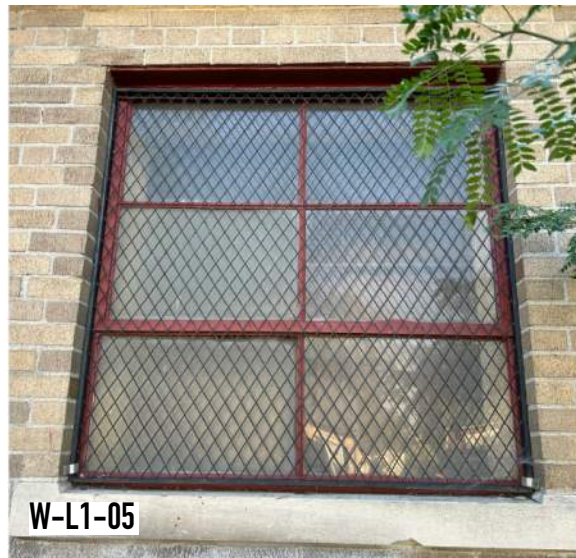
W-L1-05

STEEL WINDOW IN FAIR CONDITION

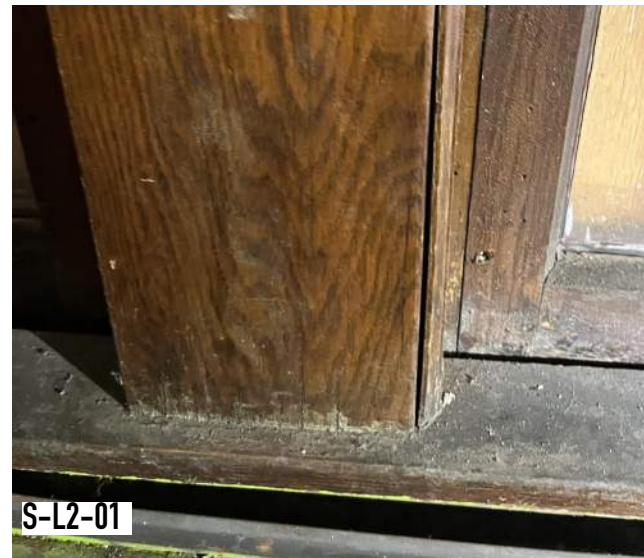
S-L2-01

MULL TRIM IN FAIR CONDITION

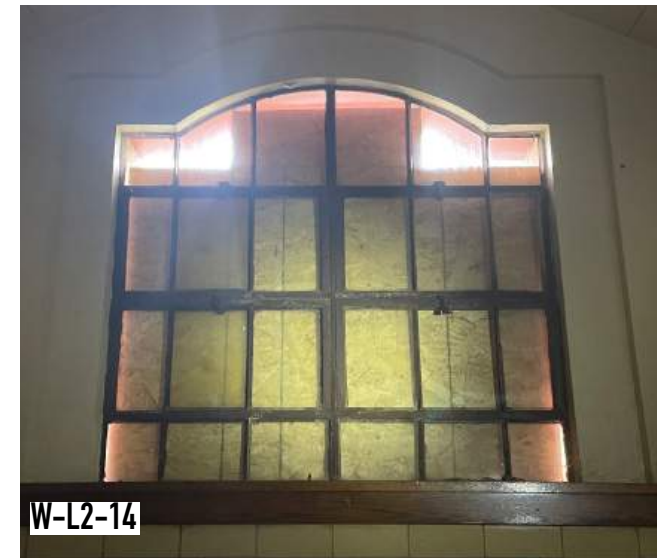
W-L2-14

DECORATIVE STEEL WINDOW WITH MINOR RUST REQUIRING PAINT AND REPLACEMENT GLASS
