4138 LINCOLN RENOVATION
WINDOW DETAILS

SUBJECTSTUDIO

1577 ASH ST. DETROIT, MI

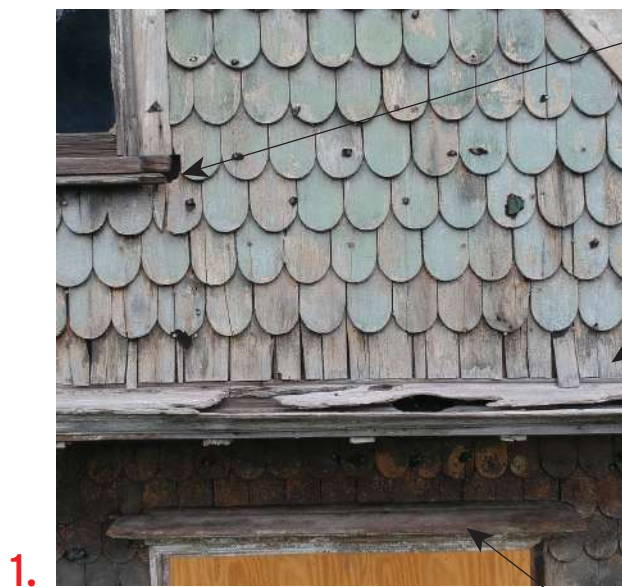
1.

DETERIORATED SUBSILL AT WINDOW ATTIC WINDOWS TO BE PATCHED
 MISSING MOLDING AT ROOF SILL TO BE REPLACED TO MATCH EXISTING
 REPLACE ALL SPLIT SHINGLES AT BOTTOM ROW
 DETERIORATED SILL CASING AT ROOF OVERHANG TO BE REPLACED

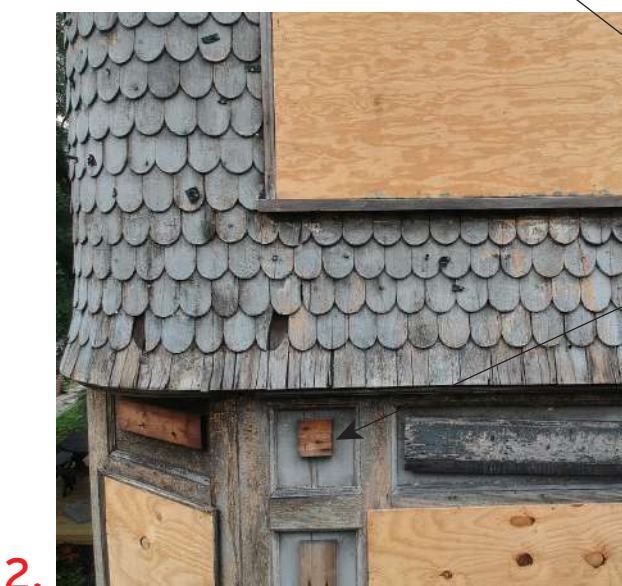
2.

CROWN MOLDING AT BOTH SECOND LEVEL WINDOWS TO BE REMAIN AND BE REFINISHED/REPAINTED
 TEMPORARY BLOCKING AT BAY WINDOW PANELING TO BE REMOVED
 REPLACE MISSING AND SPLIT SHINGLES, NEW SHINGLES AT BOTTOM ROW

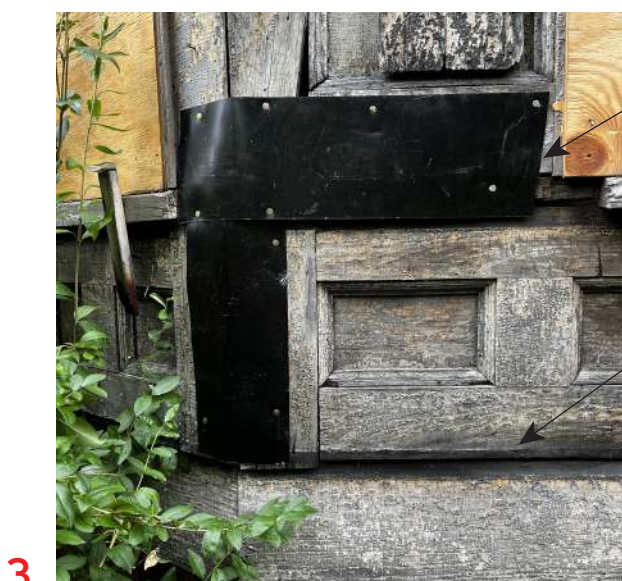
3.

DUTCHMAN REPAIR REQUIRED AT CRACKED PANEL MOLDING CONCEALED BY METAL PANEL
 REPLACE MISSING SUBSILL DRIP EDGE ACROSS MAJORITY FIRST LEVEL BAY WINDOWS

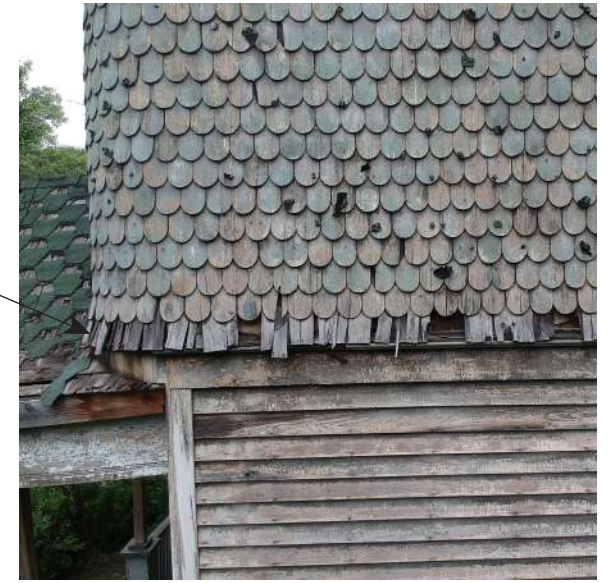
REPLACE ENTIRE BOTTOM ROW OF MISSING/SPLIT SHINGLES

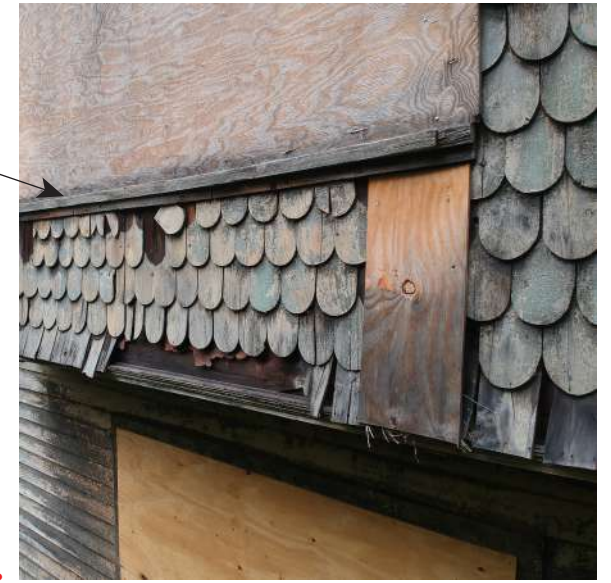
REPLACE DETERIORATED/SPLIT SUBSILL TO MATCH EXISTING IN PROFILE AND TYPE

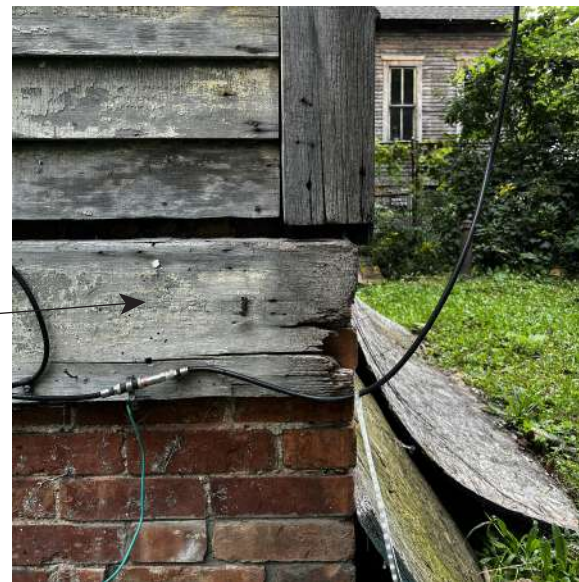
REPLACE ENTIRE DETERIORATED BASE TRIM BOARD WITH PRESSURE-TREATED BOARD INSTALL UP TO BOTOM OF SIDING TO CLOSE EXISTING GAP

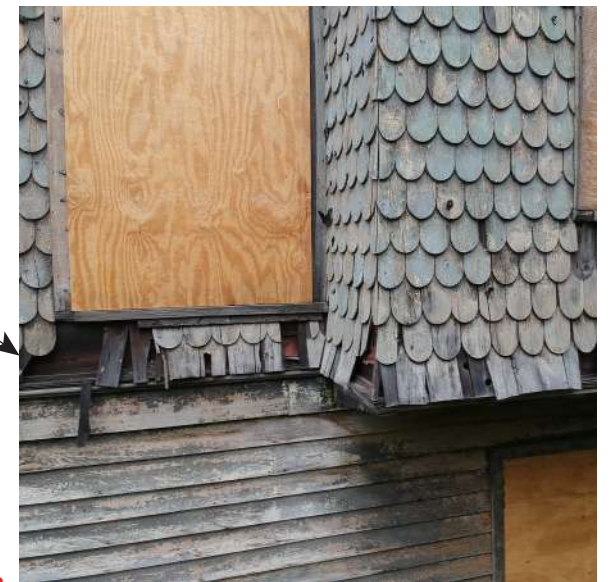
REPLACE ENTIRE BOTTOM ROW OF MISSING/SPLIT SHINGLES

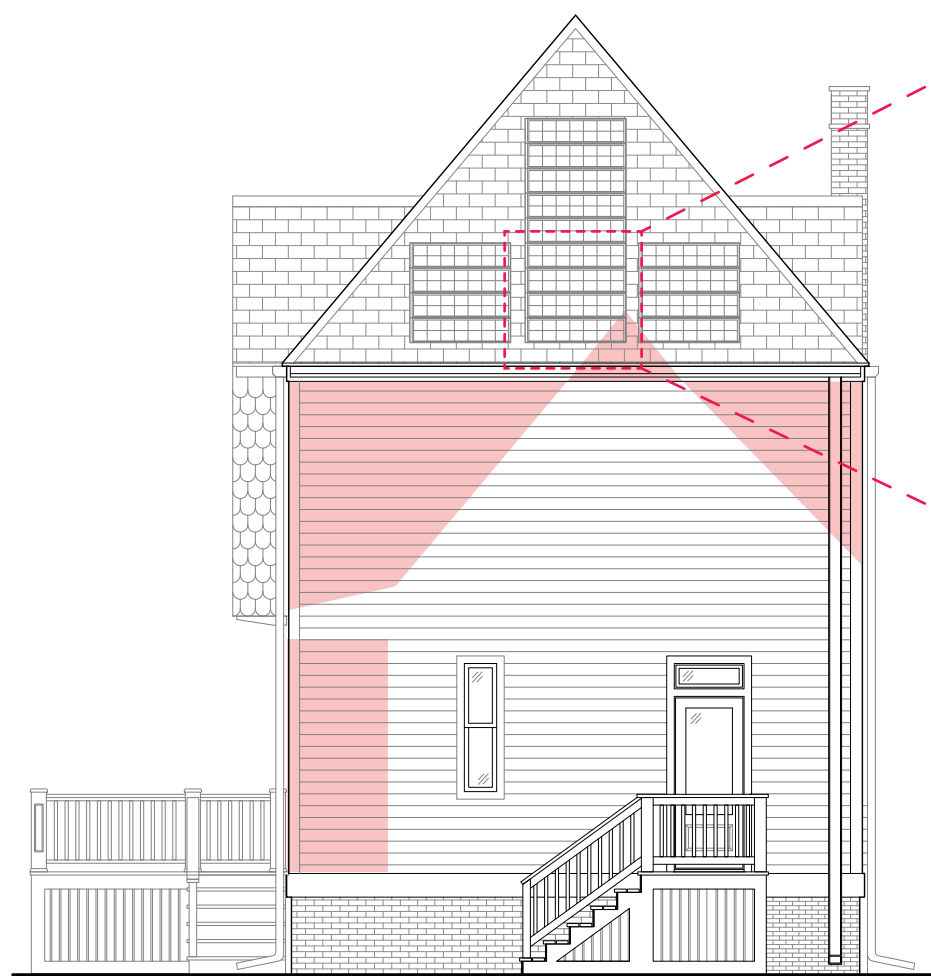
EXISTING CMU CHIMNEY TO BE REMOVED,
AND ROOF PATCHED

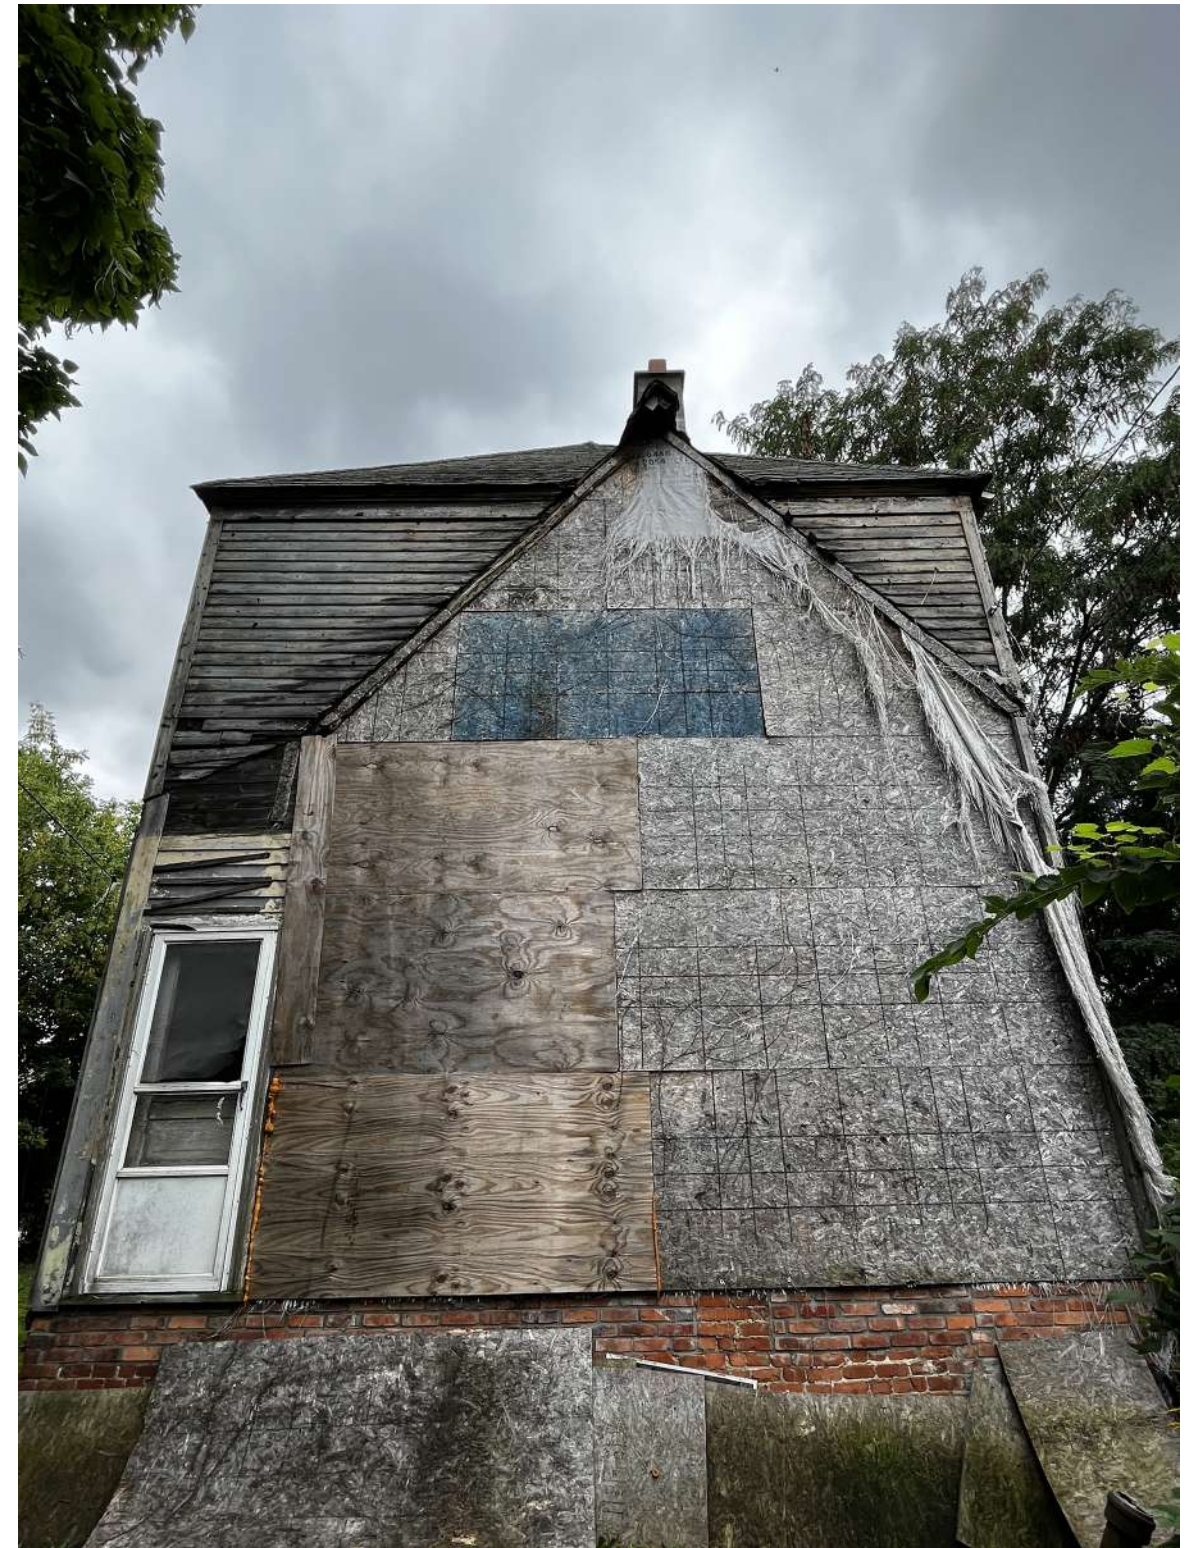
ALL EXISTING SIDING AND TEMPORARY SHEATHING AT REAR
IS TO BE REMOVED AND REPLACED WITH NEW LAP-SIDING
MATCHING EXISTING IN TYPE, PROFILE, AND EXPOSURE
