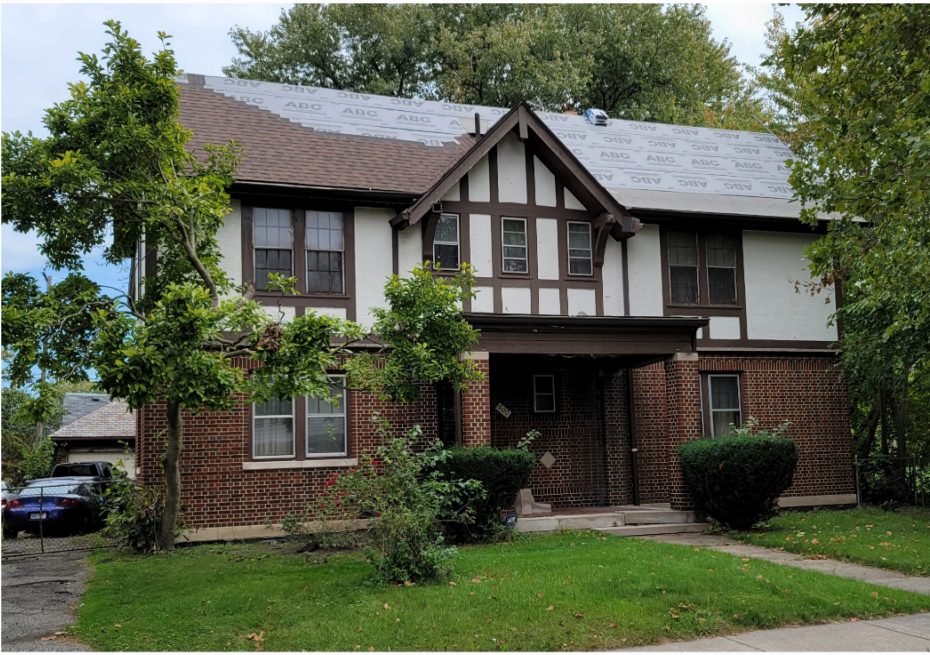
Exhibit 1, slate roof tile was removed, base on customer request for new asphalt shingle roof replacement because of constant roof leaks and hi cost for repairs, roof never stop leaking into Mr & Mrs Davis home .

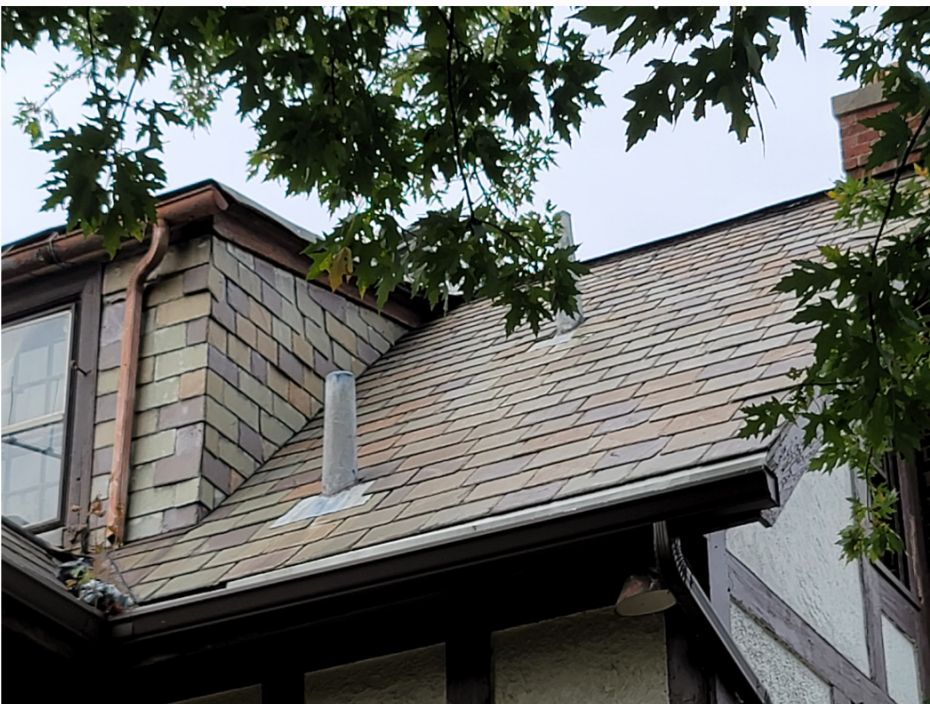
Exhibit 2 This is a section of slate tiles roof remains. This areas of slate tiles have hair lines cracked for previous roofing contractor

that repair the flat roof walked up on top of slate tile roof that made tile to crack and separated in areas.

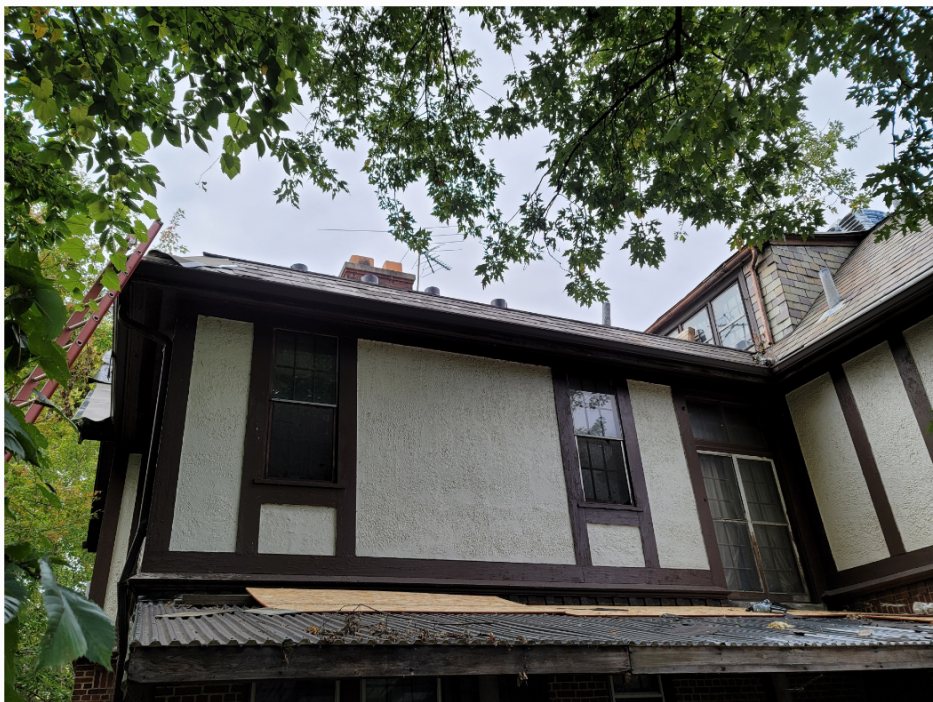
Exhibit 3 lower over hang off flatroof area is in good condition except over raked edge of flat roof is wrong no metal installed for flat roof over slate roof and damage some upper areas of slate tile.

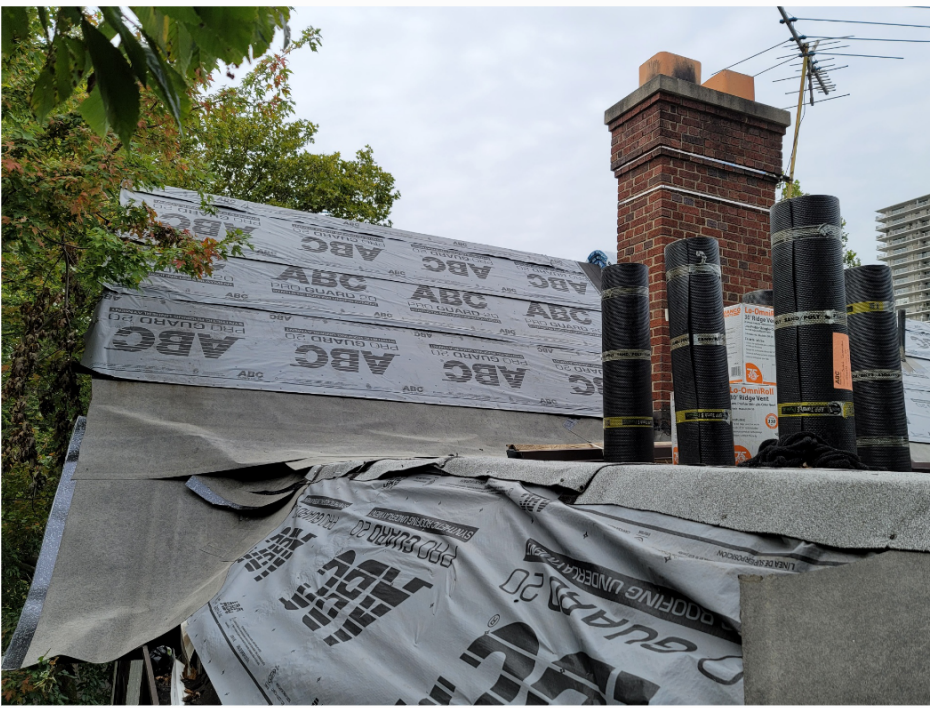
Exhibit 4. Due to the stop of work based on approval not received from historic district proof. while secured and seal water tight no water has entered since the water tight.

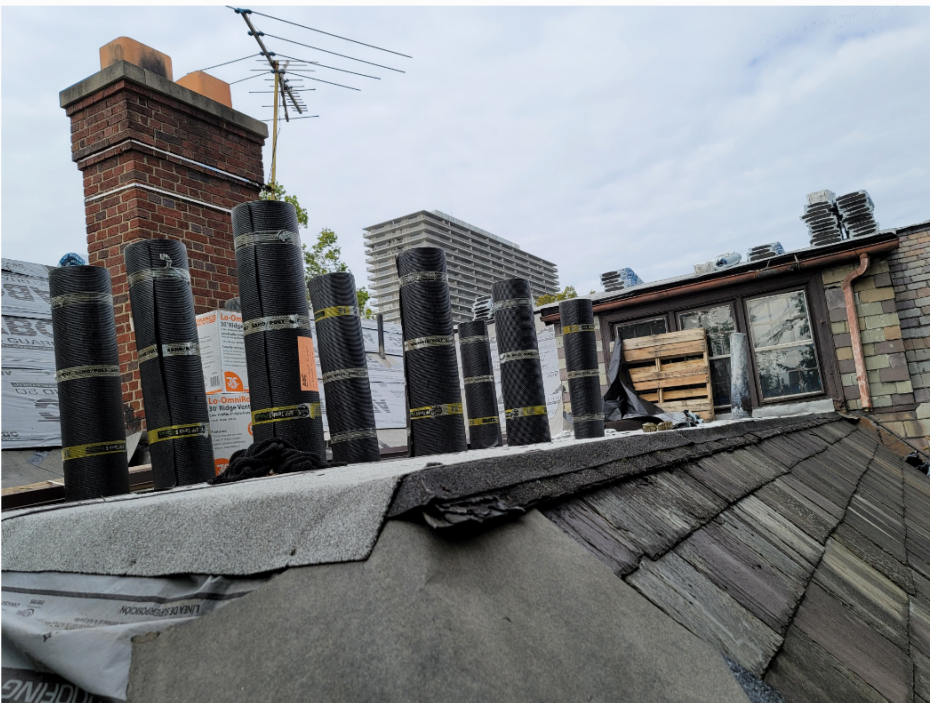
Exhibit 5. Flatroof was repaired or replaced not with metal wide drip edges to keep edges from coming up from wind stomp.

Aslo on dormer wall tiles are not connected and attach to wall

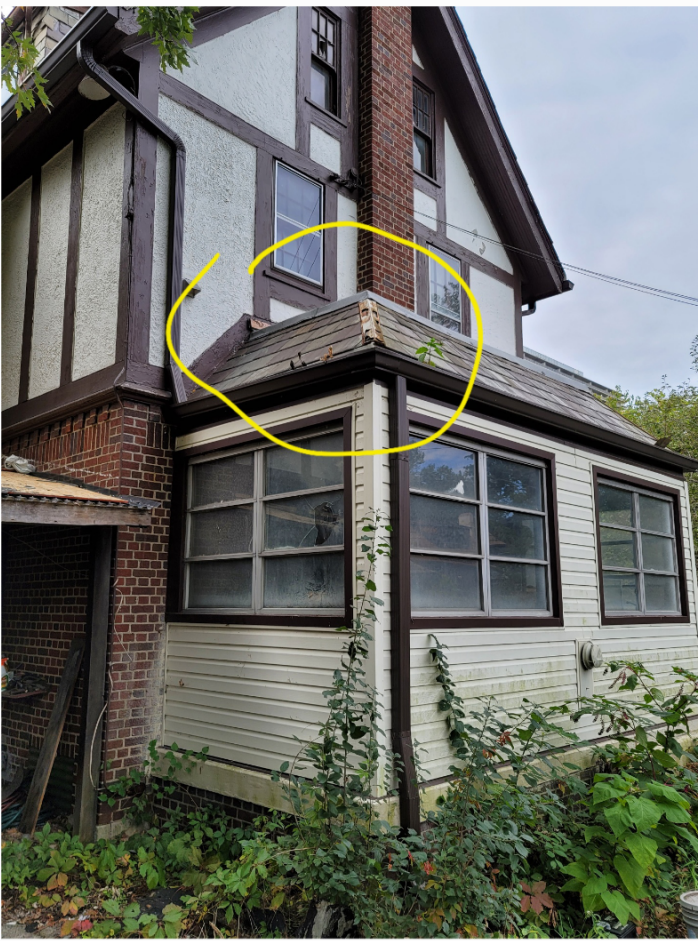
Exhibit 6. All galvanized valleys and hip metal was rusted and corrosion had holes this is one of the reasons of the decision of customer to replacing slate tile from the front valley was the same corrosion was the same all valleys back gable and front was rusted and cracked .

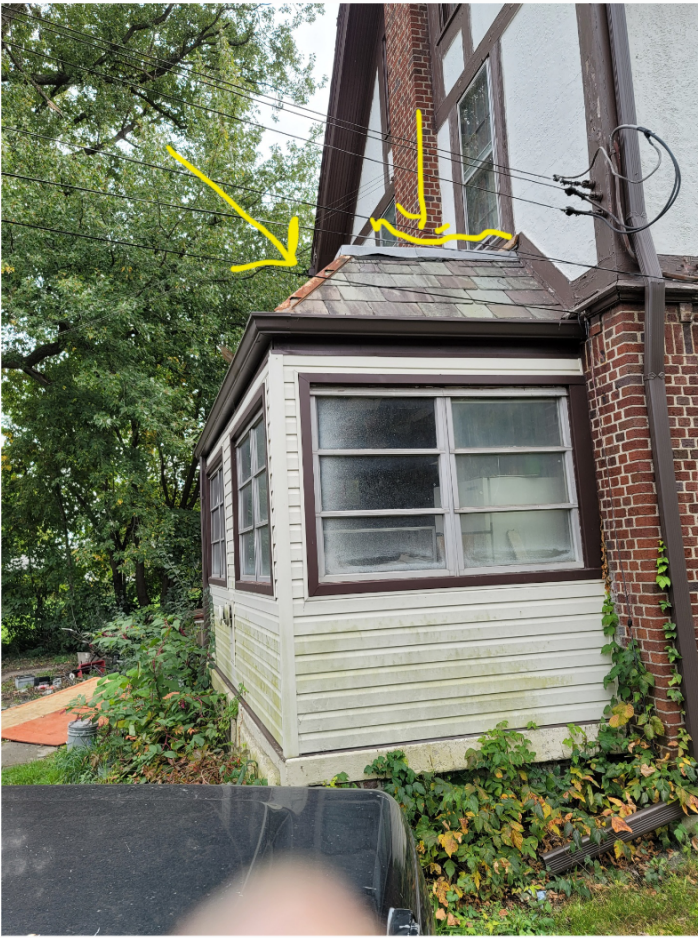
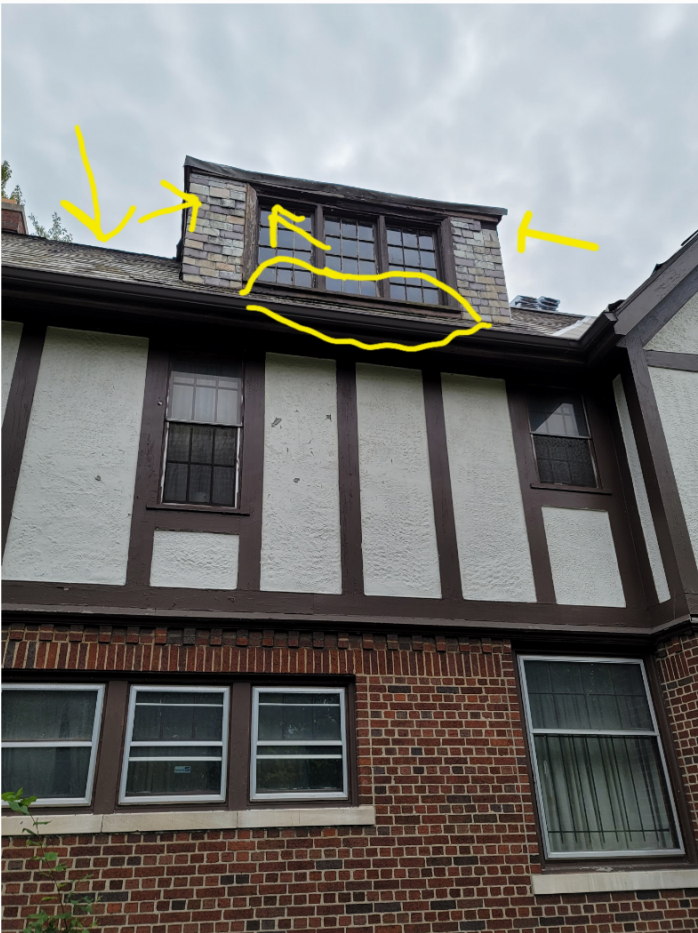
Exhibit 7. Front dormer apron, walls, flat roof

slate tile damaged, tile is not secured to wall, flat roof no wide dripe edge to cover facial boards.

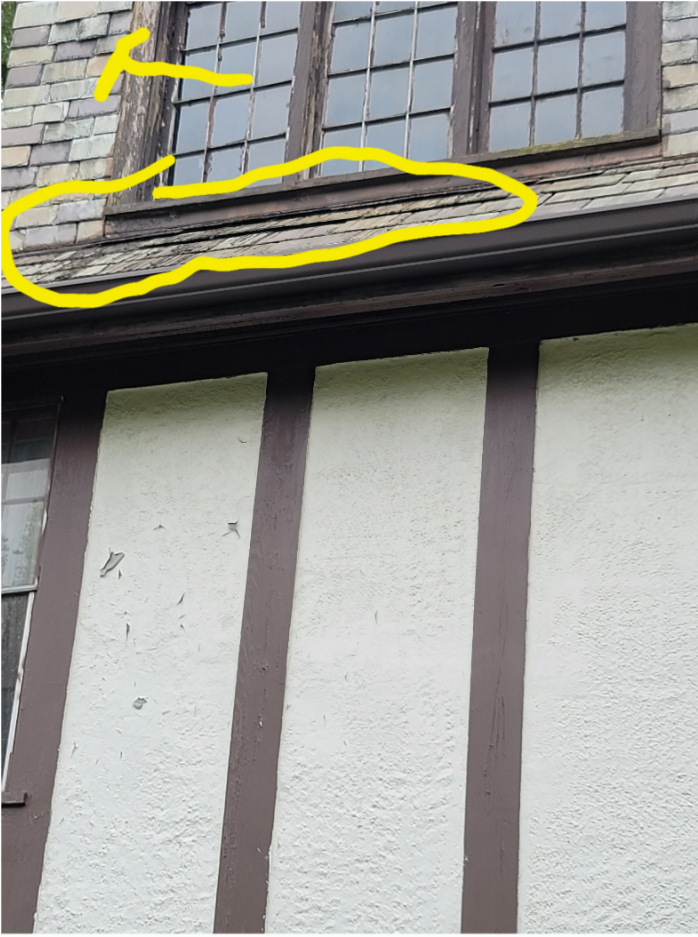
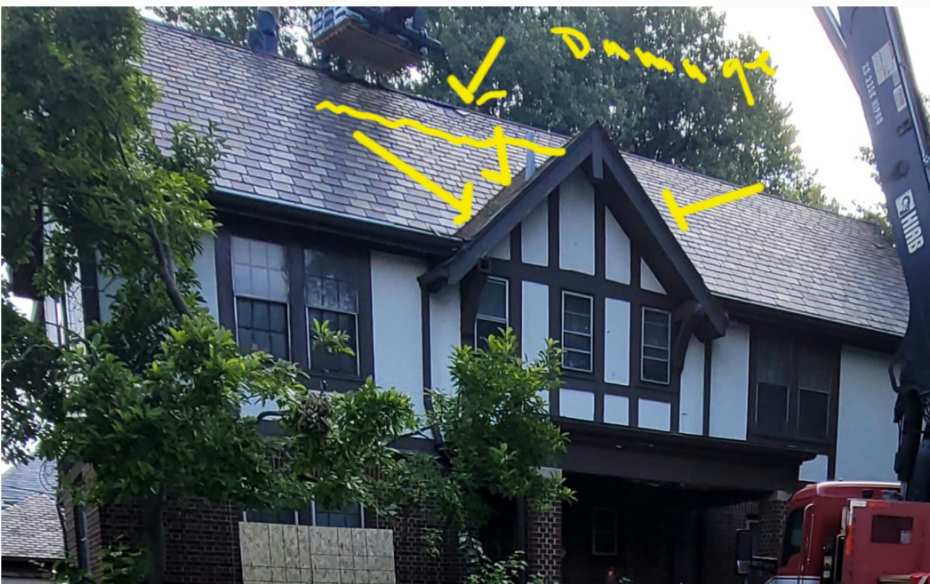
Exhibit 8. Damage valleys, cracked and

missing slate tile.

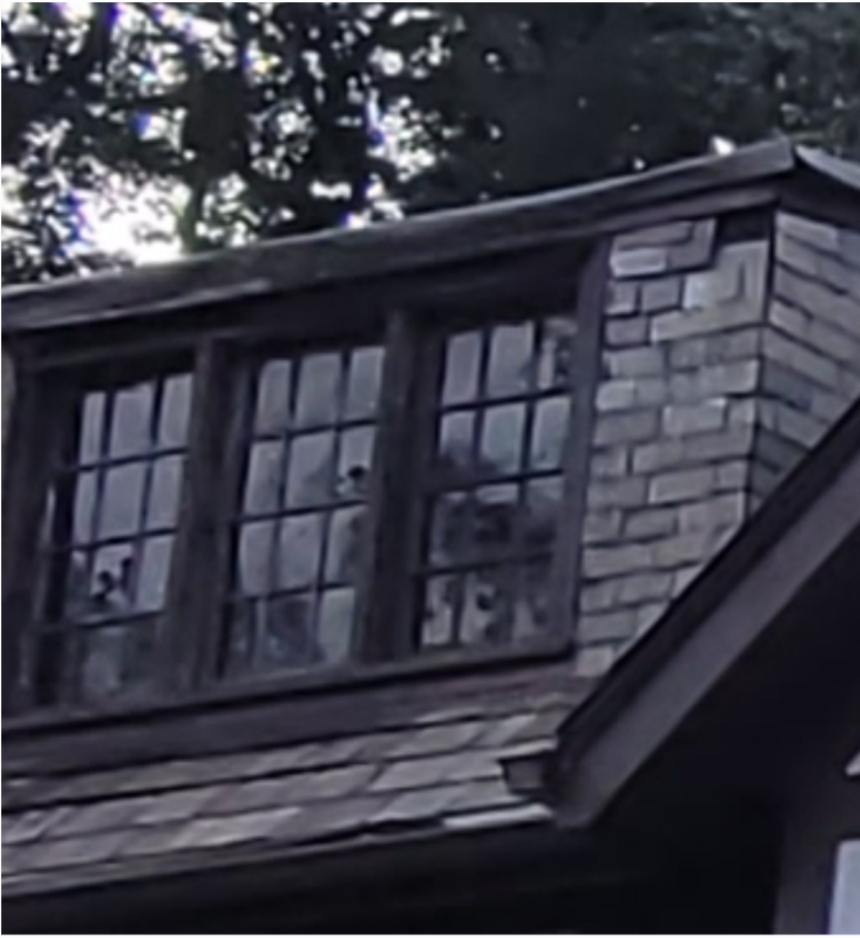
Exhibit 9. Missing slate tile, flat roof area no drip edges.

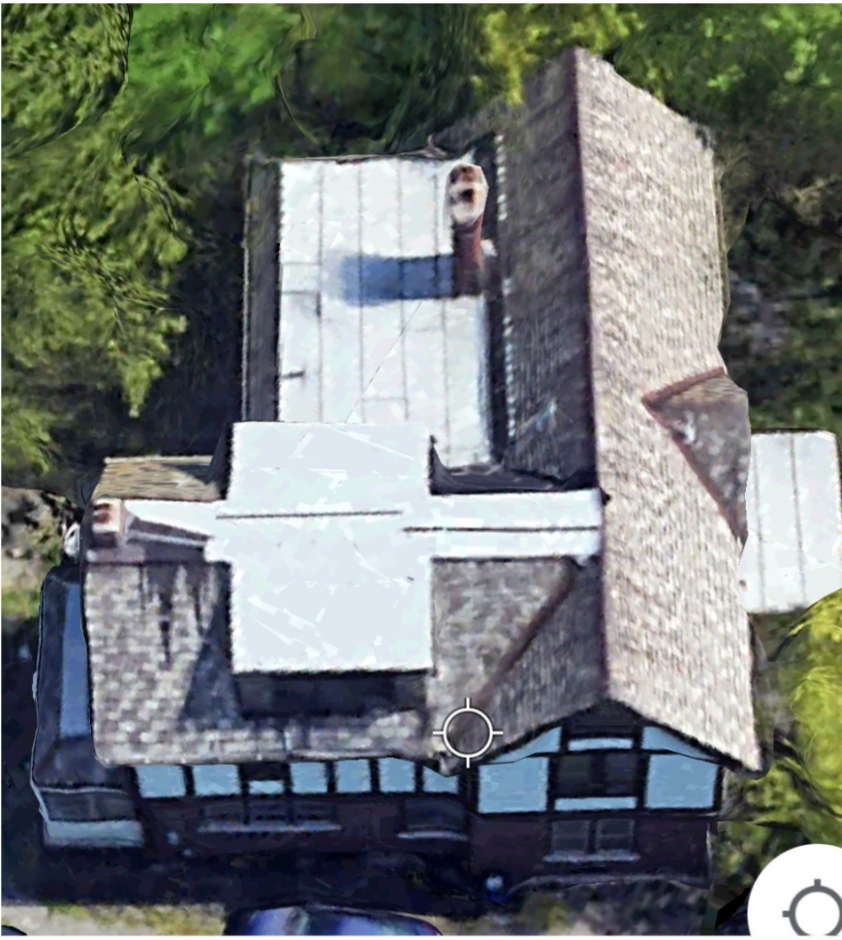
Exhibit 10. This is the slate tile before slate was removed. 4 Rusted and corrosion had holes in slate, missing slate, crack slate.
