2 story Brick duplex

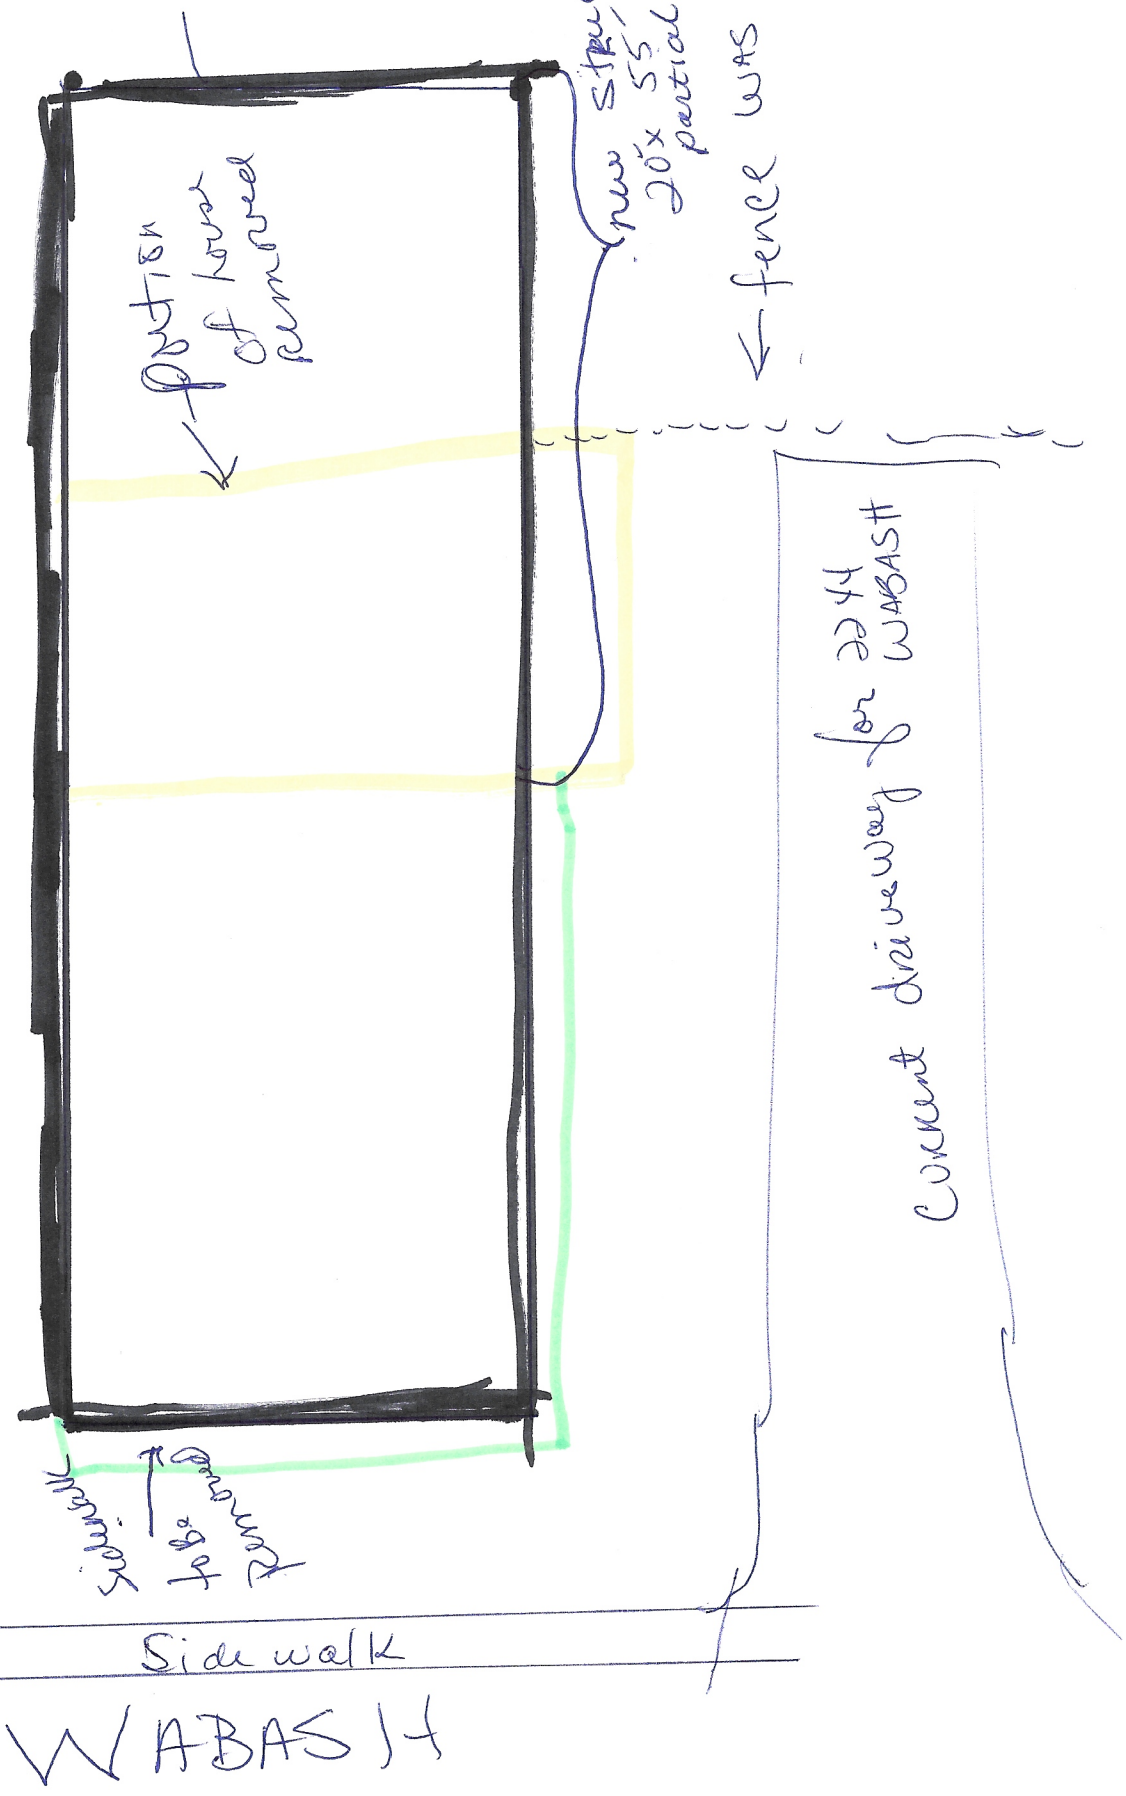
portion of house removed

new structure 20x55 with partial basement

fence was removed

Retaining Wall Removed

House - SINGLE Story - frame seems to be the same as the one that was removed ORIGINAL

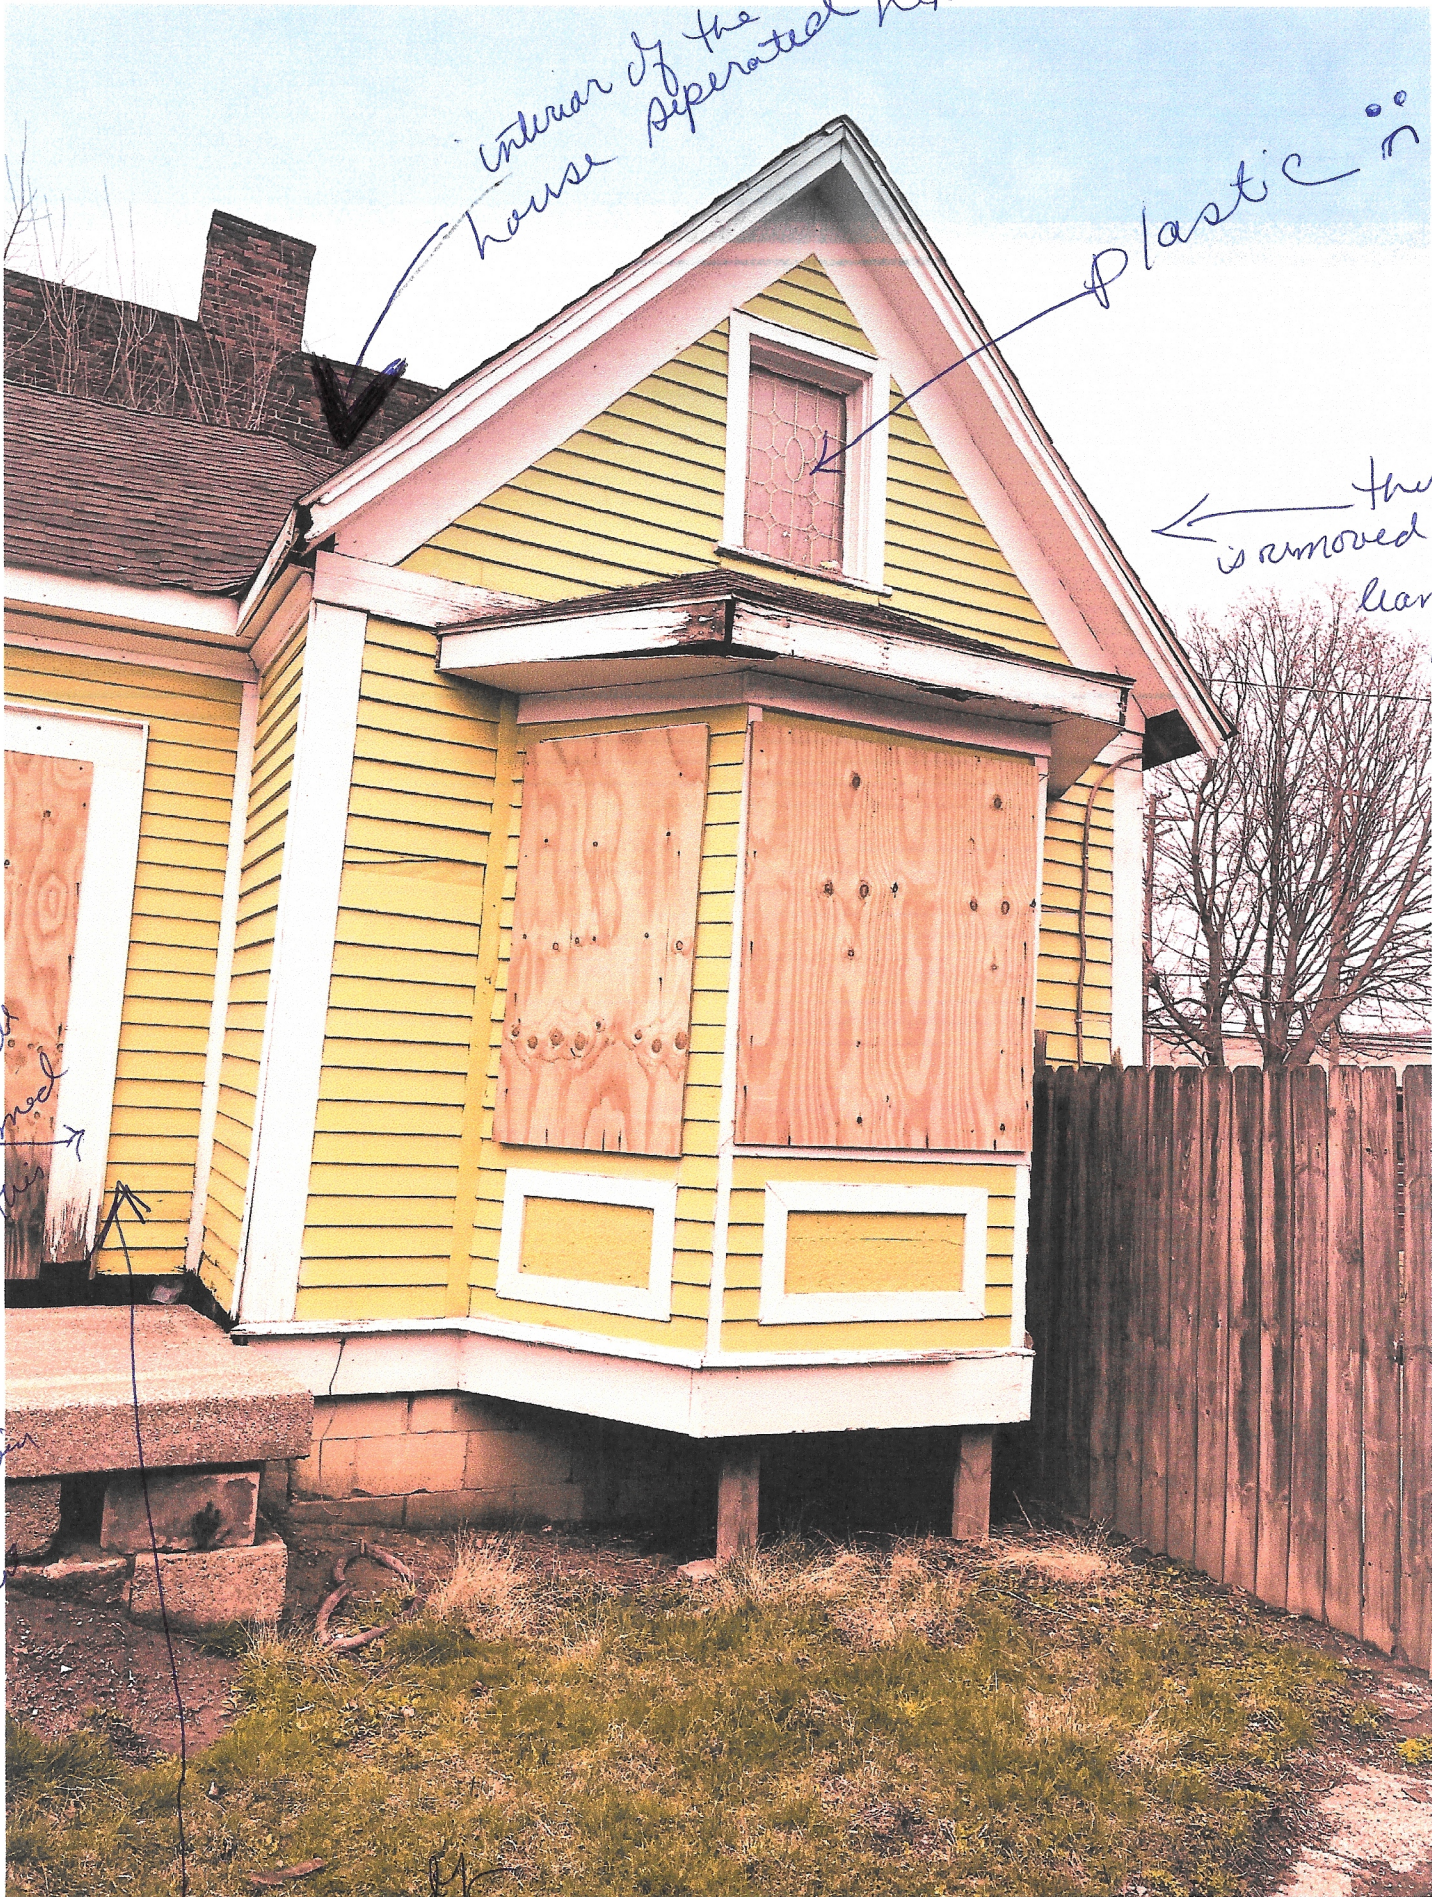
Interior of the house separated here

plastic in

this is removed. it leaned North West

leaned South

door will be framed like this

Remove this cement

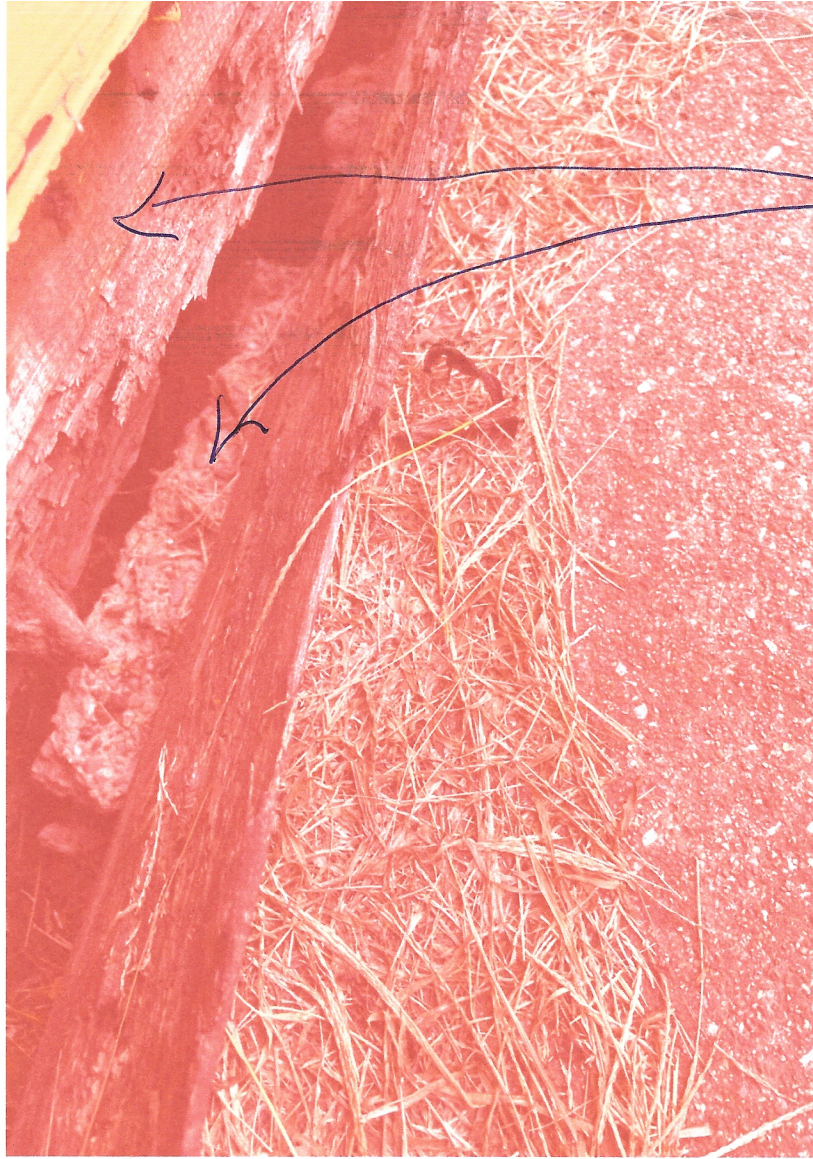
Rotted wood  
replaced  
Cement  
Removed

← Cement  
sidewalk  
to be  
Removed

← ~~Cement~~  
Cement Block  
put in for  
foundation

Original foundation  
to be repaired, by  
jacking it up to square and  
using cement block to support.
