1665 W Boston Blvd, Detroit MI

### **1665 W Boston - Description of Existing Conditions**

### **1665 W Boston - Description of Project**

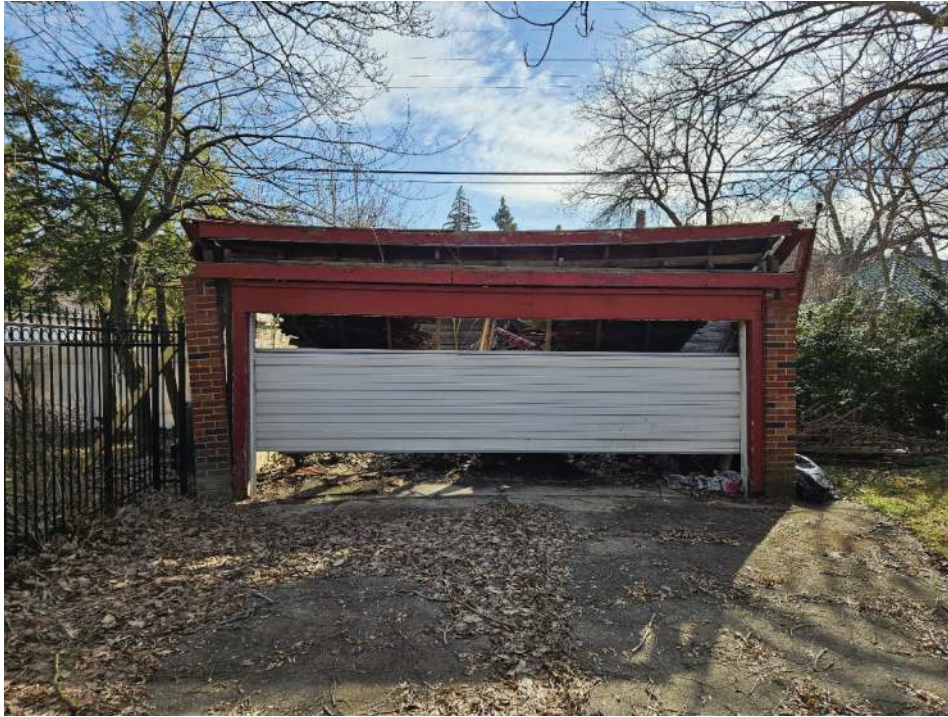
The Garage is tricolored brick masonry on wood framed back up wall. The roof was suspected of being an asphalt shingled roof assembly with a wood frame. The roof has since caved into the interior of the garage, causing cracks and displacement in the brick walls, damage to the overhead door and continued deterioration to exposed wood framing.

Garage North Elevation – Overview

The garage will be demolished due to the collapsed roof and displaced walls at all elevations. Once removed, the existing concrete pad will remain, and no other structure will be constructed. Open areas in the neighbor's fence and back fence will be installed to match adjacent existing fences.

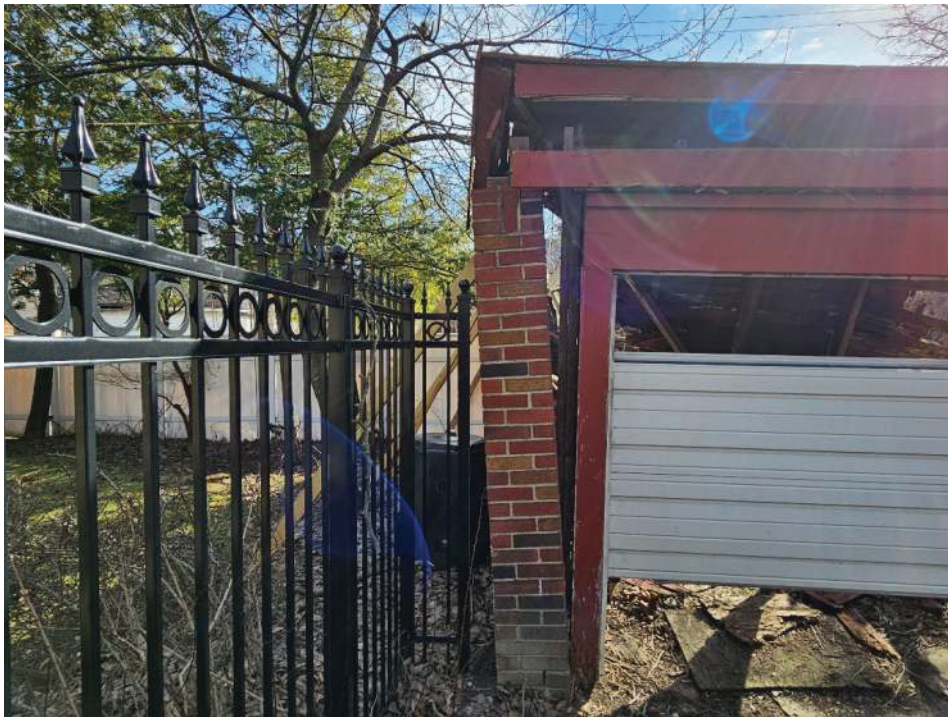
Garage North Elevation – Displaced wall

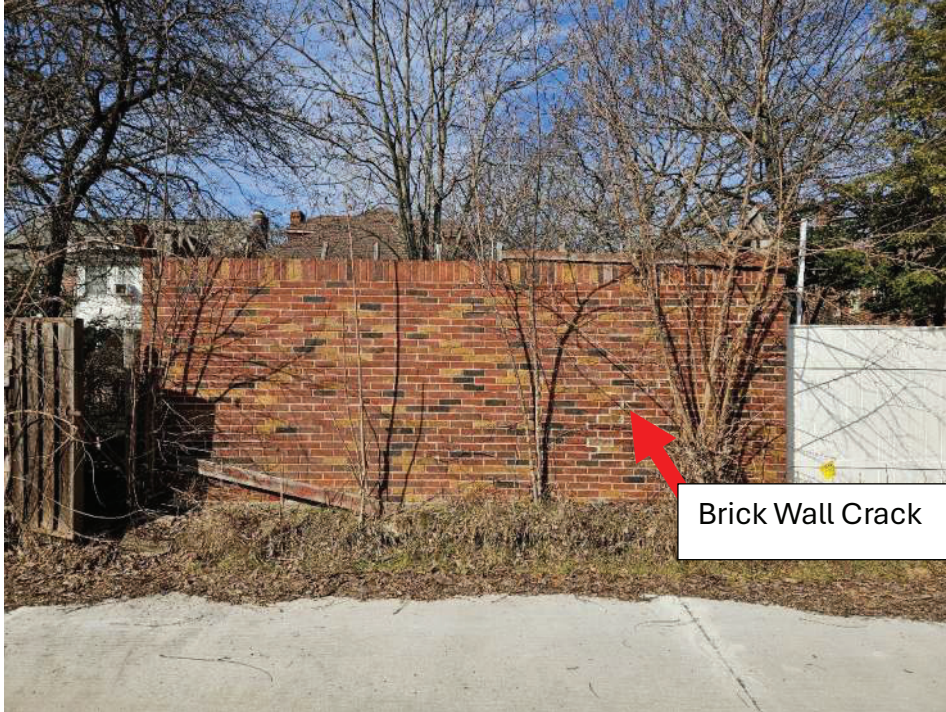
Garage South Elevation – Overview

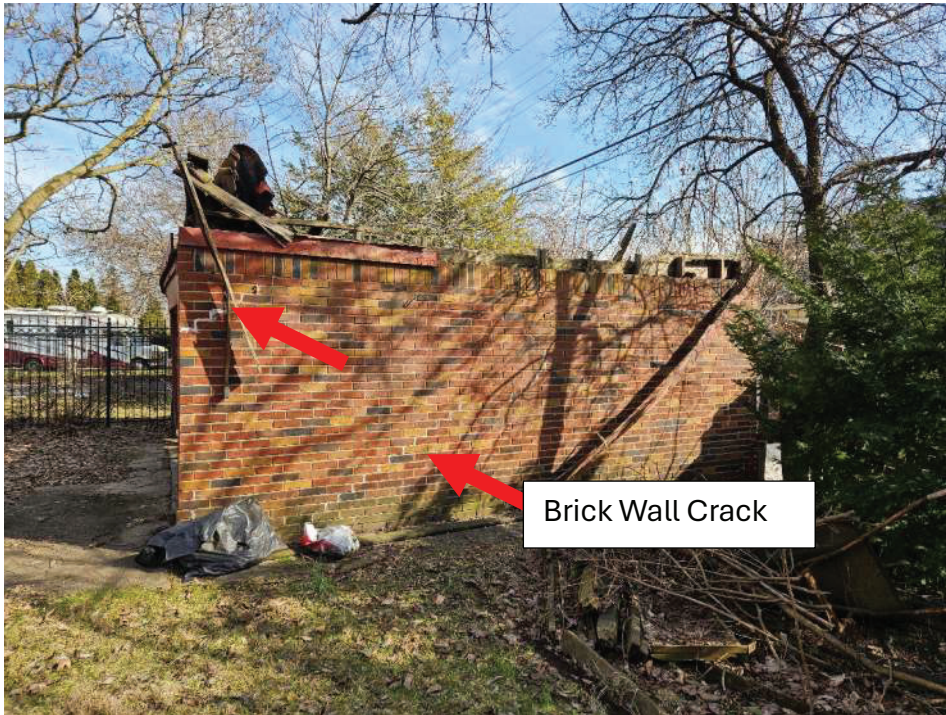
Garage West Elevation – Overview

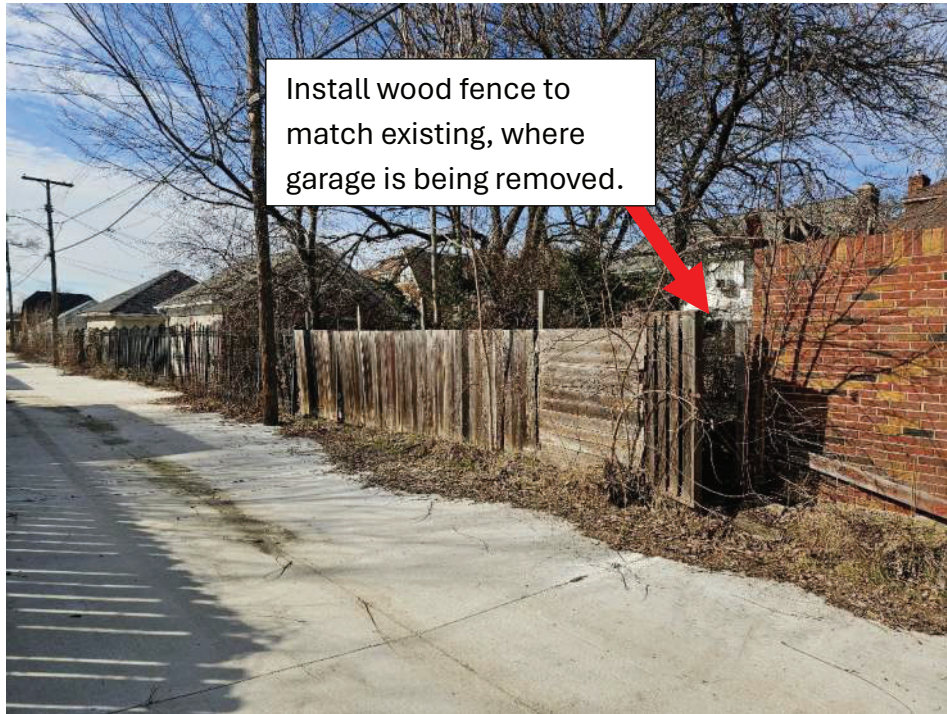
Existing wood fence at the alley

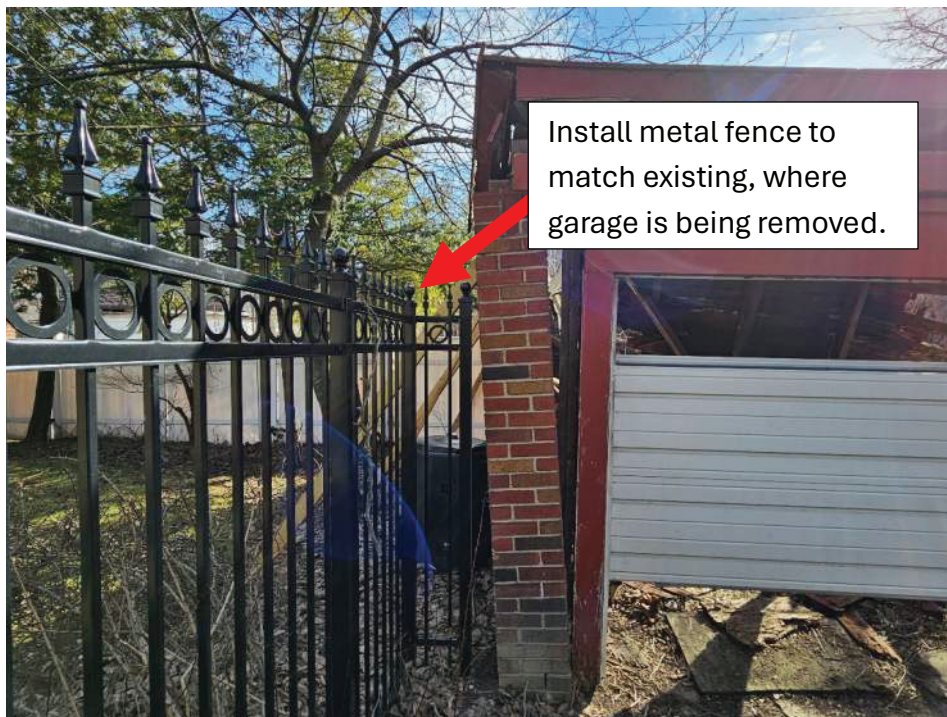
Existing metal fence near adjacent property

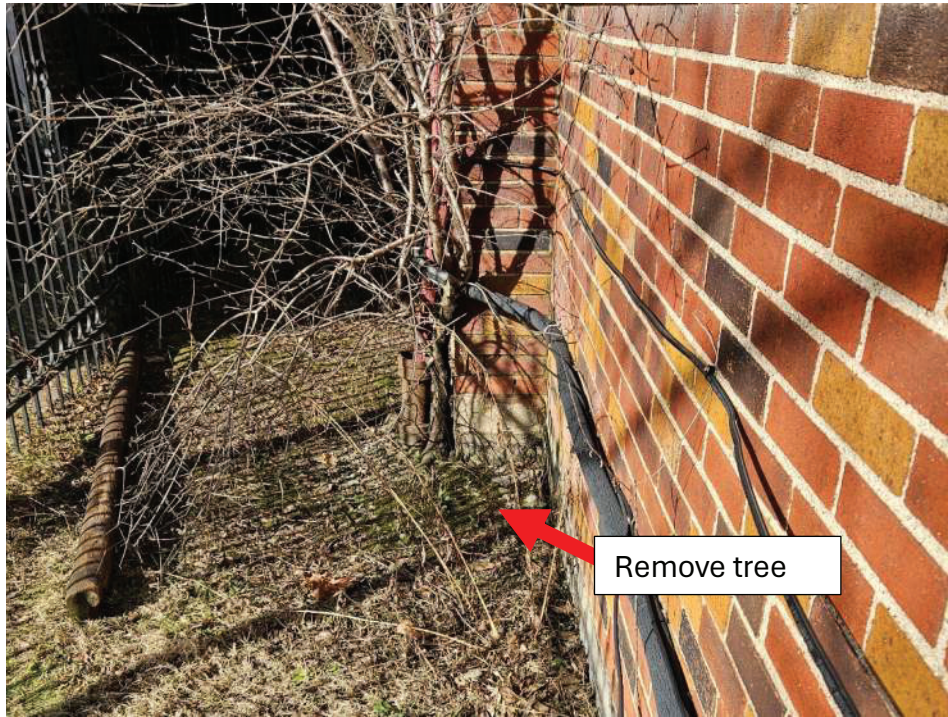
A concrete driveway exists on the east side of the house. Multiple trees and vegetation were observed throughout the site. Multiple concrete pads were displaced near the front of the house, that currently pose as tripping hazards due to trees planted too close to the driveway. Certain trees and plantings were observed growing adjacent to the foundation wall causing potential paths of water infiltration and can potentially damage the foundation wall.

House West Elevation - Example of small tree near foundation wall

Trees and planting near the foundation will be removed to avoid damage and potential water intrusion at those locations. The displaced concrete pads at the driveway will be removed and replaced. Concrete to match existing.

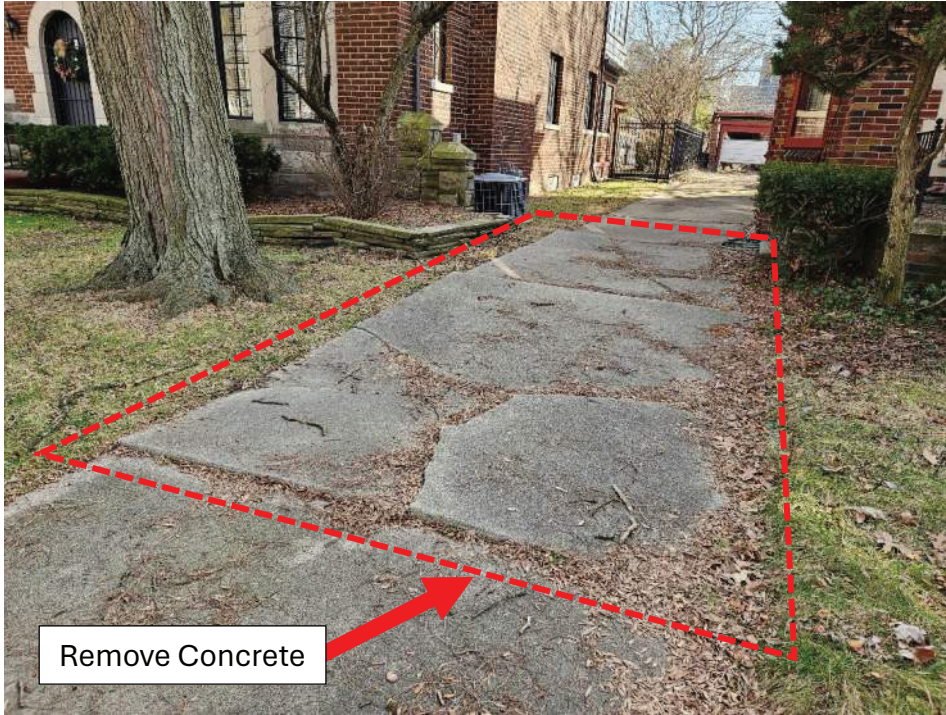
Driveway Looking South – Two damaged concrete pads

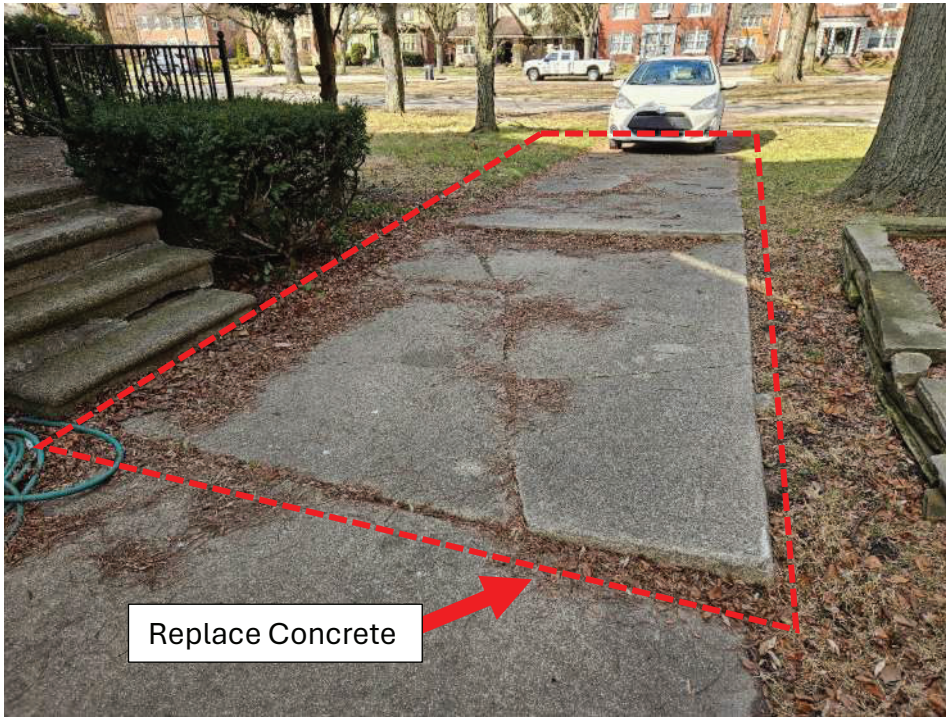
Driveway Looking North – Two damaged concrete pads

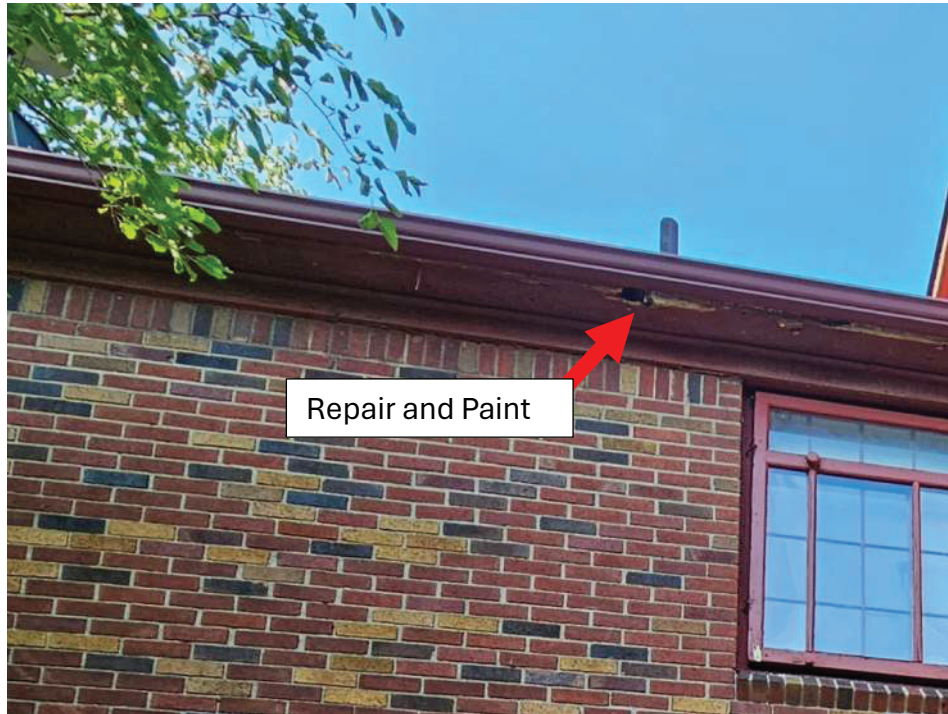
House East Elevation – Damaged wood soffit

All damaged wood framed storm windows and trim will be repaired. Holes or missing wood pieces will be replaced with similar wood materials. All repaired wood finishes will be painted to match existing A:9 Moderate Reddish Brown MS:7.5R 3/6. The missing portion of gutter and elbow will be replaced with the same material to avoid further water draining on to the façade. Downspout extensions at grade will also be installed to direct water away from the foundation. A damaged single pane metal framed window unit will be restored/repared in place.

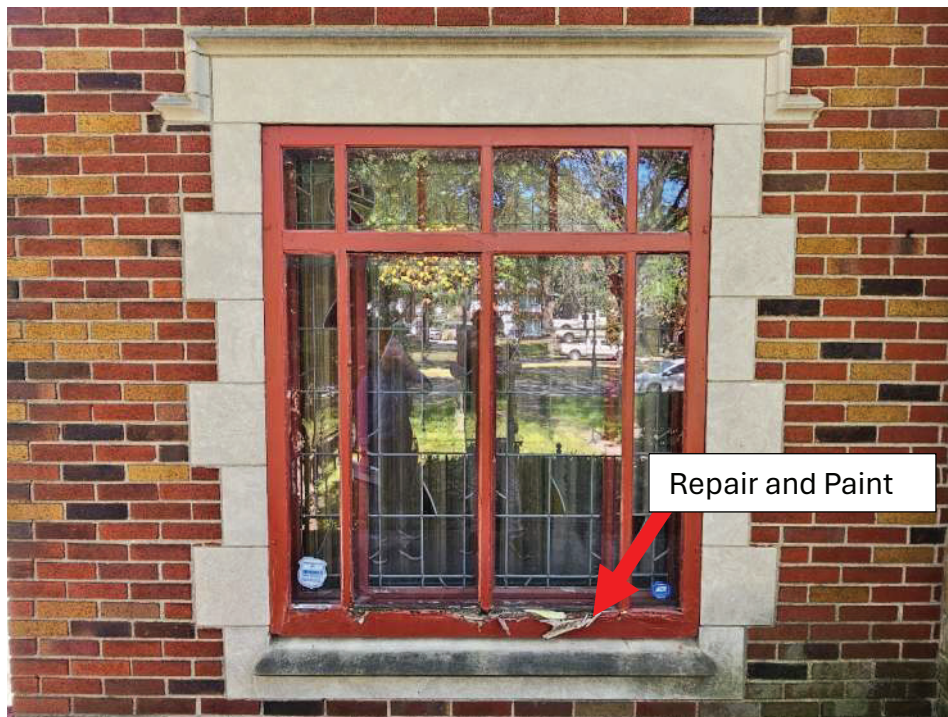
House North Elevation – Damaged wood storm window

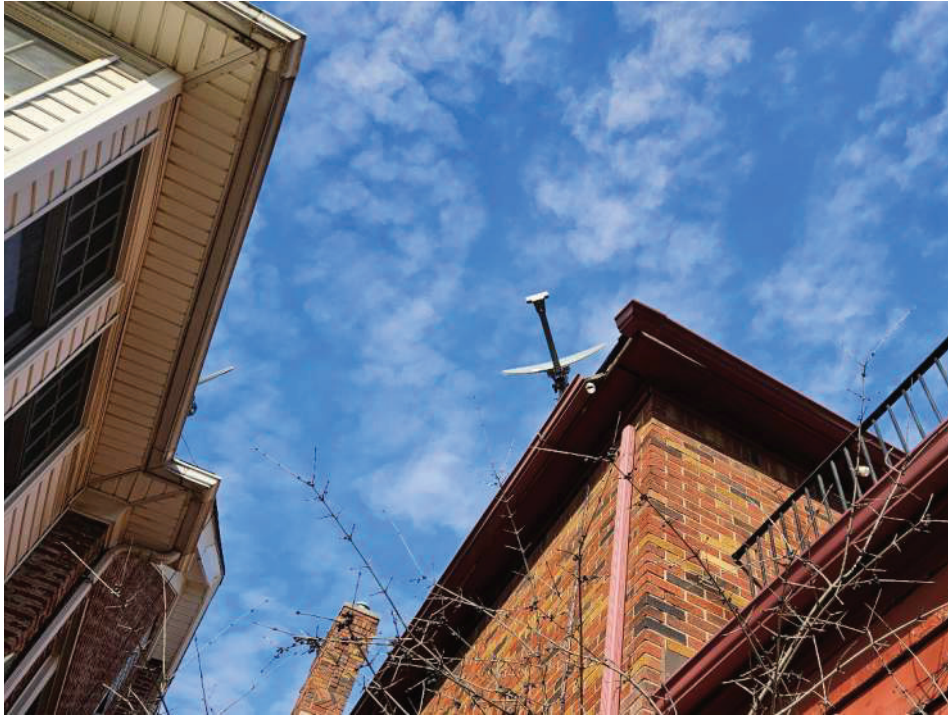
House West Elevation – Damaged gutter overview

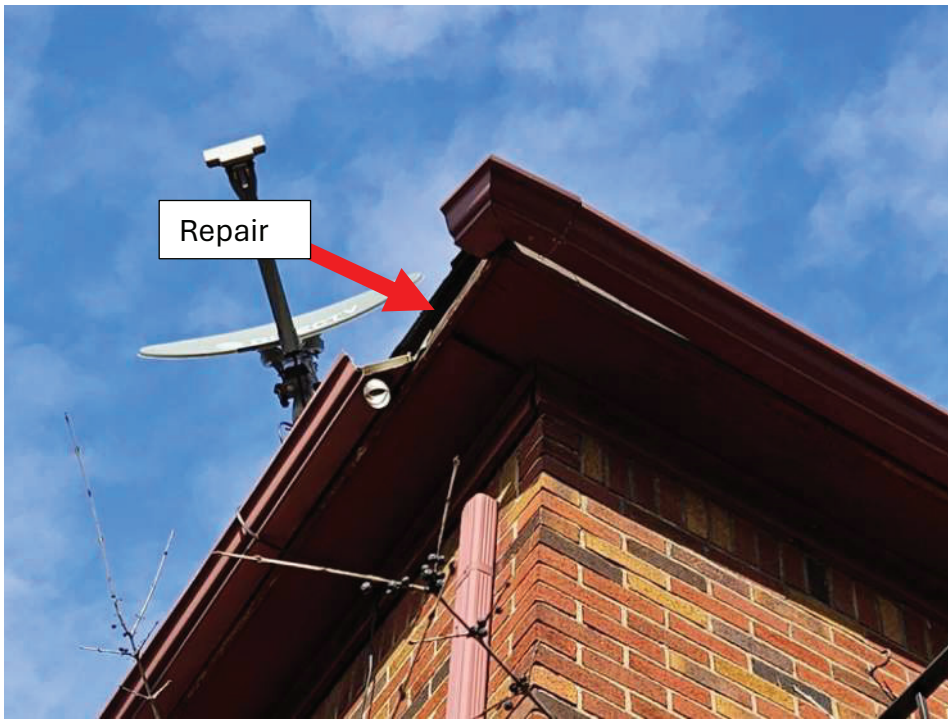
House West Elevation – Damaged gutter enlarged view

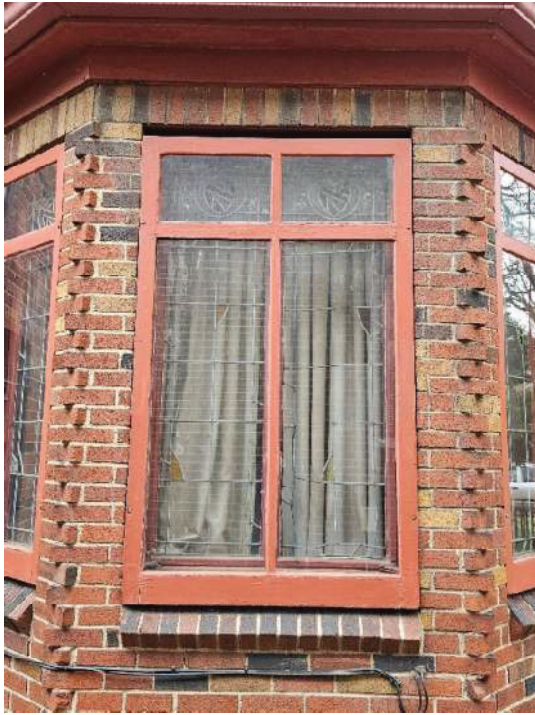
The house was constructed in 1936 and is believed to be designed in the English Revival style. All elevations are a tri-colored brick masonry wall assembly with an asphalt shingled roof assembly. Limestone accents are located at the window/door surround and an extruded bay on the north elevation. Brick masonry surrounds are located at all other window and door locations. Most windows are original single pane or stained glass with wood storms. All wood trim and wood framing are painted a reddish brown color. Most wood trim and framing were observed in good/fair condition; however, isolated areas of rotten, missing, and damaged wood were observed on the storm window framing, accent trim and soffits. The gutter and downspouts are located at the perimeter of the roof; however, a portion of the gutter was damaged on the southwest corner and a few downspout extensions were either missing or not installed at grade. A damaged single pane metal framed window unit was observed at the bay windows on the east elevation.

House East Elevation – Exterior view of damaged window

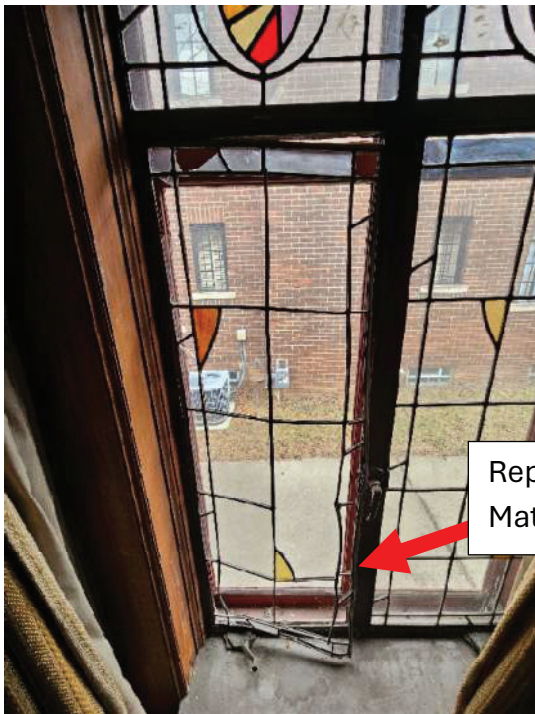
House East Elevation – Interior view of damaged window

Repair/Restore to  
Match Adjacent

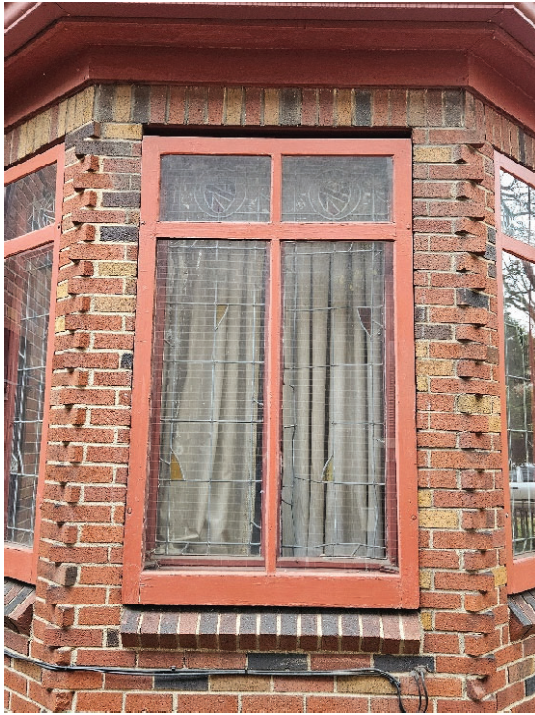
House East Elevation – Exterior view of damaged window

- Demolition of damaged garage.
- Install iron fence at east side of property (adjacent property) to match existing and  
Install wood fence at south side of property (alley) to match existing.
- Removal of trees and plantings near the foundation walls.
- Replace (2) displaced concrete pads. Concrete to match existing.
- Repair (6) damaged wood storm windows including replacing damaged, missing, or  
rotted wood. Paint existing storm to match existing.
- Replace damaged wood trim at isolated locations on the elevations and soffit. Paint  
existing storm to match existing.
- Repair partial missing gutter and downspout elbow. Install missing downspout  
extension at grade where needed.
- Repair/restore (1) damaged single pane metal framed window unit.

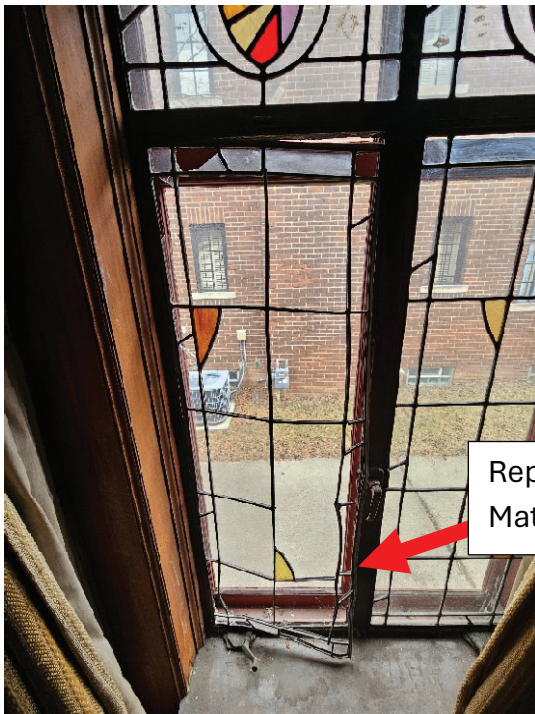
House East Elevation – Interior view of damaged window

Repair/Restore to  
Match Adjacent

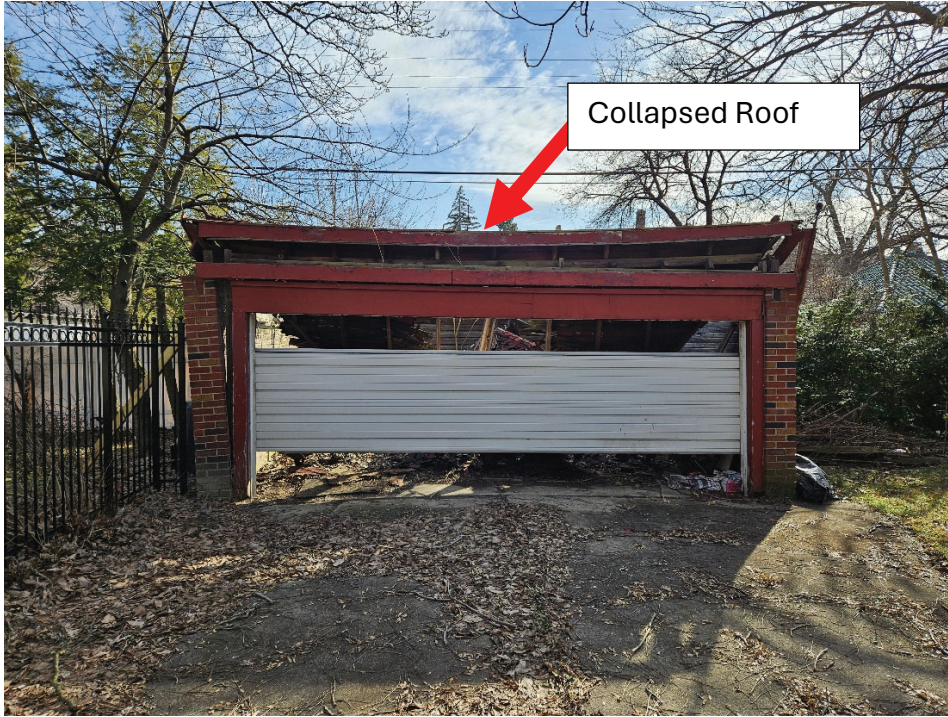
The garage roof previously collapsed which has caused the existing walls to displace and crack. A severely displaced wall is located on the east elevation of the garage encroaching on the neighboring property. The exposed wood has since rotted out causing further deterioration. The garage is no longer functioning and will be demolished. Once removed, the existing concrete pad will remain, and no other structure will be constructed. Open areas in the neighbor's fence and back fence will be installed to match adjacent existing fences.

Garage North Elevation – Overview

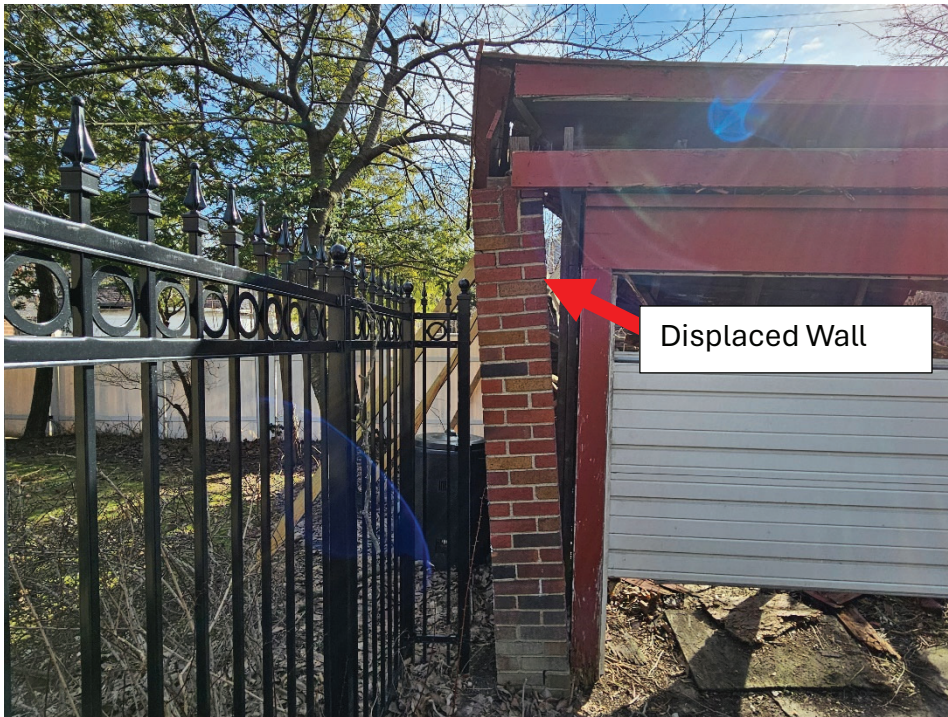
Garage North Elevation – Displaced wall

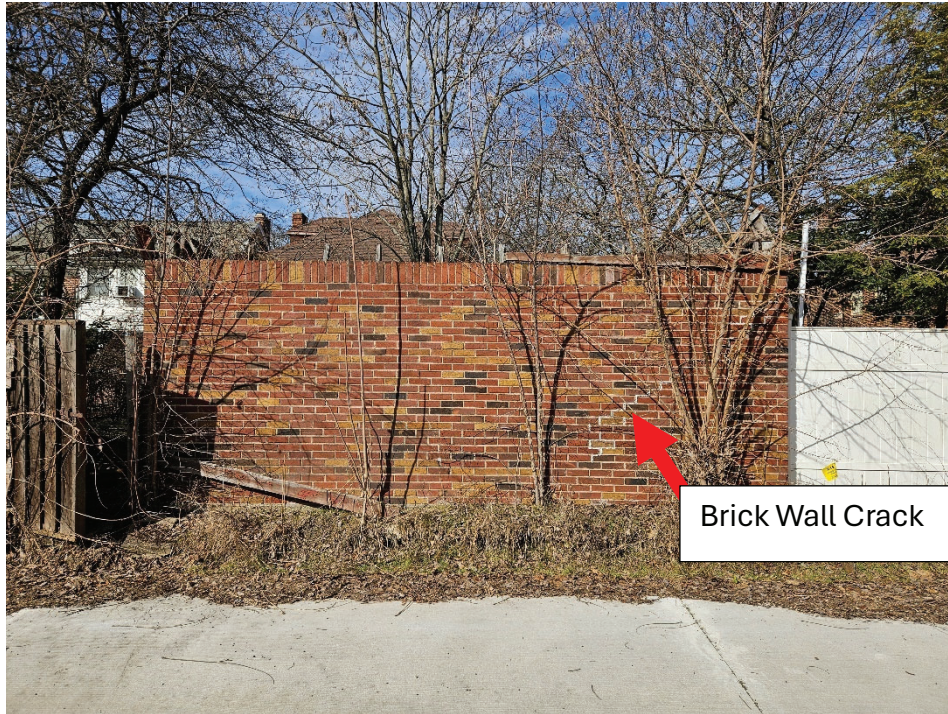
Garage South Elevation – Overview

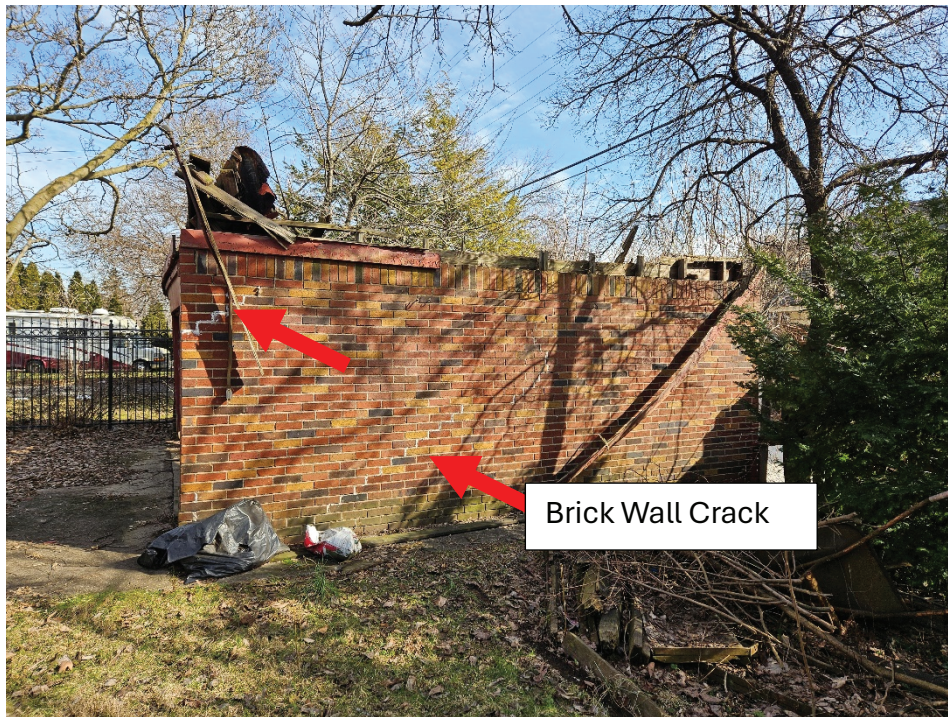
Garage West Elevation – Overview
